**SECTION 4 :
DETAILED STUDY OF THE
FLOODING INCIDENT
AT TUEN MUN ROAD
YAU KOM TAU
ON 2 AND 3 JULY 1997**

Halcrow Asia Partnership Ltd

**This report was originally produced in May 1998
as GEO Landslide Study Report No. LSR 7/98**

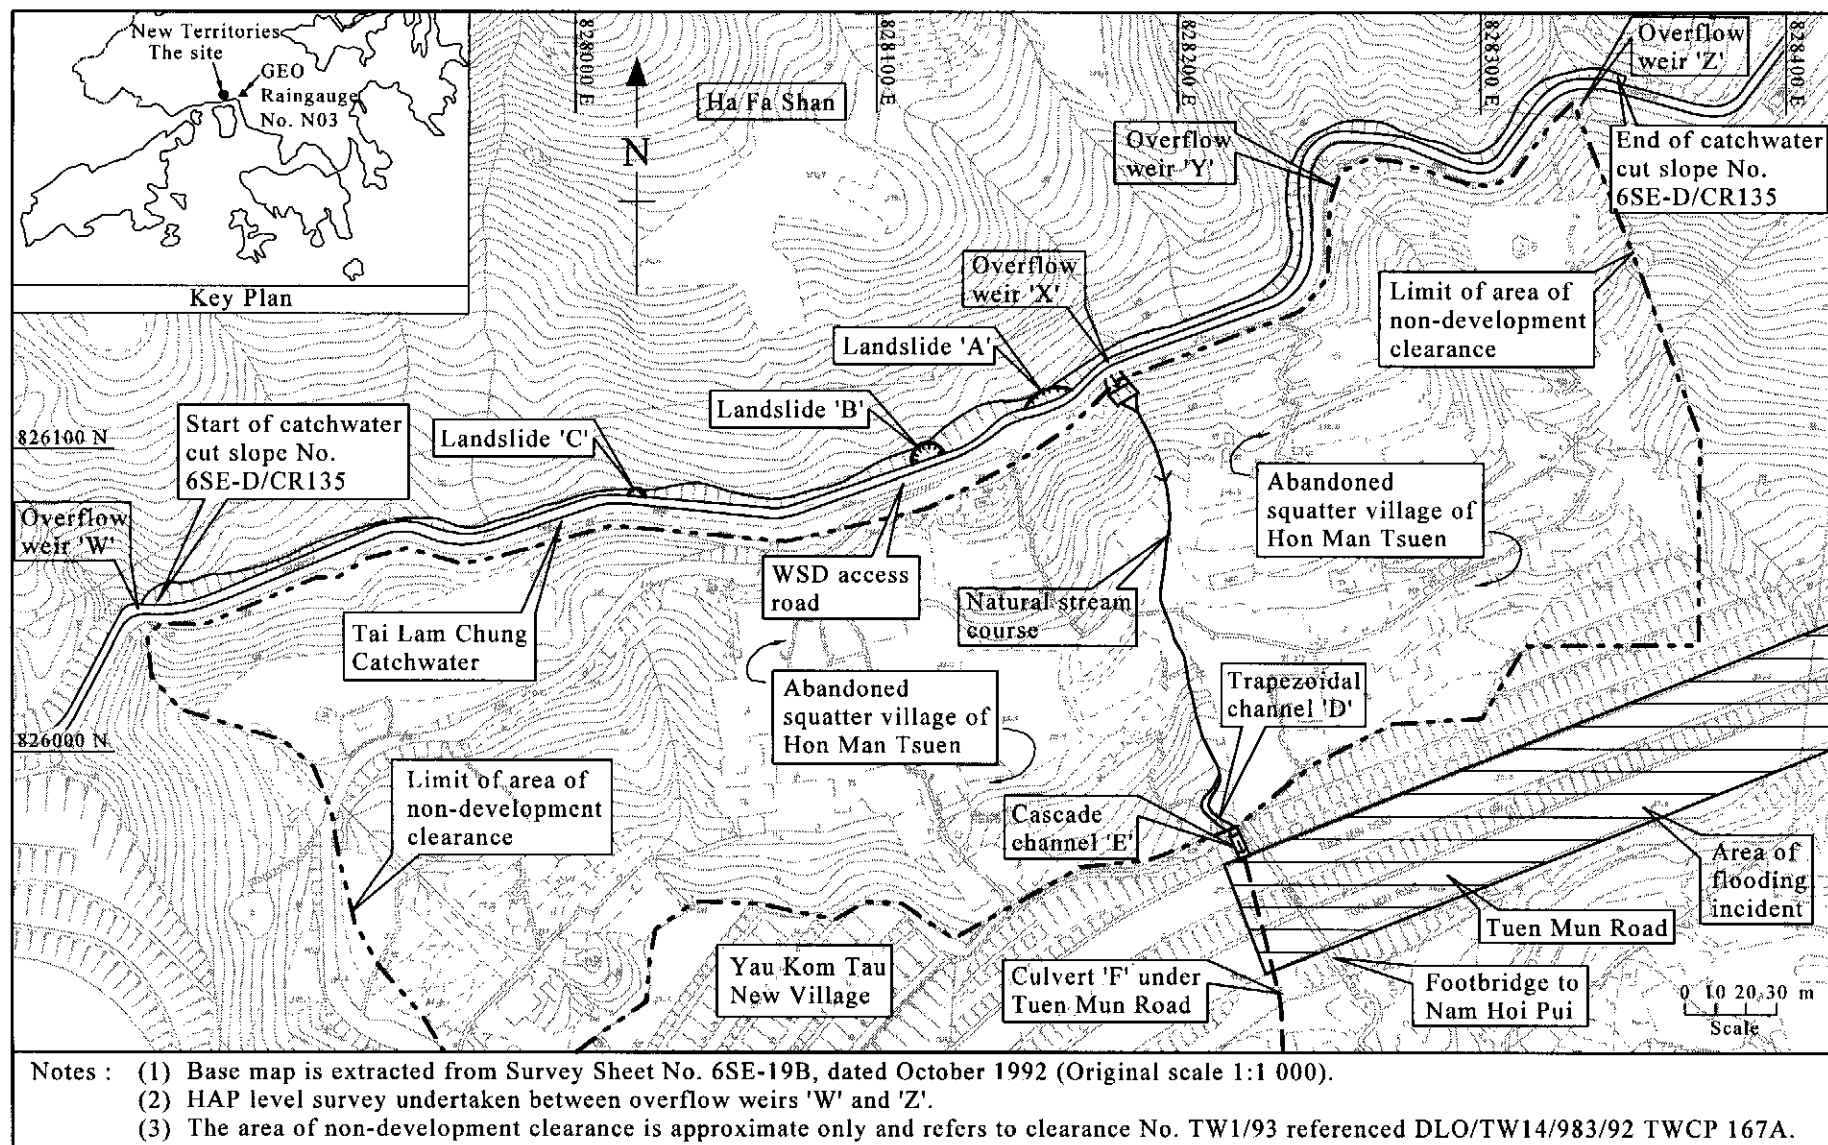
Figure 1 - Site Location Plan

In addition, the level survey determined that an 80 m long section of the catchwater parapet wall immediately upstream from overflow weir 'W' is vulnerable to overtopping in the event of a complete blockage of the catchwater along this section with landslide debris (Figures 1 and 9).

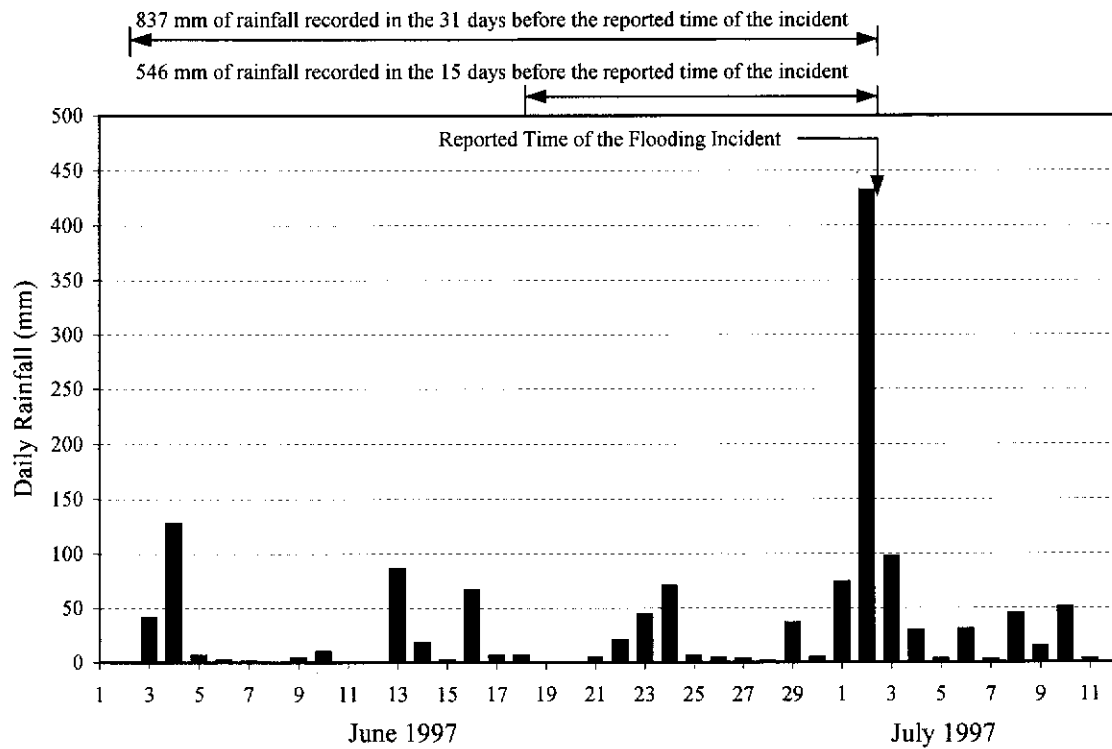
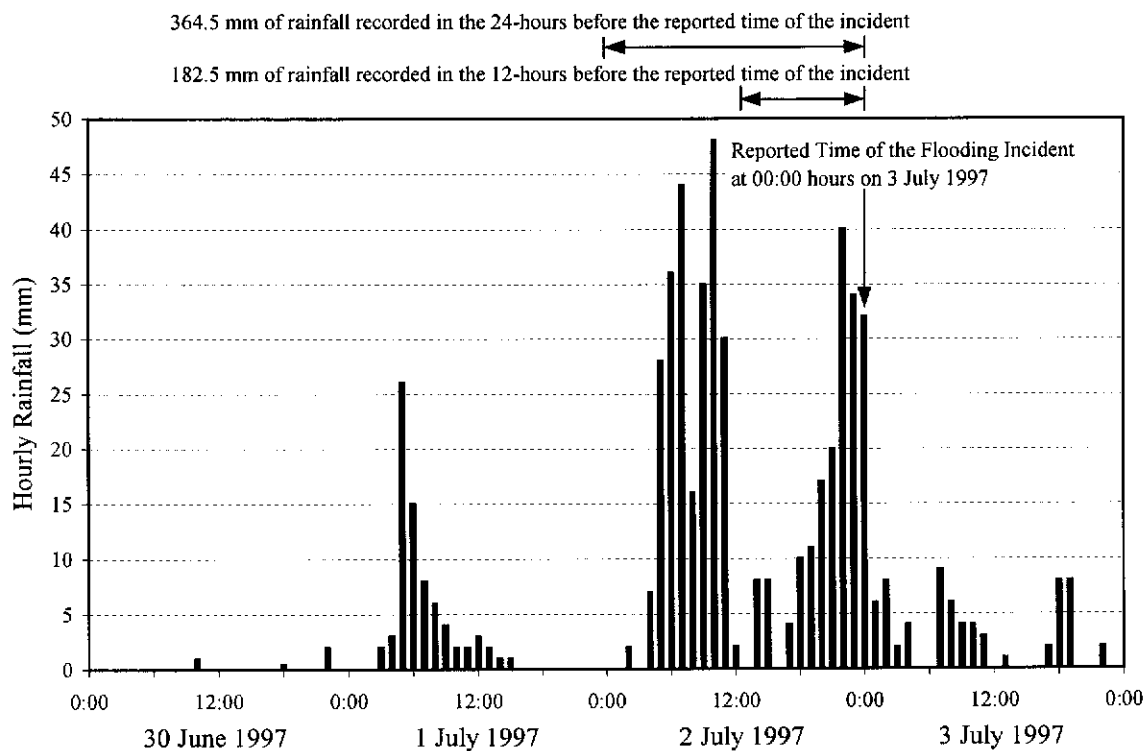
Figure 5 - Rainfall Records at GEO Raingauge No. N03

The nearest GEO automatic raingauge No. N03 is located at Tsuen Wan Treatment Works, Shing Mun Road, about 3 km to the east of the flooding incident. The daily rainfall recorded between 1 June and 11 July 1997 is shown in Figure 5a. There was 837 mm and 546 mm of rainfall in the 31 days and 15 days before the onset of the flooding incident respectively. The hourly rainfall from 30 June to 3 July 1997 is shown in Figure 5b. There was 364.5 mm and 182.5 mm of rainfall in the 24 hours and 12 hours before the flooding respectively. Isohyets of rainfall prior to the flooding incident are shown in Figure 6. The figure shows that the distribution of peak intensity rainfall was centred about 12 km northeast of the site.

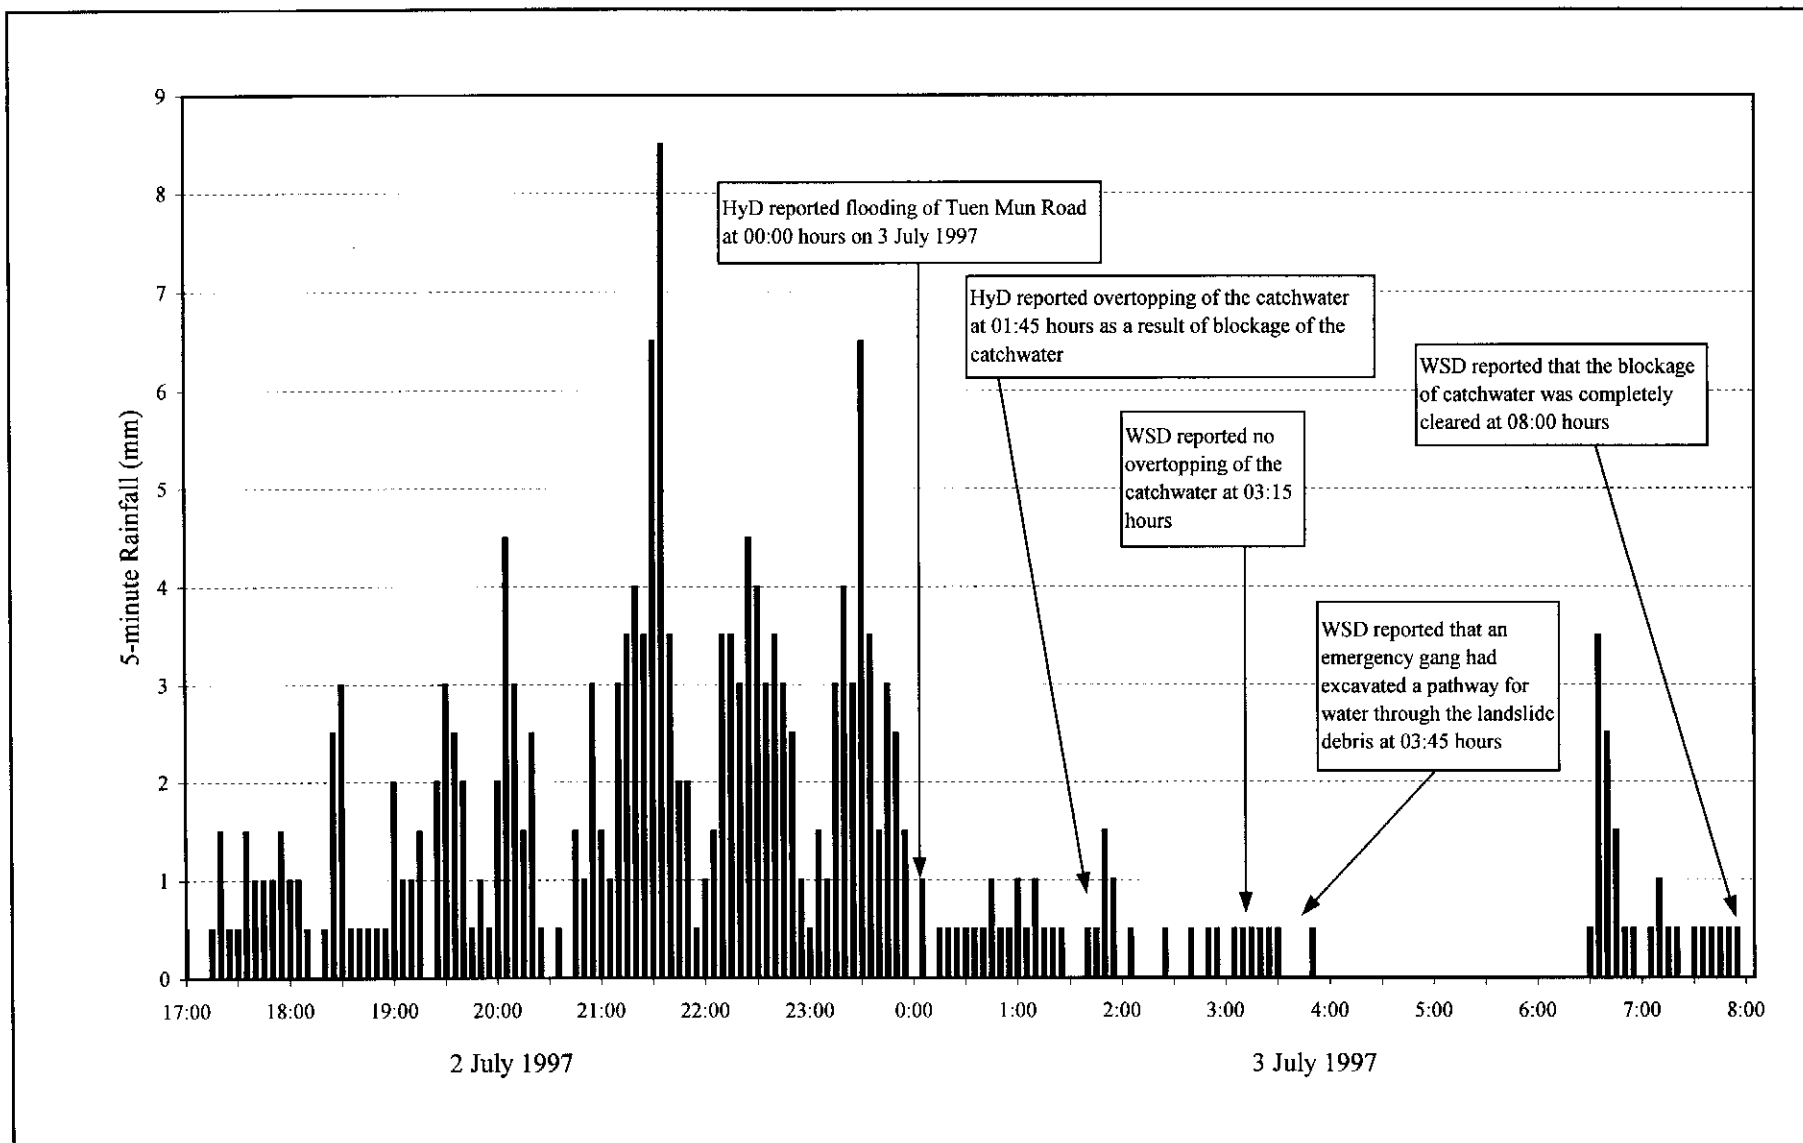
Figure 7 - Rainfall Recorded at GEO Raingauge No. N03 at 5-minute Intervals on 3 July 1997

The 5-minute rainfall recorded at GEO raingauge No. N03 is shown in Figure 7. The figure shows that the maximum intensity of the rainstorm between 17:00 hours on 2 July and 00:00 hours on 3 July was 8.5 mm and occurred between 21:35 hours and 21:40 hours on 2 July 1997.

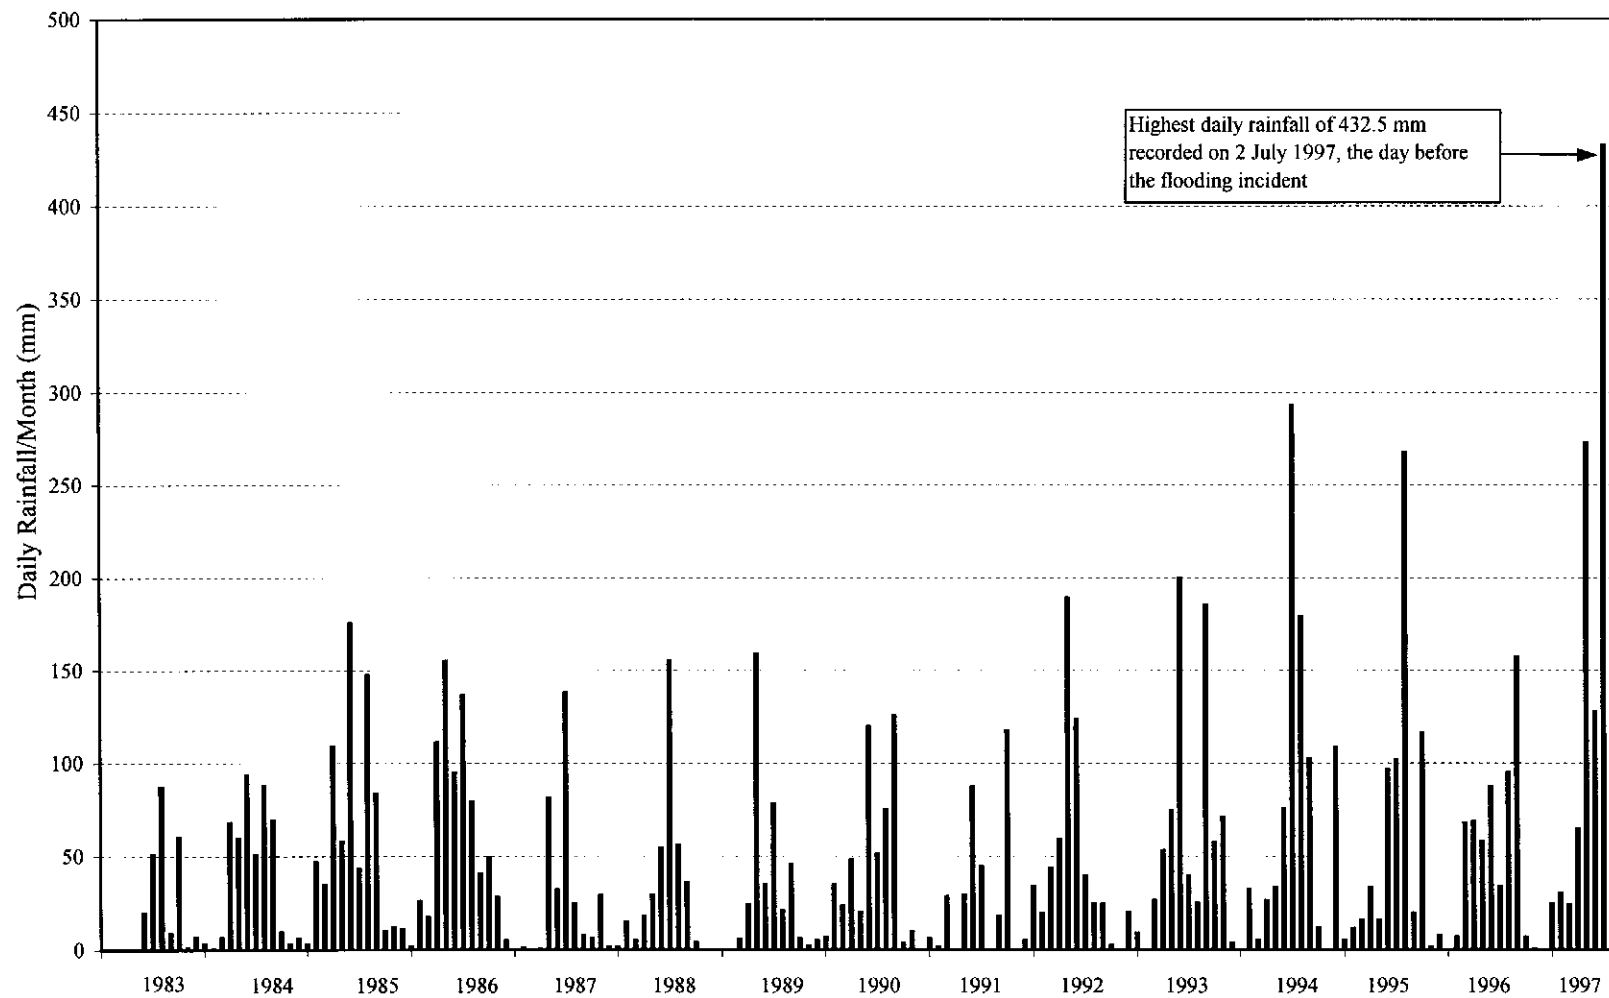
Figure 8 - Maximum Daily Rainfall in Each Month at GEO Raingauge No. N03

The maximum daily rainfall in each month recorded at the GEO raingauge No. N03 since June 1983 is shown in Figure 8. Rainfall on 2 July 1997 was the highest daily total recorded by the raingauge (HKO, 1997).
