REPORT OF THE INDEPENDENT REVIEW PANEL ON FILL SLOPES

GEO REPORT No. 86

**GEOTECHNICAL ENGINEERING OFFICE
CIVIL ENGINEERING DEPARTMENT
THE GOVERNMENT OF THE HONG KONG
SPECIAL ADMINISTRATIVE REGION**

**This report was originally produced in December 1976 by
the Independent Review Panel on Fill Slopes appointed by
the Government of Hong Kong**

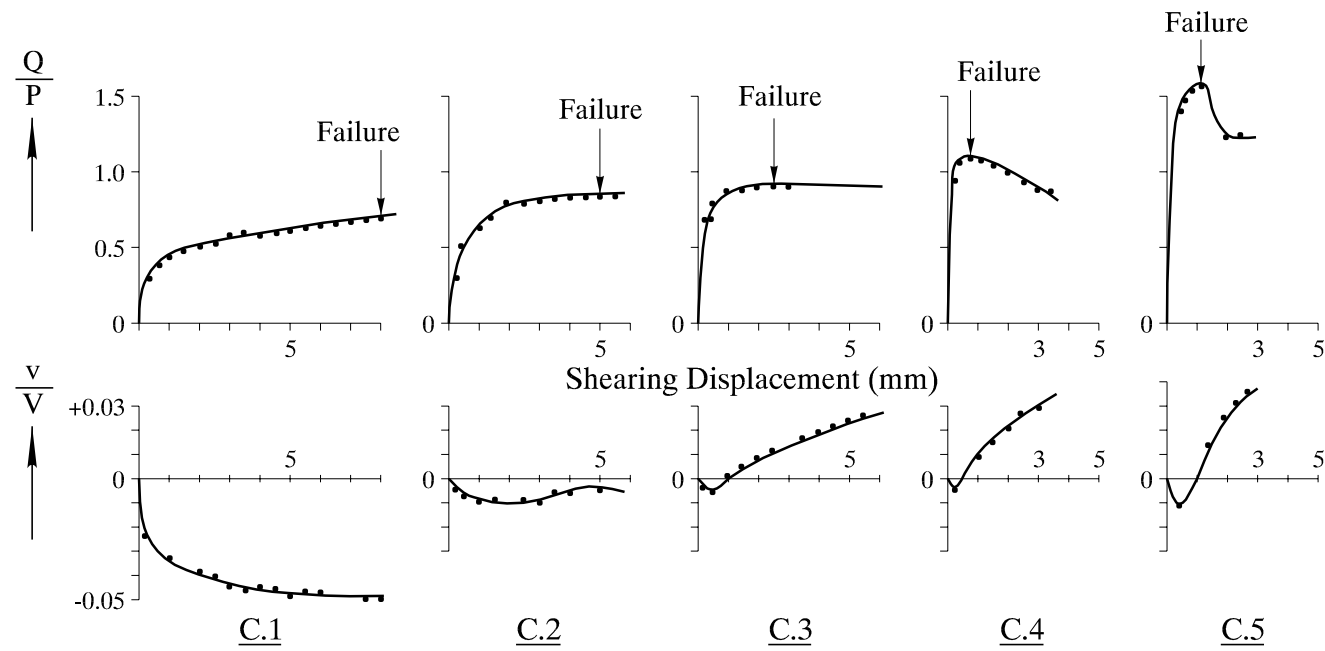
Fig.	Dry Density (t/m ³)
C.1	1.39
C.2	1.49
C.3	1.57
C.4	1.69
C.5	1.82

C.1 The change in volume during deformation was measured for the Sau Mau Ping soil by shear-box tests carried out at the University of Hong Kong. Samples were prepared at various dry densities ranging from very loose to dense, loaded to a vertical pressure of 25 kPa (corresponding to a soil depth of about one metre), and then deformed by shearing the sample at a rate slow enough to allow unrestrained volume change. As the shearing displacement increased, the shear force resistance and the volume changes were measured up to failure of the soil, as shown in Fig. C.1 to C.5. Table C.1 and Fig. C.6 to C.8 summarize the results of these tests to show the influence of the dry density on:

- (i) The ratio of Shear Force Q to Vertical Force P , at failure
- (ii) The ratio of Total Change in Volume v to Initial Volume V , at failure
- (iii) The incremental Ratio of relative volume change v/V with increasing Shear Deformation x , at failure

C.2 These results show that the dry density affects the volume change characteristics very strongly, although the strength is not affected much unless the soil is denser than a dry density of about $1.6 t/m^3$. For loose soil, with dry densities lower than about $1.5 t/m^3$, the soil contracts during shear until it reaches the failure point and then fails at constant volume. For soil with densities greater than about $1.5 t/m^3$ the soil first contracts slightly at small strains but then expands significantly and, at failure, is still expanding.

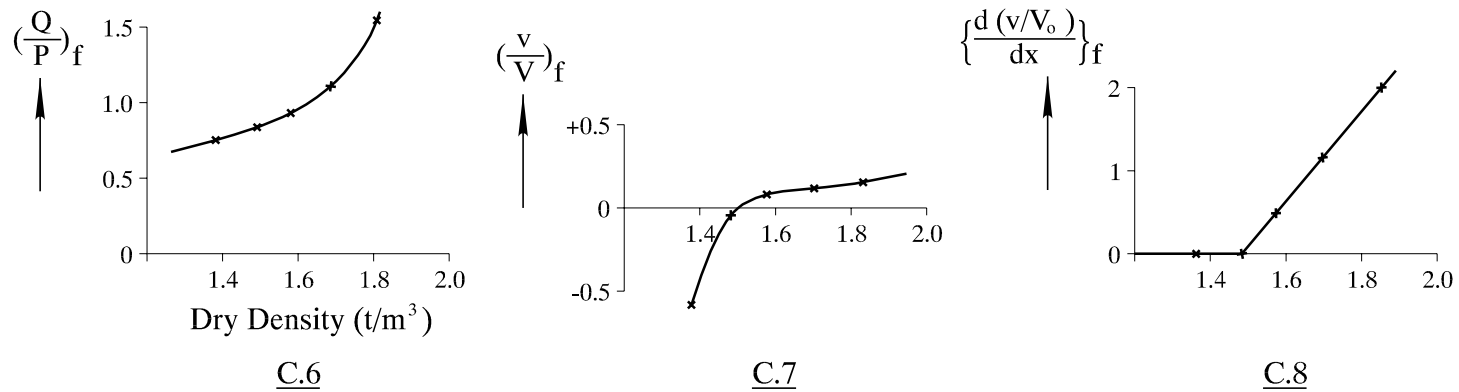
Figures C.1 to C.8

C.3 The depth to which the Sau Mau Ping soil could become significantly wet during rainstorms was determined from results of laboratory tests on a soil of similar grading to the Sau Mau Ping soil. In these tests (Ref. C.1) the rate of infiltration of water into vertical columns of dry soil was measured (the soil being compacted to various dry densities) and the depth of wetting in the soil columns was observed.

C.4 Provided that the rainfall rate is at least equal to the infiltration rate of the soil, then marked wetting-front will develop and will penetrate deeper and deeper into the soil until the rain ceases. The looser the soil the larger the infiltration rate, and the greater the rainfall rate necessary to produce a wetting-front. The wetter the soil before infiltration starts, the more rapid the rate of penetration of the wetting-front.

C.5 Assuming that no significant wetting occurs if the rainfall rate is less than the infiltration rate, and that the infiltration rate into the sloping fill surface at Sau Mau Ping is the same as for a vertical soil column (two reasonably conservative assumptions), the depth to which the wetting-front could have penetrated during the August 1976 rainstorm is as given in Table C.2. The minimum depth is for soil initially “dry”, at 50% saturation; the maximum depth is for soil initially “wet”, at 70% saturation.
