# **INVESTIGATION OF SOME SELECTED LANDSLIDE INCIDENTS IN 1997 (VOLUME 2)**

**GEO REPORT No. 88**

**Halcrow Asia Partnership Ltd.**

**GEOTECHNICAL ENGINEERING OFFICE  
CIVIL ENGINEERING DEPARTMENT  
THE GOVERNMENT OF THE HONG KONG  
SPECIAL ADMINISTRATIVE REGION**

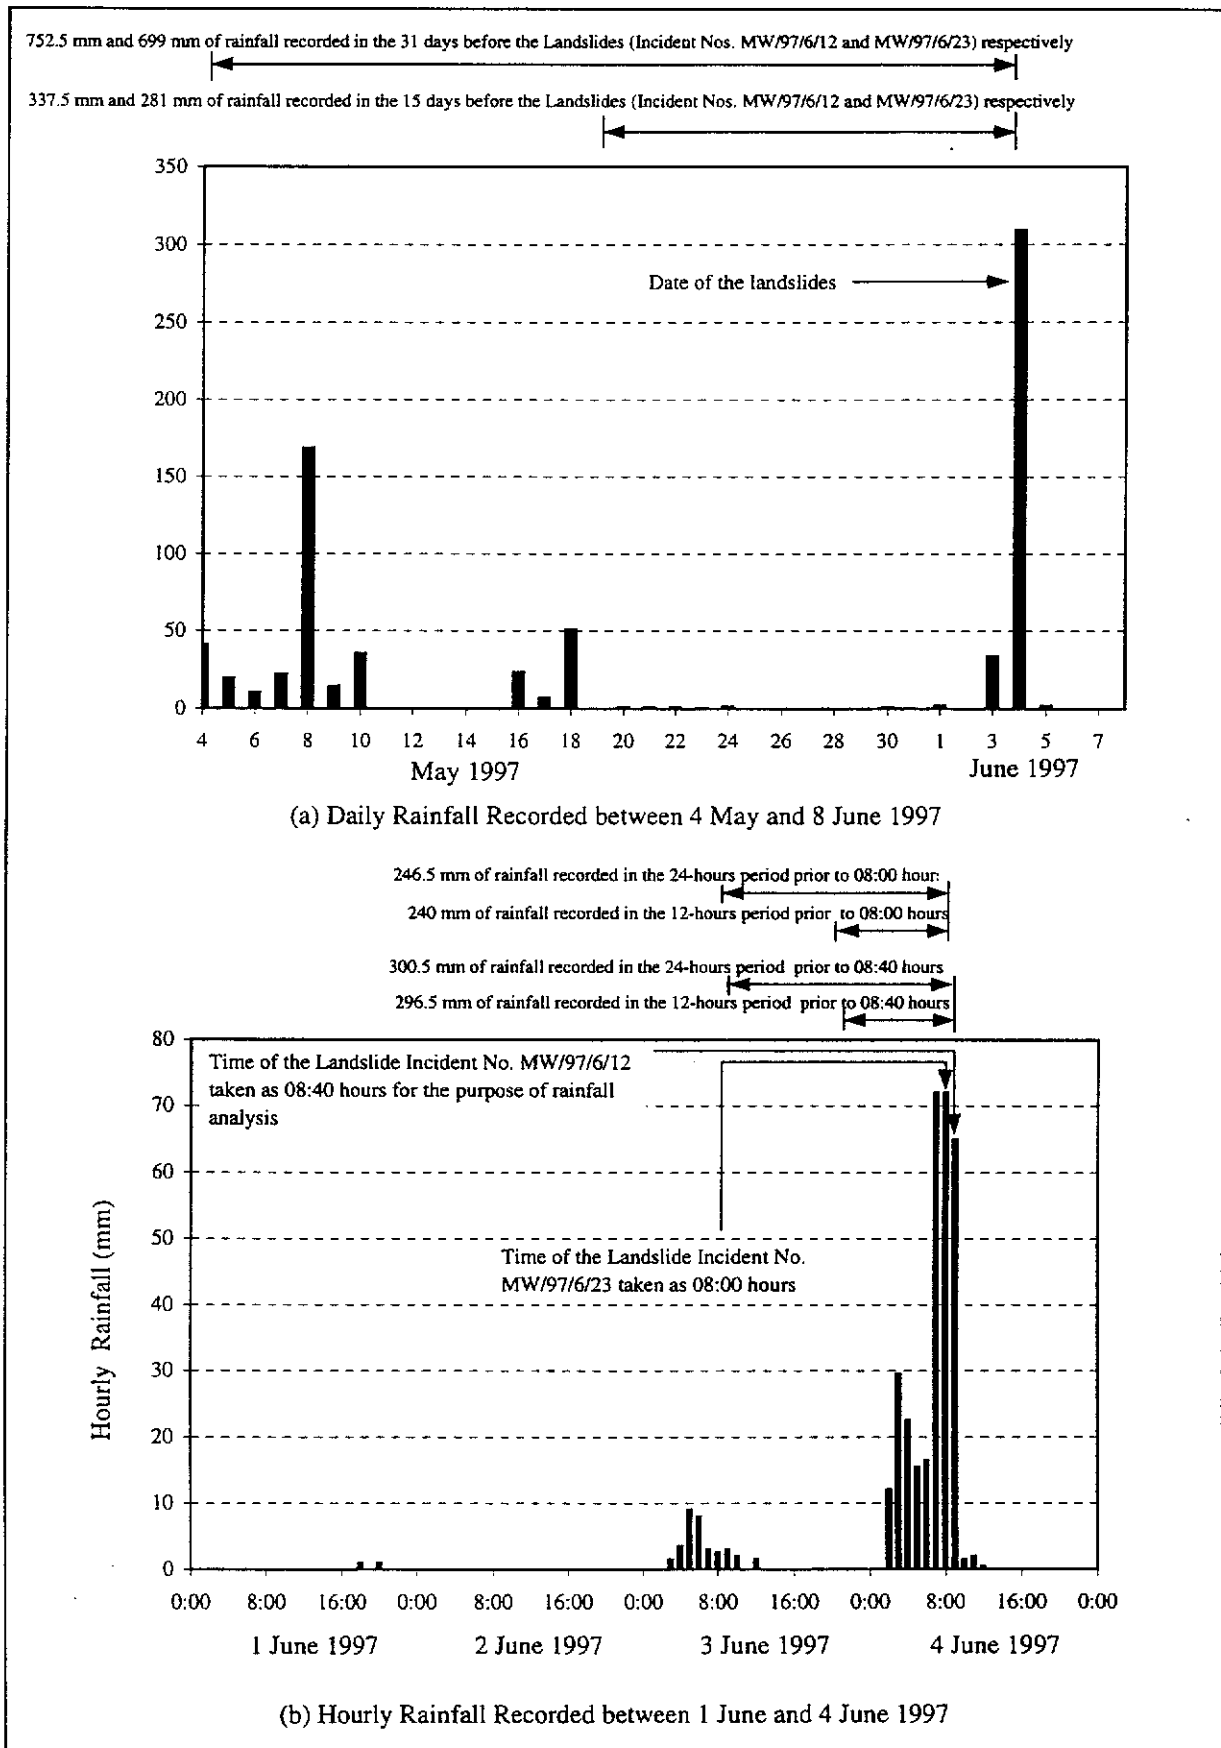
Figure 9 - Rainfall Records at GEO Raingauge No. N01

The nearest GEO automatic raingauge (No. N01) is located at the Administration Block of Sha Tin Water Treatment Works, about 750 m south of the landslides. Daily rainfall recorded at the raingauge between 4 May 1997 and 8 June 1997, and hourly rainfall between 1 June and 4 June 1997, are shown in Figures 9a and 9b respectively. Figure 10 shows the location of GEO raingauge No. N01 and presents the isohyets of rainfall recorded between 01:45 hours and 10:00 hours on 4 June 1997.

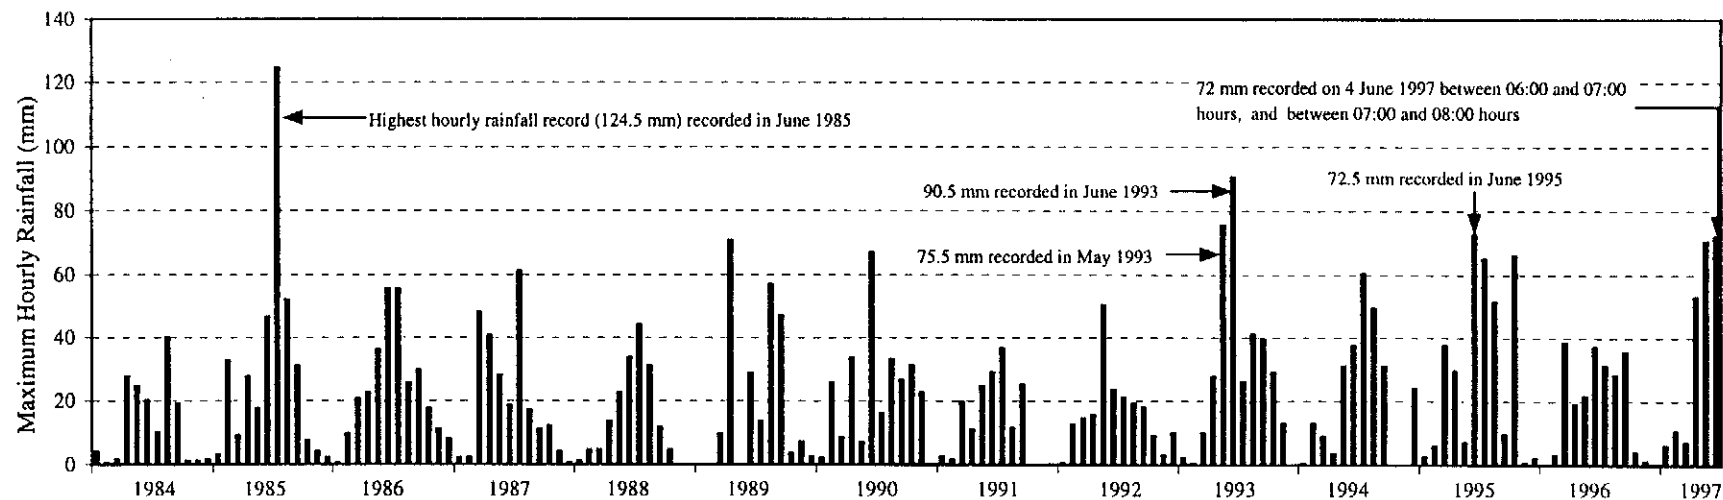
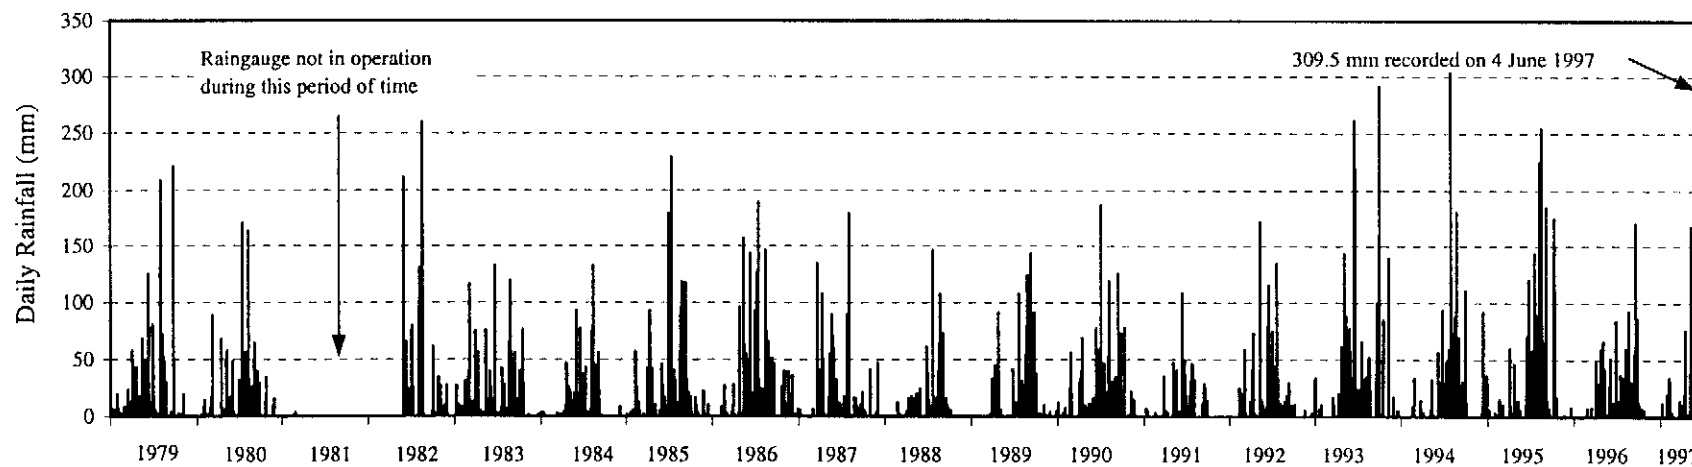
Figure 11 - Historical Rainfall Recorded at GEO Raingauge No. N01

Historical records of rainfall at GEO raingauge No. N01 are presented in Figure 11. The figure shows that the maximum hourly rainfall on 4 June 1997 (72 mm recorded between 06:00 hours and 07:00 hours and also between 07:00 hours and 08:00 hours), was the fifth highest since records began in 1984. The daily rainfall on 4 June 1997 was the highest on record, though only 296.5 mm of this fell before 08:40 hours, around the time that Incident No. MW97/6/12 was reported to the Police. 240 mm of the daily rainfall total fell before the reported time of Incident No. MW97/6/23 at 08:00 hours. It should be noted, however, that figures derived from clock-based rainfall data do not provide a basis for direct comparison of the relative severity of the rainfall events in the periods covered.
