**SECTION 2:
DETAILED STUDY OF THE
LANDSLIDE BEHIND
BLOCKS 3 AND 4
WONDERLAND VILLAS,
KWAI CHUNG
ON 8 MAY 1997**

Halcrow Asia Partnership Ltd

**This report was originally produced in May 1998
as GEO Landslide Study Report No. LSR 11/98**

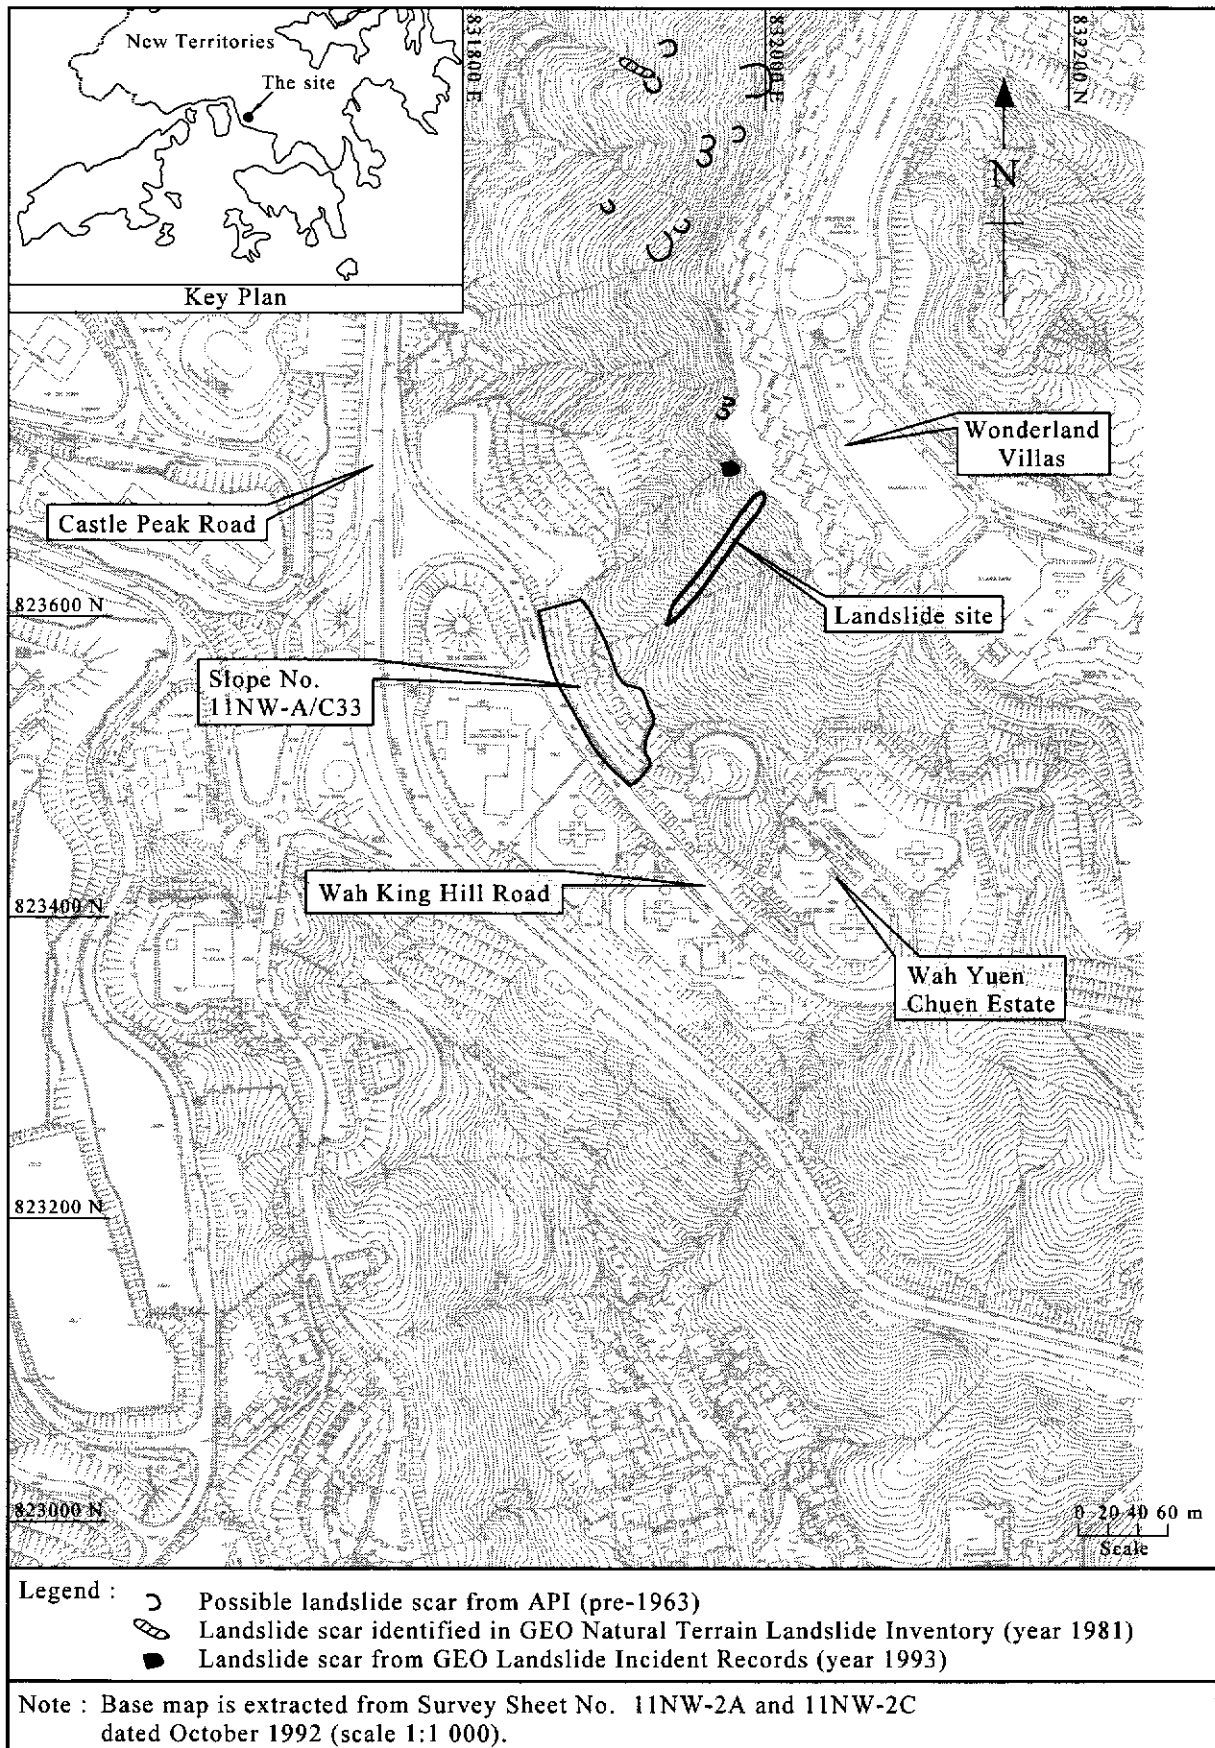
Figure 1 - Site Location Plan

On the morning of 8 May 1997, a landslide occurred at the crest of a natural hillside below Wonderland Villas, Kwai Chung (Figure 1). Landslide debris travelled about 200 m downslope onto Wah King Hill Road and partly blocked the south-bound lane. The failure caused superficial damage to a roadside cut slope (No. 11NW-A/C33) and disruption to traffic on Wah King Hill Road.

The site of the 1997 failure was located at the head of a poorly defined drainage line below the ridge. The drainage line, like much of the hillside, was covered with low shrub vegetation. From the 1963 aerial photographs, no previous instability is evident in the vicinity of the recent failure, though within the drainage lines to the north numerous relict landslide scars are present (Figure 1).

A review of the GEO landslide incident records shows that there is one previous reported landslide (Incident No. MW93/5/16) within the vicinity of the 1997 failure. The 1993 landslide occurred at the head of a drainage line, some 50 m to the north of the 1997 failure (Figure 1), and was classified as a wash out of fill material with a volume of 10 m³. The GEO's Natural Terrain Landslide Inventory identified a minor failure which occurred in 1981 within a drainage line on the hillside some 270 m to the north of the 1997 failure (Figure 1).
