**SECTION 3:
DETAILED STUDY OF THE
LANDSLIDES AT
KAU WA KENG SAN TSUEN
ON 4 JUNE 1997**

Halcrow Asia Partnership Ltd

**This report was originally produced in July 1998
as GEO Landslide Study Report No. LSR 13/98**

This report presents the findings of a detailed study of four landslides (GEO Incident Nos. MW97/5/14, MW97/6/49, MW97/6/50 and MW97/6/56) which occurred on slopes adjacent to Kau Wa Keng San Tsuen on 4 June 1997. Debris from the landslides affected the squatter village, but no fatalities or injuries were reported.

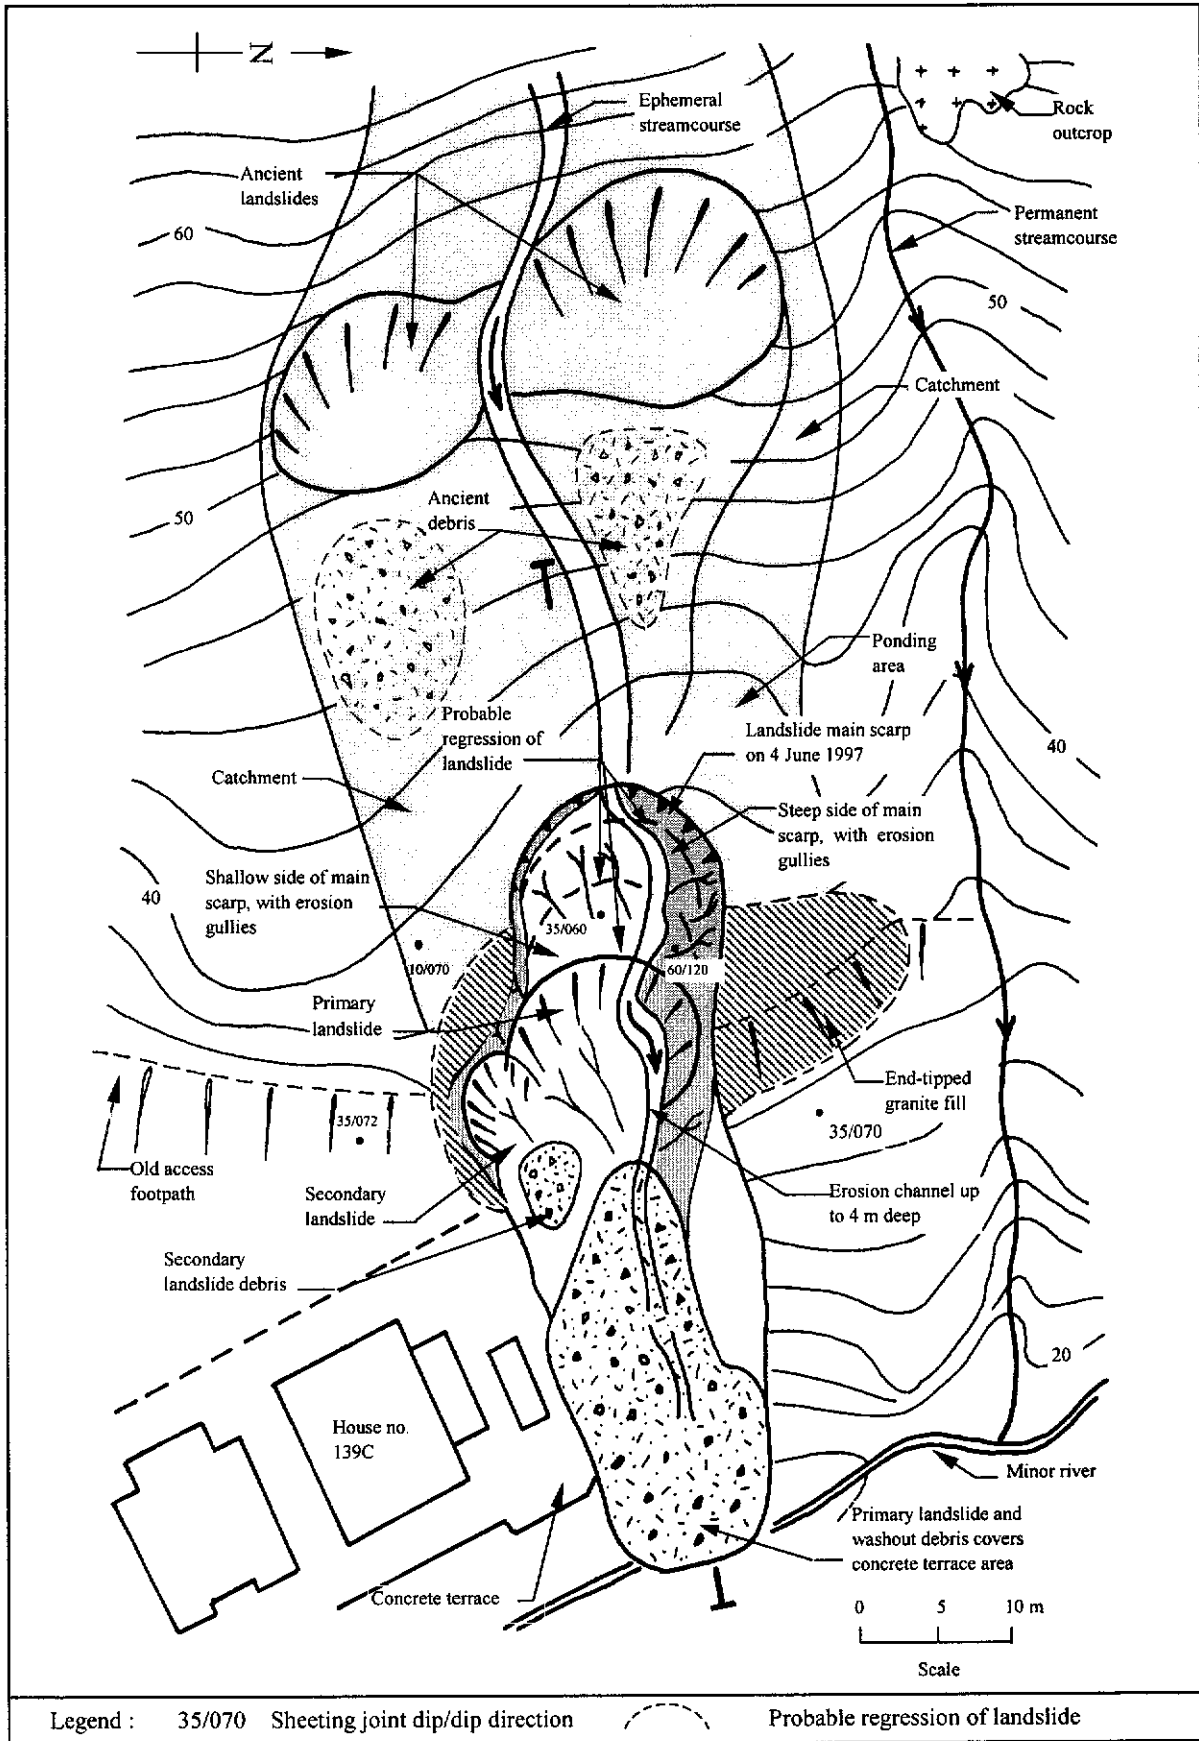
Figure 10 - Plan and Details of Landslide D

A plan and cross-section of the landslide (GEO Incident MW97/6/56) are shown in Figures 10 and 11 respectively. A general view of the landslide is shown in Plate 12.

The landslide mostly involved the failure of a fill slope and was 35 m long, 11 m wide and 4 m deep, with an estimated volume of about 500 m³. The geometry of the main scarp suggests there were two phases of failure. An initial failure most likely occurred at the front of the fill slope where the gradient was steep, which was later followed by a washout caused by surface water flow from an ephemeral stream (Figures 10 and 11). The travel angle of the initial landslide debris was slightly in excess of 30° and within the typical range for rain-induced failures in Hong Kong (Wong & Ho, 1996).

During inspections by HAP several weeks after the landslide, a dry streamcourse containing cobbles, small boulders and flattened vegetation was identified above the crest of the landslide. The fill adjacent to the main scarp was also found to be in a saturated condition. Interviews with residents in the vicinity of the landslide have confirmed that on the day of the failure, water was seen flowing over the crest of the main scarp. The washout phase of the landslide cut a deep, stepped erosion channel (Plate 13) and extended the main scarp further up the hillside.

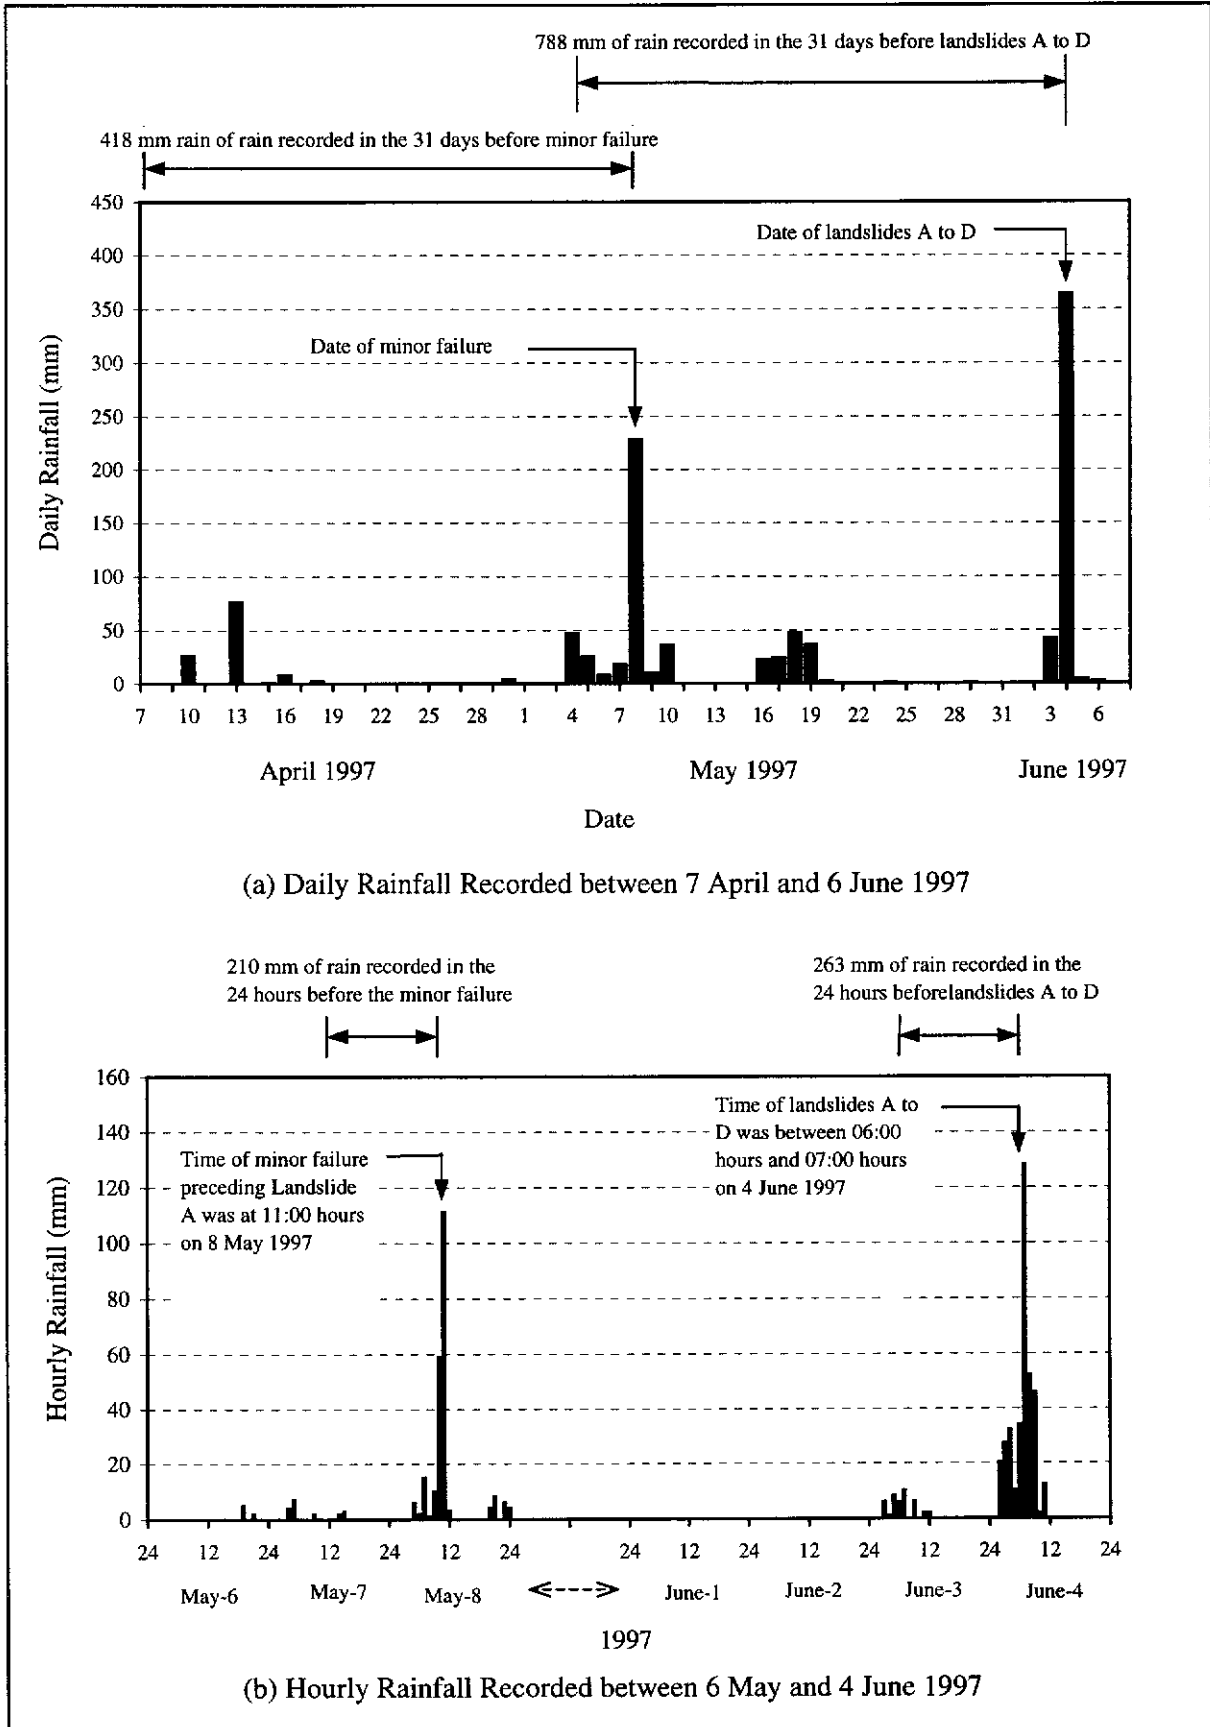
Figure 12 - Rainfall Recorded at GEO Raingauge No. N04

The nearest GEO automatic raingauge to Kau Wa Keng San Tsuen is raingauge No. N04, located at Cho Yiu Estate, about 500 m southwest of the village (Figure 1). The daily rainfall recorded between 8 April and 8 June 1997 and hourly rainfall intensities for the periods between 3 May to 8 May and 1 June to 6 June 1997 are presented in Figure 12. Prior to the minor failure on 8 May 1997, the 24-hour and 12-hour rainfall totals were 210 mm and 204.5 mm respectively. The landslides on 4 June 1997 were preceded by 24-hour and 12-hour rainfall totals of 263 mm and 252.5 mm respectively. Isohyets of rainfall for the period between 00:00 hours to 07:00 hours on 4 June 1997 are shown in Figure 13.

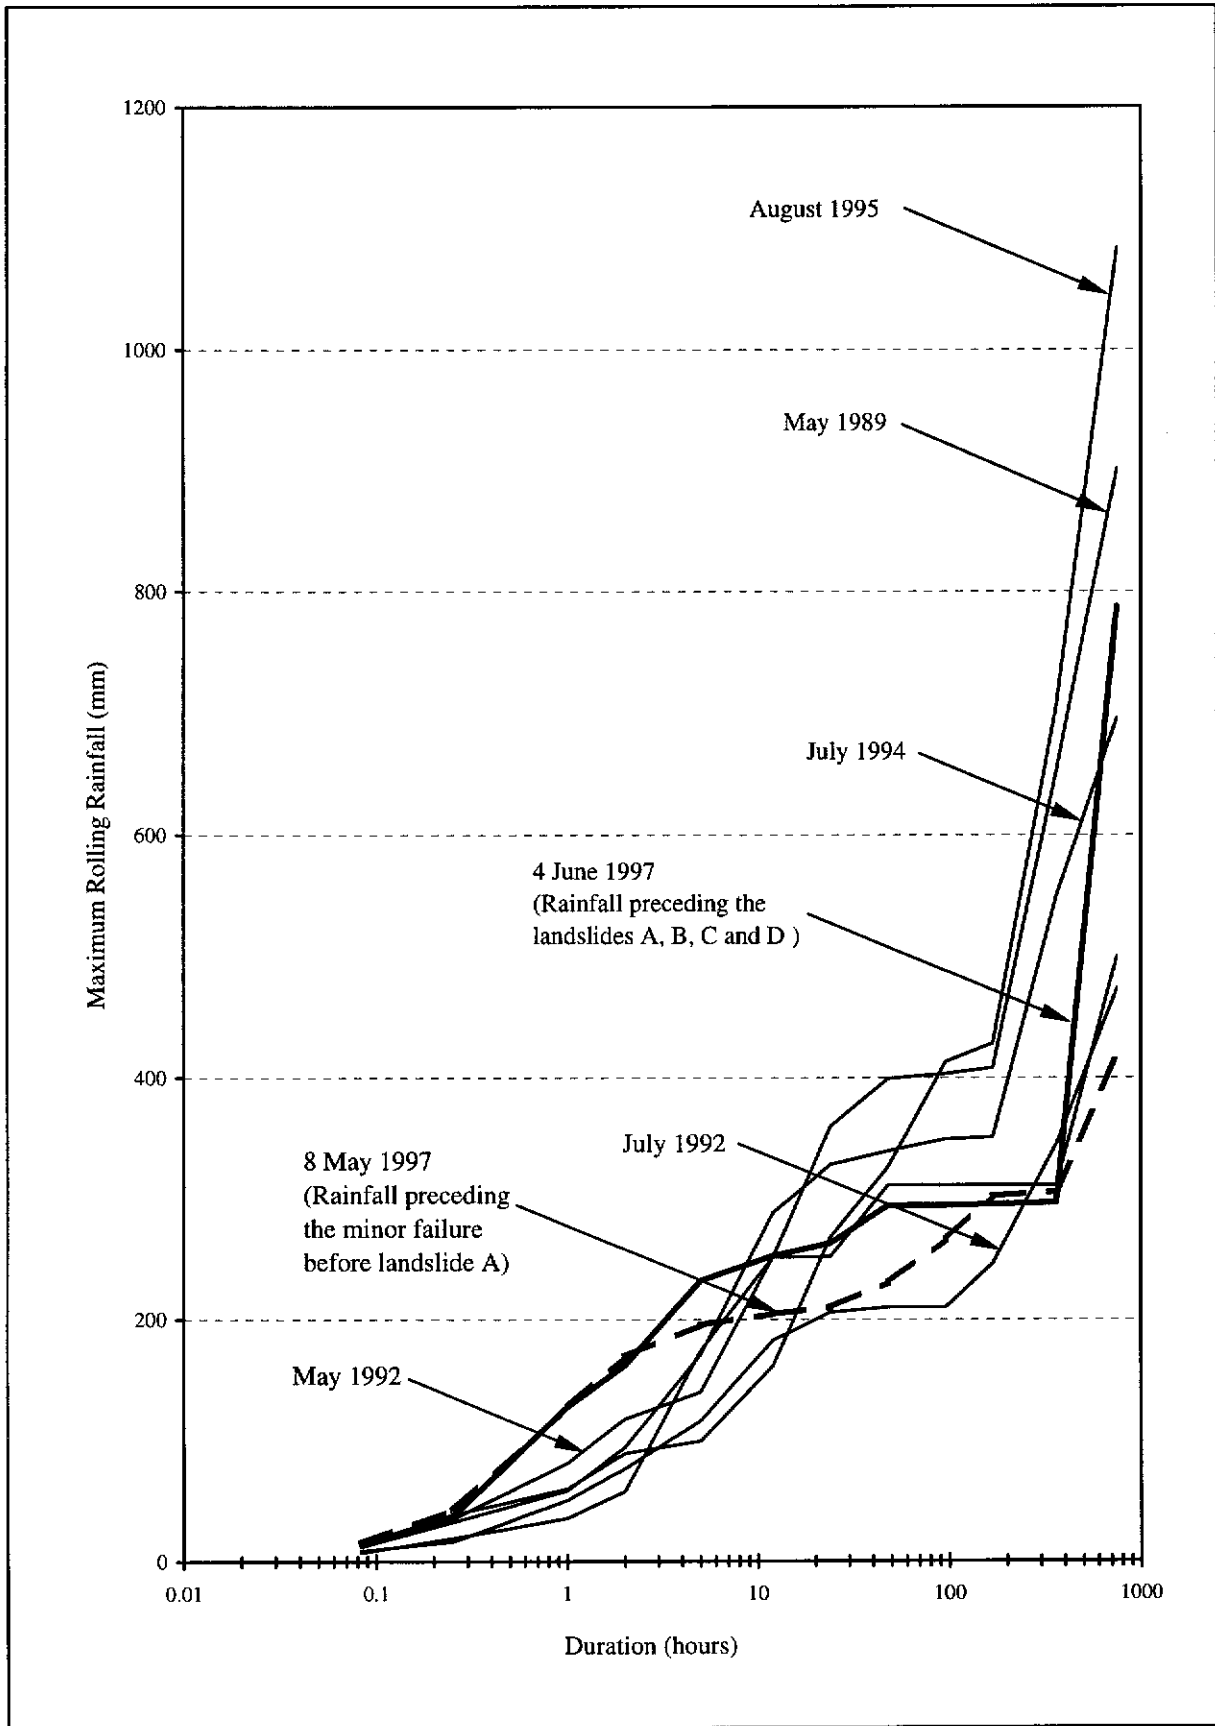
Figure 14 - Maximum Rolling Rainfall at GEO Raingauge No. N04 for Major Rainstorms

The maximum rolling rainfall for the rainstorms on 8 May 1997 and 4 June 1997 have been compared with the most extreme rainstorms recorded at the raingauge since it began operation in 1982 (Figure 14). The maximum rolling rainfall prior to 11:00 hours on 8 May 1997 and 07:00 hours on 4 June 1997 exceeded the intensities of previous rainstorms for durations up to 6 hours and 8 hours respectively. The maximum rolling rainfall for longer durations was less intense than for previous rainstorms.

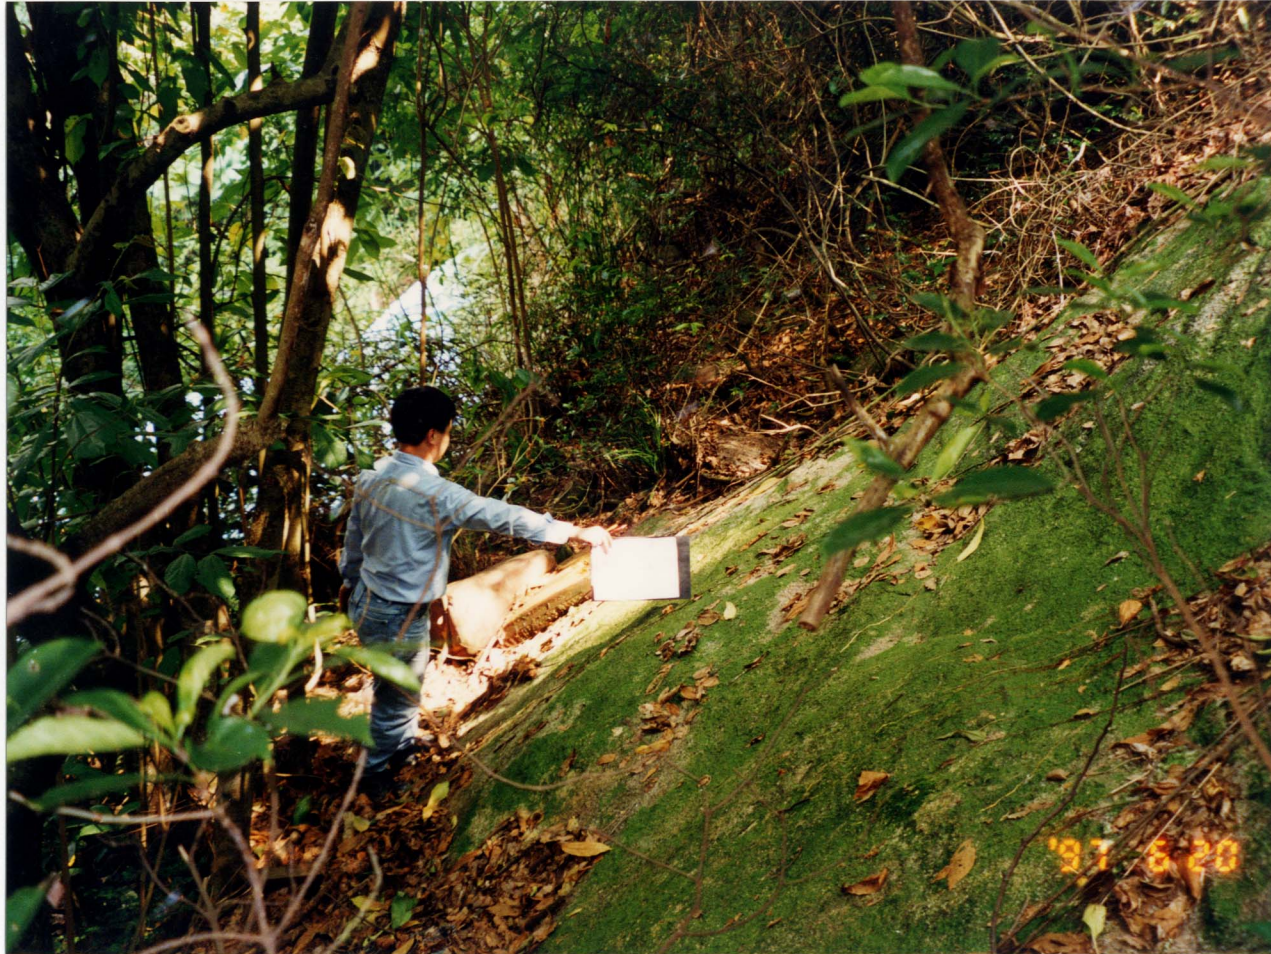
Plate 2 - A Sheeting Joint Rock Surface Above Landslide A (Photograph Taken on 20 June 1997)

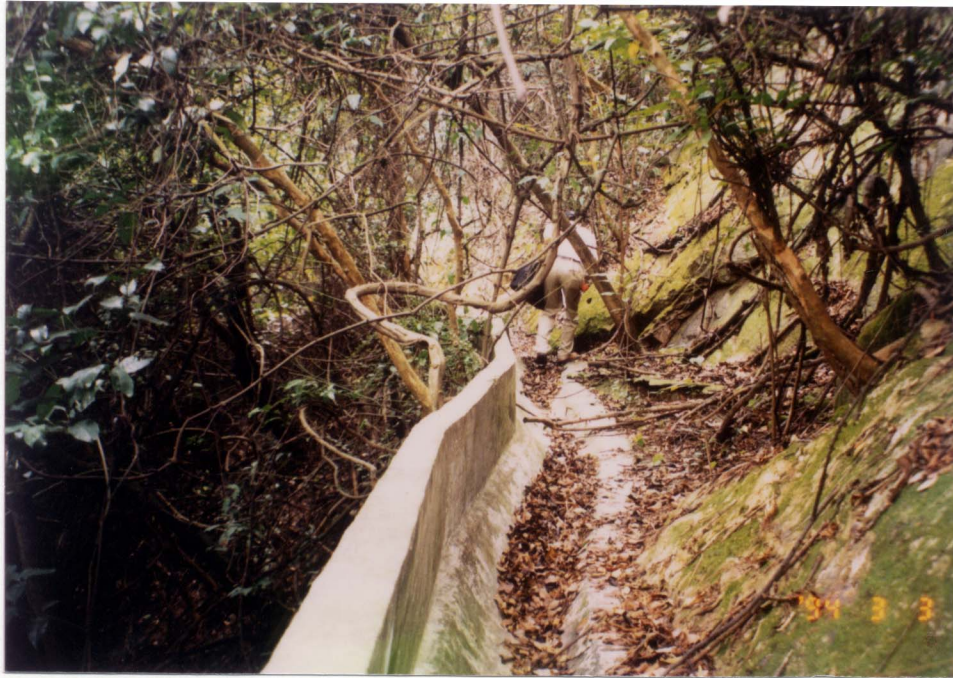
Plate 3 - View of the Surface Water Run-off Channel Above the Village
(Photograph Taken on 3 March 1998, Between House Nos. 45
and 69)
