**SECTION 4:  
DETAILED STUDY OF THE  
LANDSLIDE AT  
TUEN MUN ROAD  
NEAR TING KAU  
ON 2 JULY 1997**

**Halcrow Asia Partnership Ltd**

**This report was originally produced in June 1998  
as GEO Landslide Study Report No. LSR 14/98**

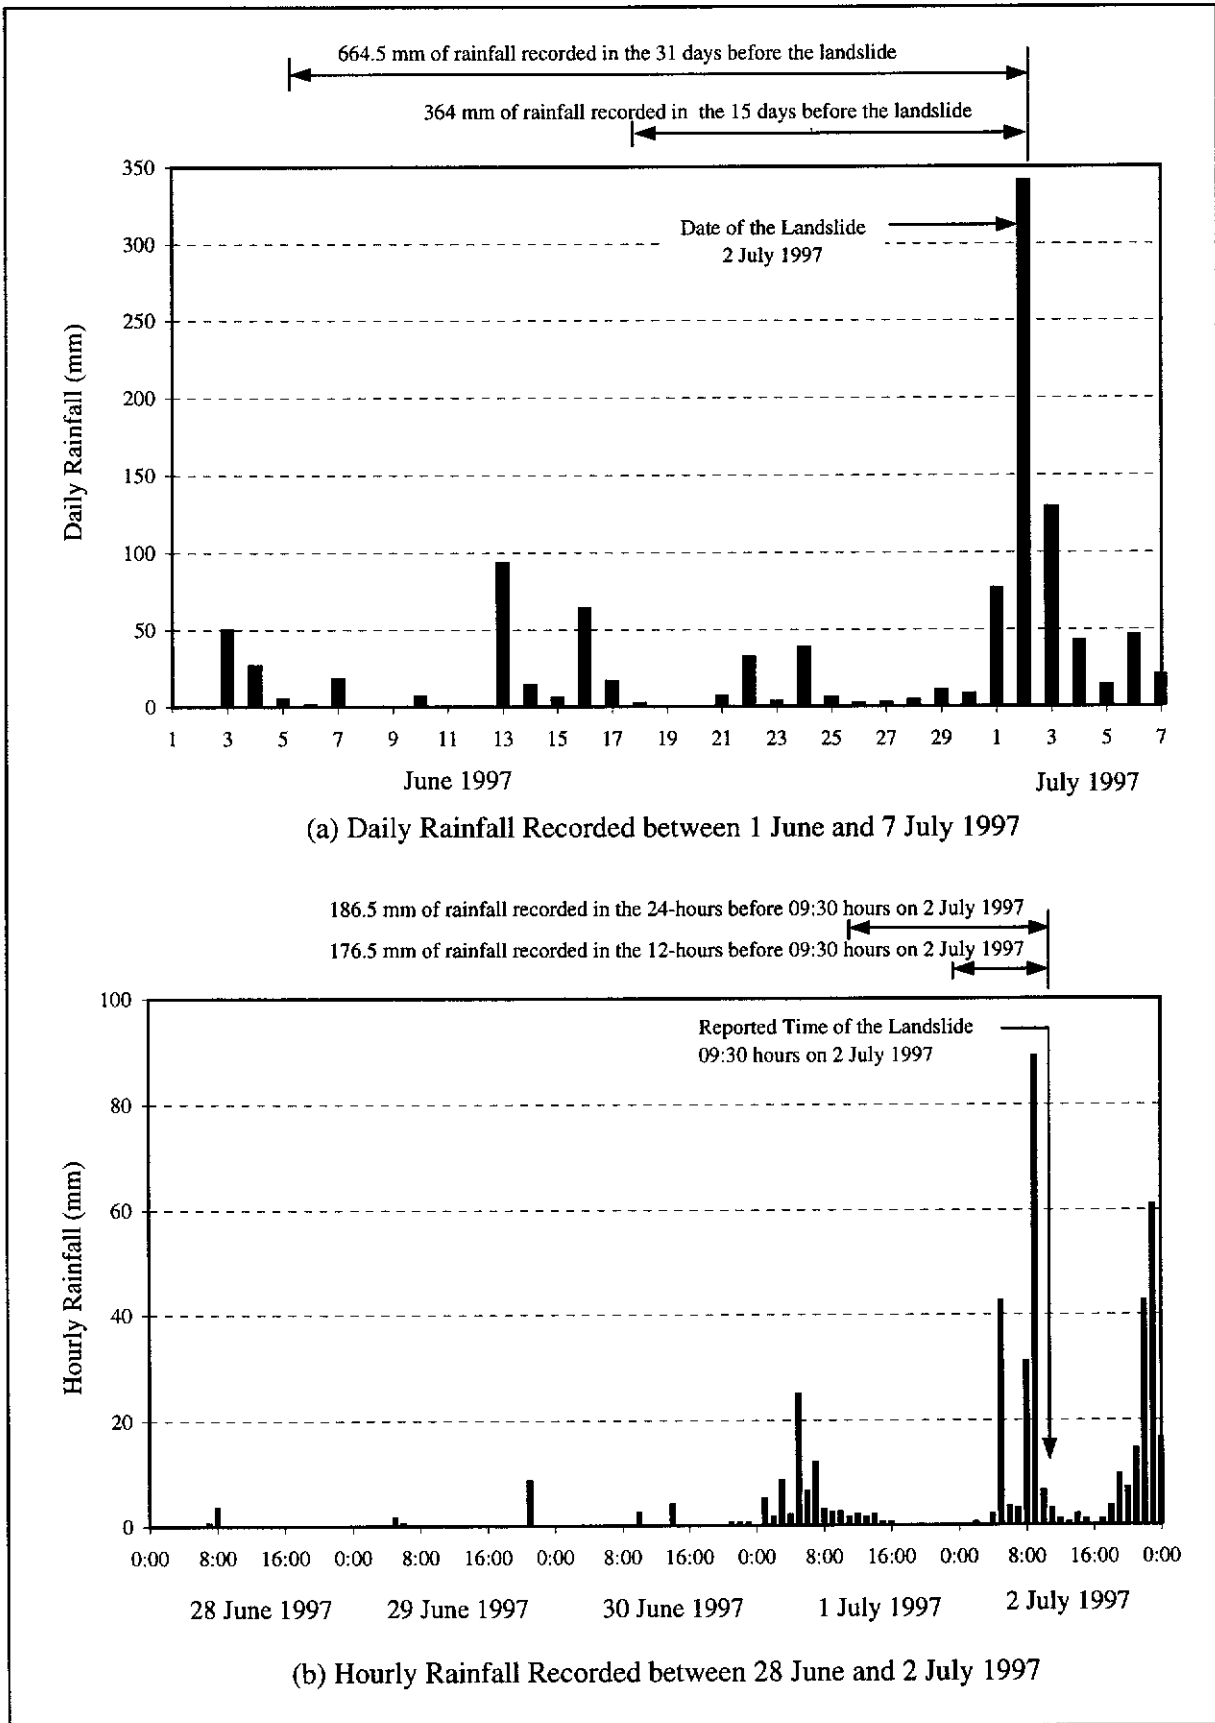
Figure 5 - Rainfall Recorded at GEO Raingauge No. N10

The nearest GEO automatic raingauge No. N10 is located at Sham Tseng Emmanuel Primary School, about 2.5 km west of the landslide site (Figure 1). The daily rainfall recorded in June and July 1997 is shown in Figure 5a. There was 664.5 mm and 364 mm of rainfall in the 31 days and 15 days before the landslide respectively. The hourly rainfall from 29 June 1997 to 2 July 1997 is shown in Figure 5b. There was 186 mm and 178 mm of rainfall in the 24 hours and 12 hours before the landslide respectively. Isohyets of rainfall prior to the landslide on 2 July 1997 are shown in Figure 6.
