**SECTION 5:  
DETAILED STUDY OF THE  
LANDSLIDE  
AT LAI CHO ROAD  
KWAI CHUNG  
ON 4 JUNE 1997**

**Halcrow Asia Partnership Ltd**

**This report was originally produced in October 1998  
as GEO Landslide Study Report No. LSR 16/98**

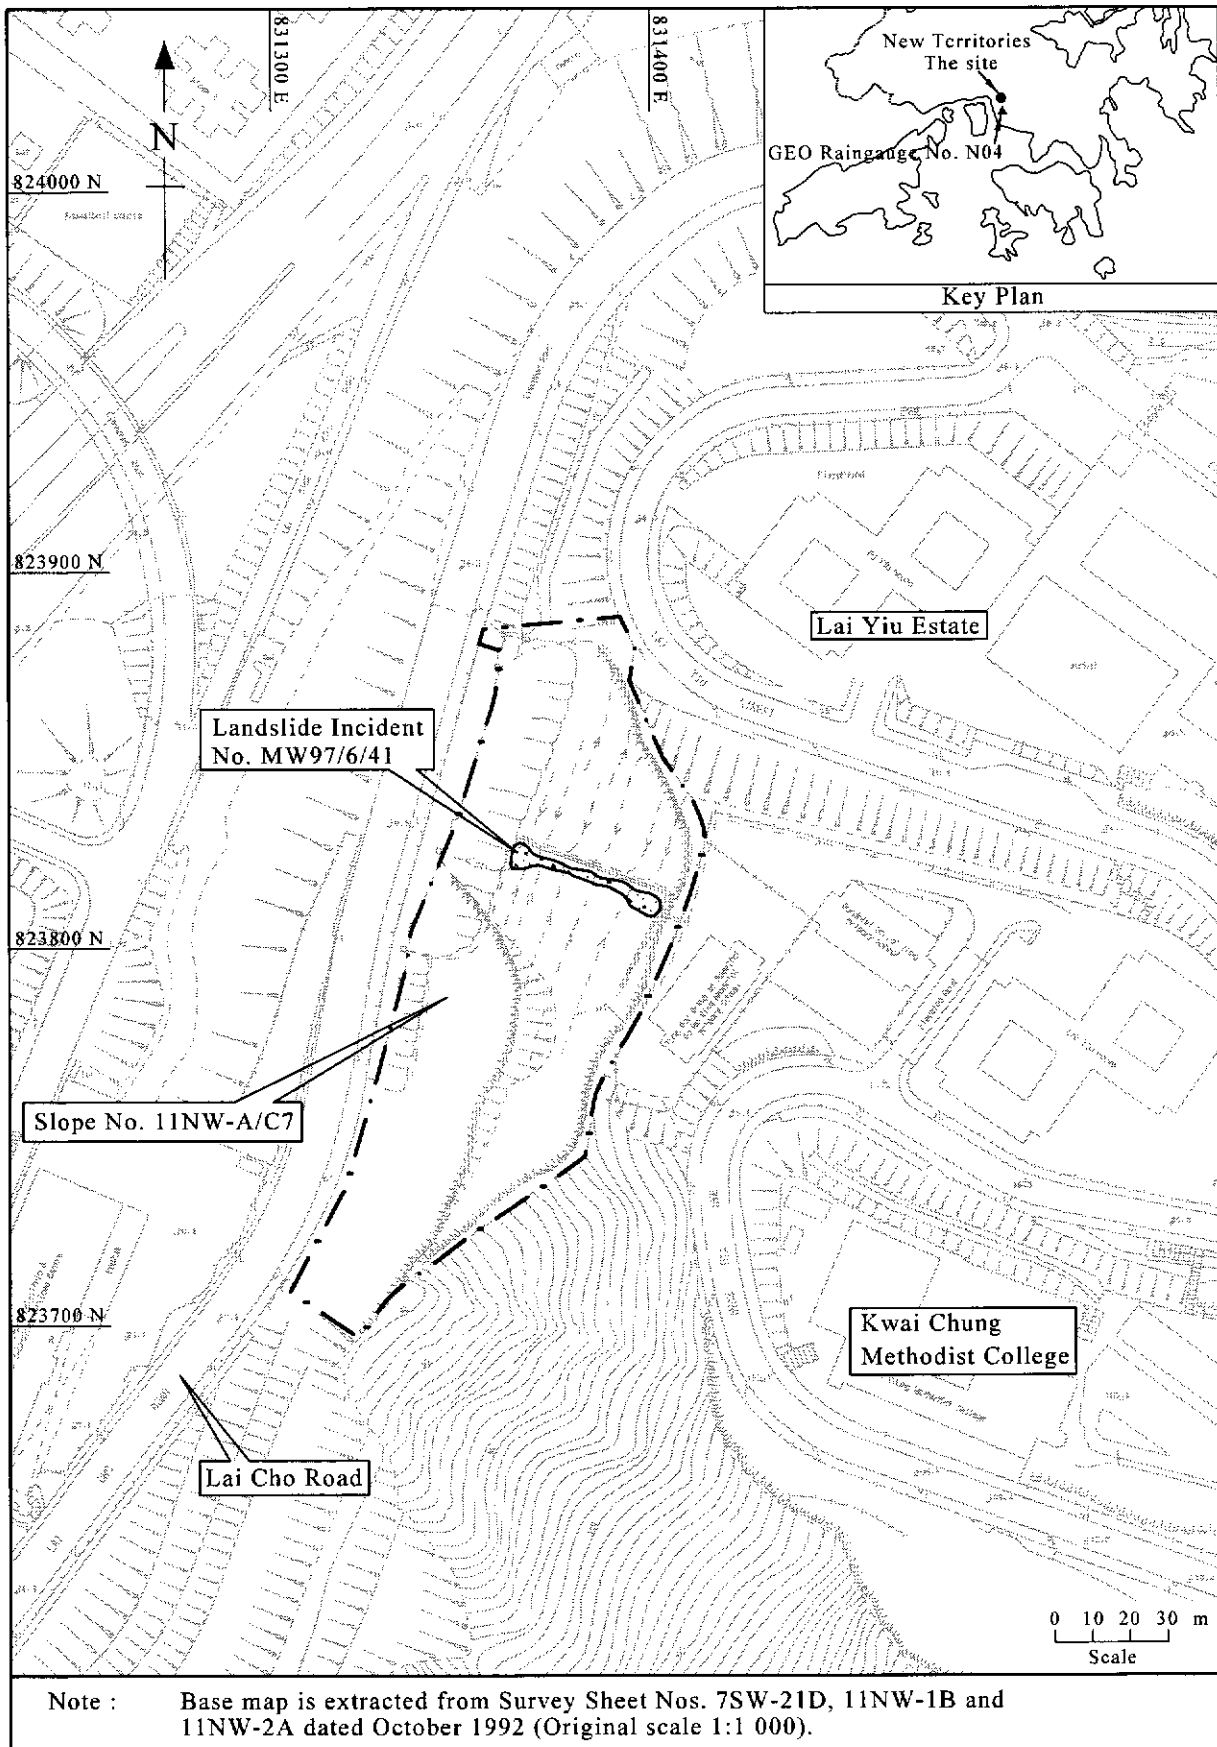
Figure 1 - Site Location Plan

There were no witnesses to the landslide and the earliest observation of the landslide was made at about 12:00 hours on 4 June 1997 by the Principal of Kwai Chung Methodist College, which is situated 100 m southeast of the landslide site (Figure 1).

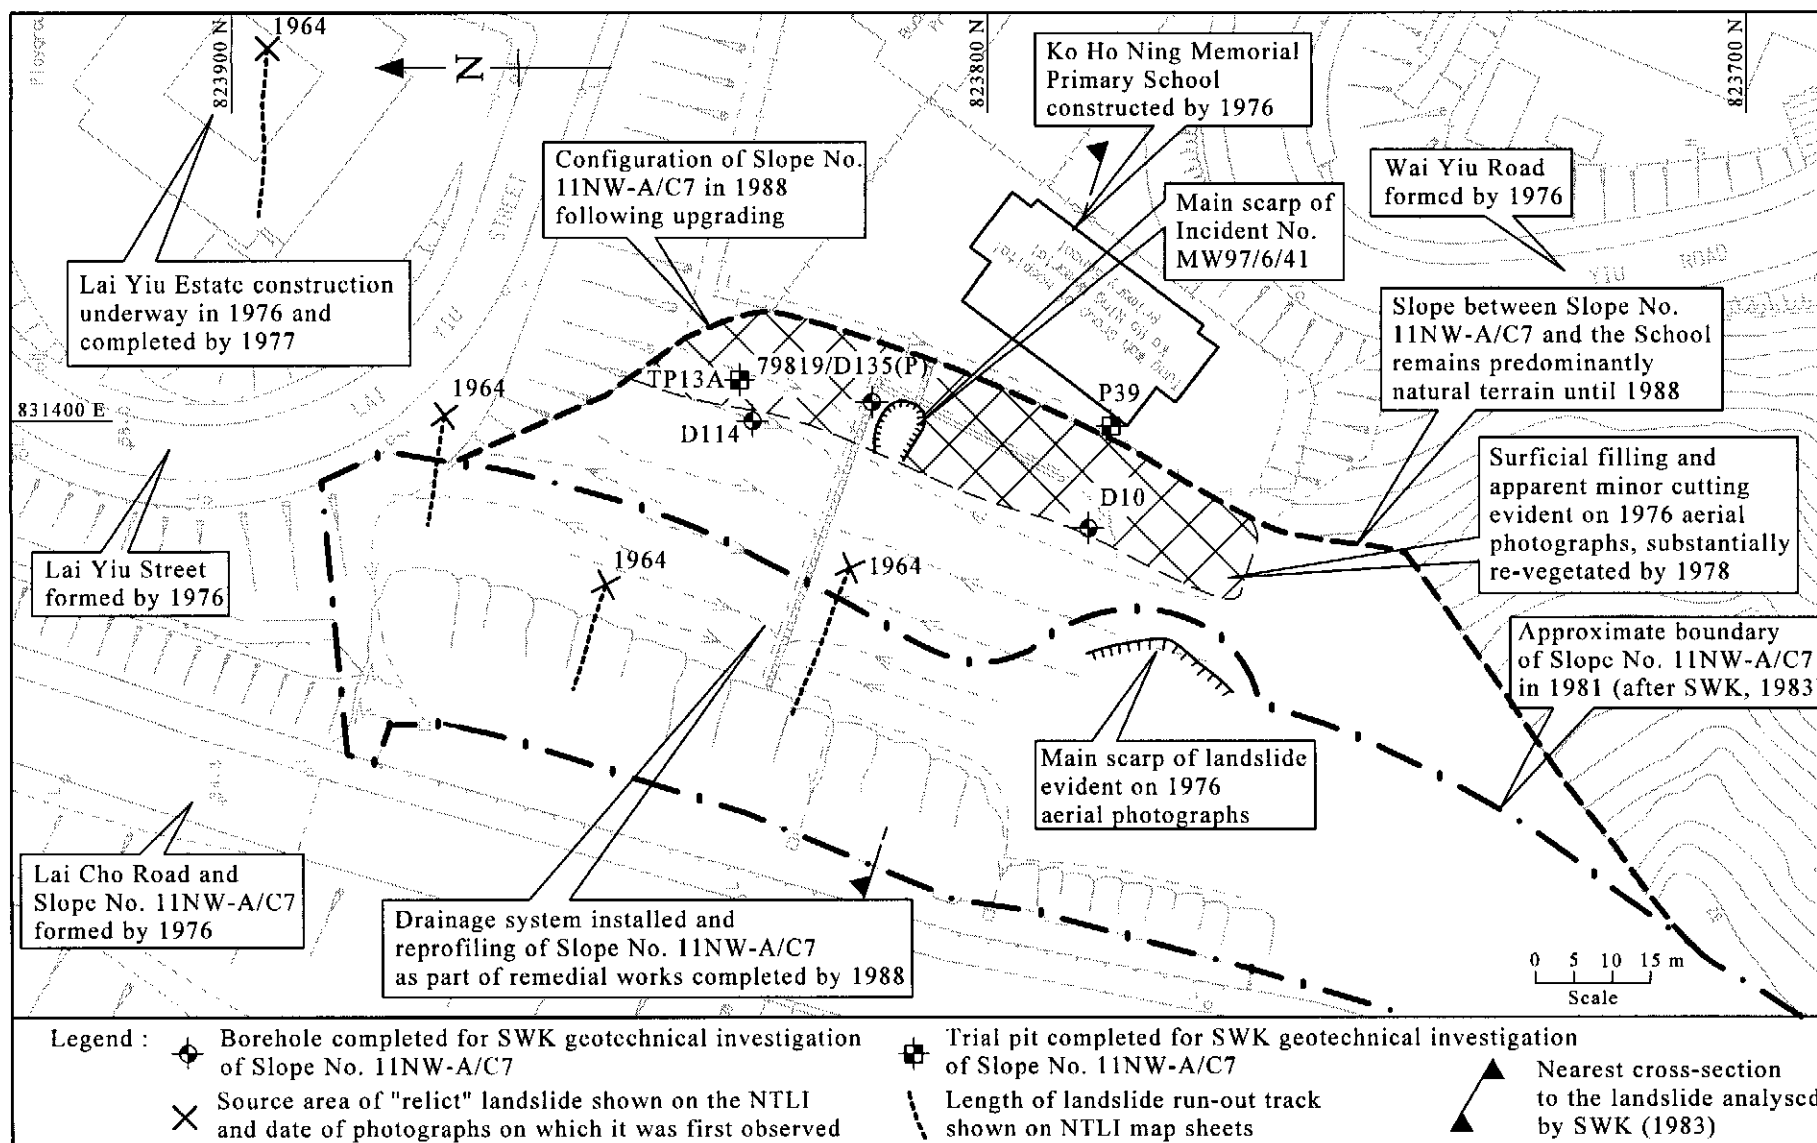
Figure 3 - Site History

Aerial photographs taken in 1976 show a landslide scar about 40 m southwest of the location of the 1997 incident (Figure 3). The landslide was about 20 m wide and appeared to

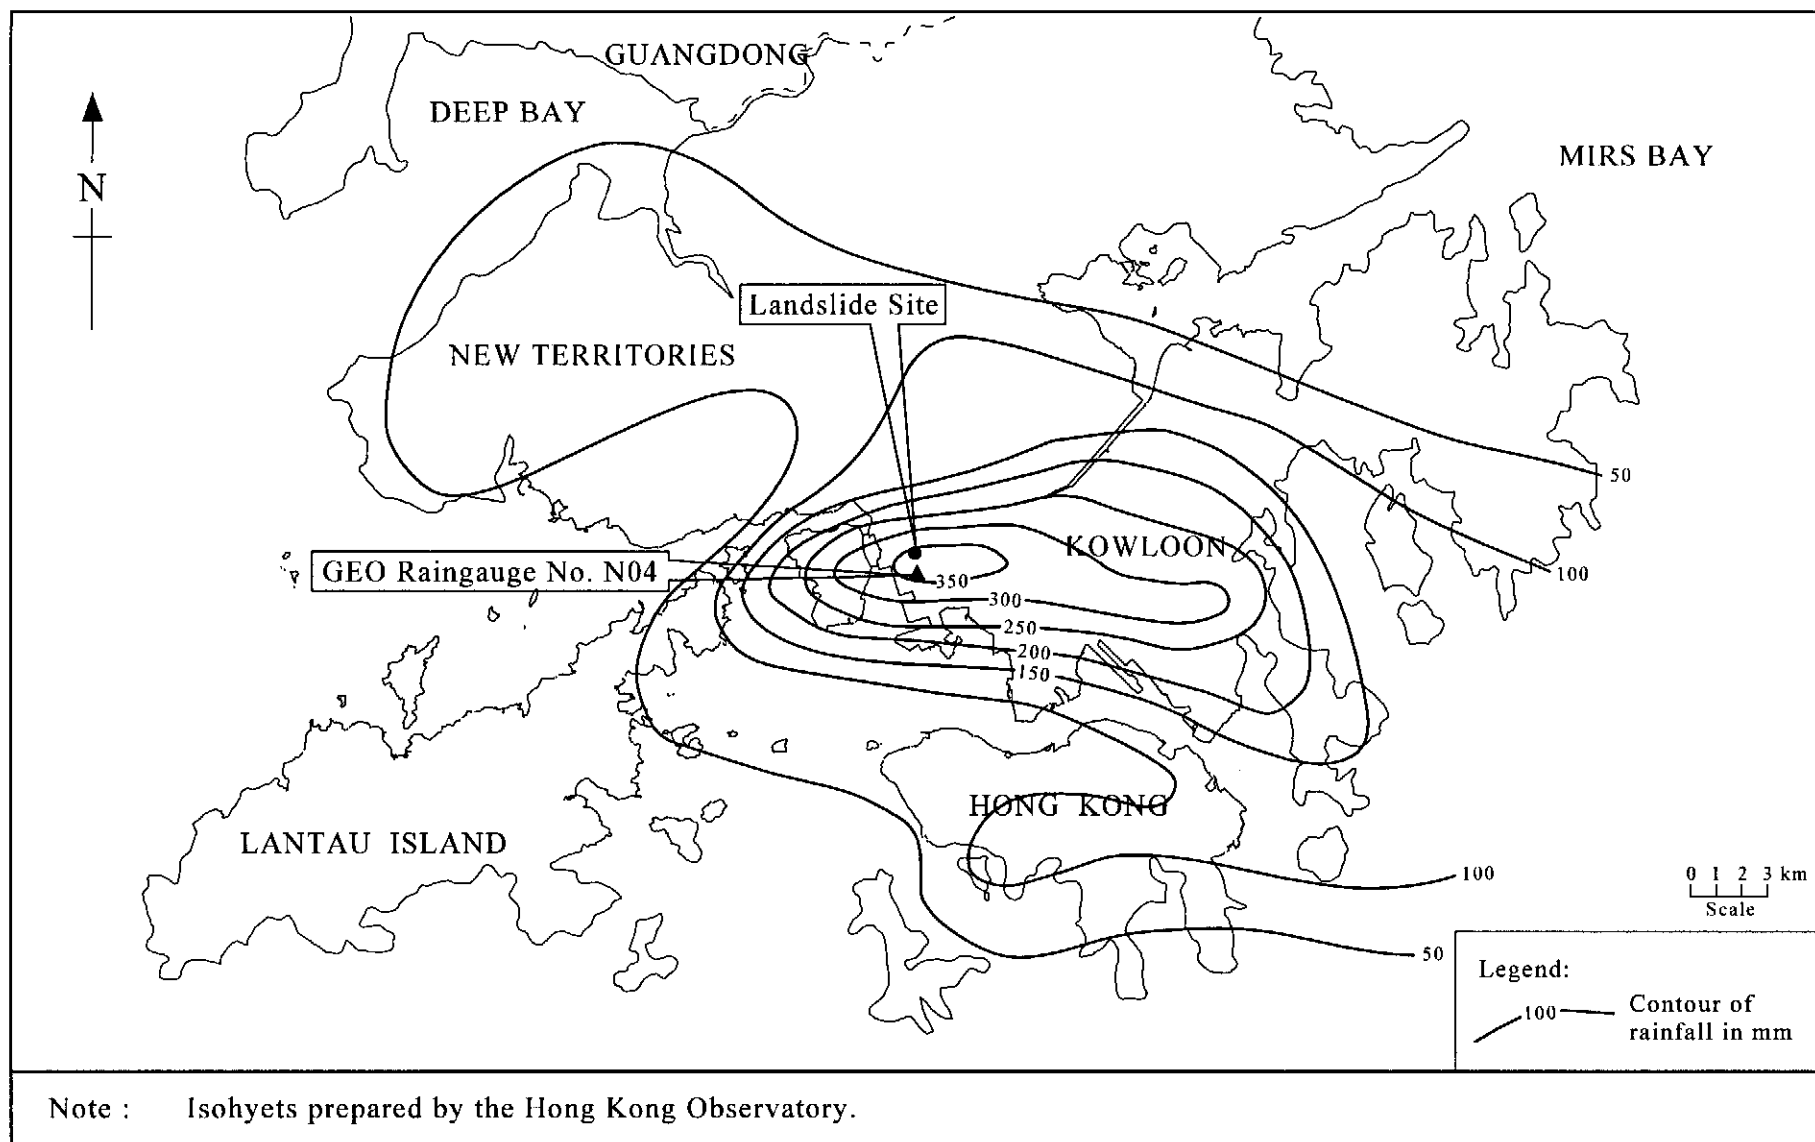
Figure 6 - Isohyets of Rainfall between 01:25 Hours and 12:00 Hours on 4 June 1997

The nearest GEO automatic raingauge No. N04 is located at Kai Kwong Lau of Cho Yiu Estate, about 900 m south of the landslide site (Figures 1 and 6). The time of failure is not precisely known but for the purpose of analysis, all rainfall recorded up to 12:00 hours on 4 June 1997, by which time the landslide is known to have occurred, has been included.

An isohyet map of rainfall recorded between 01:25 hours on 4 June 1997 and 12:00 hours on 4 June 1997 is shown in Figure 6. The daily rainfall recorded between 1 May and 10 June 1997 and clock hourly rainfall between 2 and 4 June 1997 are shown in Figures 7a and 7b respectively.

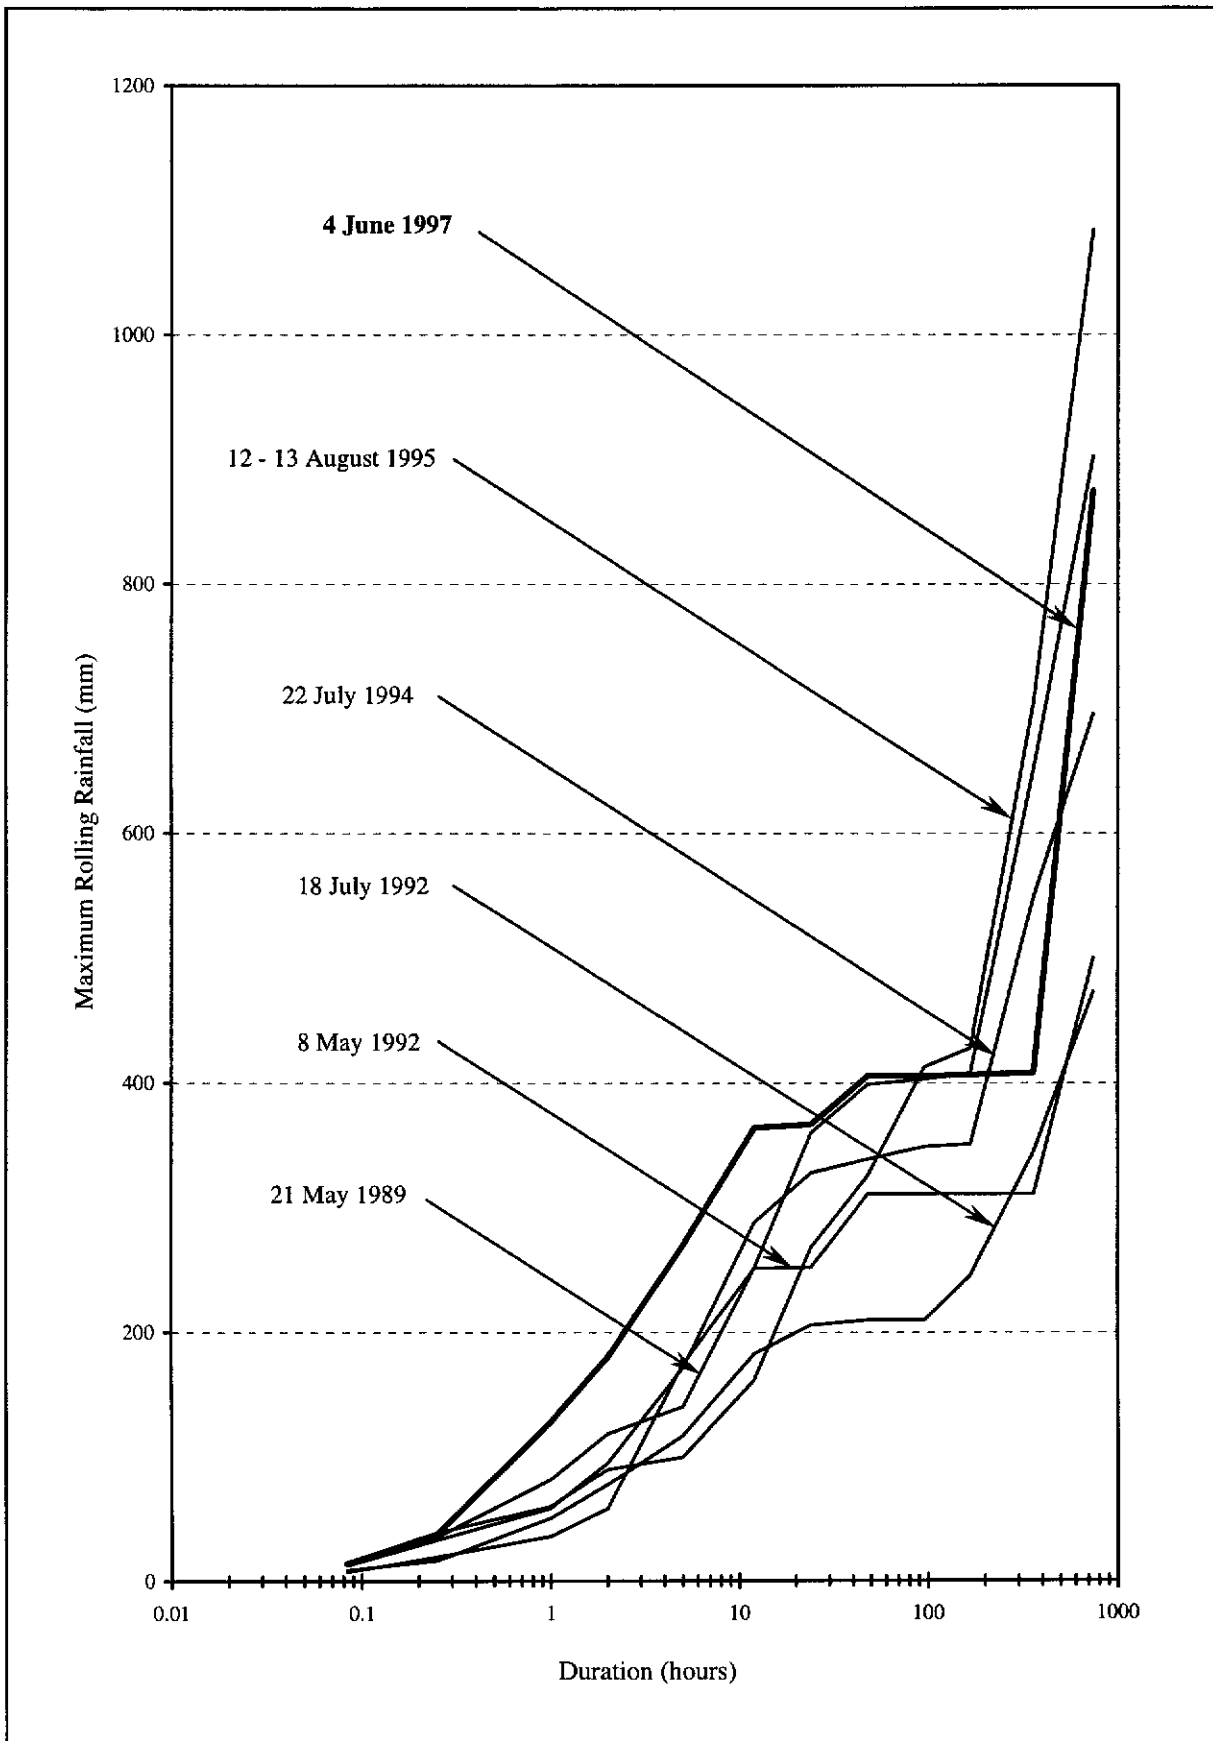
Figure 8 - Maximum Rolling Rainfall at GEO Raingauge No. N04 for Selected Major Rainstorms

The maximum rolling rainfall for the rainstorm has been compared with selected past severe rainstorms recorded at raingauge No. N04 since 1982 when the raingauge began operation (Figure 8). The maximum rolling rainfall for the rainstorm of 4 June 1997 for
