INVESTIGATION OF SOME SELECTED LANDSLIDE INCIDENTS IN 1997 (VOLUME 3)

GEO REPORT No. 89

SECTION 1: DETAILED STUDY OF THE LANDSLIDES AT TAO FUNG SHAN CHRISTIAN CEMETERY ON 2 JULY 1997

**This report was originally produced in March 1998
as GEO Landslide Study Report No. LSR 2/98**

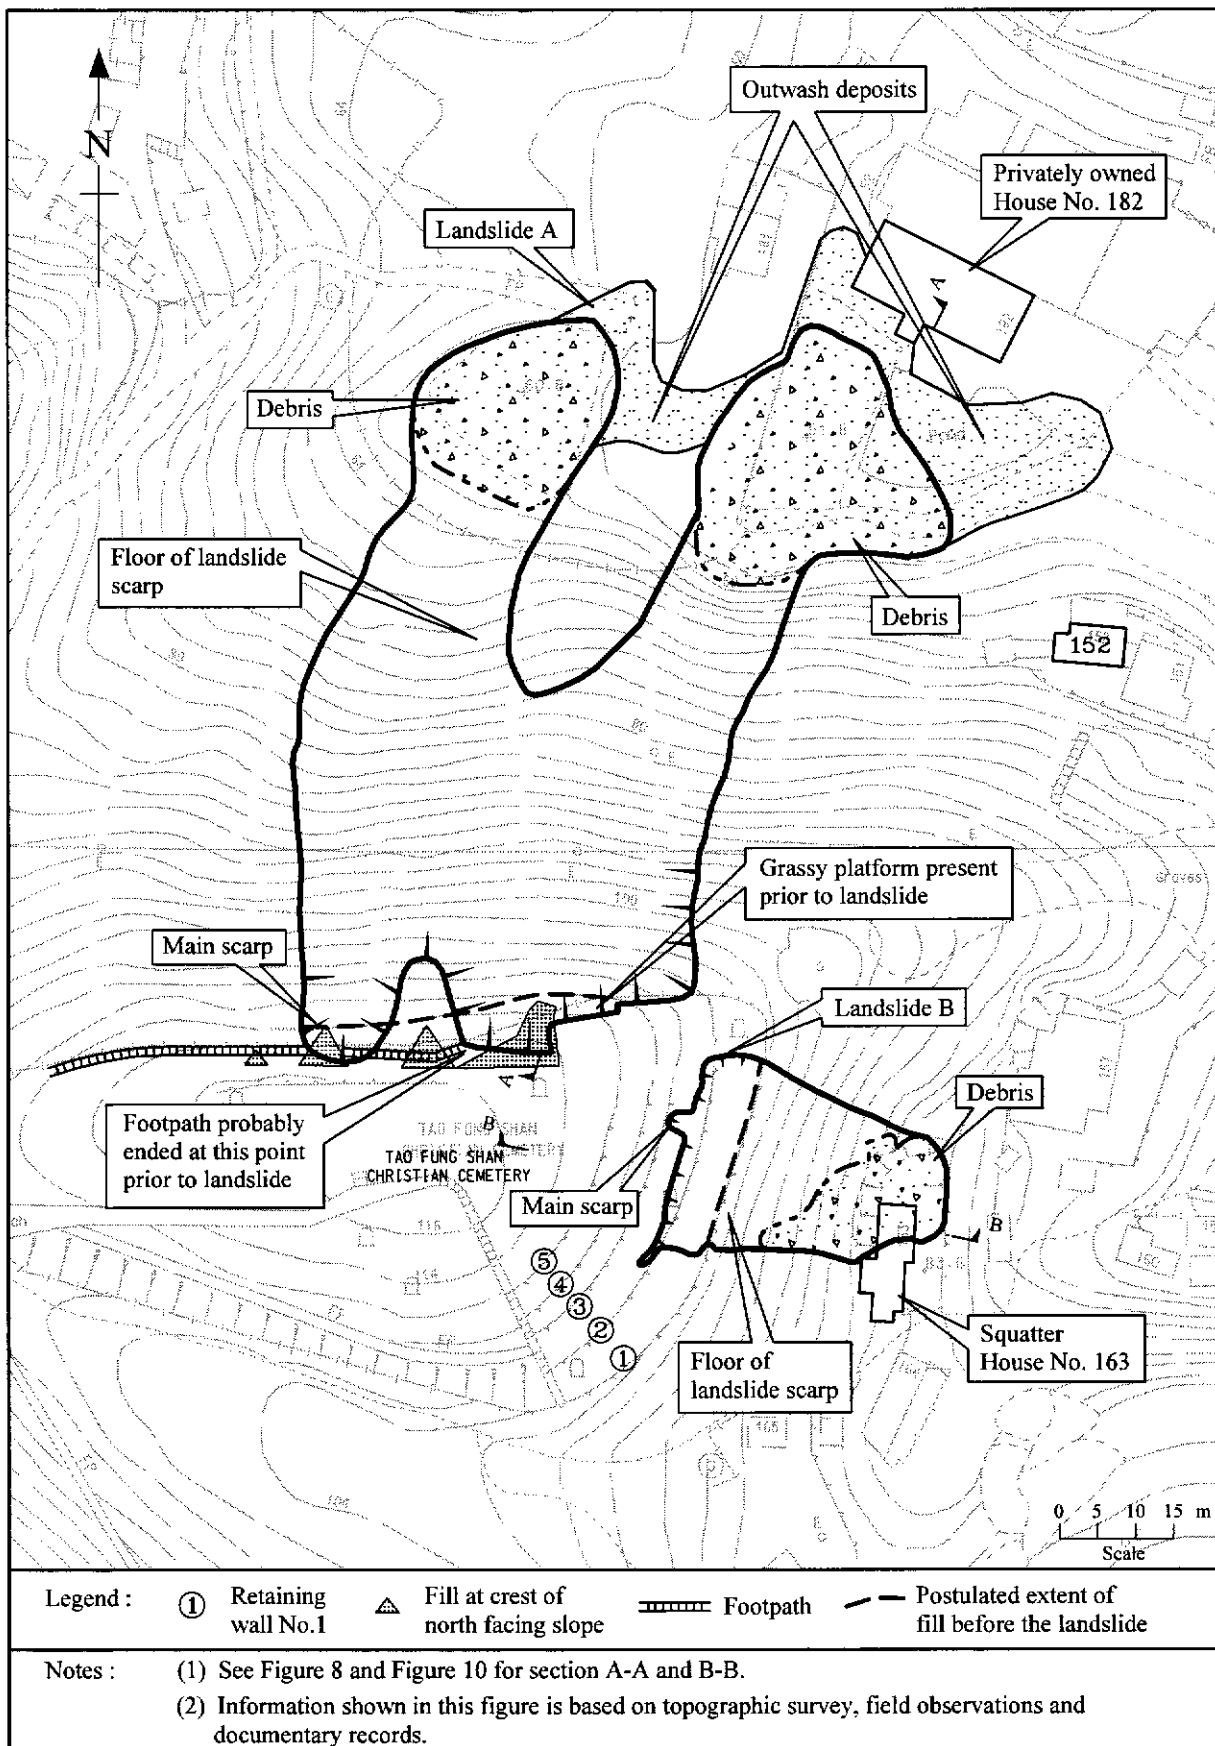
Figure 2 - Plan of the Landslides

The eastern end of the cemetery comprised five terraces of graves, each terrace being primarily composed of fill that was retained by a concrete wall. Retaining wall Nos. 1 and 2 (Figure 2), located closest to the boundary of the cemetery, were about 2.5 m to 3.0 m high. The fill terrace behind retaining wall No. 1 was inclined at about 28° and covered by deteriorated chunam, while the fill terrace behind retaining wall No. 2 was partly occupied by graves with the remainder being grassed. The drainage provision for the walls was limited to weepholes of 20 mm diameter spaced at centres of about 2 m. No drainage filter layers were observed behind the parts of the walls remaining after the landslide.

Squatter huts were located mid-way down the eastern slope. One of these was house No. 163, measuring 6 m wide by 27 m long and located on a cut and fill platform, which was partly demolished by Landslide B (Figure 2). The masonry-clad and chunam cut slope at the back of the platform was about 5 m high.

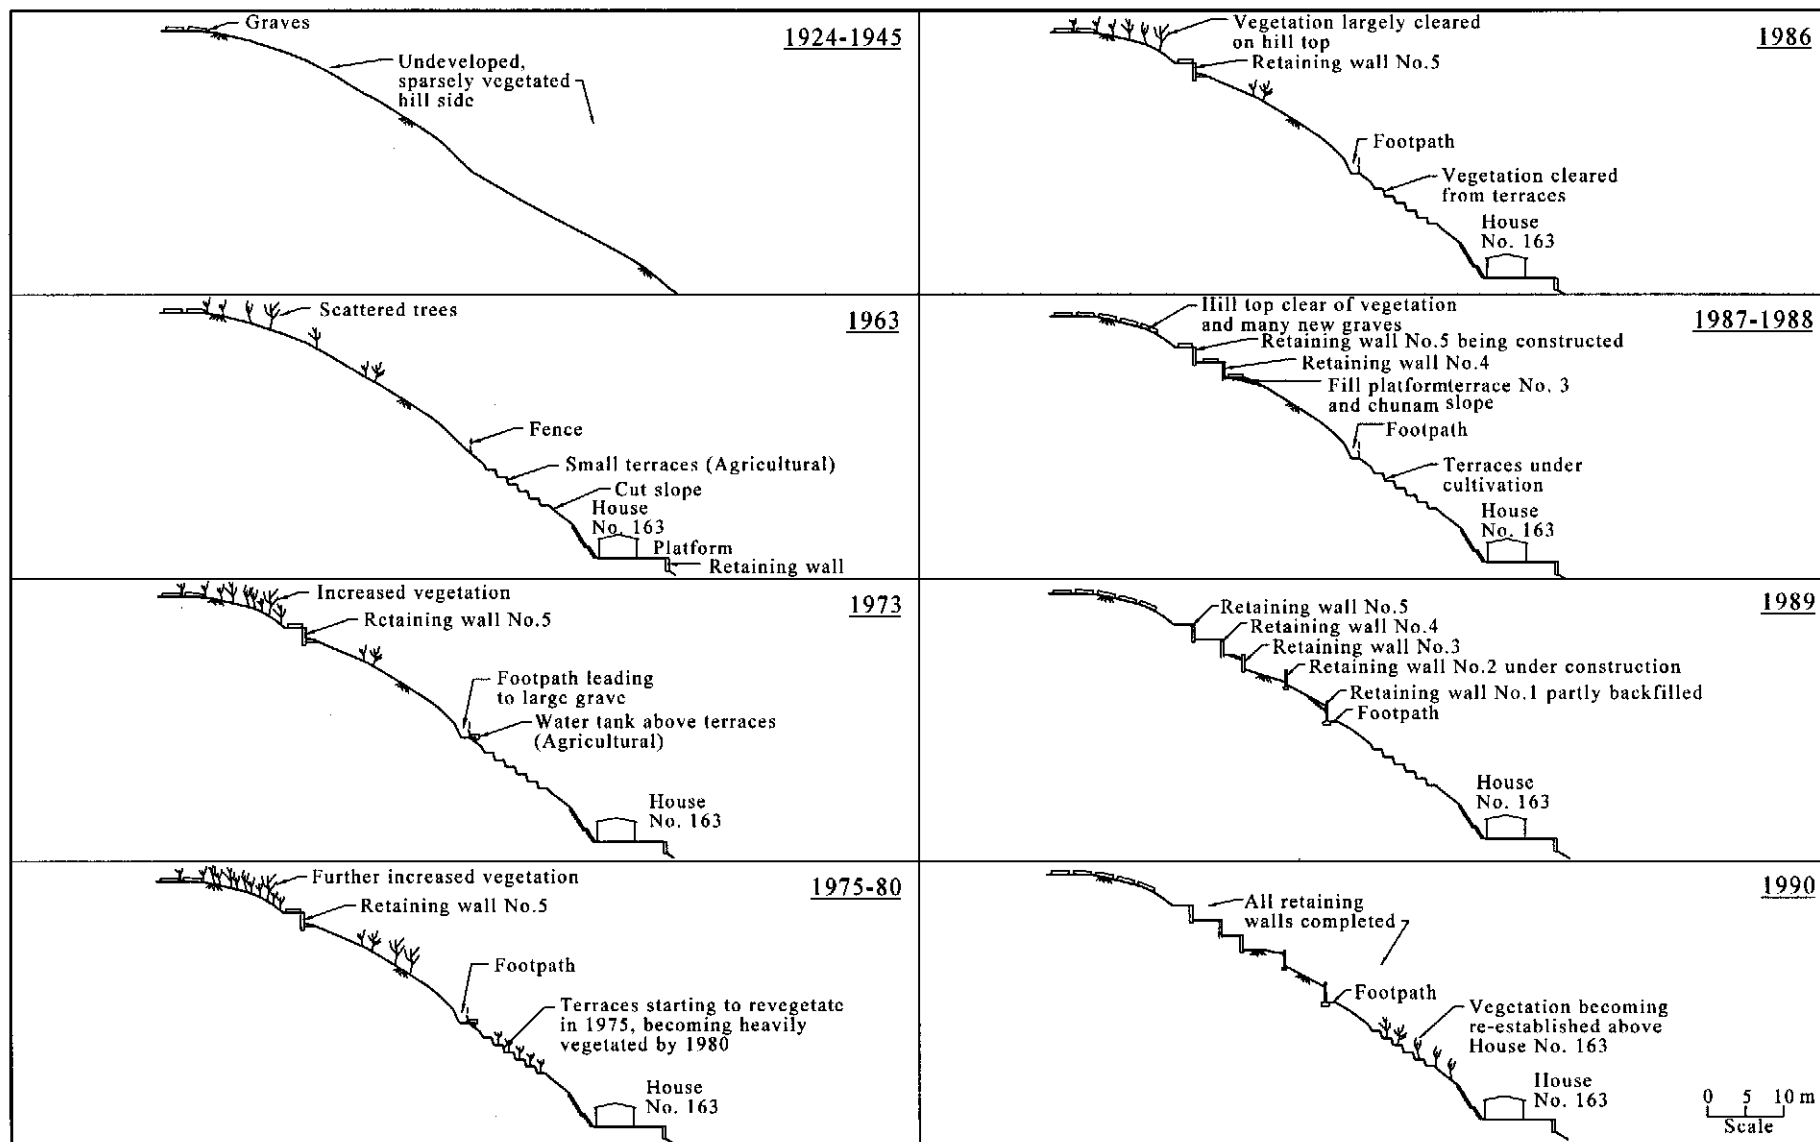
Figure 5 - Schematic Representation of Slope Development at Site of Landslide B

The history of vegetation cover and clearance of the eastern slope is shown in Figure 5.

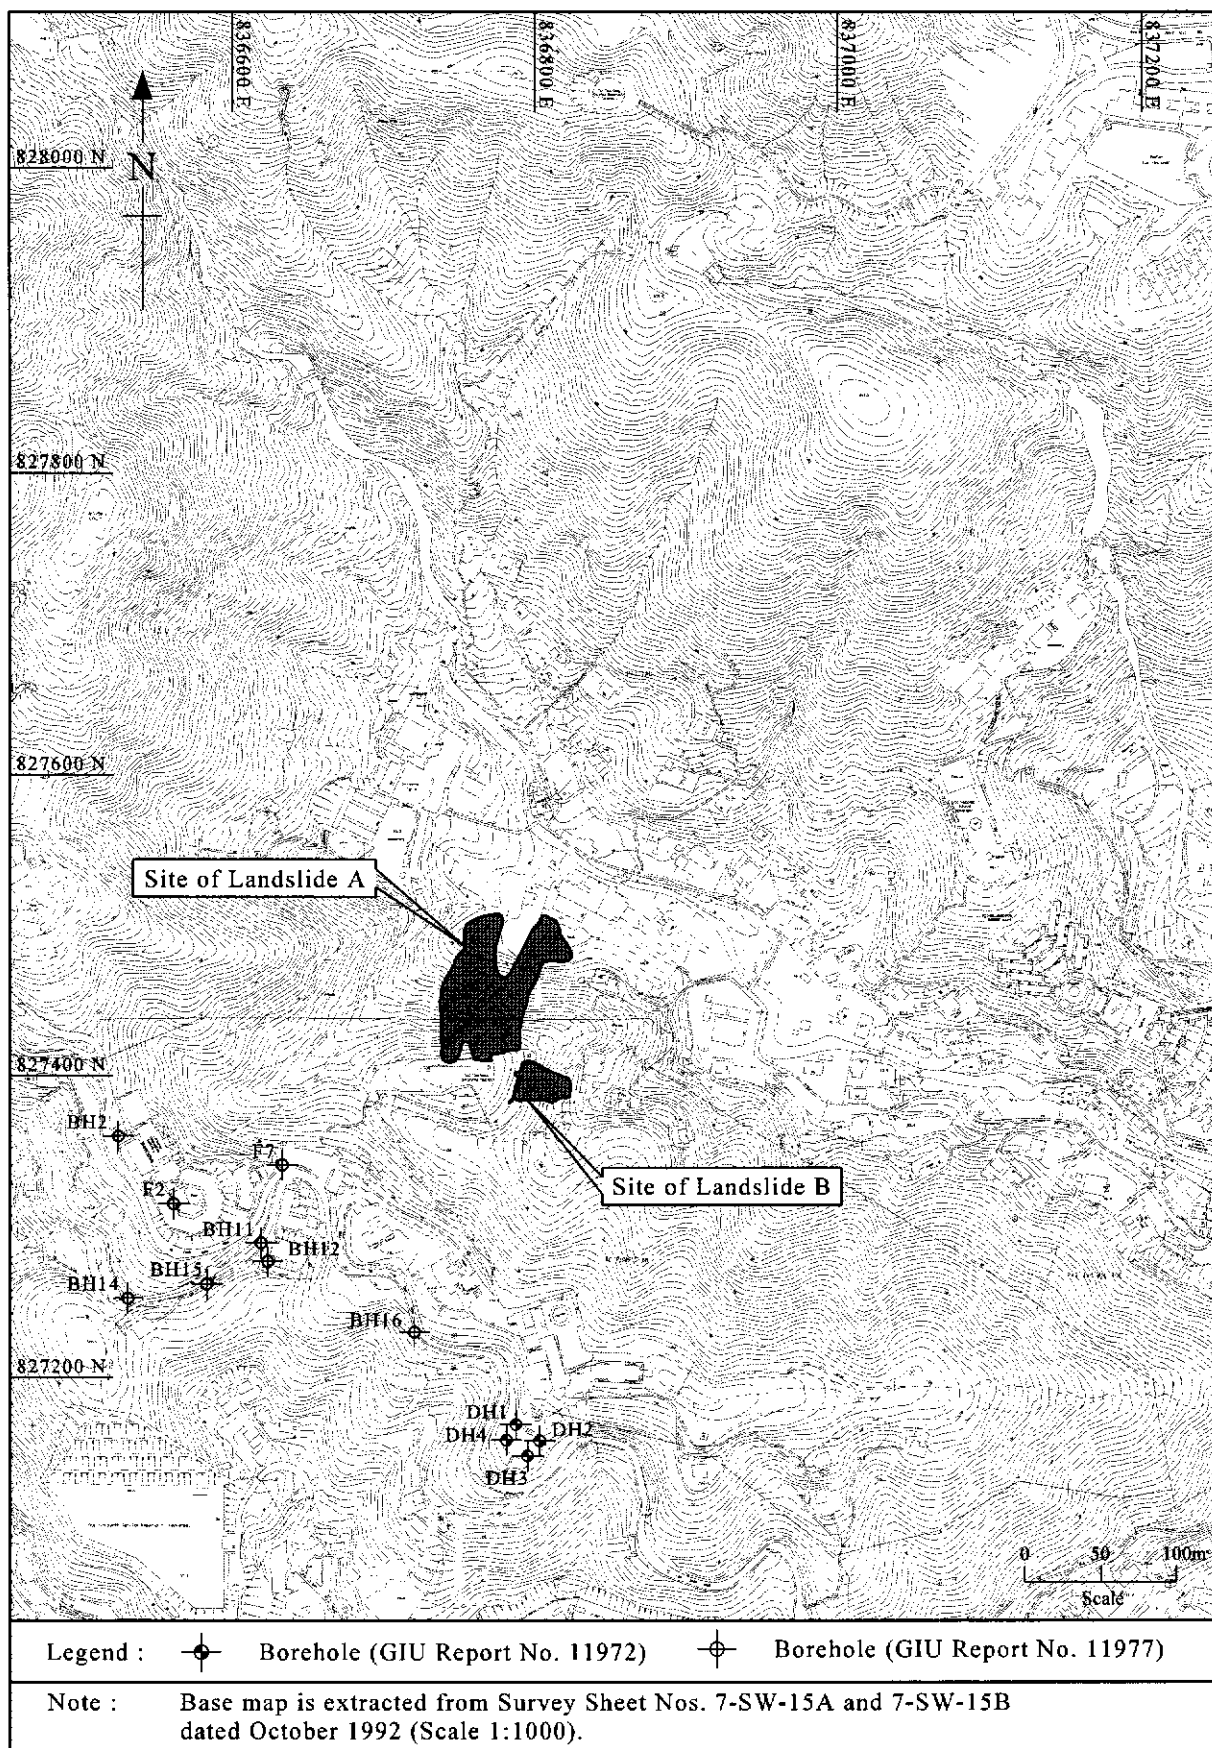
Figure 6 - Location Plan of Previous Ground Investigation Works

Three ground investigations have previously been conducted within 300 m of the site (Figure 6). These investigations, which in terms of terrain and elevations were located in similar settings to the site of the cemetery, indicate the presence of a thin layer of residual soil overlaying completely decomposed granite, which increases in density with depth (Table 1). Moderately to slightly decomposed granite (i.e., rockhead) was typically encountered at depths greater than 30 m below ground level, at an elevation of about 100 mPD. The drillholes did not encounter groundwater at this elevation. Observations at the landslide sites generally concur with this geology and hydrogeology. In particular, the observations of a natural spring line at about 80 mPD to 65 mPD on the northern slope below the cemetery (see Section 3.2.1 and Figures 7 and 8), confirm the existence of a deep groundwater table.

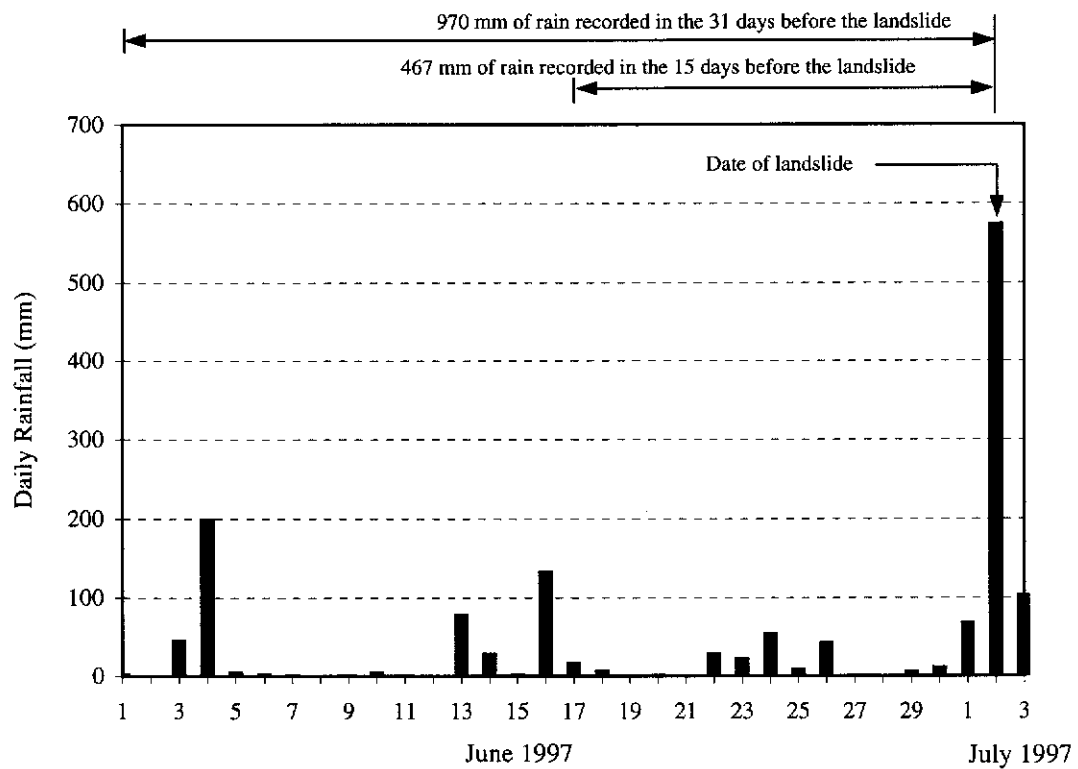
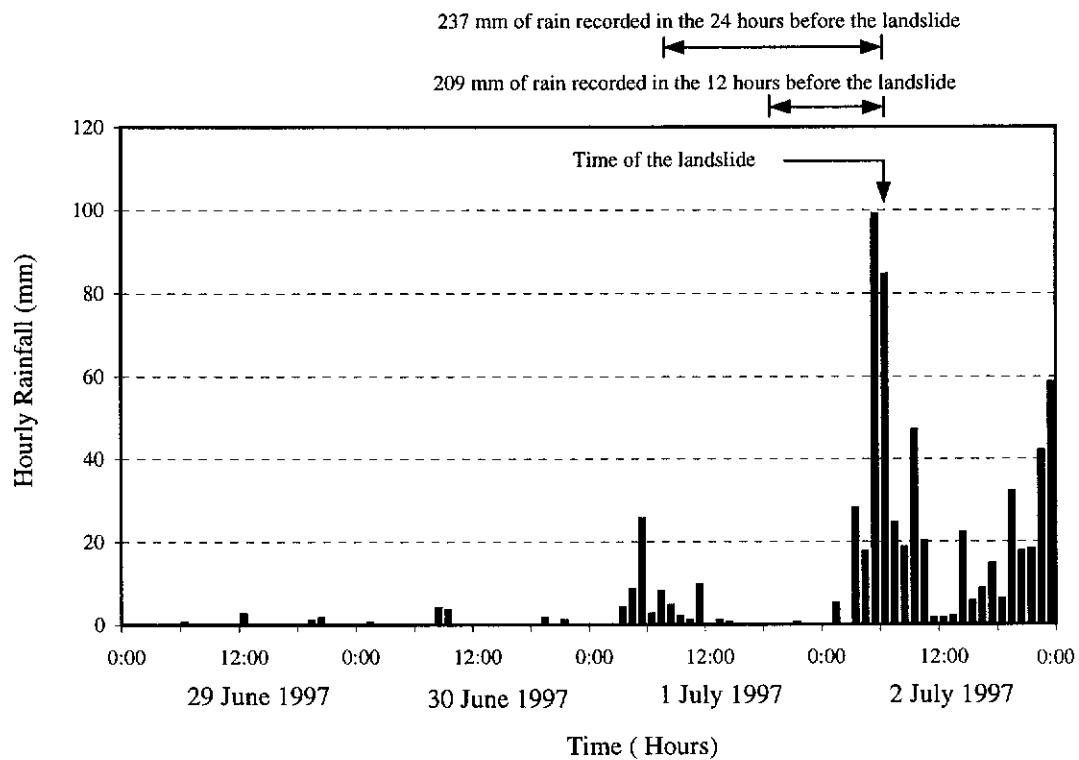
Figure 11 - Rainfall Records of GEO Raingauge No. N02

The nearest GEO automatic raingauge No. N02 is located at Shun Wo House on Wo Che Estate, approximately 950 m to the southeast of the landslide. The daily rainfall recorded in June and July 1997, together with the hourly rainfall from 29 June to 2 July 1997, are shown in Figure 11.

A total of 970 mm of rain was recorded by raingauge No. N02 in the 31 days before the landslide. Rain was heavy in the morning of 2 July 1997 to the time of the failure at 06:30 hours. The 12-hour and 24-hour rainfalls before the landslide were 209 mm and 237 mm, respectively. The peak 1-hour rainfall of 124 mm was recorded in the hour prior to the landslides on 2 July 1997. Isohyets of rainfall prior to the landslide are shown in Figure 12.

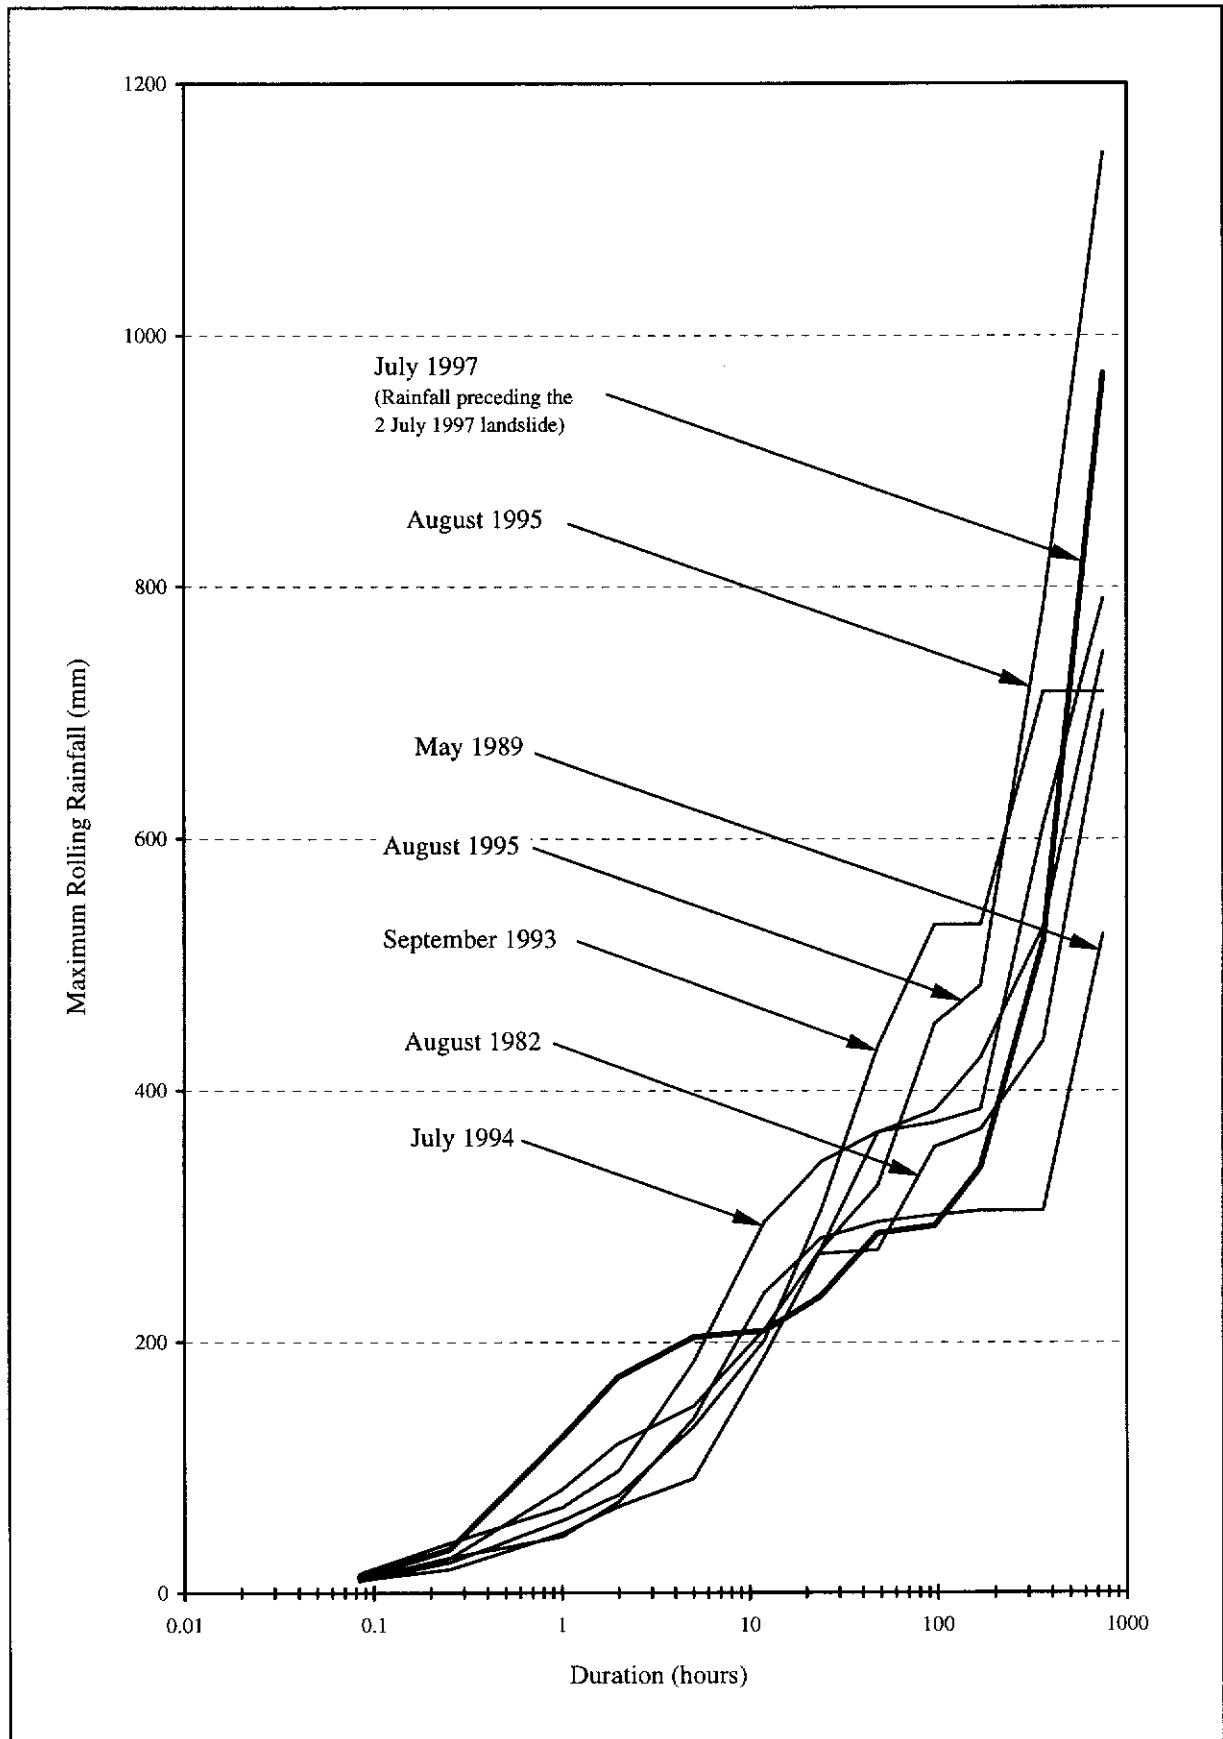
Figure 13 - Maximum Rolling Rainfall at GEO Raingauge No. N02 for Major Rainstorms

The maximum rolling rainfalls for the rainstorm on 2 July 1997 have been compared with the previous most severe rainstorms since February 1980 (Figure 13). The maximum rolling rainfall for durations of between 20 minutes and 5 hours exceeds that from previous rainstorms at the raingauge.

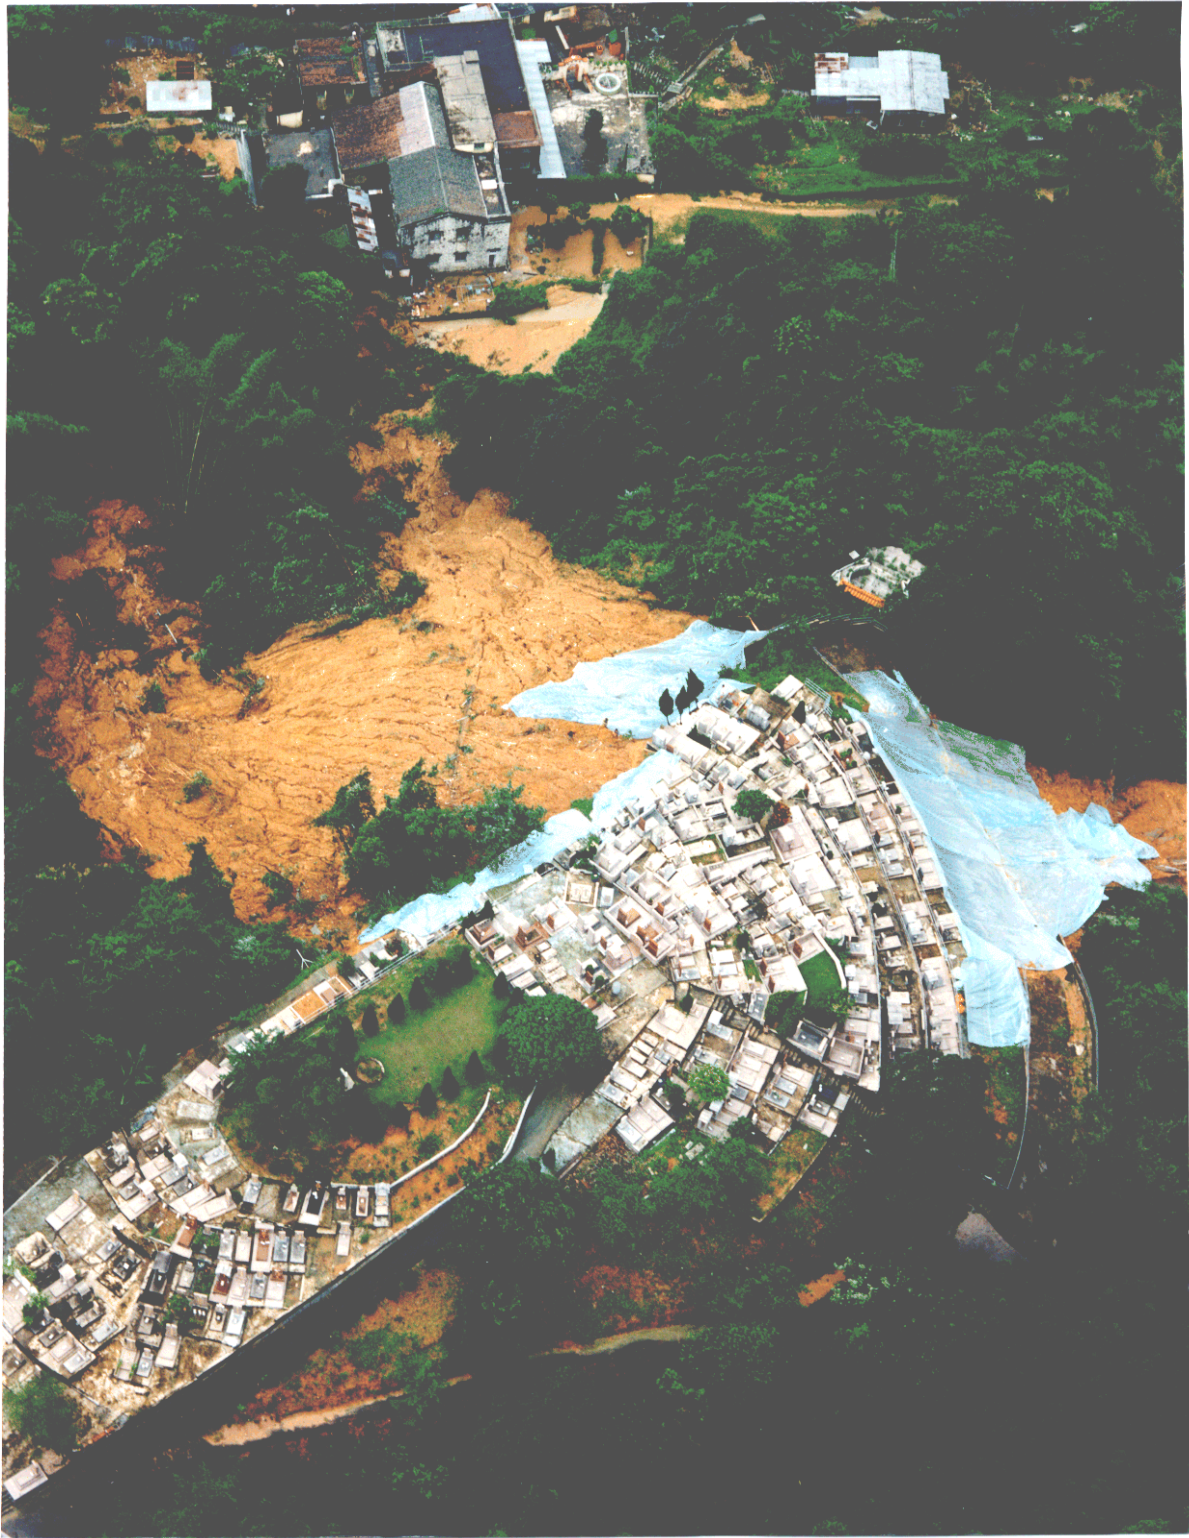
Plate 1 - Aerial View of the Site, Showing Landslides A and B

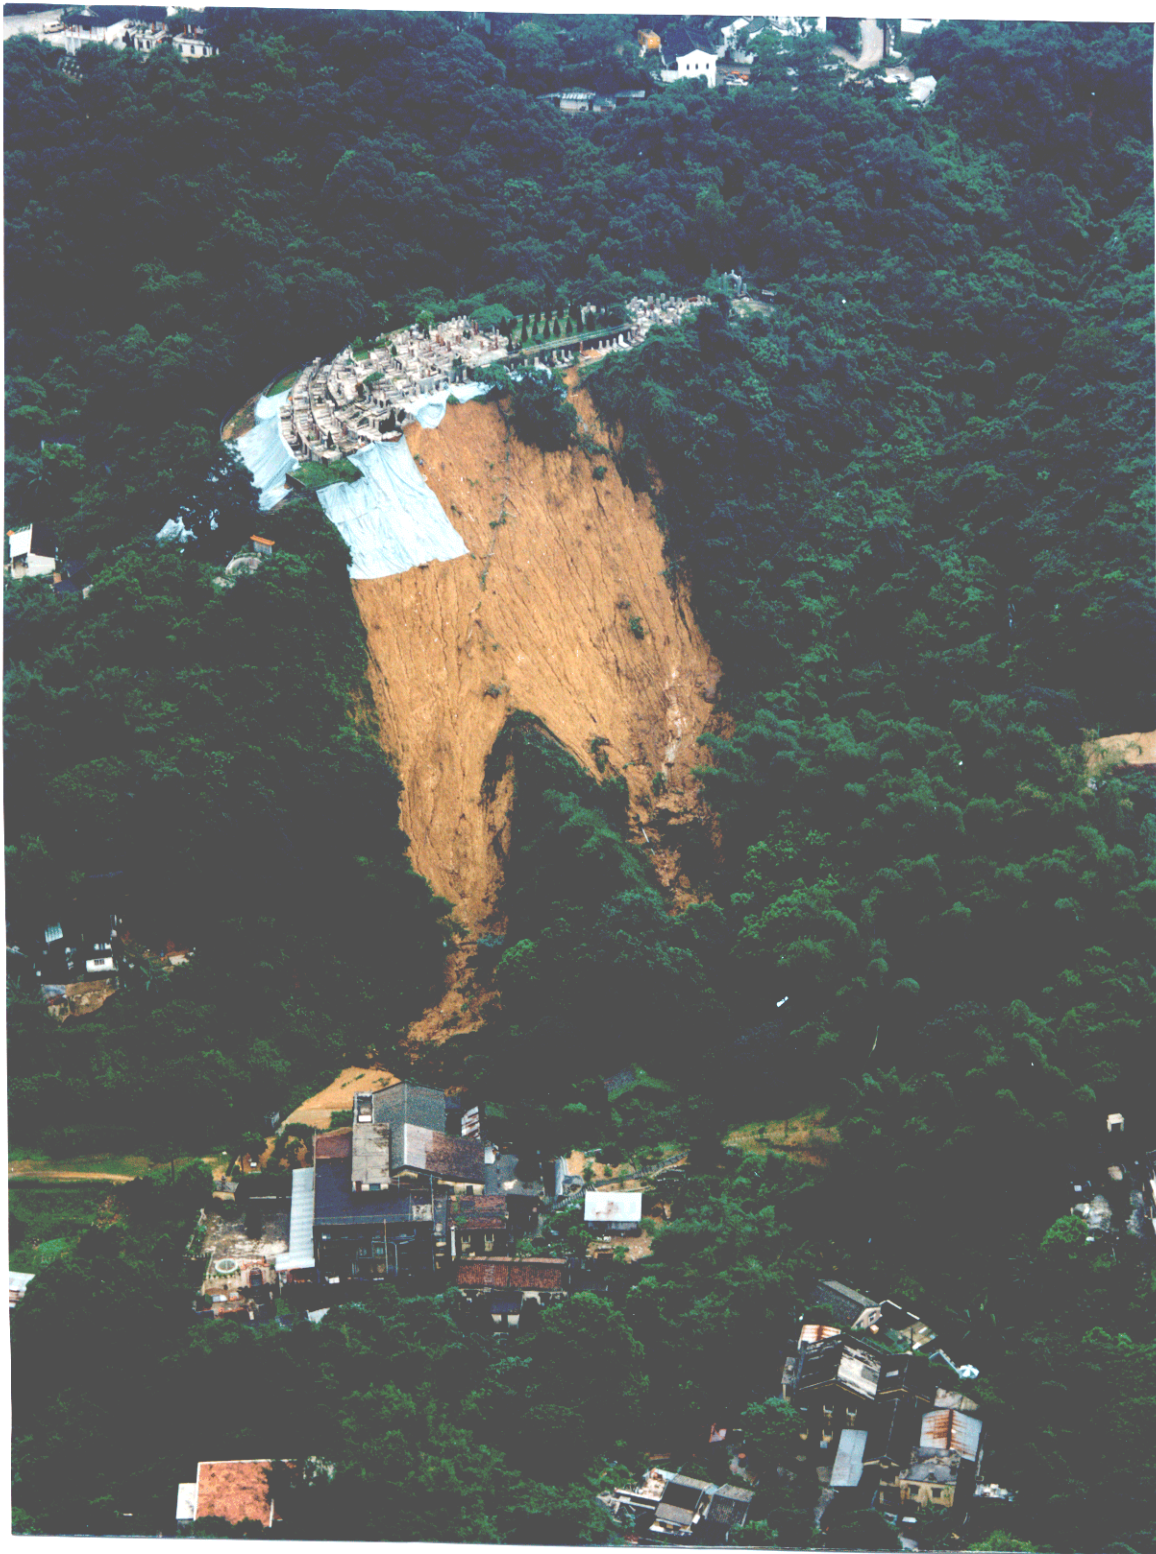
Plate 2 - Aerial View of Landslide A on the Northern Slope
(Photograph Taken on 2 July 1997)

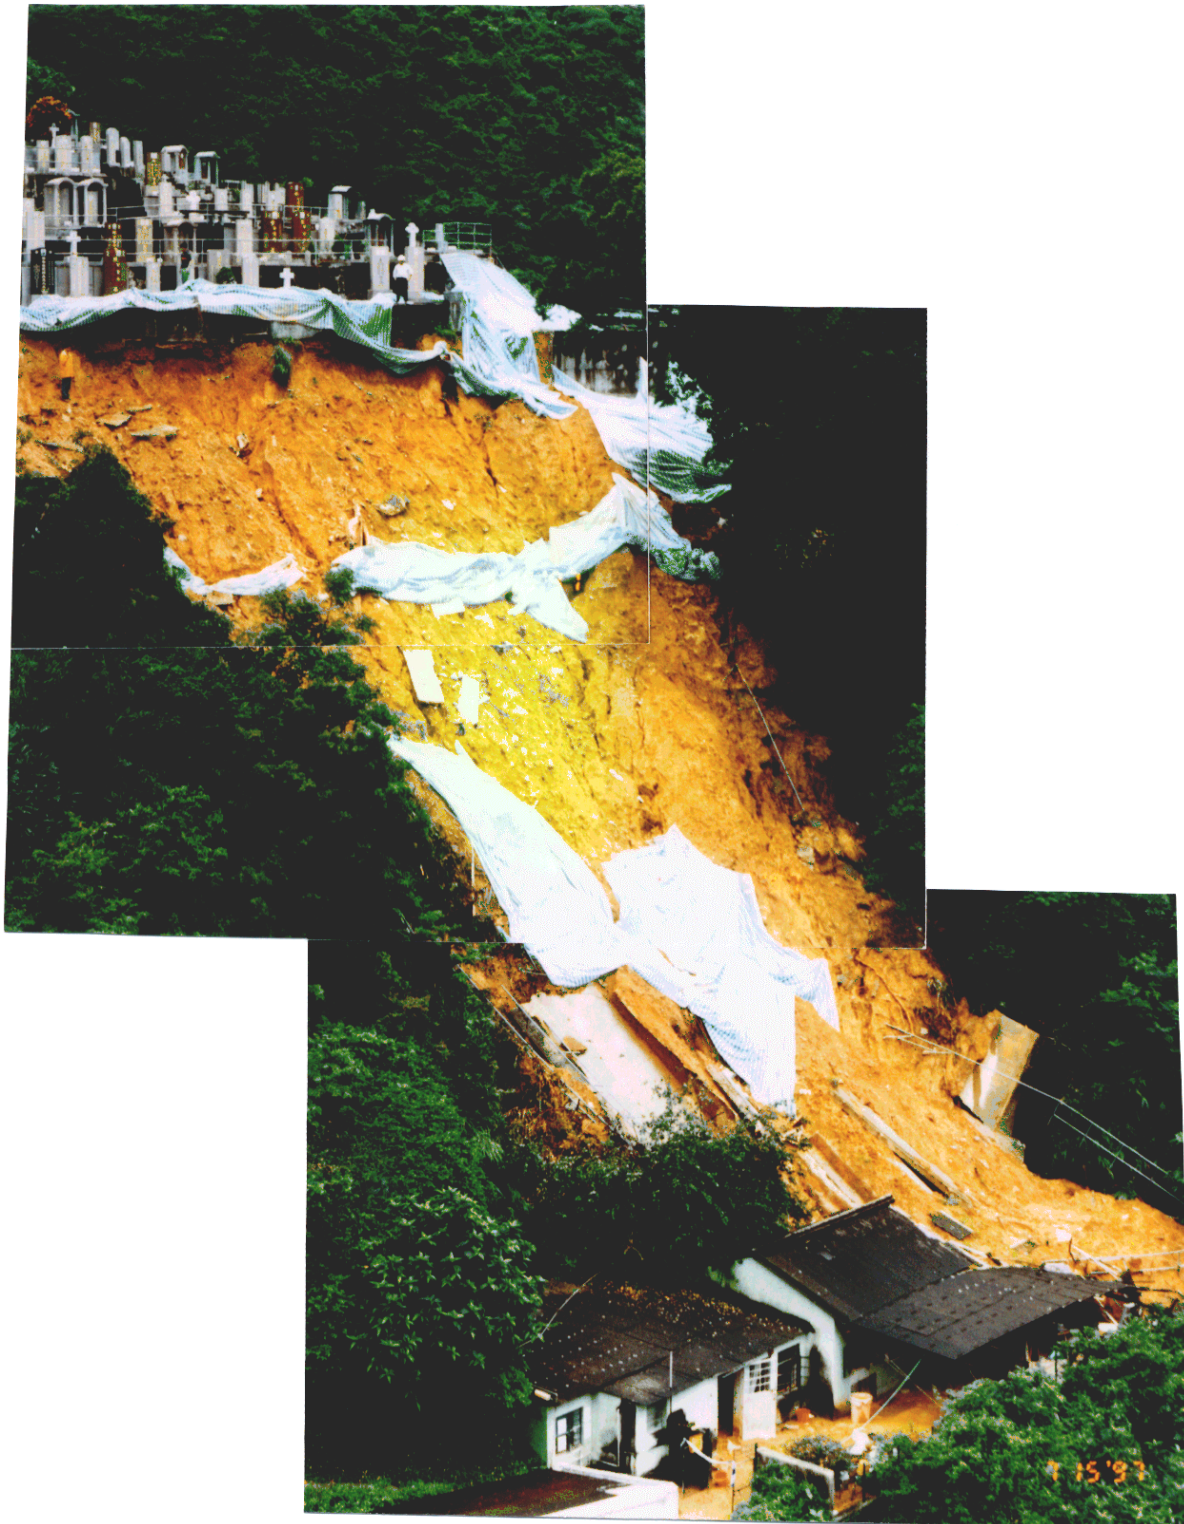
Plate 3 - General View of Landslide B on the Eastern Slope
(Photograph Taken by GEO on 15 July 1997)
