**SECTION 3:  
DETAILED STUDY OF THE  
LANDSLIDE AT  
GLORIOUS PRAISE CHRISTIAN  
CENTRE, KWAI CHUNG  
ON 8 MAY 1997**

**Halcrow Asia Partnership Ltd**

**This report was originally produced in July 1998  
as GEO Landslide Study Report No. LSR 5/98**

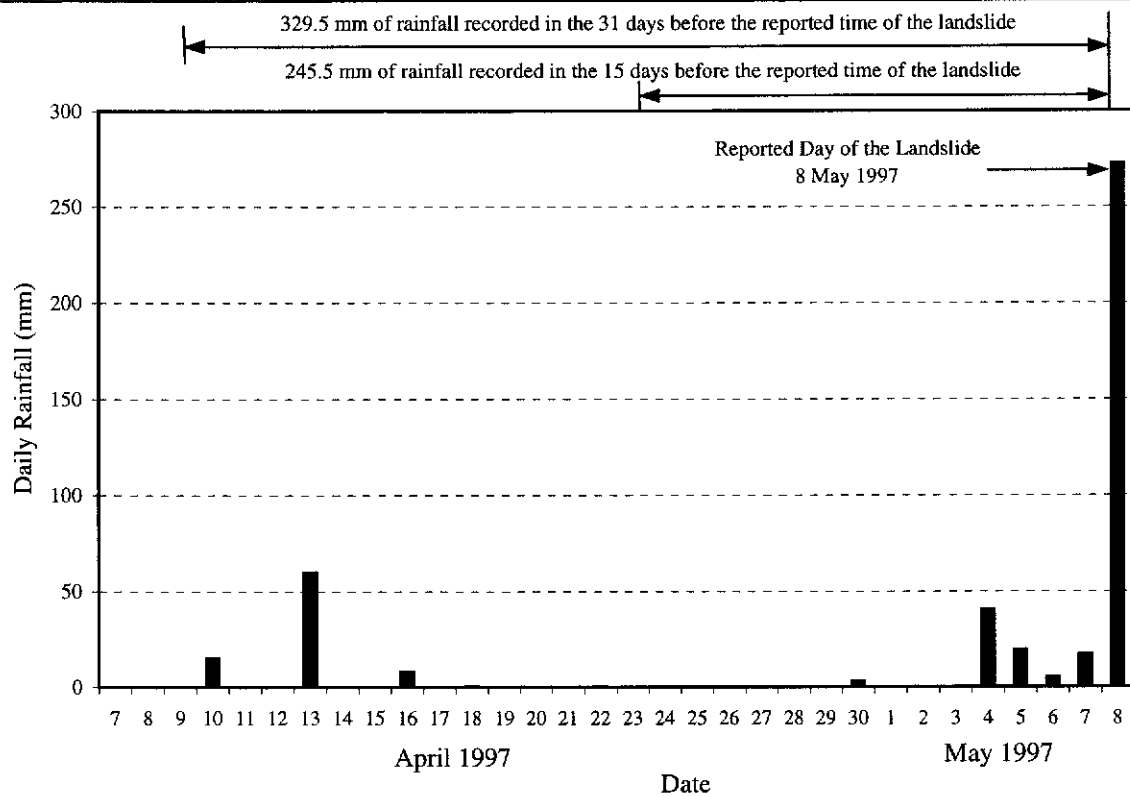
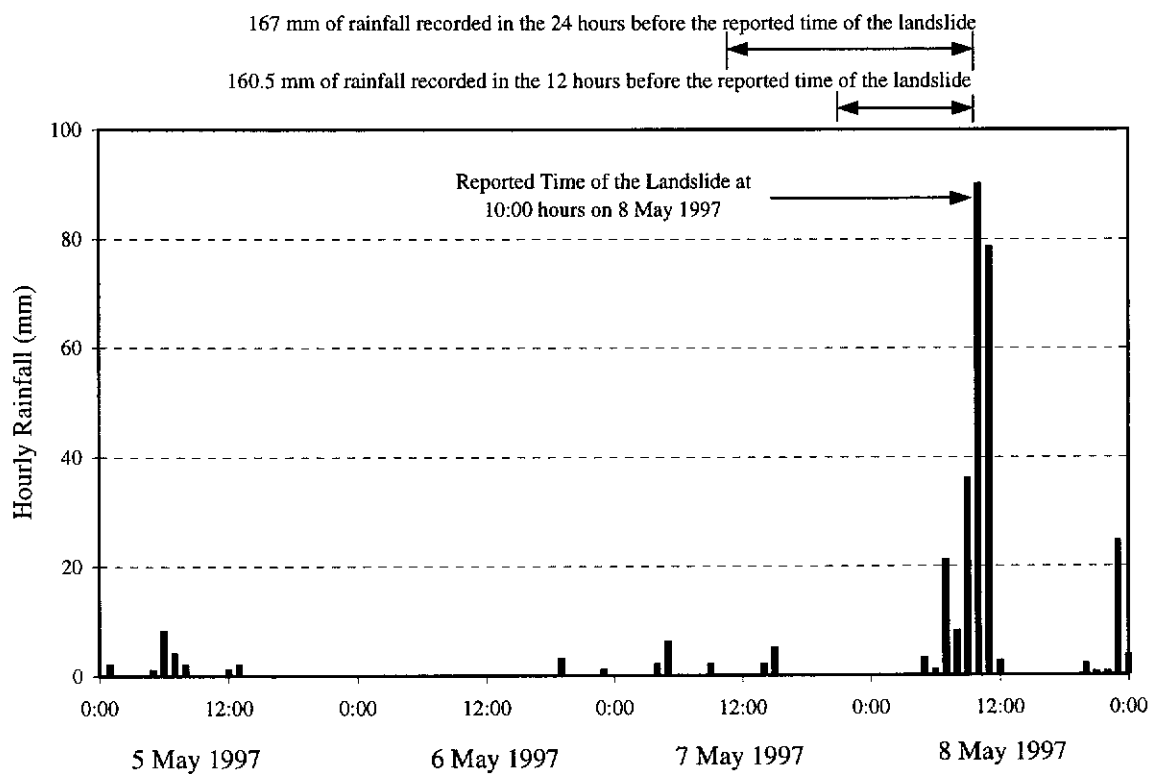
Figure 5 - Rainfall Recorded at GEO Raingauge No. N03

The nearest GEO automatic raingauge No. N03 is located at Tsuen Wan Treatment Works, Shing Mun Road, about 400 m to the northwest of the landslide (Figure 1). The daily rainfall recorded in April and May 1997 is shown in Figure 5a. There was 441.5 mm and 357.5 mm of rainfall in the 31 days and 15 days before the landslide respectively. The hourly rainfall from 5 May to 8 May 1997 is shown in Figure 5b. There was 167 mm and 160.5 mm of rainfall in the 24 hours and 12 hours before the landslide respectively. Isohyets of rainfall prior to the landslide on 8 May 1997 are shown in Figure 6. The figure shows that the distribution of peak intensity rainfall was centered about 7 km east northeast of the site.

(a) Daily Rainfall Recorded between 7 April and 8 May 1997

(b) Hourly Rainfall Recorded between 5 May and 8 May 1997

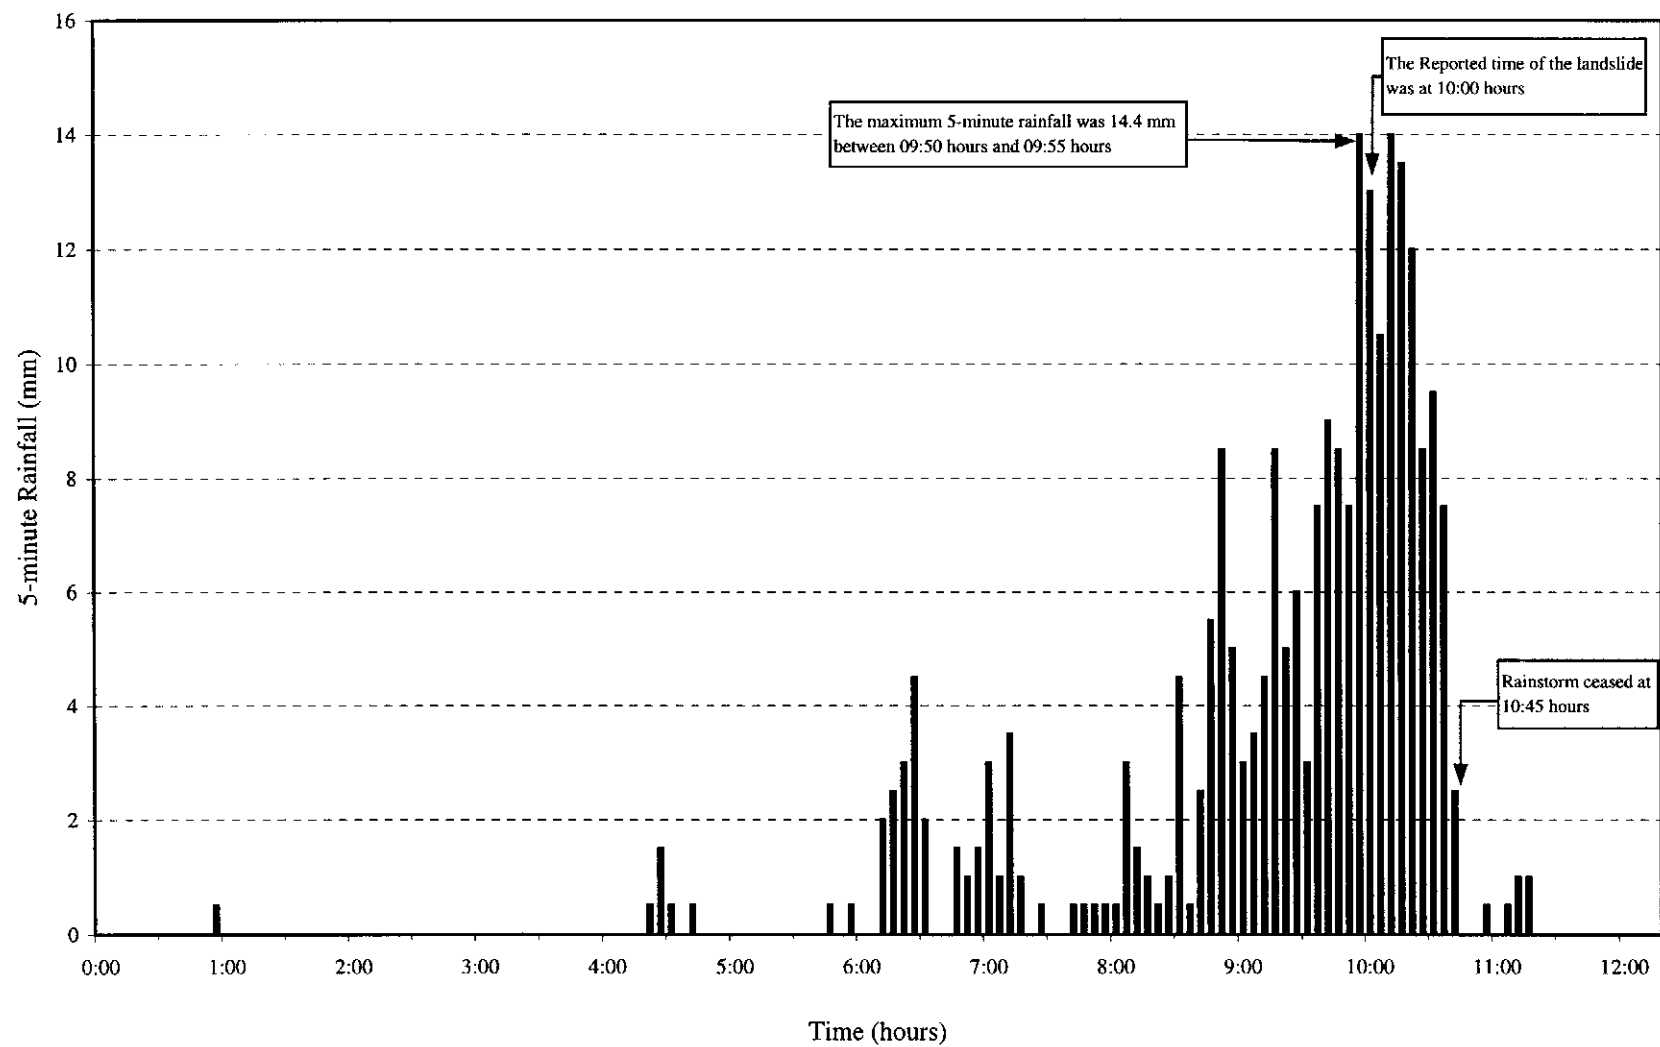
Figure 7 - Rainfall Recorded at GEO Raingauge No. N03 at 5-minute Intervals on 8 May 1997

The rainfall recorded at GEO raingauge No. N03 at 5-minute intervals is shown in Figure 7. The figure shows that the maximum 5-minute rainfall was 14.4 mm between 09:50 hours and 09:55 hours. In addition, the figure shows that there was 45 minutes of heavy rainfall after the reported time of the landslide at 10:00 hours on 8 May 1997.
