**SECTION 4:
DETAILED STUDY OF THE
LANDSLIDE NEAR
LIDO BEACH,
CASTLE PEAK ROAD
ON 2 JULY 1997**

Halcrow Asia Partnership Ltd

**This report was originally produced in June 1998
as GEO Landslide Study Report No. LSR 8/98**

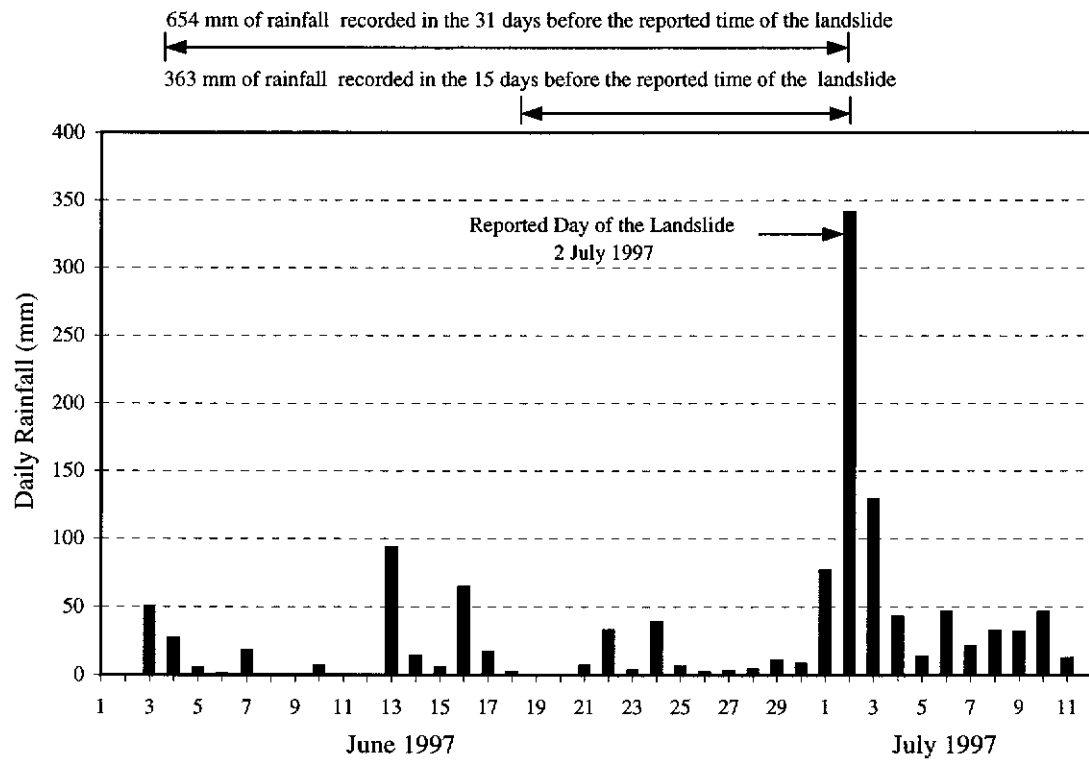
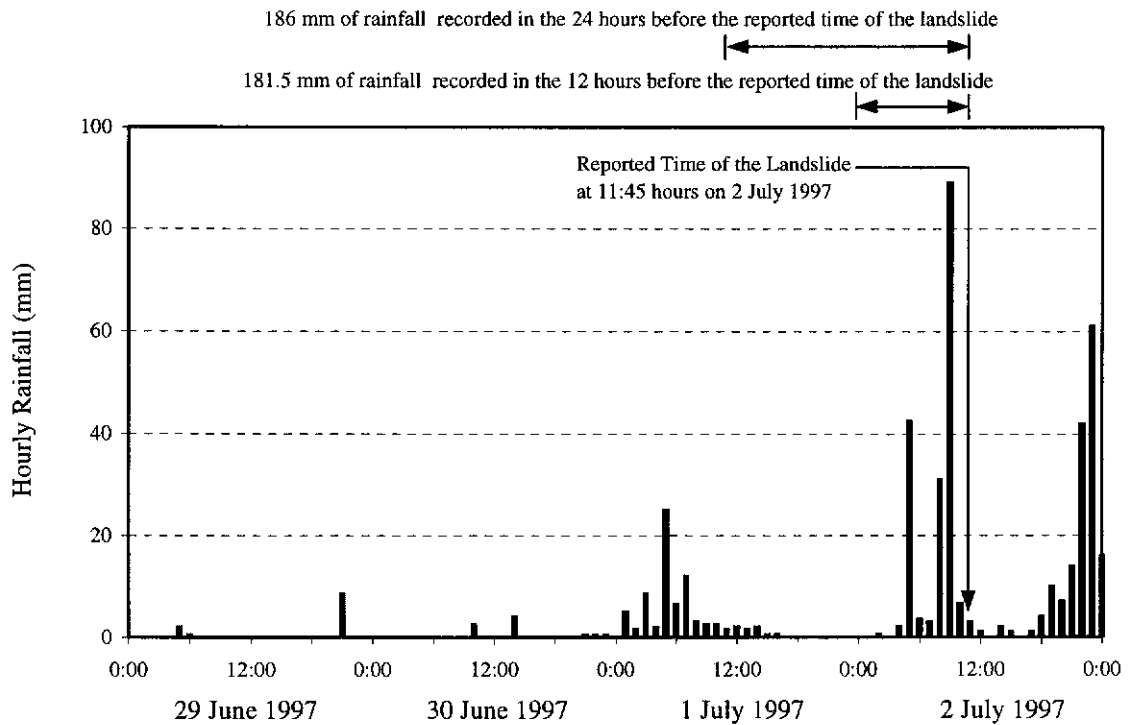
Figure 5 - Rainfall Recorded at GEO Raingauge No. N10

The nearest GEO automatic raingauge No. N10 is located at Sham Tseng Emmanuel Primary School, about 2 km west of the landslide site. The daily rainfall recorded in June and July 1997 is shown in Figure 5a. There was 492.5 mm and 208.5 mm of rainfall in the 31 days and 15 days before the landslide respectively. The hourly rainfall from 29 June to 2 July 1997 is shown in Figure 5b. There was 186 mm and 181.5 mm of rainfall in the 24 hours and 12 hours before the landslide respectively. Isohyets of rainfall prior to the landslide on 2 July 1997 are shown in Figure 6. The figure shows that the distribution of peak intensity of rainfall was centered about 14.5 km east northeast of the site.

(a) Daily Rainfall Recorded between 1 June and 12 July 1997

(b) Hourly Rainfall Recorded between 29 June and 2 July 1997

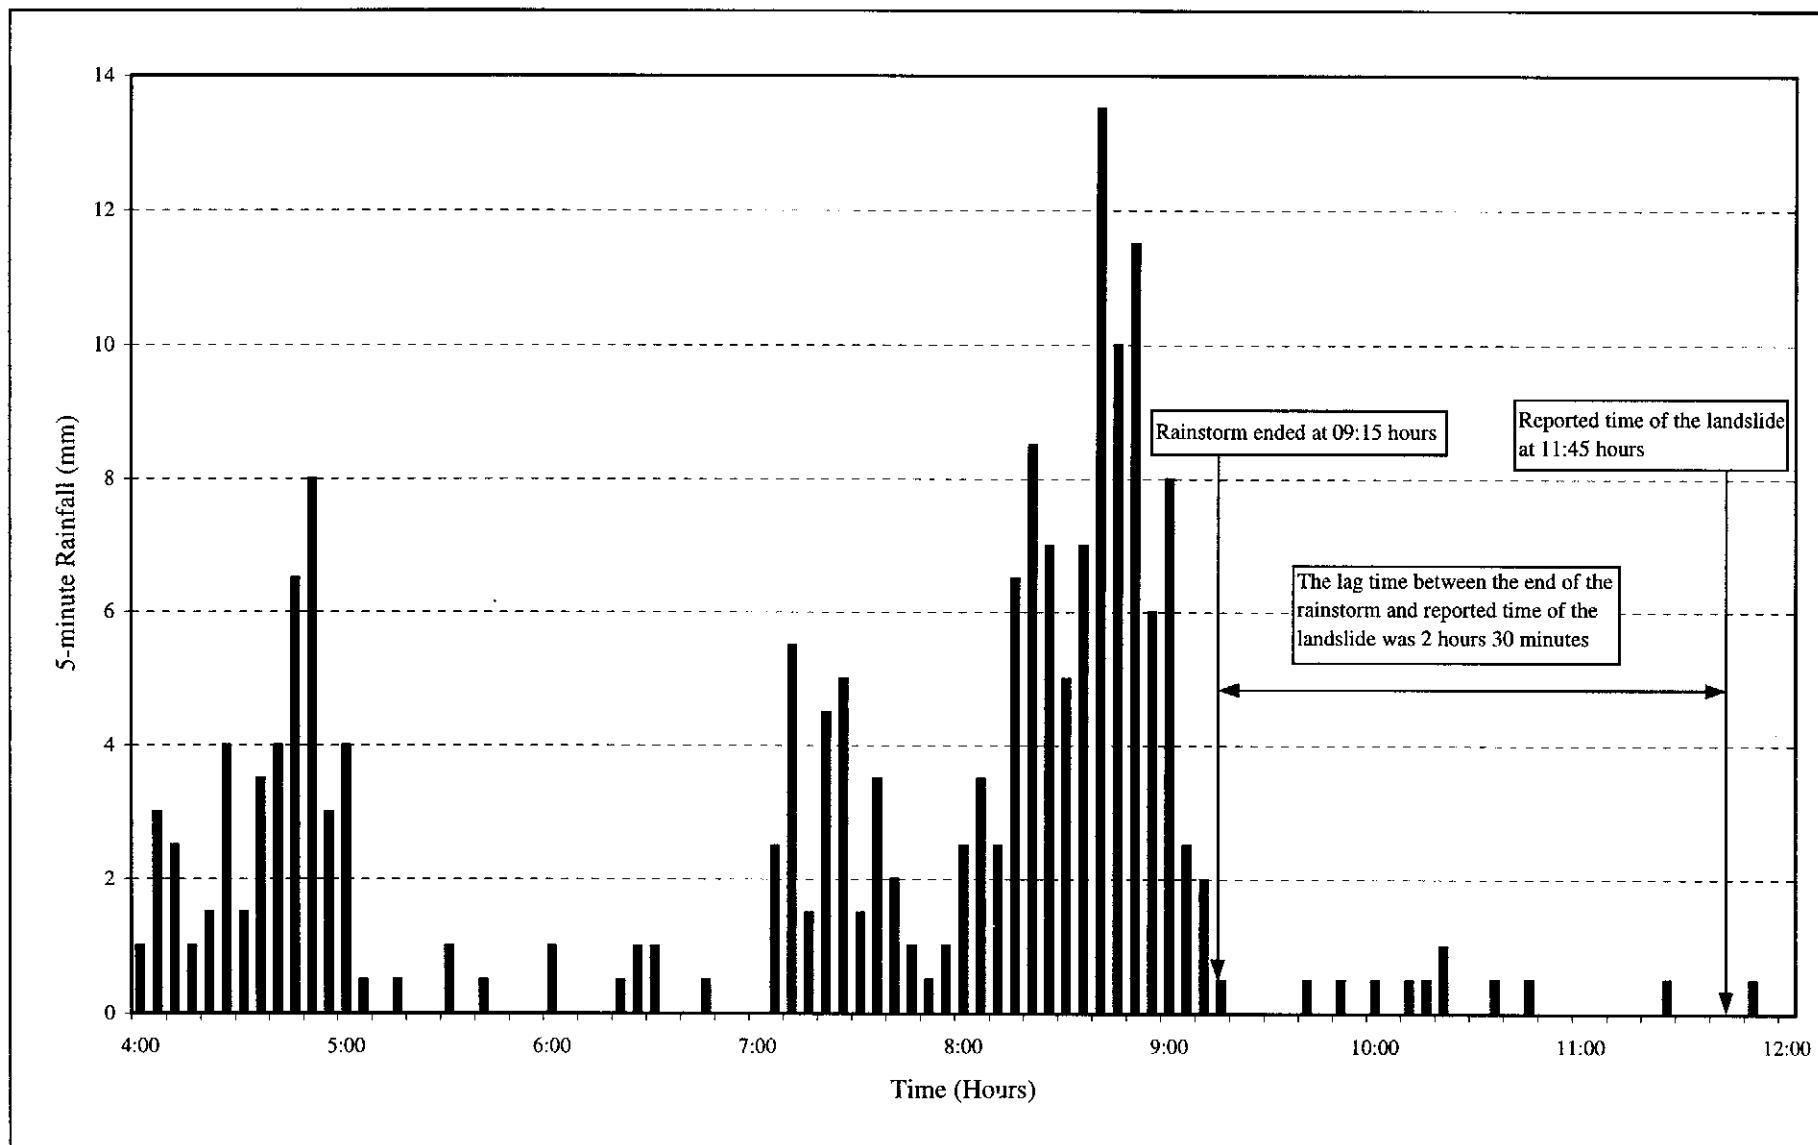
Figure 7 - Rainfall Recorded at GEO Raingauge No. N10 at 5-minute Intervals on 2 July 1997

The rainfall recorded at GEO raingauge No. N10 at 5-minute intervals on 2 July 1997 is shown in Figure 7. The figure shows that there was a lag of about 2.5 hours between the end of the rainstorm and the reported time of the landslide at 11:45 hours on 2 July 1997.

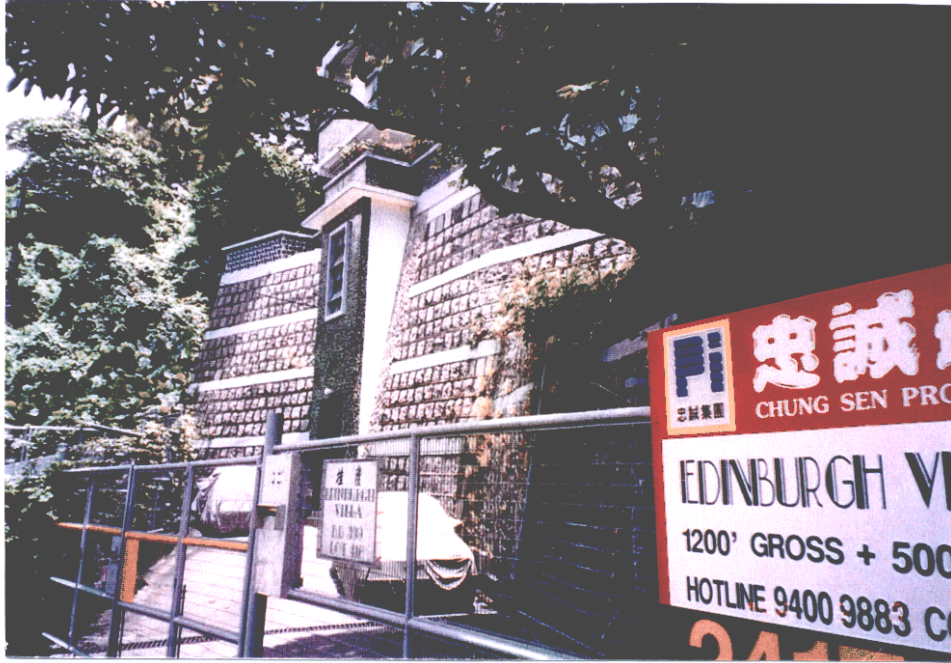
Plate 2 - View of No. 370 Edinburgh Villas (Photograph Taken on 3 June 1997)
(Note the Slope on which the Main Landslide Occurred is Visible on the Left-hand side of the Photograph)

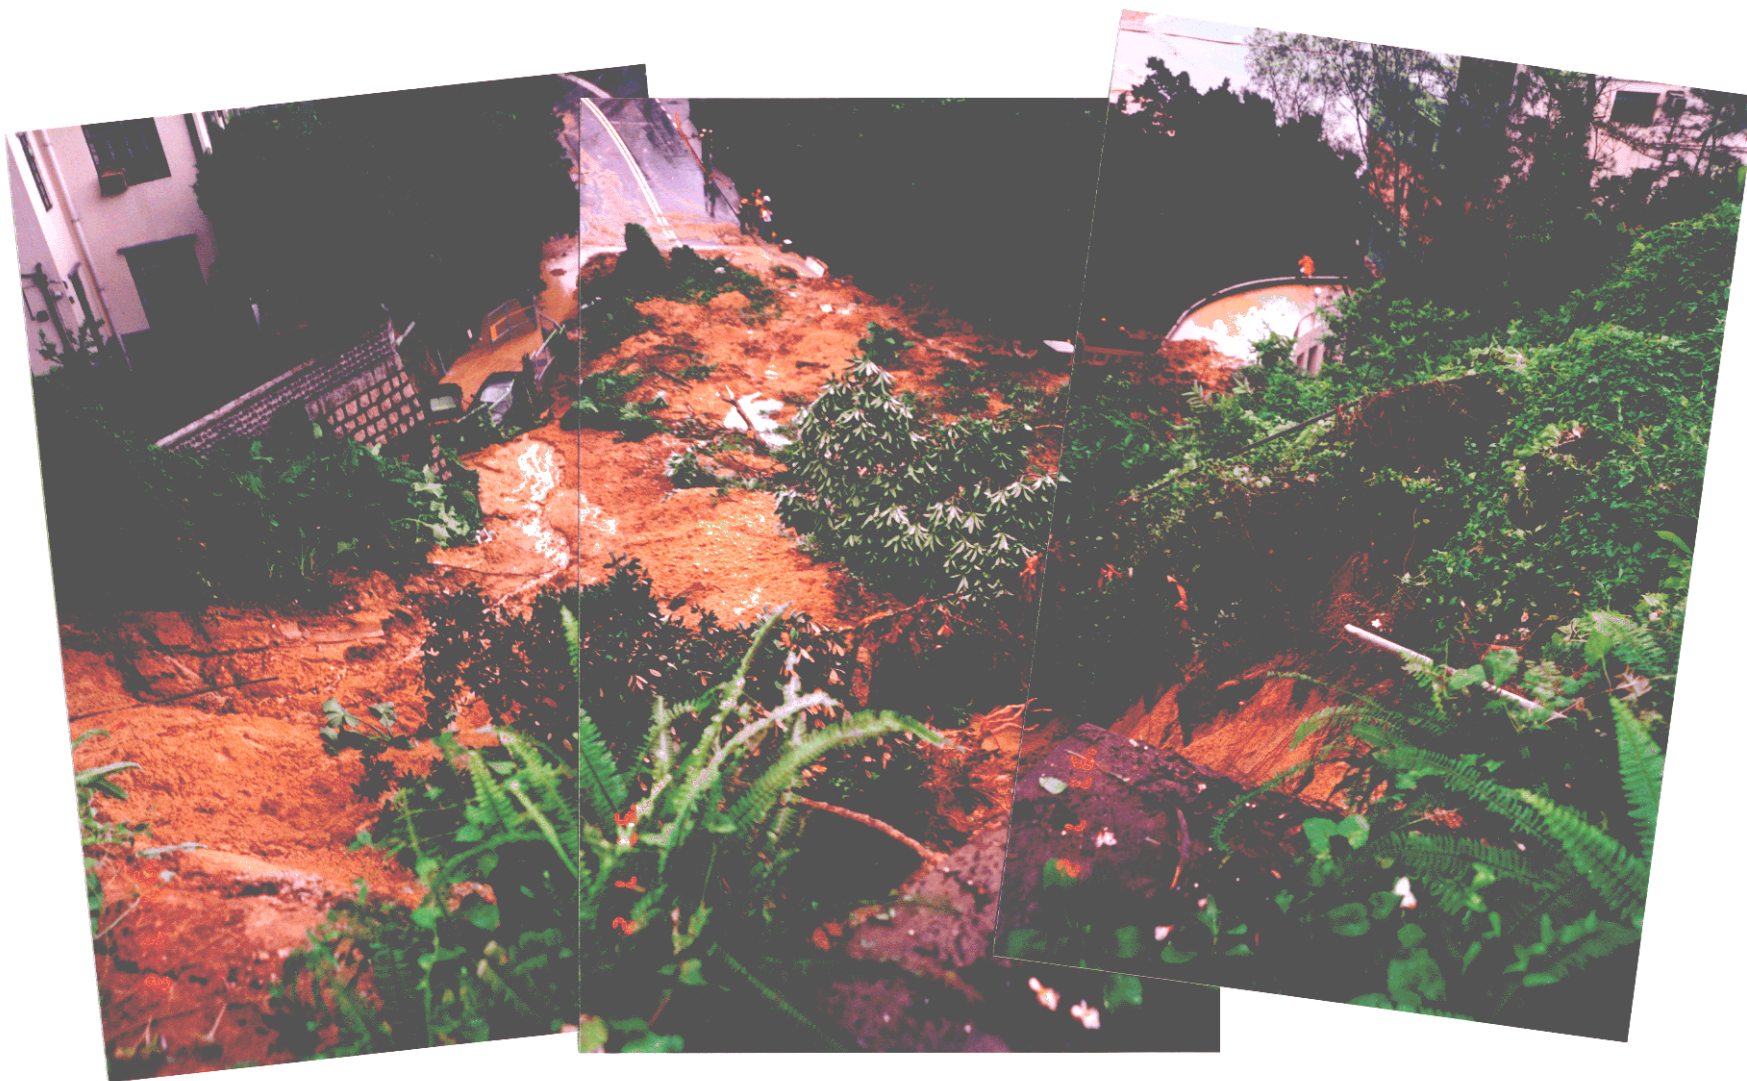
both lanes. A fully-laden stationary dump truck parked on Castle Peak Road was carried by the debris down a 5 m high fill slope (No. 6SE-C/FR52) into the garden of Riviera Apartments (Plate 6). A 5 m long section of the pavement above the fill slope was undermined around a service access chamber as a result of washout and surface water run-off after the landslide. The debris on Castle Peak Road was about 30 m wide and up to 1.5 m deep (Plate 7).

Plate 7 - View from the Crest of the Main Landslide (Photograph Taken on 2 July 1997)
