**INVESTIGATION OF SOME
SELECTED LANDSLIDE
INCIDENTS IN 1997
(VOLUME 4)**

GEO REPORT No. 90

**SECTION 1:
DETAILED STUDY OF THE
LANDSLIDE AT
ST. JOSEPH'S ANGLO
CHINESE SCHOOL
NGAU TAU KOK
ON 3 AUGUST 1997**

**This report was originally produced in November 1998
as GEO Landslide Study Report No. LSR 17/98**

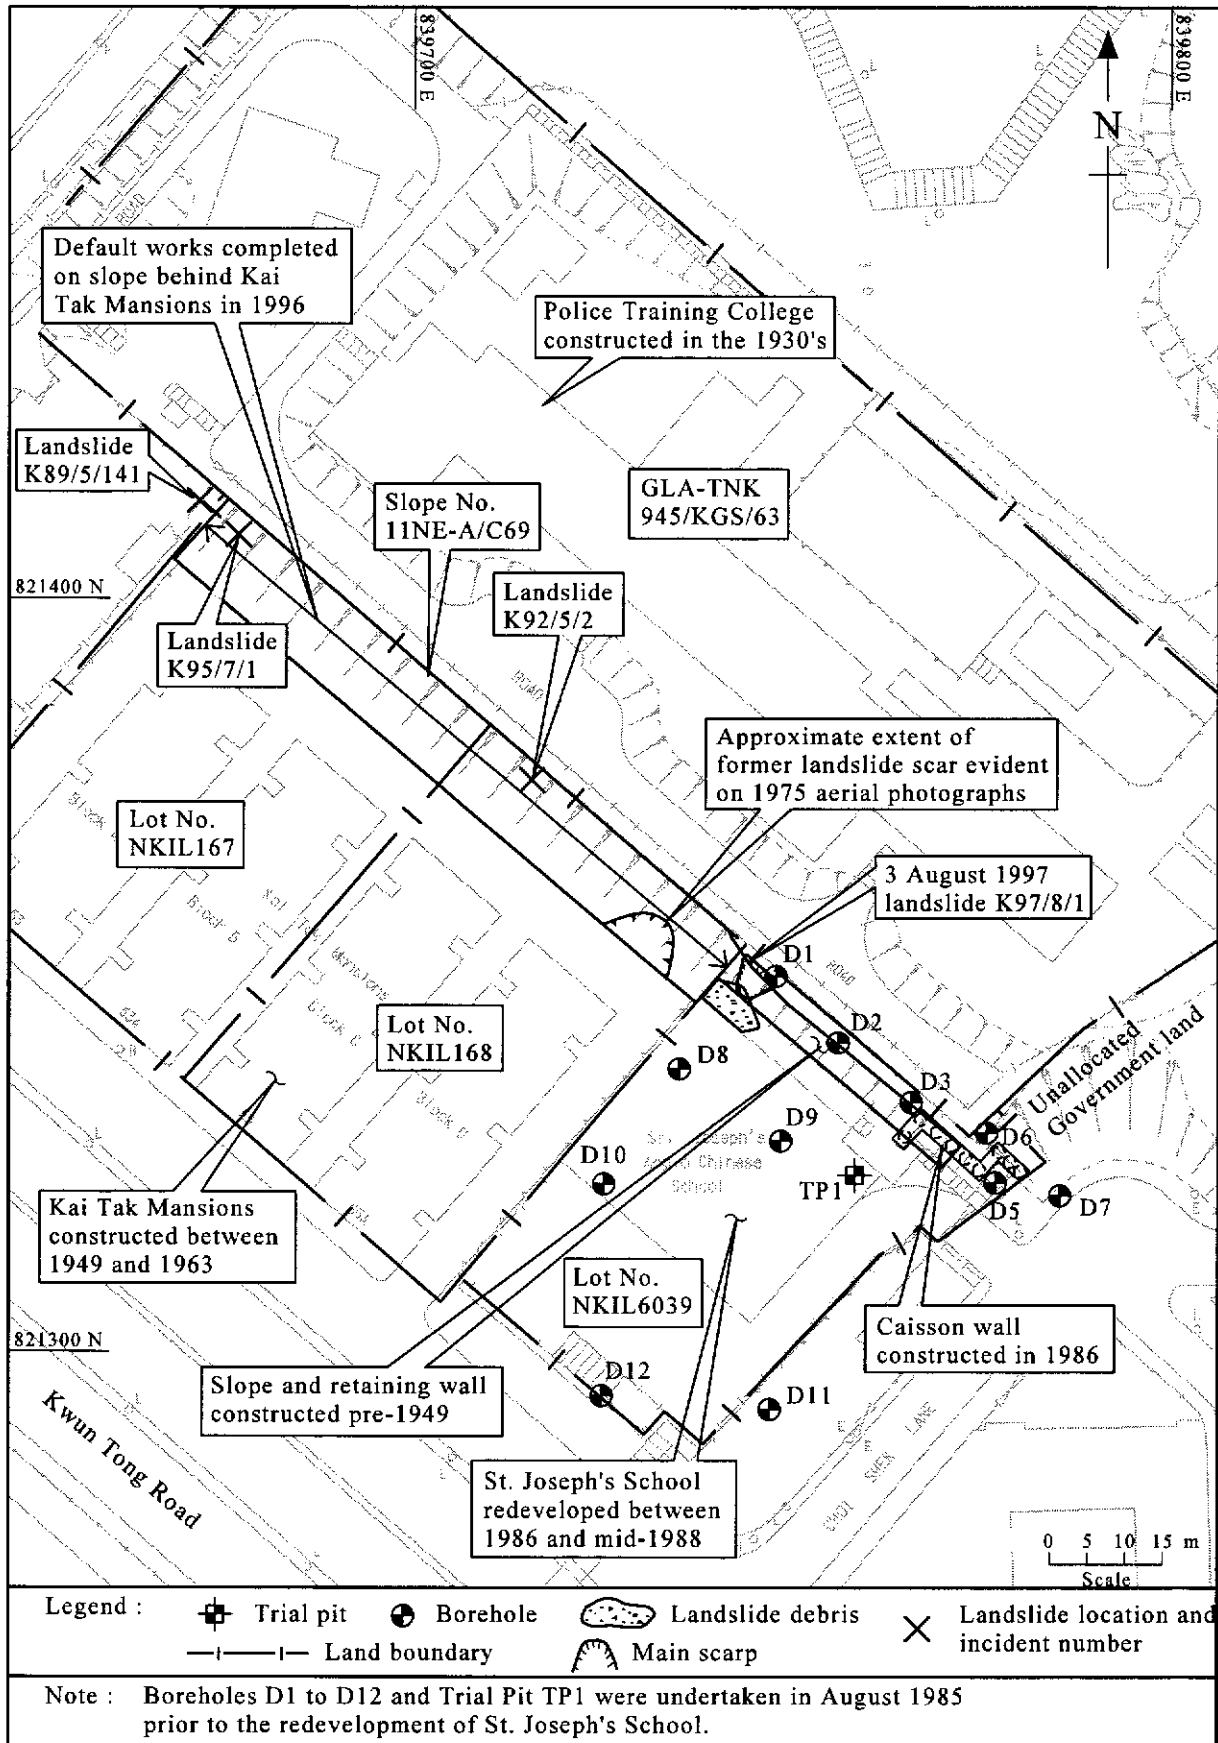
Figure 3 - Land Status and History of Development

Photographic and other documentary records provide evidence of three further failures. A failure scar approximately 6 m by 12 m towards the base of the slope behind Block D of Kai Tak Mansions was noted on aerial photographs dated December 1975 (Figure 3). A report by Maunsell Geotechnical Services (MGS, 1985) refers to a small failure that occurred behind the school sometime between 1975 and 1977. The failure was reported to have occurred "at the bottom part of the slope about 8 to 10 years ago. A rock overhang was left there and hence two I-beam/concrete composite columns have been cast to support the overhang. No further instability has been reported either before or since then." The exact location of this failure is not known.

A contiguous cantilevered caisson wall was constructed along the eastern boundary of the site to provide space for vehicular access to the school from Choi Shek Lane (Figure 3). It would appear that only minor trimming and chunam repairs were considered necessary for the rest of the slope.

The locations of exploratory holes and a trial pit carried out prior to redevelopment of the school are shown in Figure 3. A review of the borehole records indicates that the top of the moderately to slightly decomposed granite bedrock dips towards the southwest, approximately following the pre-development contours of the original natural terrain.

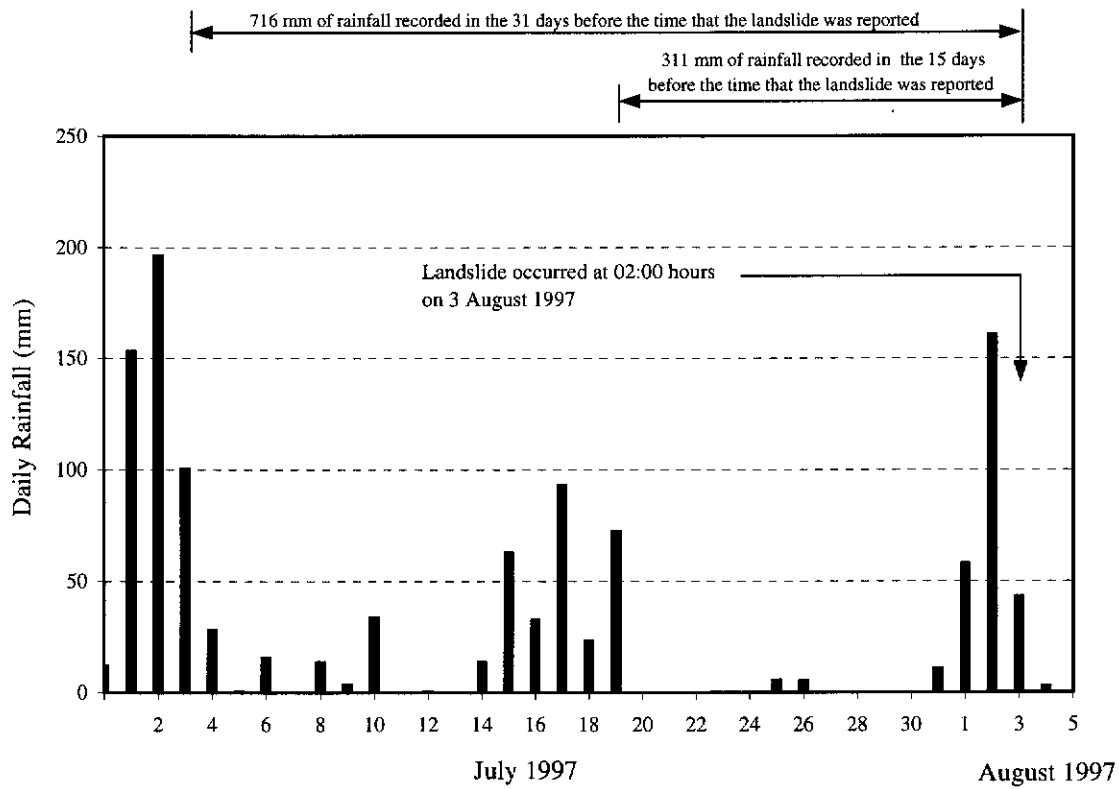
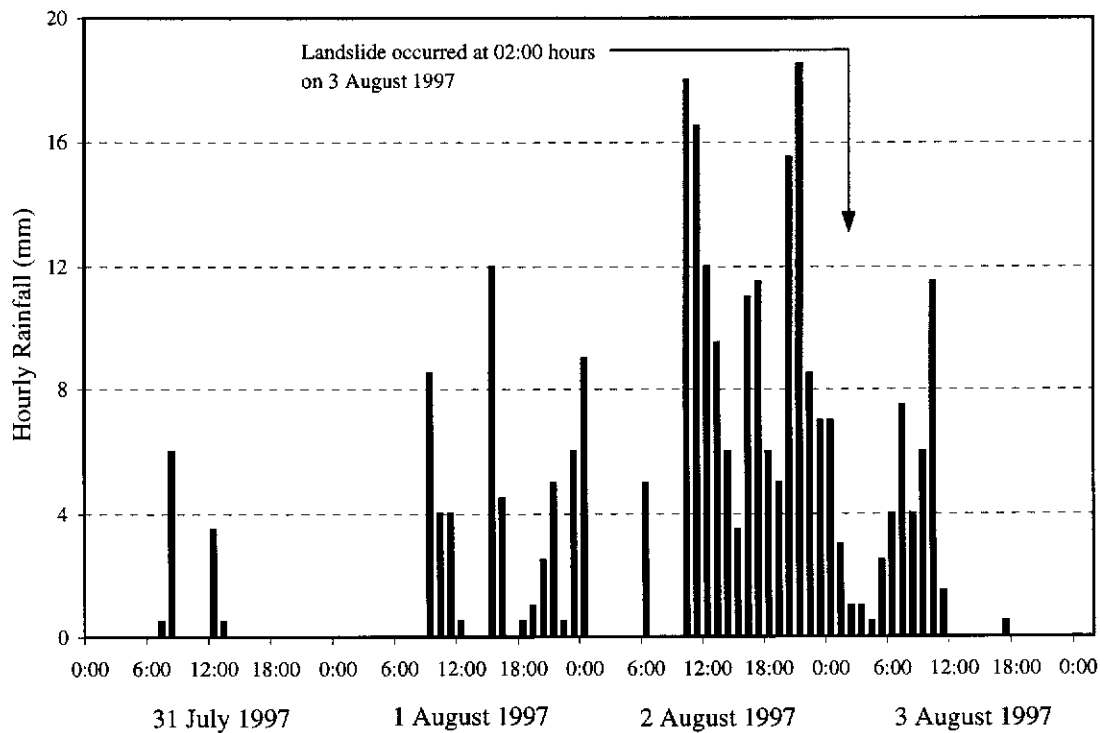
Figure 5 - Rainfall Recorded at GEO Raingauge No. K04

The nearest GEO automatic raingauge No. K04 is located at Lee Cheung House, Shun Lee Estate, Lee On Road, about 1.5 km to the east of the site of the landslide. The daily rainfall recorded in July and early August 1997 and the clock hourly rainfall from 31 July 1997 to 3 August 1997 are shown in Figure 5. Figure 5a shows that the early August rainstorm associated with the landslide followed two periods of significantly wet weather in July. If the reported time of failure of 02:00 hours on 3 August 1997 is correct, the landslide occurred sometime after the peak of the rainstorm (Figure 5b). The isohyets of rainfall prior to the landslide are shown in Figure 6.

(a) Daily Rainfall Recorded between 1 July and 5 August 1997

(b) Hourly Rainfall Recorded between 31 July and 3 August 1997

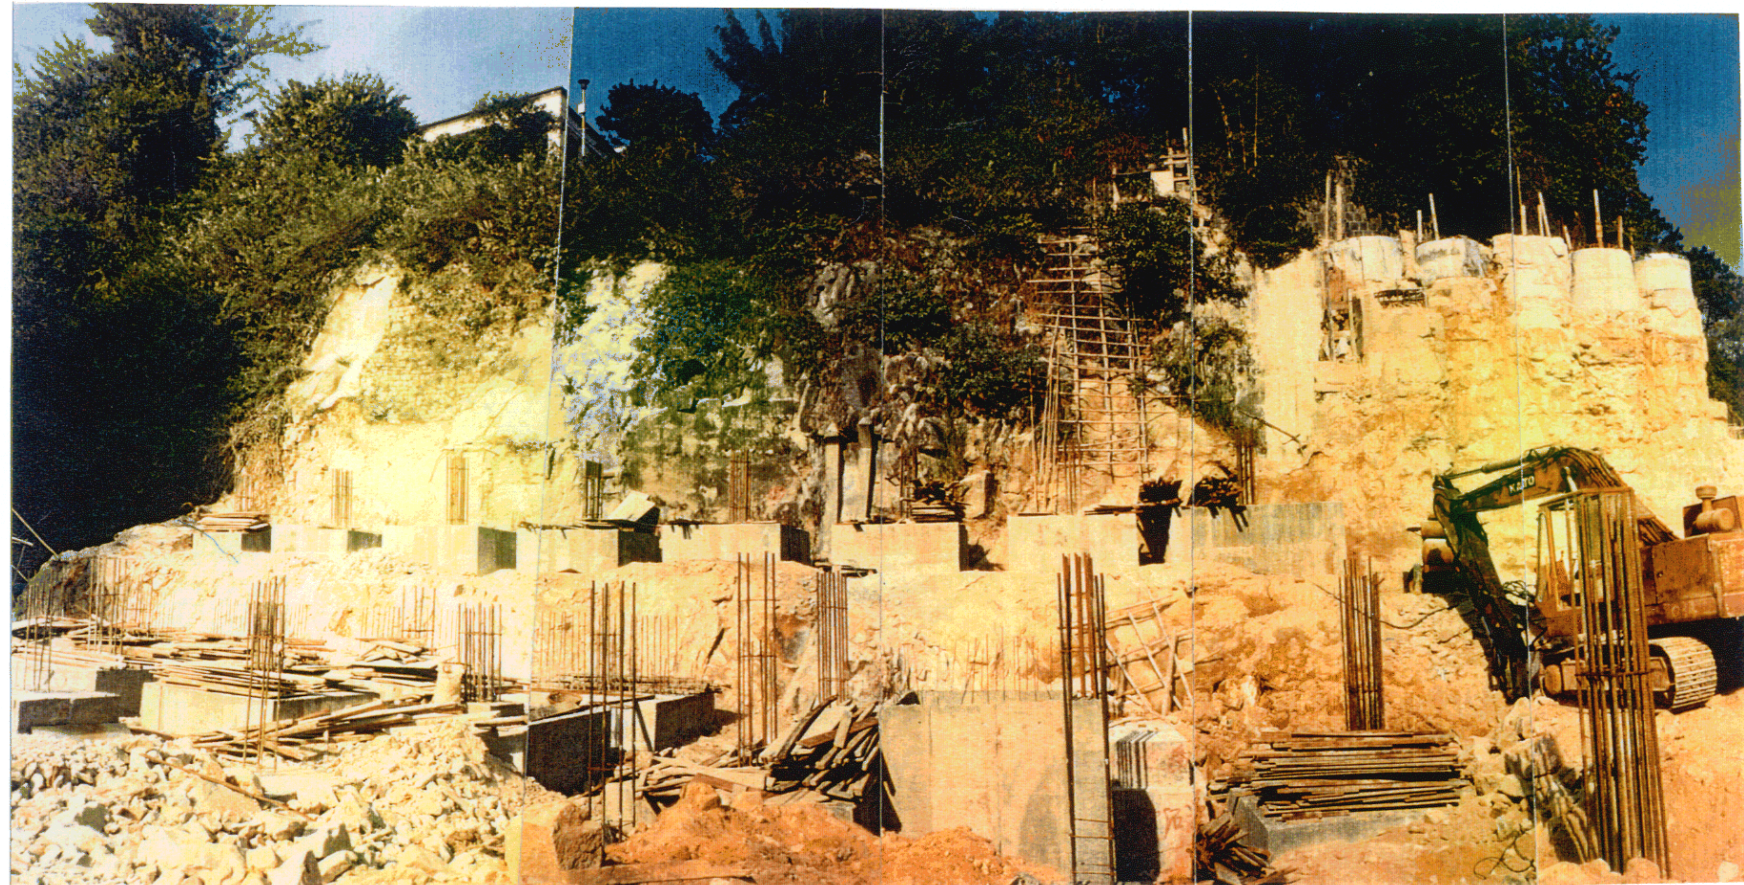
Plate 9 - General View of the Slope During the Redevelopment of the School (Photograph Taken on 10 November 1986)
