**SECTION 4:  
DETAILED STUDY OF  
TWO LANDSLIDES  
AT KWAI CHUNG ROAD  
LAI KING  
ON 8 MAY 1997 AND  
4 JUNE 1997**

**Halcrow Asia Partnership Ltd**

**This report was originally produced in November 1998  
as GEO Landslide Study Report No. LSR 20/98**

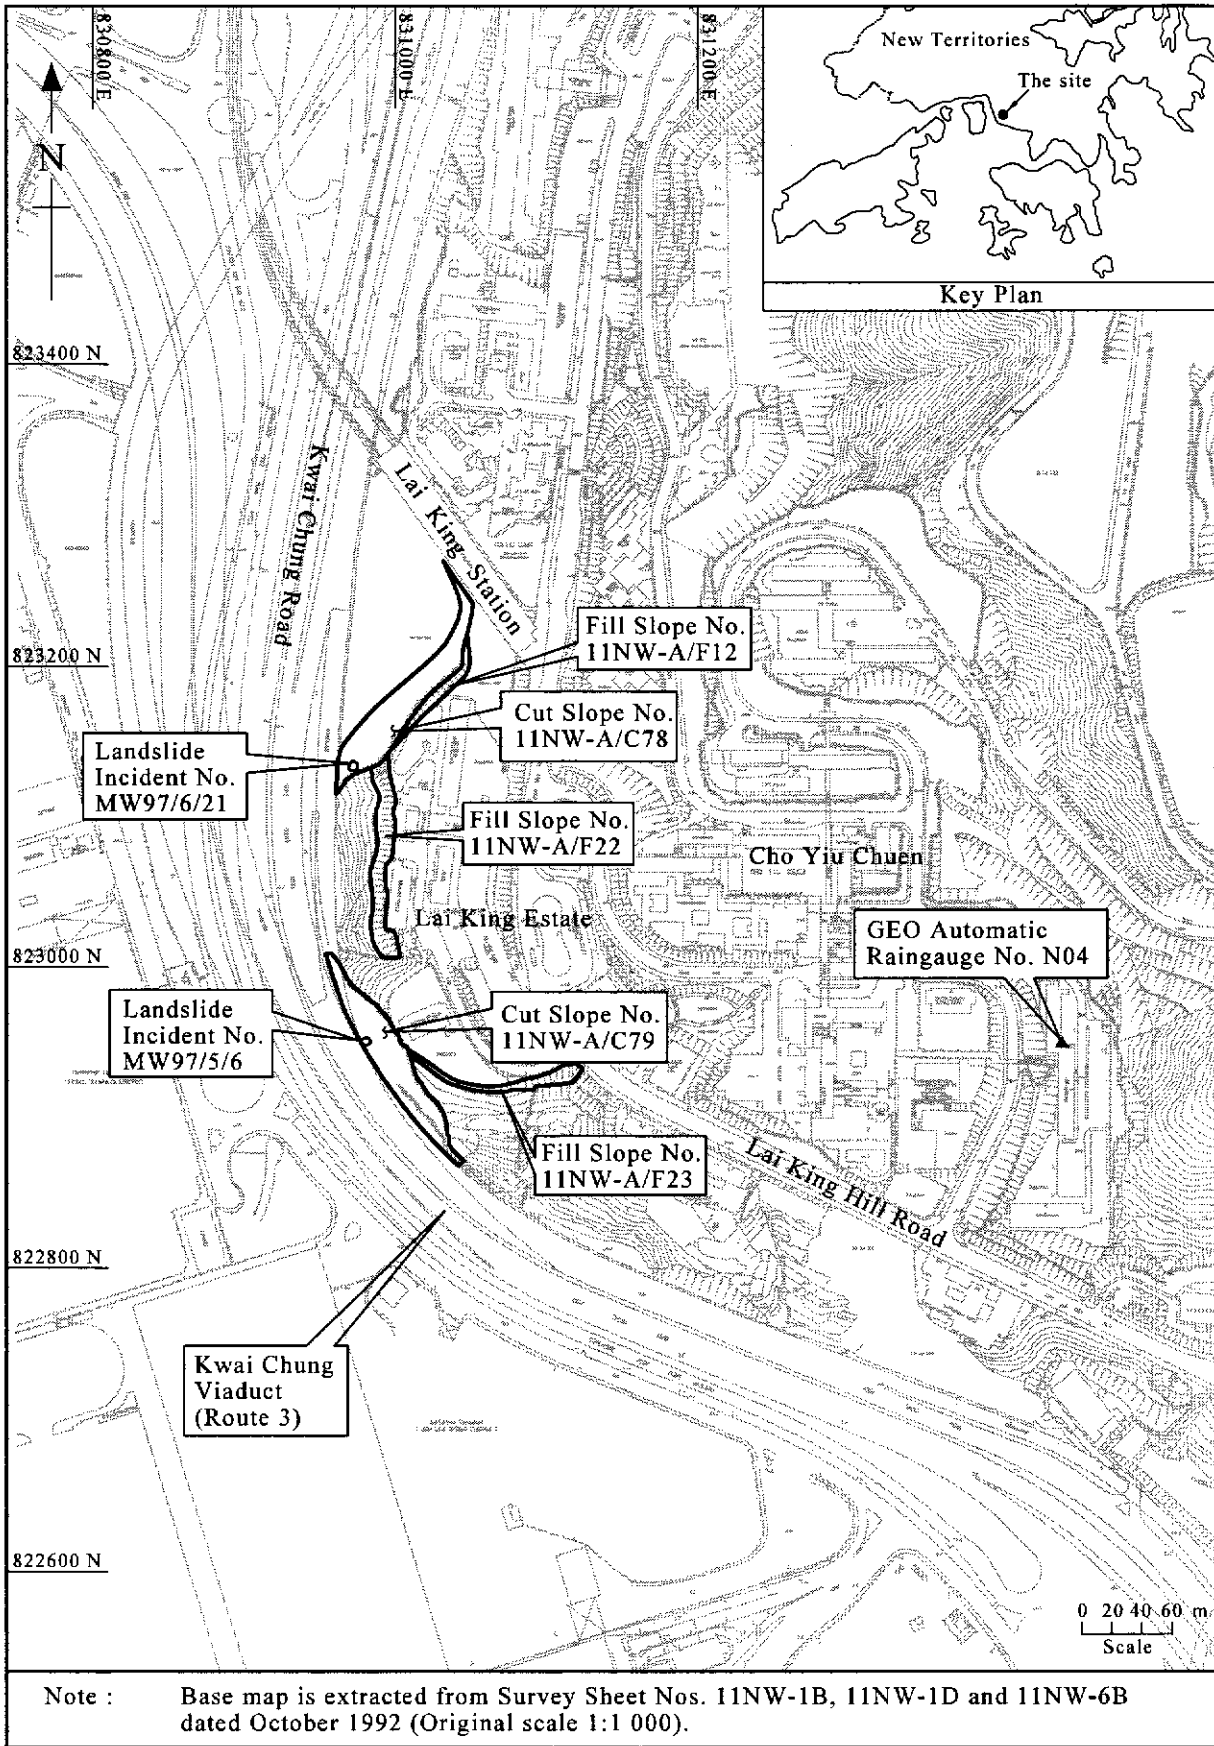
Figure 1 - Location Plan

partly shotcreted and partly vegetated. The cut slope is located on the eastern side of Kwai Chung Viaduct on Route 3 (Figure 1).

The nearest GEO automatic raingauge to the site is No. N04 which is located at Kai Kwang Lau, Cho Yin Estate, Lai King, about 450 m east of the landslides (Figure 1).

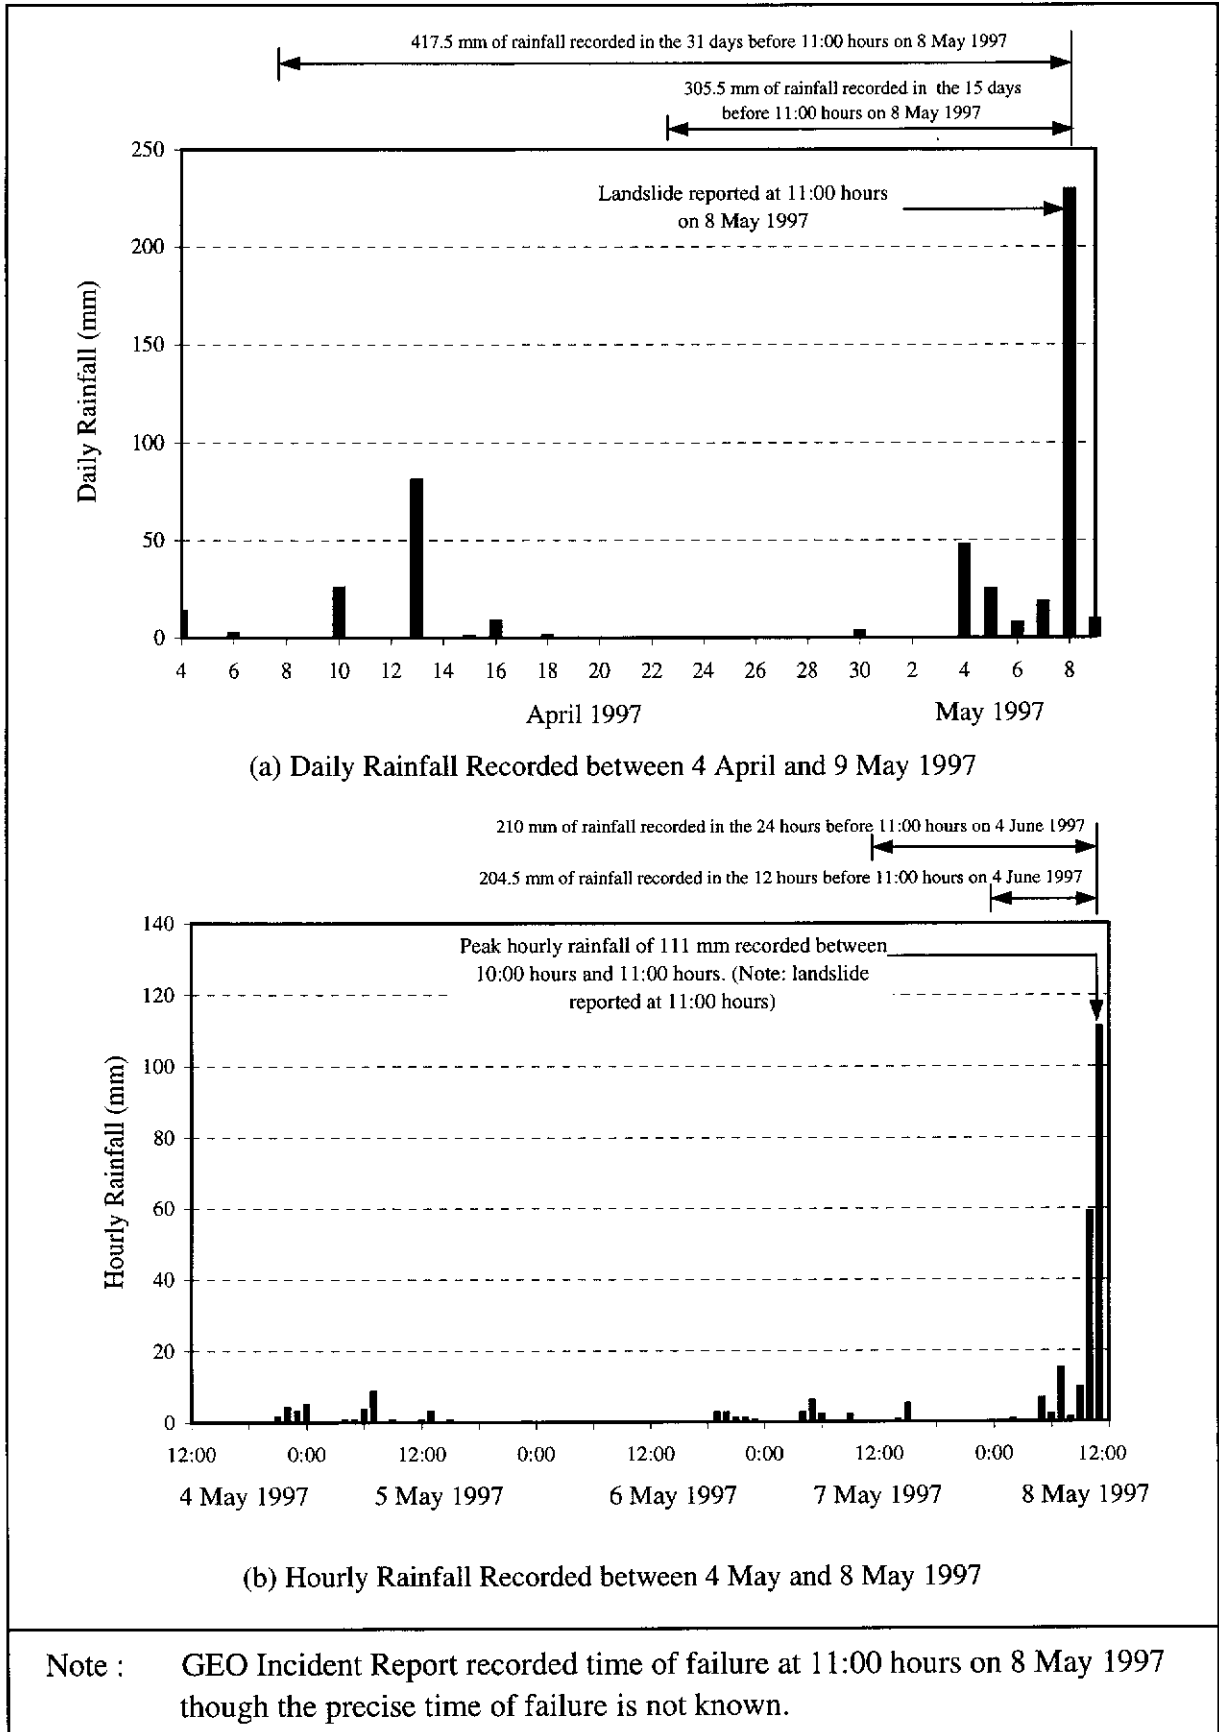
Figure 8 - Rainfall Records at GEO Raingauge No. N04 between 4 April and 9 May 1997

The daily rainfall recorded between 4 April and 9 May 1997, and hourly rainfall recorded between 4 May and 8 May 1997 are shown in Figure 8. An isohyet plot of rainfall distribution between 00:00 hours and 11:00 hours on 8 May 1997 is shown in Figure 9.

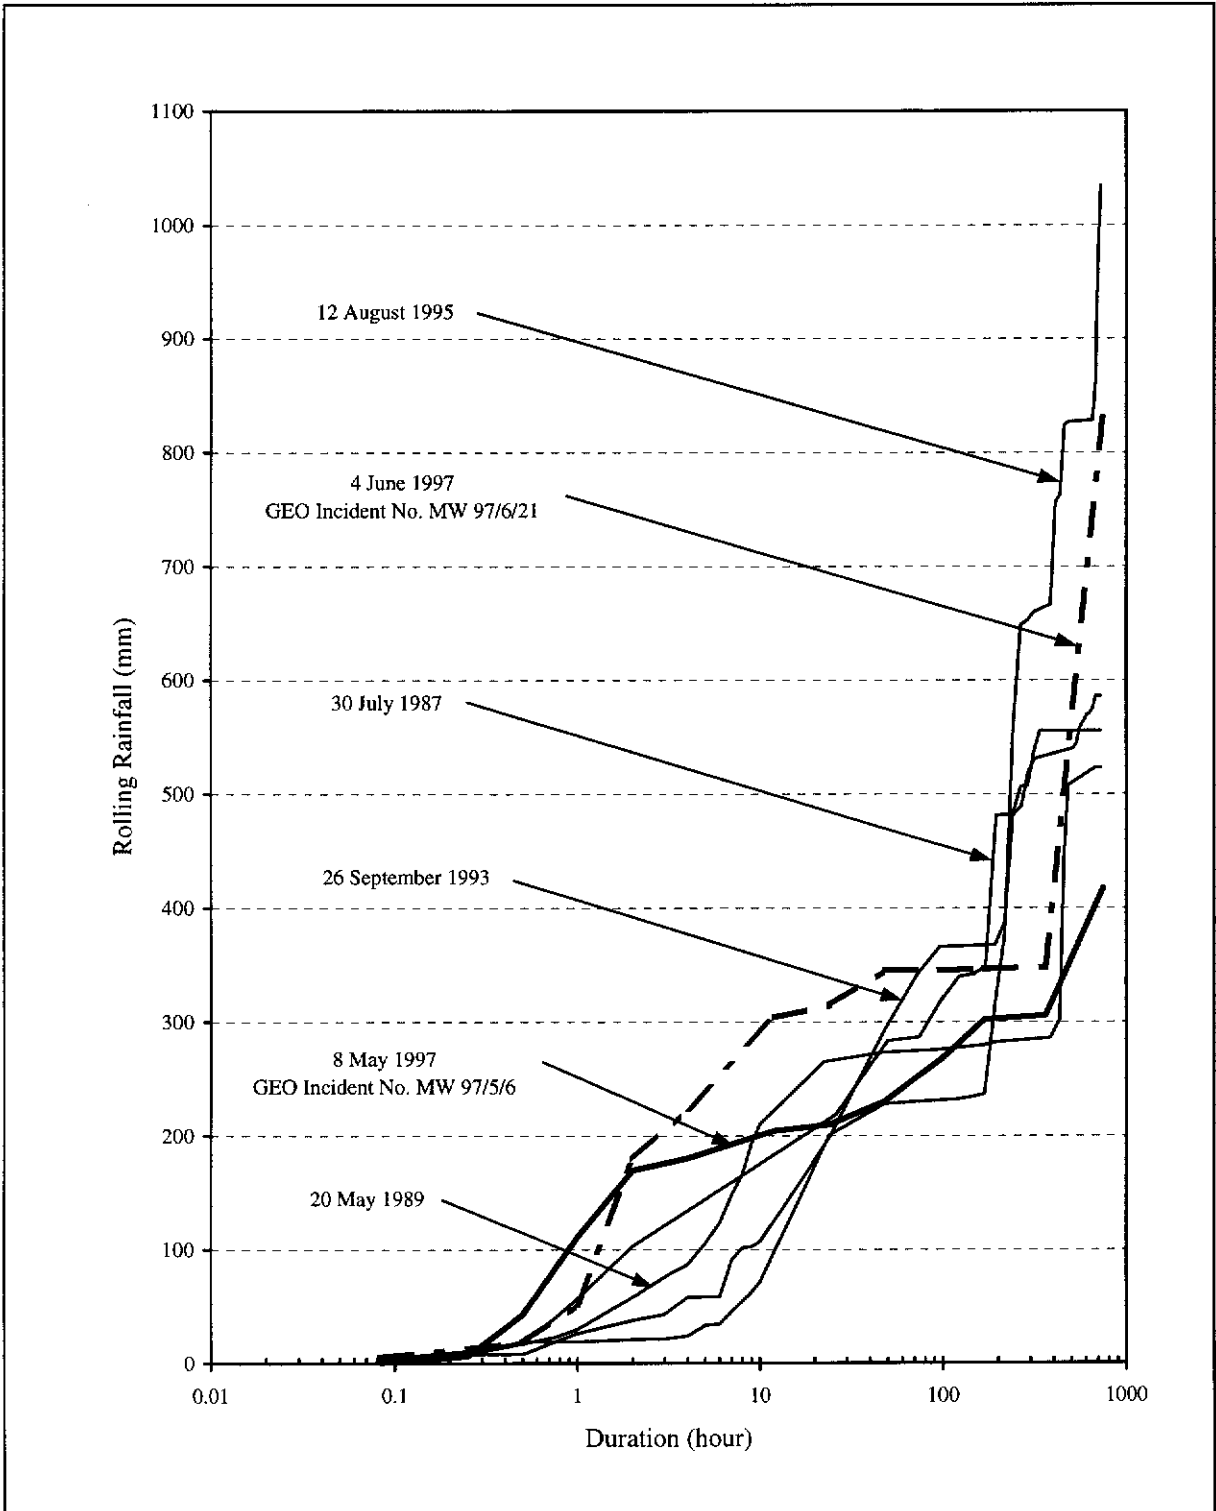
Figure 10 - Maximum Rolling Rainfall at GEO Raingauge No. N04 for Major Rainstorms

A comparison of the rainfall prior to the landslide with previous major rainstorms recorded at raingauge No. N04 is shown in Figure 10. The rainfall preceding the landslide was the highest recorded by the raingauge since its installation in 1978 for durations of less than 8 hours.

A comparison of the rainfall prior to the landslide with previous major rainstorms recorded by raingauge No. N04 is shown in Figure 10. The rainfall preceding the landslide was the highest recorded by the raingauge since its installation in 1978 for durations of between 2 hours and 4 days.

- Notes :
- (1) GEO Incident Report recorded time of failure at 11:00 hours on 8 May 1997 though the precise time of failure is not known.
  - (2) Landslide incident first noted at 08:00 hours on 4 June 1997 by staff at the construction site offices though the precise time of failure is not known.

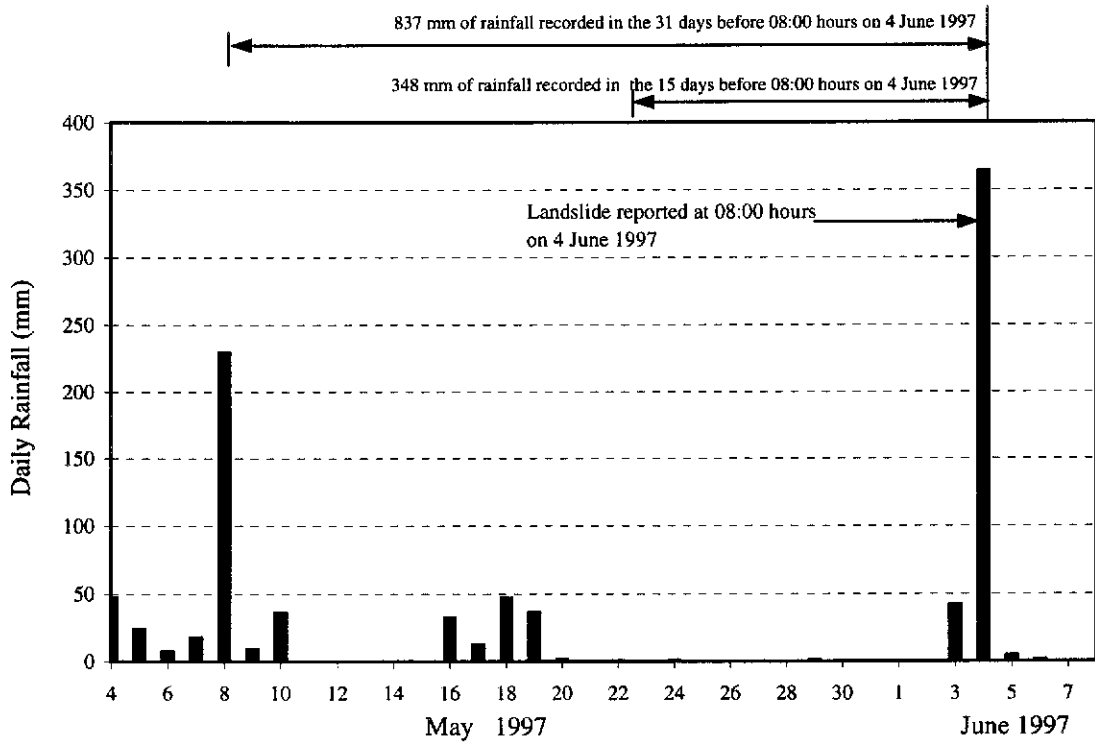
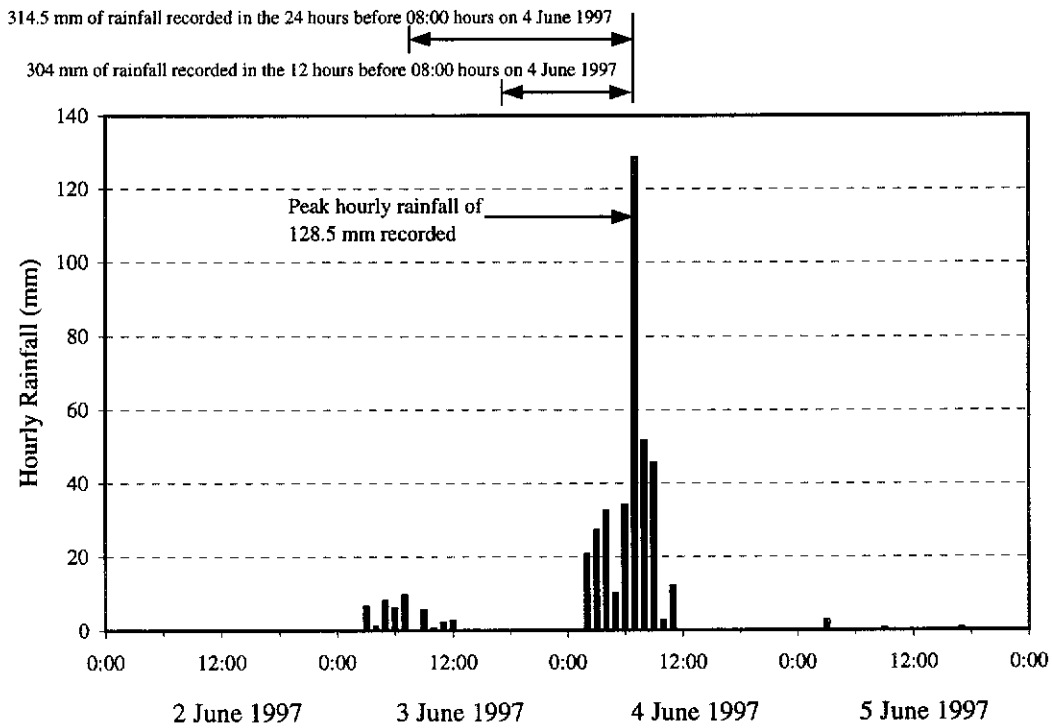
Figure 11 - Rainfall Records at GEO Raingauge No. N04

The daily rainfall recorded between 4 May and 8 June 1997, and hourly rainfall recorded between 1 June and 5 June 1997 are shown in Figure 11. An isohyet plot of rainfall distribution between 00:00 hours and 08:00 hours on 4 June 1997 is shown in Figure 12.

(a) Daily Rainfall Recorded between 4 May and 8 June 1997

(b) Hourly Rainfall Recorded between 2 June and 5 June 1997

Note : Landslide incident first noted at 08:00 hours on 4 June 1997 by staff at the construction site offices though the precise time of failure is not known.
