INVESTIGATION OF SOME SELECTED LANDSLIDE INCIDENTS IN 1997 (VOLUME 5)

GEO REPORT No. 91

**SECTION 1:
DETAILED STUDY OF THE
LANDSLIDE AT
HONG TSUEN ROAD,
SAI KUNG
ON 3 JULY 1997**

**This report was originally produced in December 1998
as GEO Landslide Study Report No. LSR 21/98**

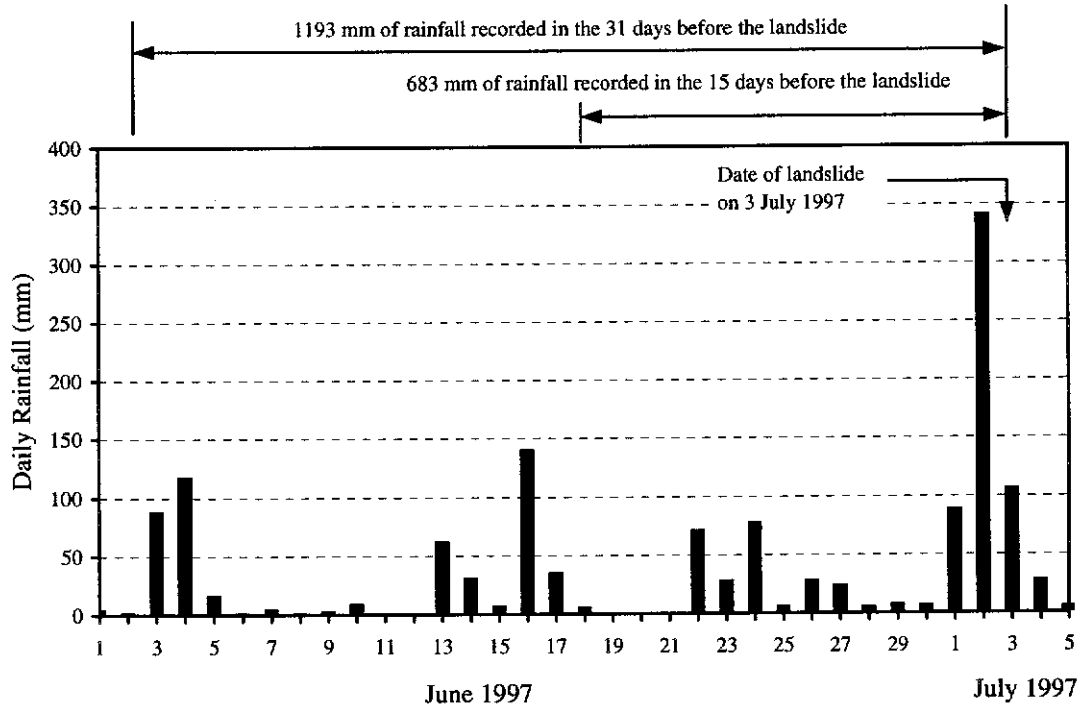
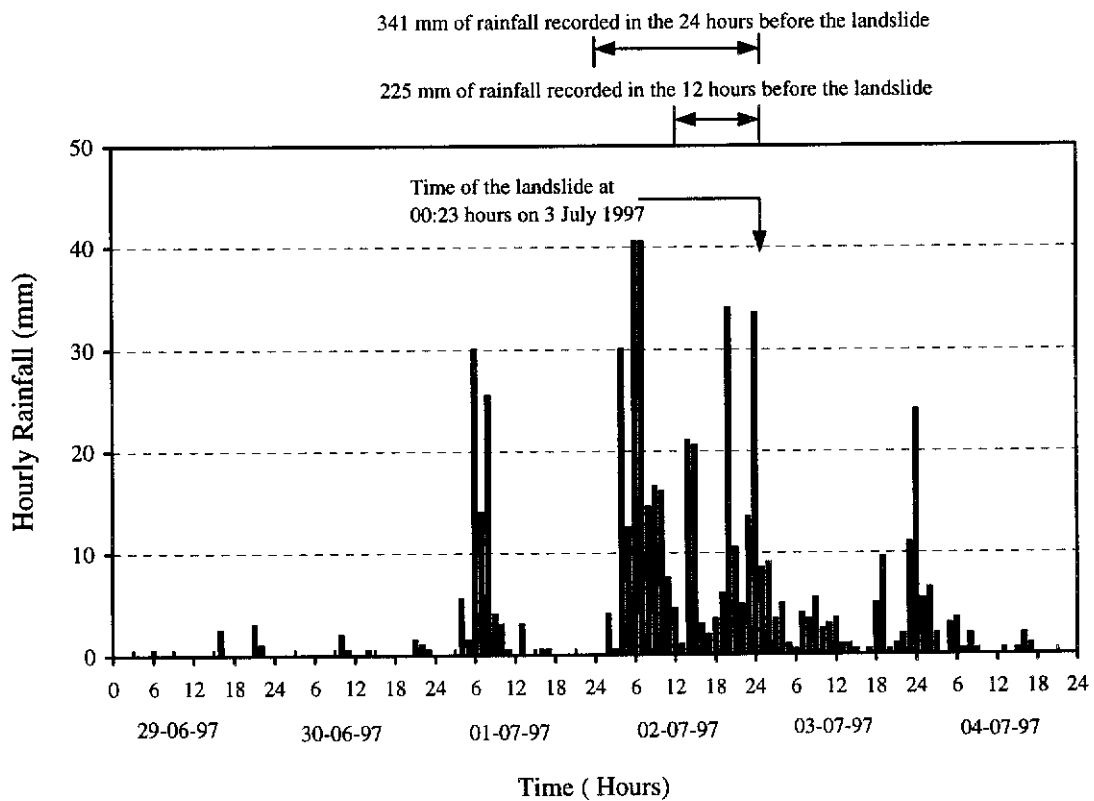
Figure 7 - Rainfall Records at GEO Raingauge No. N15

The daily rainfall recorded in June and early July 1997, together with the hourly rainfall from 29 June to 4 July 1997, is shown in Figure 7. The daily record shows that in the 31 days and 15 days prior to midnight on 2 July 1997 (i.e. shortly before the landslide at 00:23 hours on 3 July 1997), the rainfall totals were 1 193 mm and 683 mm respectively. The rainfall totals in the 24-hour and 12-hour periods before midnight on 2 July were 341 mm and 225 mm respectively.

(a) Daily Rainfall Recorded between 1 June and 5 July 1997

(b) Hourly Rainfall Recorded between 29 June and 4 July 1997

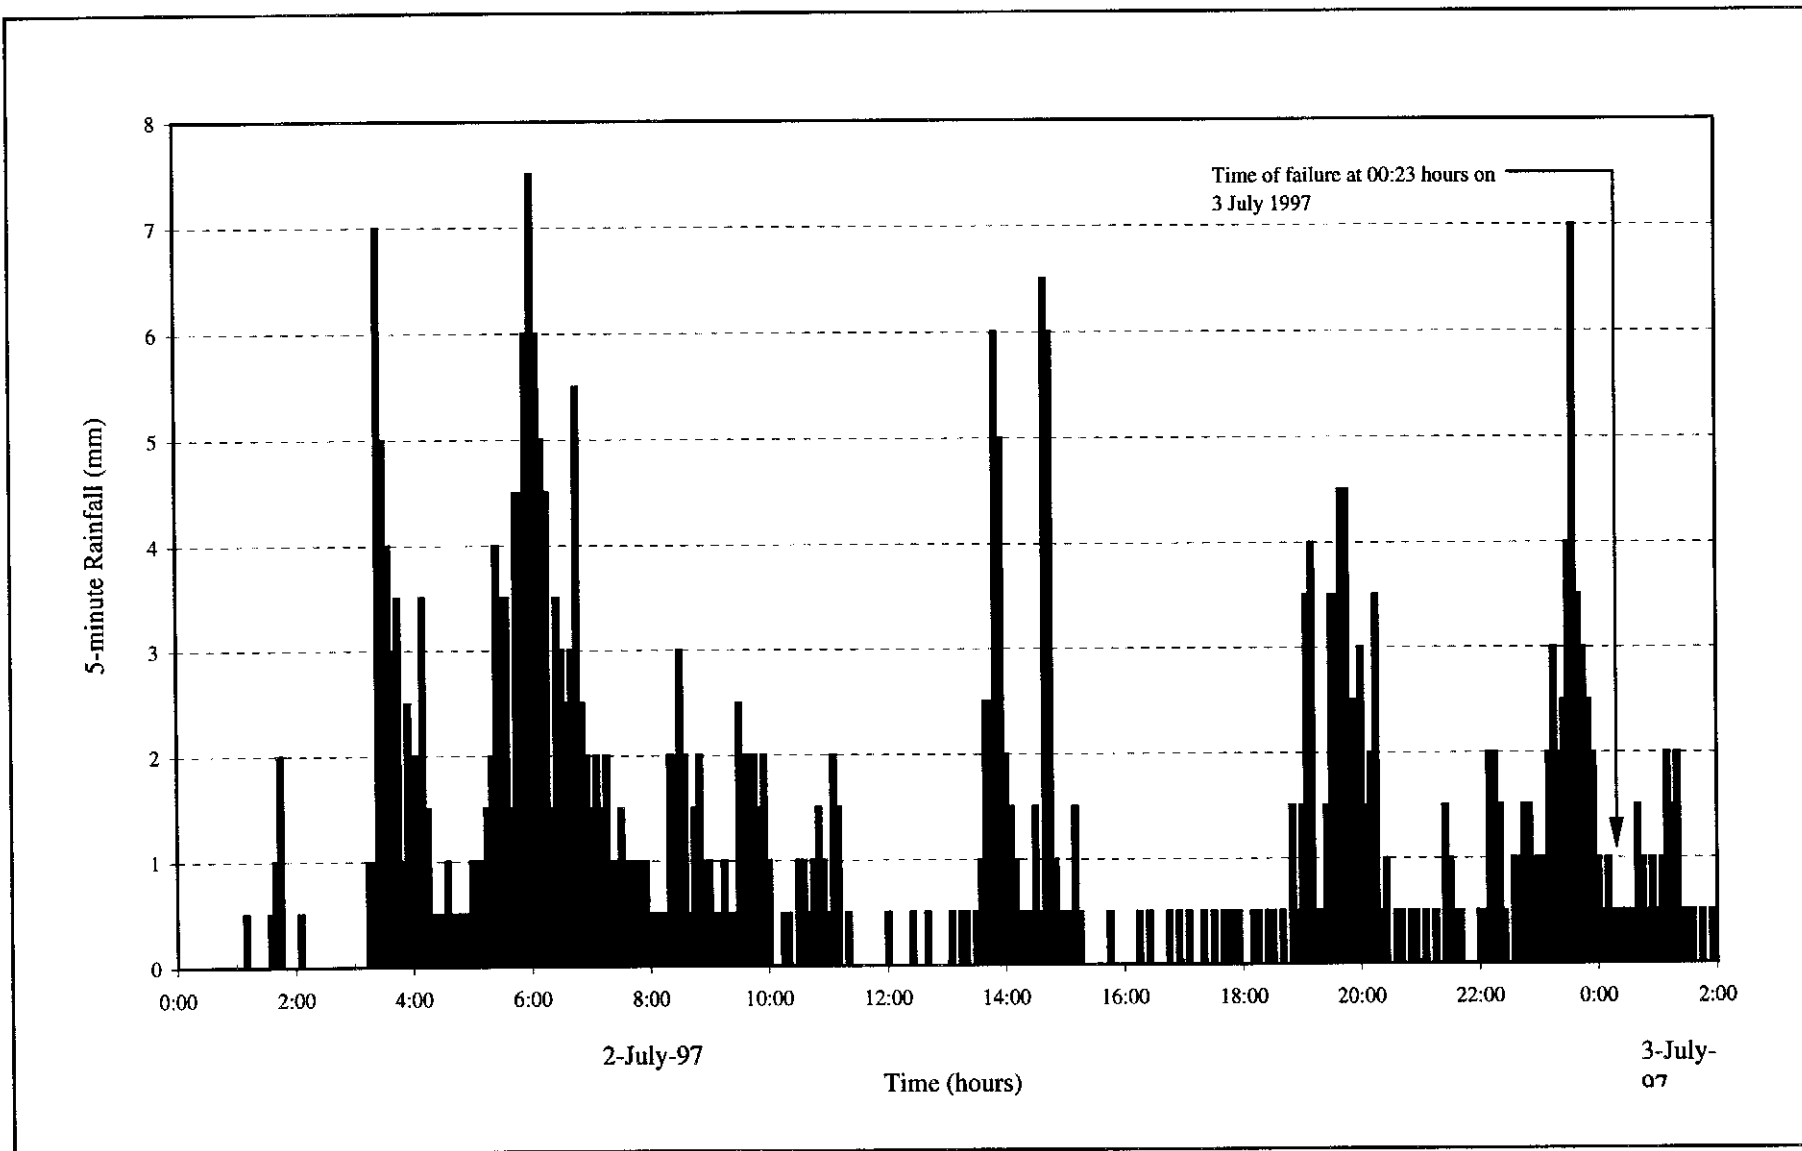
Figure 8 - Rainfall Records at GEO Raingauge No. N15 at 5-minute Intervals

The 5-minute rainfall record (Figure 8) shows that heavy pulses of intense rainfall occurred on the day before the landslide, with the heaviest being around 06:00 hours on 2 July 1997. The last pulse of heavy rainfall reached peak intensity at 23:35 hours on 2 July 1997, about 50 minutes before the landslide occurred.

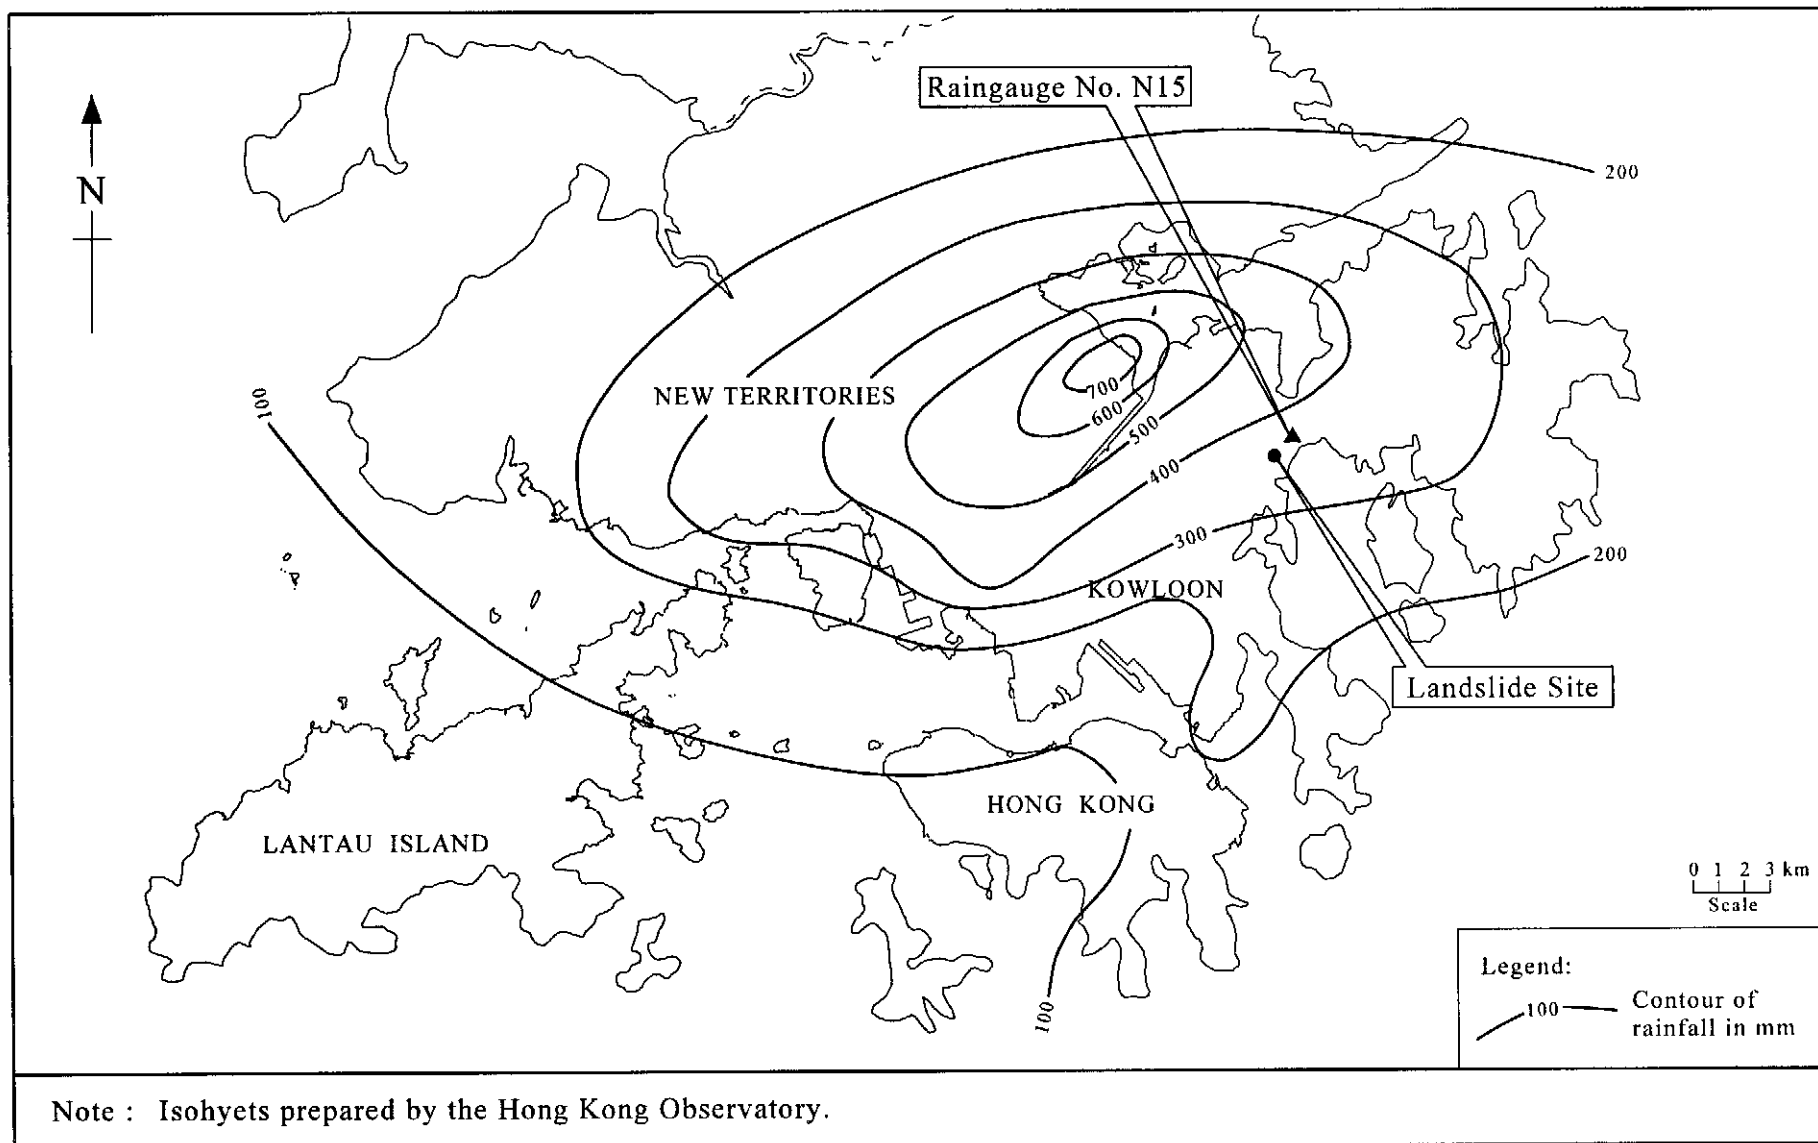
Figure 9 - Isohyets of Rainfall between 00:00 Hours on 2 July 1997 and 00:25 Hours on 3 July 1997

Isohyets of rainfall over Hong Kong for the period between 00:00 hours on 2 July to 00:25 hours on 3 July are given in Figure 9.

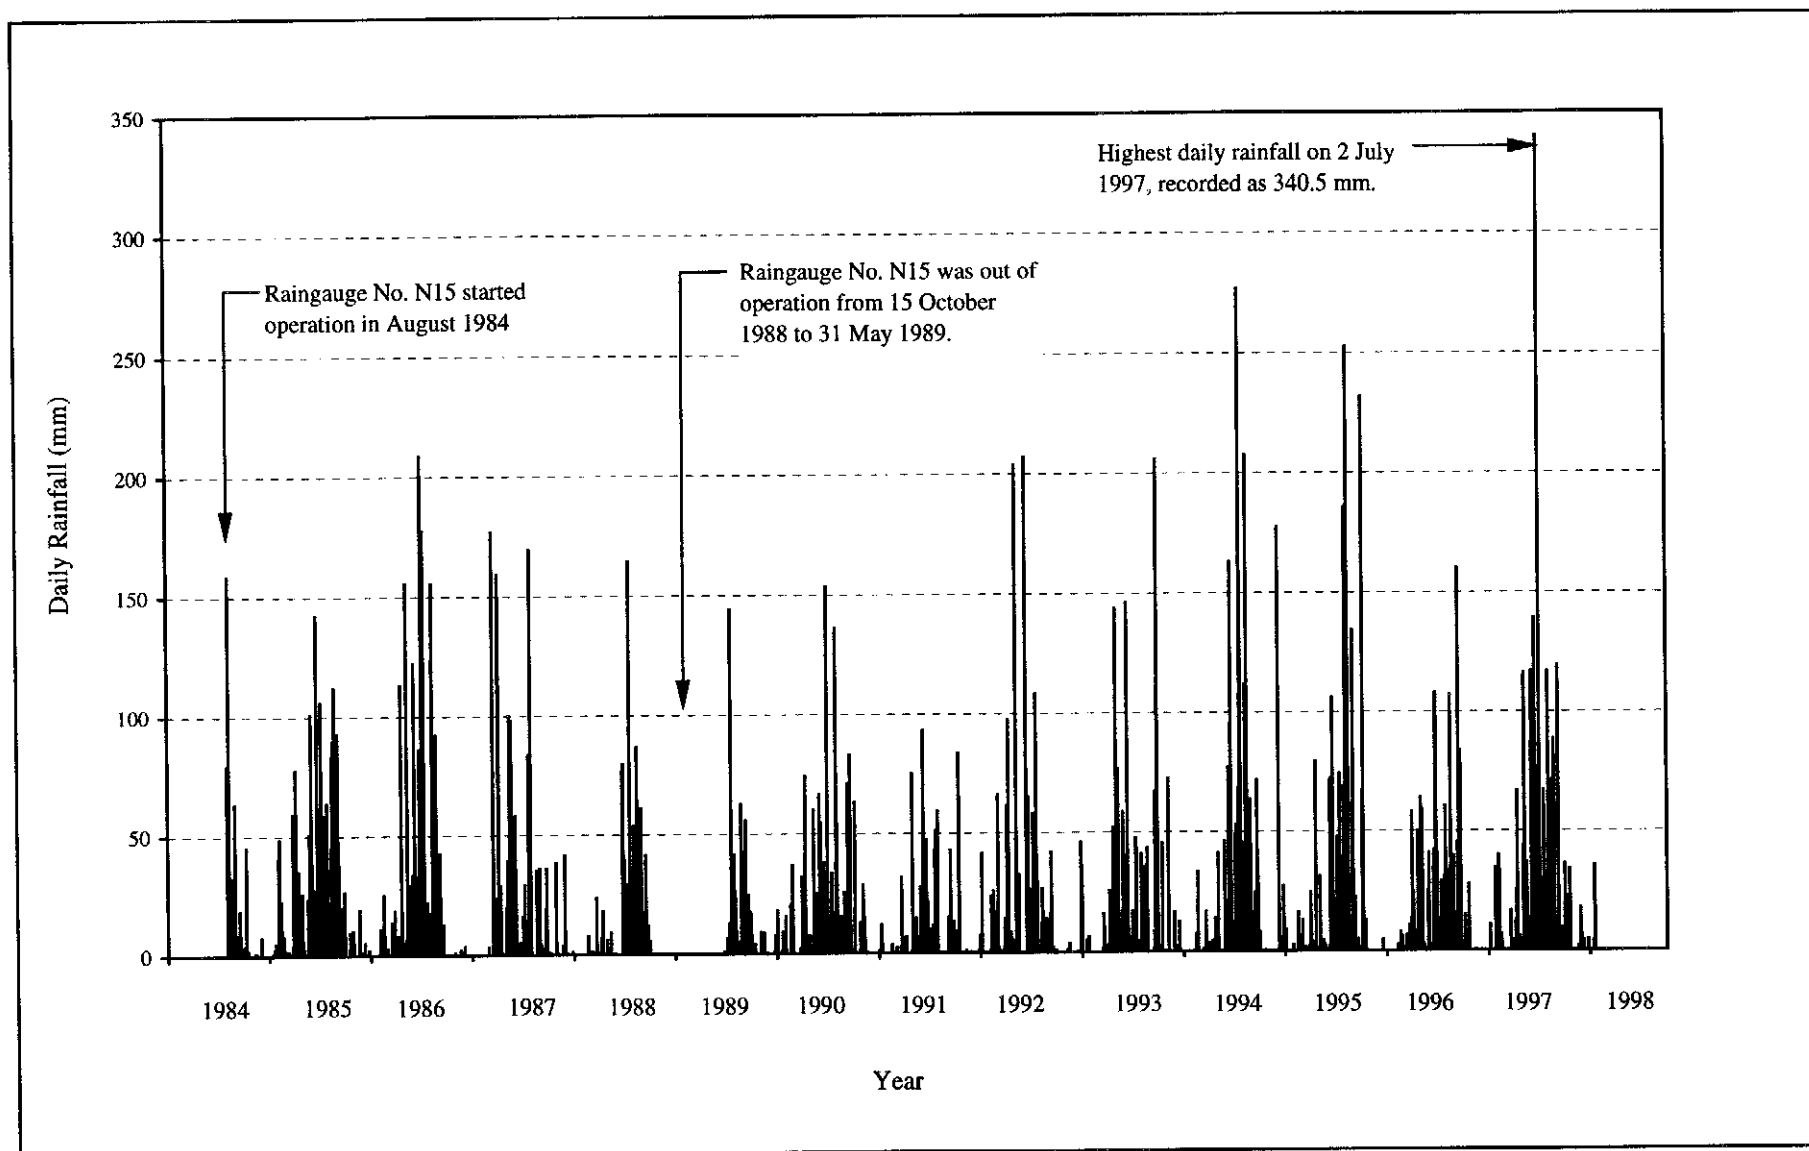
Figure 10 - Historical Daily Rainfall Recorded at GEO Raingauge No. N15 between August 1984 and January 1998

The daily rainfall on 2 July 1997 was the highest since raingauge No. N15 was installed in 1984 (Figure 10).

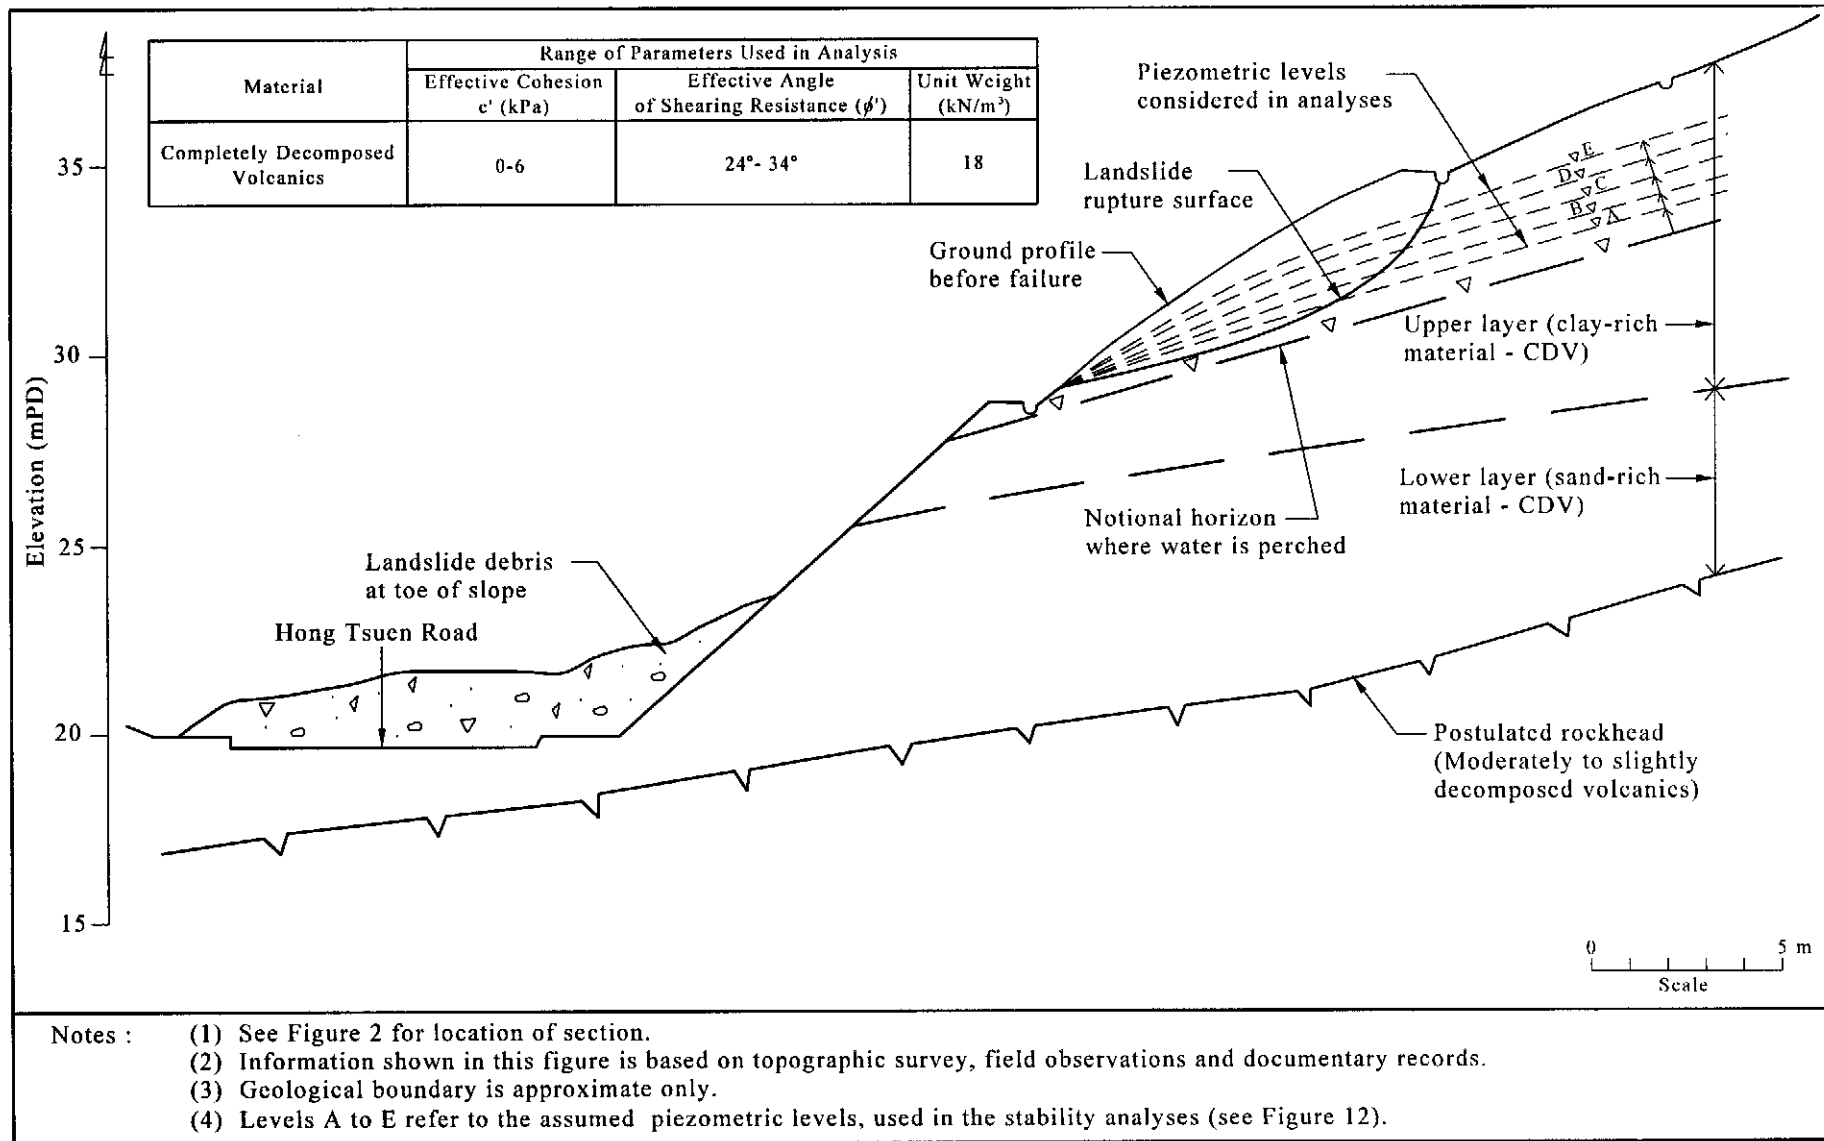
Figure 11 - Cross-section of the Landslide Used for Theoretical Stability Analyses

Stability analyses were carried out to assess the possible range of shear strengths and groundwater pressures that may have been operational at the time of failure. The cross-section through the landslide, on which stability analyses were carried out using the rigorous method of Morgenstern and Price (1965), is presented in Figure 11. The pre-failure profile was established from topographical survey plans and the geometry of the failure surface was based on site measurements made by HAP (Figure 4).
