**SECTION 2:
DETAILED STUDY OF
THE LANDSLIDES
AT NOS. 1 TO 5
CHUNG SHAN TERRACE
LAI CHI KOK
ON 4 JUNE 1997**

Halcrow Asia Partnership Ltd

**This report was originally produced in December 1998
as GEO Landslide Study Report No. LSR 22/98**

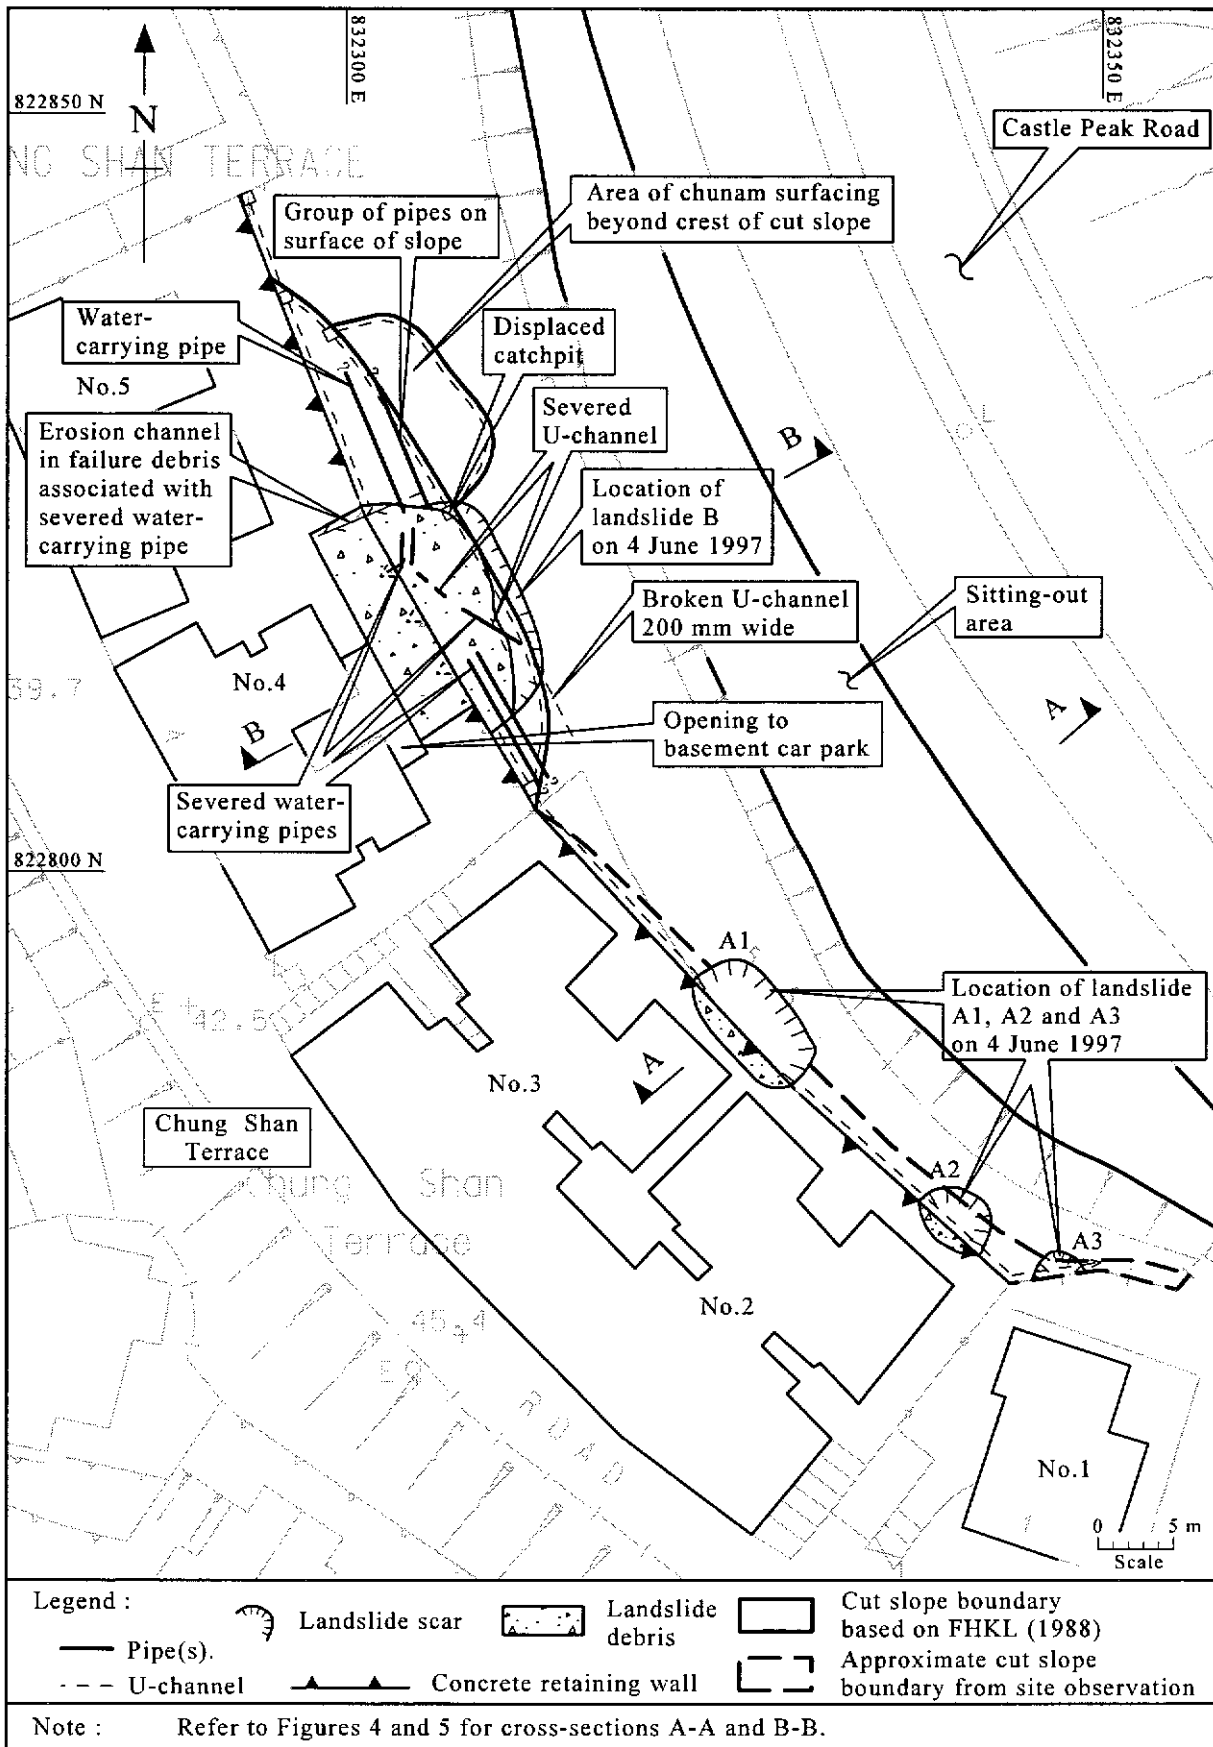
Figure 2 - Plan of the Landslide Sites

The locations of the landslides are shown in Figure 2.

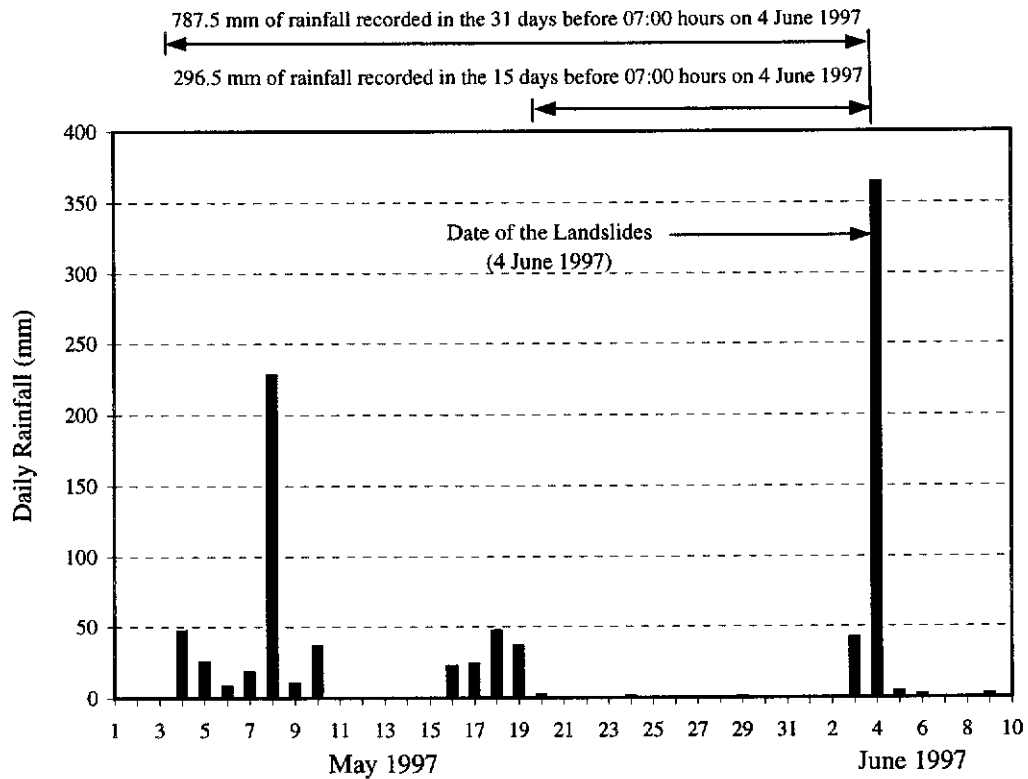
(a) Daily Rainfall recorded between 1 May and 10 June 1997

The nearest GEO automatic raingauge No. N04 is located about 870 m northwest of the site at Kai Kwong Lau, Cho Yiu Estate, Lai King (Figures 1 and 7). The daily rainfall between 1 May and 10 June 1997 is shown in Figure 6a. A total of 296.5 mm of rainfall was recorded in the 15 days before 07:00 hours on 4 June 1997.

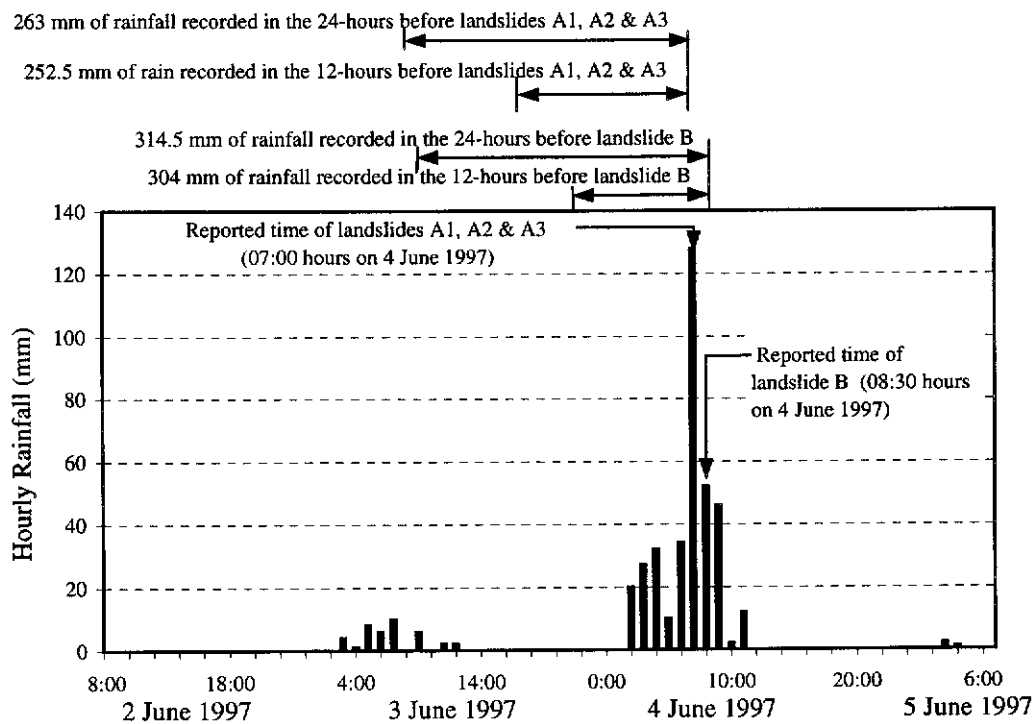
(b) Hourly Rainfall Recorded between 08:00 hours on 2 June and 06:00 hours 5 June 1997

Hourly rainfall between 2 June 1997 and 5 June 1997 is presented in Figure 6b. Rainfall was continuous between 01:30 hours and 06:00 hours on 4 June 1997 and intensified between 06:00 hours and 07:00 hours immediately before the reported time of landslides A1 to A3. The isohyets of rainfall between 01:30 hours and 08:30 hours on 4 June 1997 are shown on Figure 7.

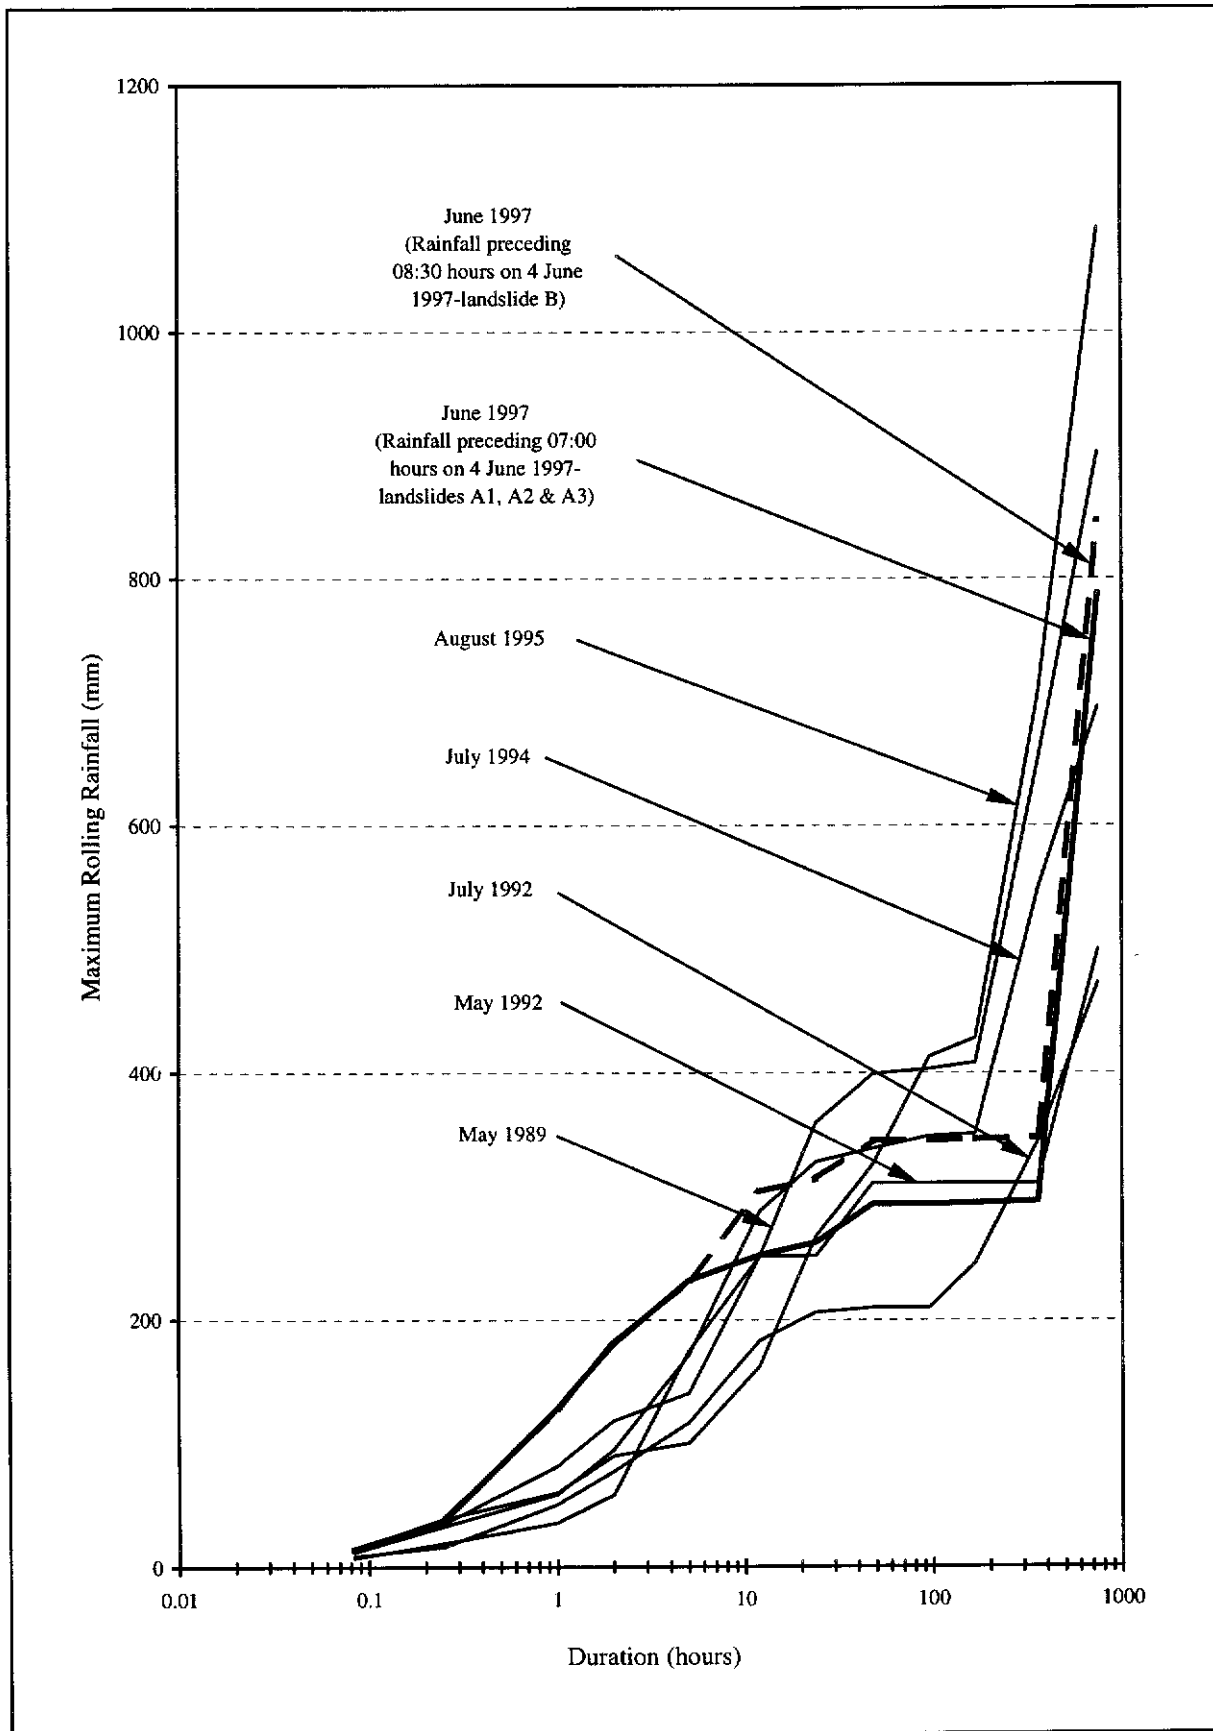
Figure 8 - Maximum Rolling Rainfall at GEO Raingauge No. N04 for Selected Major Rainstorms

Figure 8 shows the maximum rolling rainfall at raingauge No. N04 for selected major rainstorms. The rainfall was the highest recorded for durations of between 15 minutes and 9 hours for landslides A1 to A3 and between 15 minutes and about 15 hours for landslide B.
