**SECTION 3:
DETAILED STUDY OF
THE LANDSLIDES
AT KA TIN COURT,
SHATIN
ON 2 JULY 1997**

Halcrow Asia Partnership Ltd

**This report was originally produced in December 1998
as GEO Landslide Study Report No. LSR 24/98**

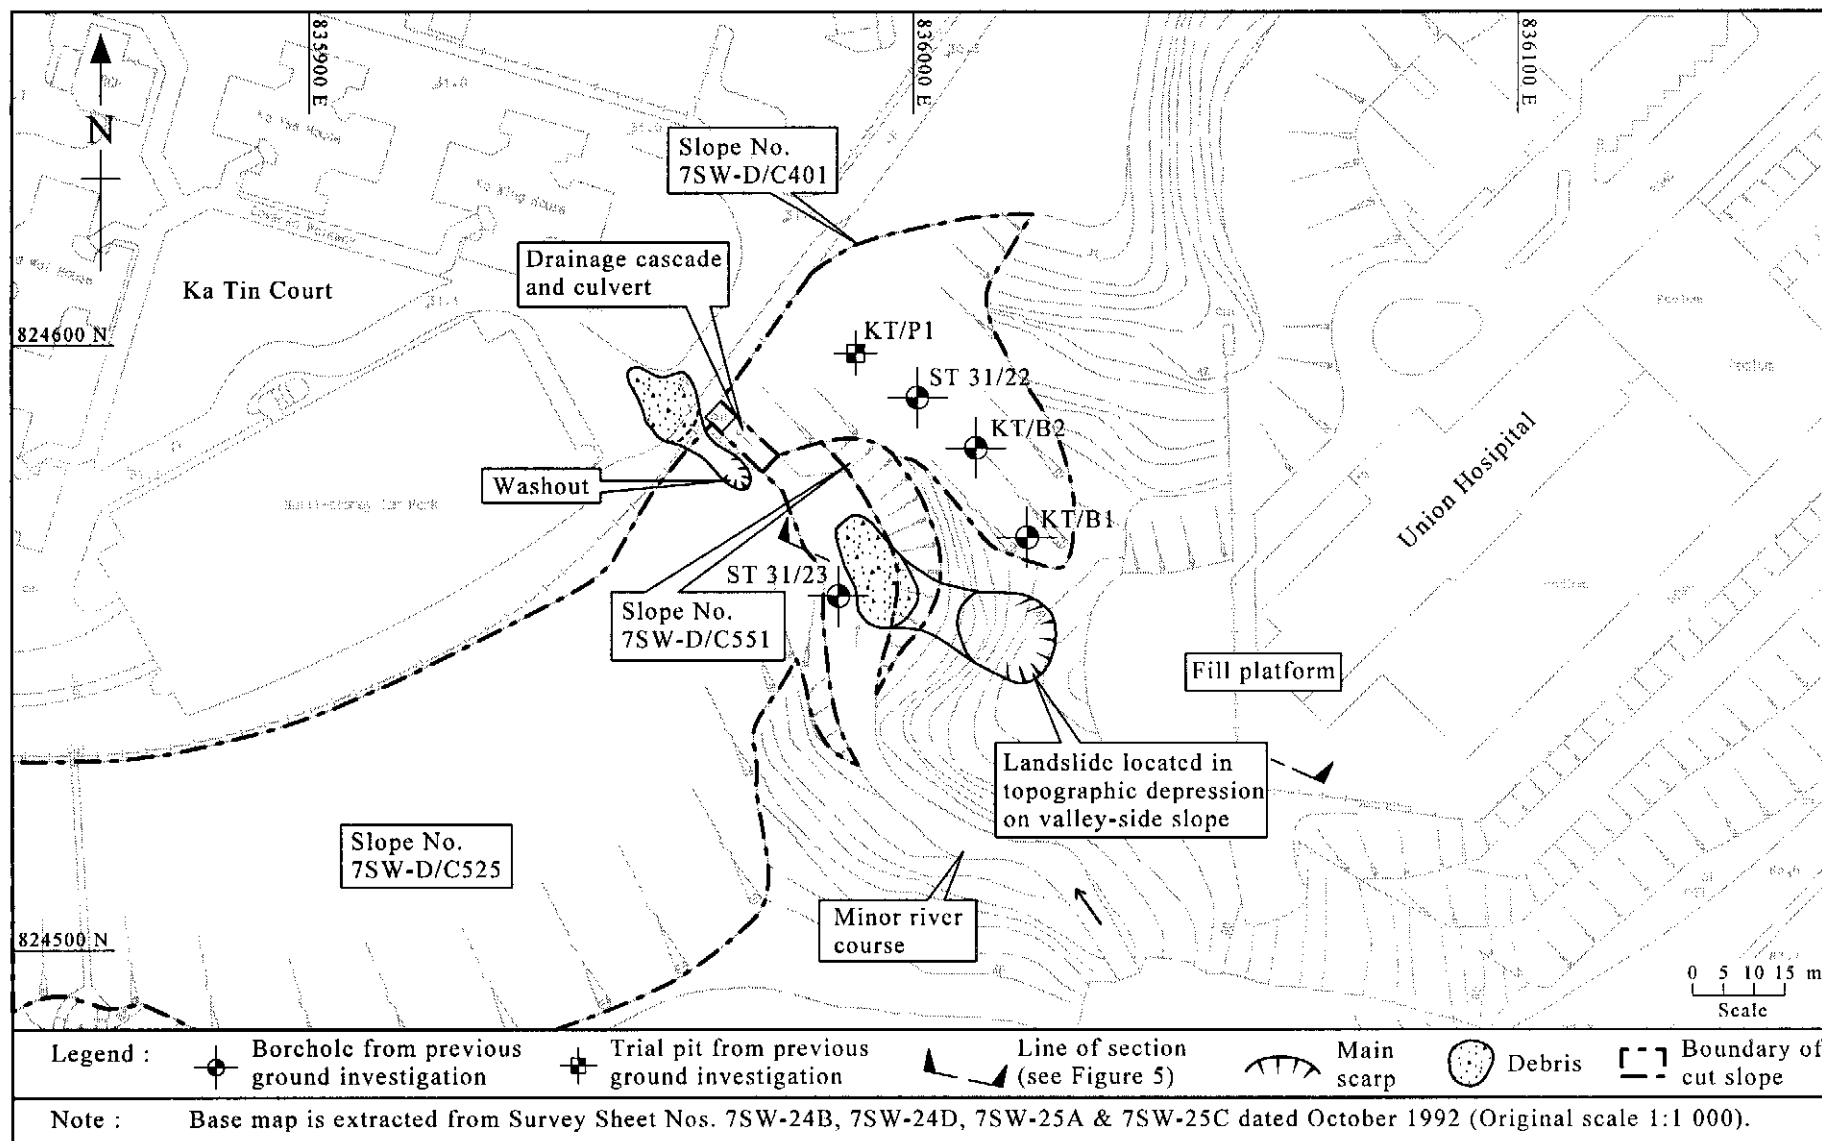
Figure 2 - Plan of the Failures and Previous Ground Investigations

In 1982 a ground investigation was carried out in the area (Lam Construction, 1982). Borehole ST 31/23, drilled from 39 mPD in the river bed below the landslide (Figure 2) identified predominantly boulders of moderately decomposed granite to about 34 mPD, below which alluvial sands and silts were logged to a depth of 28 mPD. The alluvial sands and silts overlay a sequence of moderately and slightly decomposed granite (Figure 4).

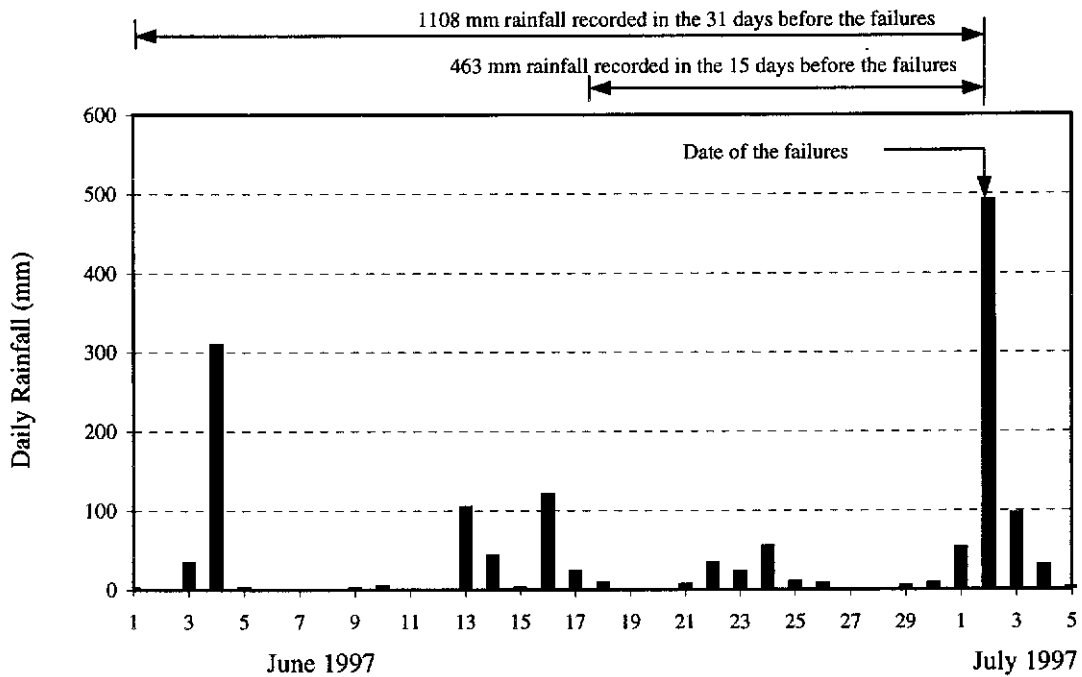
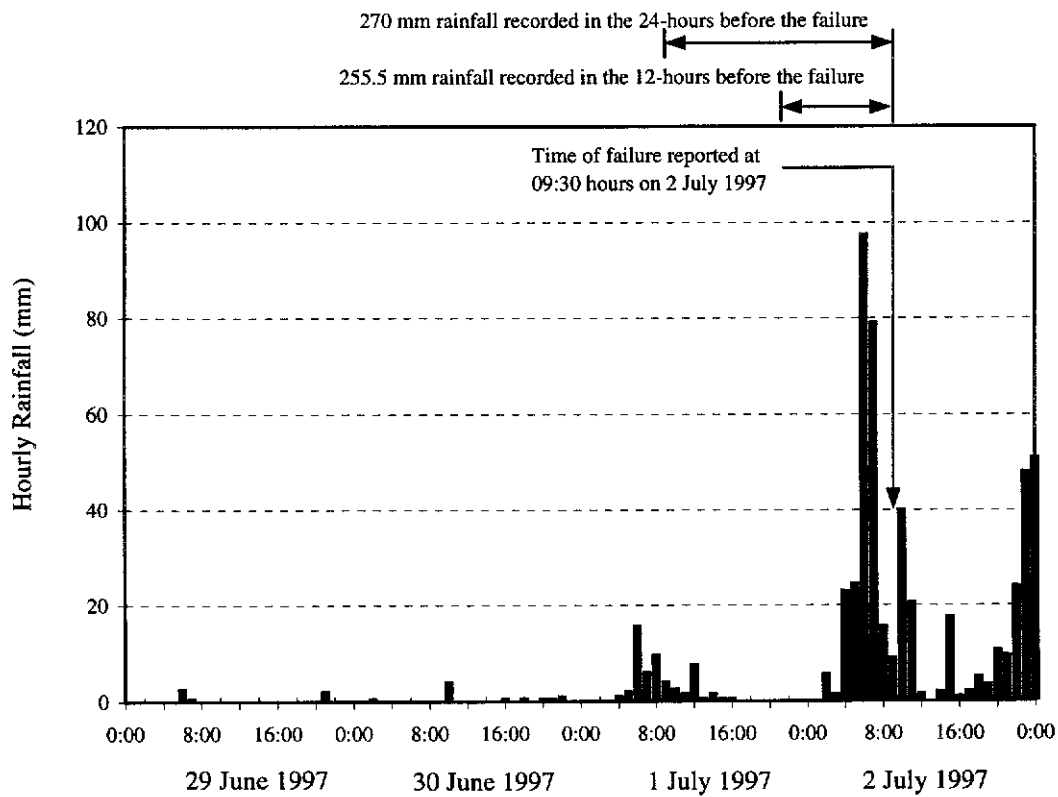
Figure 6 - Rainfall Records at GEO Raingauge No. N01

The cumulative 31-day rainfall before the landslide was 1108 mm and the 12-hour rainfall was 255.5 mm (Figure 6). Isohyets of rainfall between 02:55 hours and 09:30 hours on 2 July 1997 are shown in Figure 7.

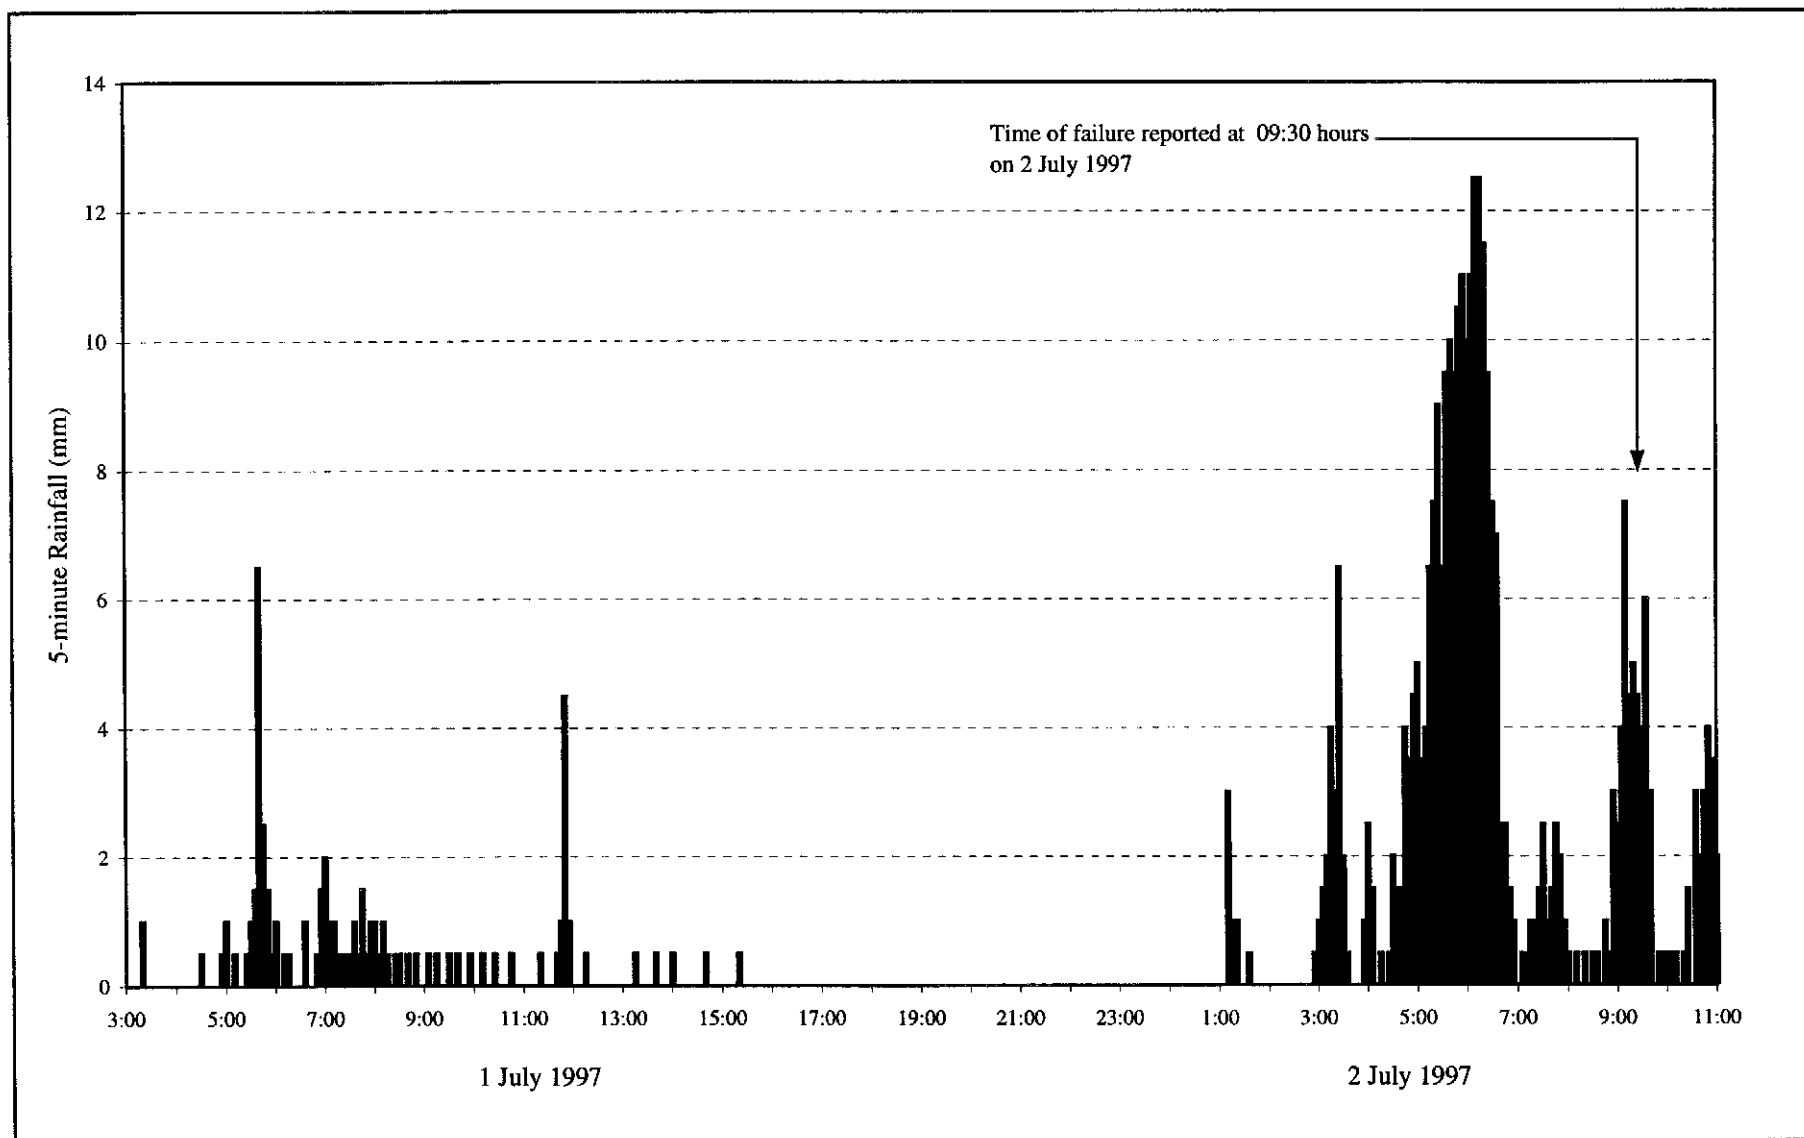
Figure 8 - Rainfall Recorded at GEO Raingauge No. N01 at 5-minute Intervals on 1 July and 2 July 1997

Figure 8 presents the 5-minute rainfall data prior to the reported time of the incident. It is apparent that the reported time of the failures at 09:30 hours occurred around 3.5 hours after the most intense period of the rainstorm. This may be attributed to the lag-time response of increased discharge within the river valley and the likely occurrence of the landslide and subsequent blockage of the entrance to the drainage cascade sometime before the washout.
