**INVESTIGATION OF SOME
SELECTED LANDSLIDE
INCIDENTS IN 1997
(VOLUME 6)**

GEO REPORT No. 92

**SECTION 1:
DETAILED STUDY OF THE
LANDSLIDES AT
NO. 7 KENG HAU ROAD
ON 4 JUNE 1997 AND
NO. 5 KENG HAU ROAD
ON 2 JULY 1997**

**This report was originally produced in May 1998
as GEO Landslide Study Report No. LSR 9/98**

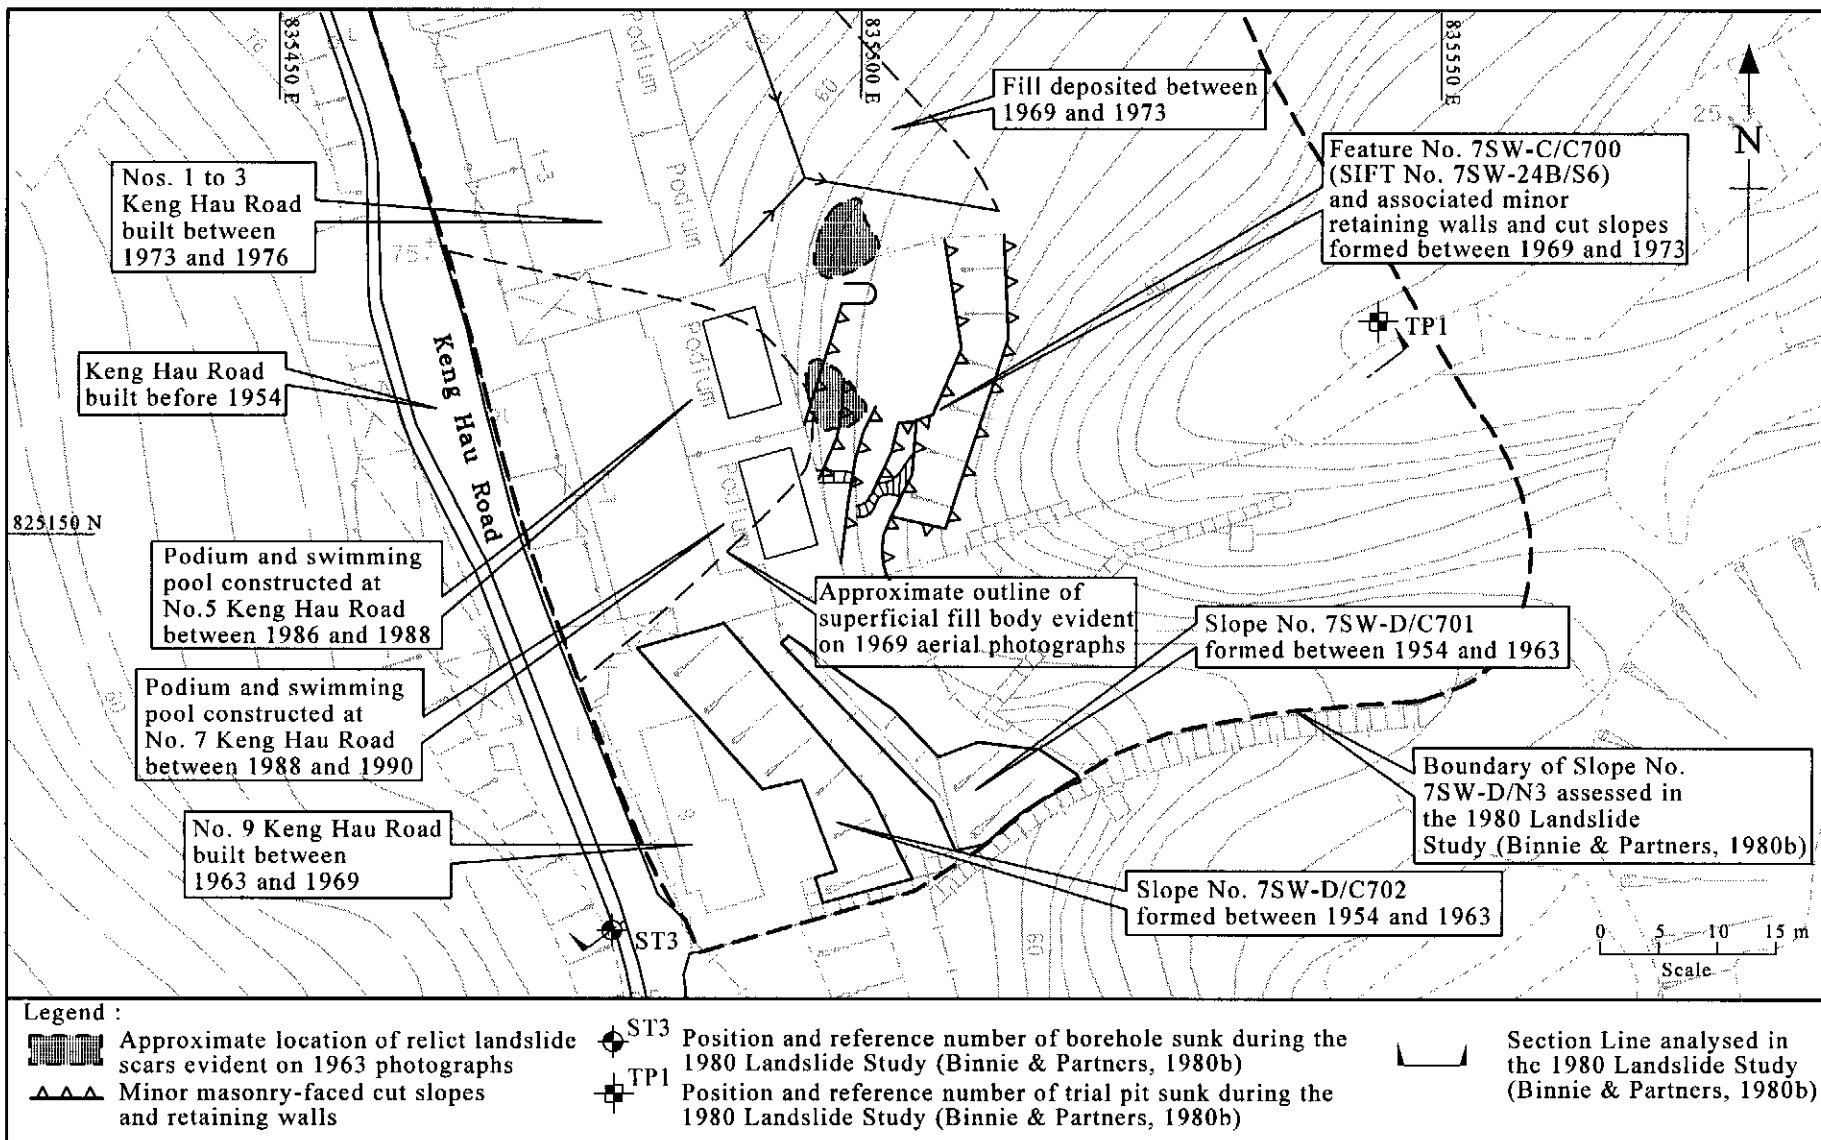
Figure 3 - Site History

The fill body below Nos. 1 and 3 Keng Hau Road (Figure 3), evident on aerial photographs (see Section 2.2 above), was not identified by the SIFT study.

Ground investigations and analyses for the slope below No. 9 Keng Hau Road were carried out under the 1980 Landslide Study (Binnie & Partners, 1980b). The location of the section analysed and the positions of relevant exploratory holes are shown in Figure 3. Borehole ST3, drilled immediately west of No. 9 Keng Hau Road, identified 1.5 m of fill and 2 m of granitic residual soil overlying completely decomposed, coarse-grained granite. Moderately decomposed coarse-grained granite was encountered at about 22 m below ground level. Piezometers installed in the borehole at depths of 16.5 m and 21.1 m respectively, were monitored between August 1979 and December 1980. The results indicated that the main groundwater table was near the top of the moderately decomposed granite.

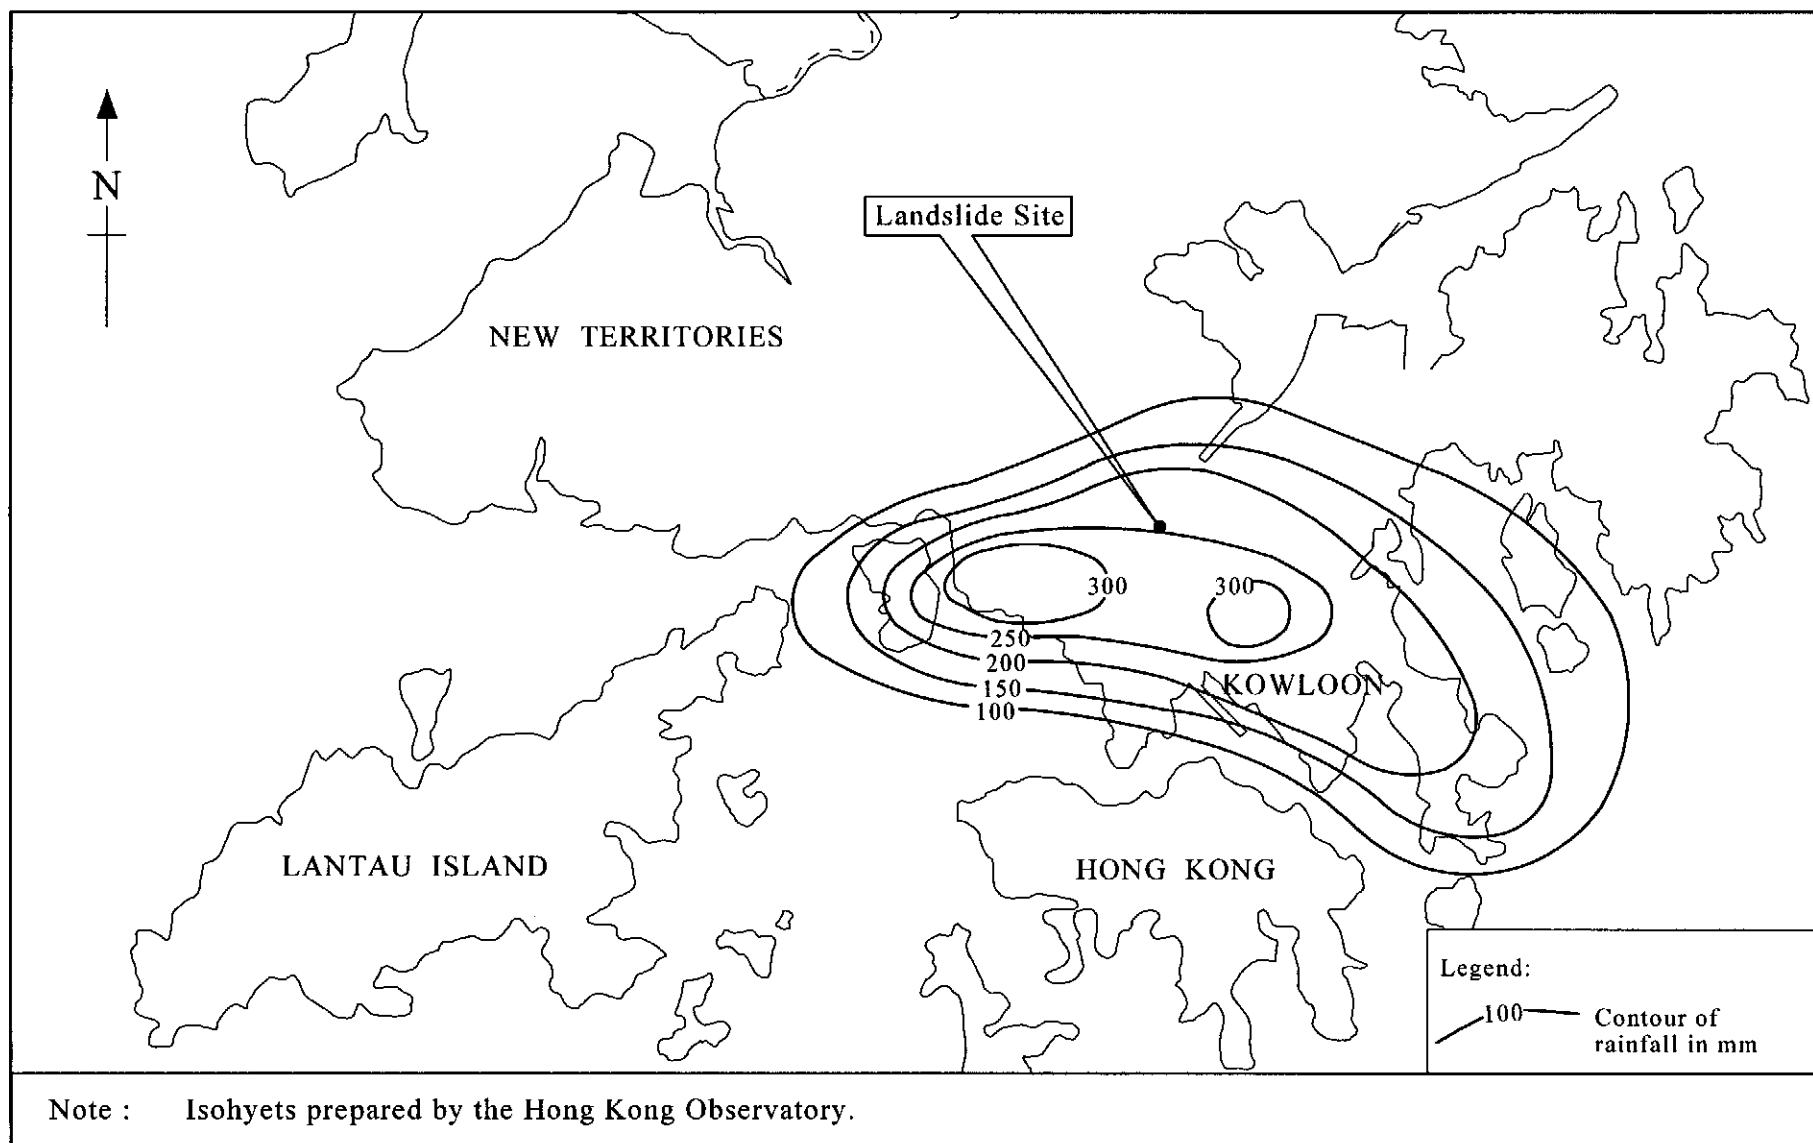
Figure 8 - Isohyets of Rainfall from 01:45 Hours to 10:00 Hours on 4 June 1997

An isohyet map of rainfall recorded between 01:45 hours and 10:00 hours on 4 June 1997 is presented in Figure 8. The daily rainfall recorded between 5 May and 8 June 1997 and hourly rainfall intensities recorded between 1 June and 4 June 1997, are shown in Figure 9.

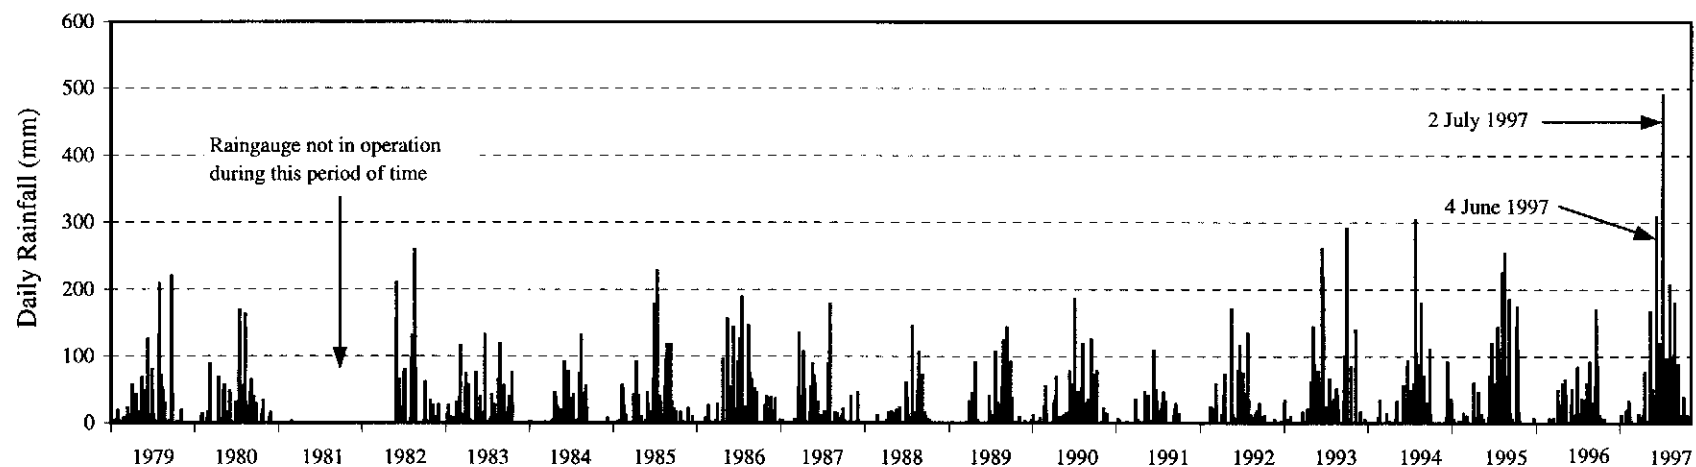
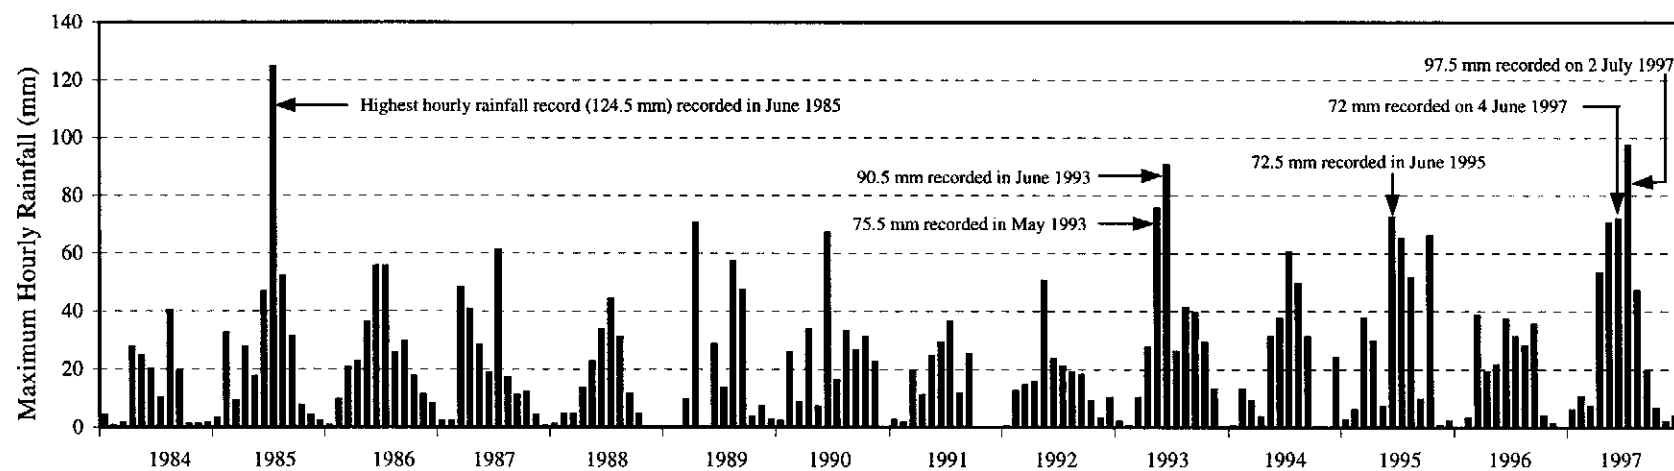
Figure 10 - Historical Rainfall Recorded at GEO Raingauge No. N01

The historical monthly maximum daily and hourly rainfall totals recorded at GEO raingauge No. N01 are shown in Figure 10. Figure 10a shows that the daily rainfall on 4 June 1997 was the highest on record. Figure 10b shows that the maximum hourly rainfall on 4 June 1997 (72 mm) was the fifth highest on record. It should be noted, however, that hourly and daily rainfall totals do not enable a direct comparison of absolute maximum rolling intensities of different rainfall events.

Figure 10a shows that the daily rainfall recorded on 2 July 1997 was the highest on record. It should be noted, however, that only 231 mm of this total fell before 07:00 hours when the landslide was first observed. Figure 10b shows that the maximum hourly rainfall total on 2 July 1997 (97.5 mm) was the second highest on record.

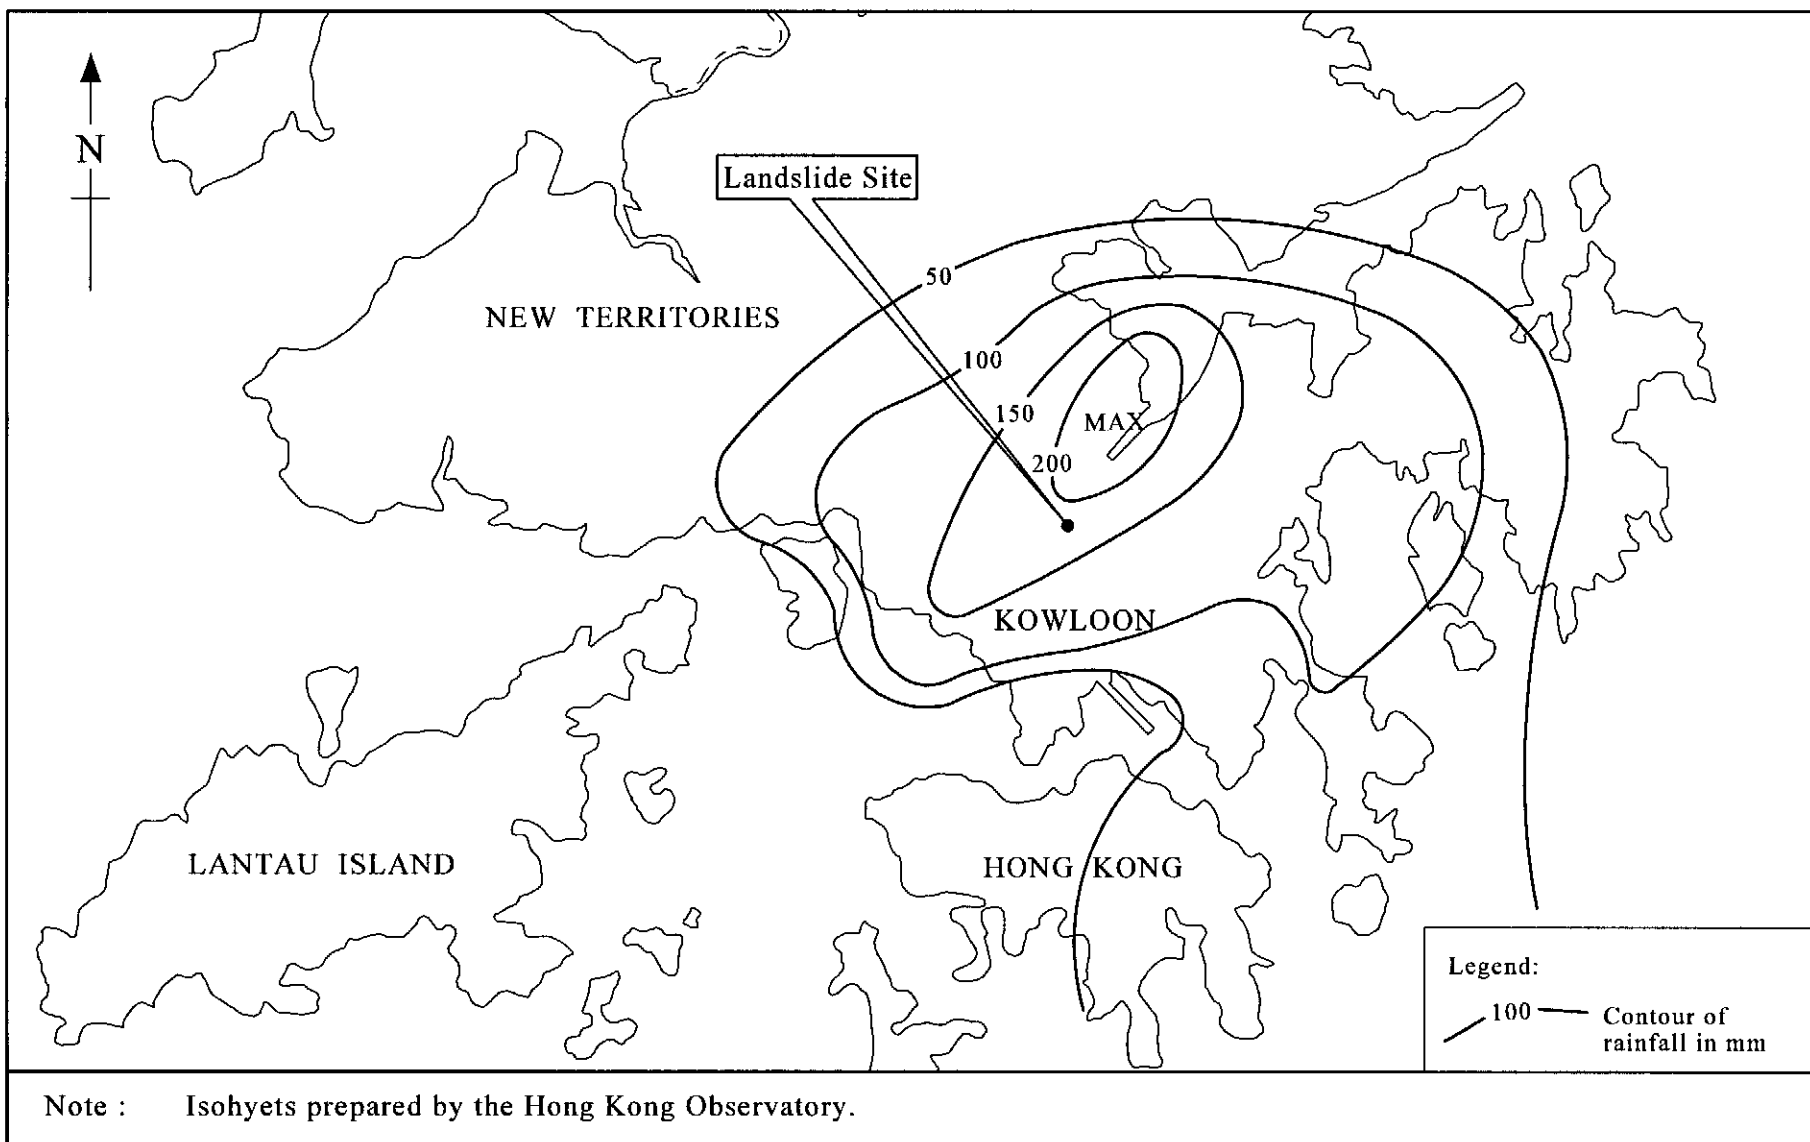
Figure 11 - Isohyets of Rainfall from 02:55 Hours to 07:00 Hours on 2 July 1997

An isohyet map of rainfall recorded between 02:55 hours and 07:00 hours on 2 July 1997 is shown in Figure 11. The daily rainfall recorded at the raingauge between 1 June and 6 July 1997 and hourly rainfall intensities recorded between 29 June and 2 July 1997, are shown in Figure 12.
