**SECTION 2:
DETAILED STUDY OF THE
LANDSLIDE AT
SHING MUN TUNNEL ROAD
ROUTE 5, TAI WAI
ON 2 JULY 1997**

Halcrow Asia Partnership Ltd

**This report was originally produced in December 1998
as GEO Landslide Study Report No. LSR 26/98**

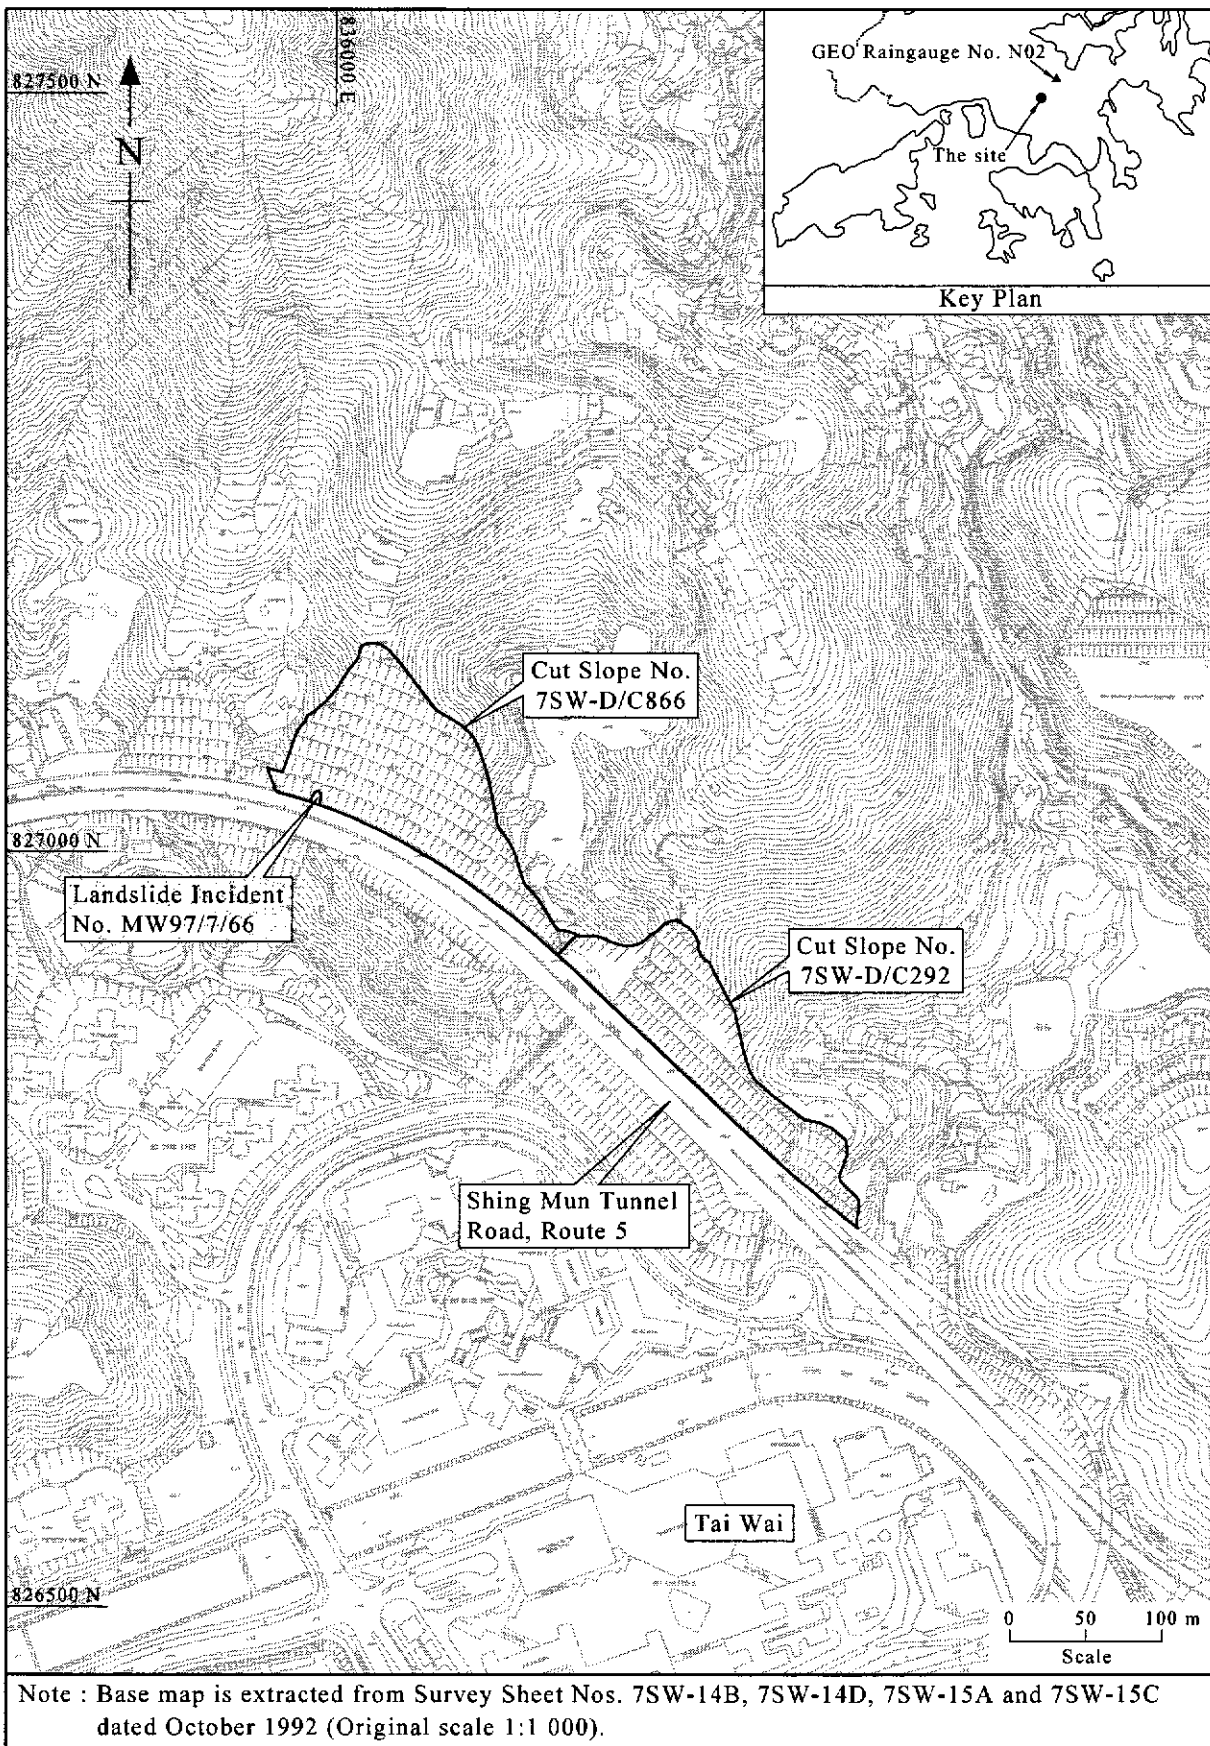
Figure 1 - Site Location Plan

The landslide occurred on the lower part of the western end of cut slope No. 7SW-D/C866, which is located on the northern side of Shing Mun Tunnel Road, Route 5, Tai Wai (Figure 1).

The nearest GEO automatic raingauge No. N02 is located at Shun Wo House, Wo Che Estate, about 2.1 km northeast of the landslide (Figure 1). The precise time of failure is not known but for the purpose of analysis, all rainfall recorded up to 17:00 hours on 2 July 1997 has been included by which time the landslide is known to have occurred. Figure 6 shows that 385.5 mm of rain fell during the 24 hours up to 17:00 hours on 2 July 1997.
