**SECTION 4:
DETAILED STUDY OF THE
LANDSLIDE AT
VILLE DE CASCADE,
FO TAN, SHATIN
ON 3 JULY 1997**

Halcrow Asia Partnership Ltd

**This report was originally produced in December 1998
as GEO Landslide Study Report No. LSR 29/98**

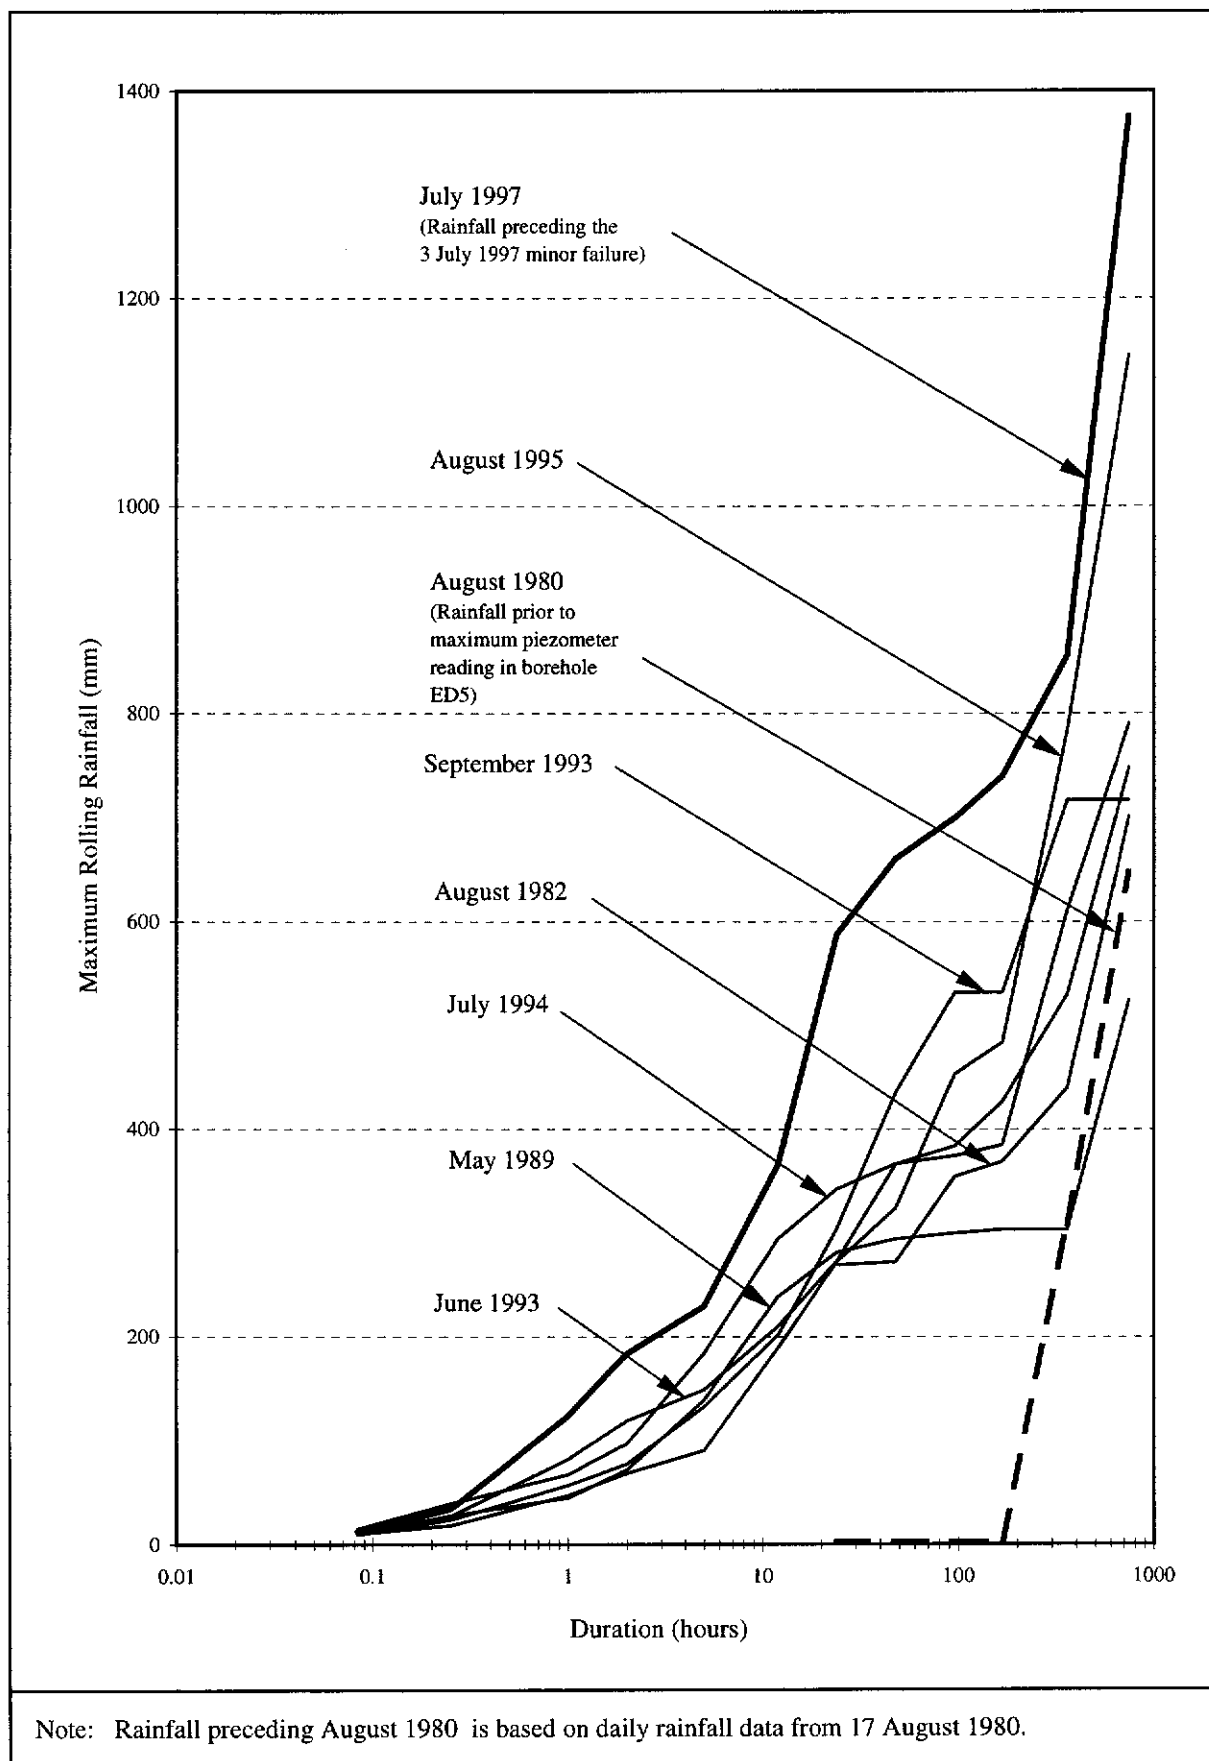
Figure 5 - Maximum Rolling Rainfall at GEO Raingauge No. N02 for Major Rainstorms

The base water table in borehole No. ED5, located in the upper slope about 10 m to the west of the 1997 landslide (Figure 6), was monitored for a 10-month period that included parts of the 1980 and 1981 wet seasons. The maximum piezometric level recorded on 17 August 1980 was some 4 m higher than the typical dry season level. The rainstorm associated with the maximum piezometric level in borehole No. ED5 in August 1980 was notably less severe than that recorded between 2 and 3 July 1997 (Figure 5).

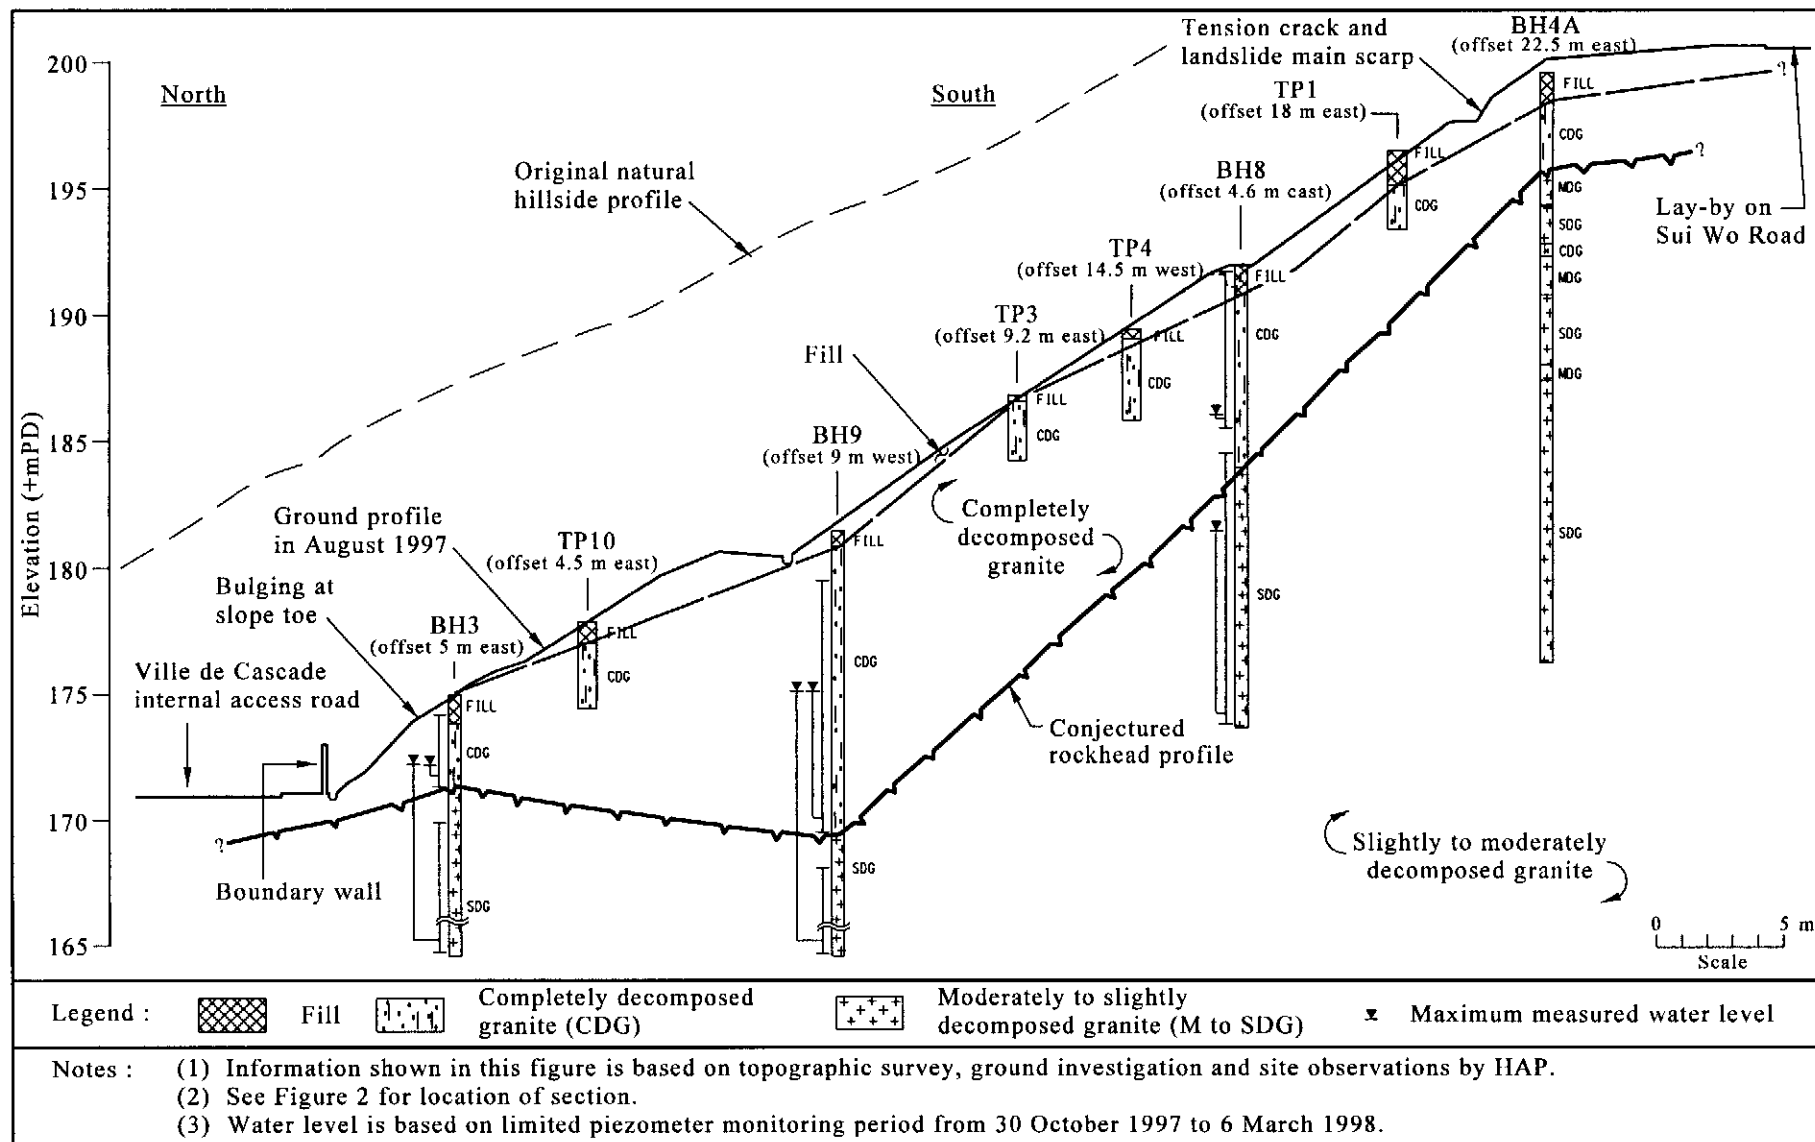
Figure 7 - Geological Cross-section A-A through the Landslide

A representative geological cross-section through the landslide based on the 1997 landslide ground investigation is shown in Figure 7.

The base water table is between 1 m and 5 m above rockhead in the lower part of the slope and becomes progressively deeper and is within bedrock beneath the upper part of the slope (Figure 7). Piezometers in boreholes Nos. BH2, BH3 and BH9 in the lower slope indicated hydraulic continuity across the rockhead interface. Piezometric levels in the lower slope recorded during the monitoring period remained above rockhead with a fluctuation of less than about 1 m. The perennial seepage and dampness at the toe of the slope are likely to be fed by groundwater from this source.

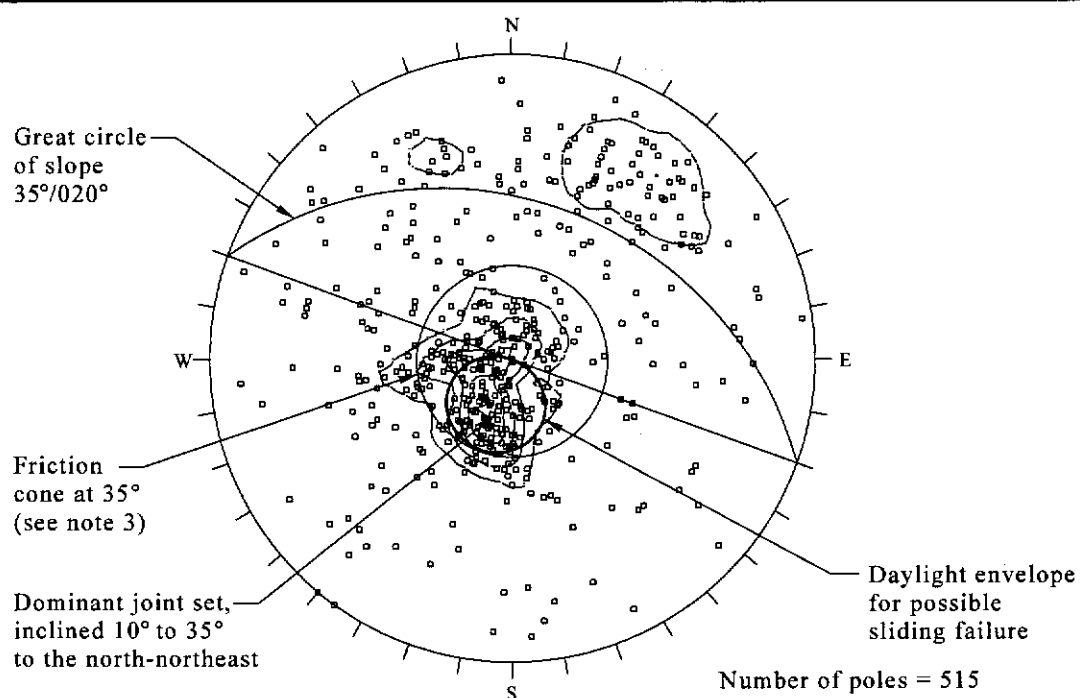
(a) Discontinuity data from boreholes, surface strips and trial pits in ground investigation following 1997 landslide

An analysis of kaolin-infilled and slickensided discontinuities (Figure 8b) shows a similar distribution to the overall discontinuity pattern (Figure 8a). Most of the kaolin-infilled and slickensided discontinuities are associated with the dominant discontinuity sets. Individual discontinuities however could not be traced between adjacent boreholes.

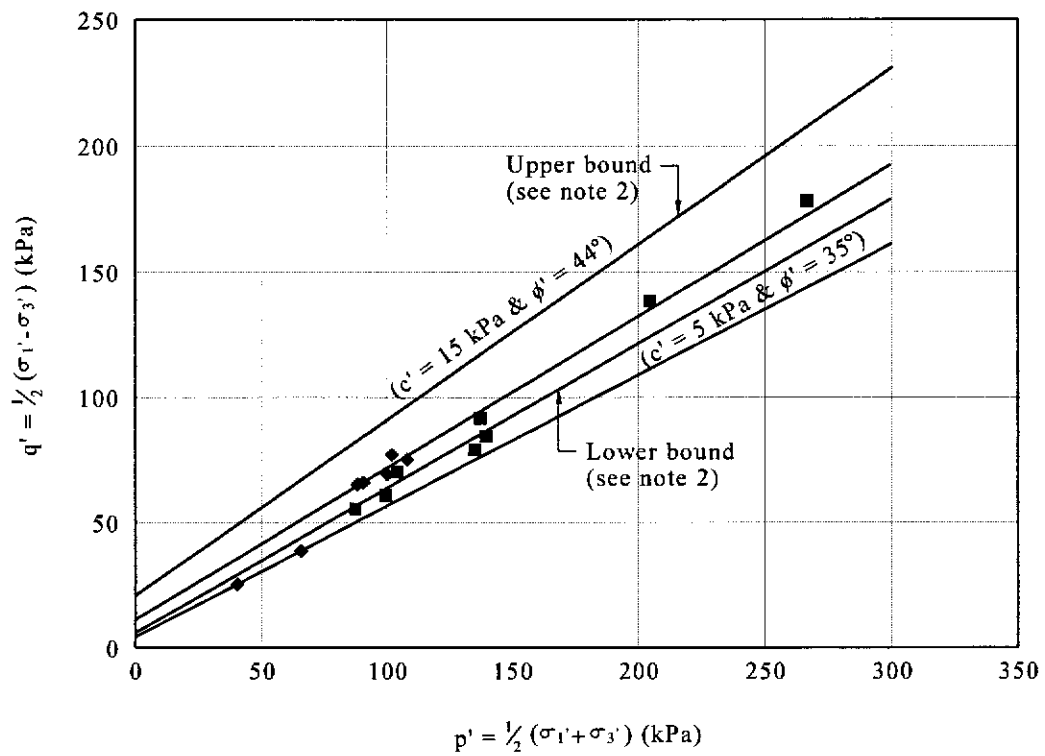
Figure 9 - Triaxial Compression Test Results for Completely Decomposed Granite

The shear strength properties of the completely decomposed granite matrix were determined using consolidated undrained triaxial compression tests. The test results (Figure 9) show a range of shear strength parameters that broadly fall within the typical range of published data (GEO, 1993).

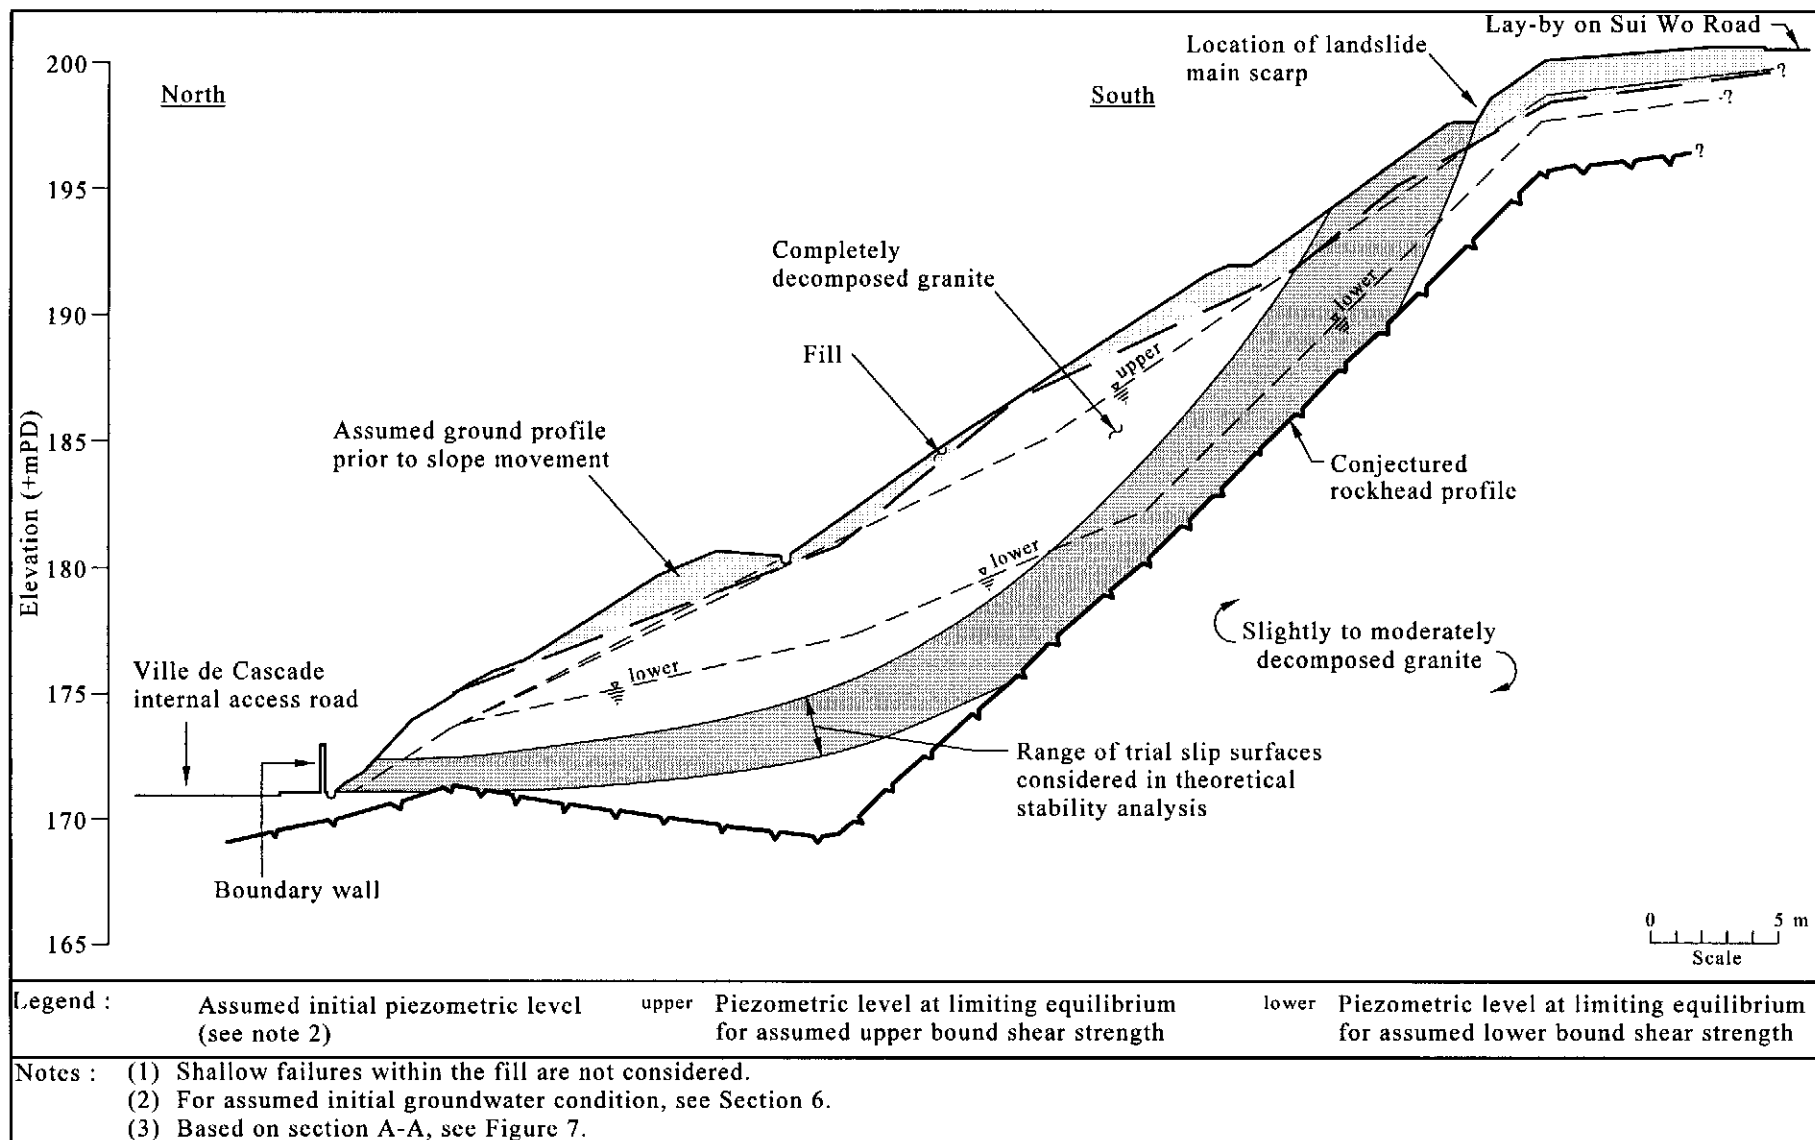
Figure 10 - Slope Model for Theoretical Stability Analysis

The stability analyses were carried out using the rigorous method of Morgenstern and Price (1965) using a representative pre-failure cross-section (Figure 10), which is based on the geological cross-section given in Figure 7.

In the analysis the rises in piezometric level have been taken relative to the piezometric surface deduced from the groundwater observations made during the 1997/98 dry season (Figure 10).
