**REPORT ON THE
ROCK SLOPE FAILURE
AT CUT SLOPE 11NE-D/C7
ALONG SAU MAU PING ROAD
ON 4 DECEMBER 1997**

GEO REPORT No. 94

B.N. Leung, S.C. Leung & C.A.M. Franks

**GEOTECHNICAL ENGINEERING OFFICE
CIVIL ENGINEERING DEPARTMENT
THE GOVERNMENT OF THE HONG KONG
SPECIAL ADMINISTRATIVE REGION**

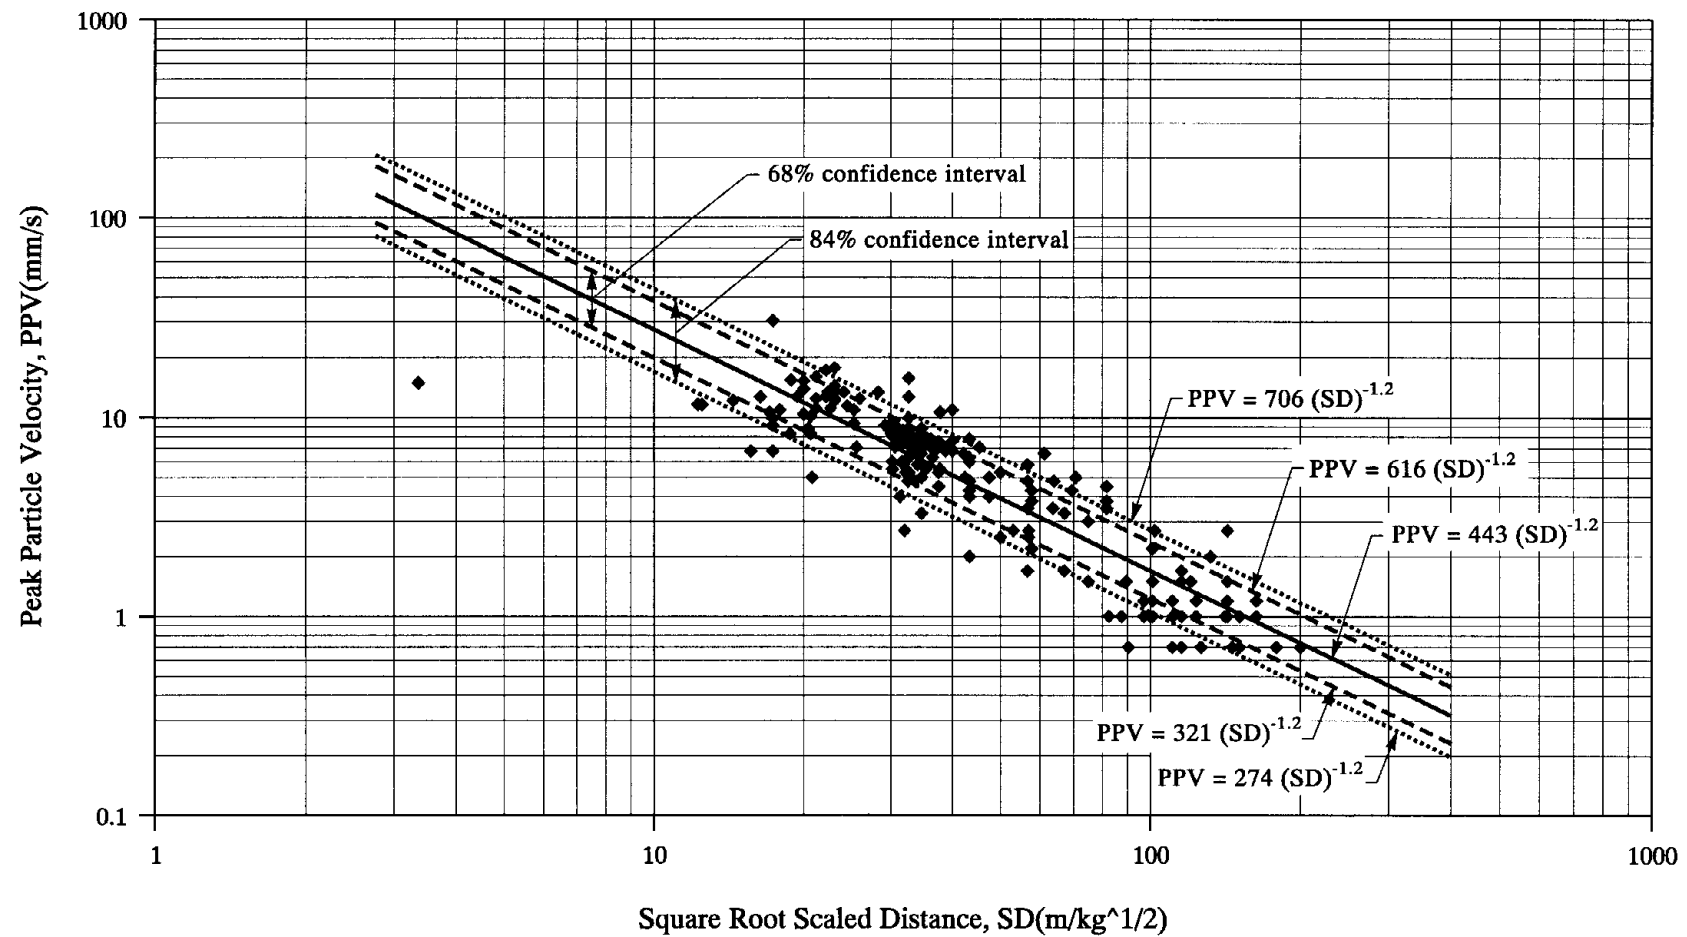
Figure 10 - Peak Particle Velocity versus Square Root Scaled Distance

193 sets of vibration monitoring data were obtained at the site by the Contractor during the 3-months period before the failure. These data were plotted with peak particle velocity (PPV) versus scaled distance and also peak particle acceleration (PPA) versus scaled distance, and they are shown in Figures 10 and 11 respectively.

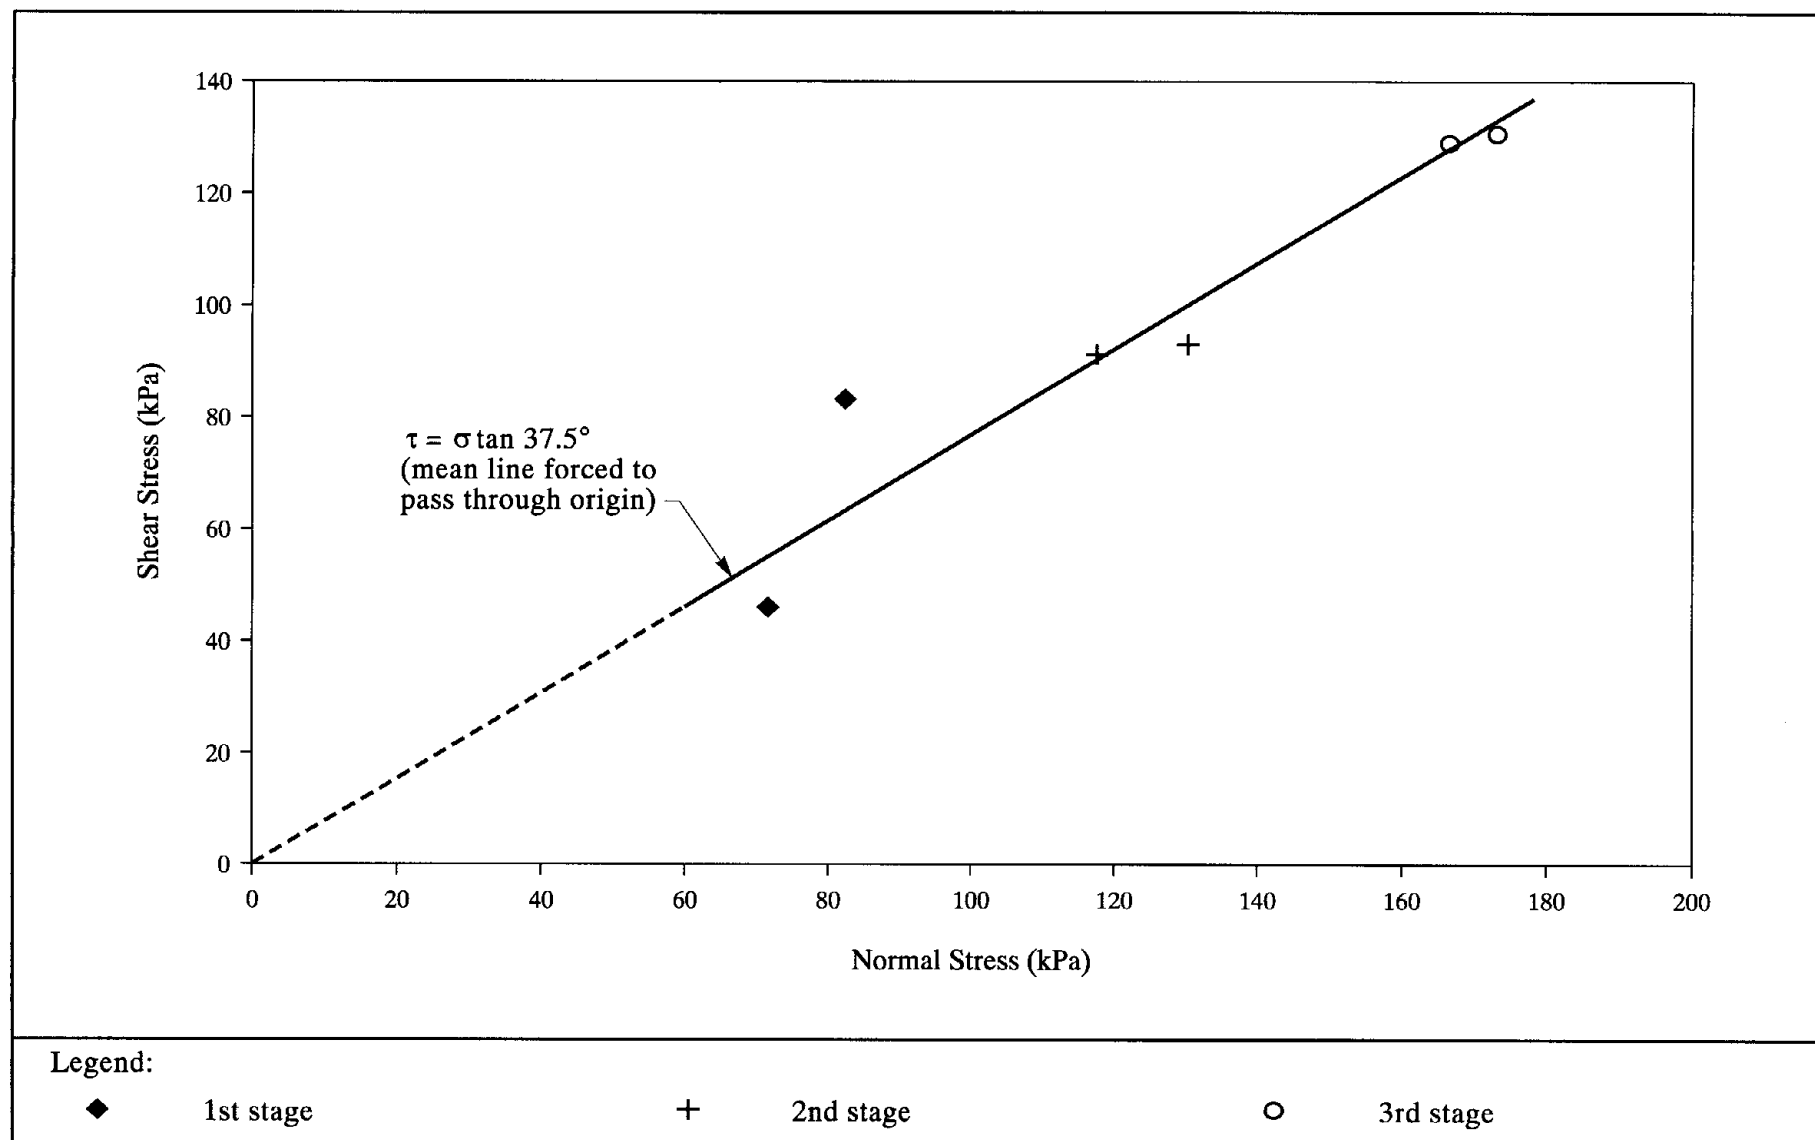
Figure B1 - Results of Multi-stage Direct Shear Tests on Specimens of Decomposed Granite Recovered from the Base of the Largest Block of Rock

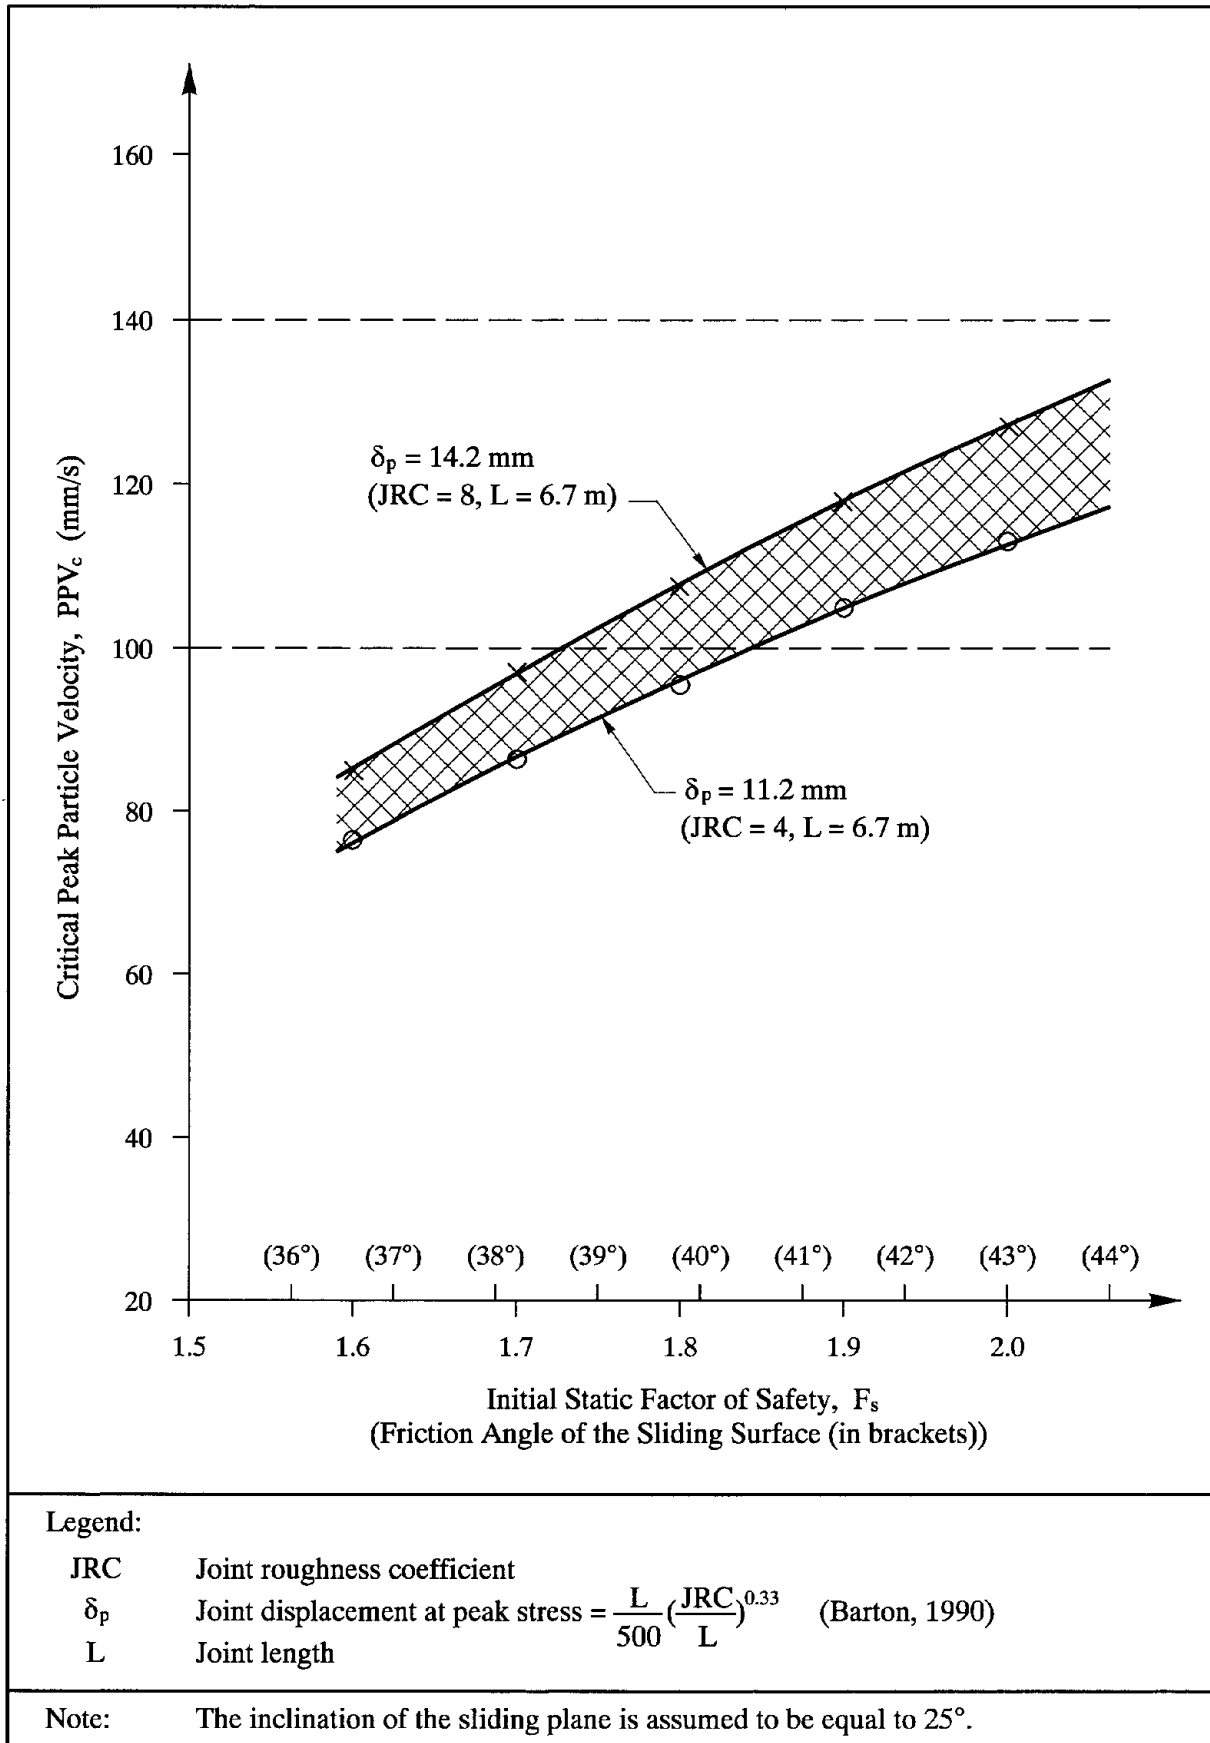
Figure B2 - Critical Peak Particle Velocity versus Initial Static Factor of Safety

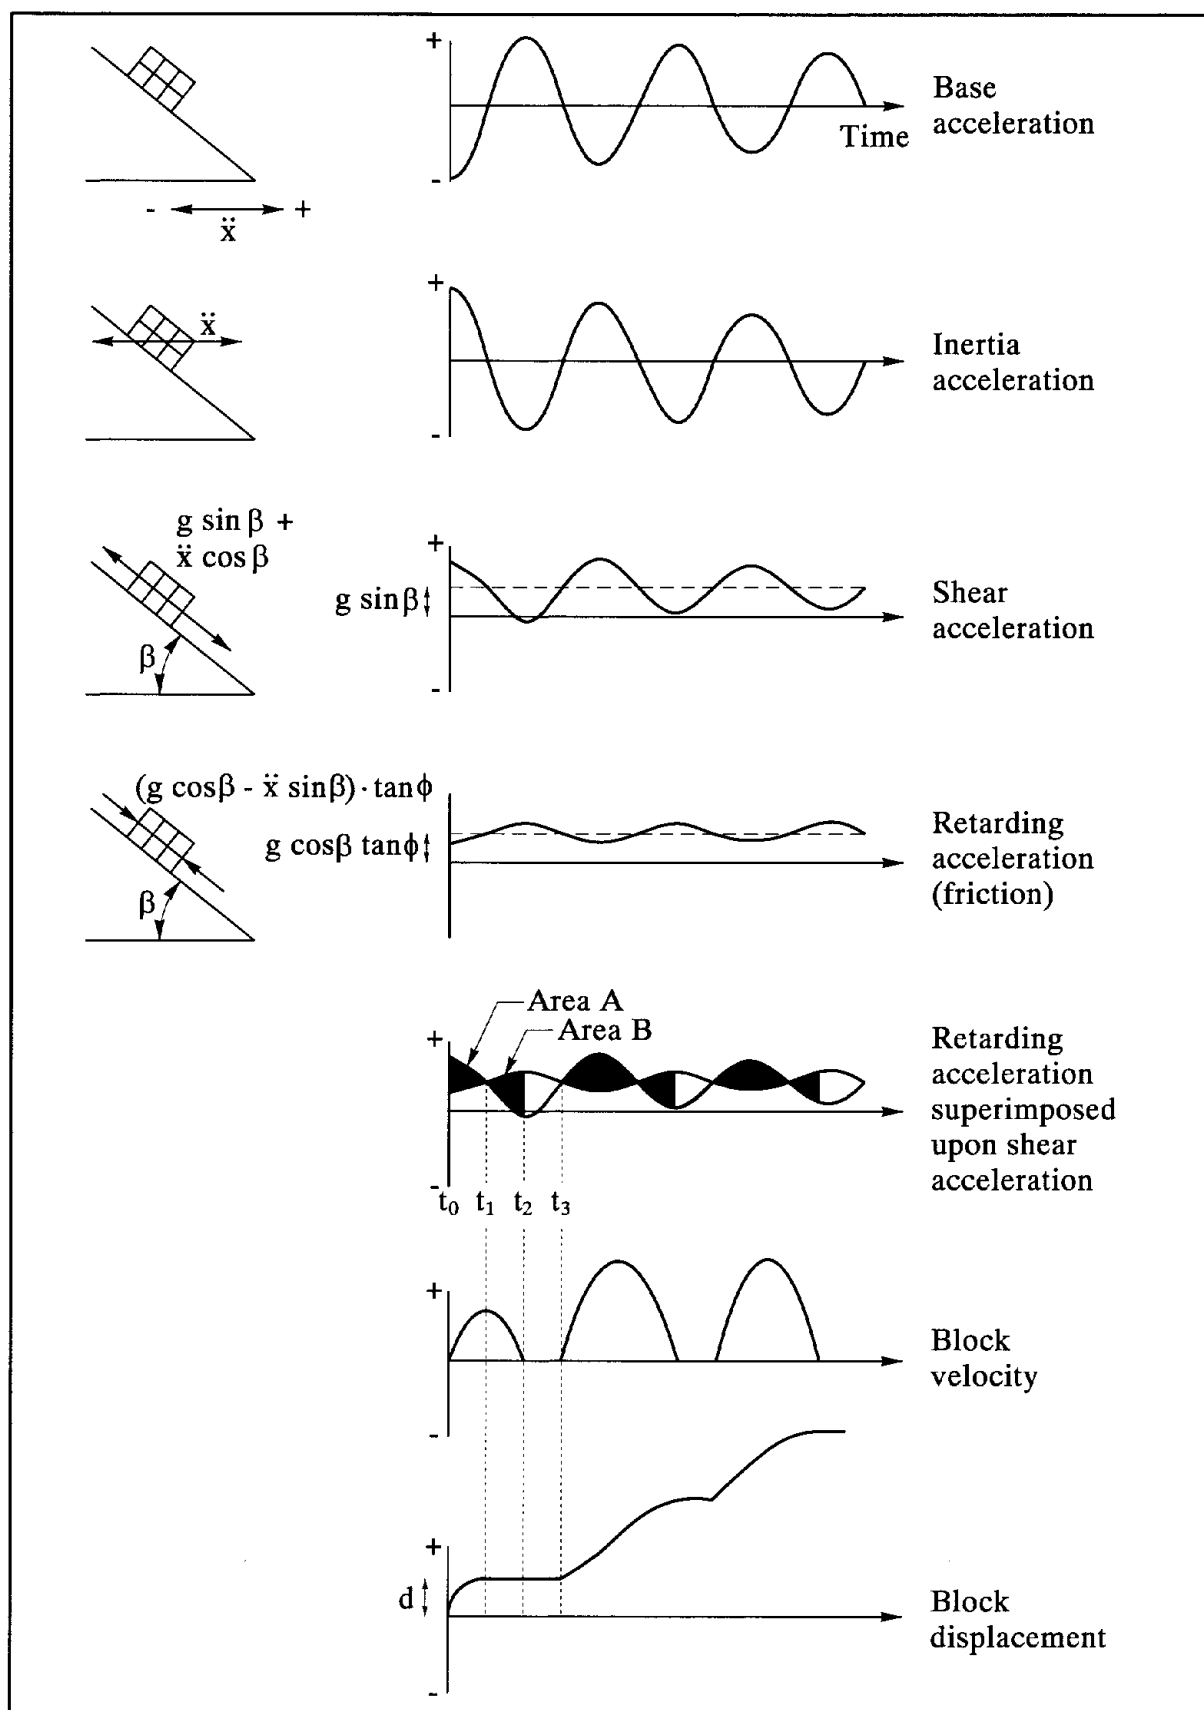
Figure B3 - Cumulative Displacement of a Block on an Inclined Plane Subjected to Horizontal Vibrations (after Hencher, 1981)

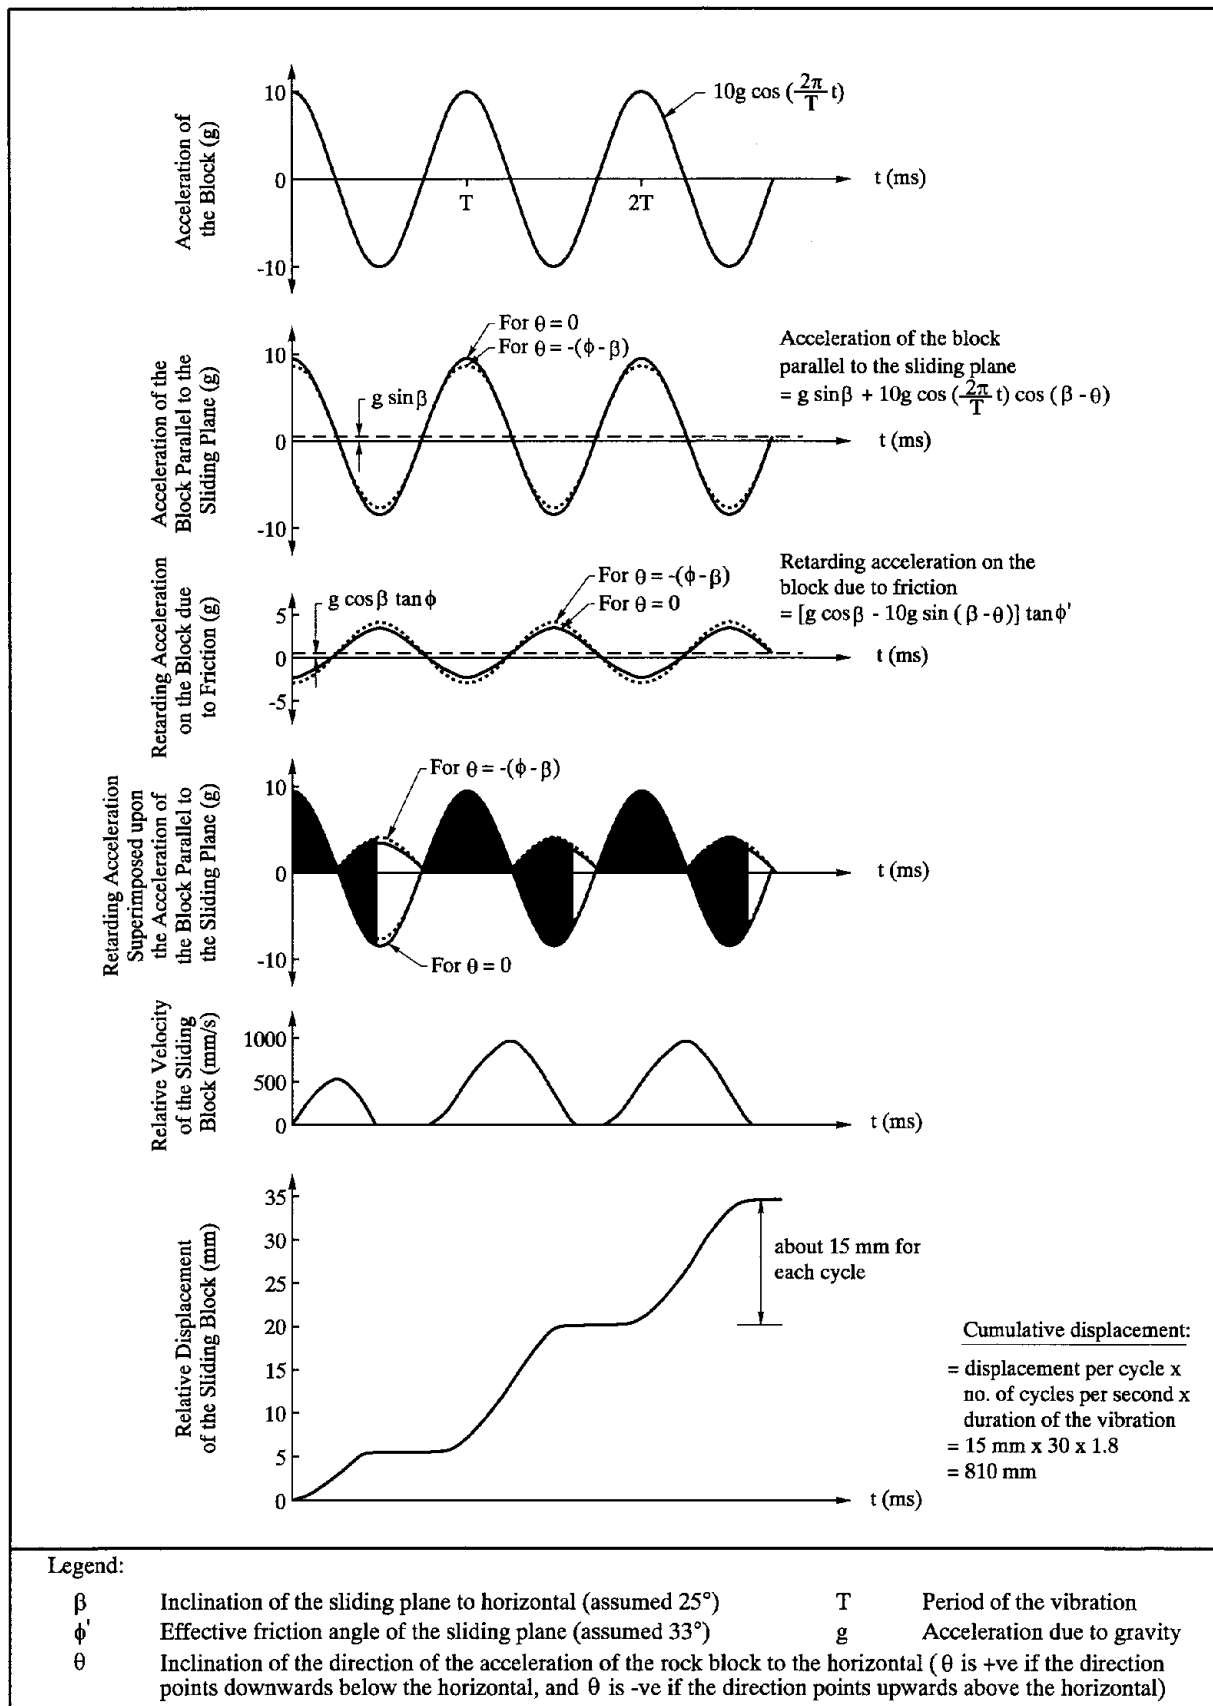
Figure B4 - Estimate of the Relative Cumulative Displacement of the Rock Mass Subjected to Sinusoidal Acceleration of a Maximum Magnitude of 10 g
