SECTION 2: REPORT ON THE RAINSTORM AND LANDSLIDES OF 1-4 JULY 1997

T.W.K. Lam

ABSTRACT

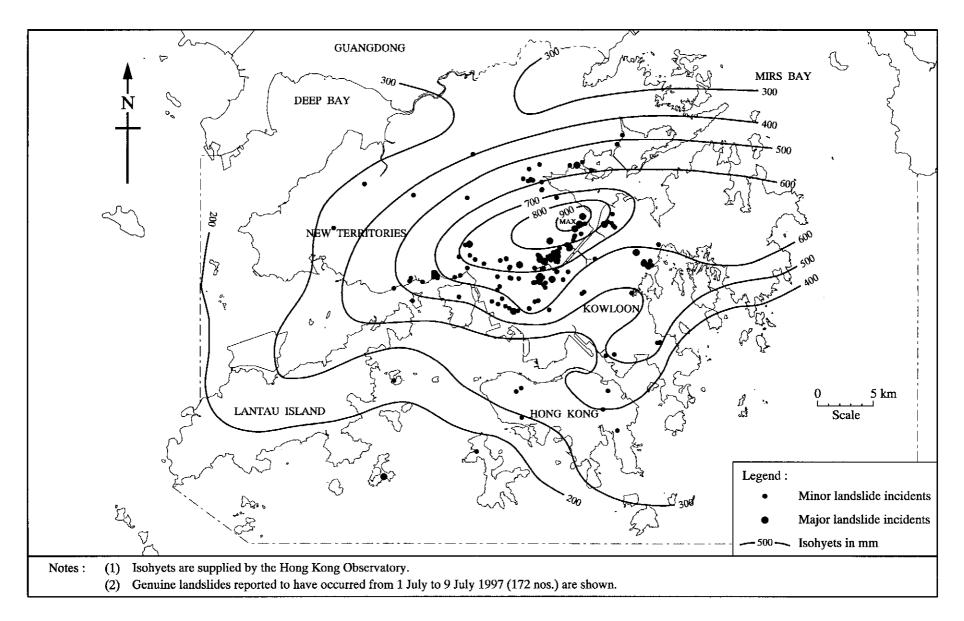
Figure 4 - Total Rainfall Distribution from 1 to 4 July 1997 and Locations of Landslides

The relationship between rainfall and landslides during the 1-4 July rainstorm is illustrated in plots of total rainfall distribution from 1 to 4 July in Figure 4, and 24-hour rainfall isohyets and landslides in Figures 7 to 9. Figure 4 shows the total rainfall distribution from 1 to 4 July and the locations of landslides which resulted from the 1-4 July rainstorm. Figures 7 to 9 show the locations of landslides for which both the time and date of occurrence are known.

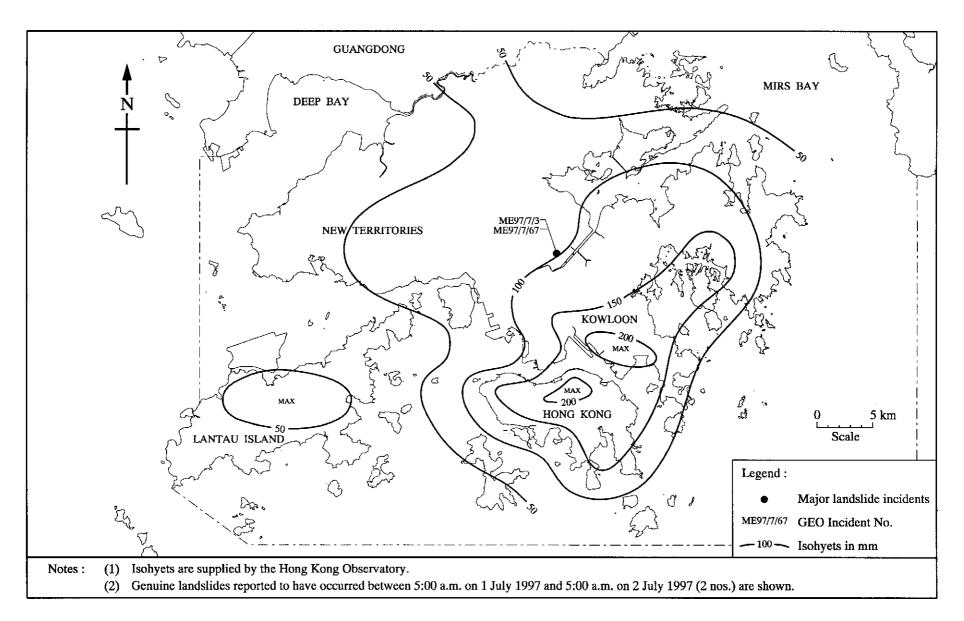
Figure 7 - 24-hour Rainfall Distribution from 5:00 a.m. on 1 July 1997 to 5:00 a.m. on 2 July 1997 and Locations of Landslides

Figure 7 shows that heavy rainfall occurred on 1 July in the urban areas. Heavy rain occurred on 2 July as intensified rainbands moved over the Tsuen Wan and Sha Tin areas (Figure 8). Rainfall was fairly evenly distributed on 3 July over the whole of Hong Kong (Figure 9). Most areas recorded more than 100 mm, and rainfall continued until the early hours of 4 July in the urban areas and over the western New Territories.

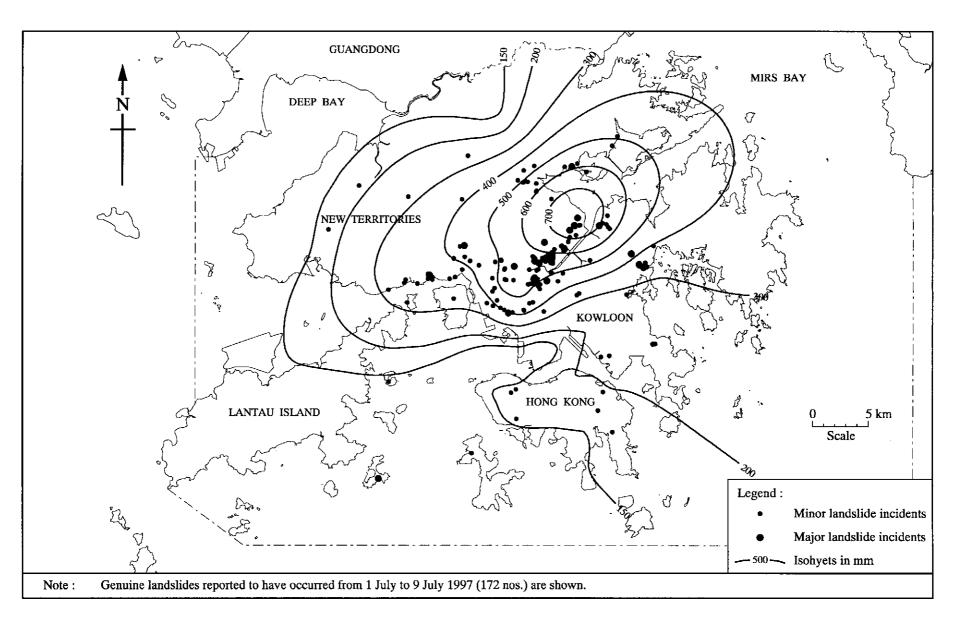
Figure 10 - Maximum 24-hour Rainfall Distribution in the Rainstorm of 1 to 4 July 1997 and Locations of Landslides

To further show the relationship between rainfall and landslides for the 1-4 July rainstorm, Figure 10 shows the maximum 24-hour rainfall distribution in the rainstorm of 1-4 July and the locations of landslides that occurred as a result. In addition, Figure 11 shows the maximum hourly rainfall distribution in the rainstorm of 1-4 July and locations of landslides that occurred as a result. The maximum 24-hour rainfall distribution in Figure 10 and the maximum hourly rainfall distribution in Figure 11 were plotted based on the maximum rolling 24-hour rainfall and the maximum hourly rainfall, respectively, from raingauge stations in the whole of Hong Kong.
