APPENDIX H
GROUND INVESTIGATION AND
ENGINEERING GEOLOGICAL STUDY

H.1 INTRODUCTION

A comprehensive ground investigation and engineering geological study were carried out by the Geotechnical Engineering Office (GEO) shortly after the landslide. The main objectives were :

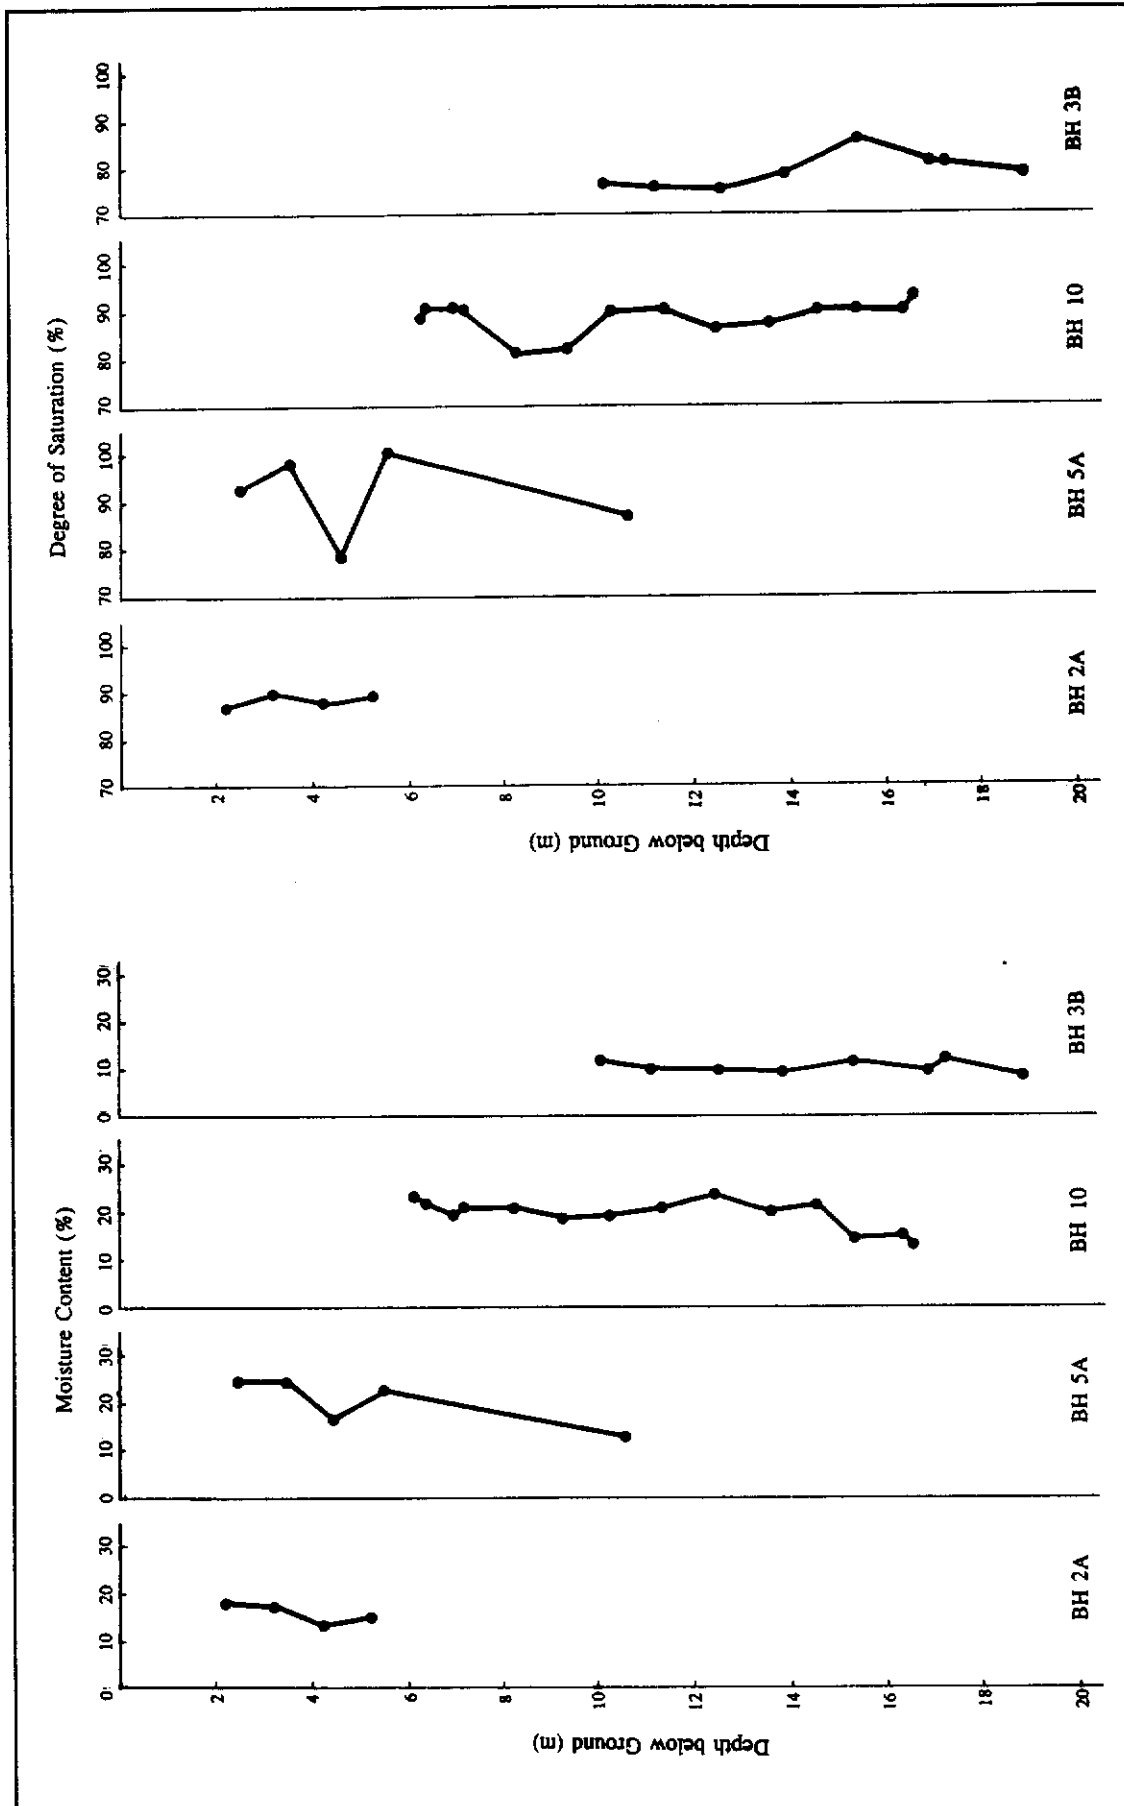
Figure I2 - Profiles of Moisture Content and Degree of Saturation

Apart from measurements of the water contents of isolated triaxial test specimens, continuous profiles of water content and degree of saturation were determined using samples from four drillholes (Table I2). The profiles are plotted in Figure I2. It can be seen that material throughout the upper 6 to 10 m (or about 7 to 11 m of the pre-failure profile) in Drillhole No. 5A was wetter and more saturated than the deeper material. The pattern of wetting, however, was more erratic and less clearly defined in Drillholes No. 2A & 10. Samples from Drillhole No. 3B, which was located further away from the foulwater sewer than Drillholes No. 2A, 5A and 10, had a degree of saturation that varied between about 75% and 85% at depths ranging from 10 m to 19 m.

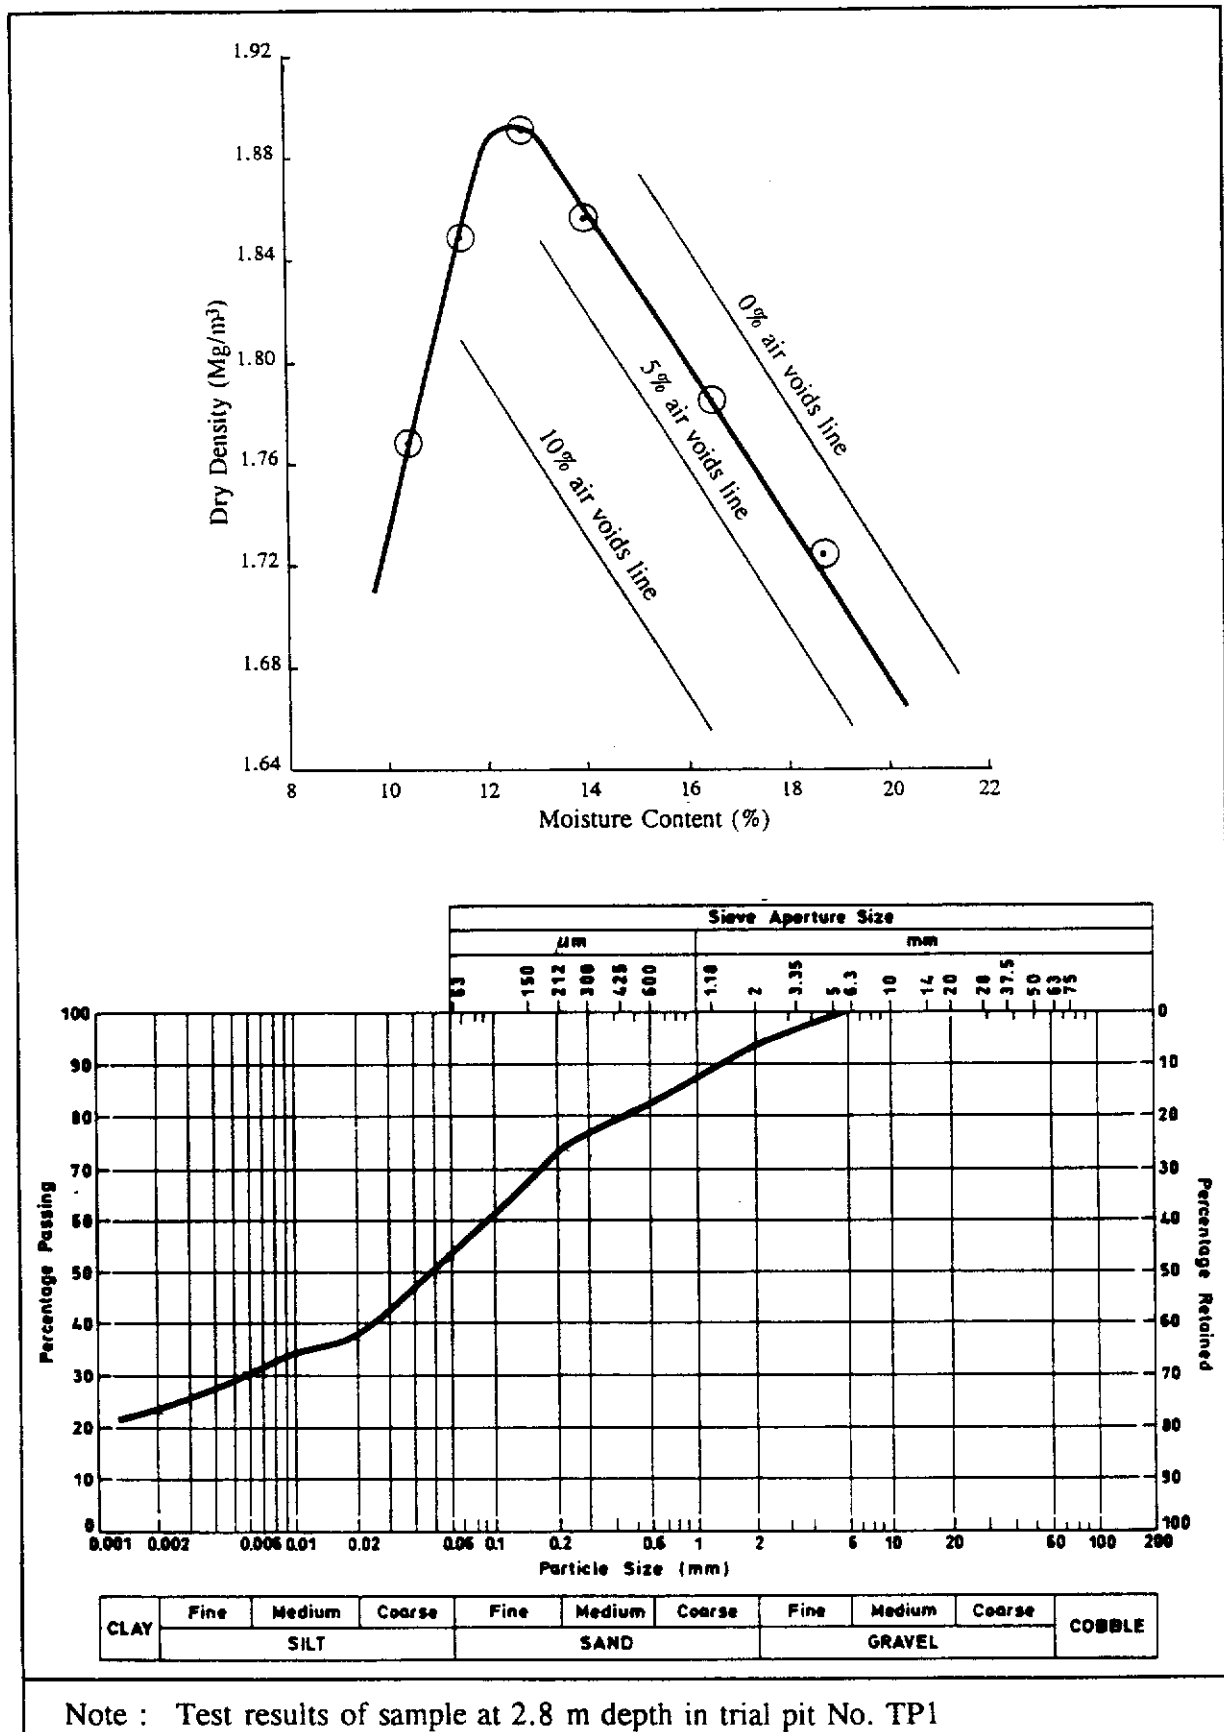
Figure I3 - Results of Compaction Tests on Fill from Trial Pit No. TP1

The results of the tests are shown in Figures I3 & I4 in terms of dry density versus moisture content. Also shown in the figures are the corresponding particle size distribution curves of the samples.

The maximum dry densities of the two fill samples were 1.78 Mg/m^3 and 1.89 Mg/m^3 respectively, with the corresponding optimum moisture content being 16% and 13%. The insitu dry densities of the fill were determined from sand replacement tests and ranged from 1.42 Mg/m^3 to 1.70 Mg/m^3 . The average insitu dry density was about 1.57 Mg/m^3 , which corresponds to about 85% of the maximum dry density, suggesting that the fill is generally loose. The scatter in the results indicates that the fill at the landslide site was variable and locally could be in a very loose state.

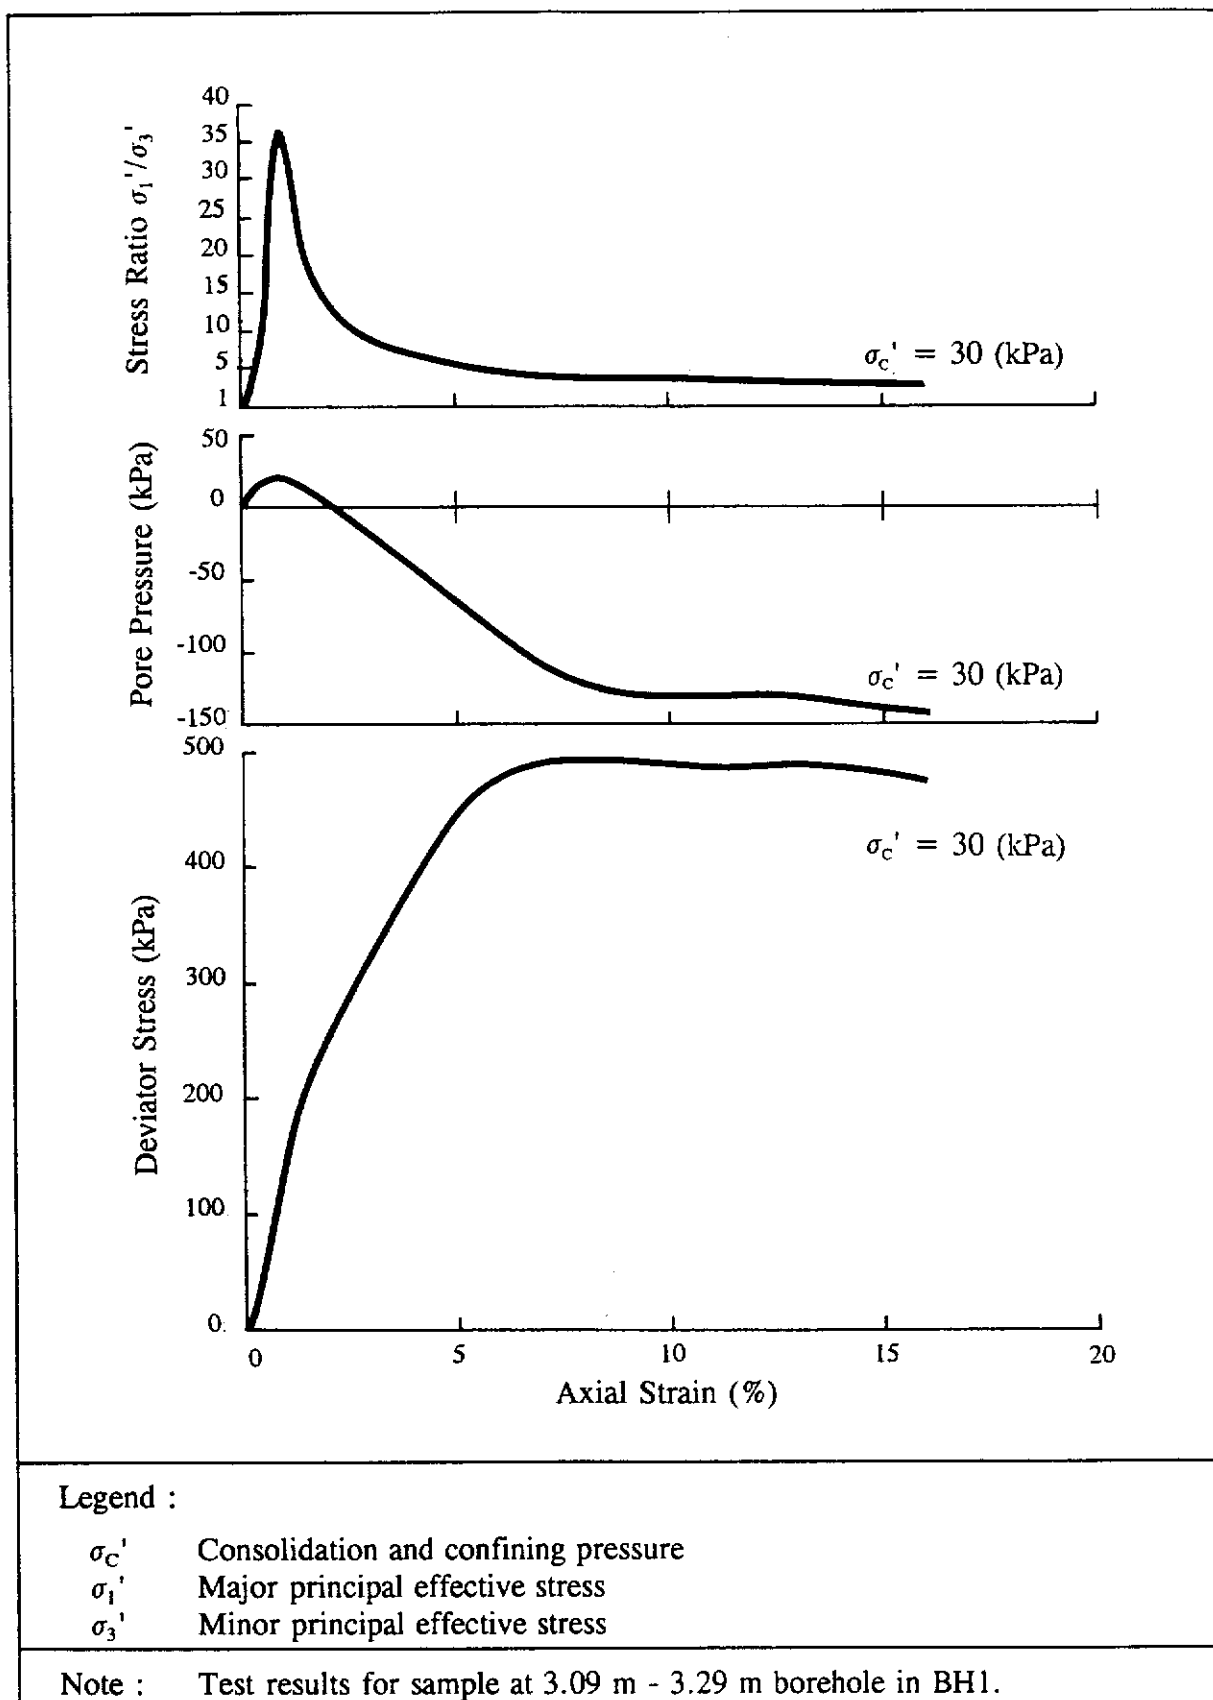
Figure I9 - Typical Behaviour of C/HDV in Triaxial Compression Tests Excluded from the Analyses

It should be noted that two of the C/HDV specimens were not included in the analysis because of their apparently unusual behaviour. An example of the shear behaviour of a specimen for which the results have been excluded from the analyses is shown in Figure I9. It can be seen that the initial stress-strain behaviour was very stiff, and the stress state of the sample reached an atypically high stress ratio before brittle failure. Such material characteristics may reflect the influence of large inclusions or bonding. The test procedure adopted and the stress paths involved in conventional undrained triaxial compression tests are such that the strength parameters of the more weathered material can reasonably be obtained. However, the effect of any remnant bonding, which may give rise to increased peak strength and stiffness with a brittle response upon failure, may not be fully recovered because of possible disturbance during sampling and specimen preparation.

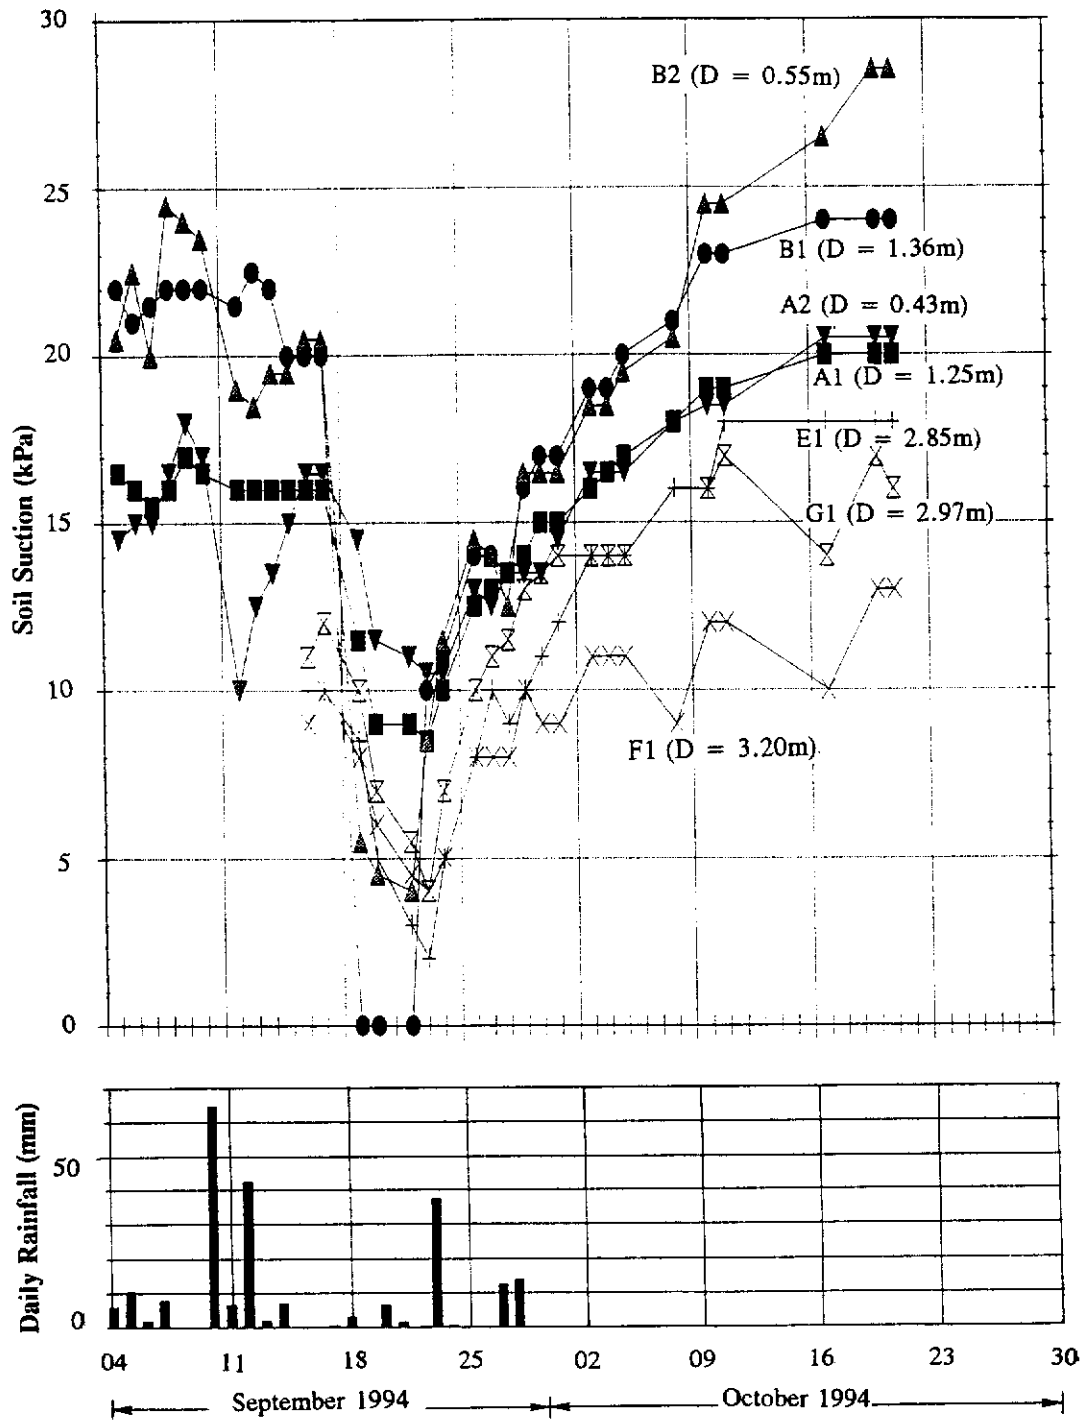
Figure K9 - Results of Soil Suction Monitoring in the Ground underneath the Landslide Scar

- Notes :
- (1) D denotes depth of the tensiometer below ground level.
 - (2) The tensiometers were installed vertically into the ground.
 - (3) See Figure K8 for locations of tensiometers.

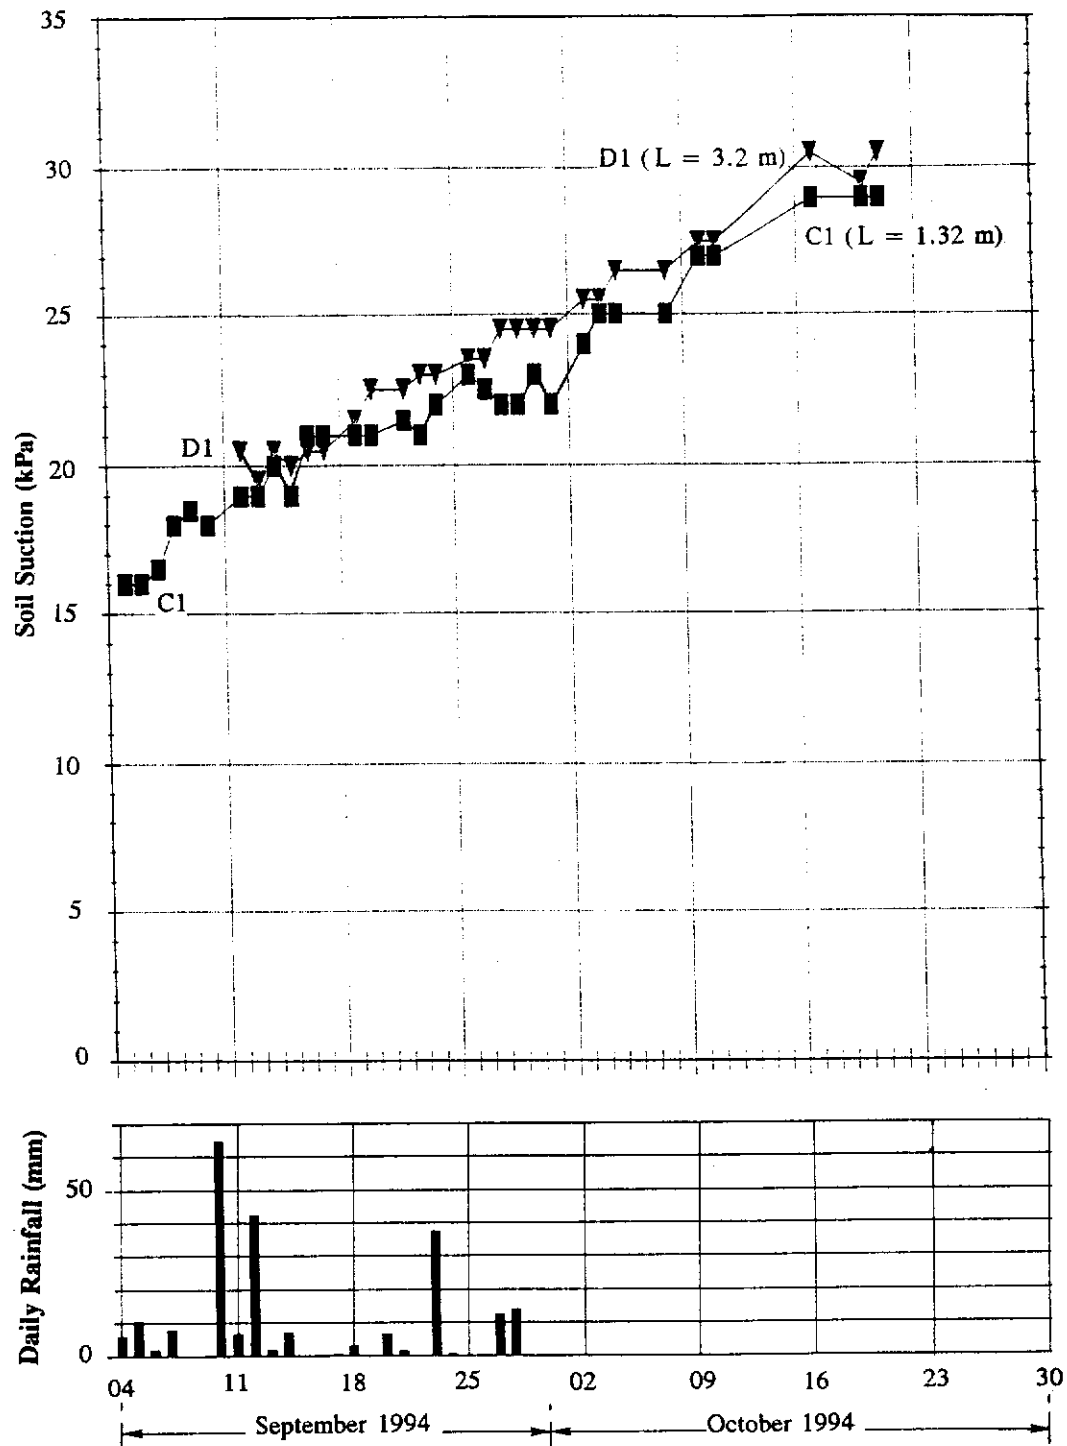
Figure K10 - Results of Soil Suction Monitoring in the Ground behind the Masonry Wall

- Notes :
- (1) L denotes length of the tensiometer installed in the ground behind the masonry wall.
 - (2) Tensiometers C1 & D1 were installed at an inclination of about 20° to the horizontal.
 - (3) See Figure K8 for locations of tensiometers.

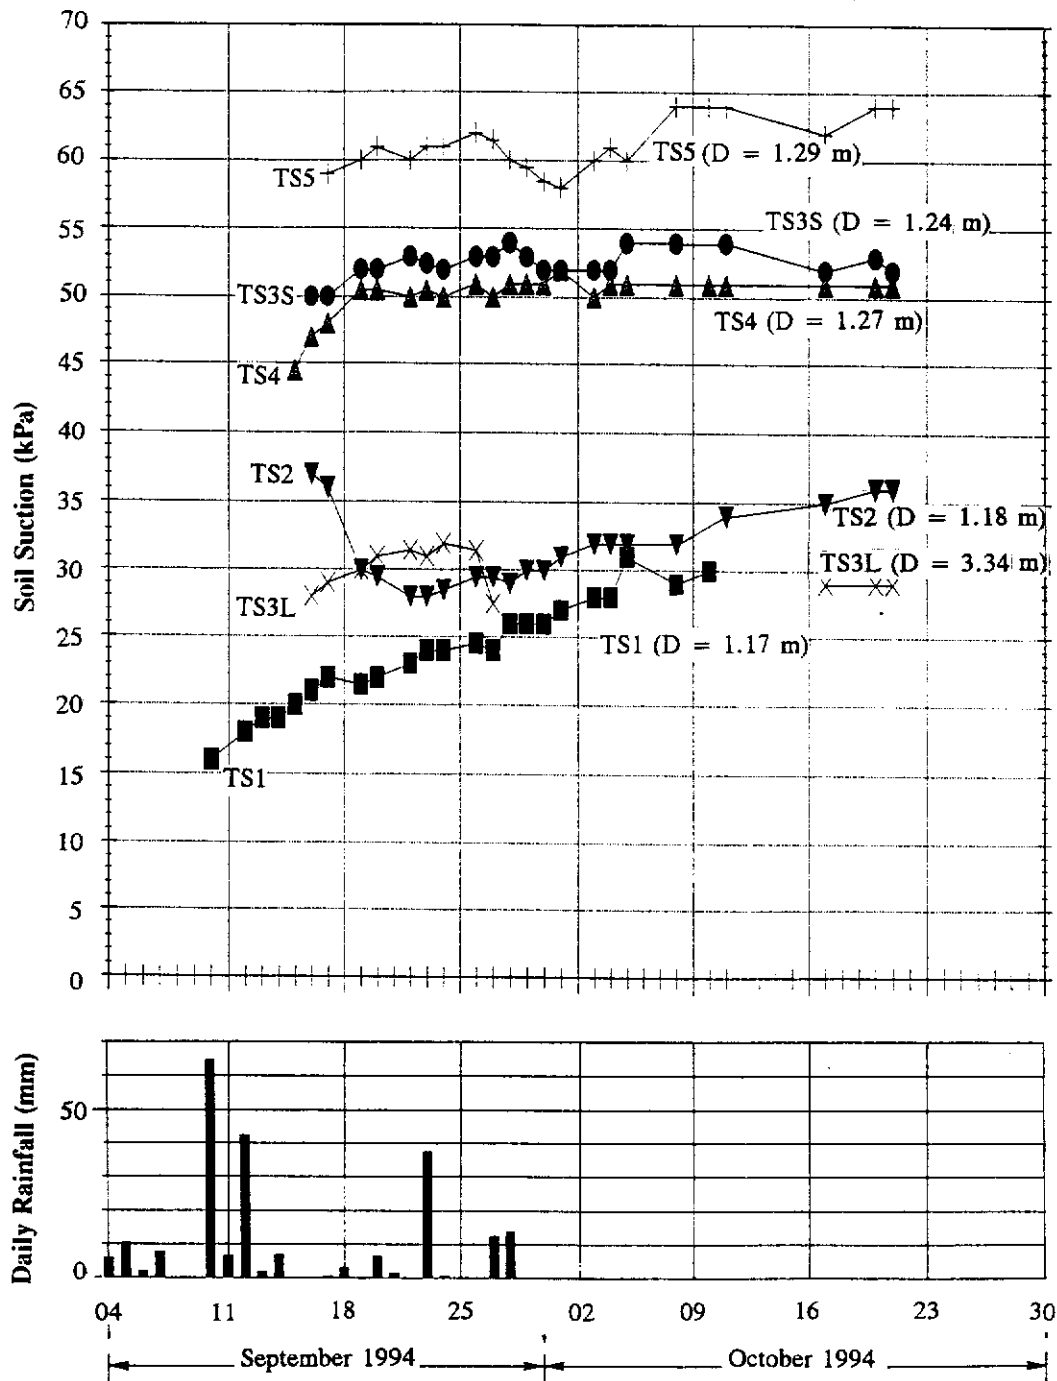
Figure K11 - Results of Soil Suction Monitoring in the Ground underneath Block D

- Notes :
- (1) D denotes depth of the tensiometer below ground level.
 - (2) The tensiometers were installed vertically into the ground.
 - (3) See Figure K8 for locations of tensiometers.

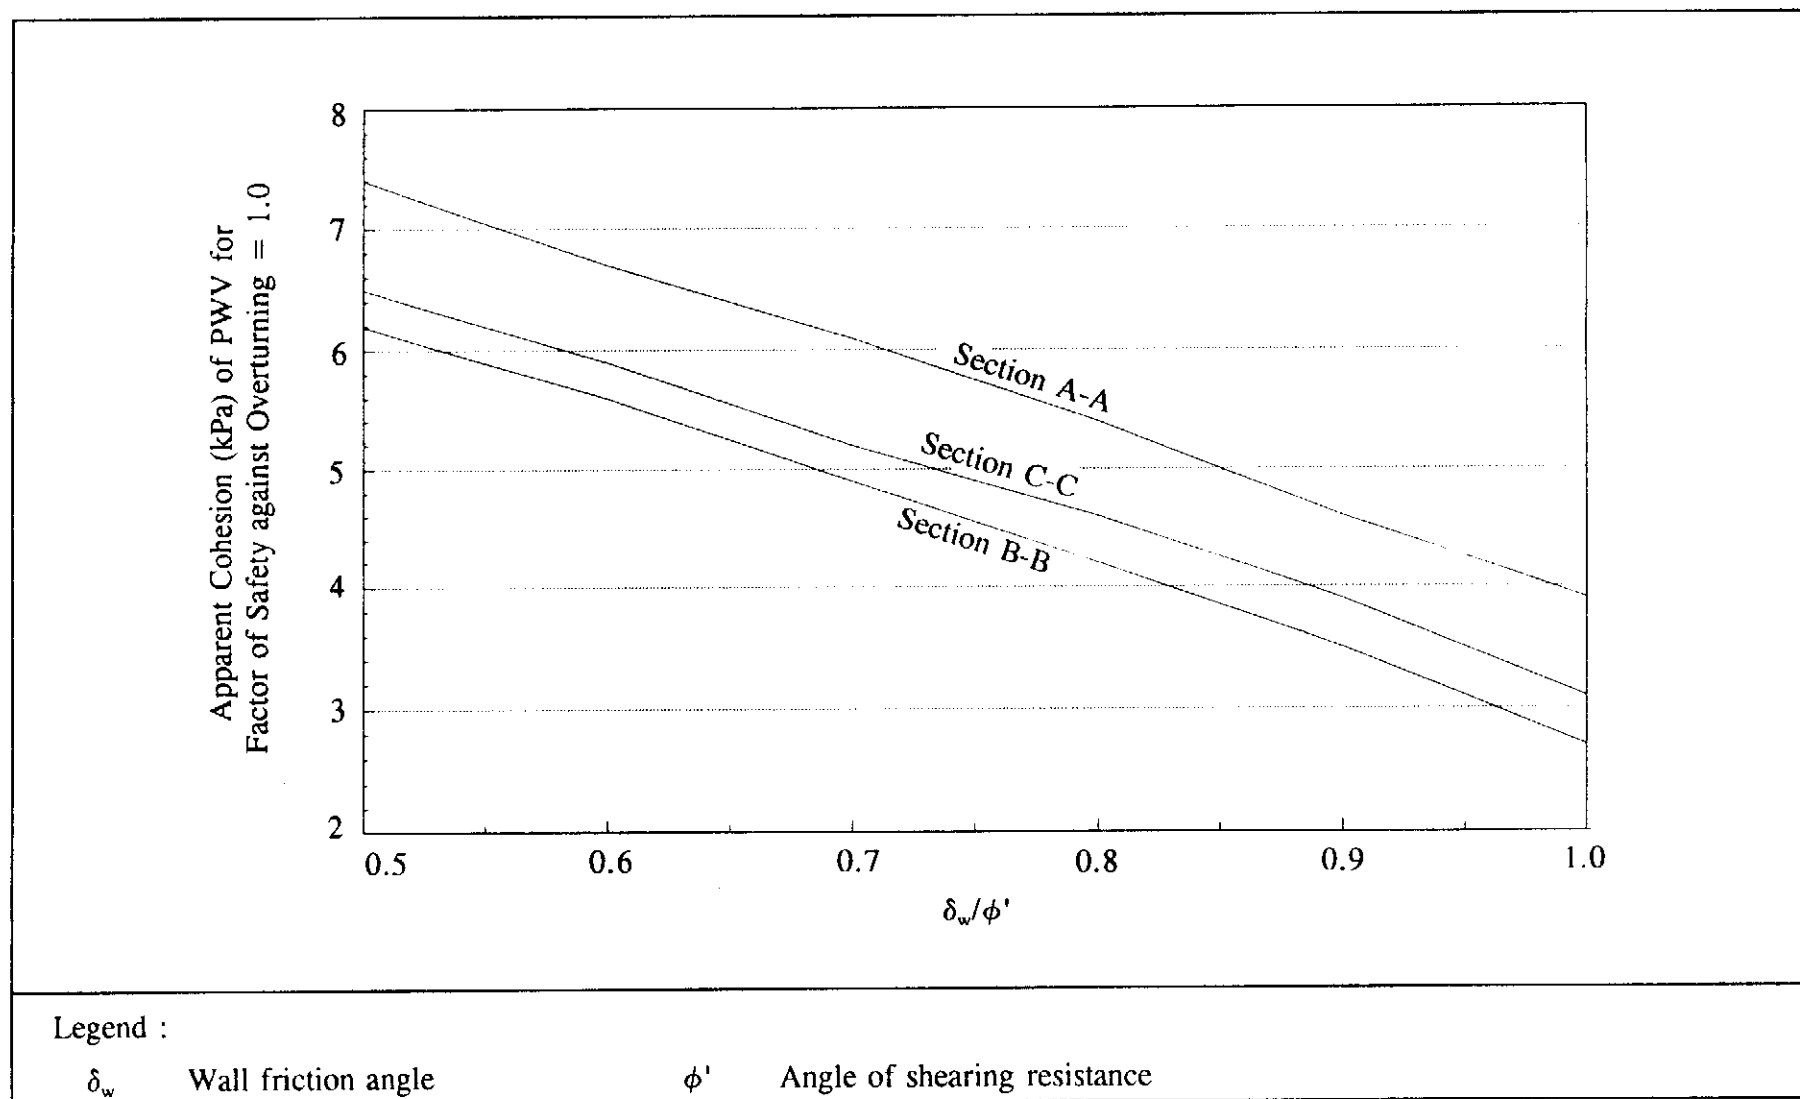
Figure L13 - Minimum Apparent Cohesion Required for Wall Stability against Overturning Failure

the apparent cohesion of the PWV. The wall required some minimum apparent cohesion in the PWV for the factor of safety against overturning to be greater than unity. Figure L13 shows the minimum c' required for stability and the influence of wall friction. The minimum c' was found to be not too sensitive to the assumed wall friction. Even with the most favourable assumption for wall friction (i.e. full ϕ'), a minimum c' for the PWV of about 3 kPa is required for the factor of safety to be greater than unity.

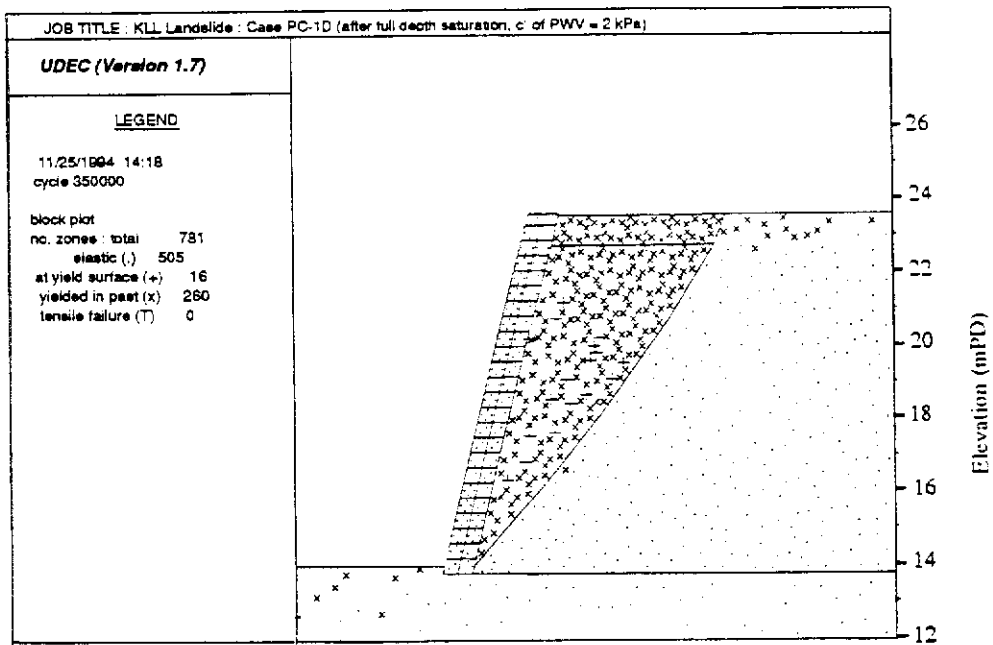
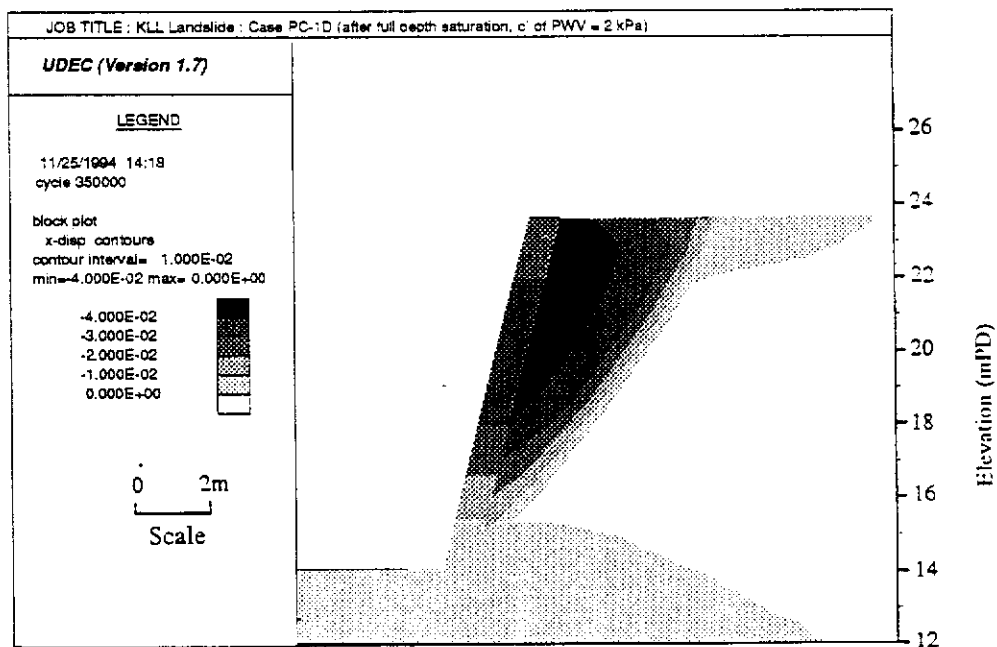
Figure L18 - Results of UDEC Analyses for Case PC-1D

- Notes :
- (1) Section C-C with the 1924 ground profile was analysed.
 - (2) The analyses show that the wall is stable. The stress state and horizontal displacement at the equilibrium condition are shown in this Figure.

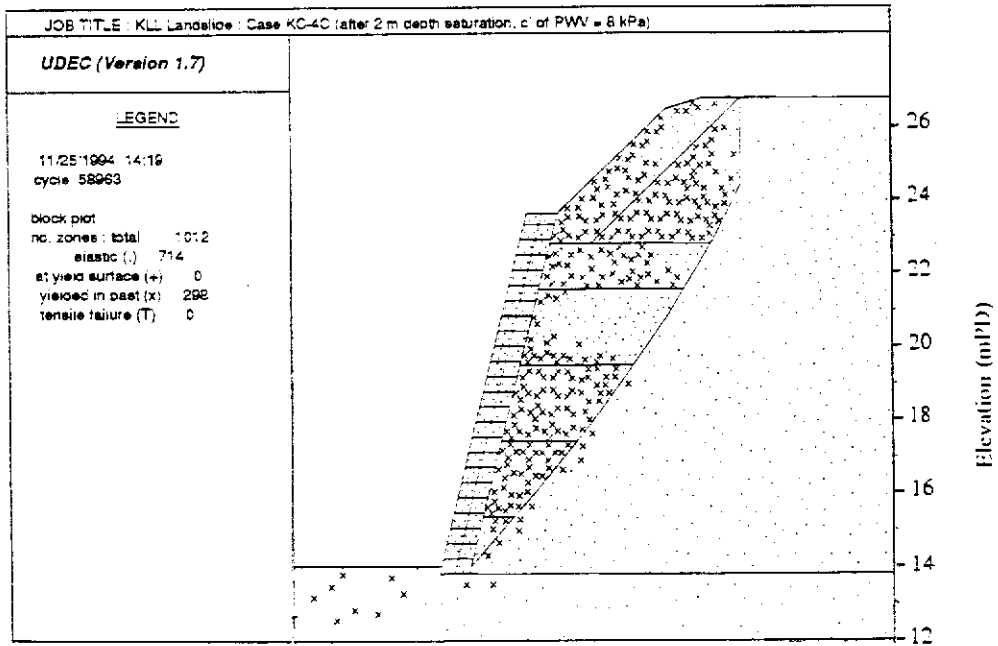
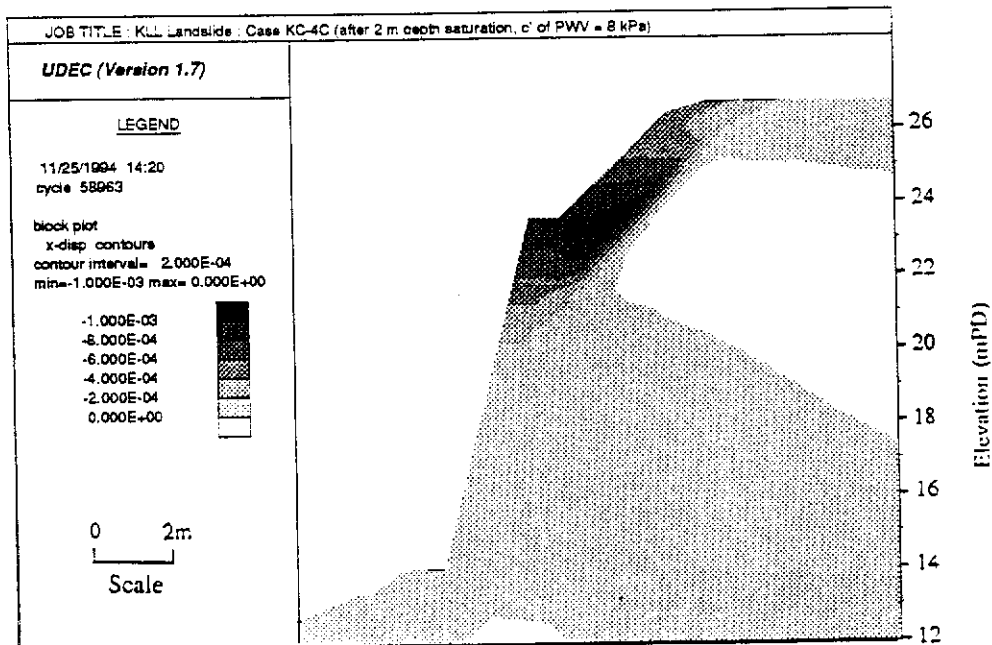
Figure L19 - Results of UDEC Analyses for Case KC-4C (Depth of Saturation = 2m)

Note : The analyses show that the wall is stable. The stress state and horizontal displacement at the equilibrium condition are shown in this Figure.

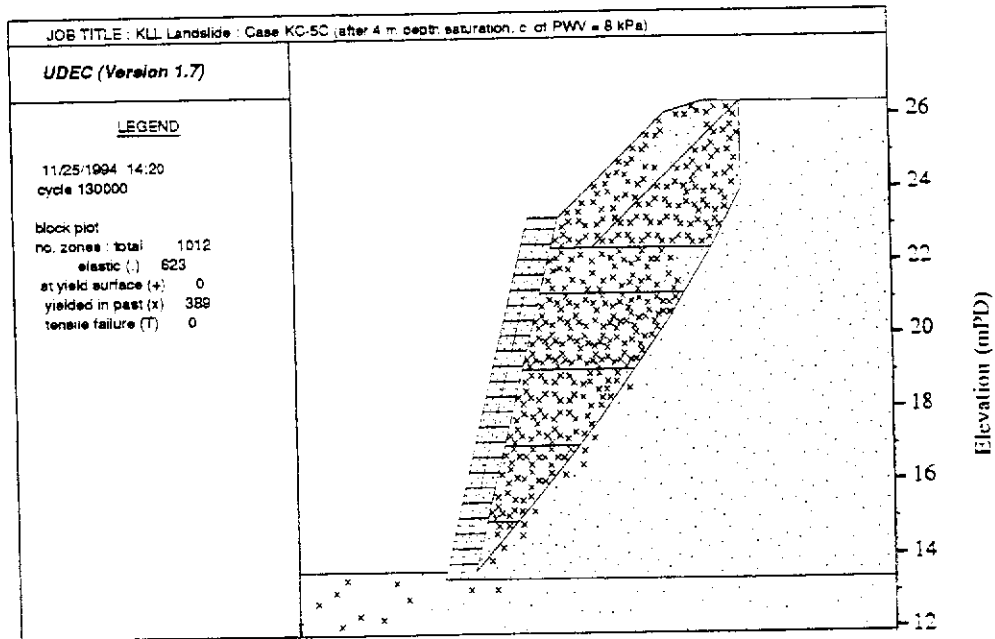
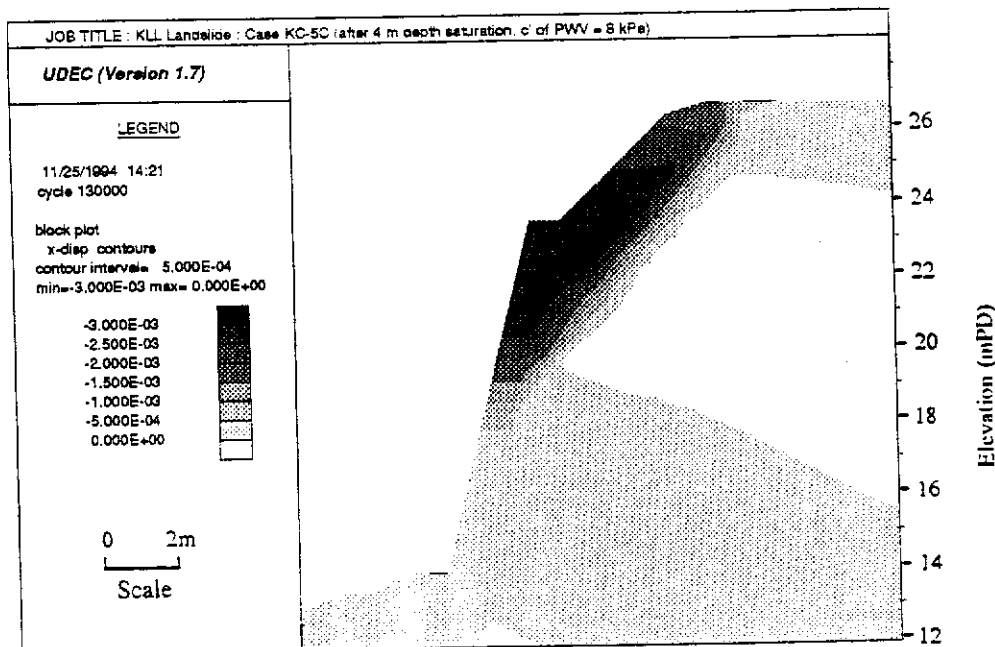
Figure L20 - Results of UDEC Analyses for Case KC-5C (Depth of Saturation = 4m)

Note : The analyses show that the wall is stable. The stress state and horizontal displacement at the equilibrium condition are shown in this Figure.

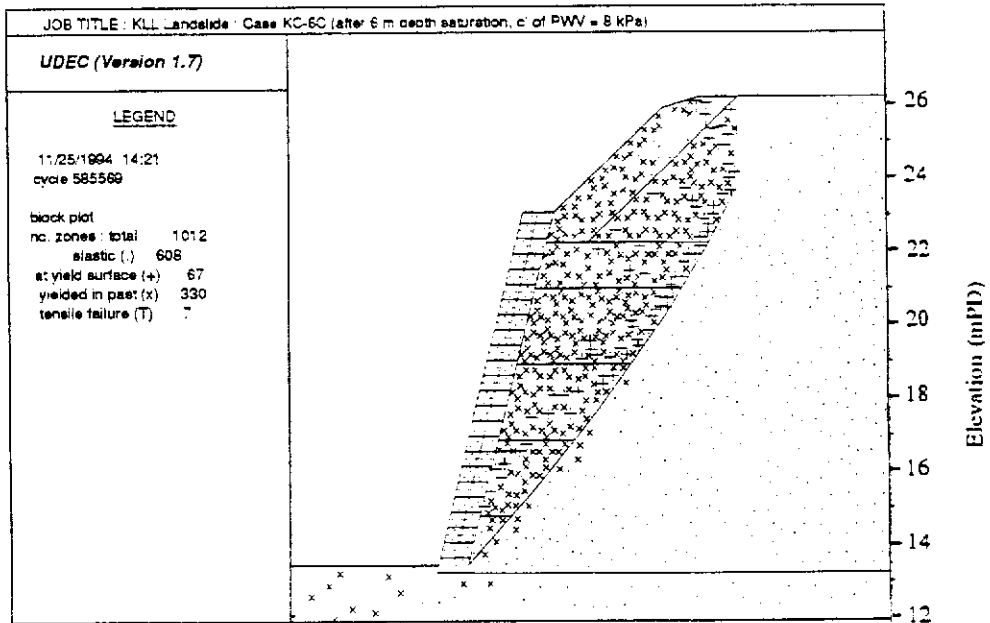
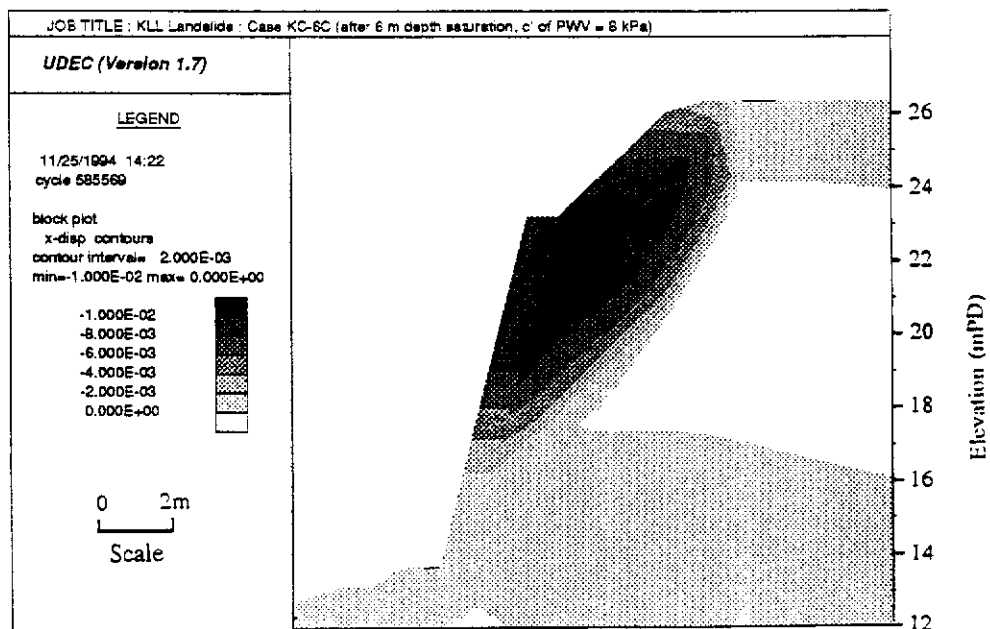
Figure L21 - Results of UDEC Analyses Case KC-6C (Depth of Saturation = 6m)

Note : The analyses show that the wall is stable. The stress state and horizontal displacement at the equilibrium condition are shown in this Figure.

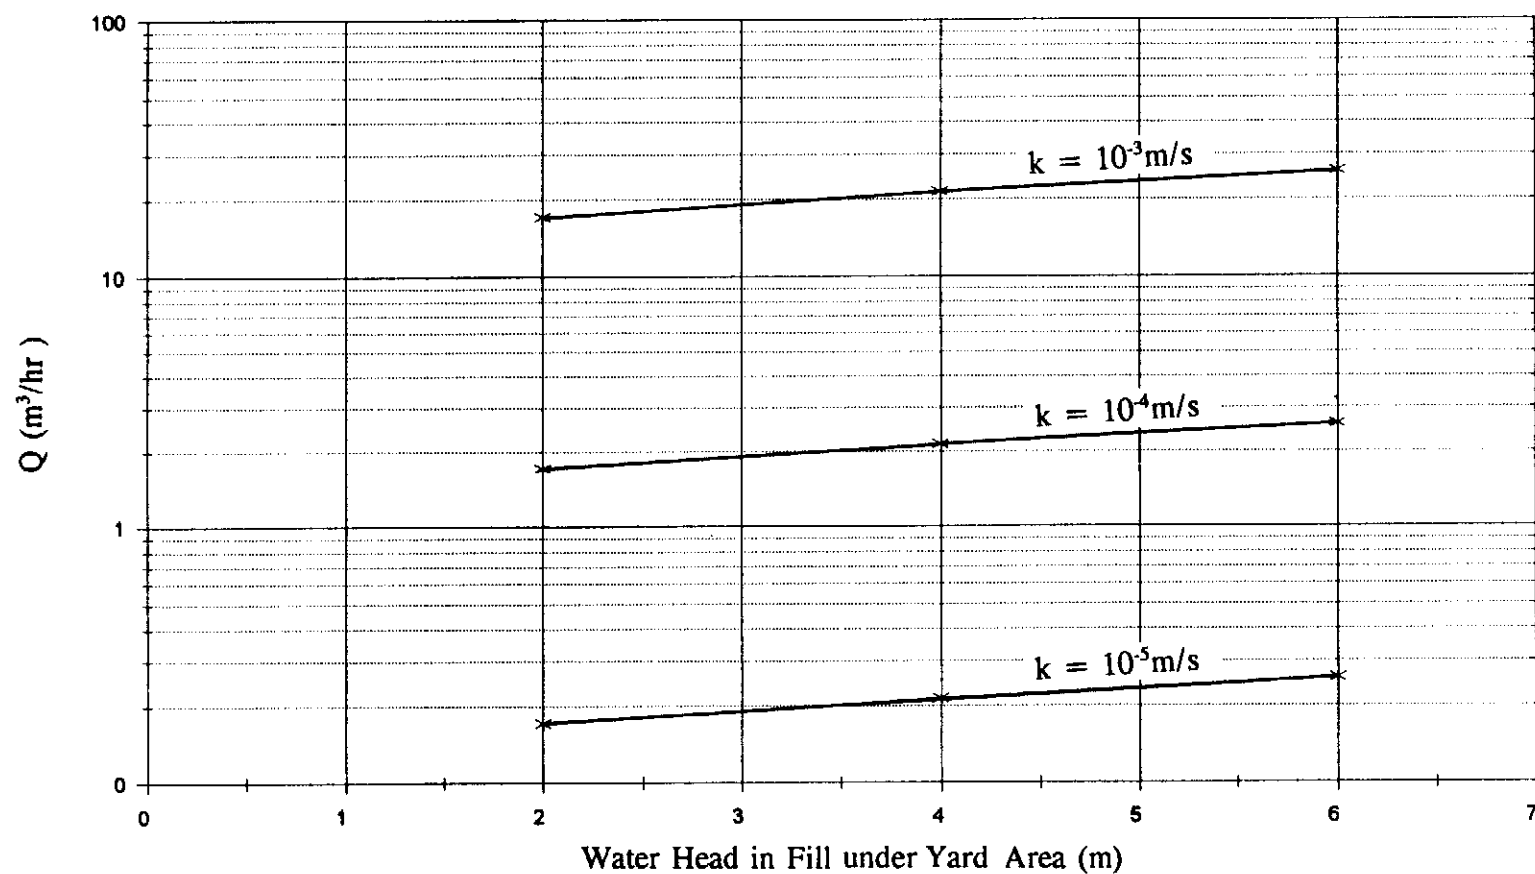
Figure L25 - Results of Seepage Analyses (Case 1)

Legend :

- k Permeability of saturated fill
- Q Rate of water flowing out from the ground underneath Block D

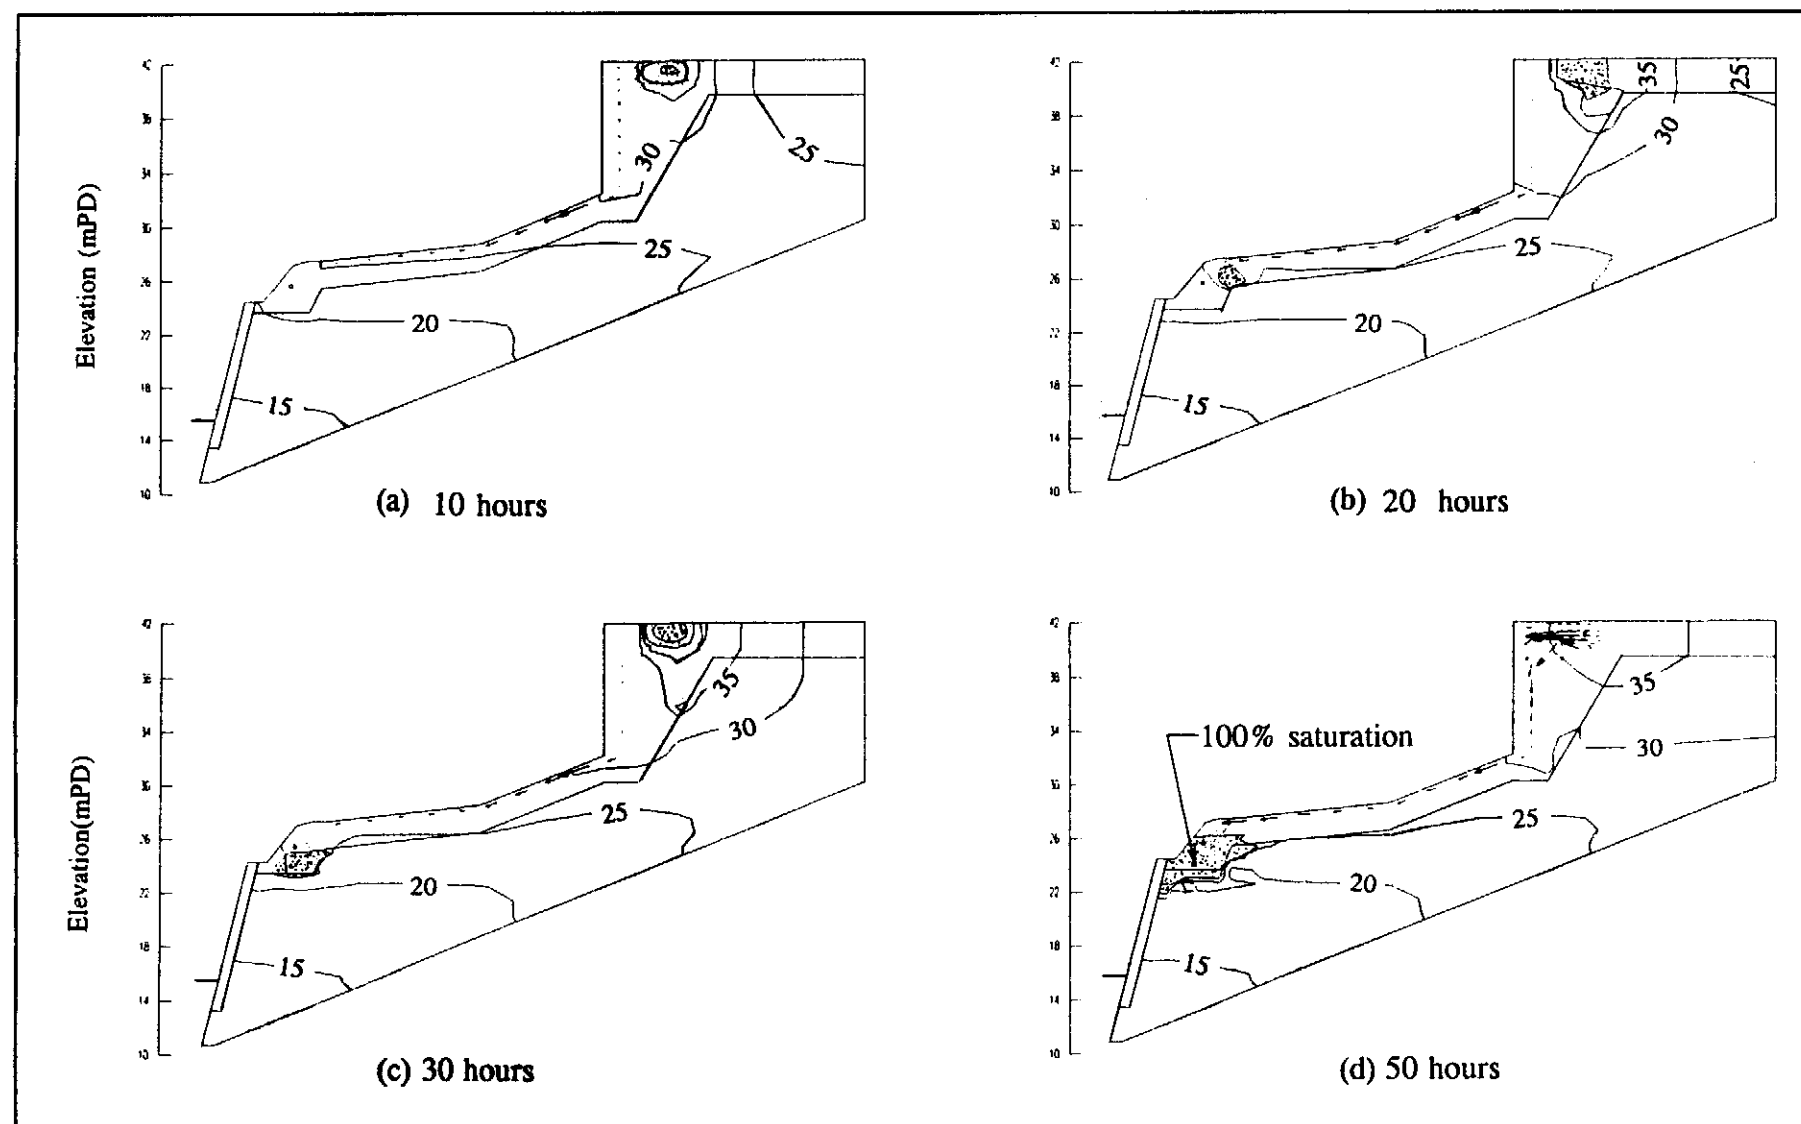
Figure L28 - Extent of Wetted Zone at Different Times due to Stormwater Leakage

The analyses indicate that it was possible for the fill stratum behind the masonry wall to become substantially saturated due to leakage from the stormwater drains. The analyses also show that substantial saturation of the fill would have occurred about one day before the landslide. With major leakage from the foulwater sewer following wetting of the fill stratum, the PWV could have become substantially saturated by the time of the landslide.
