APPENDIX H
GROUND INVESTIGATION AND
ENGINEERING GEOLOGICAL STUDY

H.1 INTRODUCTION

A comprehensive ground investigation and engineering geological study were carried out by the Geotechnical Engineering Office (GEO) shortly after the landslide. The main objectives were :

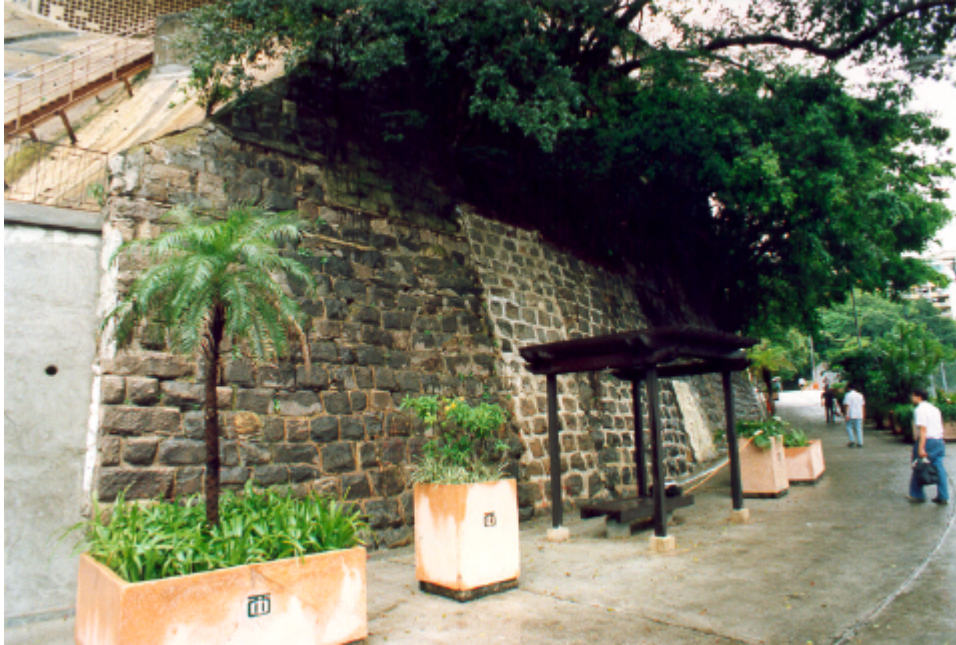
Plate M1 - Masonry Wall No. 11SW-A/R309 in July 1987

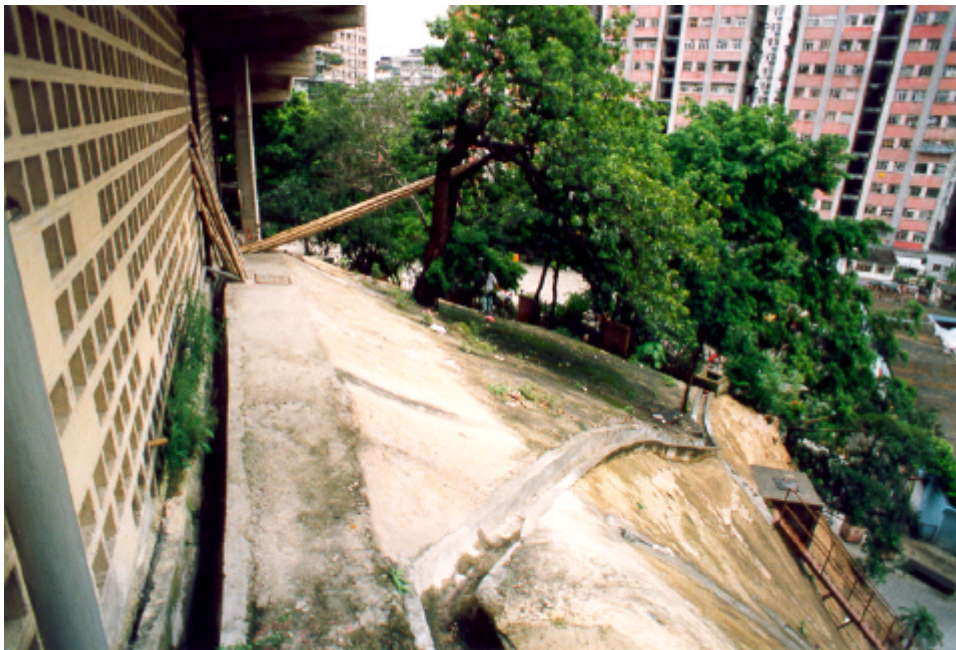
Plate M2 - Slope above Masonry Wall No. 11SW-A/R309 in July 1987

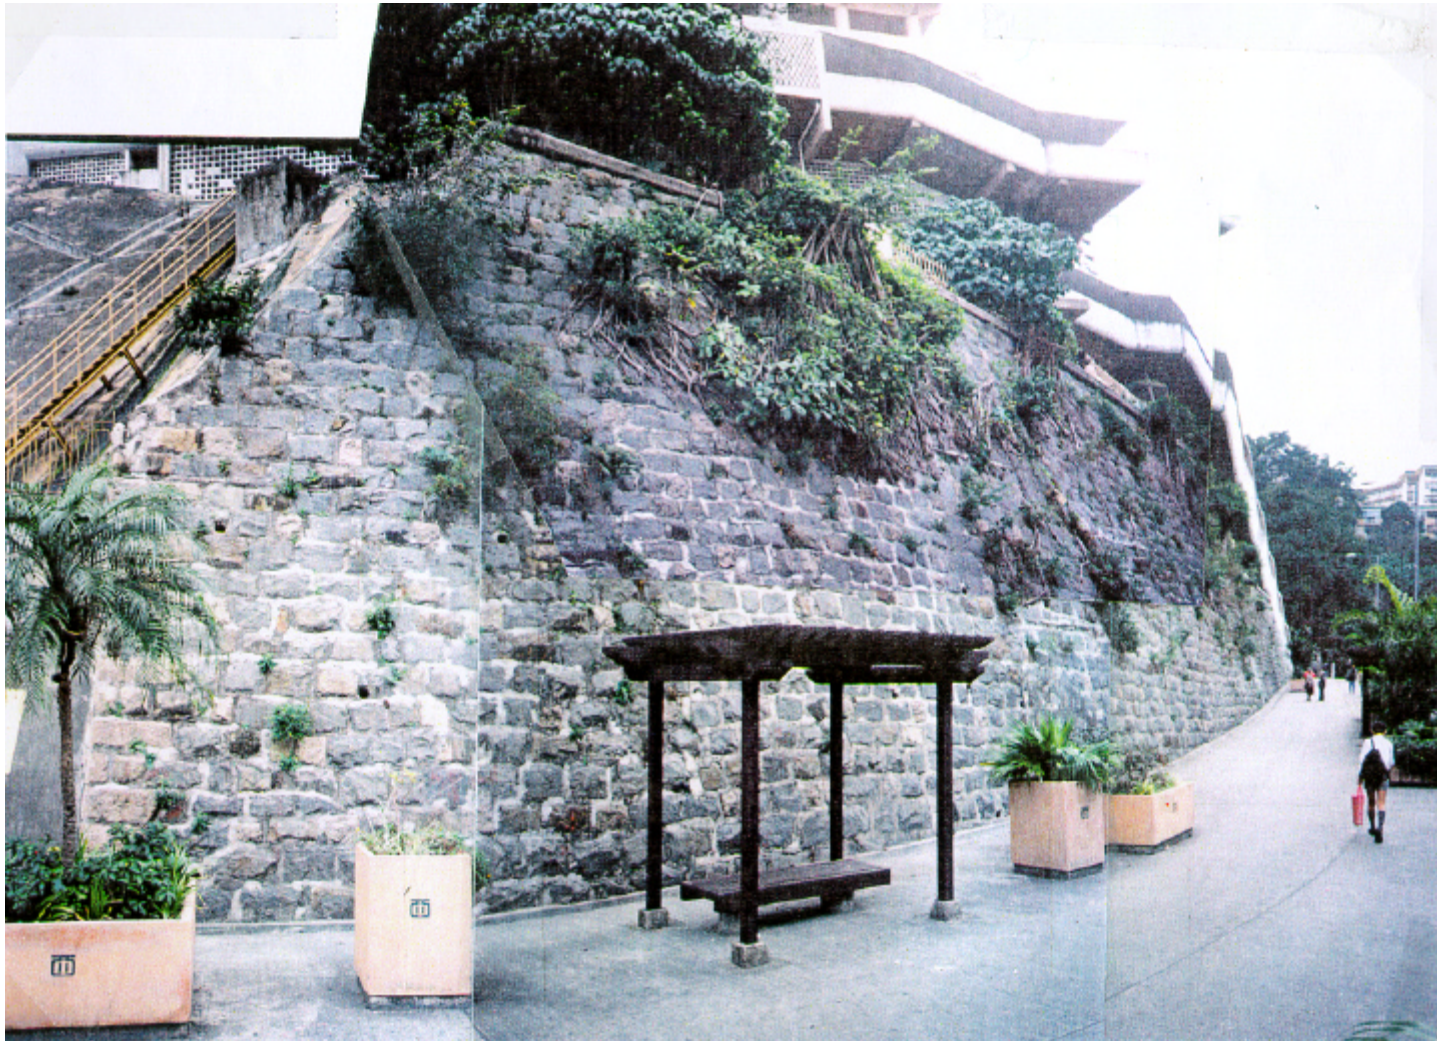
Plate M3 - Masonry Wall No. 11SW-A/R309 in January 1991

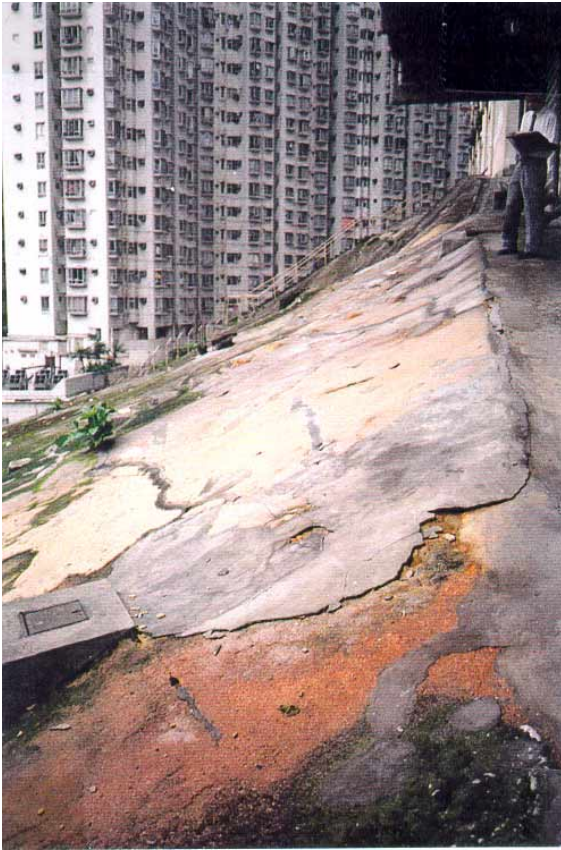
Plate M4 - Slope between
Masonry Wall
No. 11SW-A/R309
and Block D
in June 1994

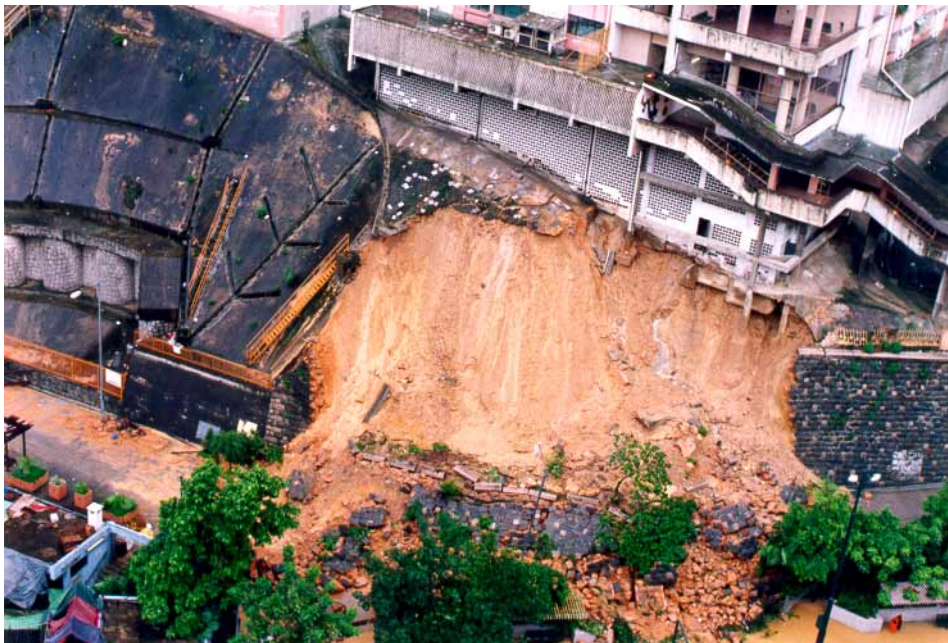
Plate M5 - View of the Landslide on 24 July 1994

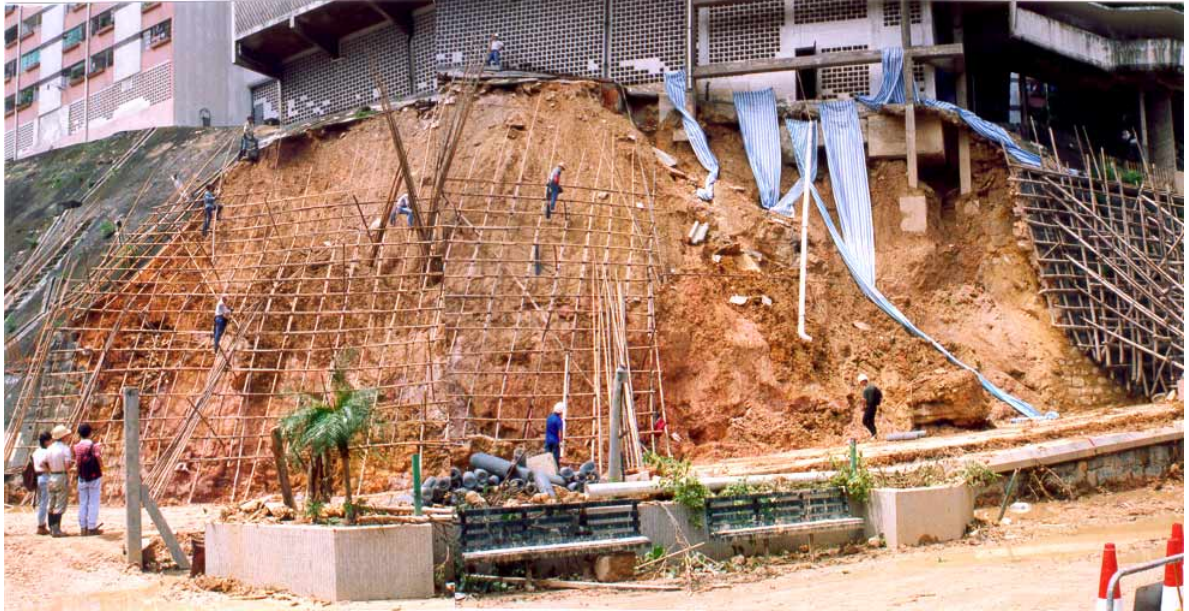
Plate M6 - View of the Landslide after Removal of Landslide Debris on 28 July 1994

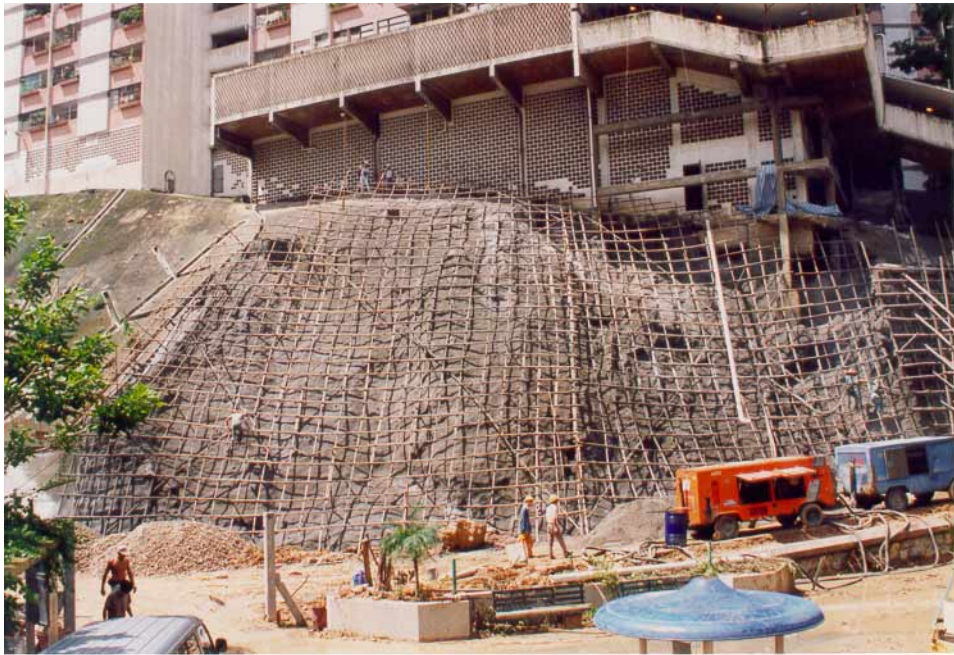
Plate M7 - View of the Landslide after Shotcreting on 29 July 1994

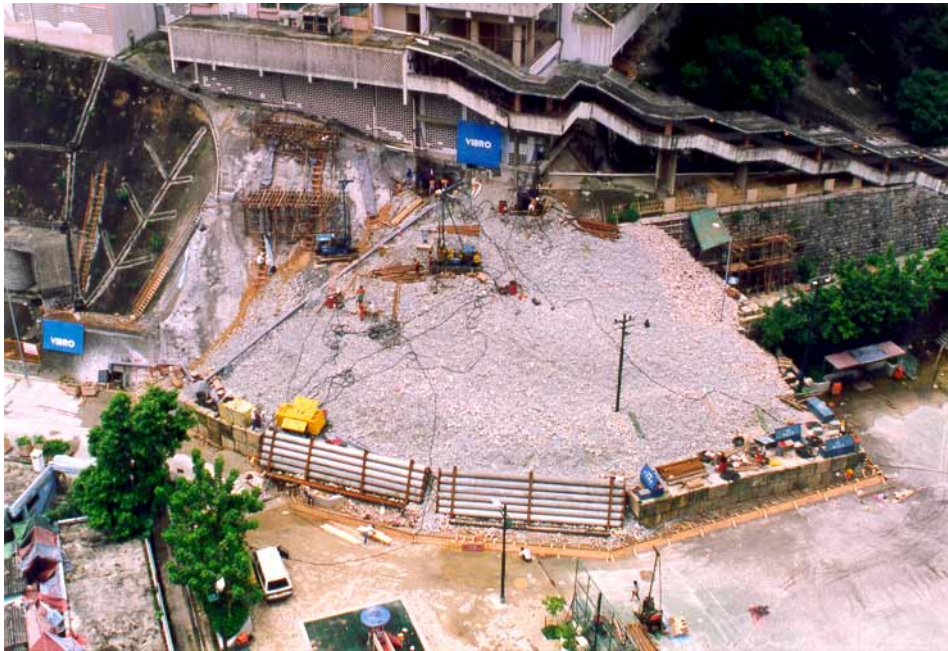
Plate M8 - View of the Landslide after Completion of Emergency Repair Works and during Ground Investigation (Photograph taken on 13 August 1994)

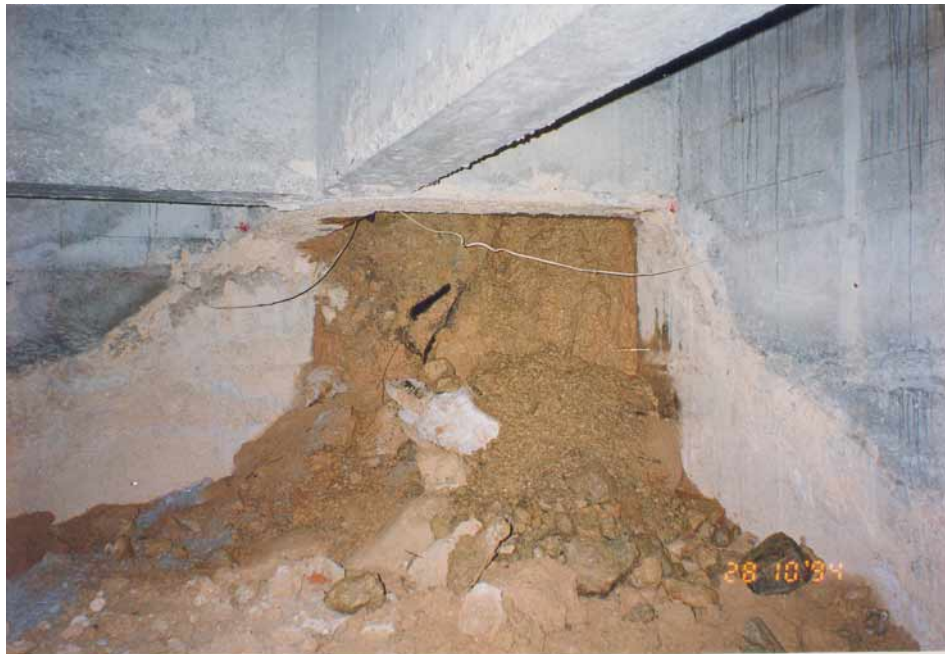
Plate M15 - The Ground below the Yard Area Exposed after Exposed after Excavation of Trial Pit No. TP 35 (Part of the ground collapsed when a field permeability test was carried out in drillhole No. BH12 sunk in the yard area. Photograph taken on 28 October 1994)
