# **REPORT ON THE KWUN LUNG LAU LANDSLIDE OF 23 JULY 1994**

**GEO REPORT No. 103**

**N.R. Morgenstern & Geotechnical Engineering Office**

# **VOLUME 1: CAUSES OF THE LANDSLIDE AND ADEQUACY OF SLOPE SAFETY PRACTICE IN HONG KONG**

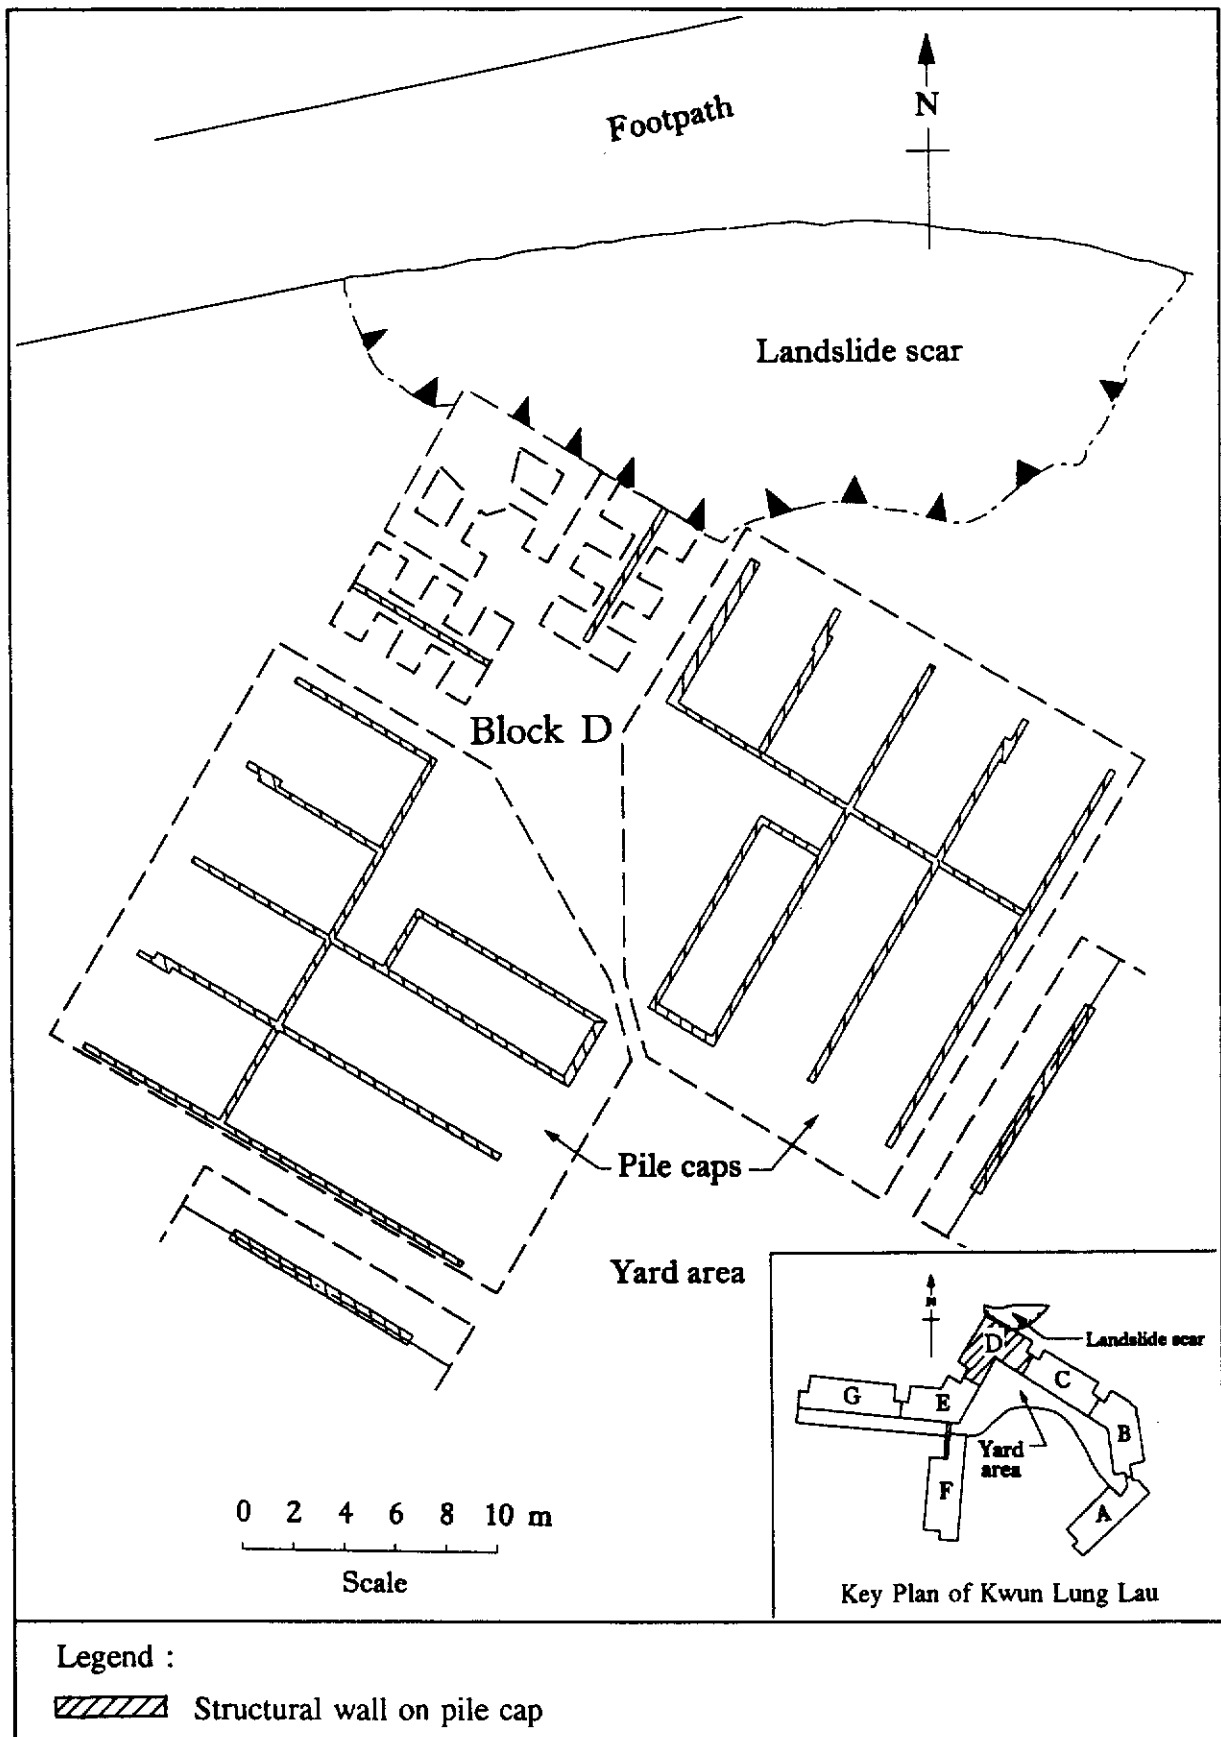
Figure 10 - Layout of Pile Caps under Block D

The layout of the pile caps and structural walls of the substructure of Block D is shown in Figure 10. Block D is underlain by two large pile caps founded on partially weathered volcanics, with fill placed between the caps. The fill extends to the landslide site and the yard area to the south of Block D, as shown in Figure 11.
