INVESTIGATION OF SOME SELECTED LANDSLIDES IN 1998 (VOLUME 1)

GEO REPORT No. 108

**SECTION 1 :
DETAILED STUDY OF THE
NATURAL TERRAIN
LANDSLIDE AT NO. 30
PAK SHA WAN ON 9 JUNE 1998**

**This report was originally produced in June 1999
as GEO Landslide Study Report No. LSR 1/99**

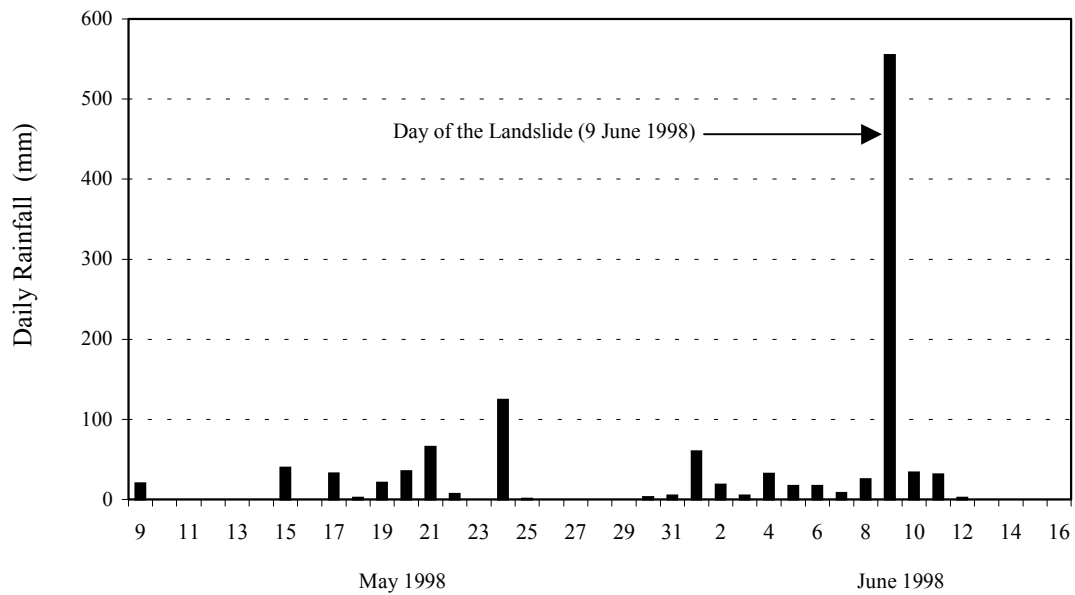
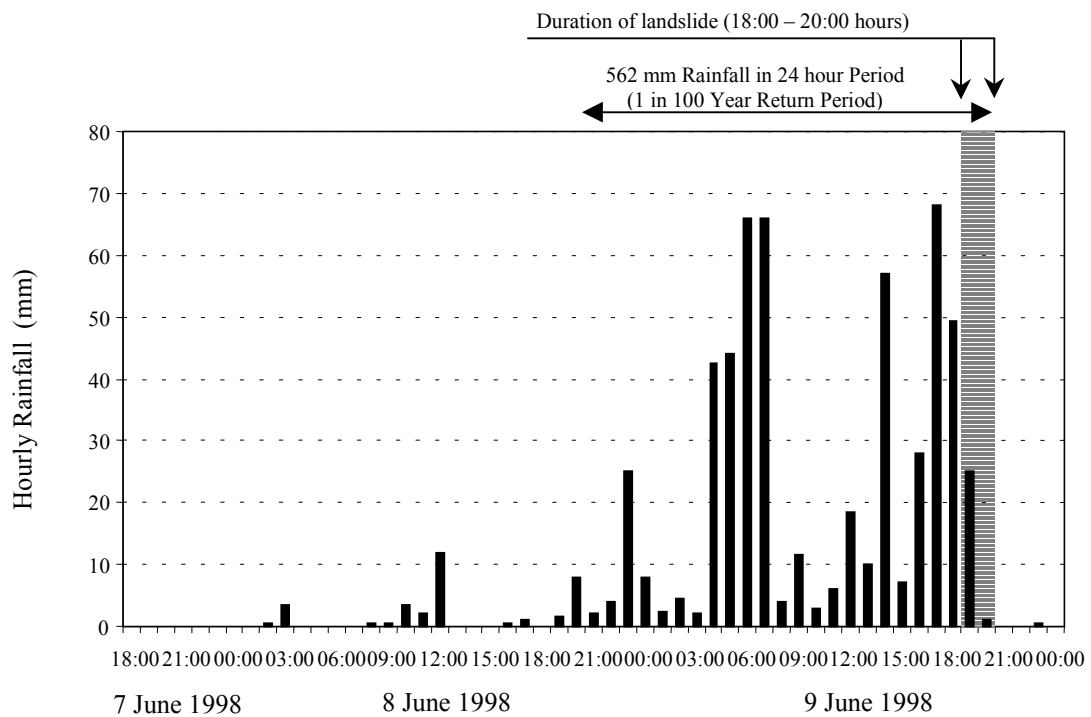
Figure 5 – Daily and Hourly Rainfall Records at GEO Raingauge No. N15

Daily rainfall for one month preceding, and seven days following the landslide, together with hourly rainfall for 48 hours before and 8 hours following the landslide, are given in Figure 5. The daily rainfall records show that the storm was concentrated around the day of 9 June 1998 (viz. the day of the landslide), with the hourly data indicating intense peaks from 03:00 to 07:00 hours, 13:00 to 14:00 hours and 15:00 to 19:00 hours, generally in the range of 40 mm/hr to 60 mm/hr.

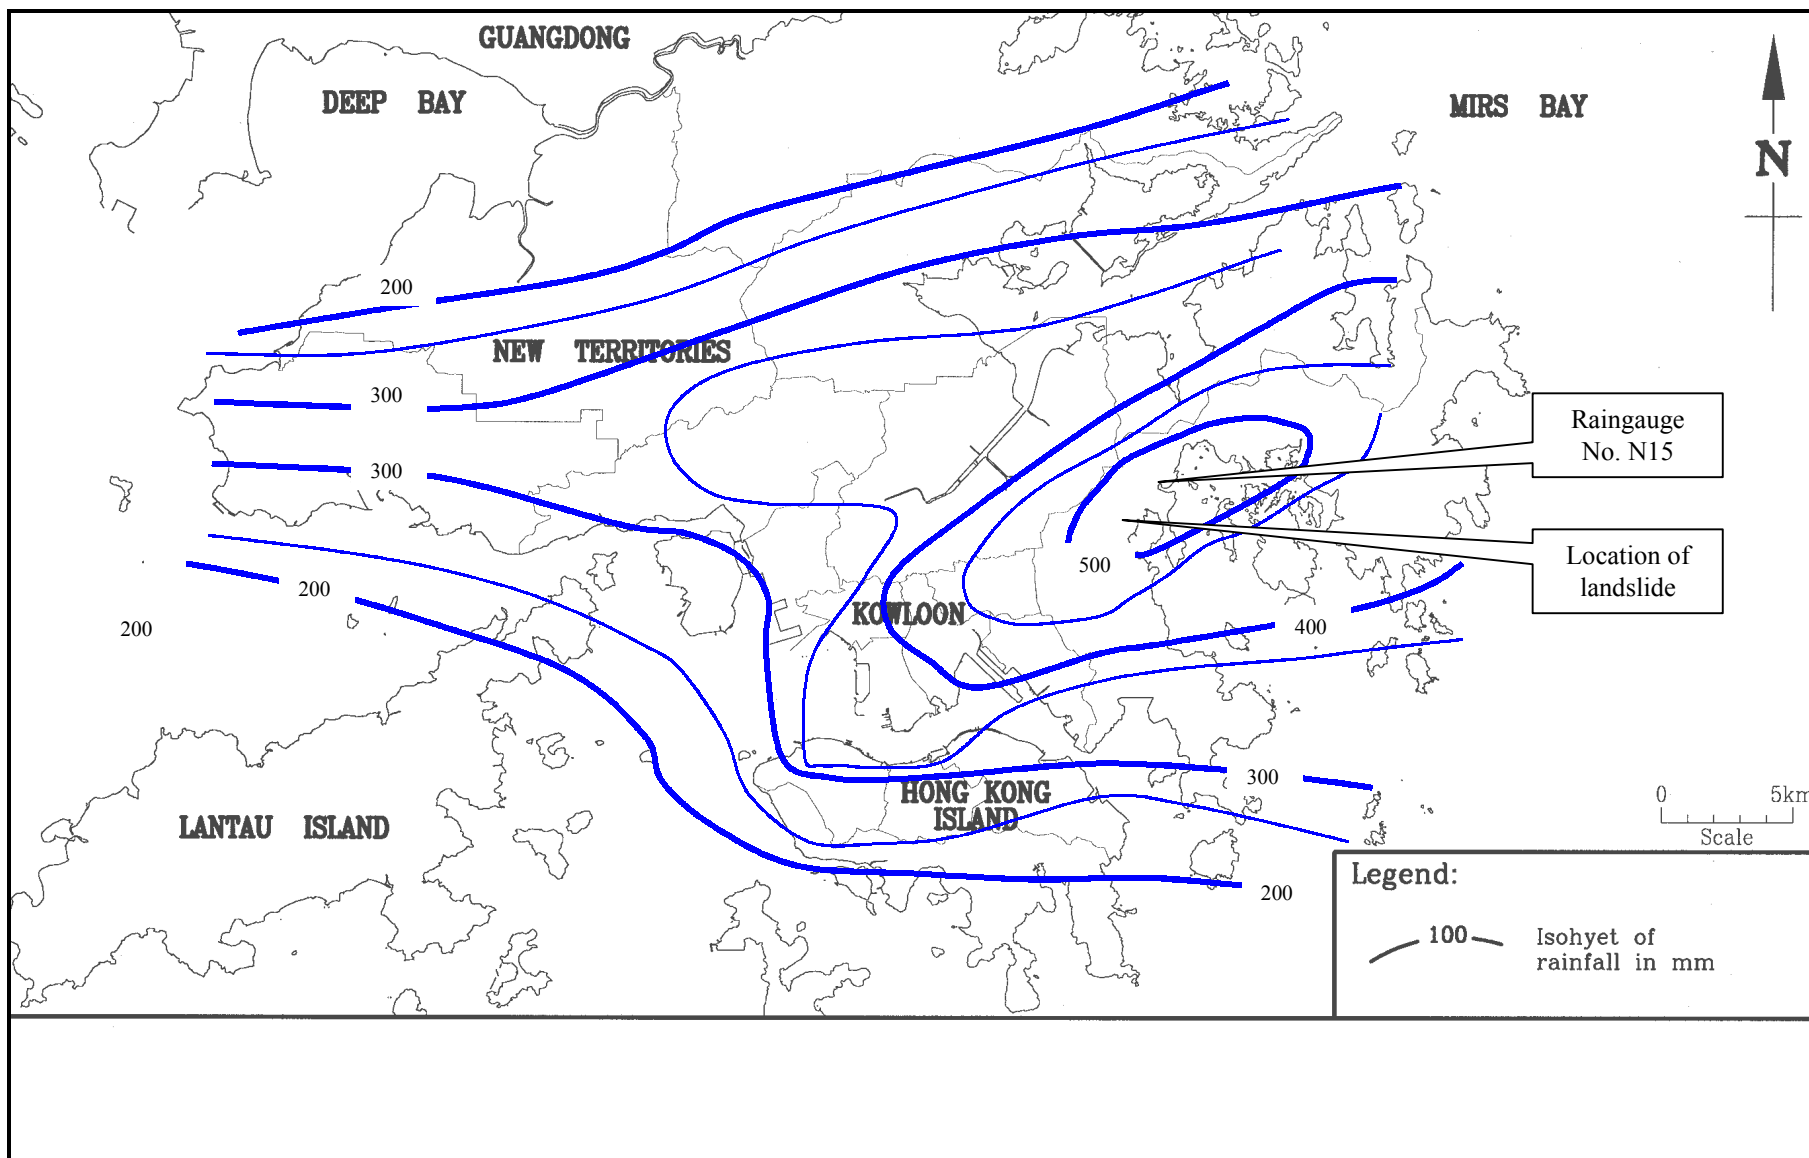
Figure 6 – Isohyets of Rainfall from 18:00 hours on 8 June 1998 to 18:00 hours on 9 June 1998

Isohyets of rainfall for the 24-hour periods ending at 18:00 hours (the reported start of the landslide) and 20:00 hours (the reported end of the event) are shown in Figures 6 and 7 respectively. These show that the rainfall conditions continued to deteriorate throughout the period when the different phases of landsliding occurred.

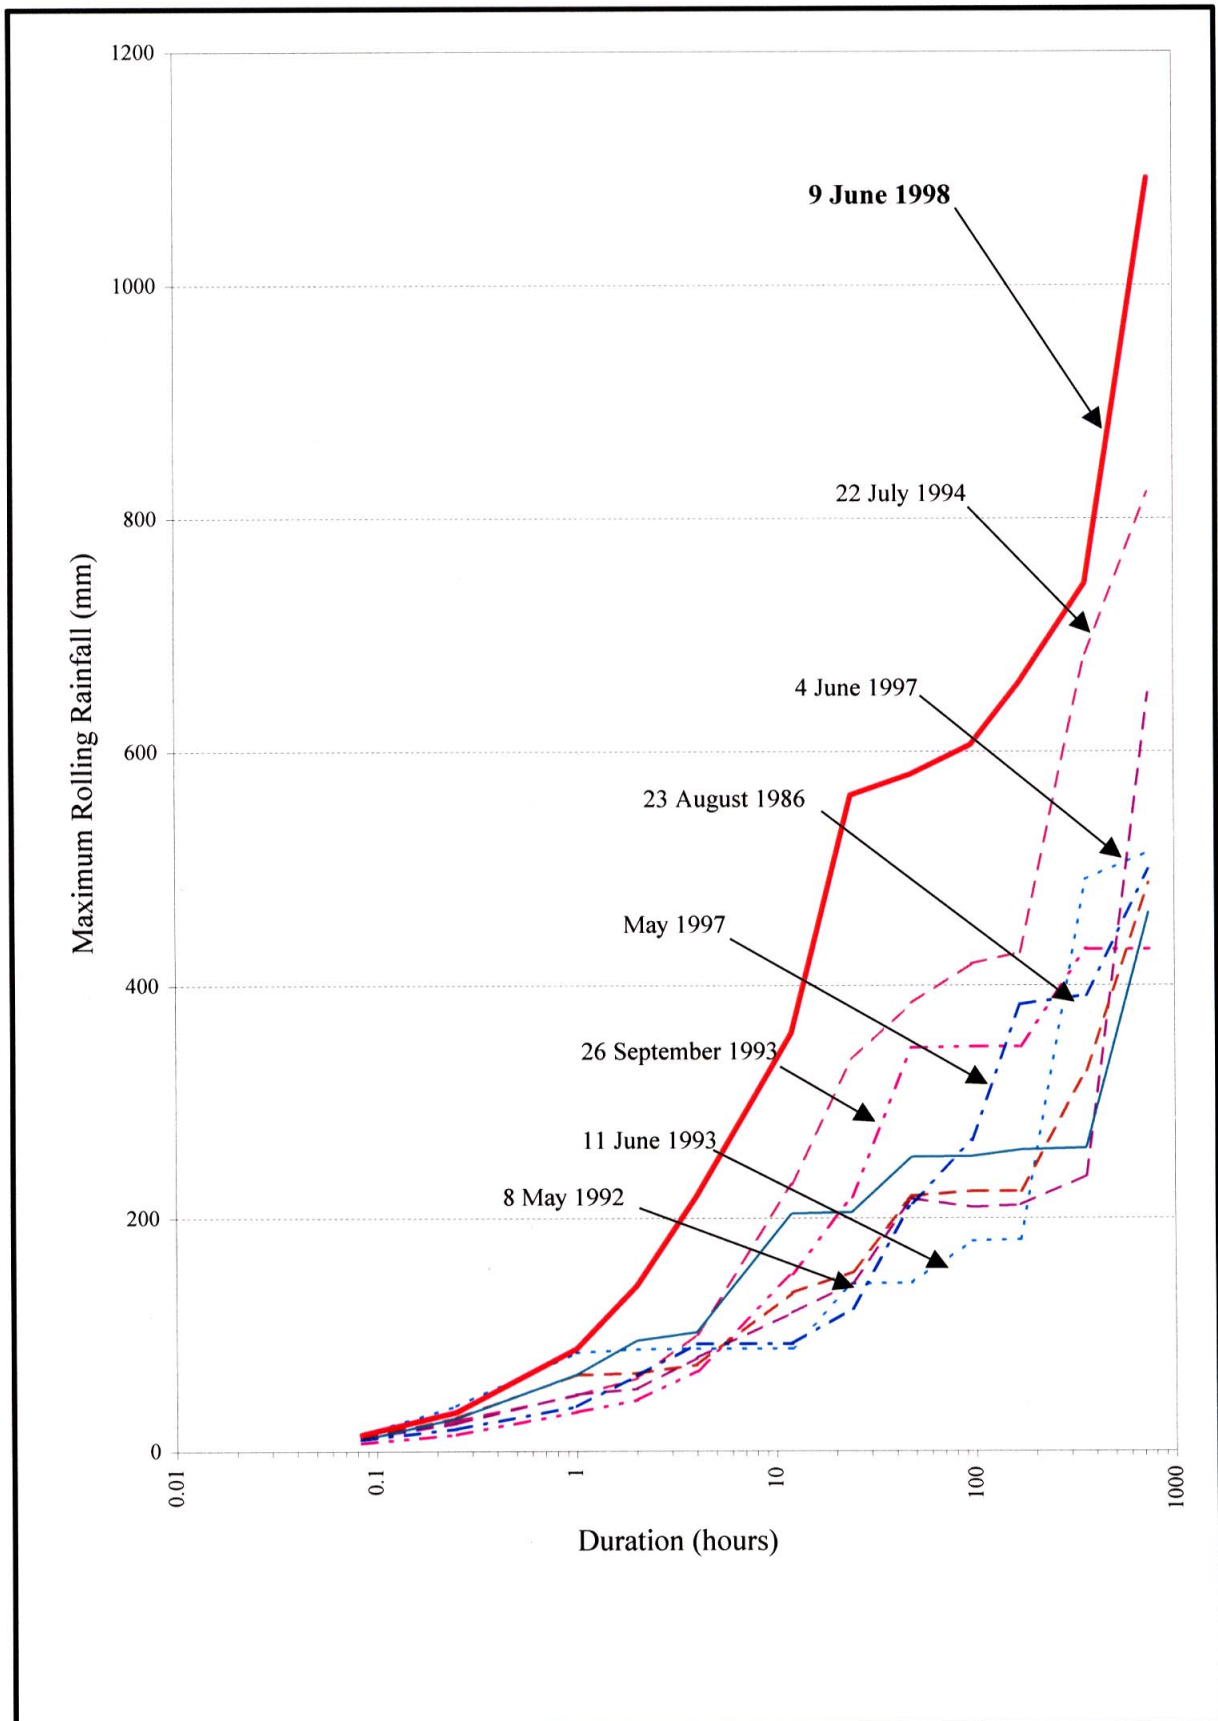
Figure 8 - Maximum Rolling Rainfall Preceding the Landslide of 9 June 1998 and that of Previous Major Rainstorms Recorded by GEO Raingauge No. N15

Table 1 presents the estimated return periods for the maximum rolling rainfalls recorded at raingauge No. H07 for various durations based on historical rainfall data recorded at the Hong Kong Observatory (Lam & Leung, 1994). Values for time intervals ending before or after 18:00 hours and 20:00 hours respectively are given. The 24-hour and 48-hour rainfall, ending at 20:00 hours, were the most severe (562 mm and 580 mm respectively), with corresponding return periods of about 100 years and 45 years respectively, although conditions at the initiation of movement (assumed to be at 18:00 hours) were also severe, with return periods of 80 years and 35 years for the same respective durations. The rainfall data for the period ending at 20:00 hours has been plotted in Figure 8, and is compared with other selected previous major rainstorms. This shows that the 9 June 1998 rainstorm was particularly severe and was the most intense rainstorm experienced by raingauge No. N15 since its installation in 1984.
