SECTION 2 : DETAILED STUDY OF THE LANDSLIDE AT THE OUTWARD BOUND SCHOOL ON 9 JUNE 1998

**This report was originally produced in August 1999
as GEO Landslide Study Report No. LSR 7/99**

This report presents the findings of a detailed study of the landslide (GEO Incident No. ME 98/6/55) that occurred on the natural hillside adjacent to the Outward Bound School, Tai Mong Tsai, near Sai Kung in the Eastern New Territories on 9 June 1998. The landslide involved the failure of approximately 30 m of the natural hillside close to the main ridgeline of a coastal peninsula. The resulting debris, estimated at about 900 m³ in volume, came within 20 m of a house at the foot of the hillside, with the subsequent alluvial outwash reaching the road and beach below. The house was uninhabited at the time of the landslide. No fatalities or injuries were reported following the landslide.

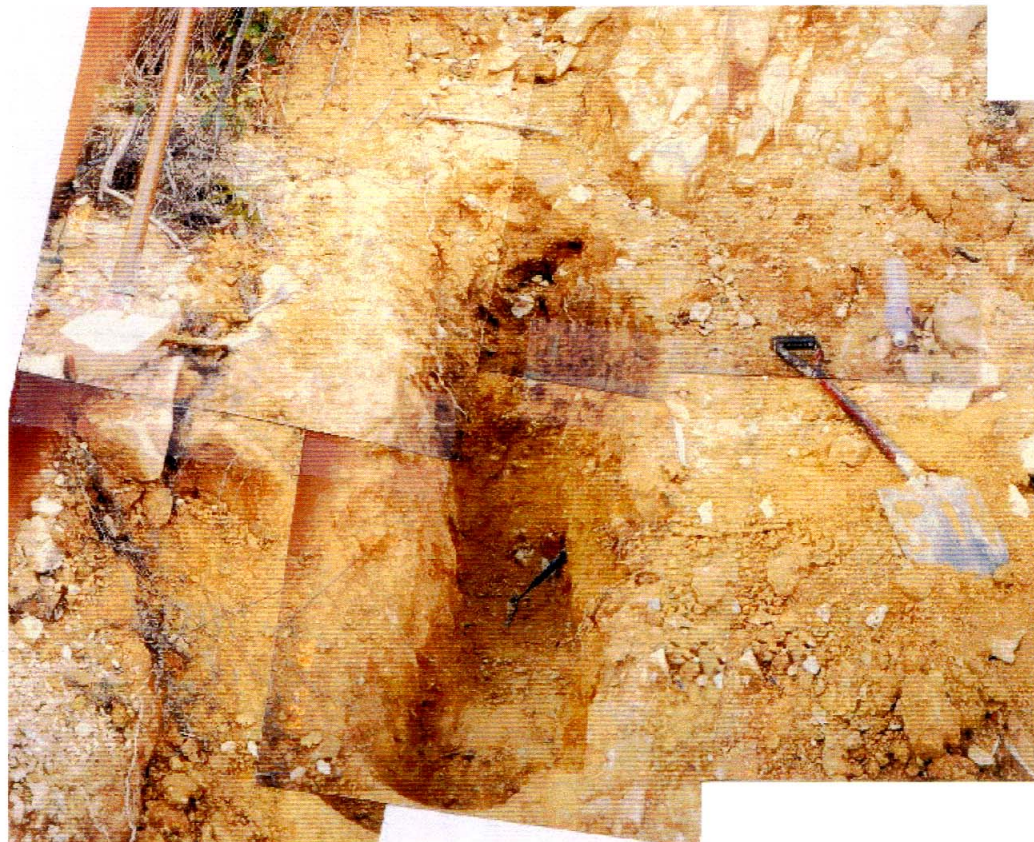
3								
SYMBOL	SAMPLES/TESTS/WATER			PLAN (NOT TO SCALE)			REMARKS		
• SMALL DISTURBED SAMPLE ▬ BULK DISTURBED SAMPLE ▬ UNDISTURBED SAMPLE HORI. (U100/U76) ▬ UNDISTURBED SAMPLE VERT. (U100/U76) ⊠ BLOCK SAMPLE ∇ IN-SITU DENSITY TEST ◊ WATER SAMPLE ⊕ SEEPAGE	PLAN (NOT TO SCALE) 			KEY 		Pit sides stable. No water encountered

General View of Trial Pit

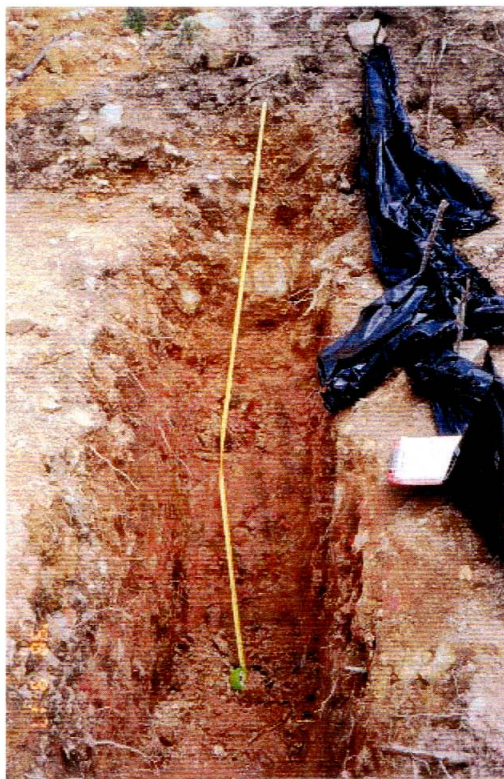
General View of Trial Pit
