**SECTION 3 :
PRELIMINARY STUDY OF
THE LANDSLIDE AT
LUK KENG WONG UK
ON 24 MAY 1998**

Fugro Scott Wilson Joint Venture

**This report was originally produced in November 1999
as GEO Landslide Study Report No. LSR 14/99**

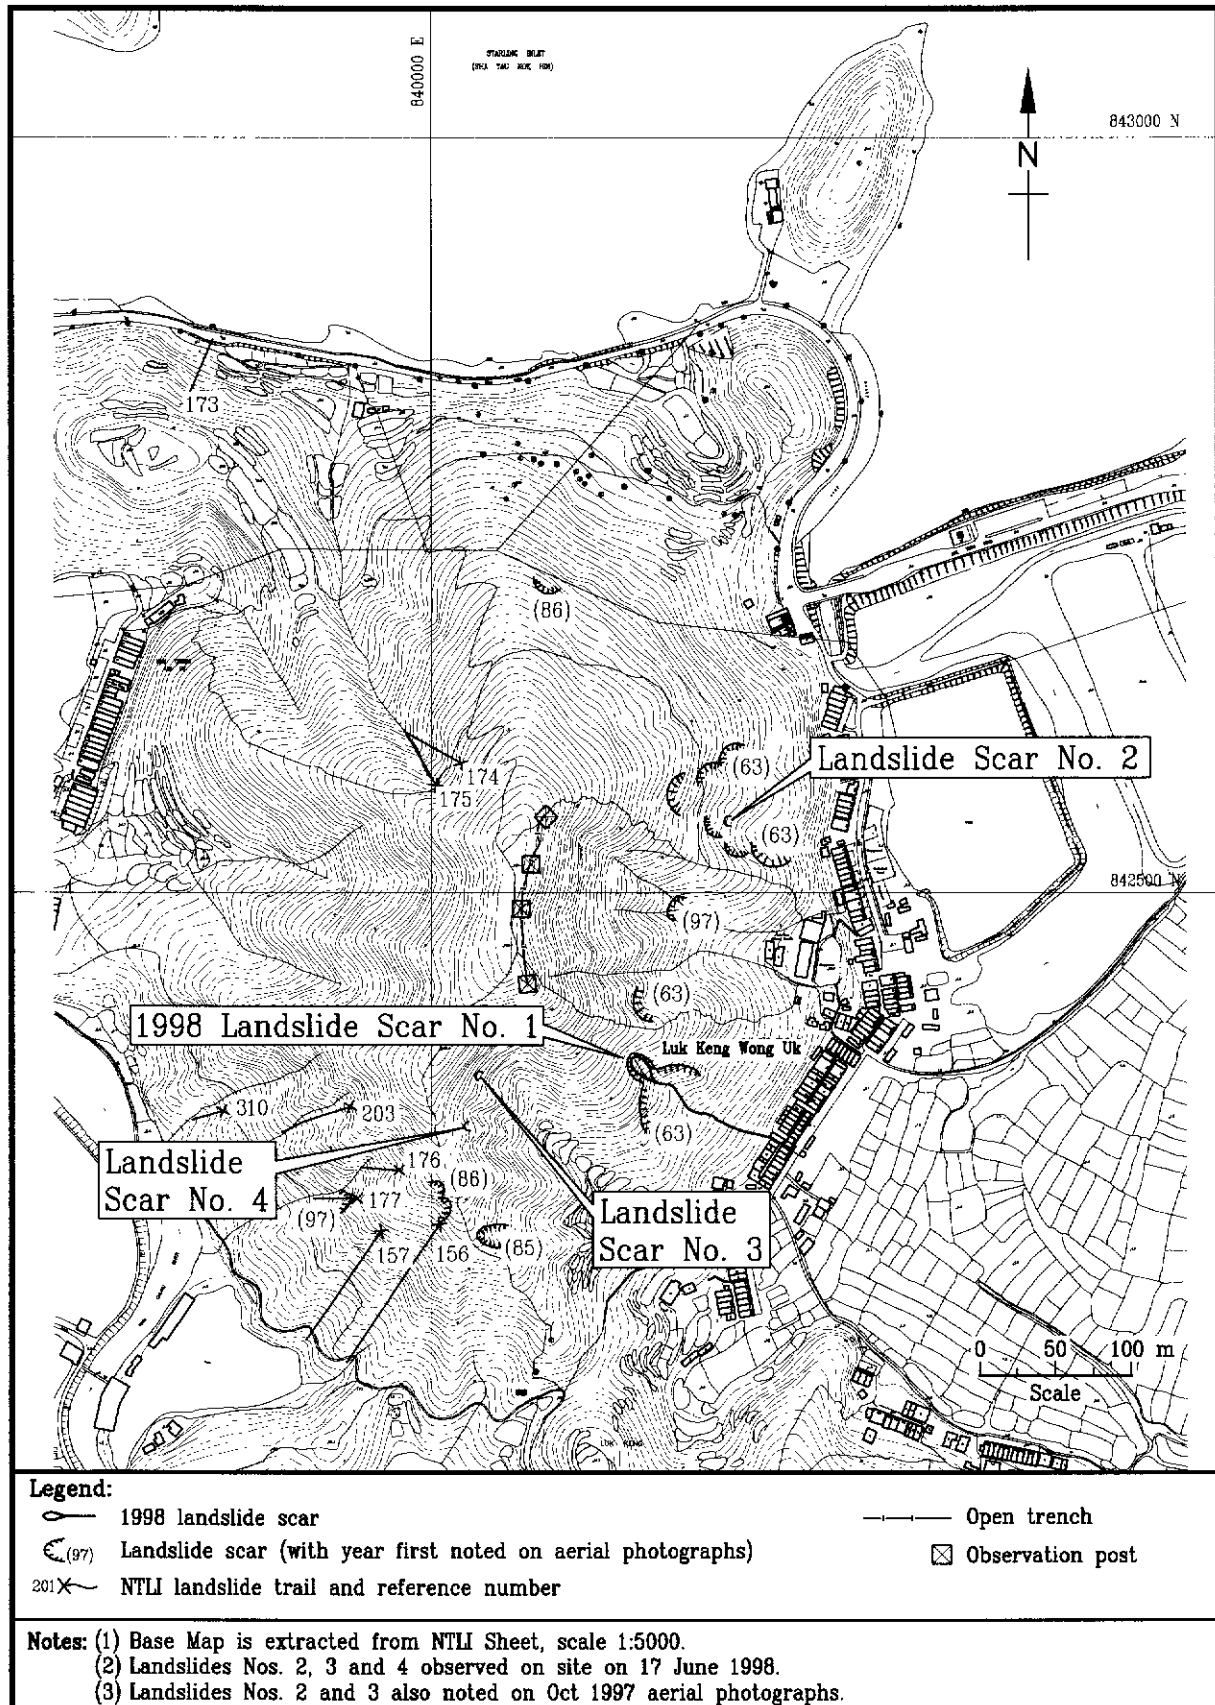
Figure 2 - General Location Plan of the Landslide at Luk Keng Wong Uk
Showing Surrounding Landslide Scars

During the field inspection on 17 June 1998, three neighbouring pre-existing landslide scars were also examined on the eastern side of the hill (Nos. 2, 3 and 4 on Figure 2). All involved instability in the insitu weathering profile of the meta-sedimentary rock mass, as with the present failure. Landslide scar No. 2 occurred on hillside inclined at about 25° to 30° and involved a large raft of material that appeared to have slumped with limited downslope movement of about 1 m (Plate 14). The failure appeared to be shallow in nature (less than

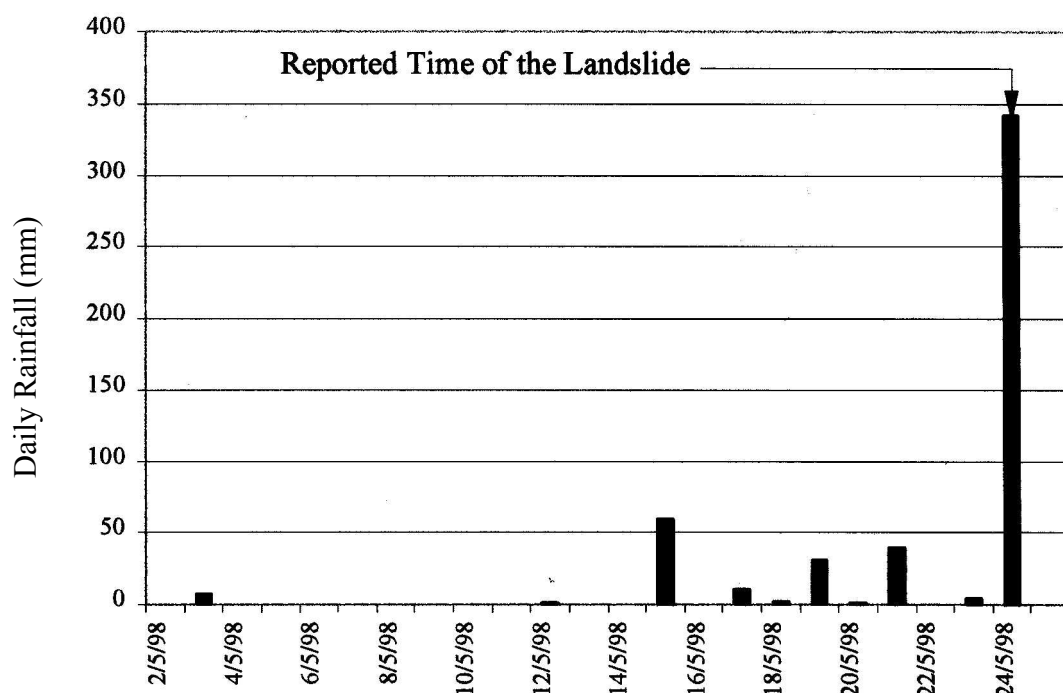
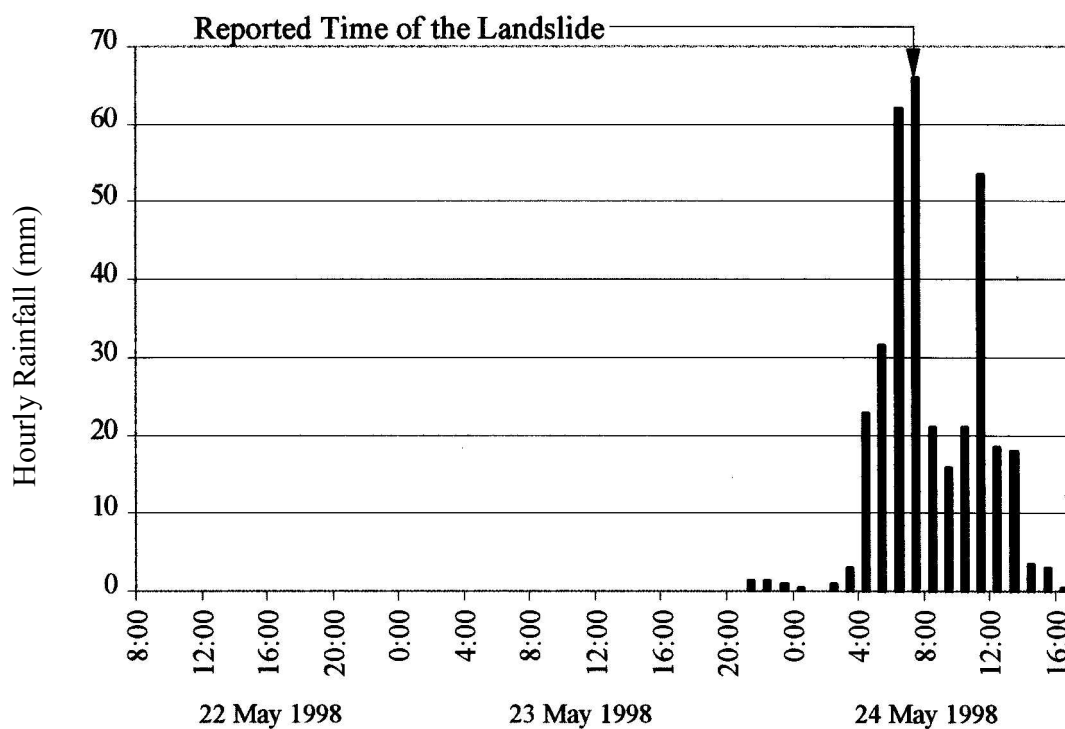
Figure 7 – Rainfall Recorded at H.K.O. Raingauge No. R24

The daily rainfall records for raingauge No. R24 from 2 May to 25 May 1998 and the hourly rainfall records from 48 hours prior to the reported time of failure to 8 hours after are presented in Figure 7.
