# **INVESTIGATION OF SOME SELECTED LANDSLIDES IN 1998 (VOLUME 2)**

**GEO REPORT No. 109**

**SECTION 1 :  
DETAILED STUDY OF THE  
DISTRESS OBSERVED IN  
SLOPE NO. 11NE-D/F10 BELOW  
HIU KWONG STREET,  
SAU MAU PING  
ON 9 APRIL 1998**

This report presents the findings of a detailed study of distress observed in fill slope No. 11NE-D/F10 located below Hiu Kwong Street, Sau Mau Ping, on 9 April 1998. The distress comprised cracking, displacement and bulging of the shotcrete cover to the upper batter of the slope, and was observed following the reporting of seepage from the toe of the slope.

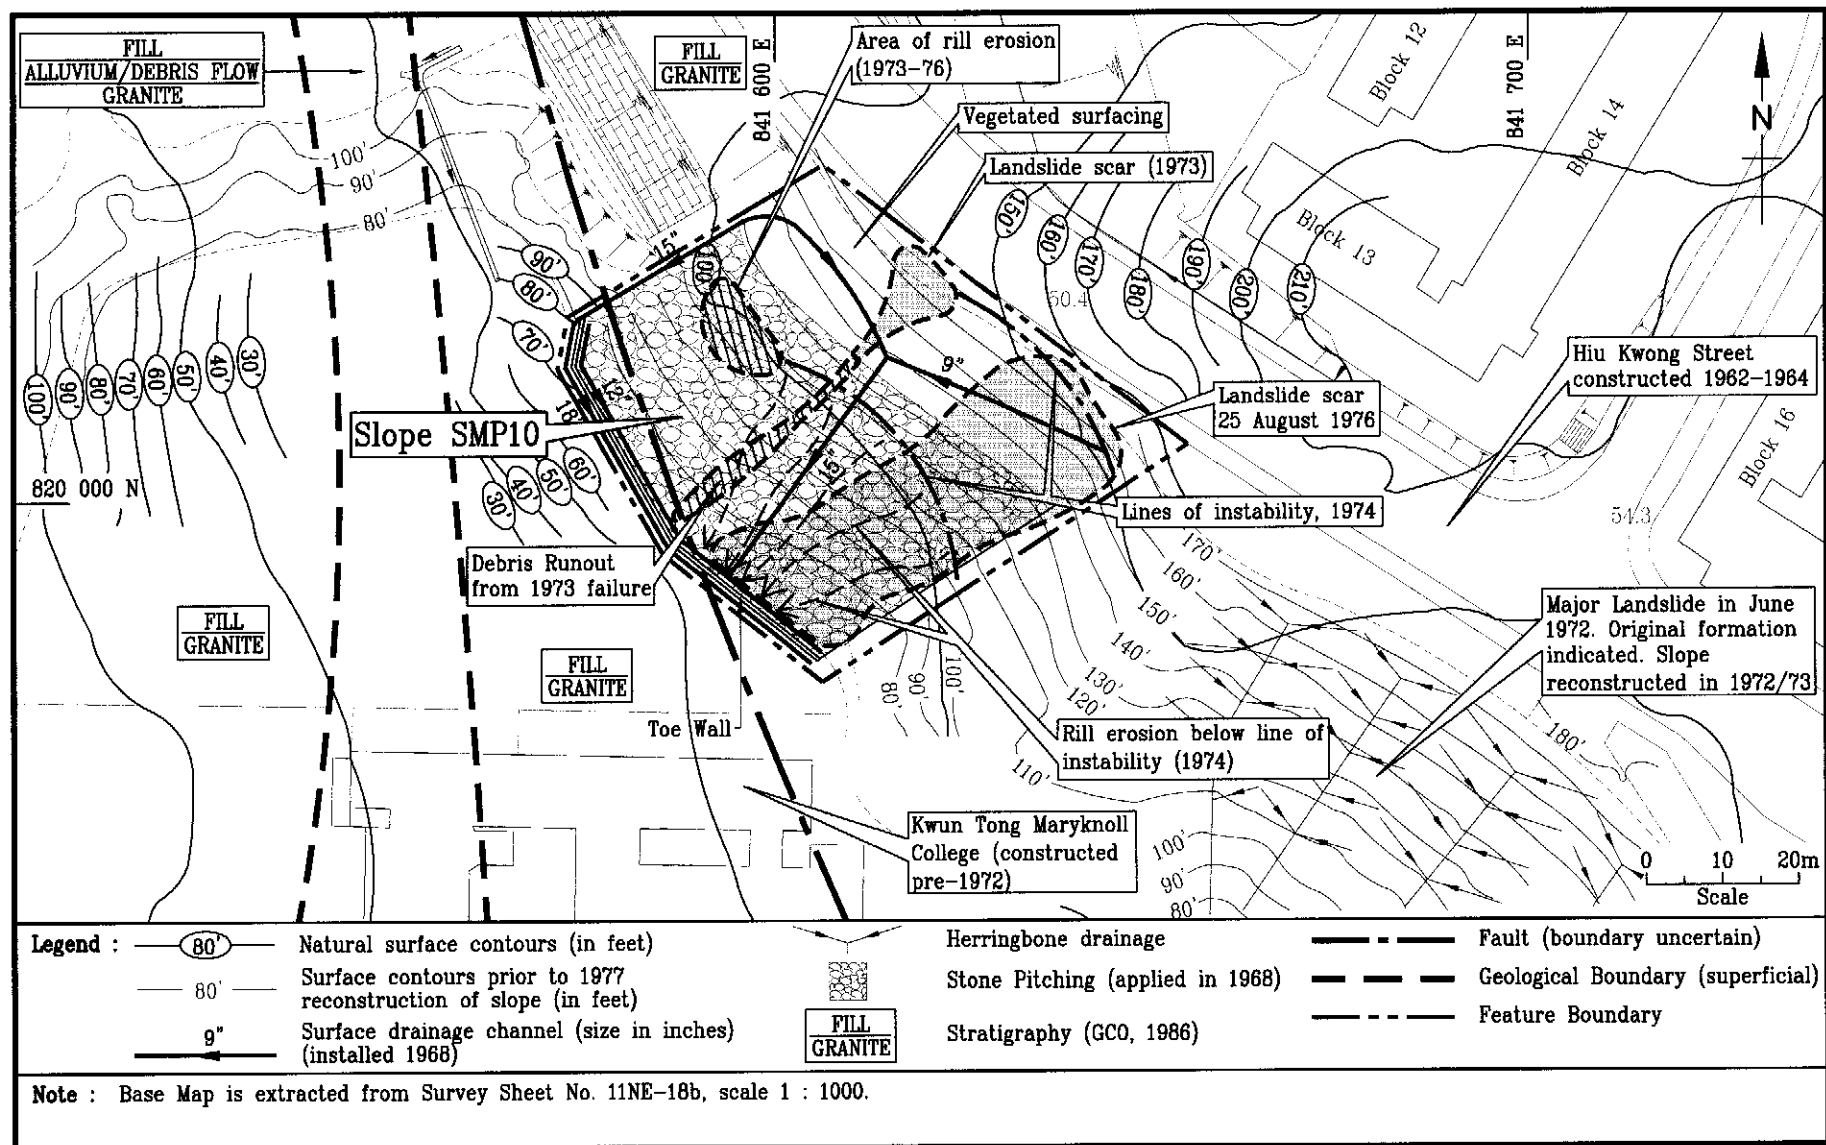
Figure 4 - Slope Formation Prior to 1977 Re-construction

Remote sources of significant transient water flow are unlikely due to the presence of the retaining structure located adjacent to the northern footpath of Hiu Kwong Street (Figure 1), which would likely act as a “cut-off”. North-west of the wall, the original ground contours (Figure 4) indicate a buried valley feature, which should direct seepage away from the concerned slope towards the north-west.

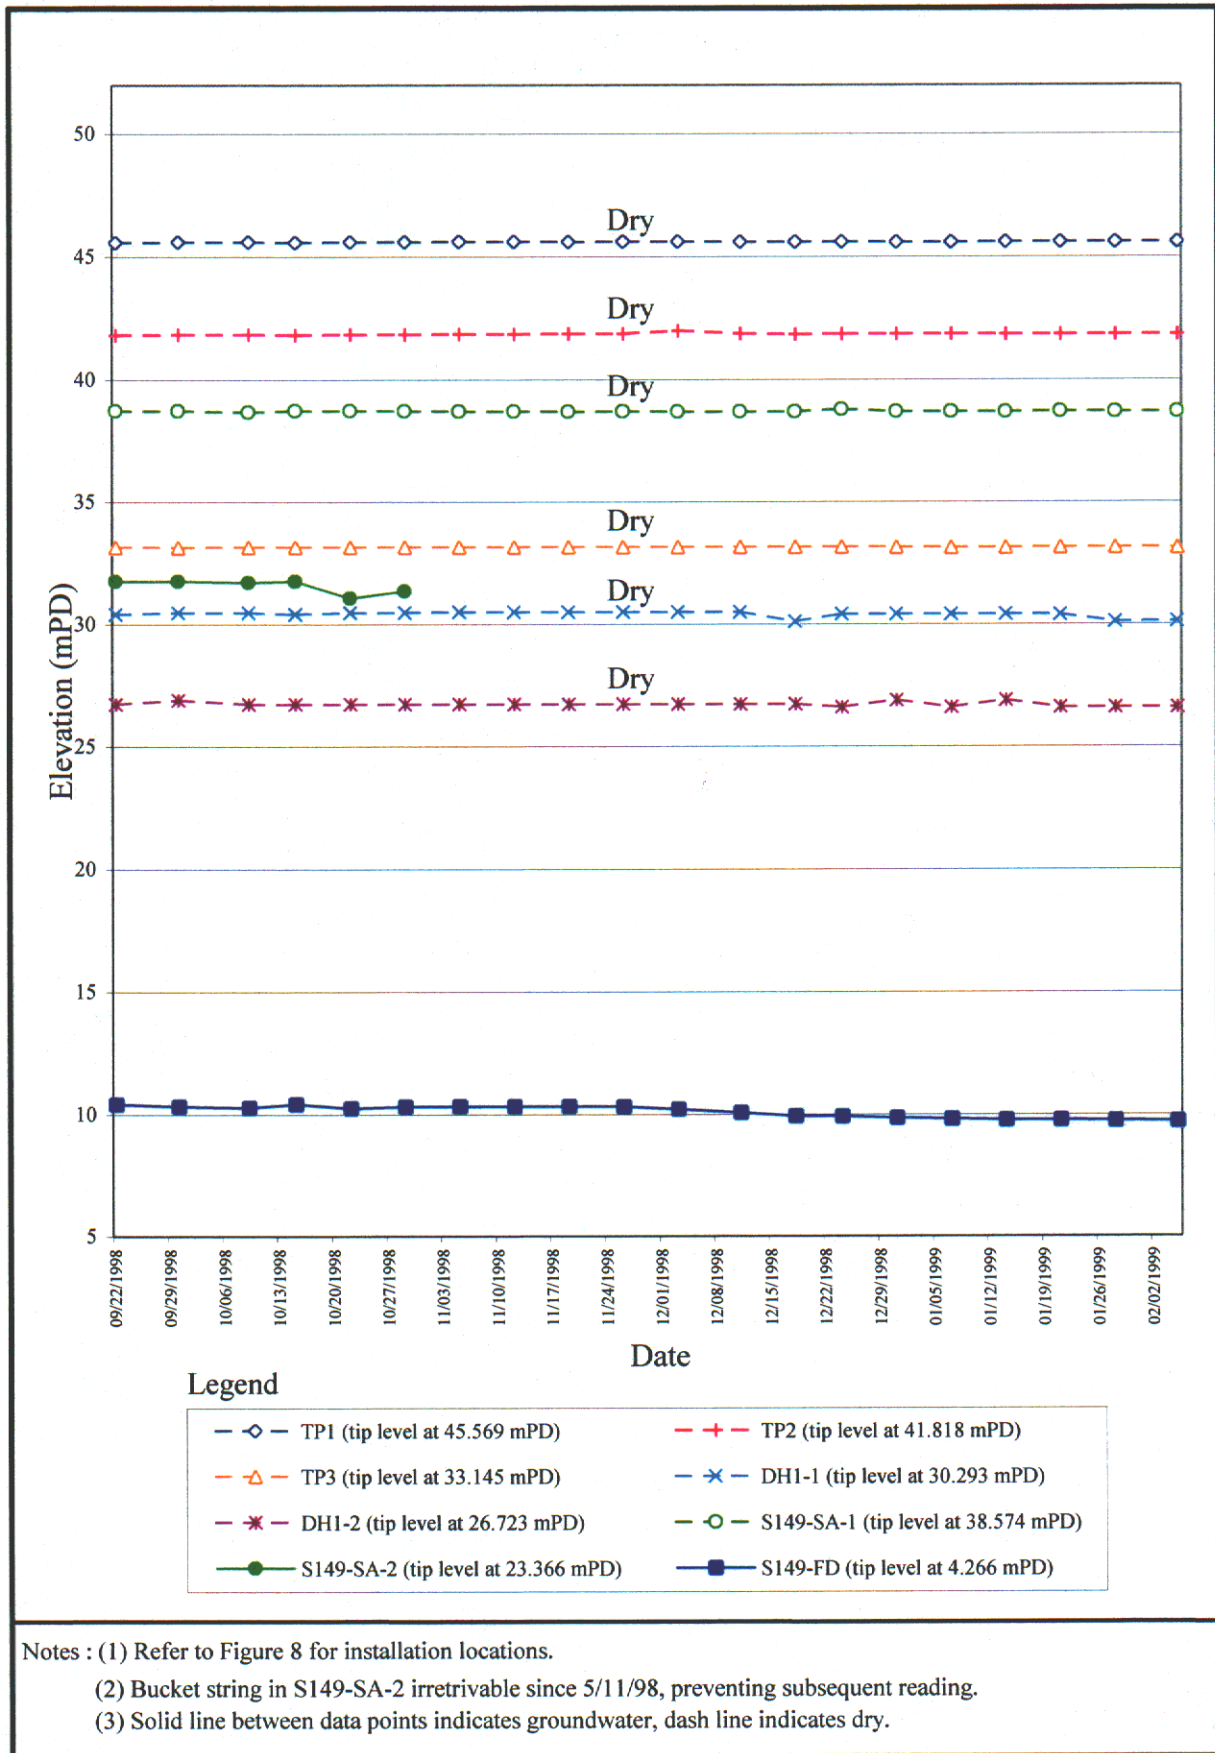
Figure 9 - Piezometer Monitoring Records

Groundwater monitoring from 22 September 1998 to 5 February 1999 has only recorded a water table at the crest and toe of the slope, with installations located on the slope remaining 'dry' throughout (Figure 9). The installation at the crest of the slope (S149-SA) comprised a piezometer tip located within slightly decomposed granite (SDG), 15 m below the insitu horizon, and a standpipe extending, essentially, the full depth of the fill (11.7 m). The installation at the toe (S149-fd) comprised a piezometer tip located in CDG, 4.7 m below the insitu horizon. Installations on the slope face comprised three standpipes extending to a depth of 1.5 m (TP1, TP2 and TP3 of the current investigation) in the 1977 fill and two piezometer tips (DH1 of the current investigation), one at the base of the filter layer and one 1 m above the base of the pre-1977 fill layer. Locations of the installations are shown on Figure 8. The groundwater levels at the crest and toe have remained essentially constant during the monitoring period (approximately 32 mPD and 10.5 mPD, respectively). These elevations are around 6.5 m below (crest) and 1 m above (toe) the insitu horizon respectively. A postulated phreatic surface corresponding to the 1998 dry season, based on the current data, is indicated on Figure 13.

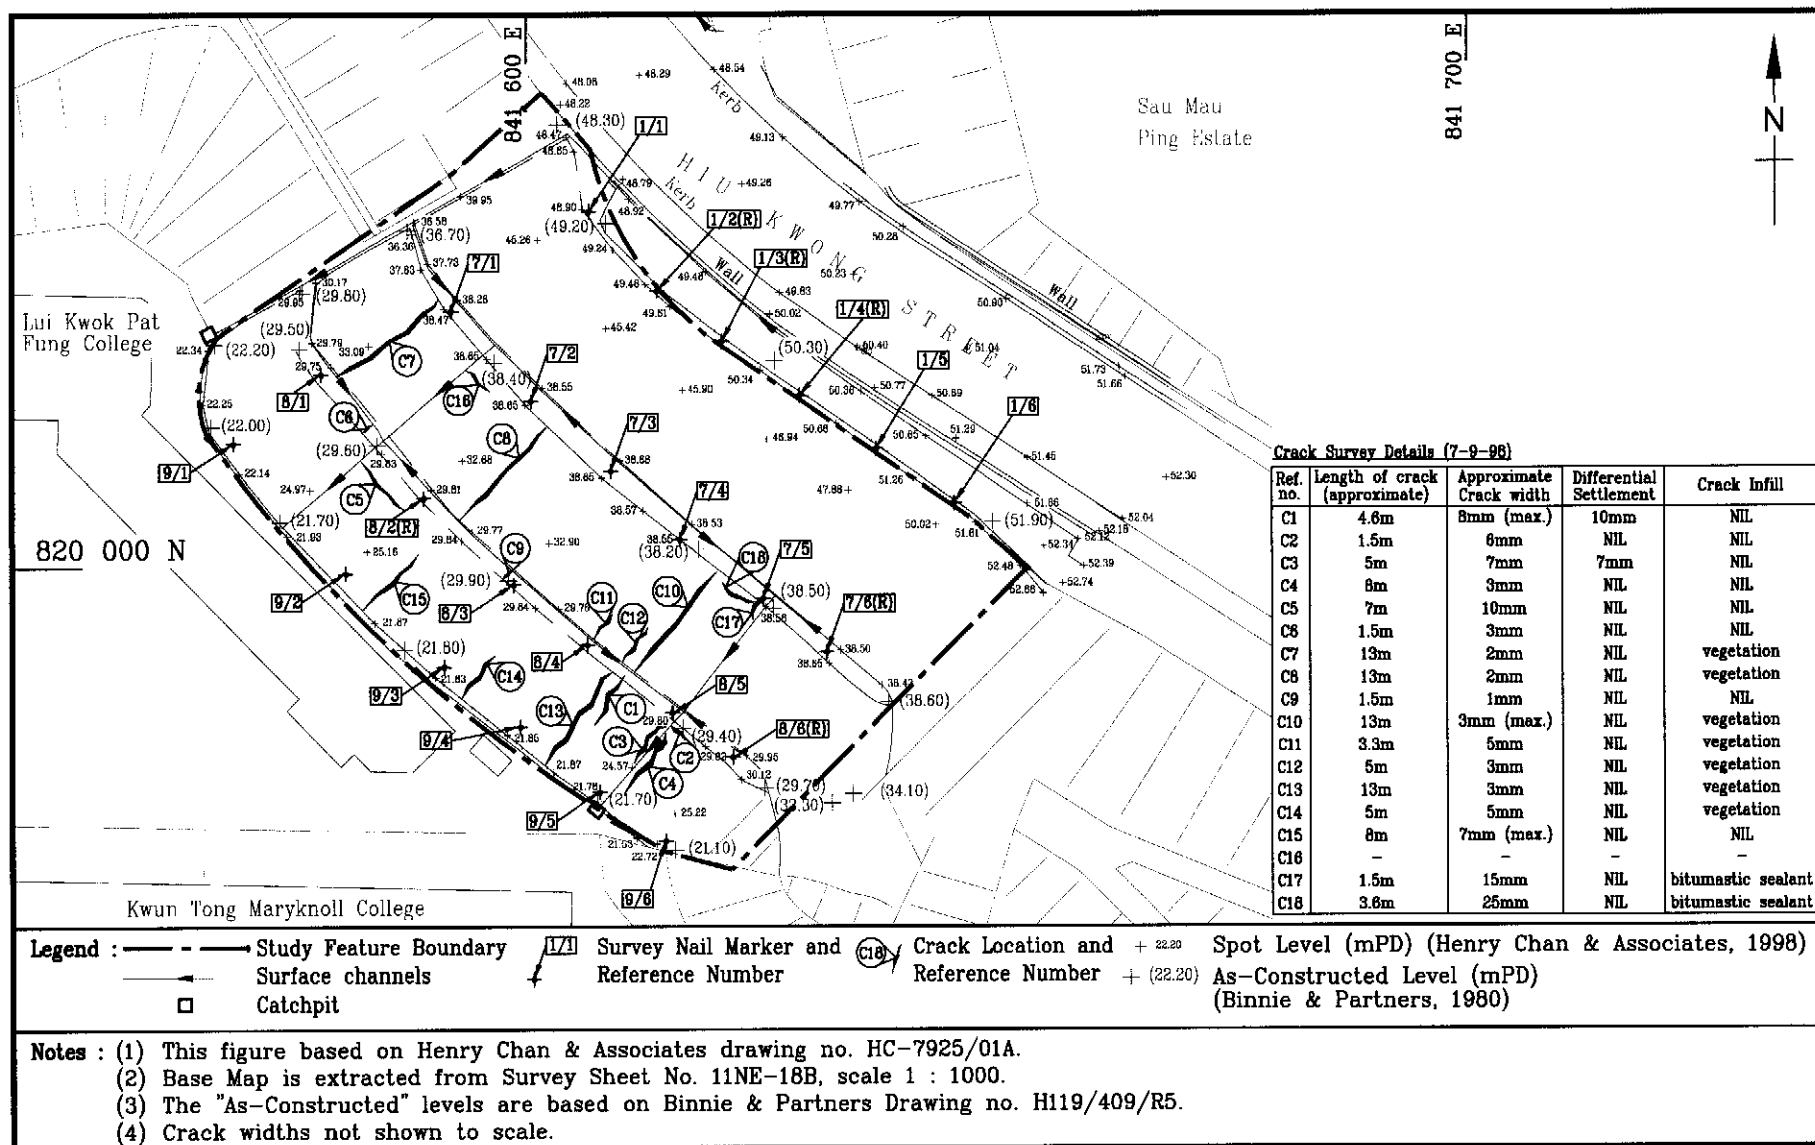
Figure 10 - Survey Plan

The data from the recent topographic survey has been compared to as-constructed levels following the 1977 slope works (Binnie & Partners, 1980), see Figure 10.

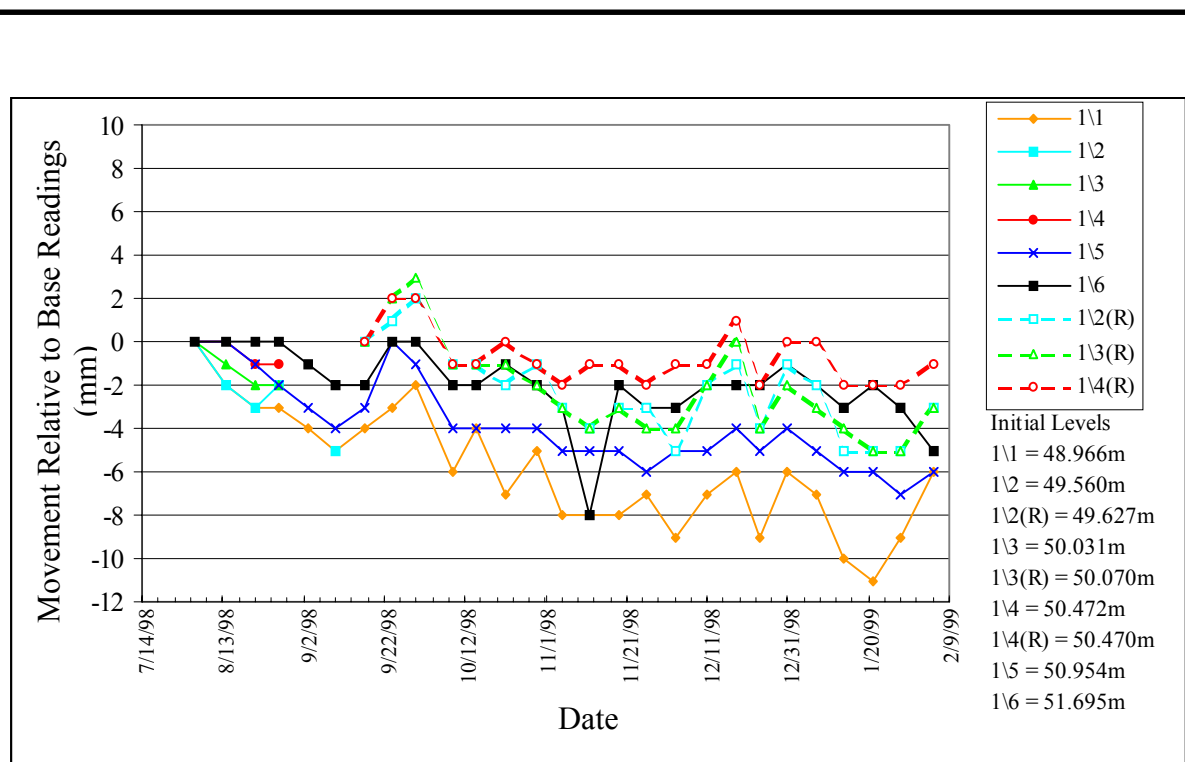
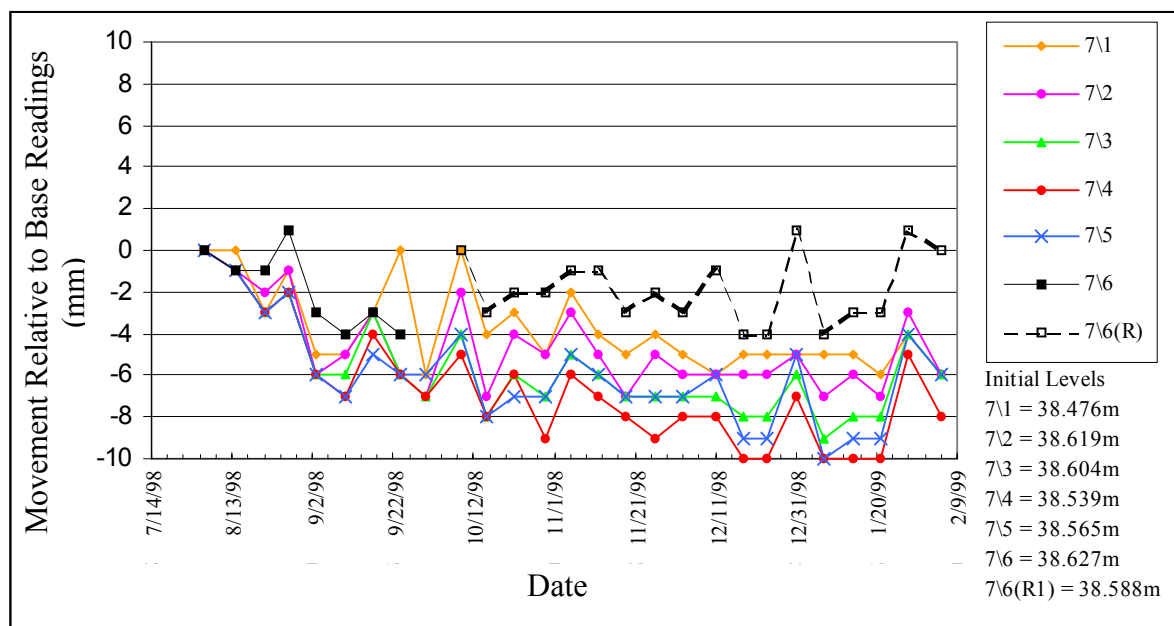
Figure 11 – Vertical Movement Plots for Slope Crest and Upper Berm

The plots of vertical movement presented in Figures 11 and 12 also indicate a degree of erratic behaviour on an individual station basis, although some consistency can be observed when comparing groups of plots from the same elevation to suggest a common levelling error, and general trends in the plots can be postulated.

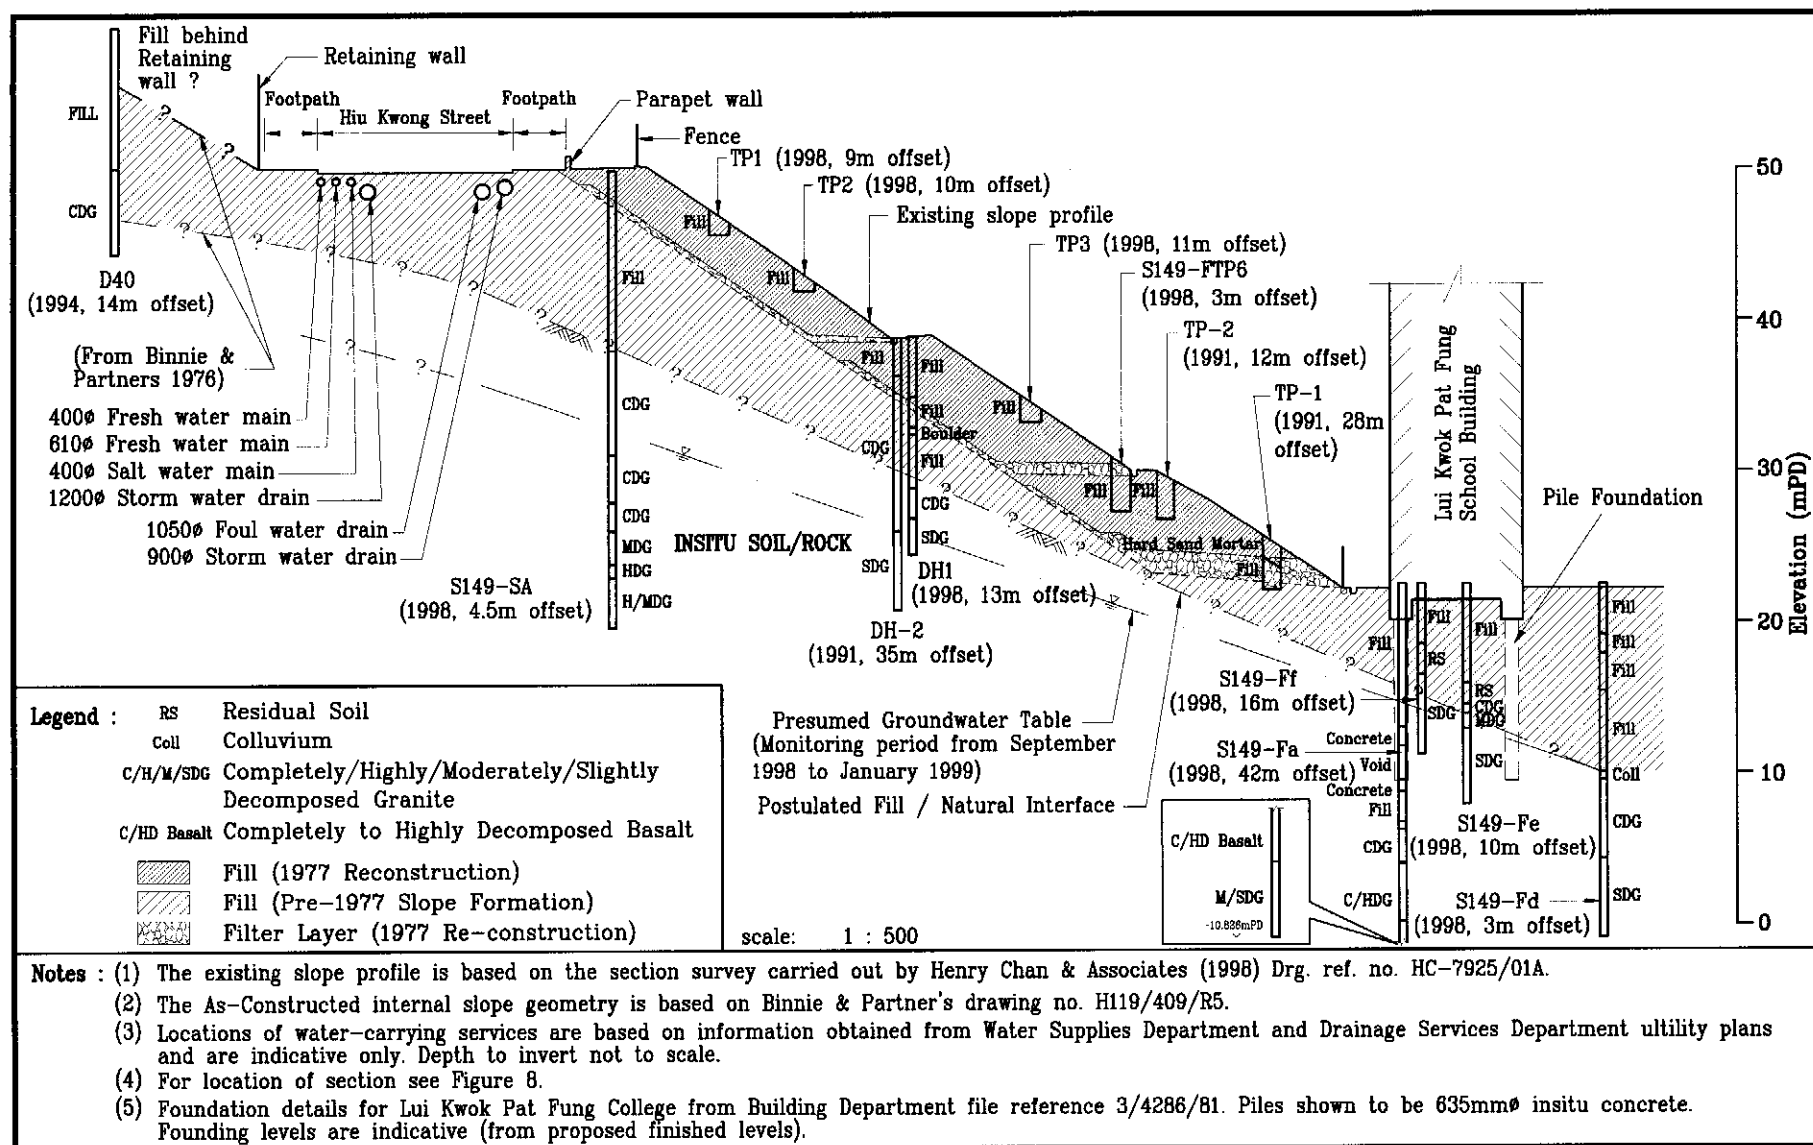
Figure 13 - Geological Profile

Transient seasonal responses in the groundwater table have also been considered. From the phreatic surface indicated in Figure 13, it can be seen that a rise of approximately 10 m to 12 m would be needed for the measured groundwater table to directly influence the 1977 fill comprising the upper batter of the slope. There is no evidence, from current and past monitoring, of significant transient rises in the base groundwater table.

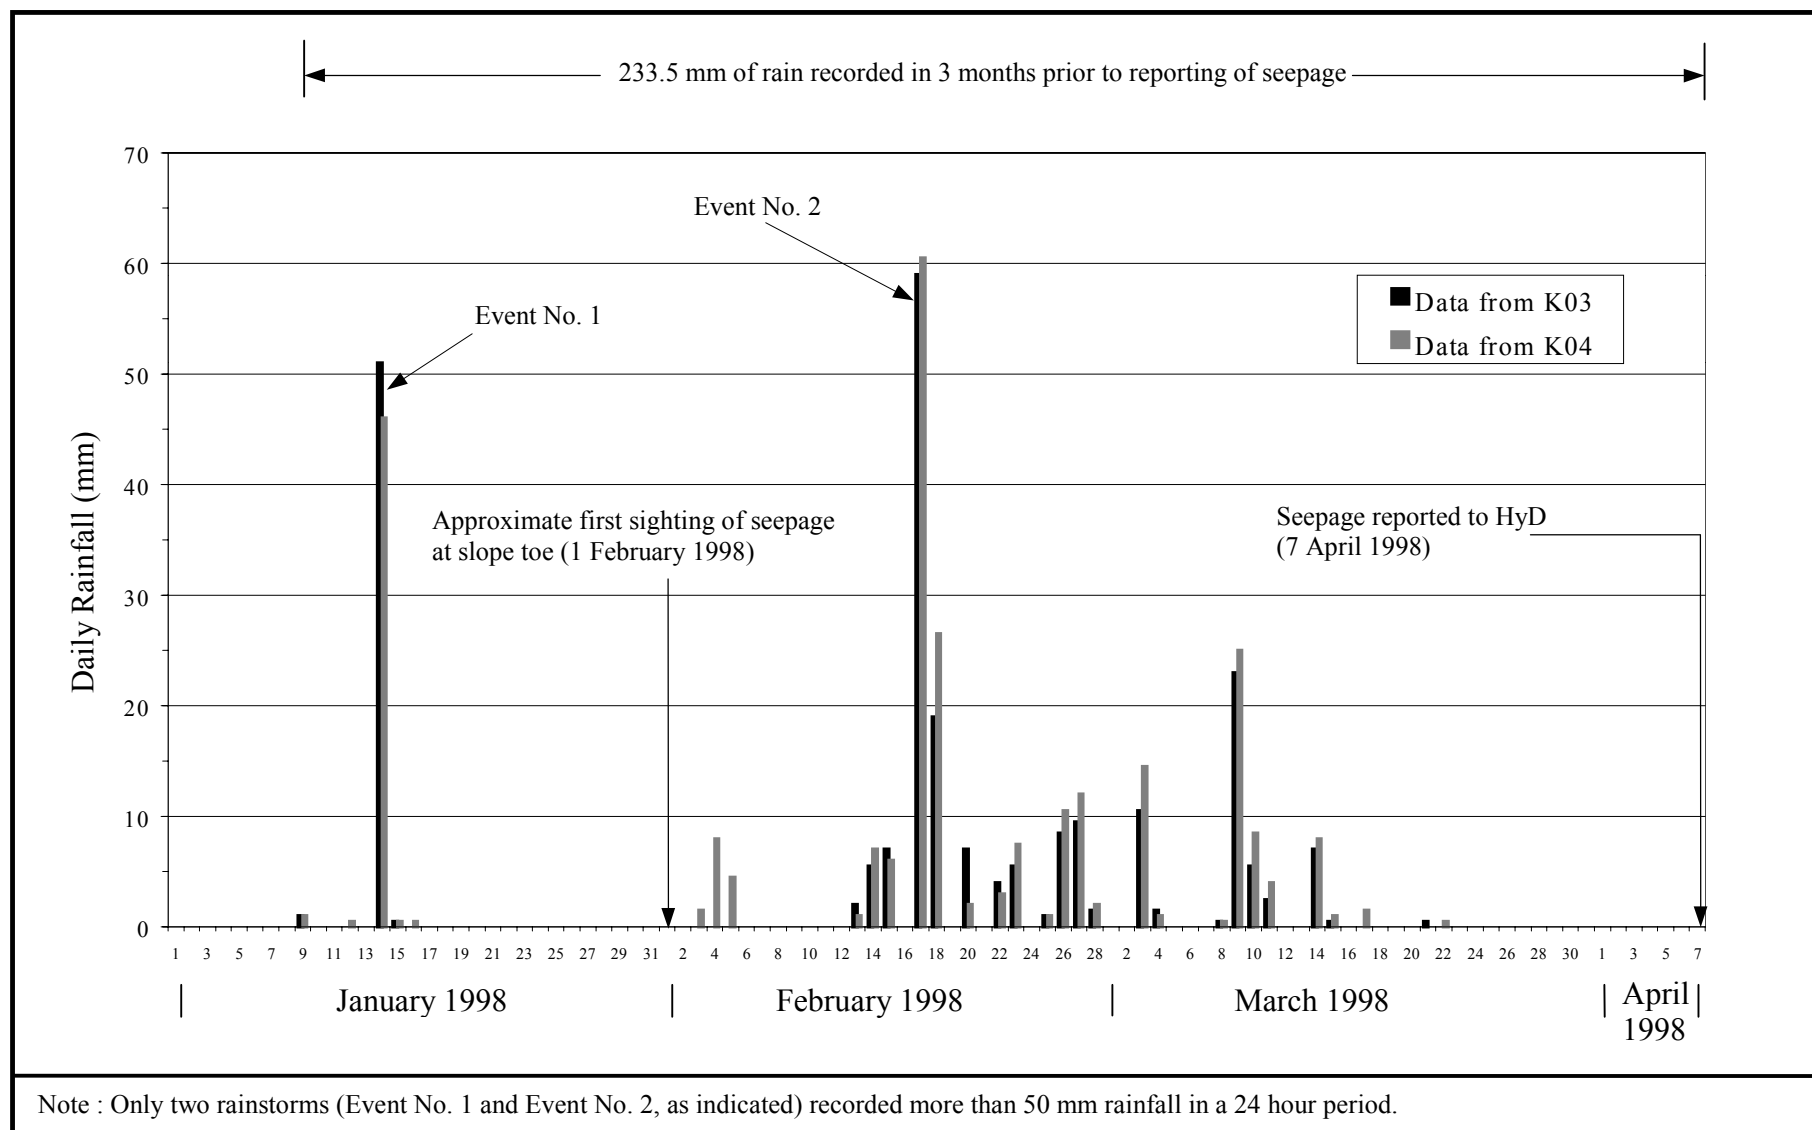
Figure 14 – Rainfall Recorded at GEO Raingauge Nos. K03 and K04 from 1 January 1998 to 7 April 1998

Daily rainfall in the period from approximately one month preceding the initial observation of seepage (taken to be 1 February 1998), to the time the seepage was reported to HyD (7 April 1998), is presented in Figure 14.

Daily rainfall data from GEO automatic raingauge No. K04, located in the Shun Lee Estate in the Clearwater Bay area, has been plotted against data from raingauge No. K03 in Figure 14. It can be seen that the rainfall records of raingauge Nos. K03 and K04 are comparable.

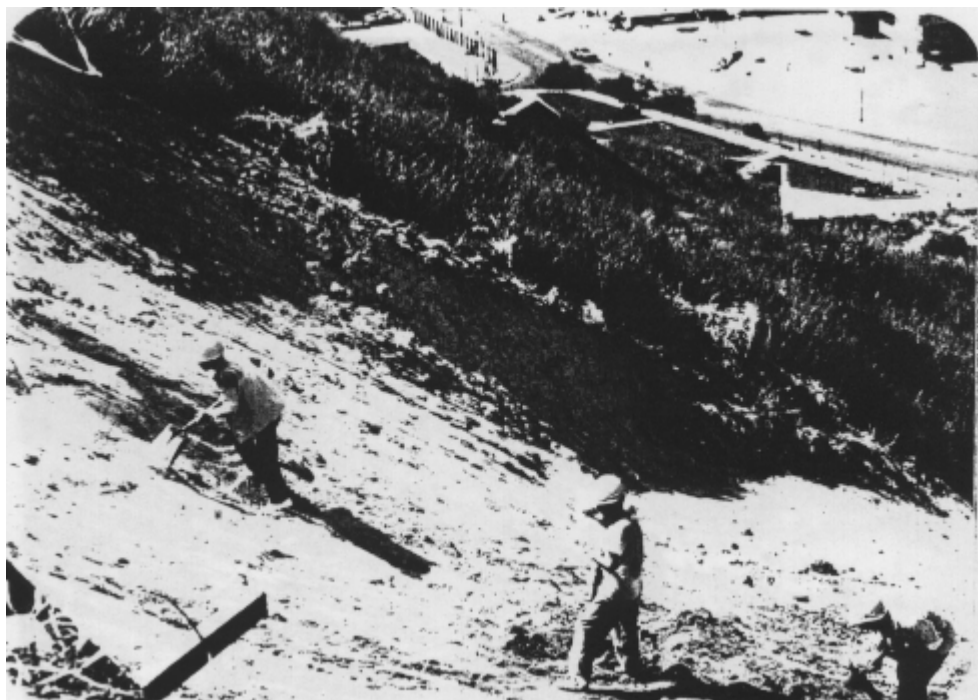
Plate 2 – View South-east Across Landslide Scar of 25 August 1976 in SMP10  
(Photograph circa Late-1976)

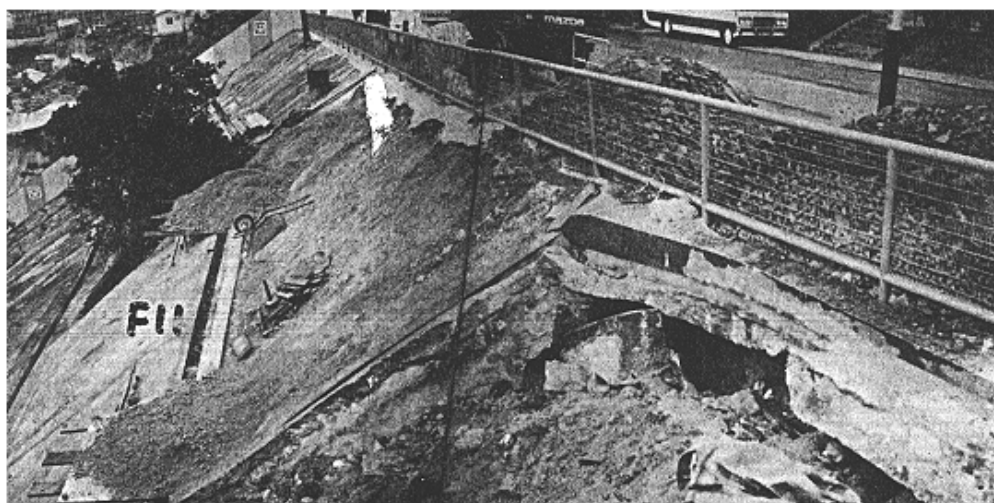
Plate 10 – View North-west Across 11NE-D/F10 and /F11 (Stepped Channel is the Separator) Indicating the Extent of Removal of 1977 Fill During 1984 Remedial Works (Photograph Taken on 25 April 1984)

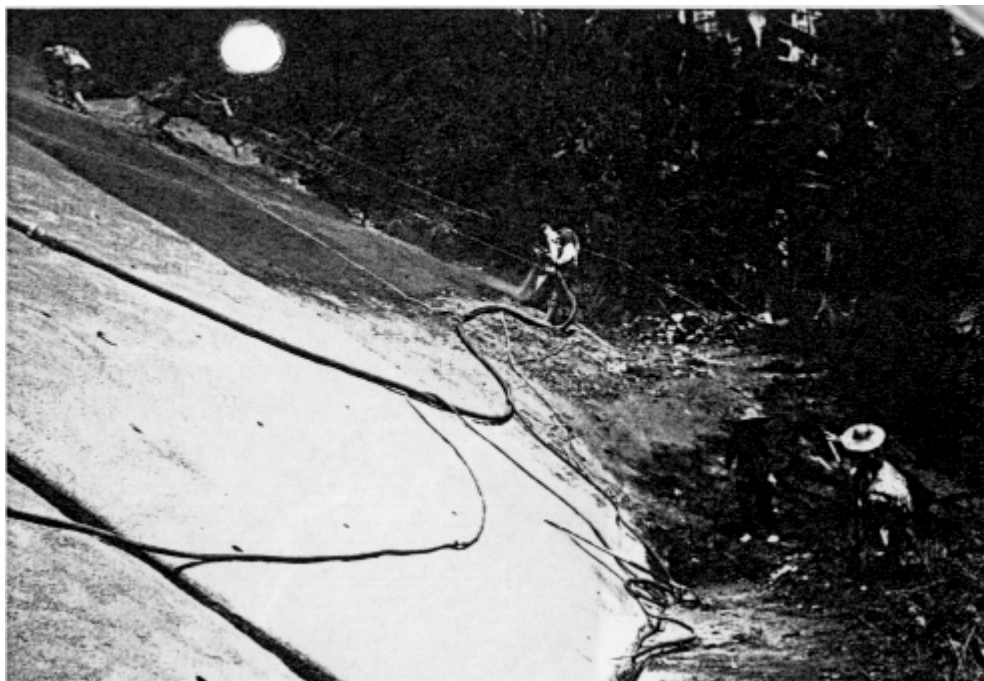
Plate 16 – View South-east Along Lower Berm. Re-Surfacing Works Underway  
(Photograph Taken on 26 May 1995)

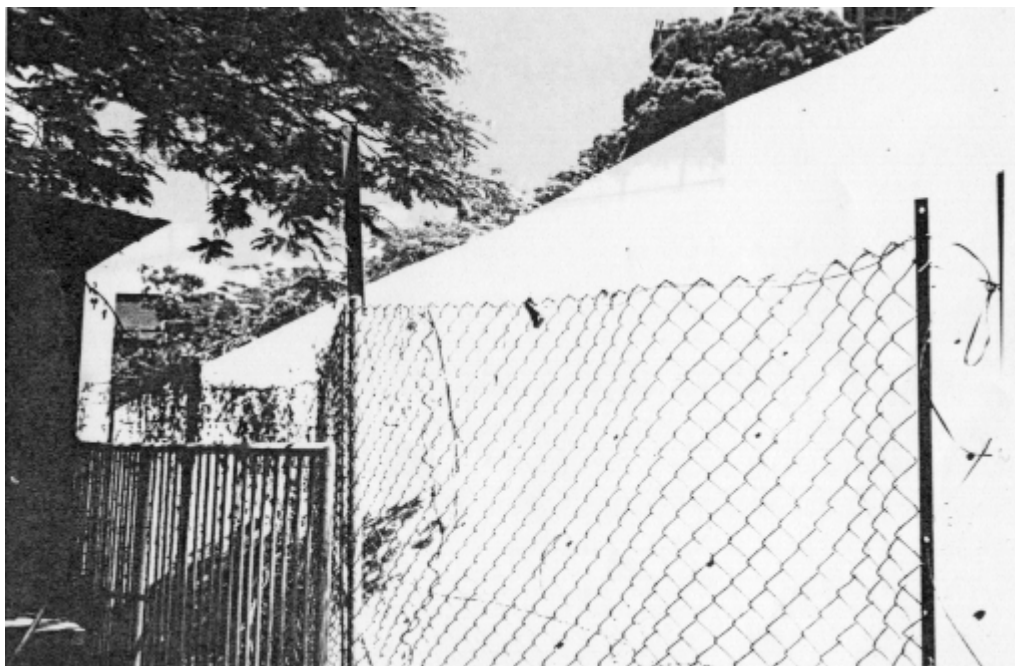
Plate 18 – View North-east From Toe of Slope Indicating Newly Shotcreted Slope. Weepholes Visible in Shotcrete (Photograph Taken on 13 June 1995)

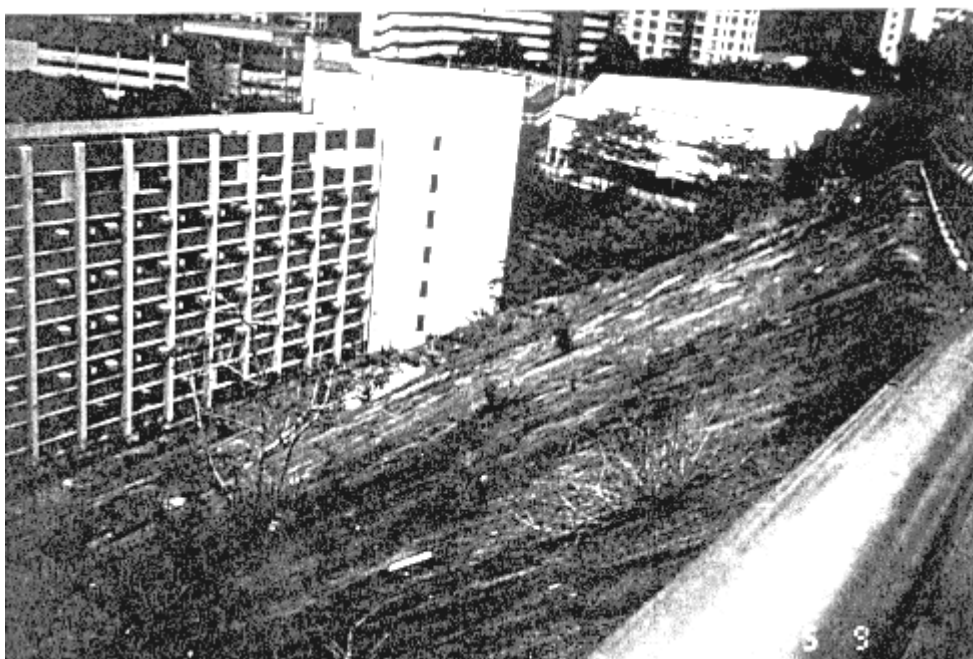
The occurrence of movement in the slope prior to the most recent distress is further confirmed by pre-1998 record photographs, presented in Plates 11 to 21.

Plate 21 – View North-west Along Crest of Slope. Note Distortion in Hand Railing Along Crest (Photograph Taken on 9 May 1997)

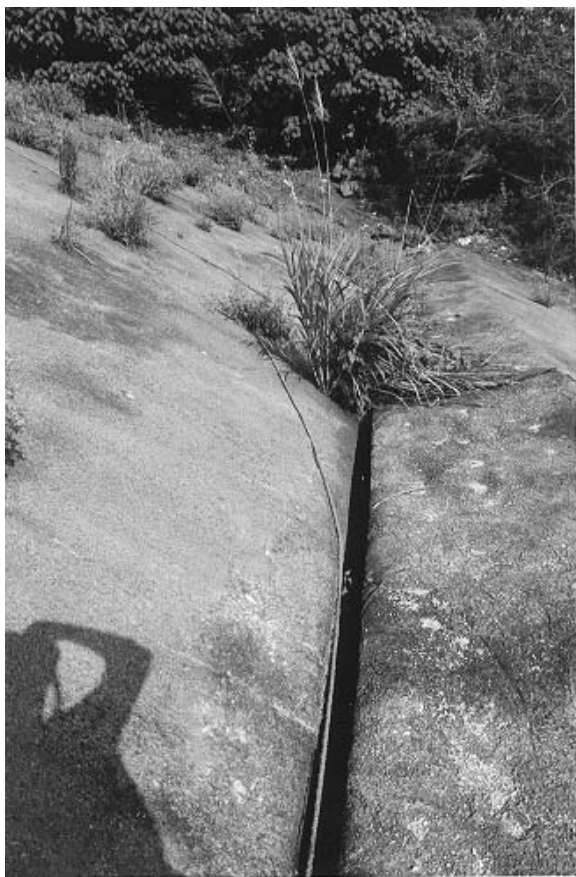
Plate 30 –  
View South-east Along Upper Berm  
at South-eastern End of Feature. Note  
Shotcrete Extending Over Lip of  
Channel and Vegetation Growing  
From Beneath Shotcrete (Photograph  
Taken on 5 May 1998)

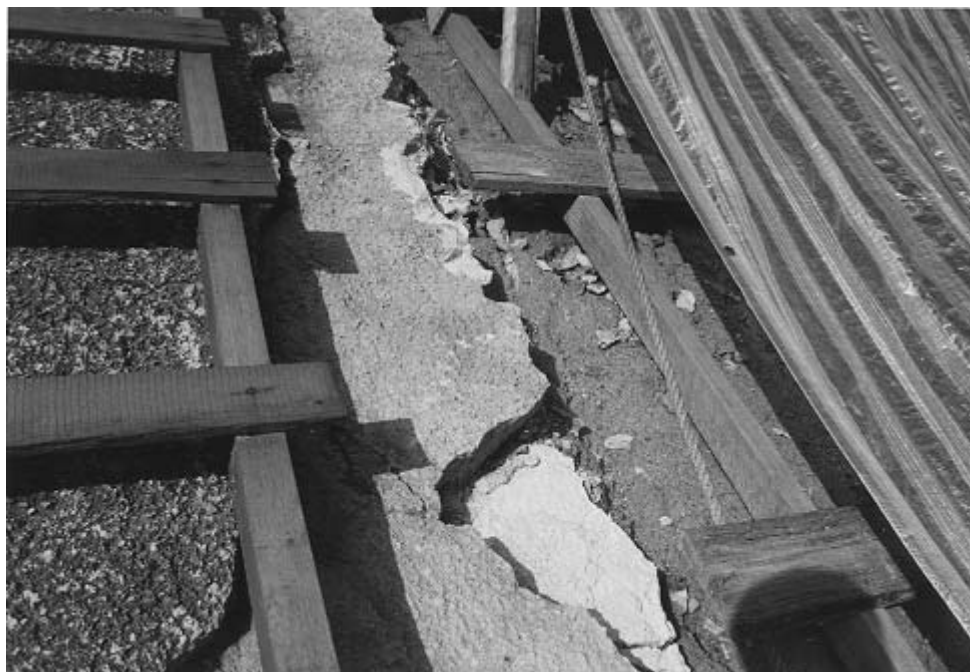
Plate 39 – View of North-western Edge of Shotcrete Strip. Note Previous Application of Hard Surfacing Beneath Shotcrete (Photograph Taken on 5 May 1998)

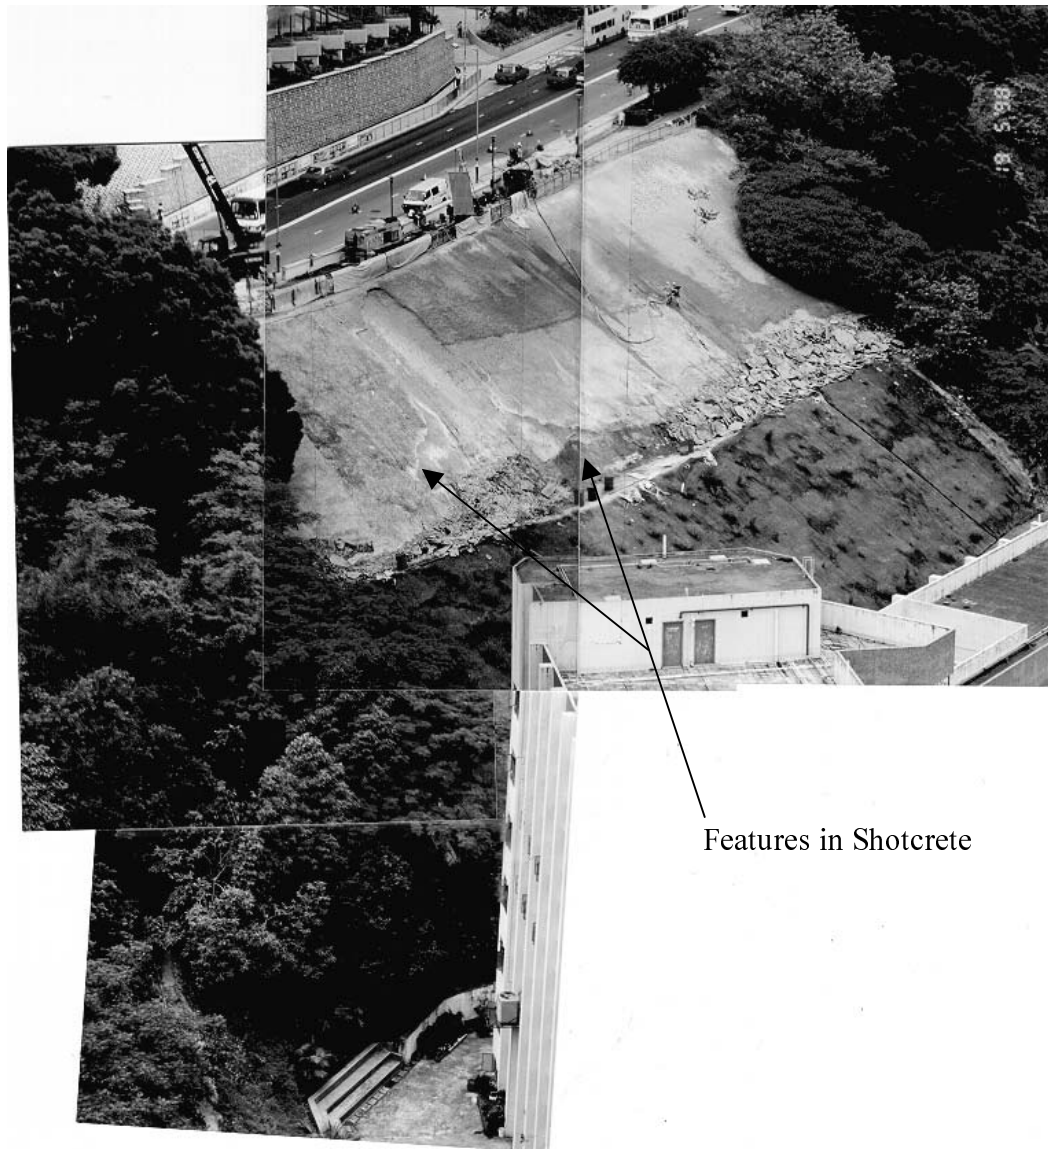
Plate 41 – View East Across Slope No. 11NE-D/F10 of Remedial Works in Progress. Some Indication is Given of Extent of Removal of 1995 Application of Shotcrete by Spoil on Berm and Extent of Removal of Previous Hard Surfacing by Features in Shotcrete. (Photograph Taken on 19 May 1998)

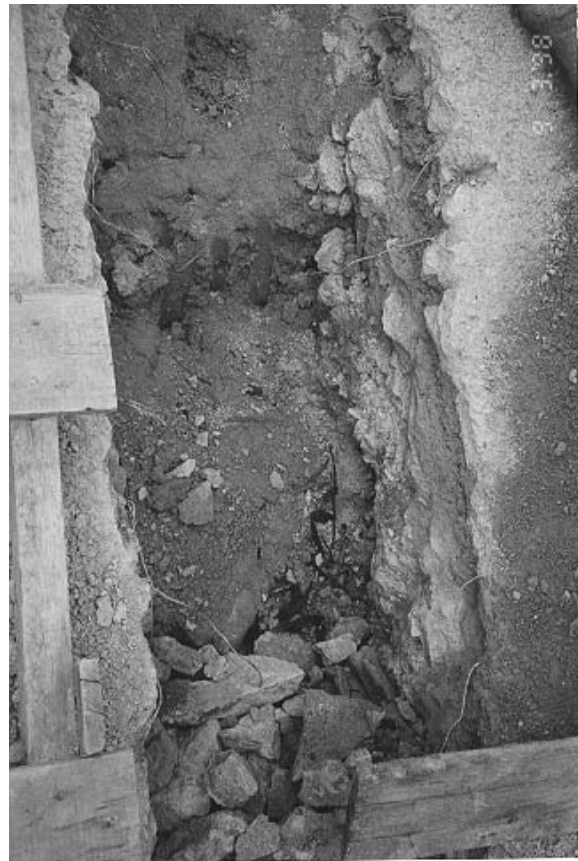
Plate 45 –  
Strip S1 Showing Fill Exposed  
Beneath Hard Surfacing 2 m  
Below Crest. Note Numerous  
Layers of Surfacing (Photograph  
Taken on 3 September 1998)

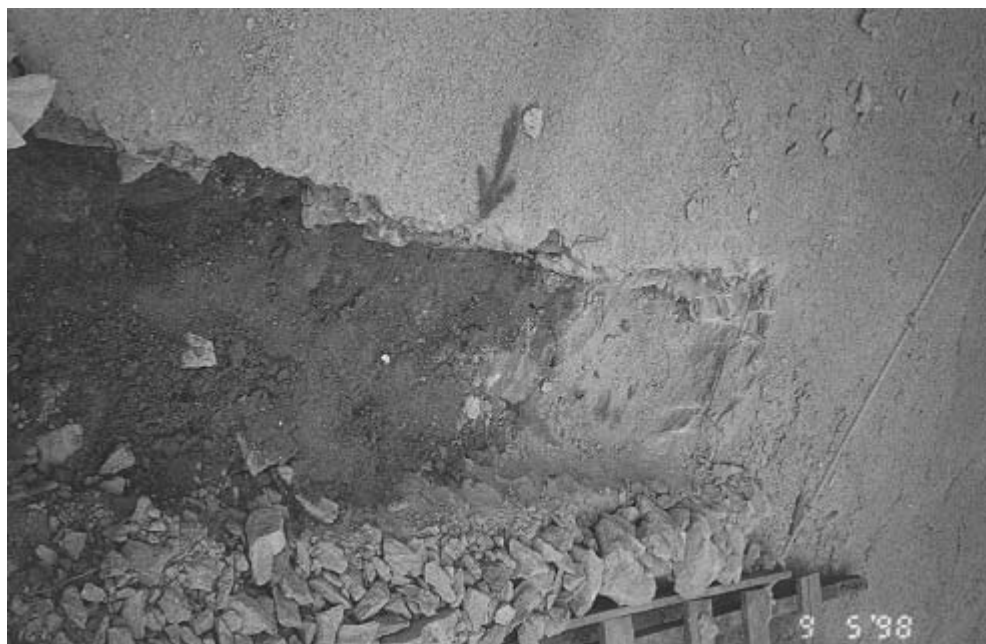
Plate 47 – Strip S1(A) Showing Fill Exposed Below Hard Surfacing (Photograph Taken on 5 September 1998)

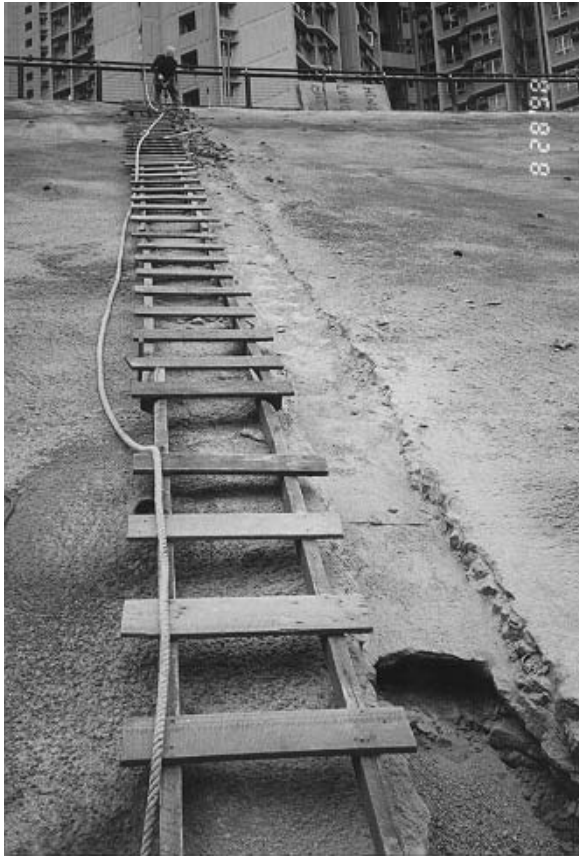
Plate 48 –  
Strip S2 – View From Upper Berm. Note  
Void Behind Previous Hard Surfacing  
Approximately 1 m Above Berm  
(Photograph Taken on 28 August 1998)

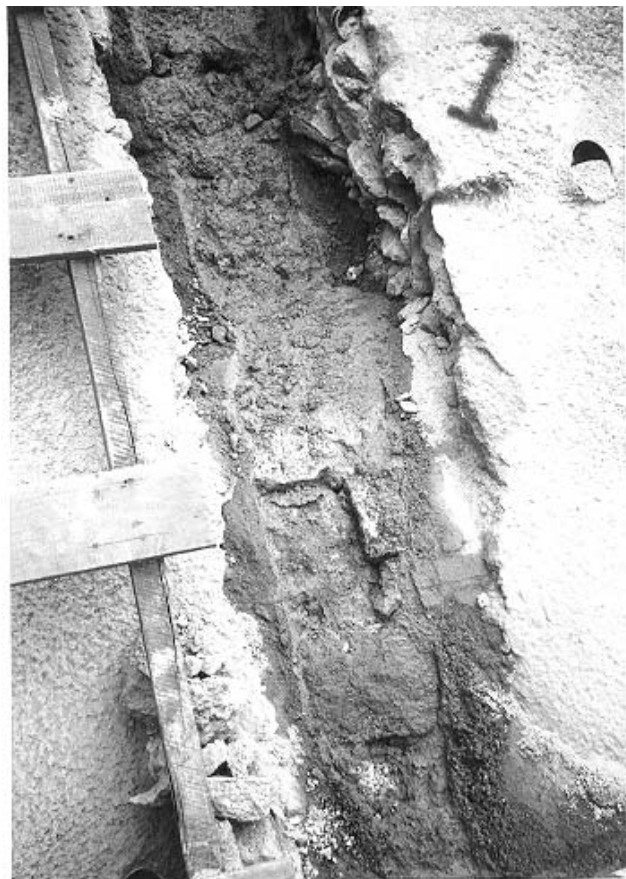
Plate 49 –  
Strip S2 Showing Stone Pitching  
Exposed Below 1998 Hard  
Surfacing. Note Numerous Layers  
of Surfacing (Photograph Taken on  
29 August 1998)

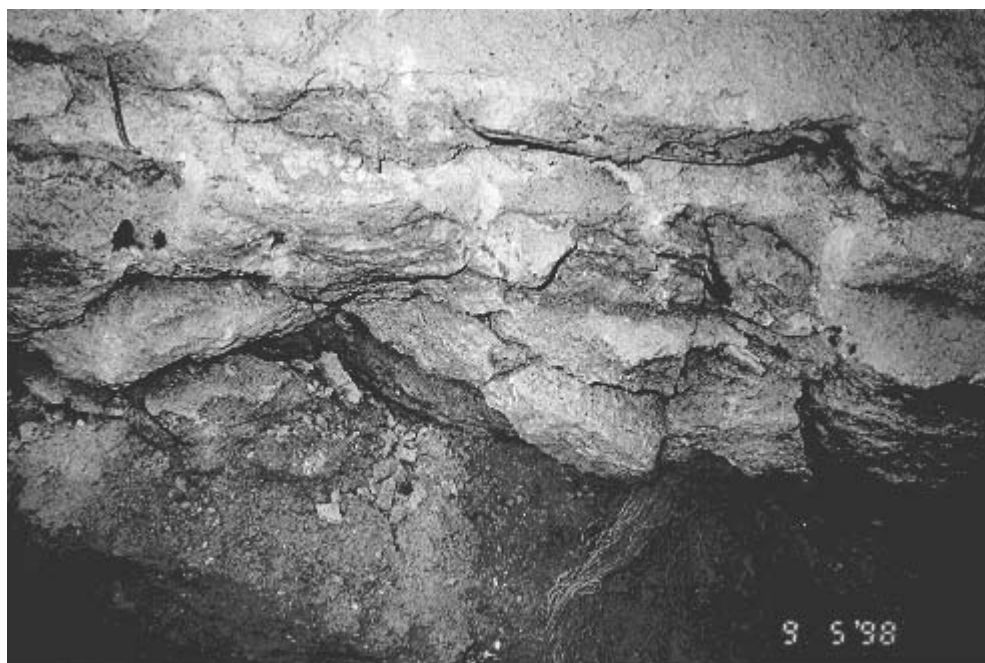
Plate 61 – Strip S3(A) Showing Close-Up of Multiple Layering of Hard Surfacing. Total Thickness Approximately 250–350 mm (Photograph Taken on 5 September 1998)

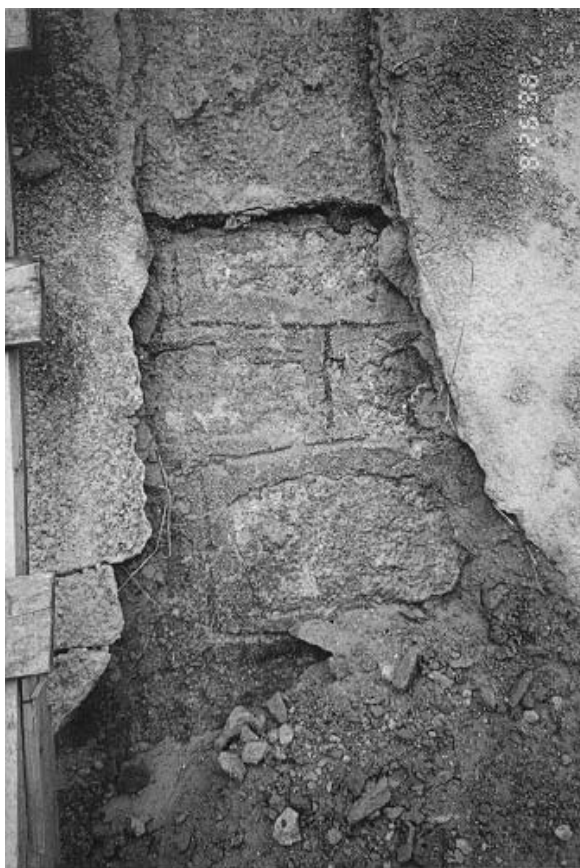
Plate 62 –  
Strip S4 (Middle Batter) Showing  
Stone Pitching Exposed Below  
1995 Application of Shotcrete at  
Toe of Batter. Note Differential  
Movement Between Previous  
Hard Surfacing and Stone  
Pitching at Interface (Photograph  
Taken on 26 August 1998)
