# **INVESTIGATION OF SOME SELECTED LANDSLIDES IN 1998 (VOLUME 2)**

**GEO REPORT No. 109**

**SECTION 1 :  
DETAILED STUDY OF THE  
DISTRESS OBSERVED IN  
SLOPE NO. 11NE-D/F10 BELOW  
HIU KWONG STREET,  
SAU MAU PING  
ON 9 APRIL 1998**

This report presents the findings of a detailed study of distress observed in fill slope No. 11NE-D/F10 located below Hiu Kwong Street, Sau Mau Ping, on 9 April 1998. The distress comprised cracking, displacement and bulging of the shotcrete cover to the upper batter of the slope, and was observed following the reporting of seepage from the toe of the slope.

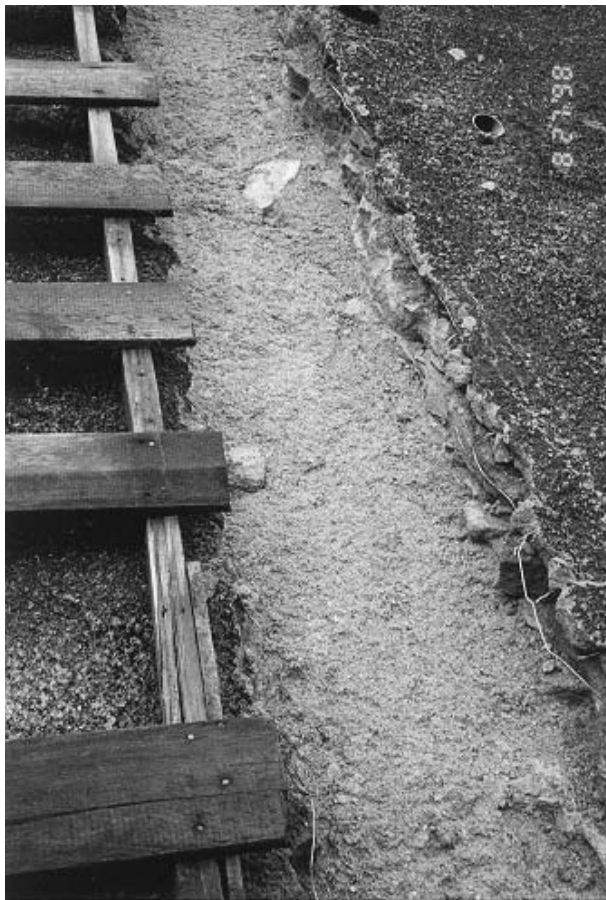
Plate 65 –  
Strip S4 (Middle Batter) Showing Fill Exposed Below Hard Surfacing 12 m Above Lower Berm. Note Single Layer of Hard Surfacing Below 1995 Application of Shotcrete (Photograph Taken on 27 August 1998)
