**SECTION 2 :
DETAILED STUDY OF THE
LANDSLIDE BELOW
AU TAU VILLAGE ROAD,
TSEUNG KWAN O
ON 9 JUNE 1998**

Fugro Scott Wilson Joint Venture

**This report was originally produced in October 1999
as GEO Landslide Study Report No. LSR 6/99**

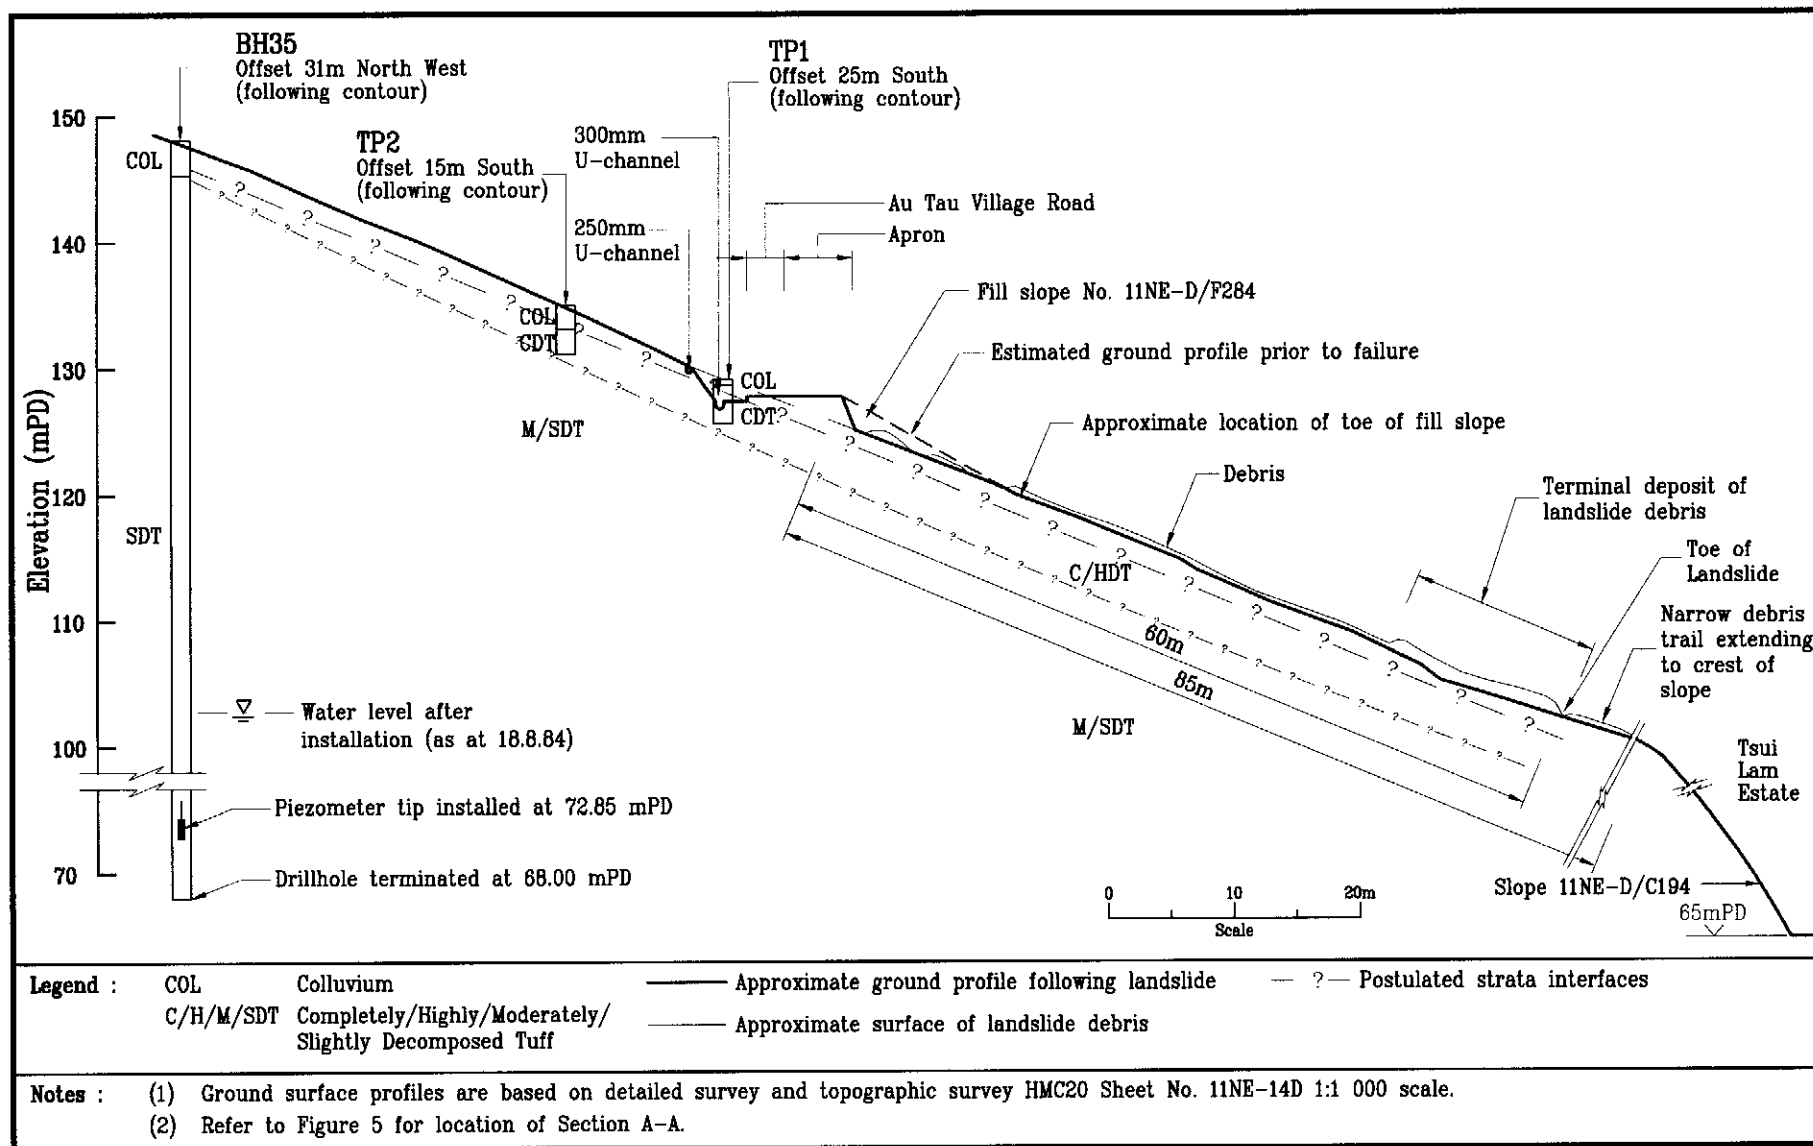
Figure 6 - Section A-A Through the Landslide

A geological section through the landslide is shown in Figure 6.

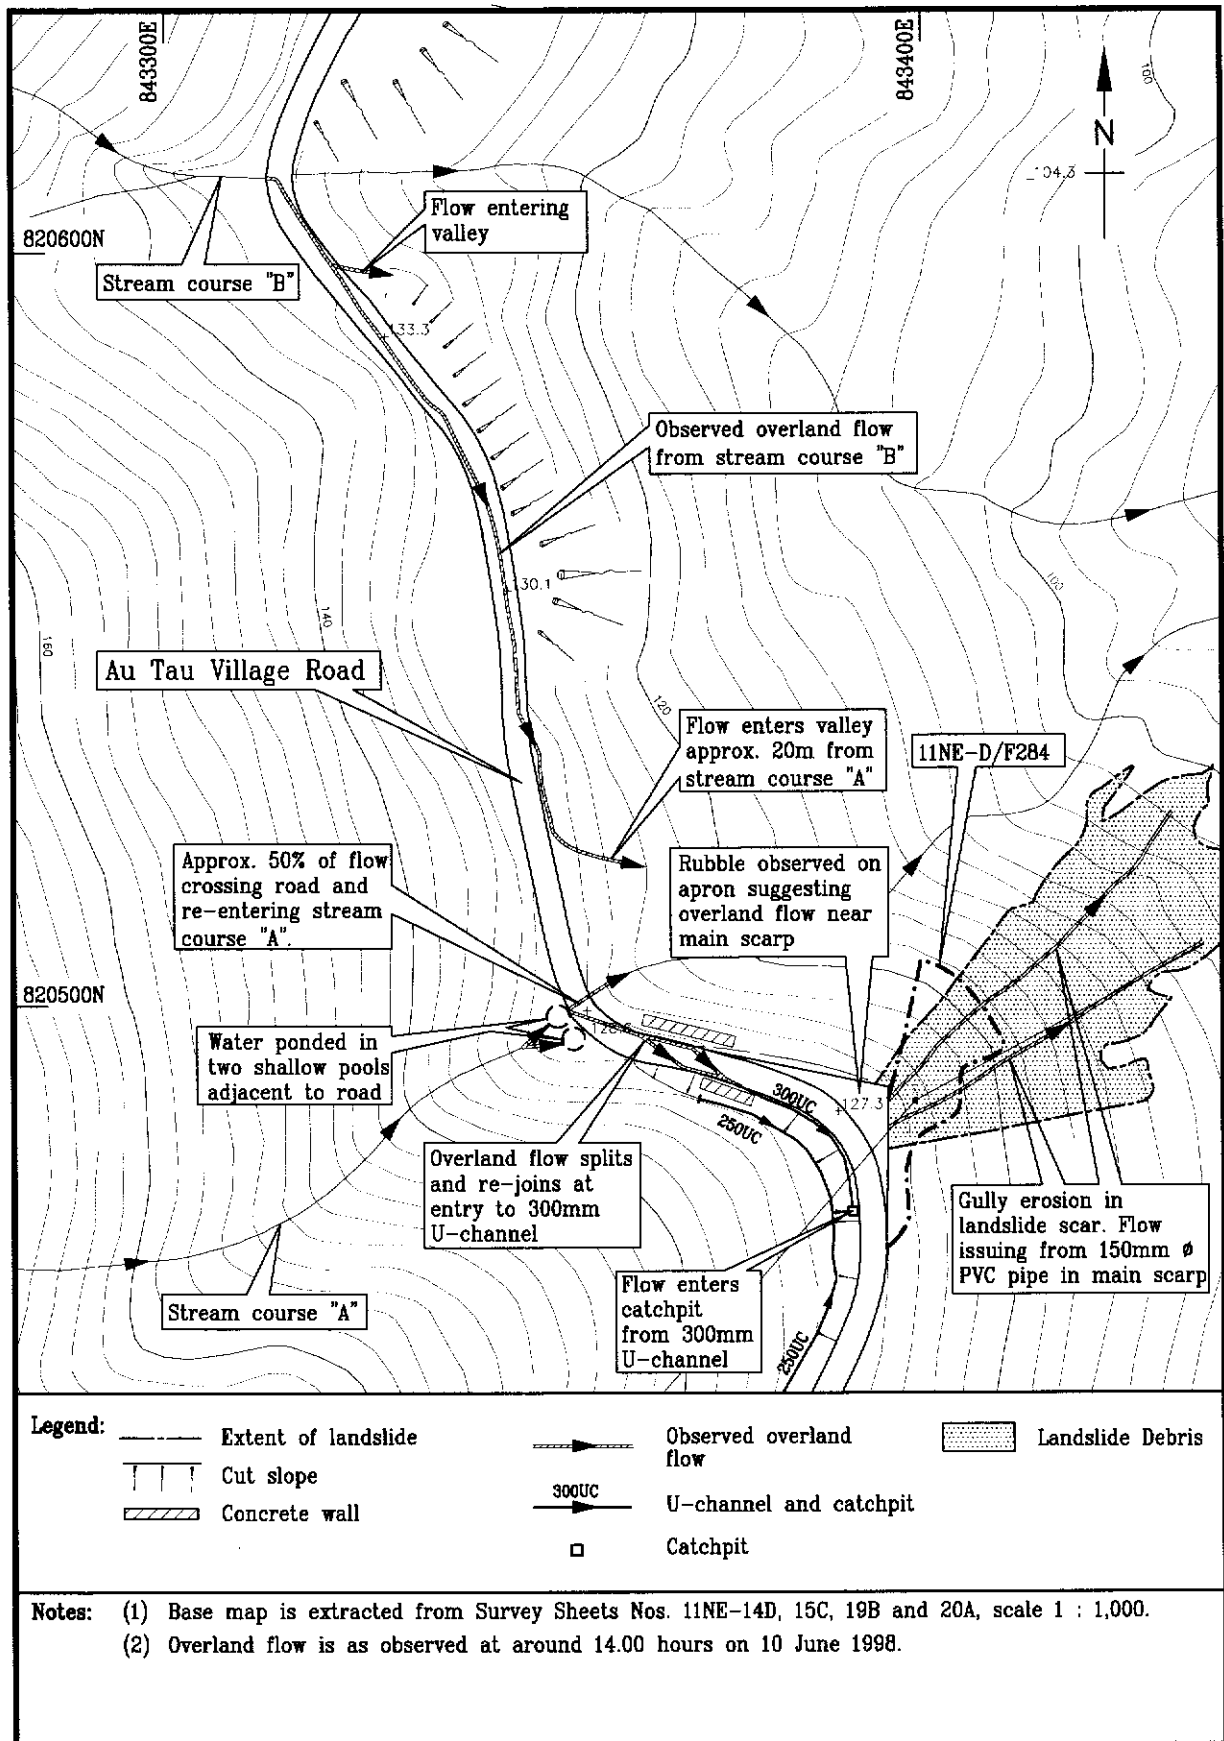
Figure 8 - Observed Overland Flow Paths

- (a) the uncontrolled dumping of fill between 1976 and 1991,
- (b) the loose nature of the fill which was susceptible to collapse and liquefaction upon water ingress,
- (c) overland flow from the road bend above the crest of the fill slope following recent road reconstruction works which adversely affected the surface water flow regime, and

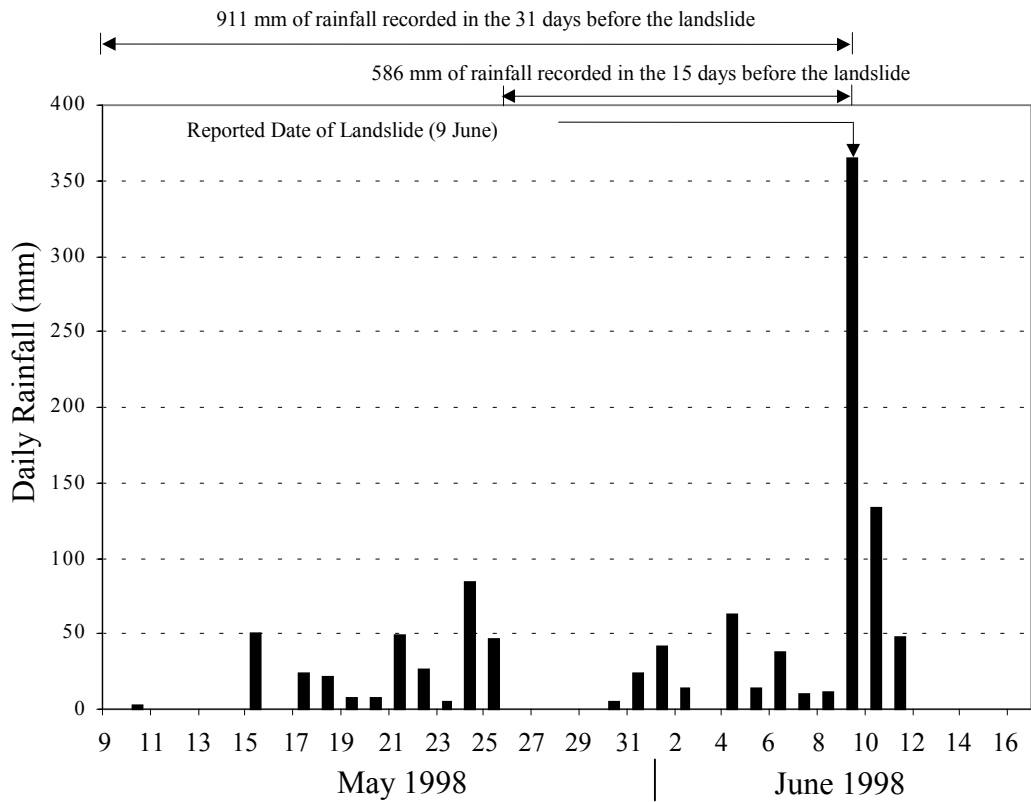
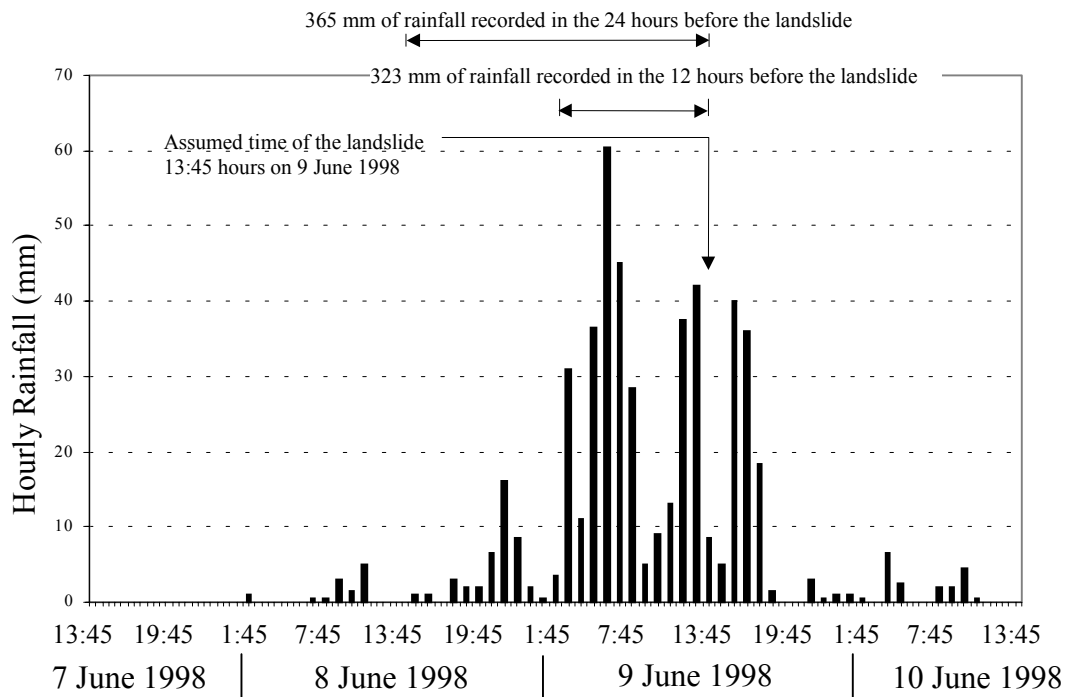
Figure 10 - Rainfall Recorded at GEO Raingauge No. N08

Daily rainfall for one month preceding, and seven days following the landslide, together with hourly rainfall for 48 hours before and 24 hours following the landslide, are given in Figure 10. The daily rainfall records show that the storm was concentrated around 9 June 1998 (the day of the landslide), with the hourly data indicating intense peaks from 02:45 to 03:45 hours, 04:45 to 08:45 hours and 11:45 to 13:45 hours, generally in the range of 30 mm/hr to 60 mm/hr.

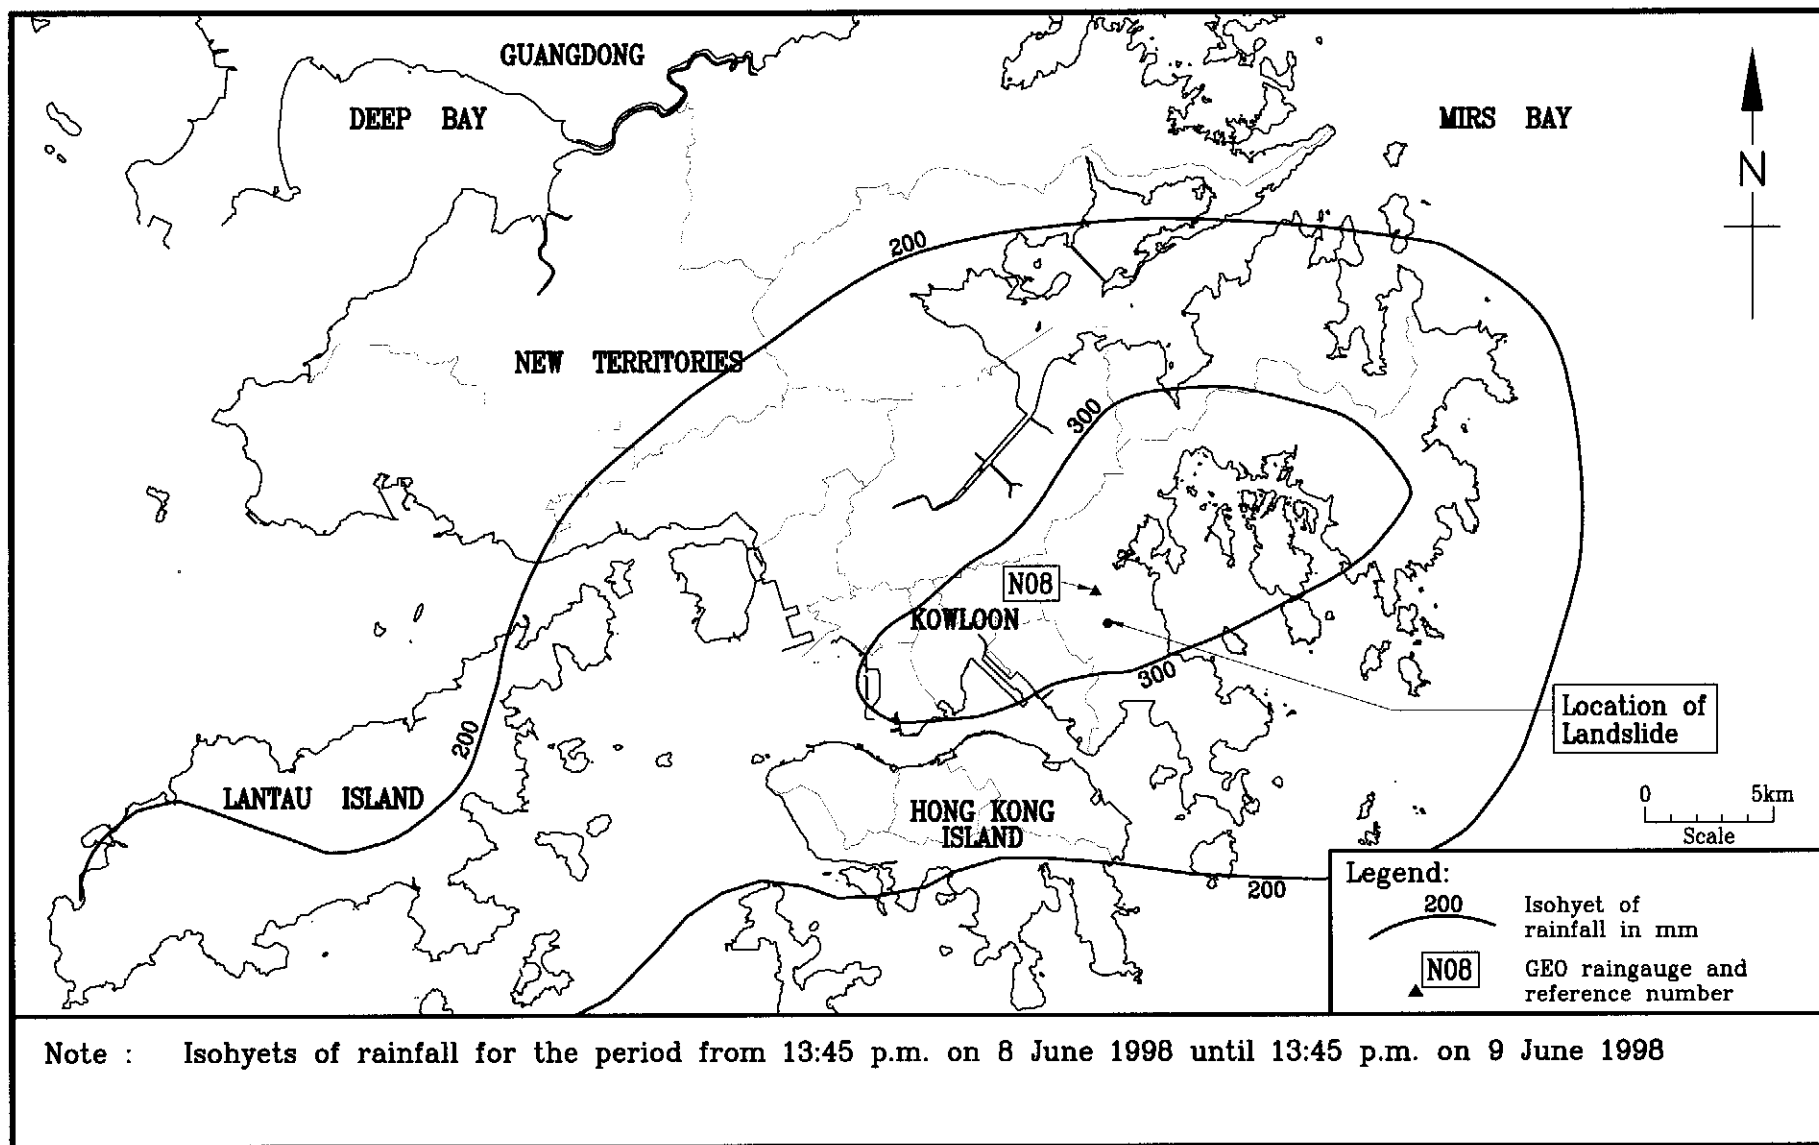
Figure 11 - Rainfall Distribution for the 24-Hour Period Preceding the Landslide of 9 June 1998

Isohyets of rainfall for the 24-hour period preceding the landslide are given in Figure 11.

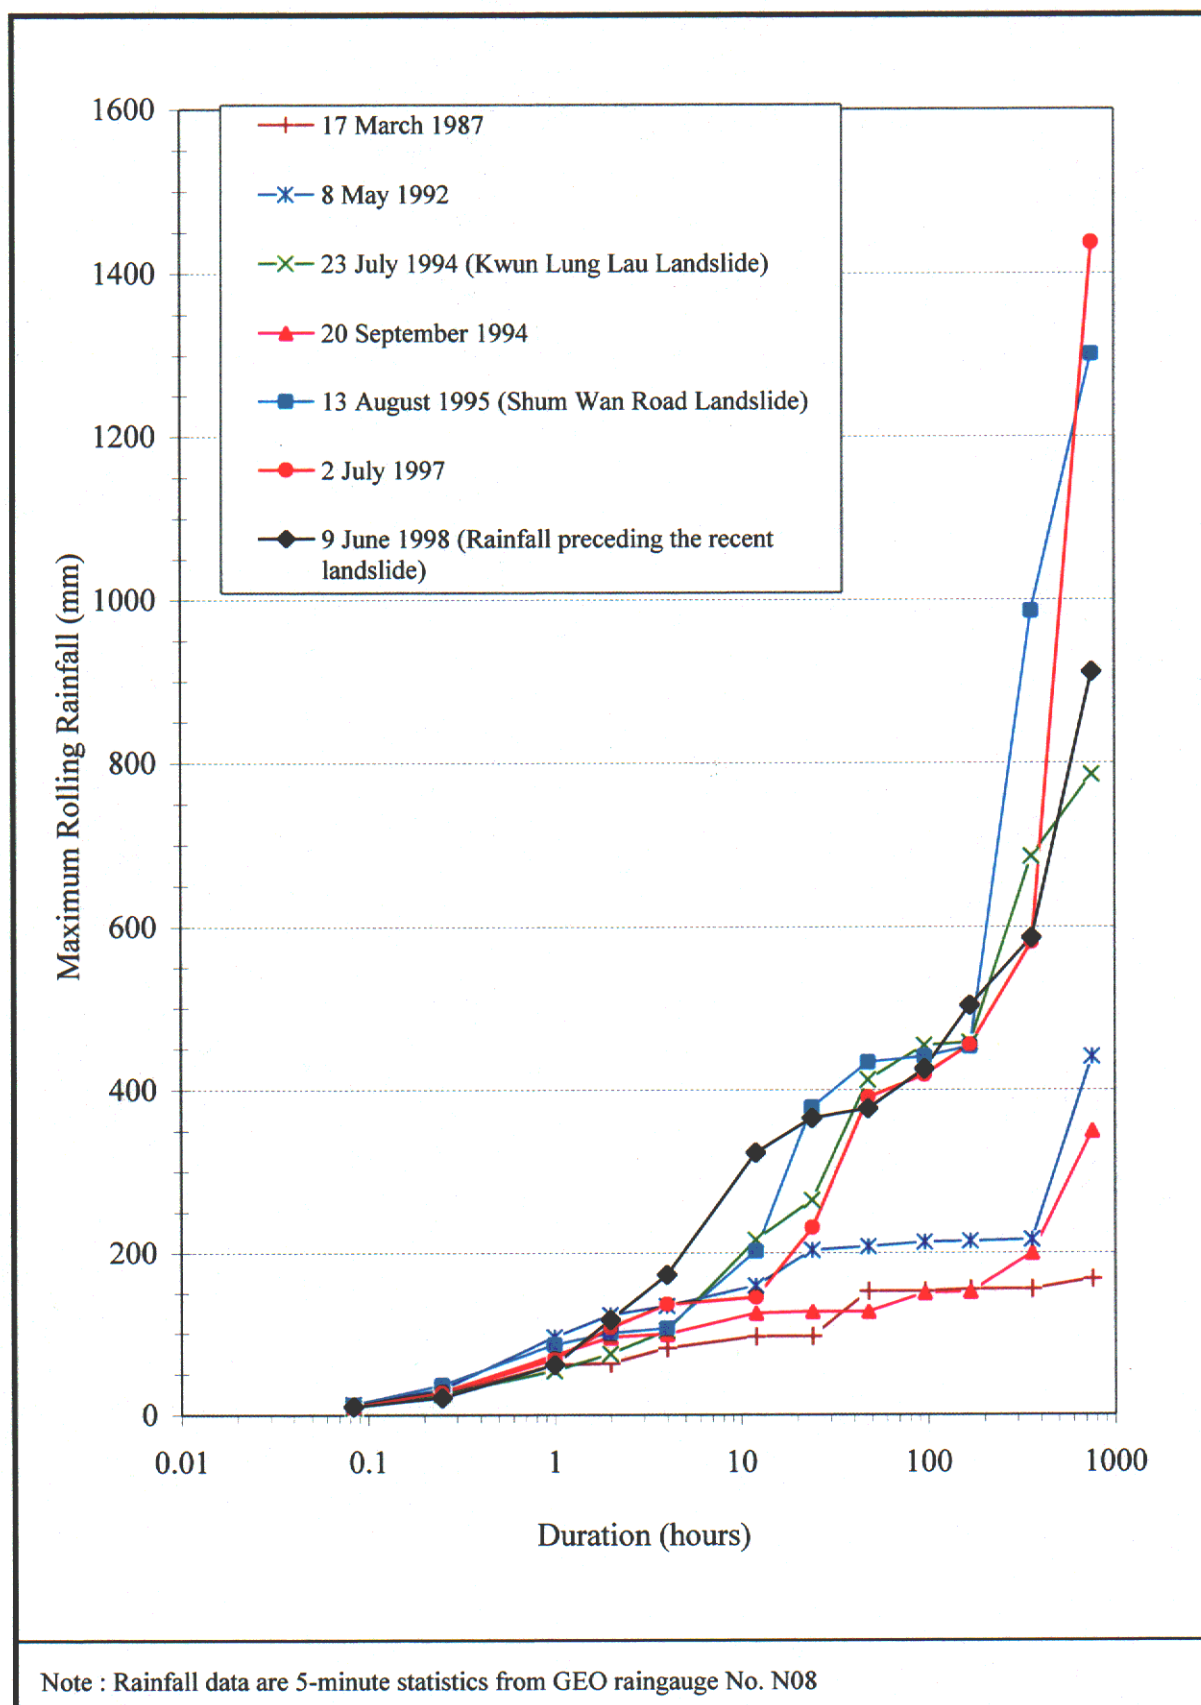
Figure 12 - Maximum Rolling Rainfall Preceding the Landslide of 9 June 1998 and Selected Previous Major Rainstorms Recorded at GEO Raingauge No. N08

Table 1 presents the estimated return period for the maximum rolling rainfall for various durations based on historical rainfall data at the Hong Kong Observatory (Lam & Leung, 1994). The 12-hour maximum rolling rainfall (323 mm) was the most severe with a return period of about 18 years. A comparison of the severity of the June 1998 rainstorm and other historical major rainstorms is presented in Figure 12. This shows that the June 1998 rainstorm was the most severe for durations of between about 2 hours and 24 hours, since installation of the raingauge in the mid-1980's.

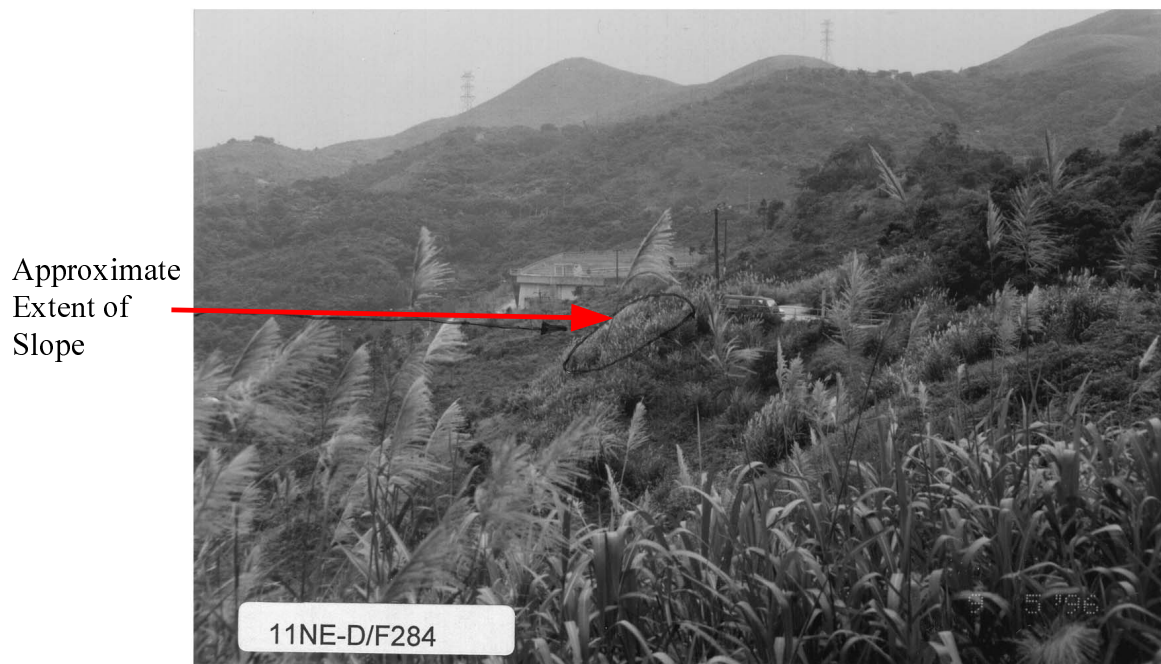
Plate 2 – View South Towards Slope No. 11NE-D/F284 From Au Tau Village Road
(Photograph Taken on 9 May 1996).

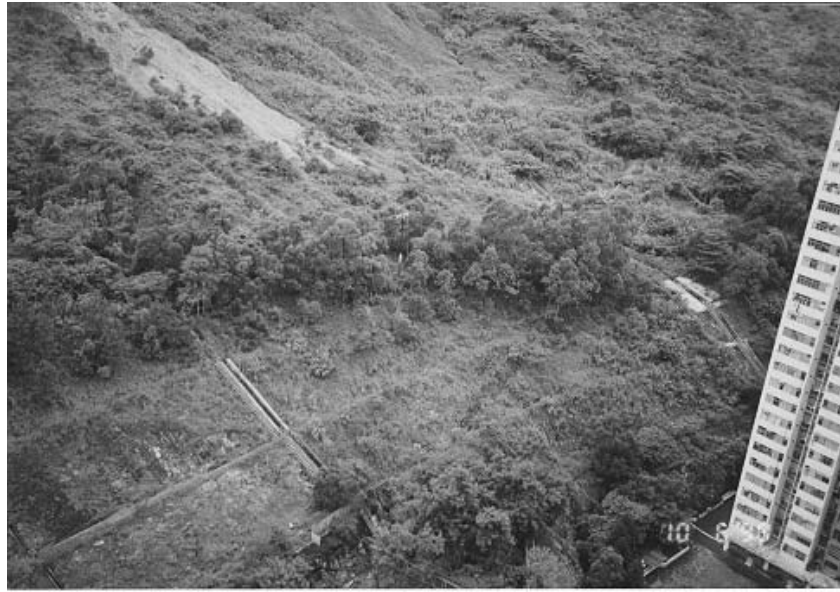
Plate 5 – View West From Yan Lam House, Tsui Lam Estate, Indicating Runout of Debris Relative to Rock Slopes Adjacent to Choi Lam House. (Photograph Taken on 10 June 1998)

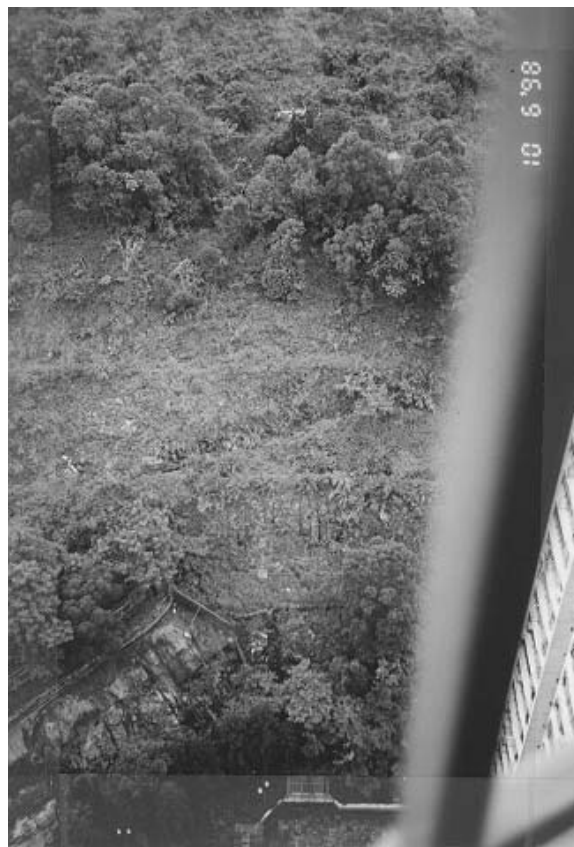
Plate 6 – View West from Choi Lam House, Tsui Lam Estate, Indicating Runout of Debris (Top of Frame) Relative to Crest of Rock Slopes Adjacent to Building. (Photograph Taken on 10 June 1998)

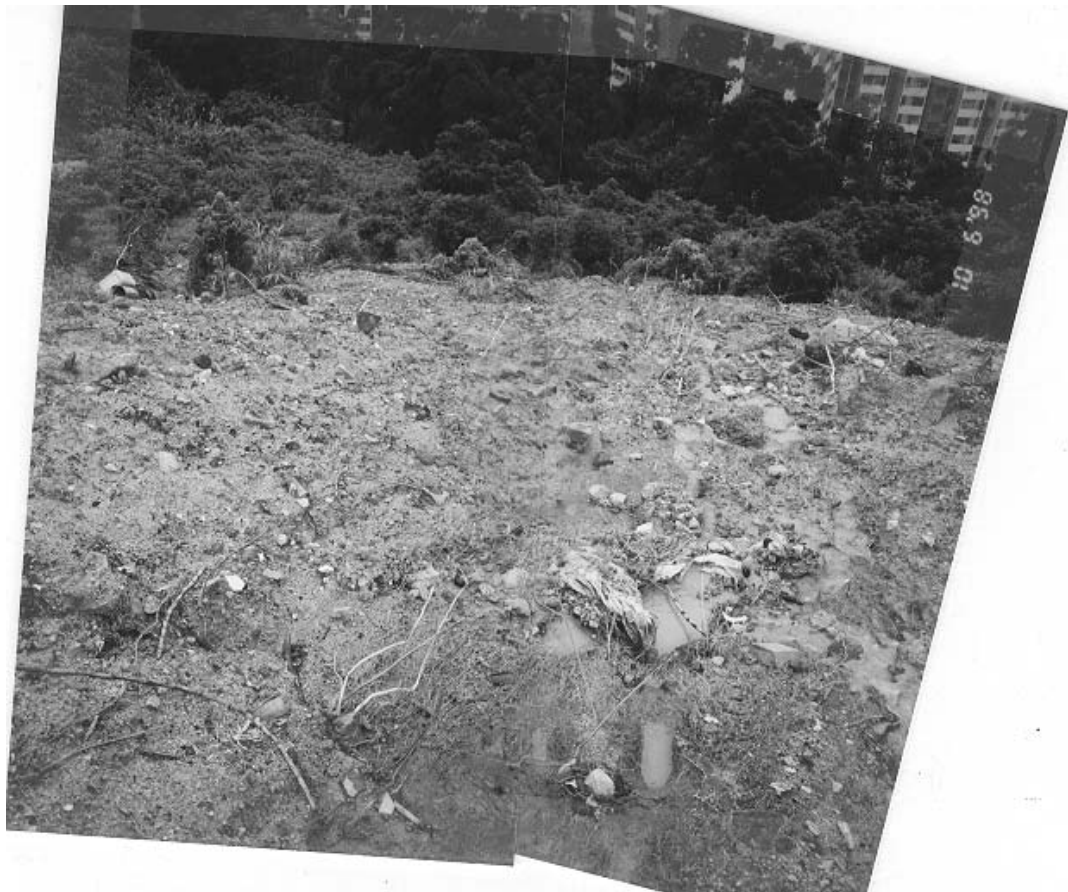
Plate 11 – View East Over Debris Deposition Zone From Approximate Location of Slope Toe Prior to Failure. Grass Rootlets and Standing Shrubs Indicate Deposition Zone Below. (Photograph Taken on 10 June 1998)

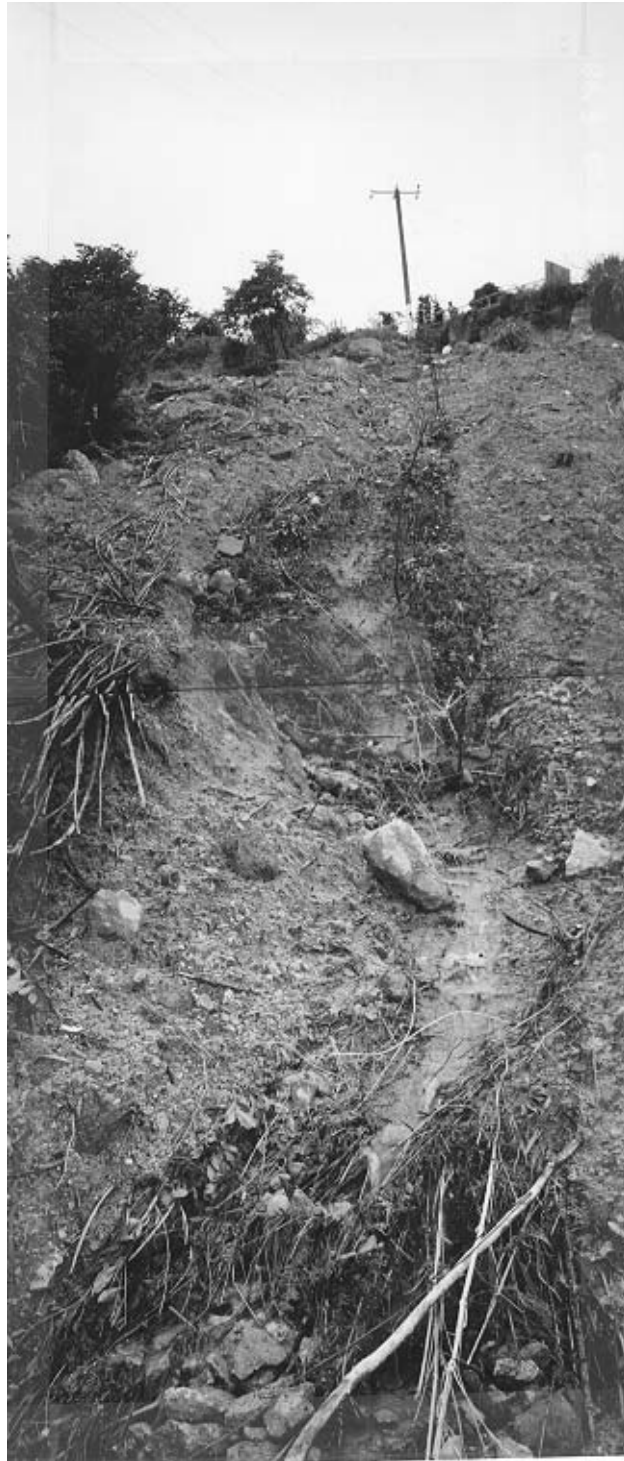
Plate 12 – View West Towards Main Scarp From Within Main Eroded Gully in Deposition Zone. Intact Vegetation Exposed in Eroded Gully.
(Photograph Taken on 10 June 1998)

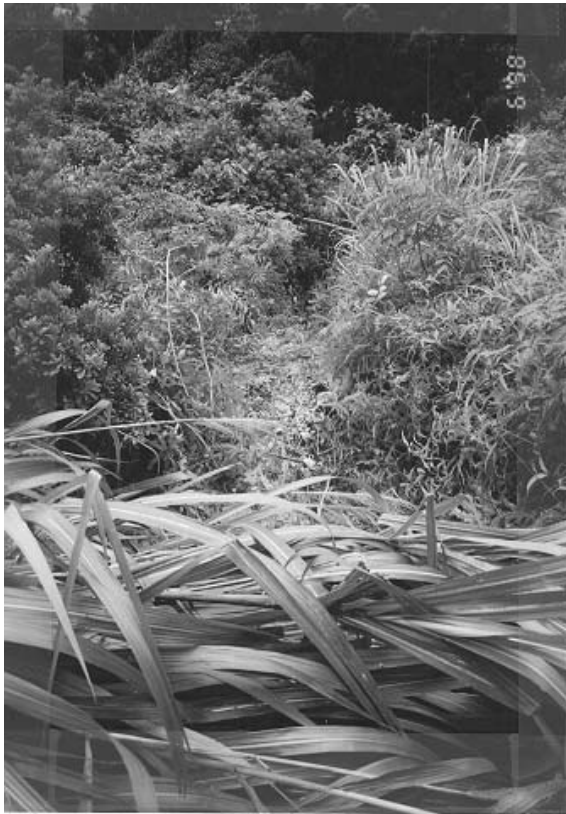
Plate 13 – View East Down Debris Trail
Extending From Main Zone of
Deposition Below Main
Eroded Gully. (Photograph
Taken on 10 June 1998)

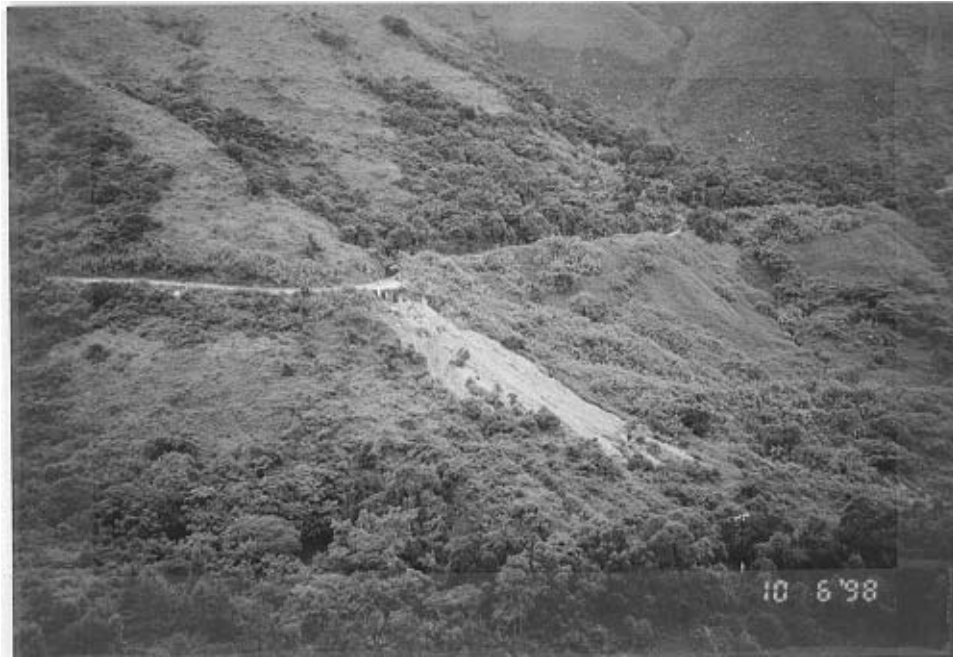
Plate 15 – View West from Yan Lam House, Tsui Lam Estate, Indicating Extent of Catchment Above Au Tau Village Road. Note Apparent Hill Fire Scarring in Hillside on Right of Frame. (Photograph Taken on 10 June 1998)

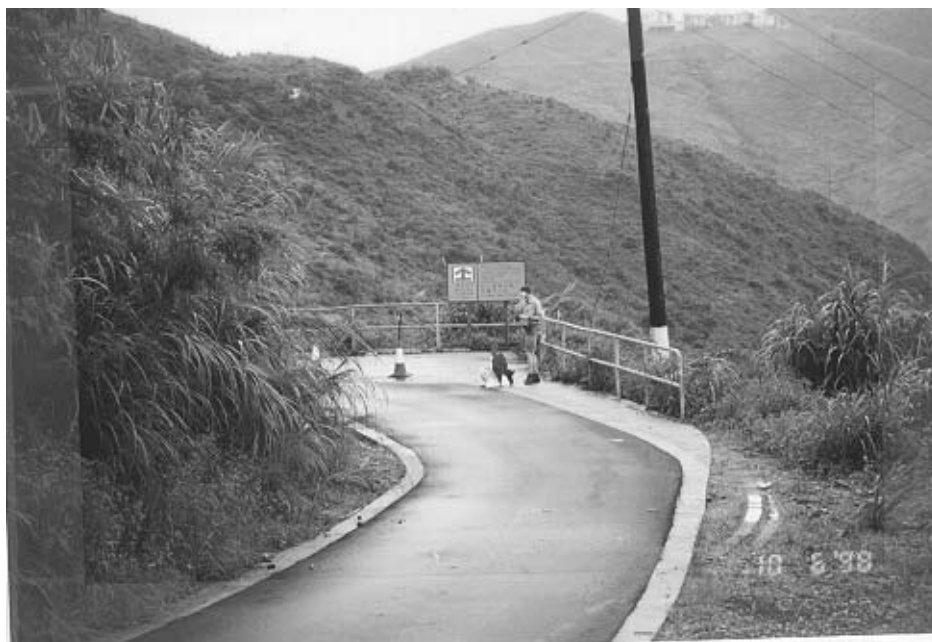
Plate 18 – View North Towards Apron on Outside of Bend in Au Tau Village Road above Location of Landslide. Note Electricity Pole, Located in Scar. (Photograph Taken on 10 June 1998)

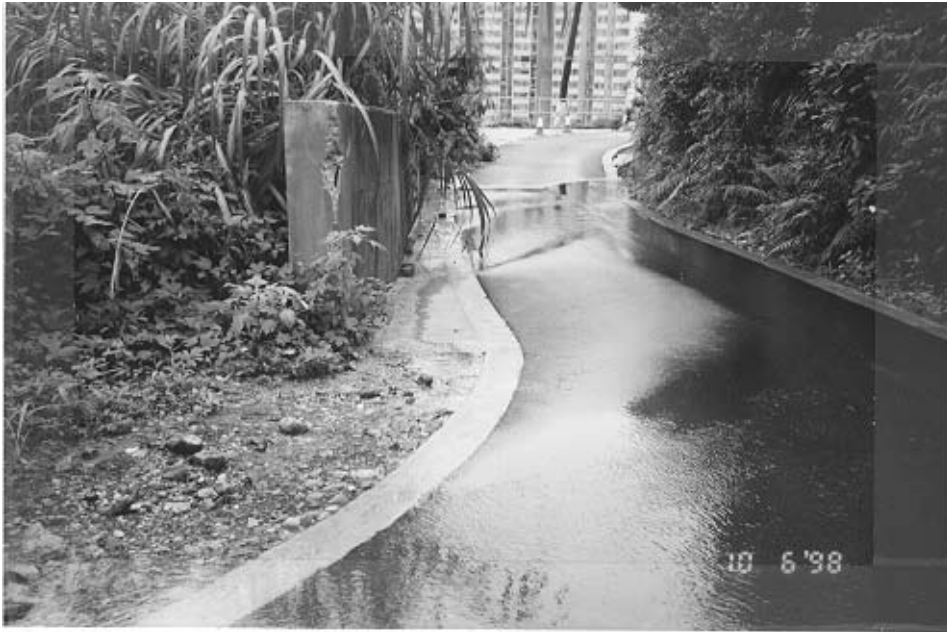
Plate 19 – View East Towards Apron on Outside of Bend in Au Tau Village Road Above Location of Landslide. Note Overland Flow on Road in Foreground and Continued Flow To East. (Photograph Taken on 10 June 1998)

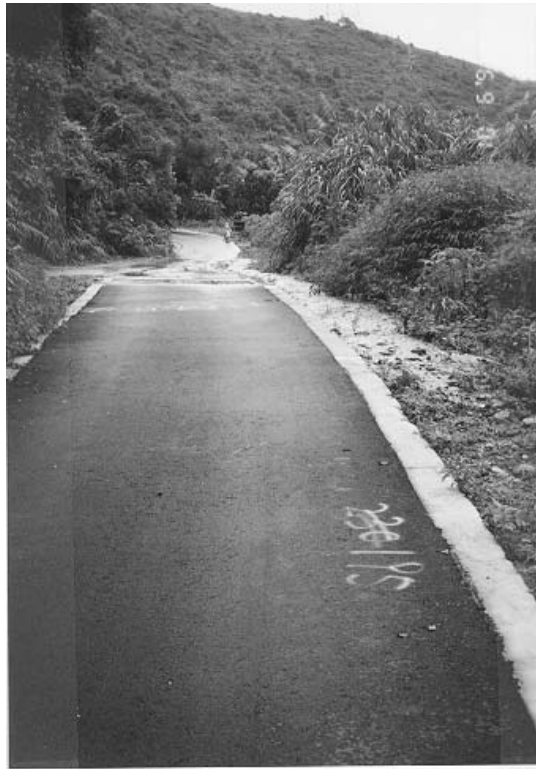
Plate 21 – View North Along Au Tau Village Road to West of Landslide Indicating Overland Flow From Stream Course “B”. Flow Discharges into Valley Below Road on Right of Frame. (Photograph Taken on 10 June 1998)

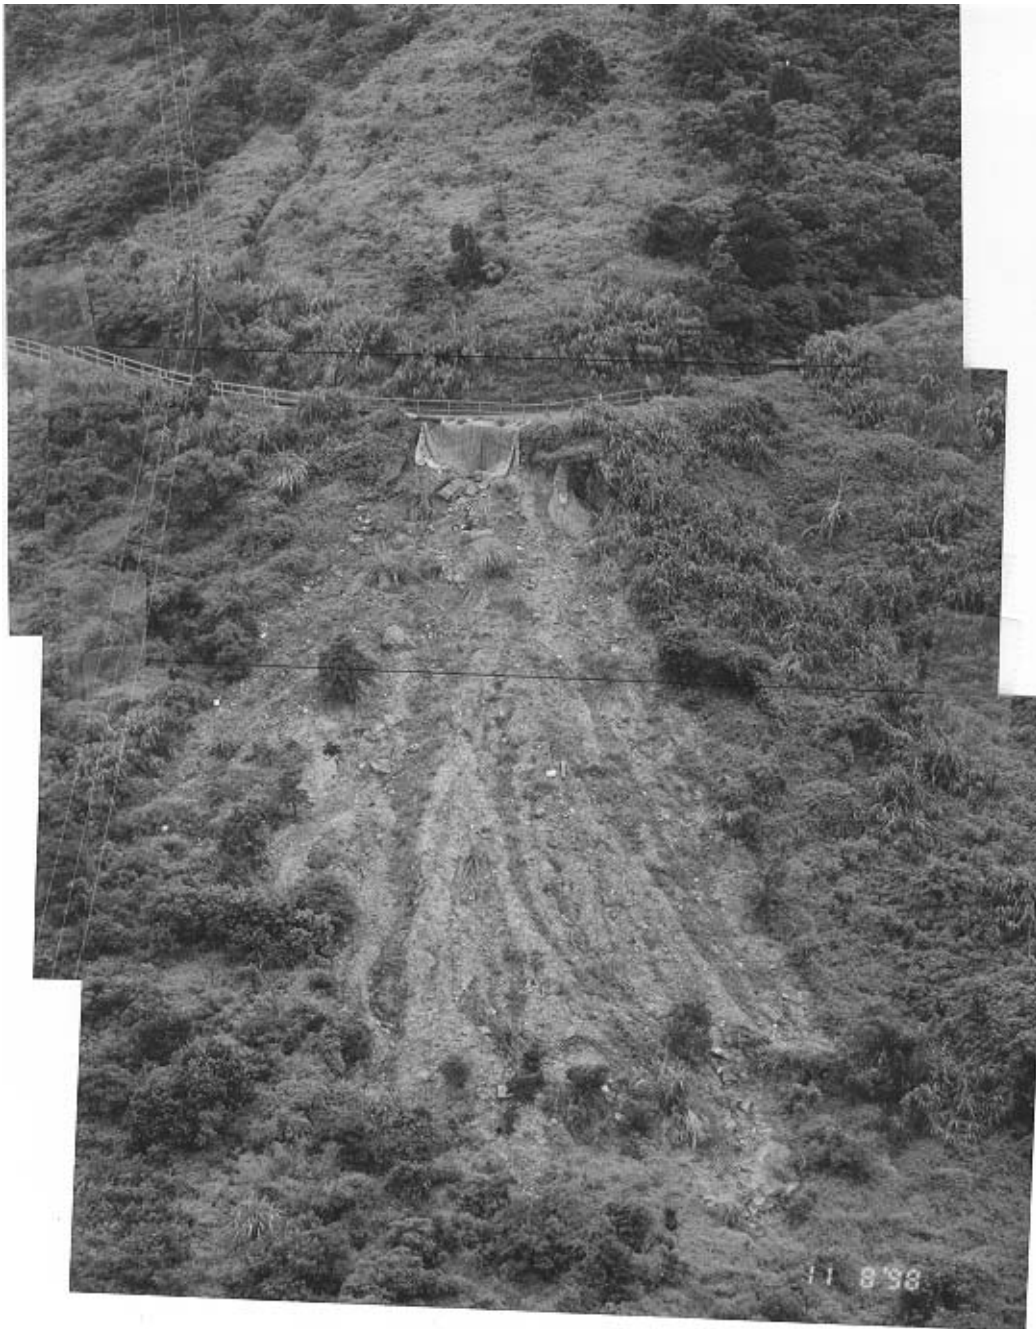
Plate 24 – View West from Choi Lam House Across Landslide Scar. Re-Vegetation in Debris Deposition Zone Provides Indication of Gully Erosion. Locations and Original Toe-Line of Fill Slope No. 11NE-D/F284 Prior to Failure. (Photograph Taken on 11 August 1998)

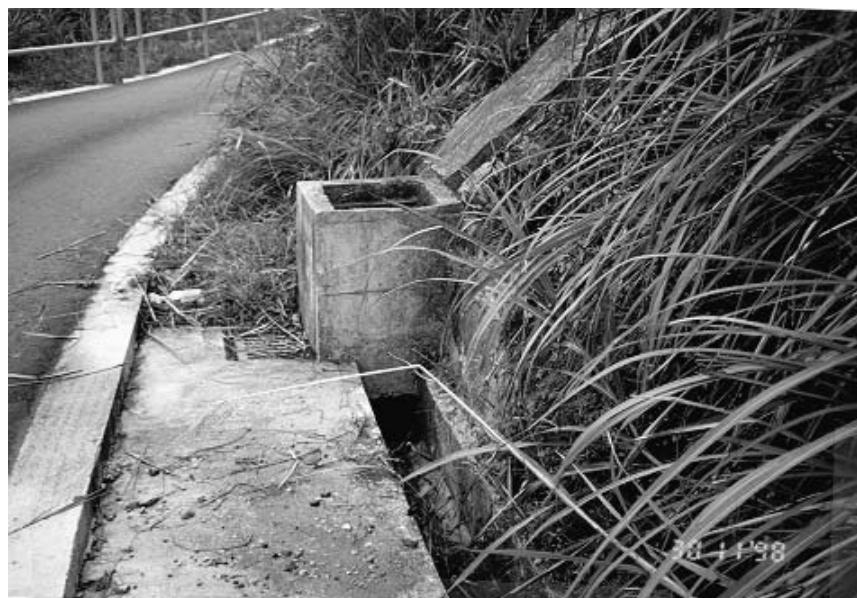
Plate 28 – Catchpit Located Behind Landslide Scar on Opposite Side of Au Tau Village Road. Note 300 mm U-Channel on Road Apron and Stepped U-Channel Providing Discharge to Crest Drainage of Cut Slopes Above Entering Catchpit. (Photograph Taken on 30 November 1998)

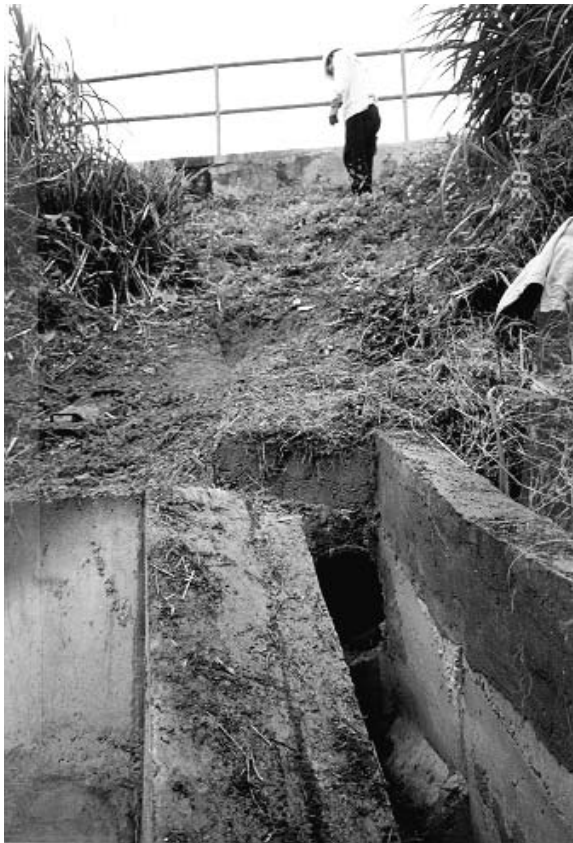
Plate 29 – Outlet to 225 mm Diameter Pipe Draining Catchpit Opposite Landslide Scar (refer Plate 28) Exposed in Slope to North of and Below Concrete Apron. Stepped Channel Extends to North. Concrete Structure Adjacent to Channel Associated with 1992 Water Main Installation by WSD. (Photograph Taken on 30 November 1998)

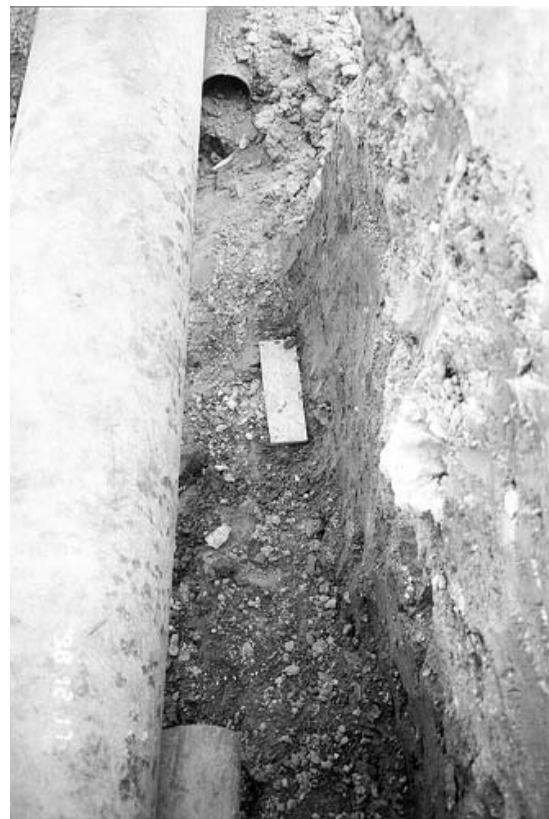
Plate 30 – View North Along Trench Excavated to Expose 400 mm Diameter Water Main Behind Landslide Scar Associated with WSD Diversion Works to Re-Locate Main Away From Slope Crest. Note Section of 150 mm Diameter PVC Pipe Removed During Trench Excavation. (Photograph Taken on 17 December 1998)

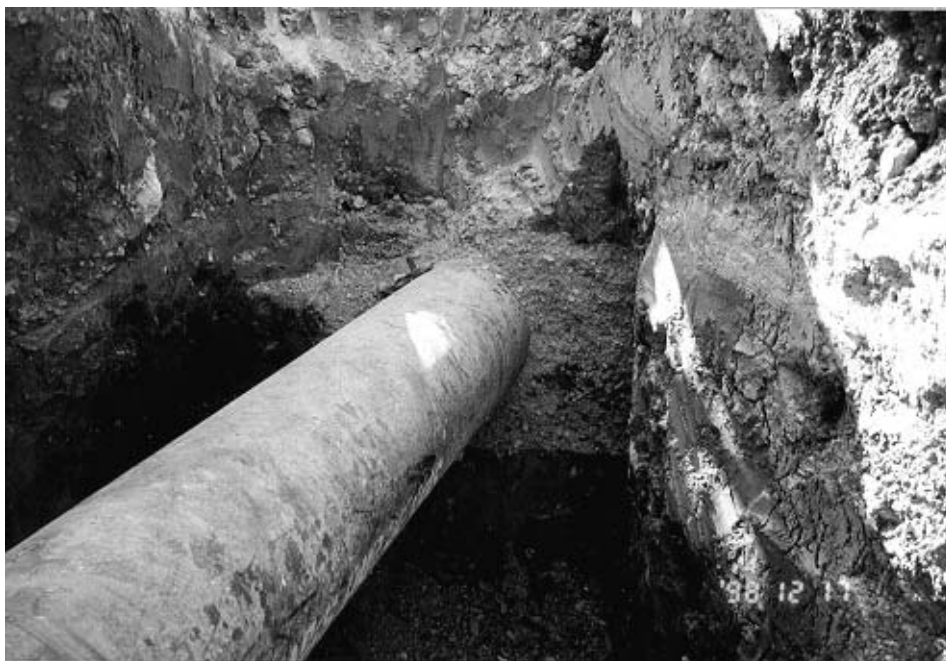
Plate 31 – View South Along 400 mm Diameter Water Main From Within WSD Trench Associated with Main Diversion Works. Note Granular Pipe Bedding Material and Layering in Fill Exposed in Sides of Excavation. (Photograph Taken on 17 December 1998)

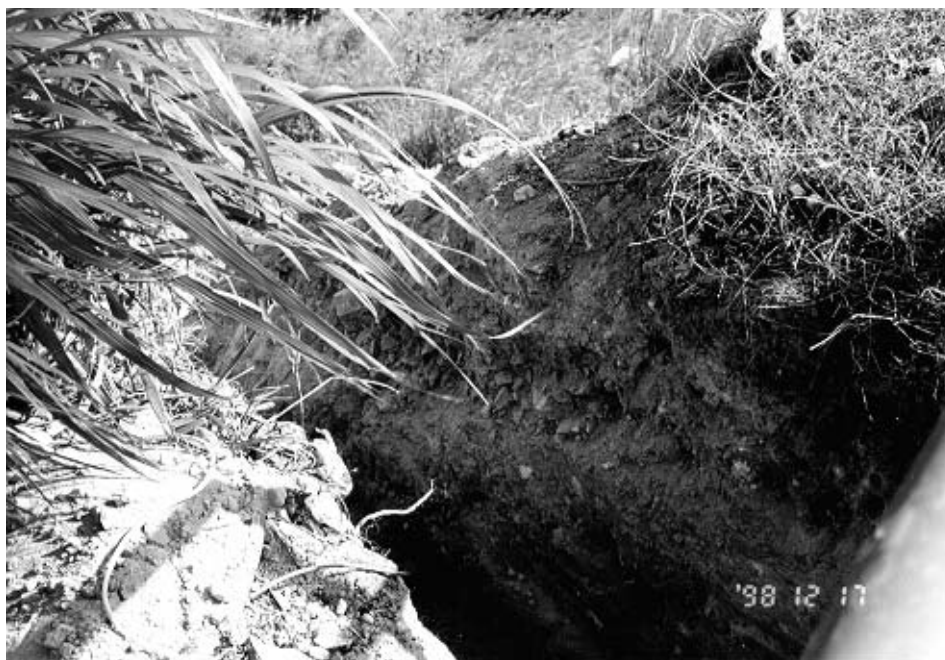
Plate 32 – View North-East Across WSD Trench Associated with Diversion Works for 400 mm Diameter Water Main Exposed in Landslide Scar. Note Variation and Layering in Fill Material Parallel to Slope Face. (Photograph Taken on 17 December 1998)
