**SECTION 3 :
DETAILED STUDY OF THE
LANDSLIDE AT A
PFA FILL SLOPE AT
SIU LANG SHUI,
TUEN MUN ON 9 JUNE 1998**

Fugro Scott Wilson Joint Venture

**This report was originally produced in October 1999
as GEO Landslide Study Report No. LSR 11/99**

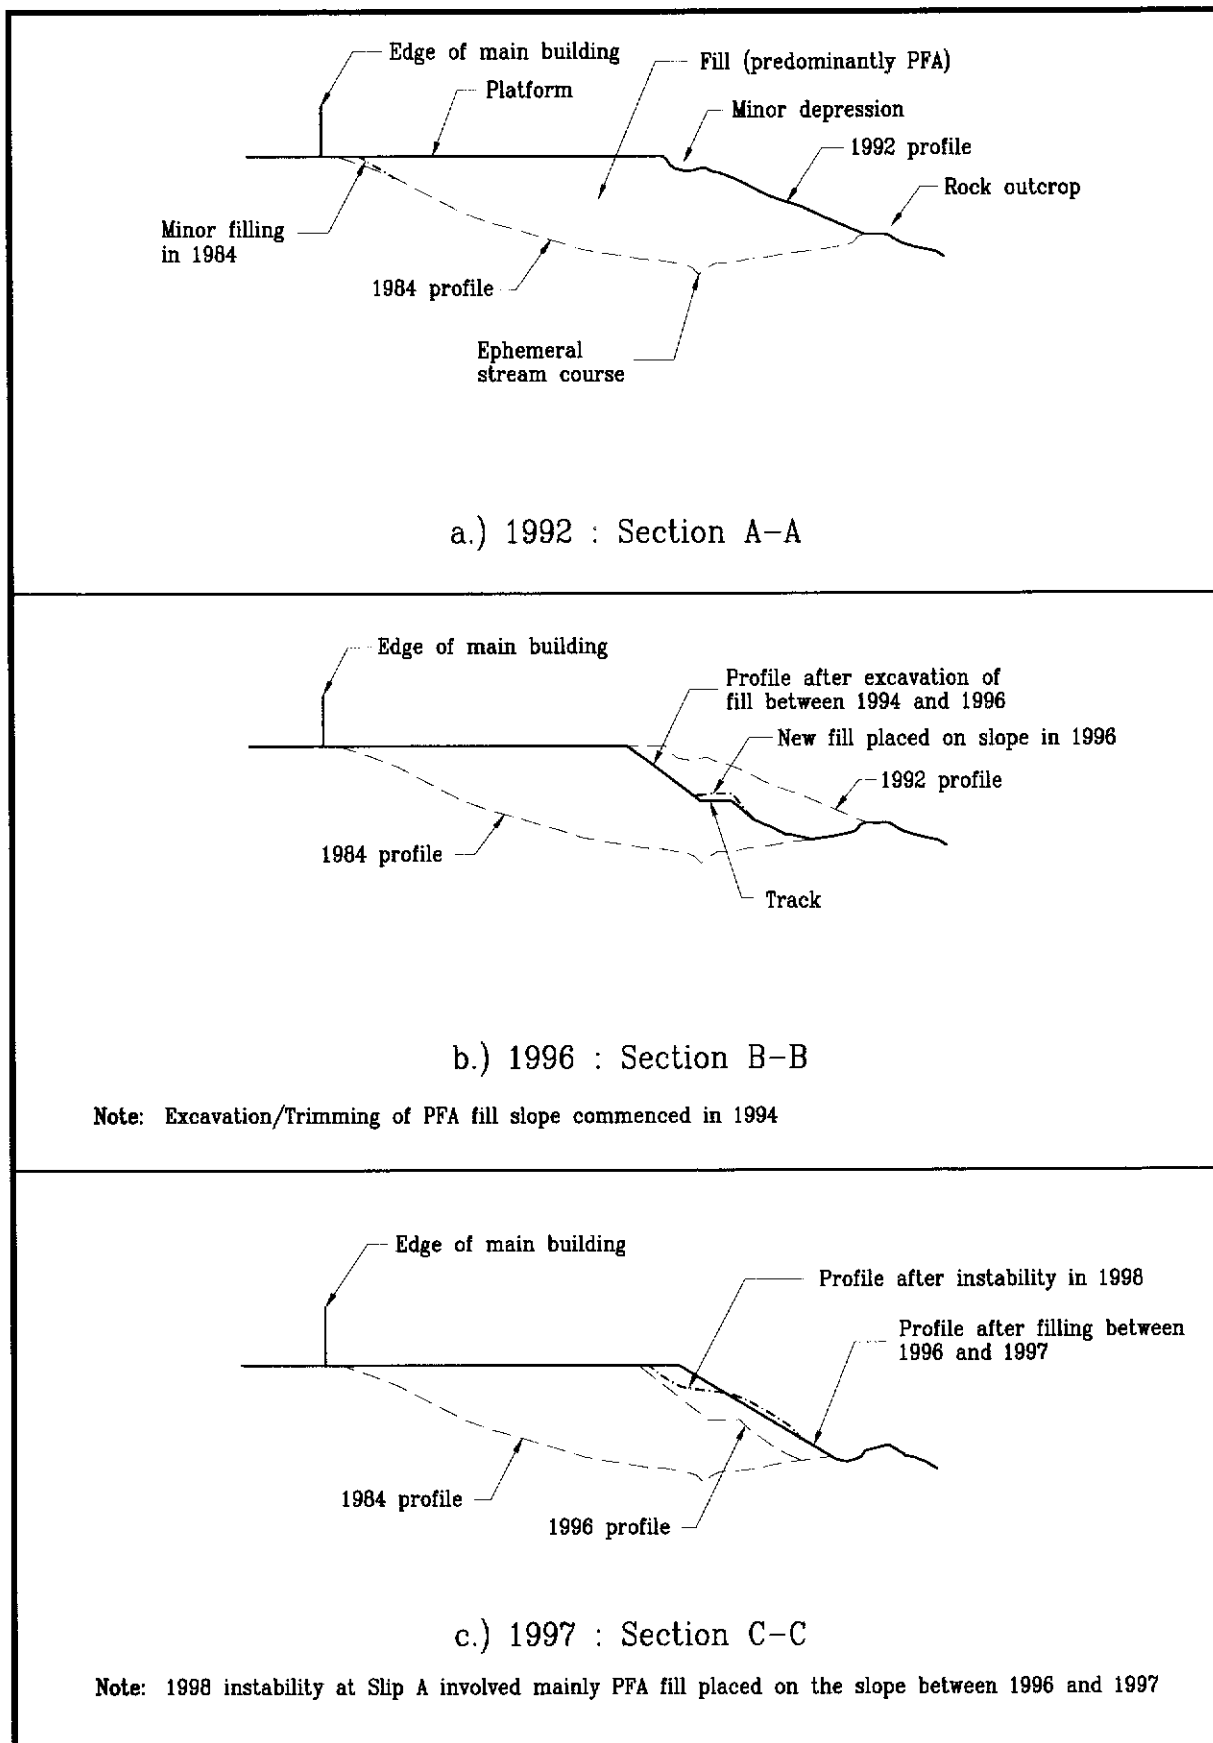
Figure 4 - Cross-sections through Landslide Slip A Location

The extent and profile of Slips A, B and C were determined by field inspection by FSW staff on 18 June 1998. The extent of the landsliding is shown in Figure 2, and a cross-section through the main landslide (i.e. Slip A) is given in Figure 4c. General views of the landslide site are shown in Plates 1 to 6.

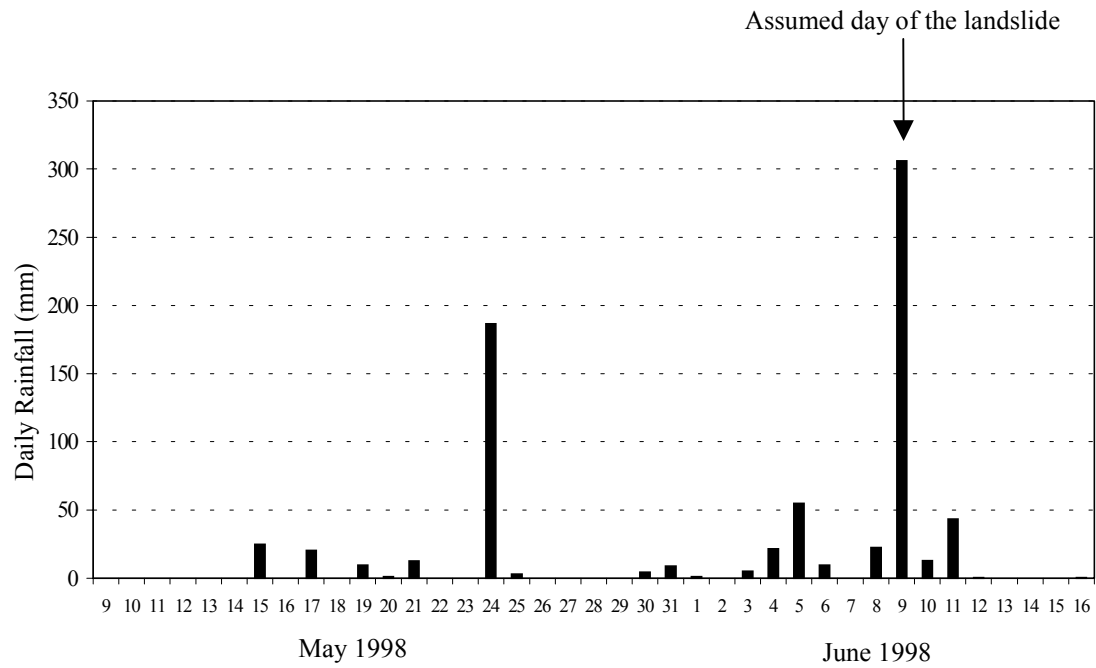
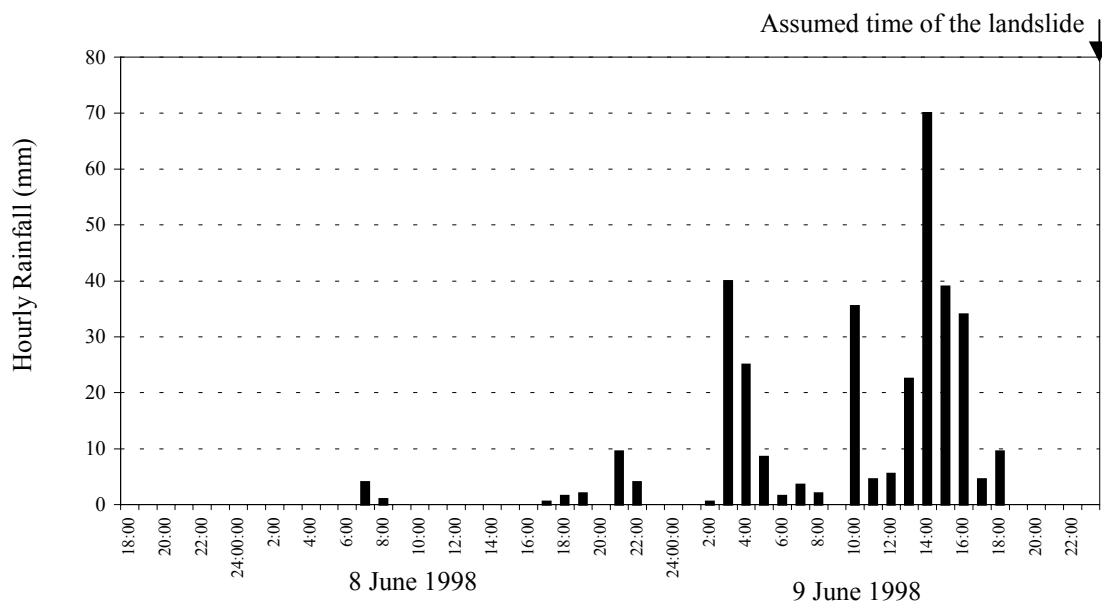
Figure 5 – Rainfall Records at GEO Raingauge No. N07

Daily rainfall for one month preceding the event, and seven days following the landslides, are shown in Figure 5, together with the hourly rainfall 48 hours before the landslides. The daily rainfall figure shows that the rain was concentrated around the day of 9 June 1998 (the presumed day of the landslide), with the hourly data indicating peaks from 03:00 to 05:00 hours, 10:00 to 11:00 hours and 13:00 to 17:00 hours ranging from about 40 mm/hr to 70 mm/hr.
