INVESTIGATION OF SOME SELECTED LANDSLIDES IN 1998 (VOLUME 3)

GEO REPORT No. 110

**SECTION 1 :
DETAILED STUDY OF THE
LANDSLIDE AT SUNNY VILLA,
218 CASTLE PEAK ROAD
ON 9 JUNE 1998**

**This report was originally produced in July 1999
as GEO Landslide Study Report No. LSR 3/99**

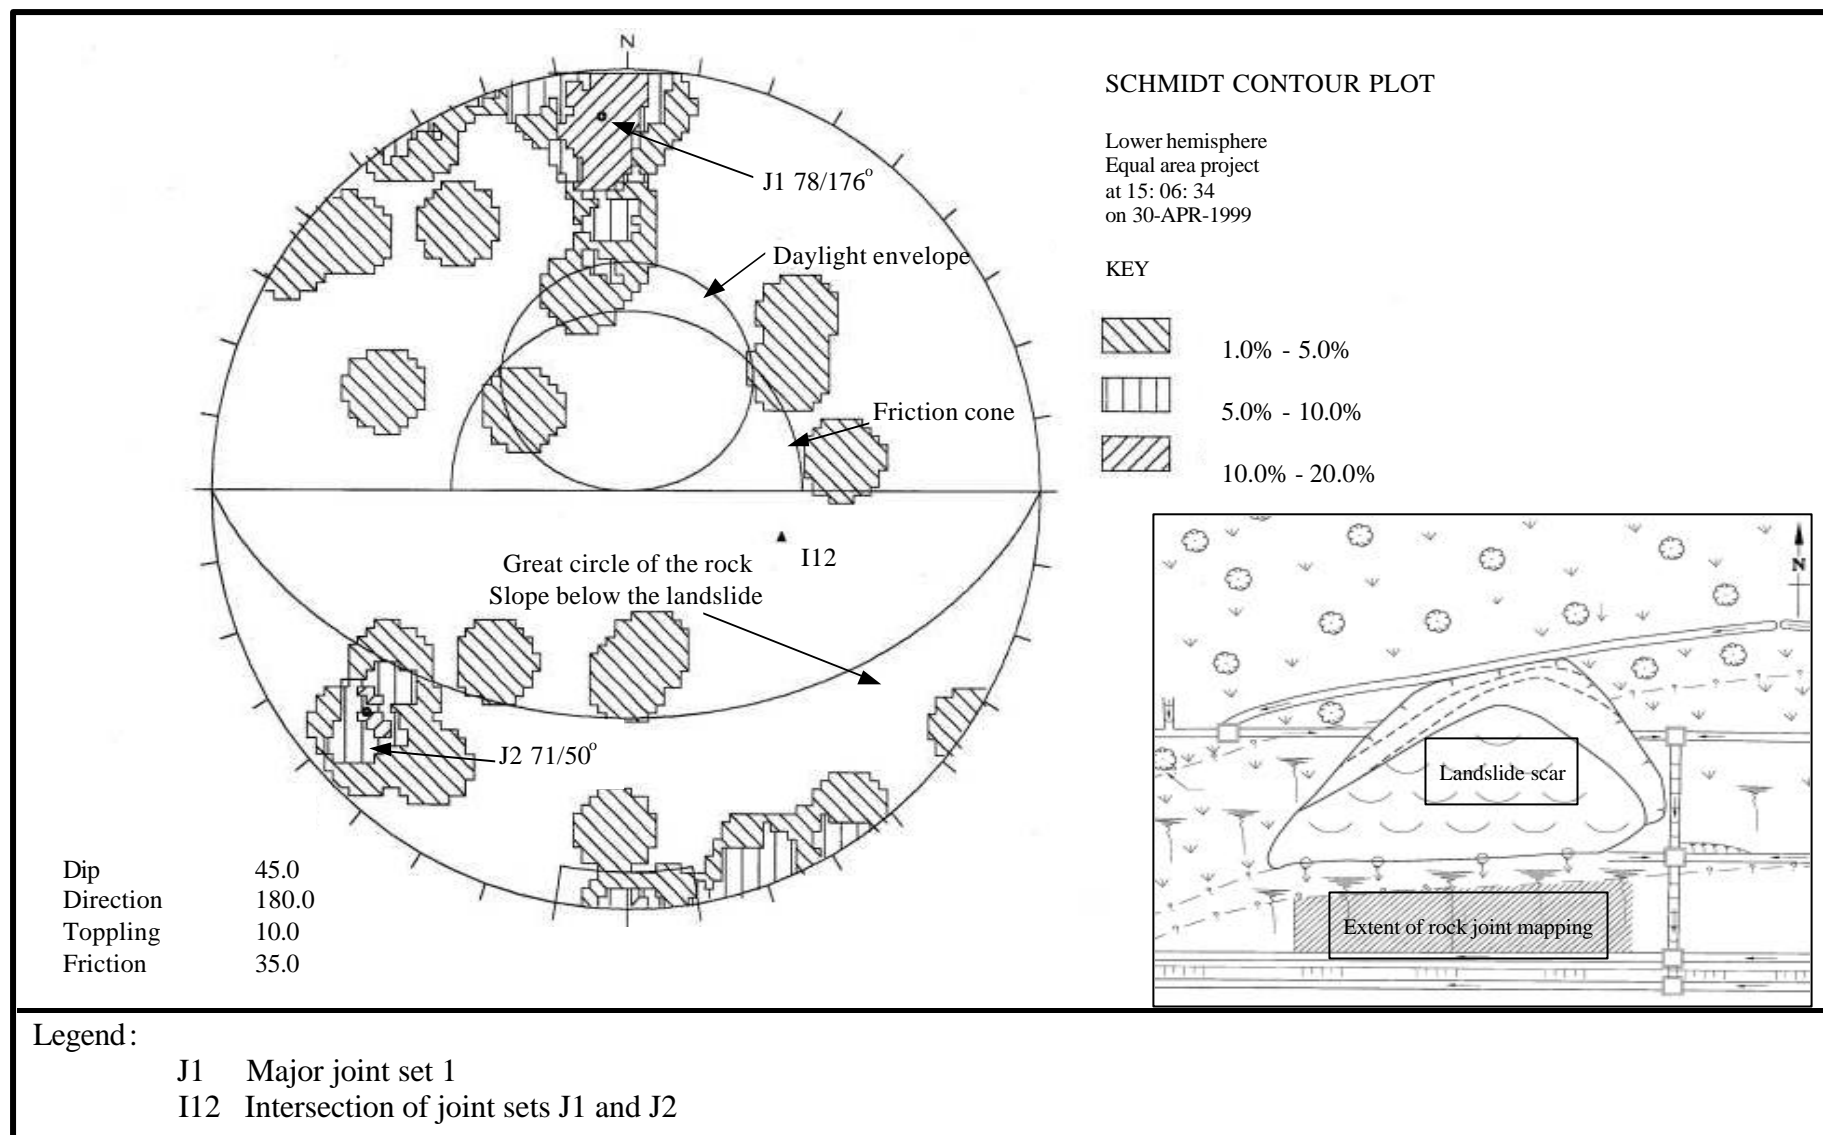
Figure 5 – Stereoplot of the Discontinuity Survey for the Exposed Rock Slope below the Landslide Scar

The landslide site consisted of a layer of colluvium comprising gravelly sandy clayey silt of about 1 m thick overlying completely to highly decomposed tuff comprising medium dense sandy clayey silt and silty sand with corestones of about 3 m thick, which in turn overlies moderately to slightly decomposed tuff. Two sets of relict joints were measured in the main scarp dipping at 18° and 85° towards 210° and 230° respectively. The joints were generally infilled with kaolin between about 2 mm and 5 mm thick (Plate 5). Joints of similar orientation were also measured on the rock cut slope below the landslide scar and the results are presented on Figure 5. However, no joints were observed in the western portion of the main scarp.

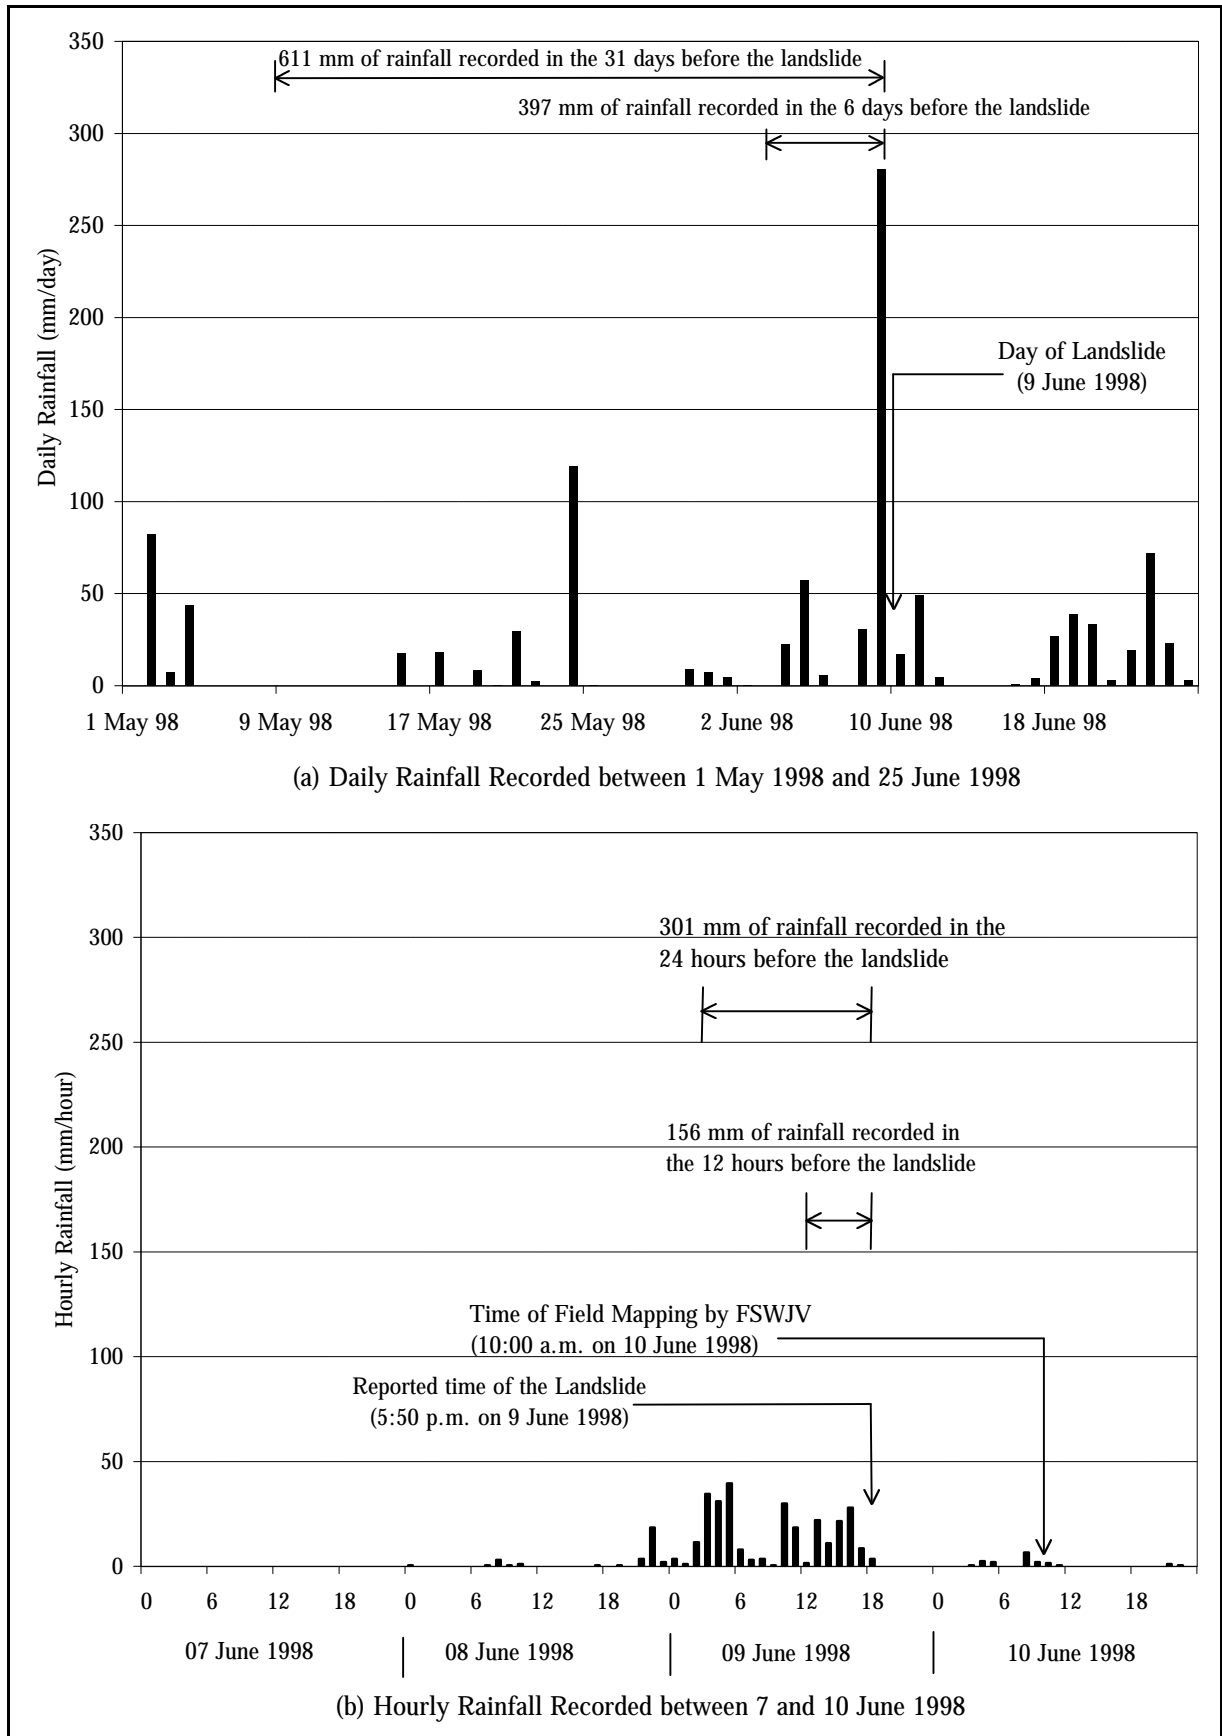
Figure 6 - Rainfall Records of GEO Raingauge No. N10

The nearest GEO automatic raingauge No. N10 is located at Emmanuel Primary School, about 3 km to the west of the landslide site (Figure 1). The daily rainfall between 1 May 1998 and 25 June 1998 is shown in Figure 6. A total of 611 mm of rainfall was recorded in the 31 days before the landslide.

Hourly rainfall between 7 June 1998 and 9 June 1998 is also presented in Figure 6. Rainfall was almost continuous from mid-night of 8 June 1998 to the time of the landslide. In this period, the average hourly rainfall was about 15 mm and the maximum hourly rainfall recorded was 40 mm between 4 a.m. and 5 a.m. on the day of the landslide. Table 1 presents the estimated return periods of maximum rolling rainfall recorded before the landslide for selected durations, based on historical rainfall data at the Hong Kong Observatory (Lam & Leung, 1994). The estimated return period for the 24-hour rainfall before the landslide was greatest, being about 5 years.

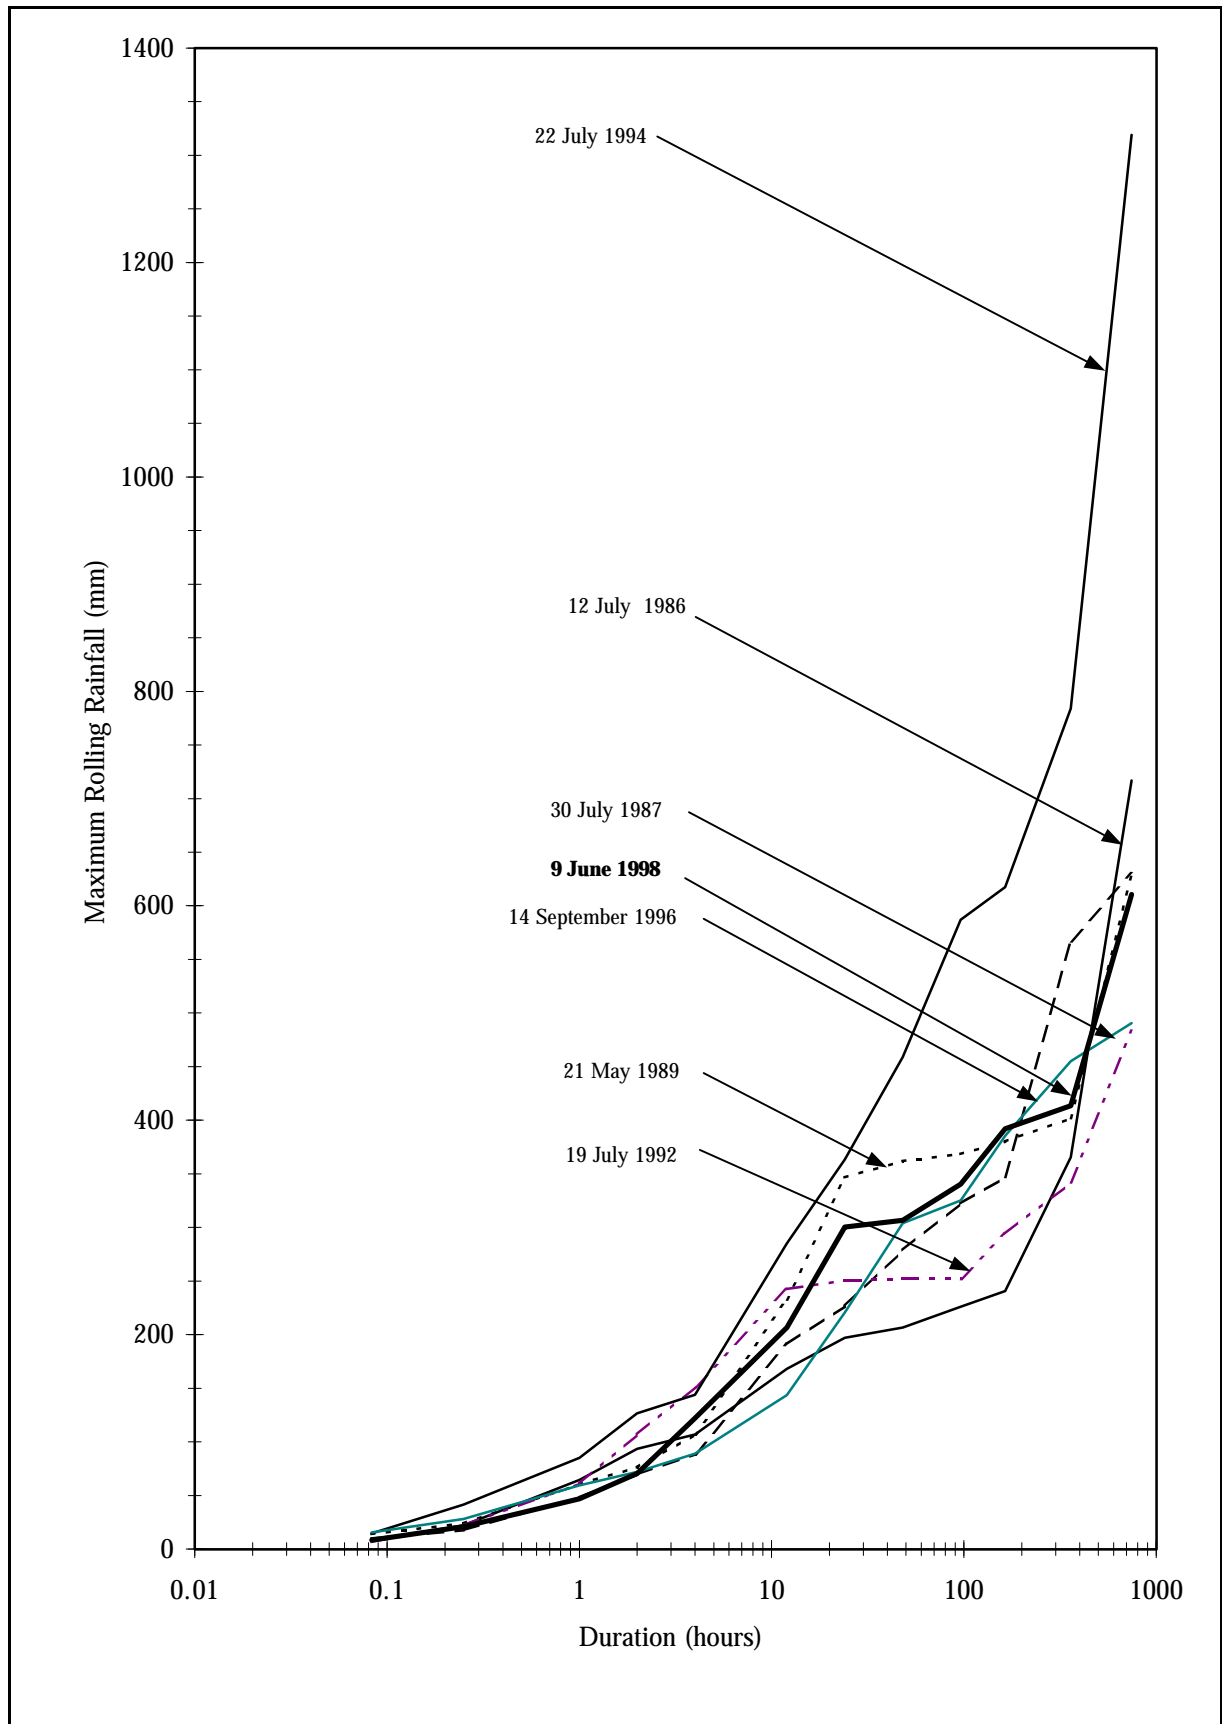
Figure 7 - Maximum Rolling Rainfalls at Raingauge No. N10 for Major Rainstorms

Figure 7 shows the maximum rolling rainfall recorded at GEO raingauge No. N10 during selected previous major rainstorms between 1 January 1984 and 9 June 1998. The rainfall preceding the 9 June 1998 landslide was not as severe as some of the previous rainstorms.

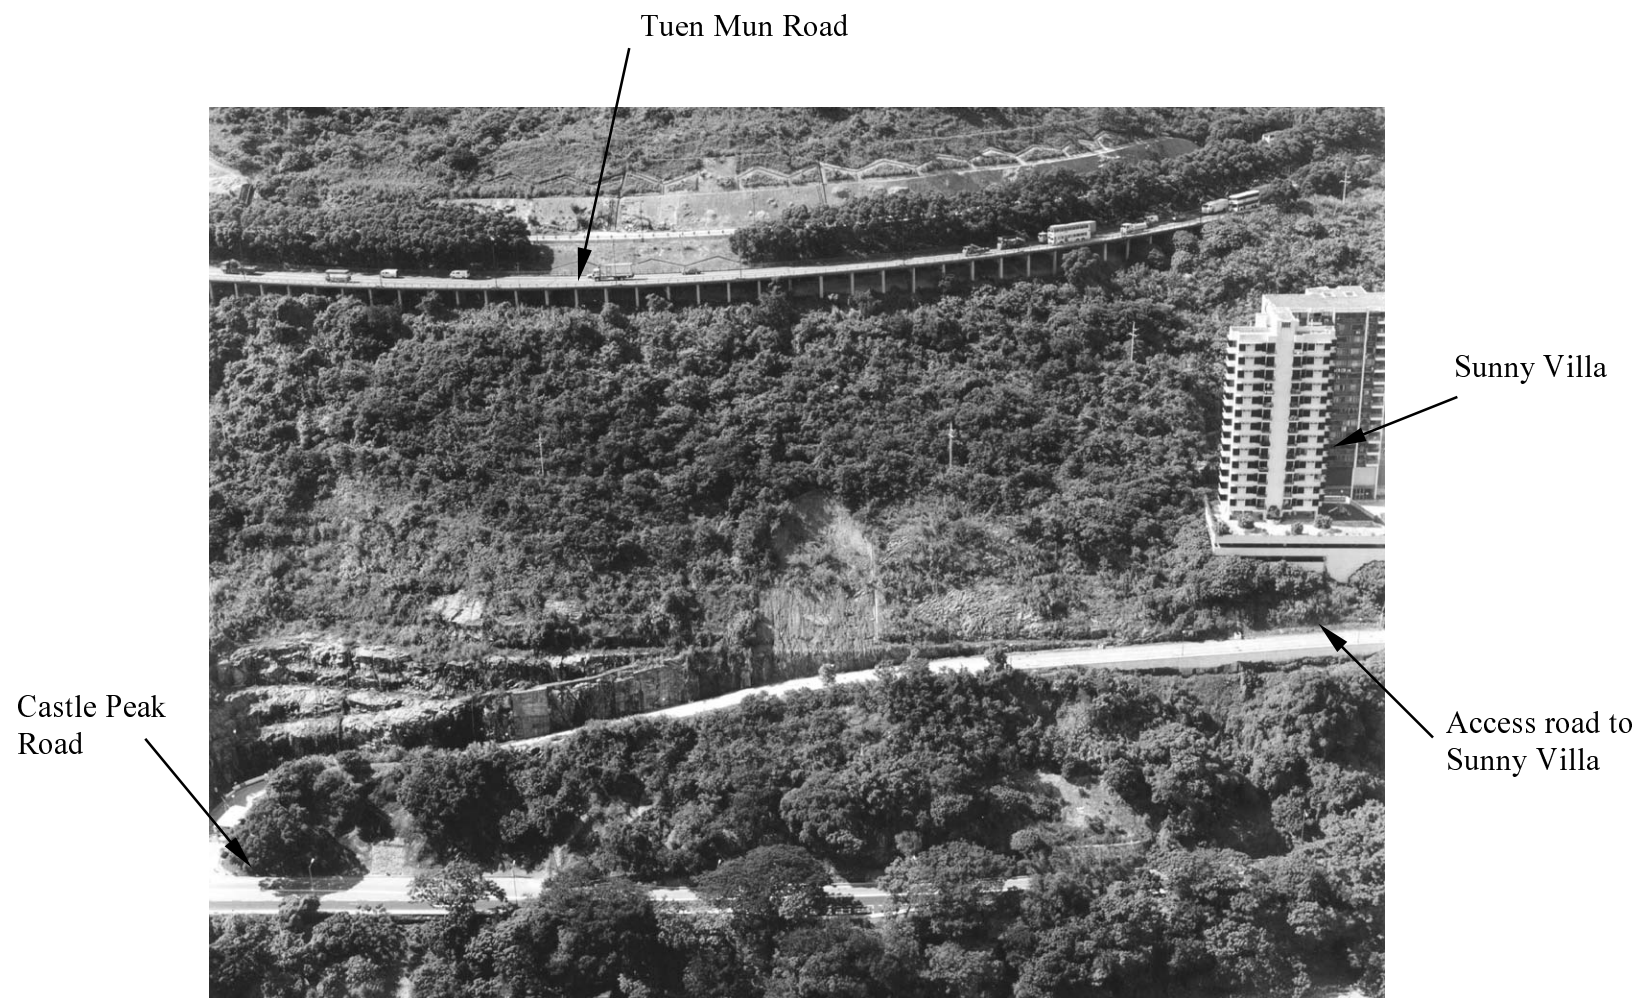
Plate 1 - General View of the Site
(Photograph taken on 29 June 1998)

FSW inspected the site on 10 June 1998, and subsequently in July, August and October 1998. The mapping results are shown on Figure 3. General views of the landslide site are shown in Plates 1 to 3.
