SECTION 2 : DETAILED STUDY OF THE LANDSLIDE AT FUNG WONG SERVICE RESERVOIR ON 9 JUNE 1998

Fugro Scott Wilson Joint Venture

**This report was originally produced in August 1999
as GEO Landslide Study Report No. LSR 5/99**

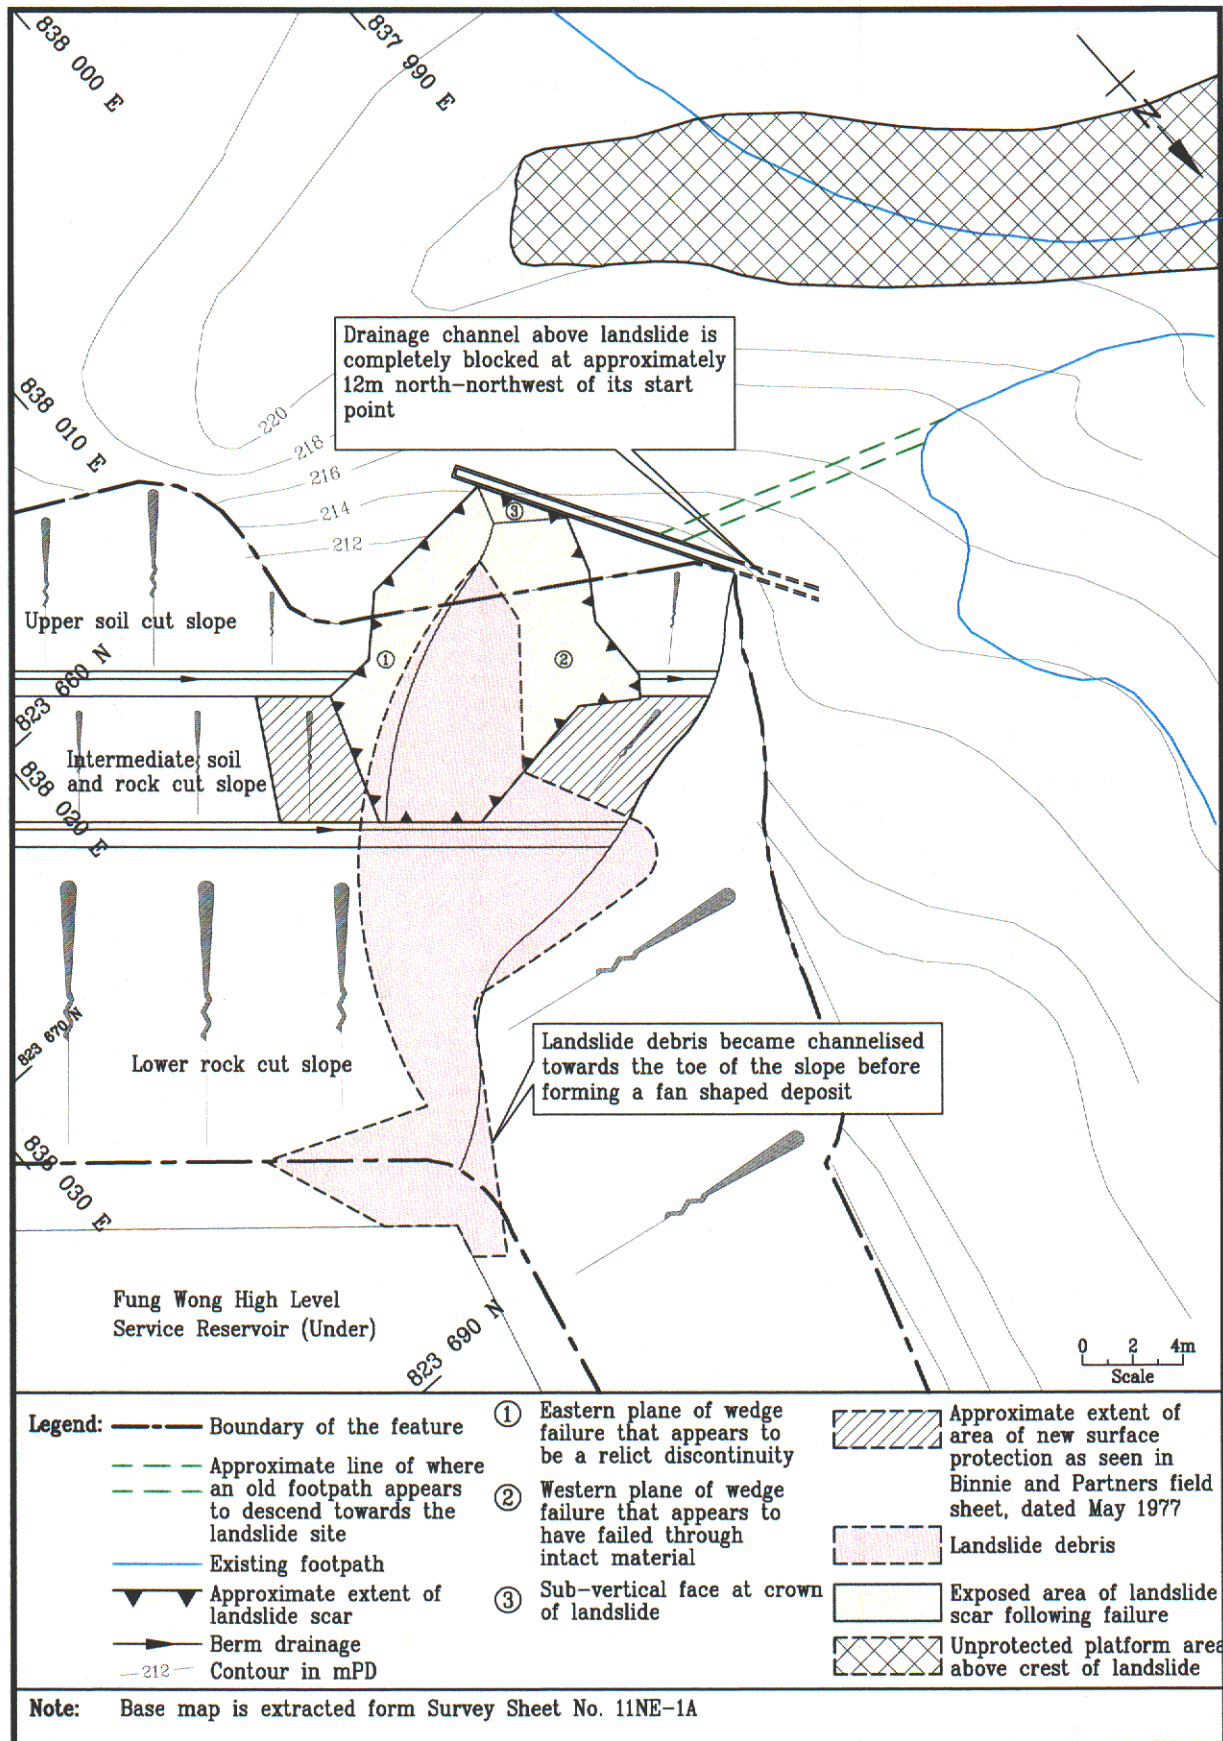
Figure 2 - Plan of the Landslide Site

A sub-vertical face trending roughly parallel with the crest channel formed the crown of the landslide (Plate 8 and Figure 2). This plane had a maximum depth of about 3 m and was roughly triangular in elevation.

It was also noted that an area of open ground has been formed along the ridgeline directly above the landslide, which based on API was formed some time between 1981 and 1982 (Figure 2 and Plate 12). This area has been levelled to form a platform about 30 m long by 5 m wide and is unprotected, being open to infiltration and could provide a source for rainwater runoff.

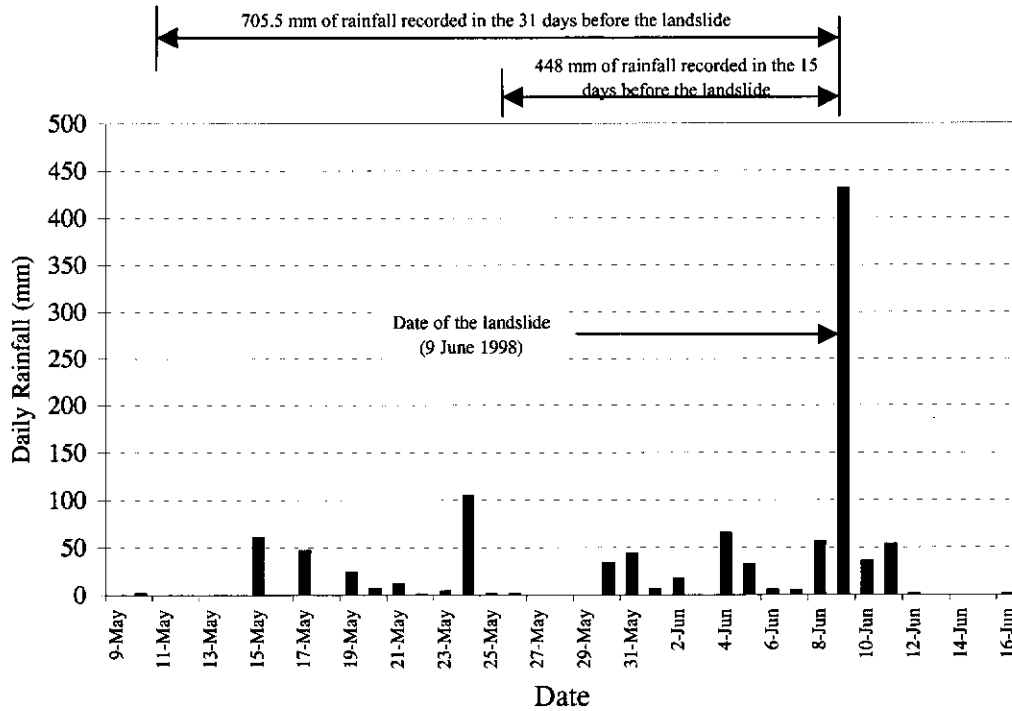
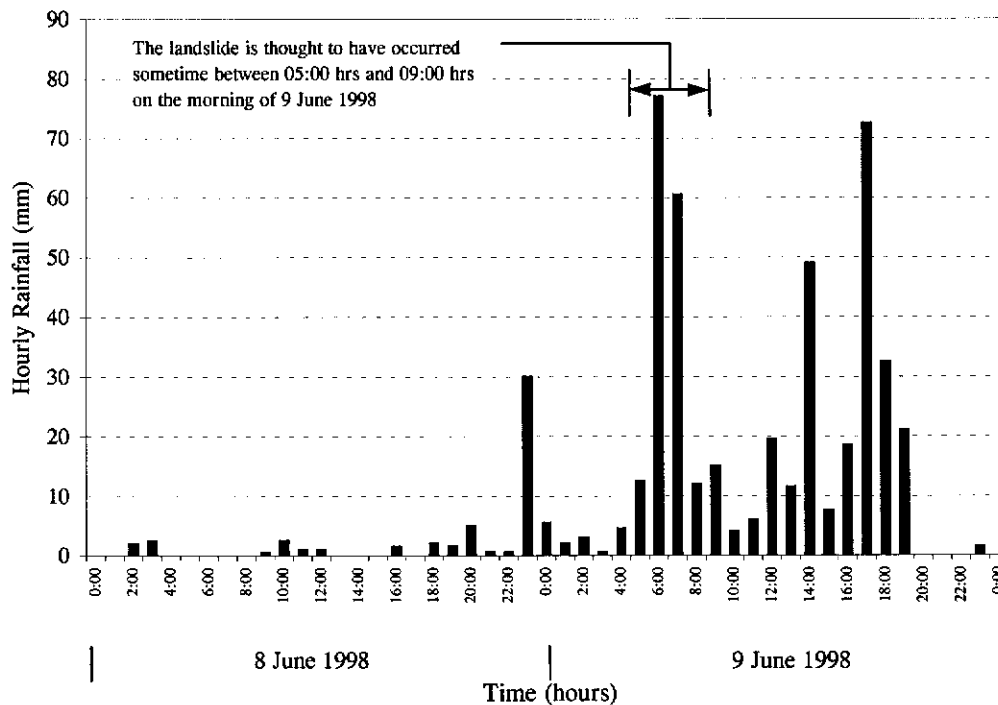
Figure 6 - Daily and Hourly Rainfall Recorded at GEO Raingauge No. K07

The daily rainfalls recorded by the raingauge in May and June 1998, together with the hourly rainfalls from 8 to 9 June 1998, are shown in Figure 6. The storm was concentrated around the day of 9 June 1998, with particularly heavy rainfall experienced in the morning between 05:30 hrs and 09:30 hrs.

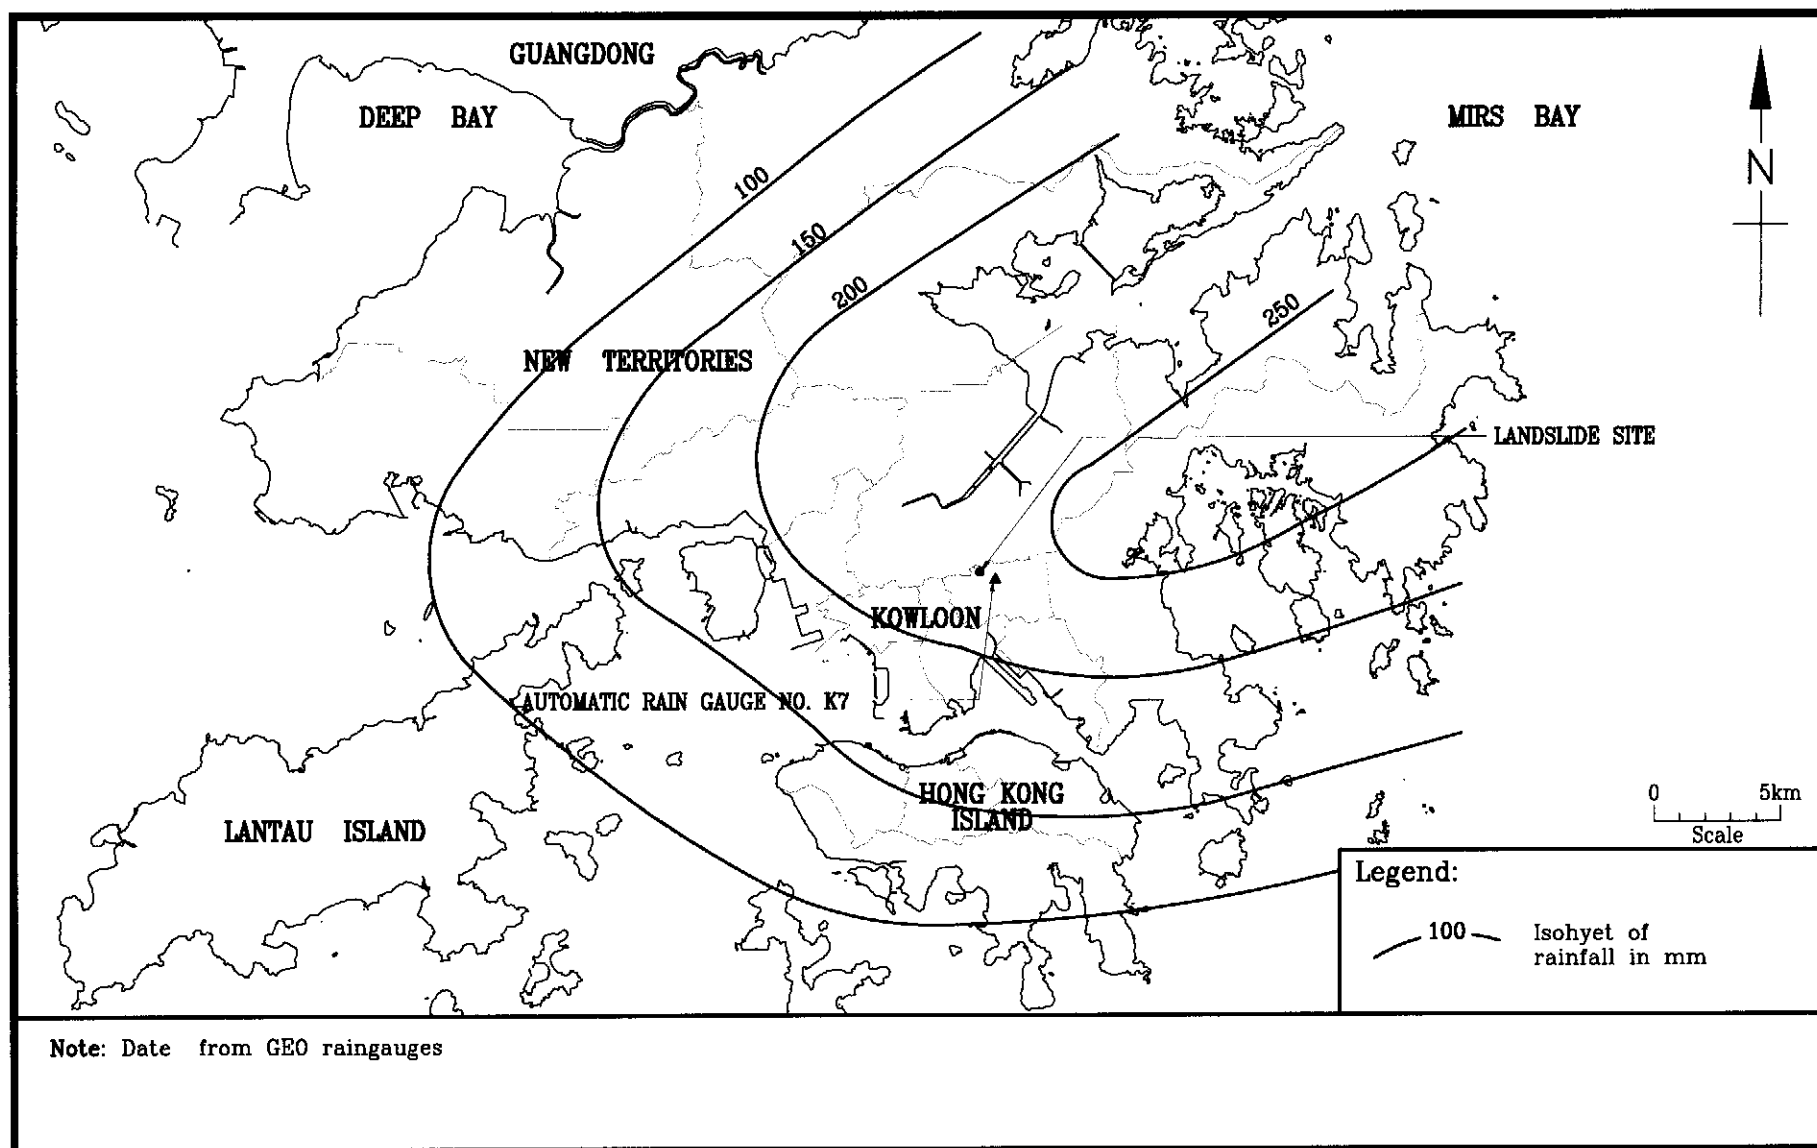
Figure 7 - Isohyet of 24-hour Rainfall Prior to the Landslide

Isohyets of rainfall for the 24-hour period prior to the first sighting of the landslide (09:00 hrs on 9 June 1998) for the whole of the SAR are shown on Figure 7.

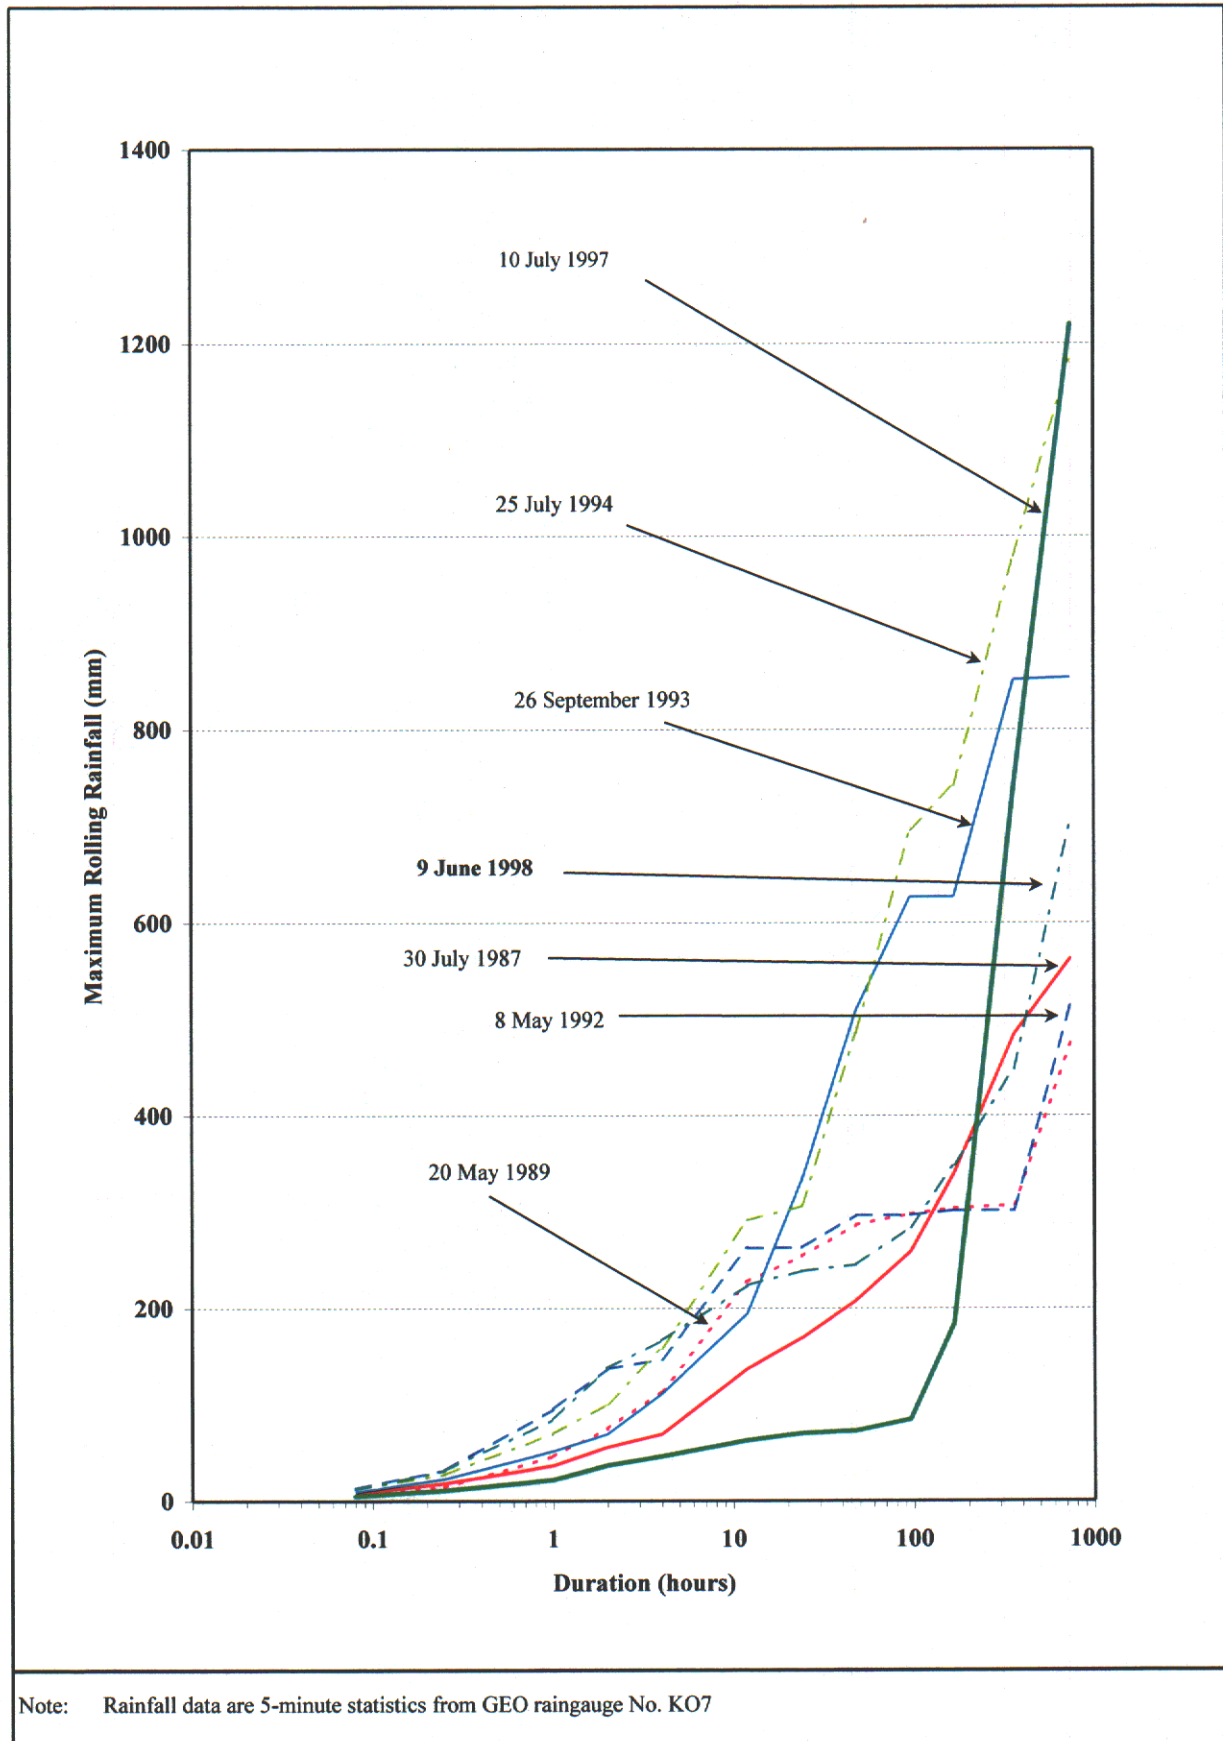
Figure 8 - Maximum Rolling Rainfall at GEO Raingauge No. K07 for Major Rainstorms

A comparison of the patterns of previous heavy rainstorms affecting the landslide site is shown in Figure 8. Although only slightly greater than previous events, it is evident that the rolling rainfall for a period up to 4 hours preceding the current landslide was the most severe of that experienced by the area since installation of raingauge No. K07 in 1983. However, given that the slope was formed before 1963, the 9 June 1998 rainstorm, which was only moderately heavy, may not be the most intense in the history of the slope.

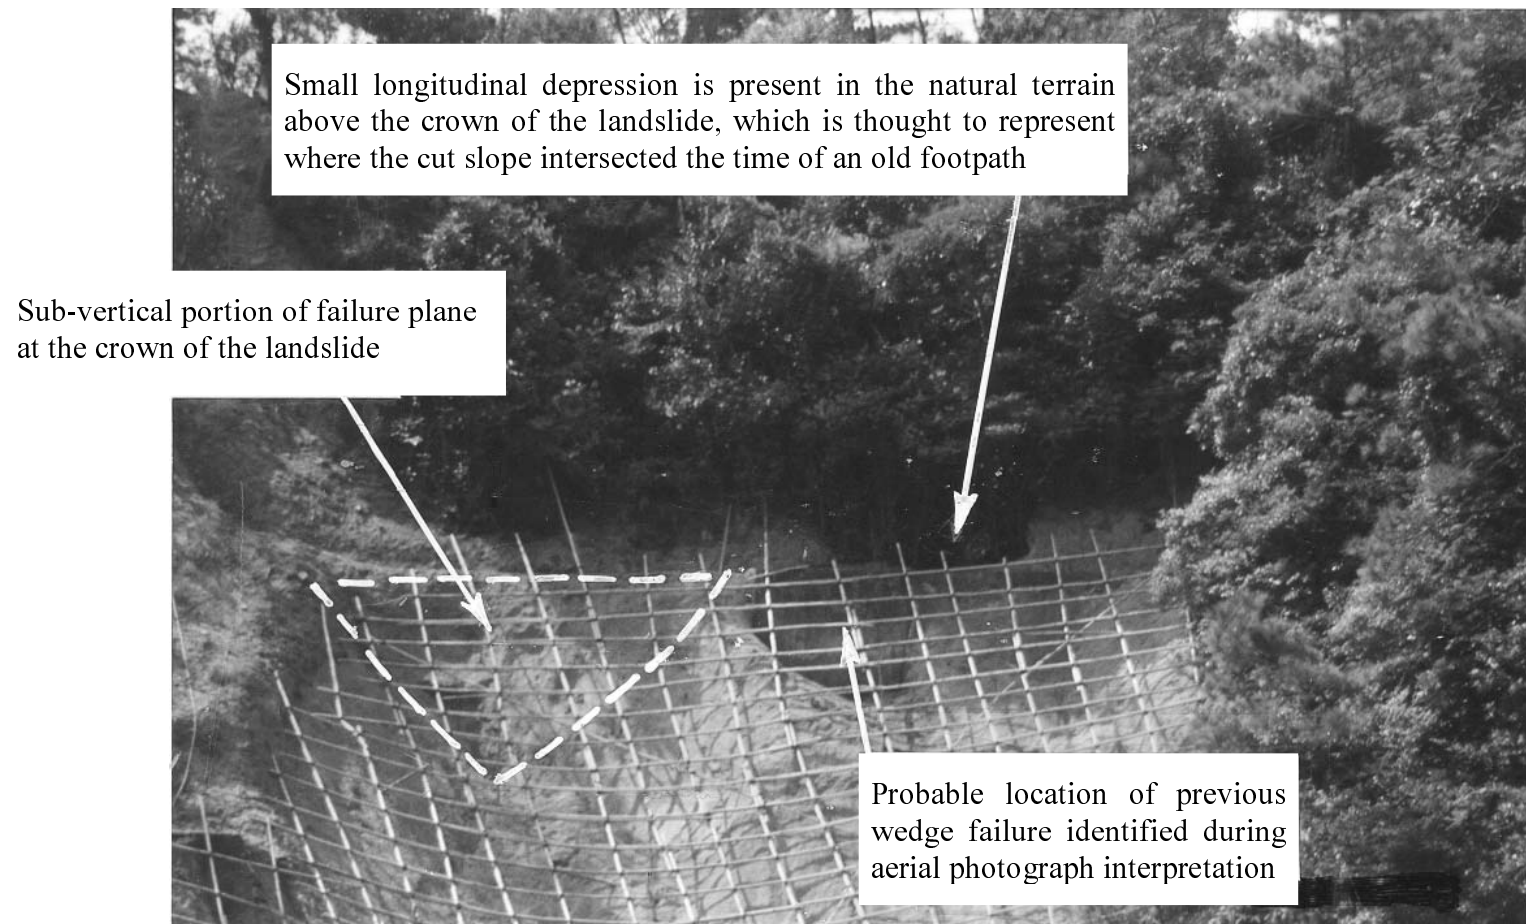
Plate 8 – View of the Upper Portion of the Failure Following Clearance Works
(Photograph taken on 14 October 1998)

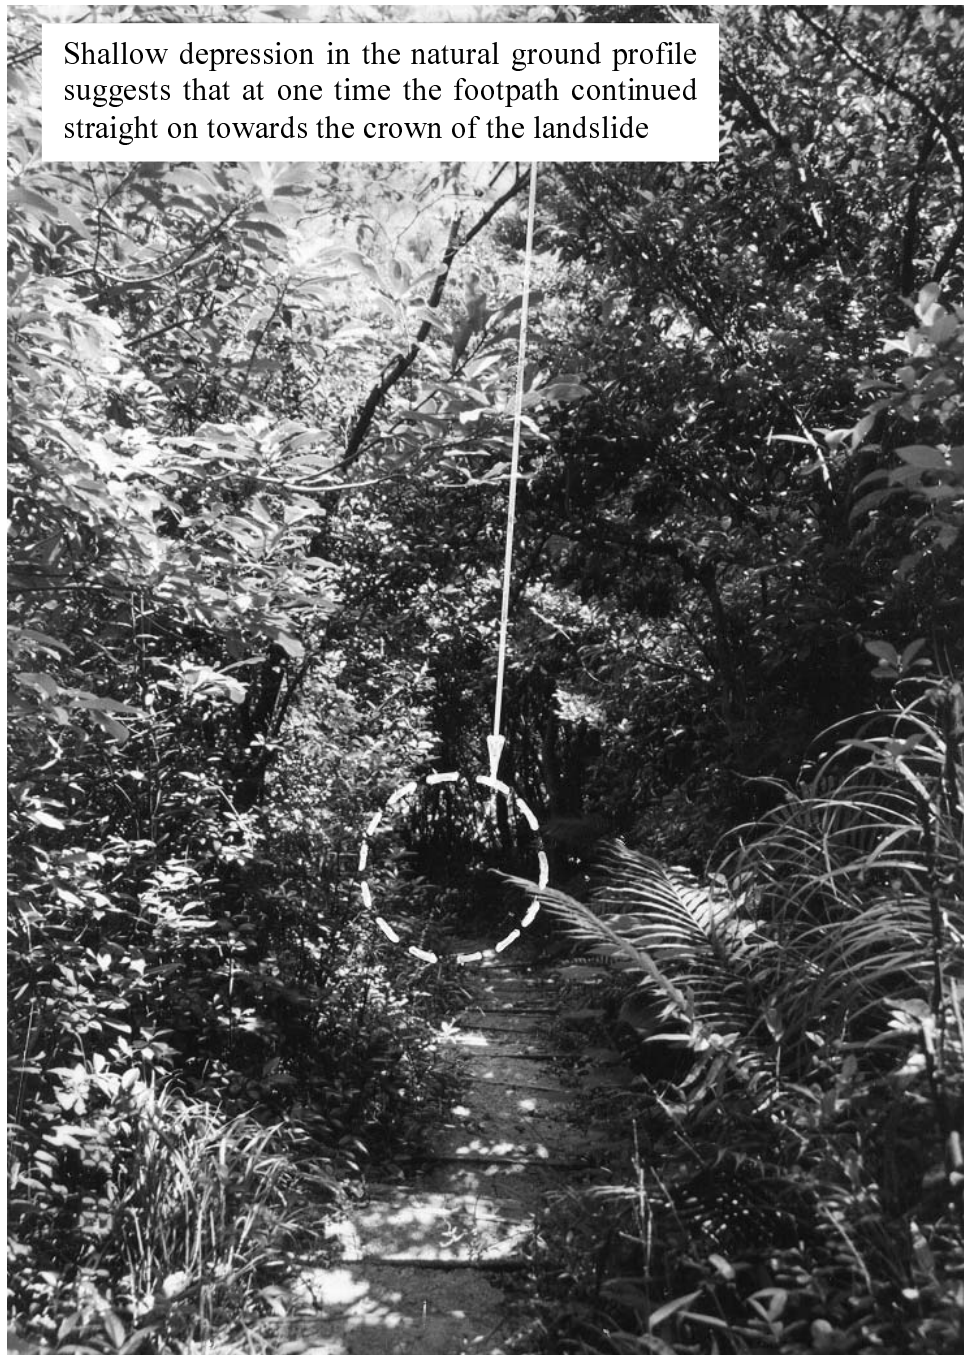
Plate 9 – View of Existing Footpath that Descends from the Ridgeline
(Photograph taken on 12 October 1998)

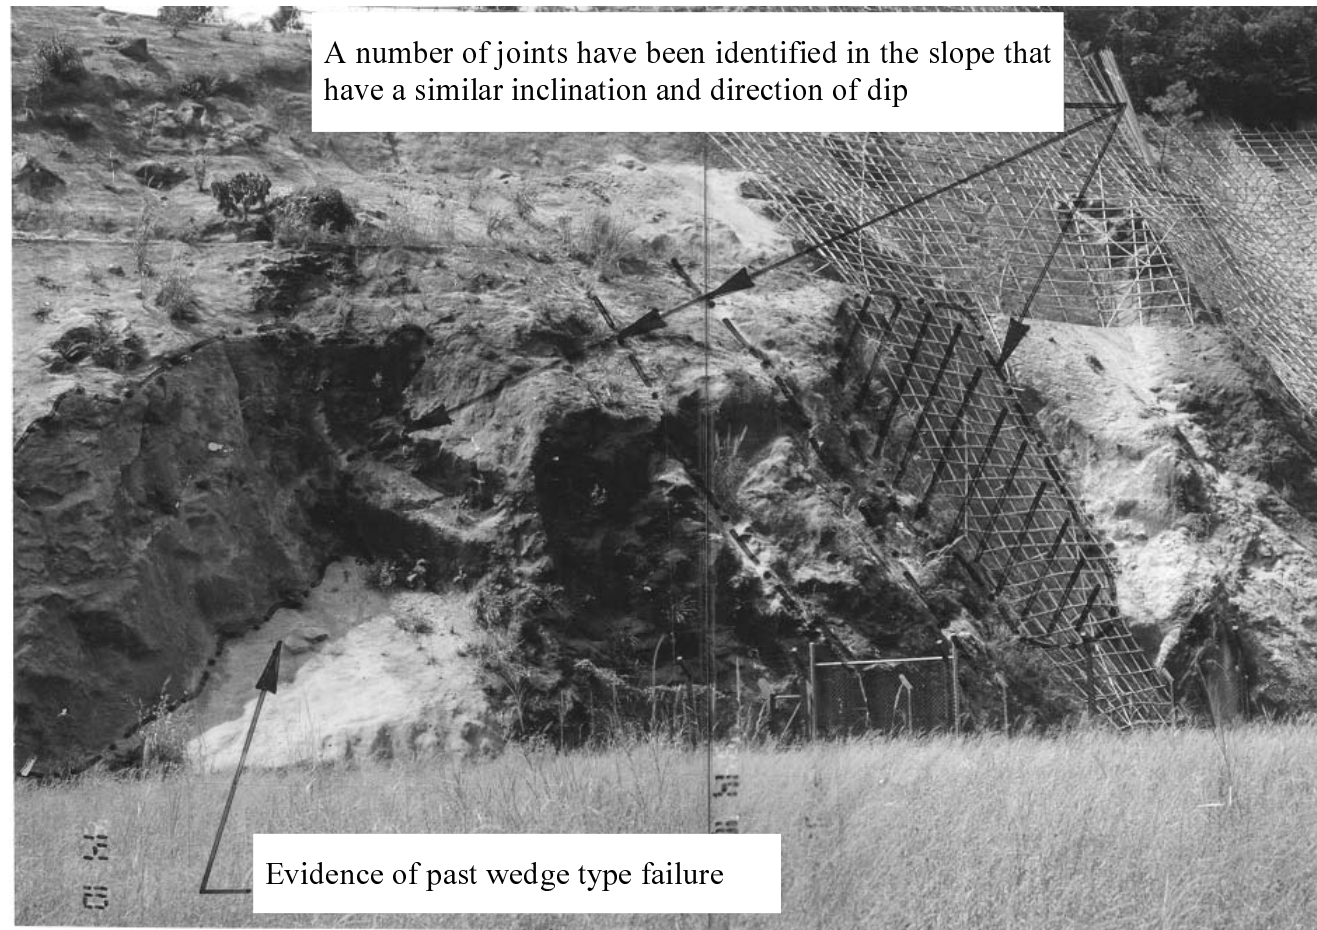
Mapping of the remaining portion of the southern cut slope revealed discontinuity surfaces dipping in a similar direction and at a similar angle to that of the relict discontinuity exposed in the failure scar (Figure 5 and Table 1). These discontinuities occurred at regular intervals along the southern slope portion in both soil and rock slope portions (Plates 13 and 14), and were typically widely to very widely spaced. One such discontinuity forms a prominent exposure in the lower batter (Figure 5). It is thought that these discontinuities probably represent sheeting joints, possibly formed following erosion of surface material over the years. Along the soil slope portion of the southern cut slope the surface of the discontinuities inspected were found to be infilled with kaolin, which in places was about 2 mm to 3 mm thick. Furthermore, there was evidence of slickensiding along one of these discontinuities that dipped steeply into the slope in a southwesterly direction (Plate 15).

Plate 13 – General View of the Southern Portion of the Cut Slope
(Photograph taken on 14 October 1998)
