SECTION 3 : DETAILED STUDY OF THE LANDSLIDE AT YUE SUN GARDEN, WO MEI ON 9 JUNE 1998

Fugro Scott Wilson Joint Venture

**This report was originally produced in October 1999
as GEO Landslide Study Report No. LSR 8/99**

This report presents the findings of a detailed study of the landslides (GEO Incident No. ME 98/6/36) that occurred within the L-shaped cut slope No. 11NE-B/C513 at Yue Sun Garden, Wo Mei, adjacent to Hiram's Highway near Sai Kung on 9 June 1998. Three landslide incidents occurred within the main southwest-facing slope of the feature and involved the failure of approximately 50 m of the slope. The resulting debris, estimated at a total volume of about 1,350 m³, inundated part of the garden nursery below, damaging a storage building, which is within a licensed area. No fatalities or injuries were reported following the landslide.

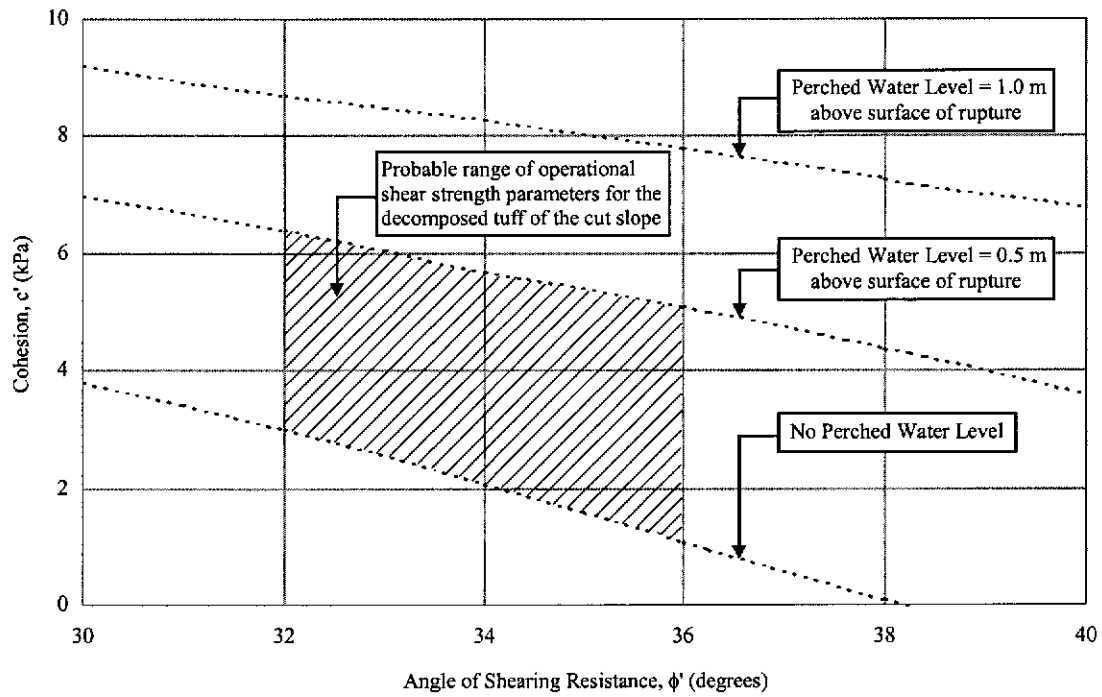
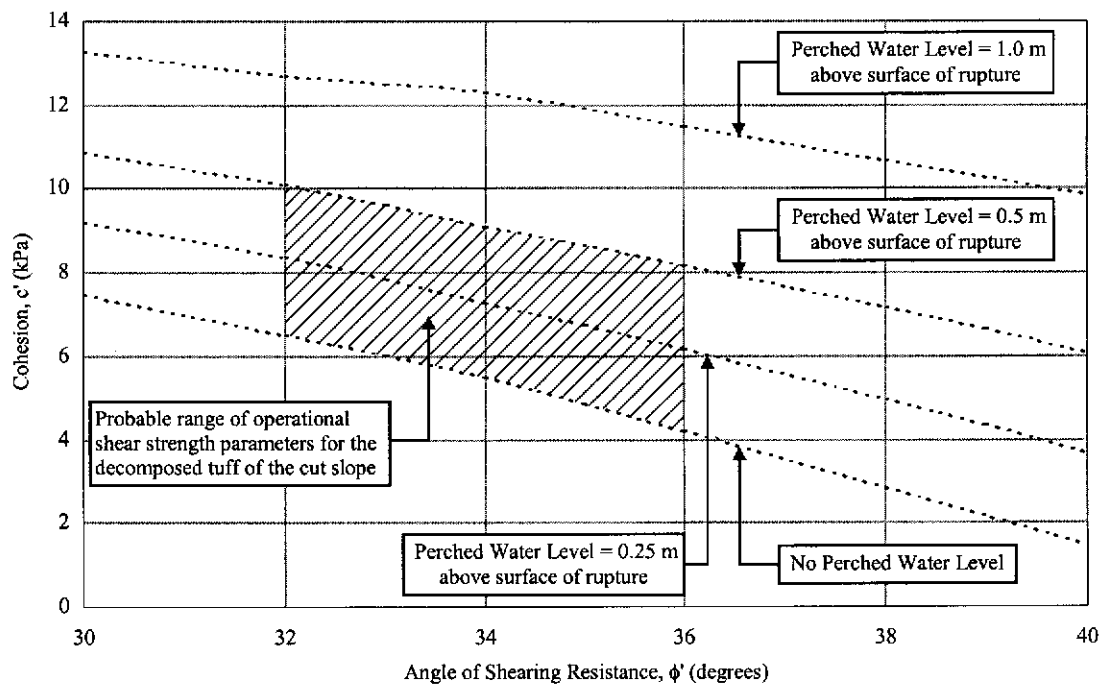
Figure 18 – Results of Sensitivity Analyses

(a) Sensitivity Analyses for the First Failure

(b) Sensitivity Analyses for the Second Failure
