INVESTIGATION OF SOME SELECTED LANDSLIDES IN 1998 (VOLUME 4)

GEO REPORT No. 111

SECTION 1 : DETAILED STUDY OF THE LANDSLIDE AT THE HONG KONG STADIUM ON 24 MAY 1998

This report presents the findings of a detailed study of the landslide (GEO Incident No. HK 98/5/2) that occurred on the northeast-facing slopes bounding the Hong Kong Stadium on 24 May 1998. Debris from the landslide was deposited primarily onto the stadium perimeter access road below although some debris was also noted on the adjacent Level 3 podium of the stadium. No fatalities or injuries were reported following the landslide.

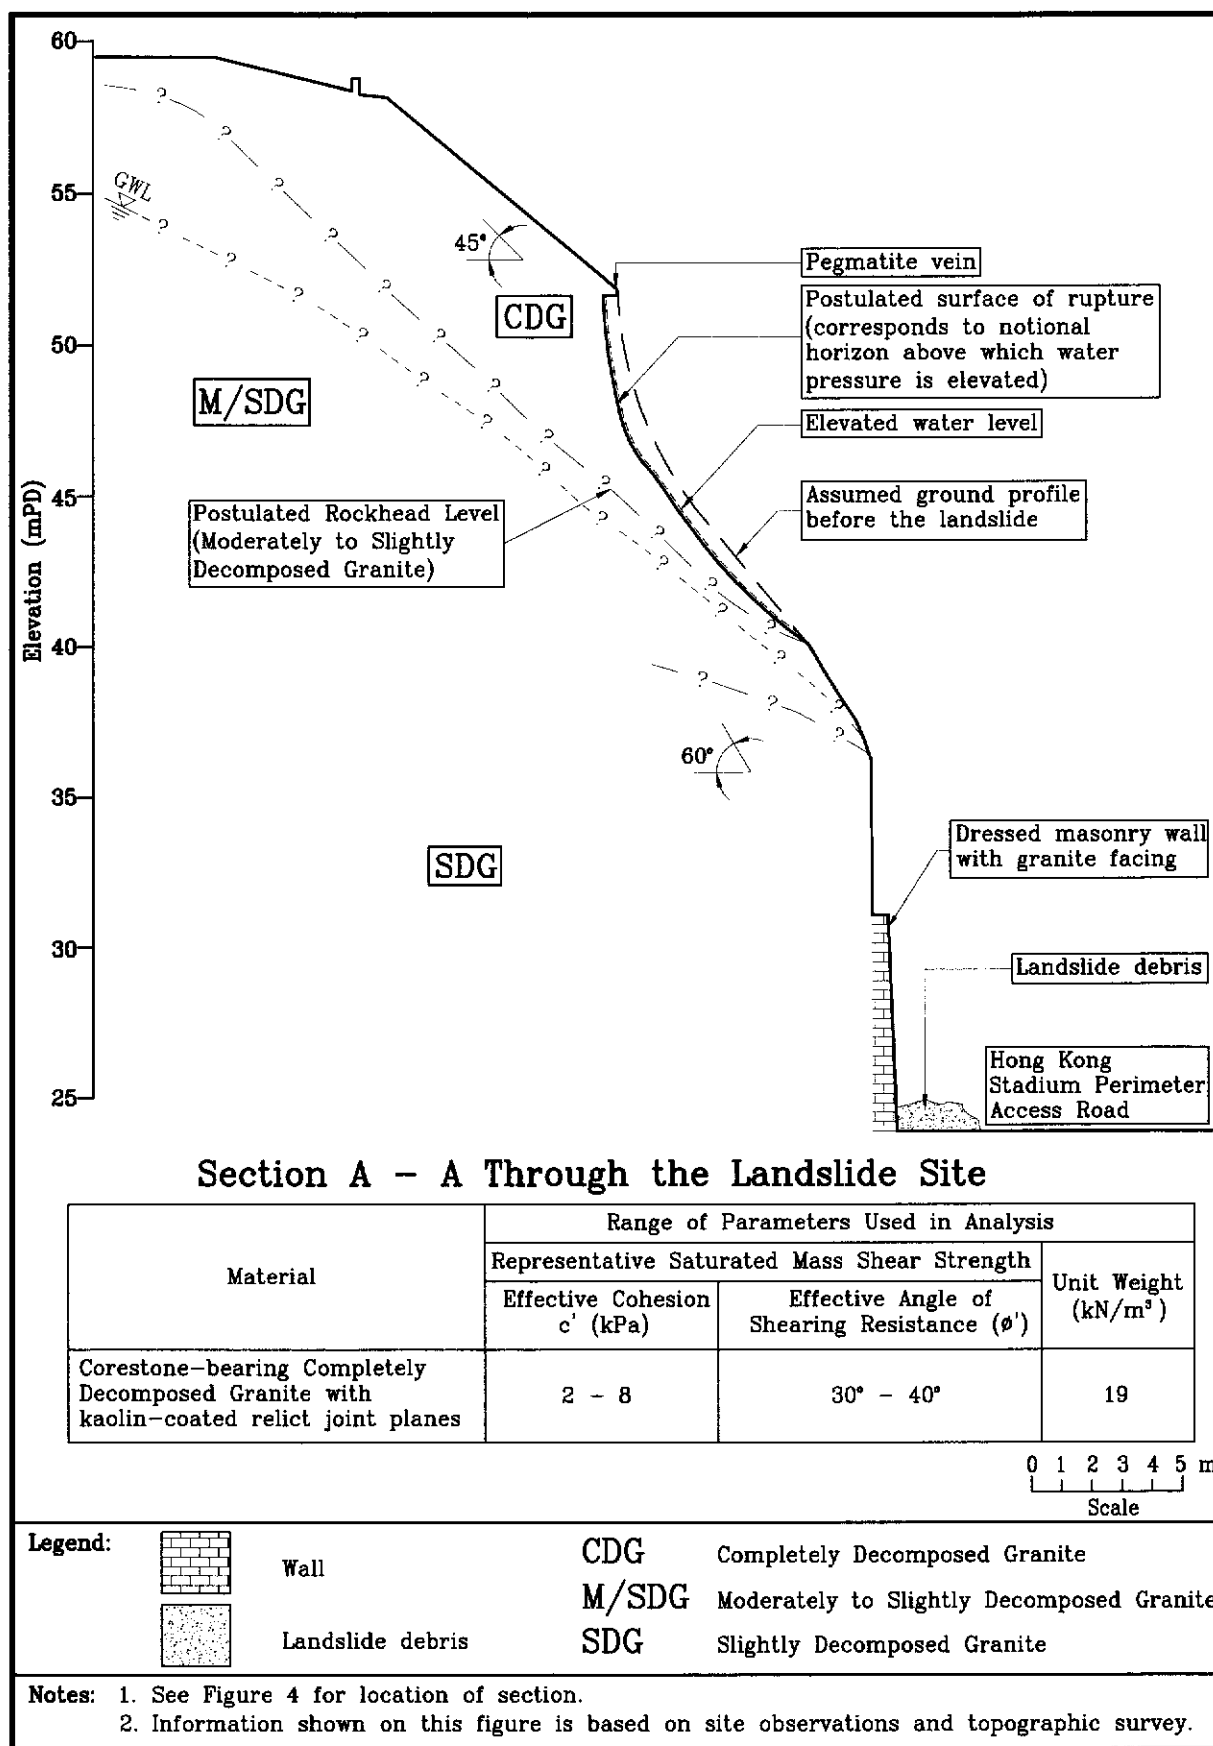
Figure 9 - Representative Cross-section of the Landslide for Theoretical Stability Analyses

The results of the stability analyses are summarised in Figure 10. The presence of an adversely orientated, locally kaolin-coated, relict joint plane, which partly controlled the failure, suggests that the likely operational value of c' along the observed surface of rupture was relatively low. Given this, it is also likely that a relatively modest increase in water pressure would have been sufficient to initiate failure.

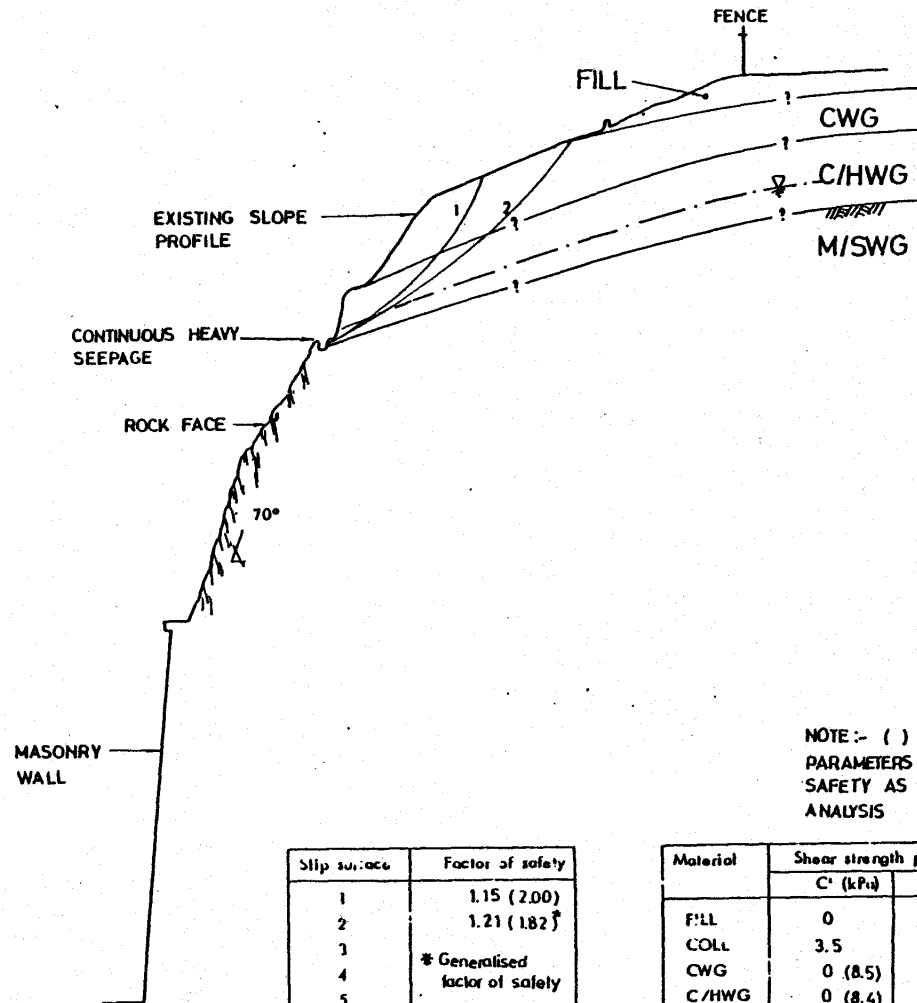
Slip surface	Factor of safety
1	1.15 (2.00)
2	1.21 (1.82)
3	* Generalised factor of safety
4	
5

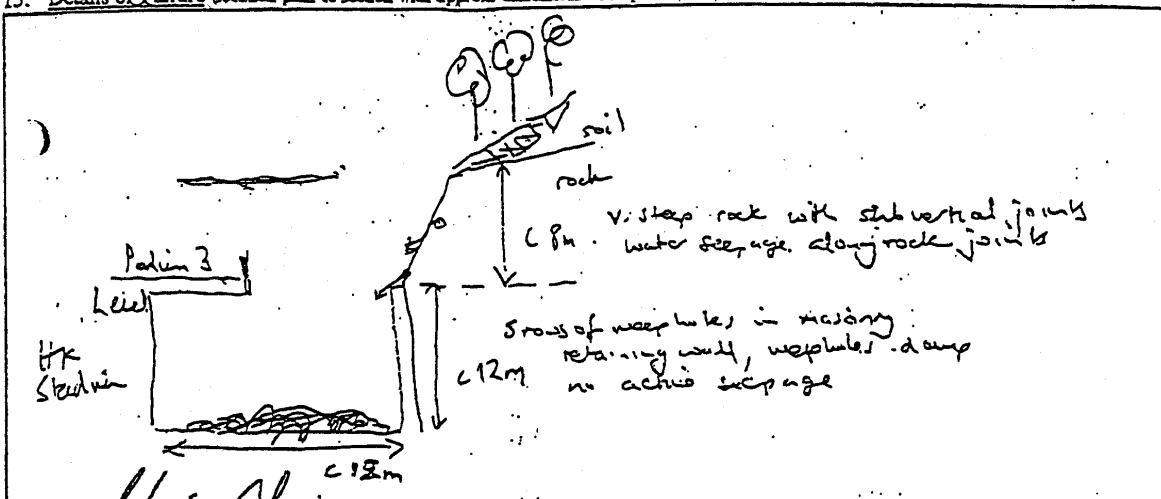
14. Is Landslip Record Card Required: ☐ Yes (for debris vol. > 50 m³ or involving death)
15. Details of Failure (location plan & section with approx. dimensions of slope height, gradients, depth of failure, debris run out etc.)
