**SECTION 2 :
DETAILED STUDY OF THE
LANDSLIDES AT THE
JUNCTION OF SAI SHA ROAD
AND TAI MONG TSAI ROAD
IN JUNE 1998**

Fugro Scott Wilson Joint Venture

**This report was originally produced in November 1999
as GEO Landslide Study Report No. LSR 13/99**

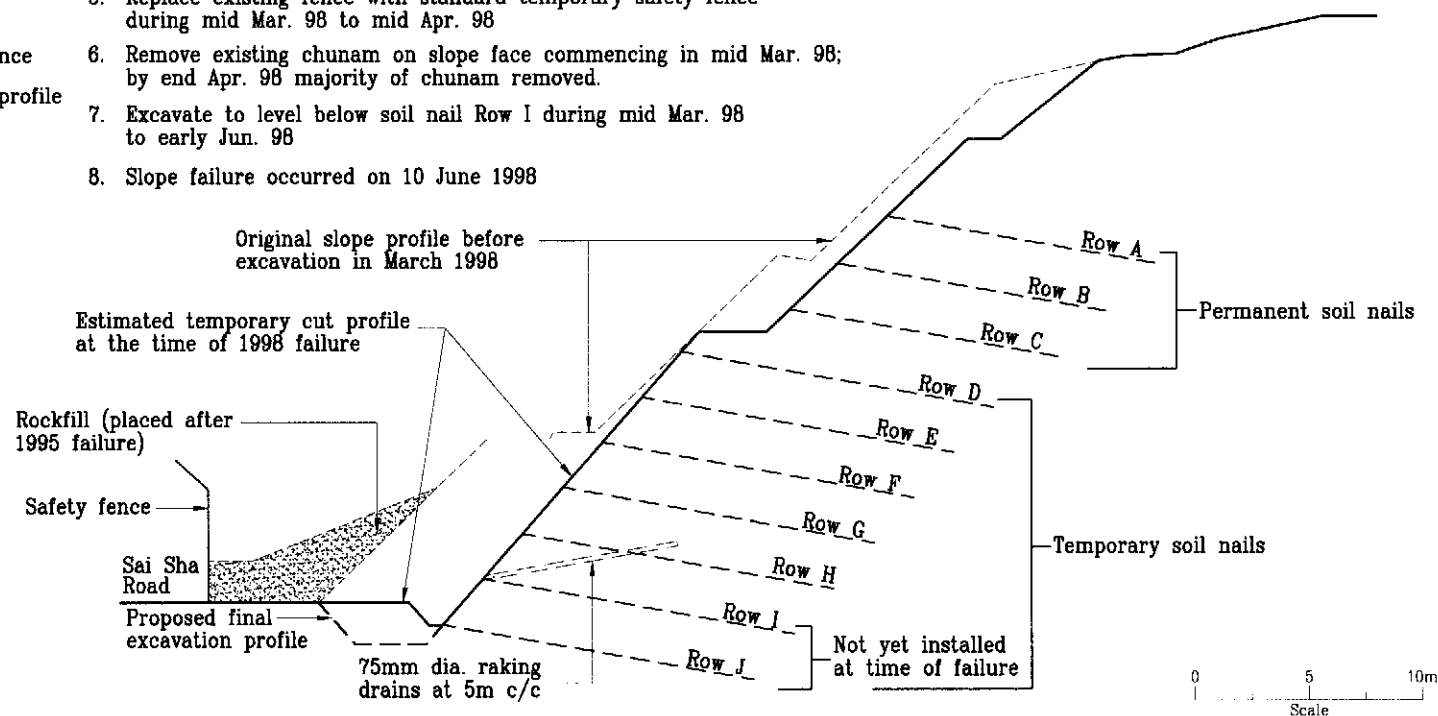
Figure 7 - Proposed and Actual Construction Sequence for Temporary Cut at the Southern Landslide Site

1. Install soil nail Rows A to F on original slope surface during mid Dec. 97 to mid Feb. 98; nail head not yet constructed
2. Remove existing rockfill to level below soil nail Row H during mid Feb. to end Feb. 98
3. Install soil nail Rows G and H during end Feb. 98 to early Mar. 98; nail head not yet constructed
4. Remove existing rockfill to ground level during mid Mar. 98
5. Replace existing fence with standard temporary safety fence during mid Mar. 98 to mid Apr. 98
6. Remove existing chunam on slope face commencing in mid Mar. 98; by end Apr. 98 majority of chunam removed.
7. Excavate to level below soil nail Row I during mid Mar. 98 to early Jun. 98
8. Slope failure occurred on 10 June 1998

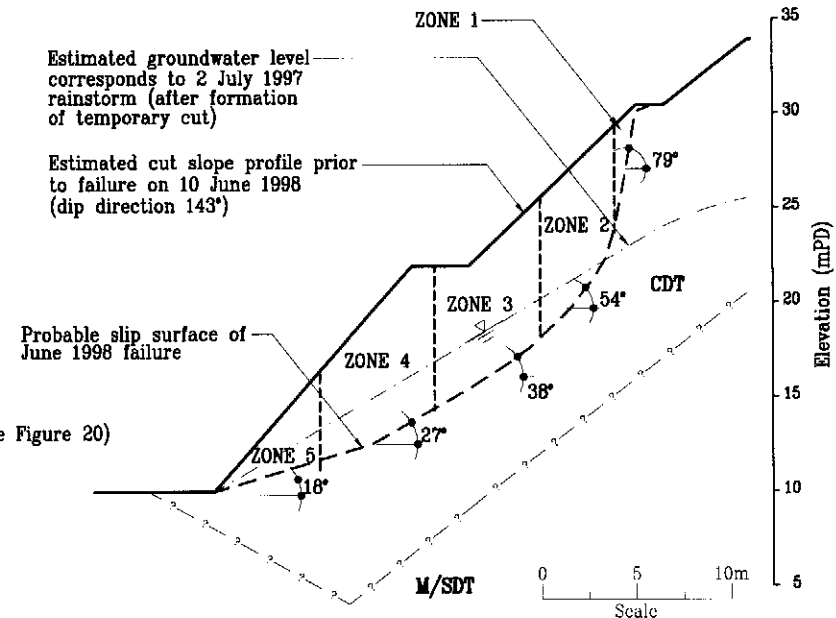
Figure 30 - Representative Cross-section and Soil Mass Strength of the Southern Landslide for Slope Stability Analysis

$$c' = 0.053 \times 2 + 0.035 \times 0 + (1 - 0.053 - 0.035) \times 8.5 = 6 \text{ kPa}$$

$$\phi' = \tan^{-1} [0.053 \tan 30^\circ + 0.035 \tan 19.1^\circ + (1 - 0.053 - 0.035) \tan 33.1^\circ] = 32.5^\circ$$

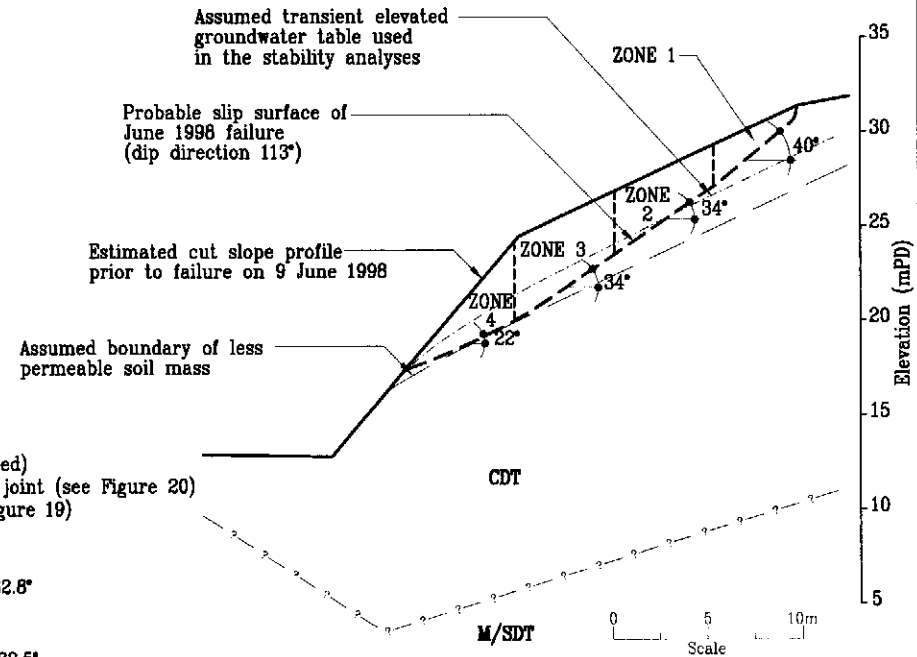
Figure 31 - Representative Cross-section and Soil Mass Strength of the Northern Landslide for Slope Stability Analysis

$$c' = 0.026 \times 2 + 0.044 \times 0 + (1 - 0.026 - 0.044) \times 6.5 = 6.1 \text{ kPa}$$

$$\phi' = \tan^{-1} [0.026 \tan 30^\circ + 0.044 \tan 19.1^\circ + (1 - 0.026 - 0.044) \tan 33.1^\circ] = 32.5^\circ$$
