INVESTIGATION OF SOME SELECTED LANDSLIDES IN 1998 (VOLUME 5)

GEO REPORT No. 112

Fugro Scott Wilson Joint Venture

SECTION 1 : DETAILED STUDY OF SLOPE DISTRESS AT QUEEN'S HILL, BURMA LINES CAMP, FANLING

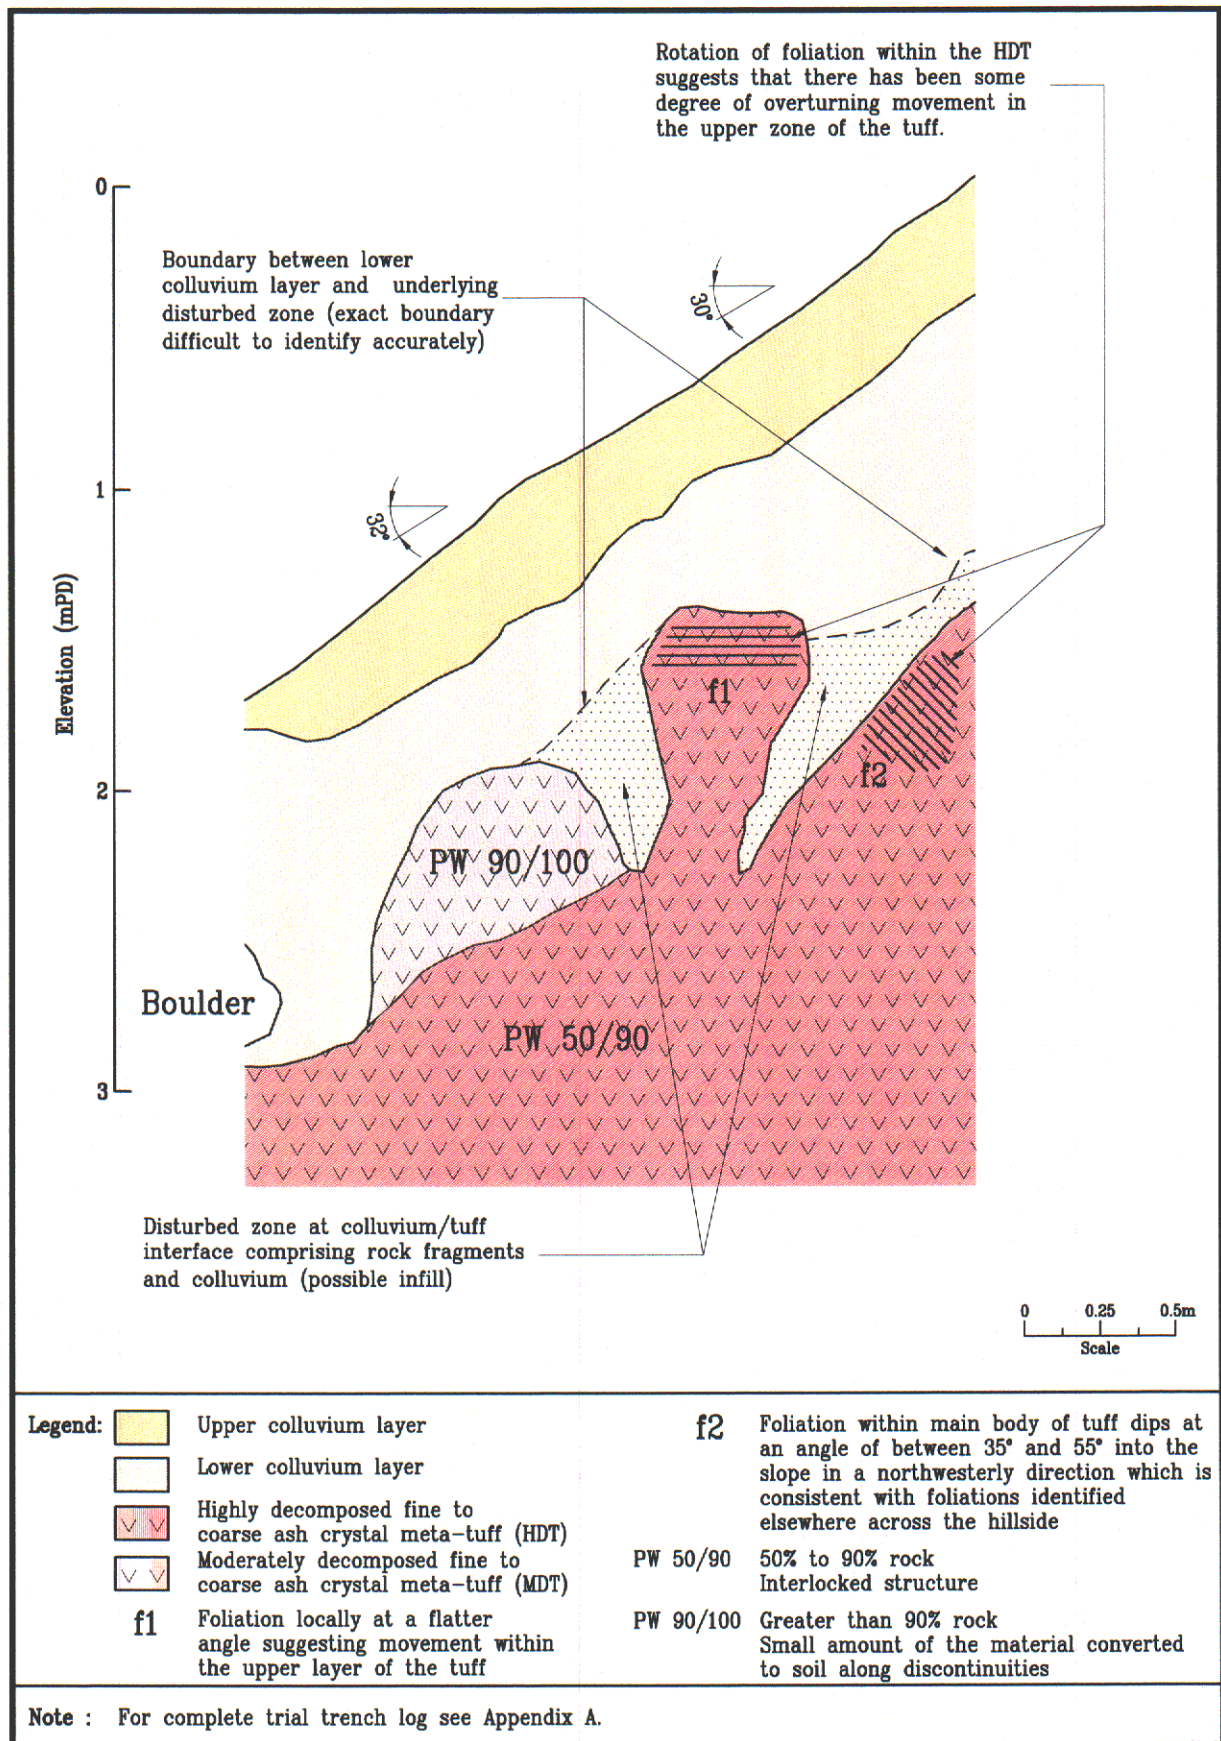
- (a) dissipation of elevated water pressure by drainage through the cracks (because the ground has opened up),
- (b) the rough, and occasionally interlocking, nature of the interface between the lower colluvium and the tuff (Figure 15) resulting in increased resistance during shearing displacement due to dilation effects (there is a general lack of a well-defined slip surface at the colluvium/tuff interface), and
- (c) the relatively planar nature of the slope surface with no significant drainage concentration or potential for concentrated surface water flow.

Figure 15 - Enlarged View of Face D of Trial Trench TT4

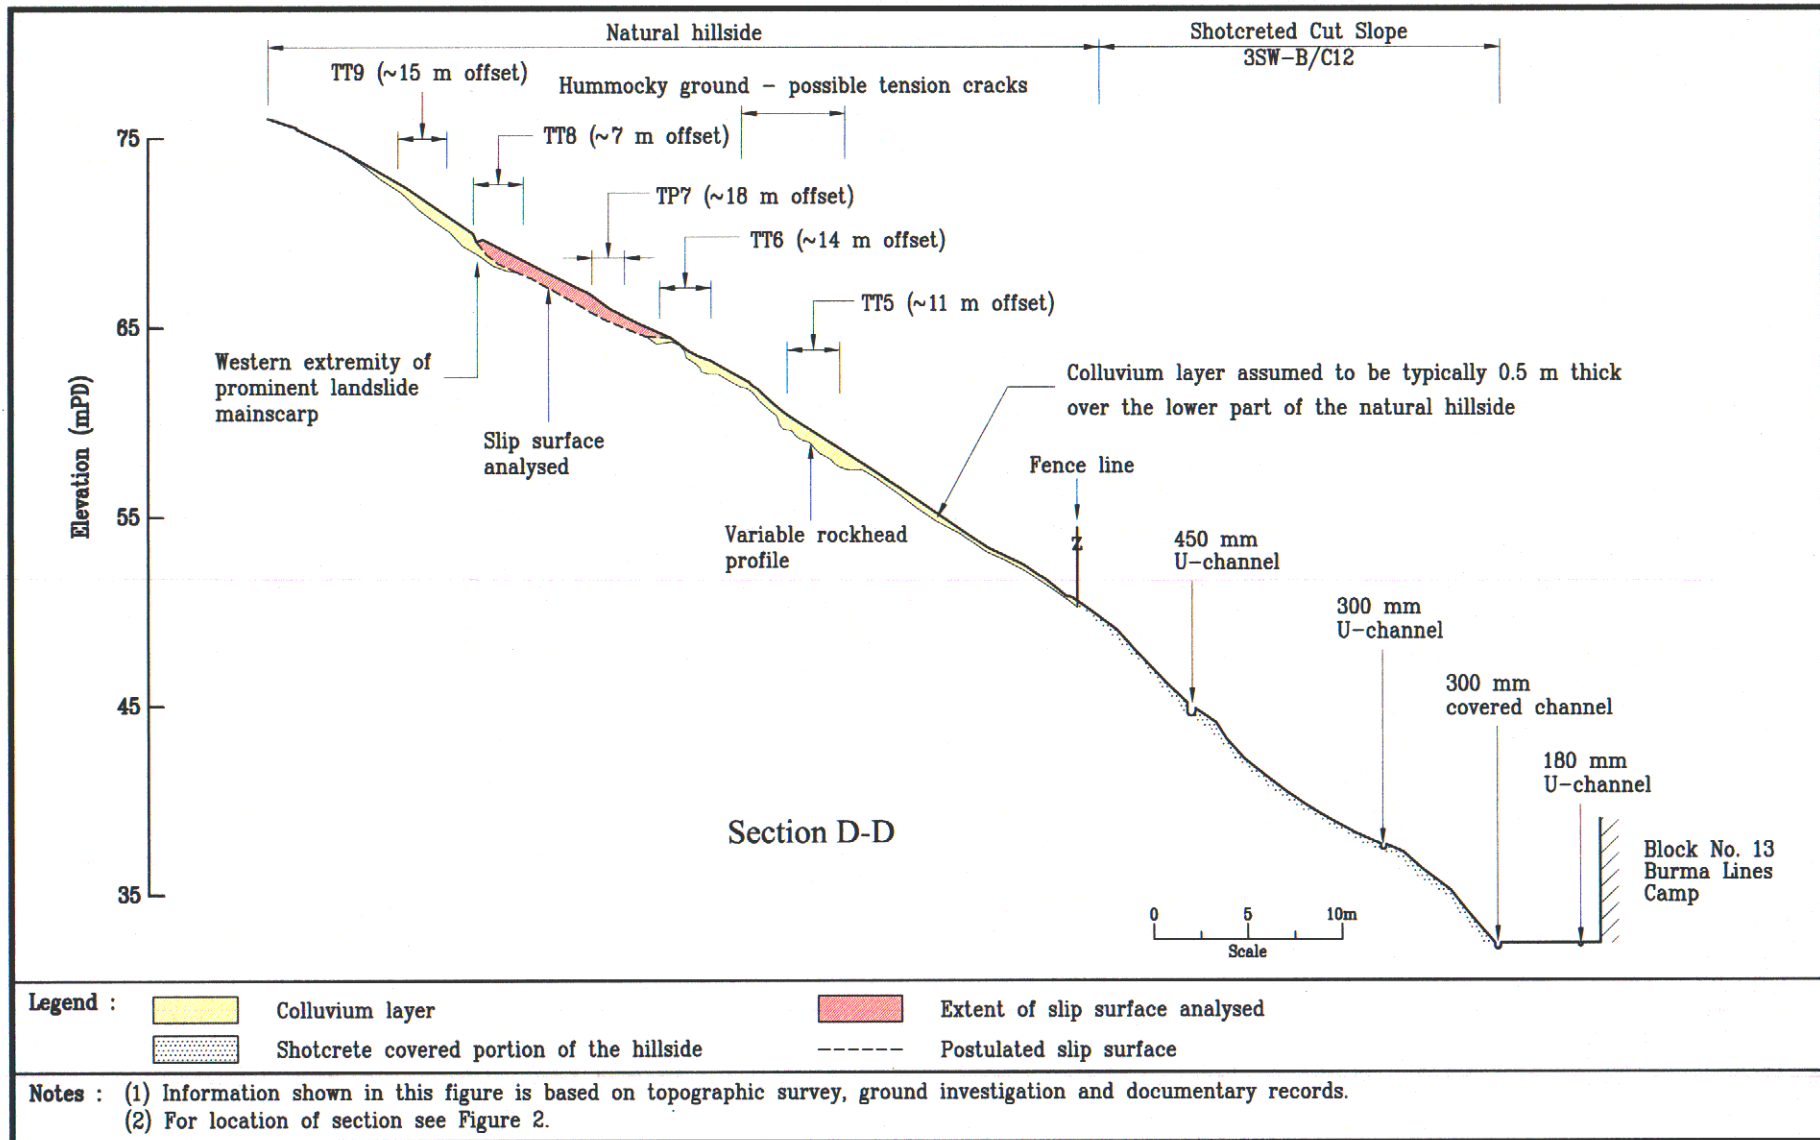
Limit equilibrium slope stability analyses based on the Morgenstern & Price (1965) rigorous solution were carried out to assist in the diagnosis of the probable causes of instability in the hillside. The effects of different transient elevated water pressure conditions in the colluvium on the factor of safety (FOS) of the hillside, assuming a range of likely mass shear strength parameters, were considered. A postulated slip surface located in the upper part of Section D-D (Figure 17) was used for the purposes of analysis to model the instability in the eastern part of the hillside.

Figure 17 - Theoretical Stability Analysis

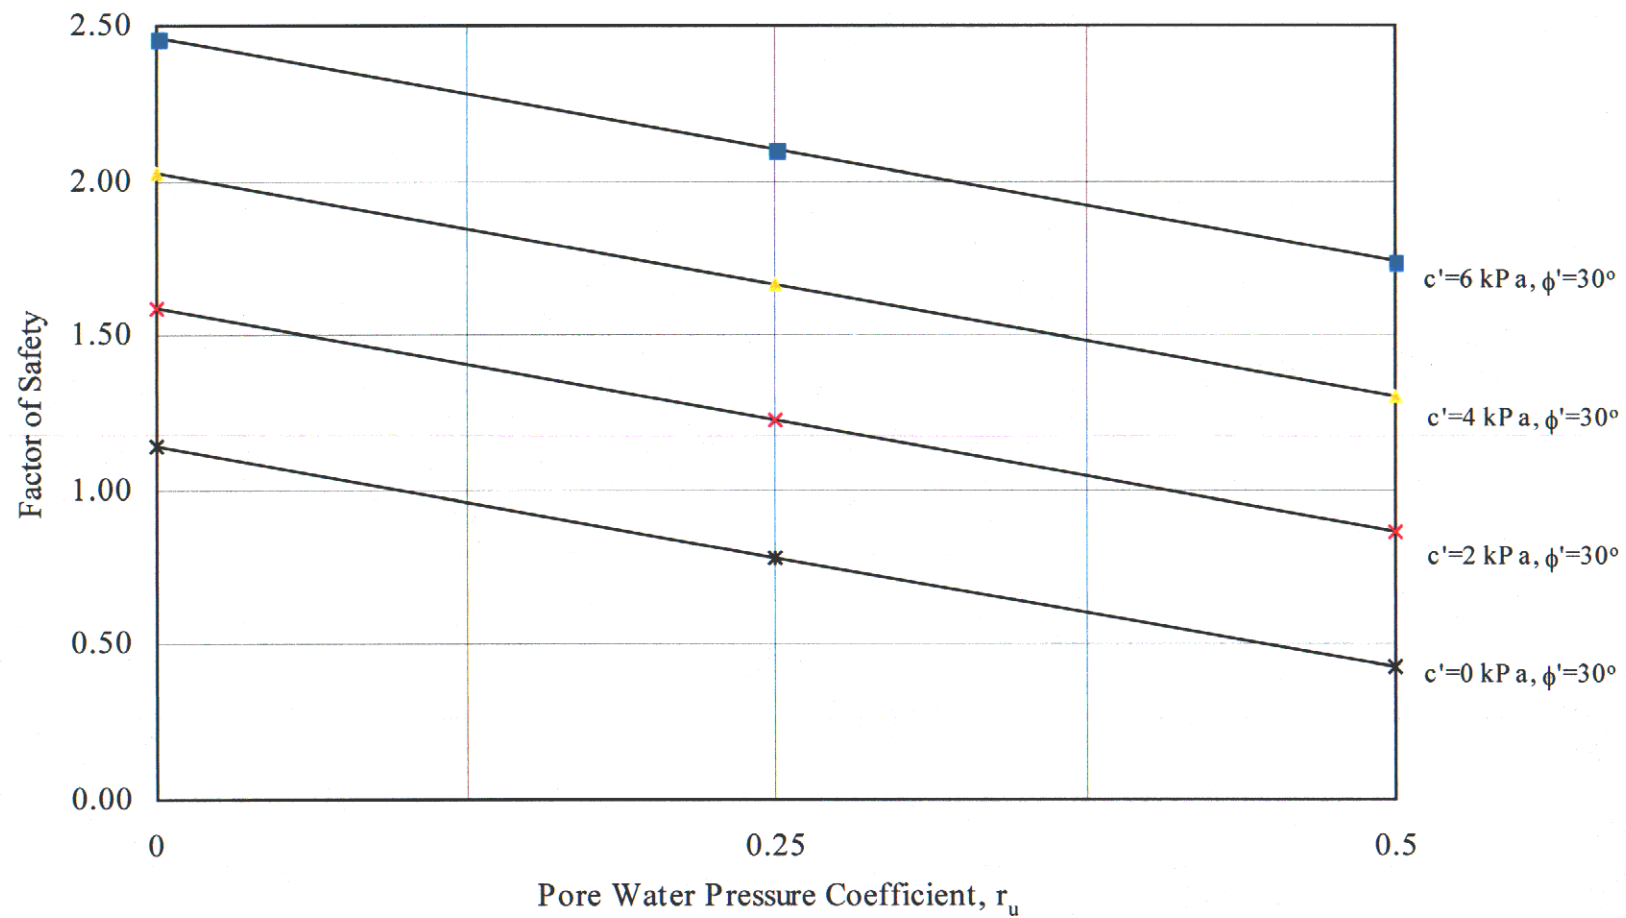
The results of the stability analyses are summarised in Figure 18. These show that under the condition of no build-up in positive water pressure in the colluvium the hillside should be stable. However, as water pressures build up within the colluvium the factor of safety falls below/towards unity for the range of shear strength parameters considered. The probable mass shear strength of the colluvium appears to be lower than that adopted in the LPM design for Slope No. 3SW-B/C12, which is consistent with the visual assessment of the material.

Figure 18 – Summary of Results of Stability Analyses

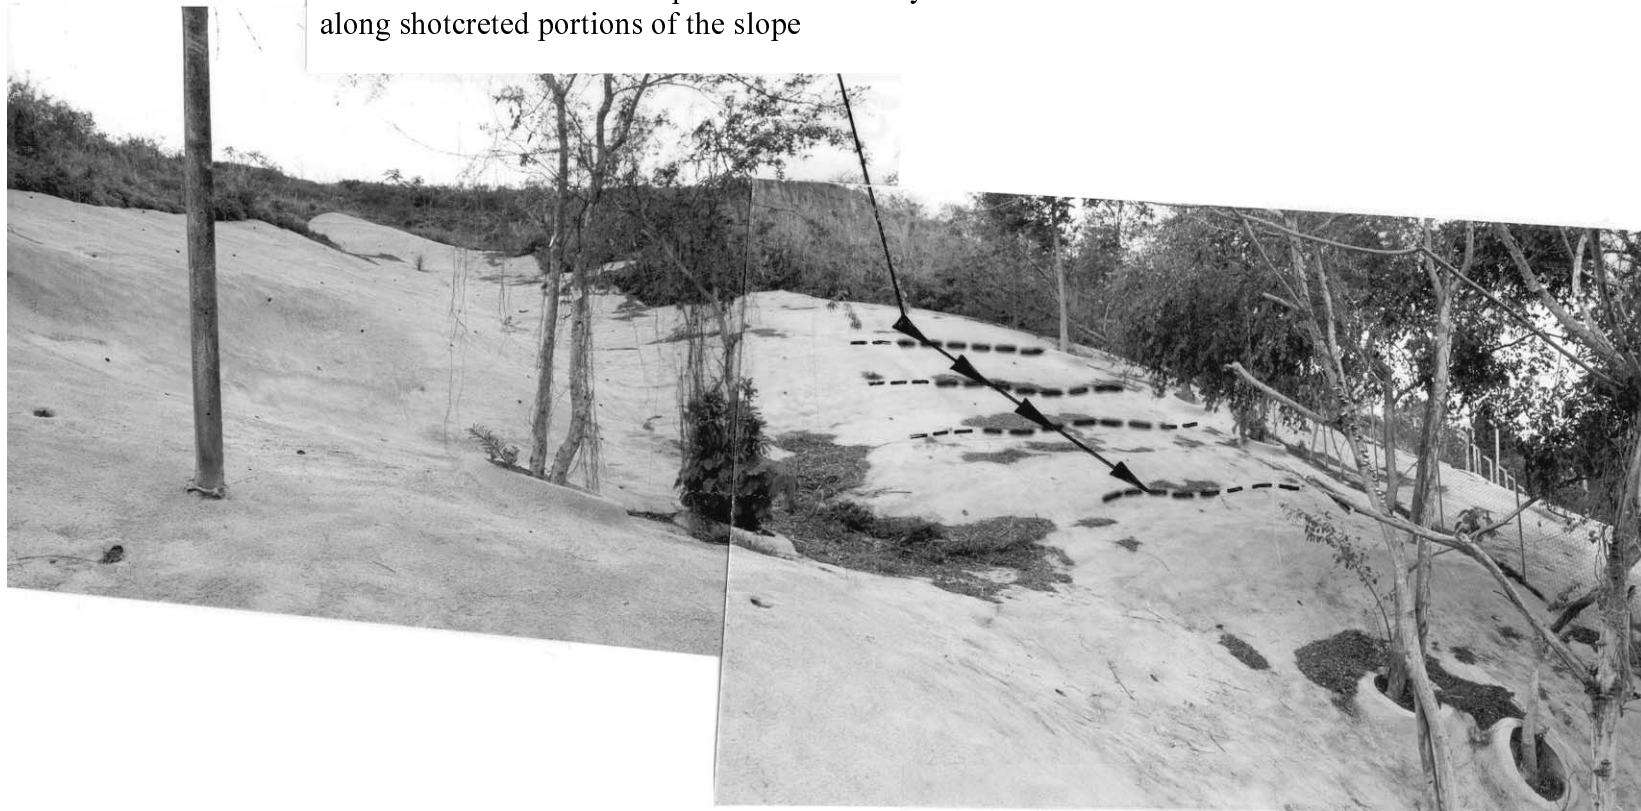
Plate 7 – General View of the Shallow Depression in the Western Half of the Site
(Photographs taken on 14 April 1999)

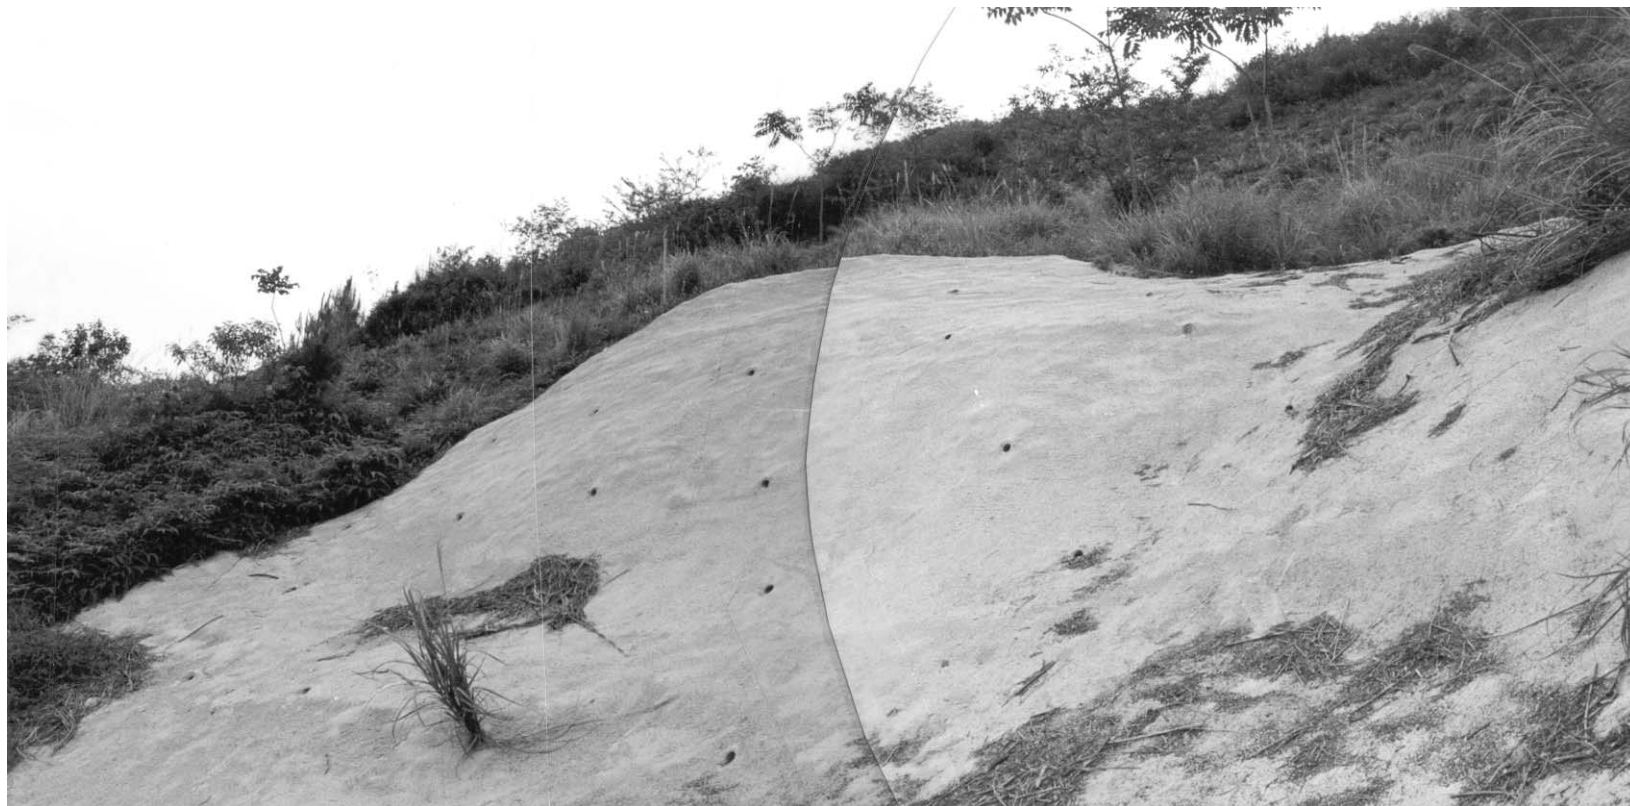
Plate 8 – View of Upper Portion of the Shallow Depression in the Western Half of the Site
(Photographs taken on 14 April 1999)

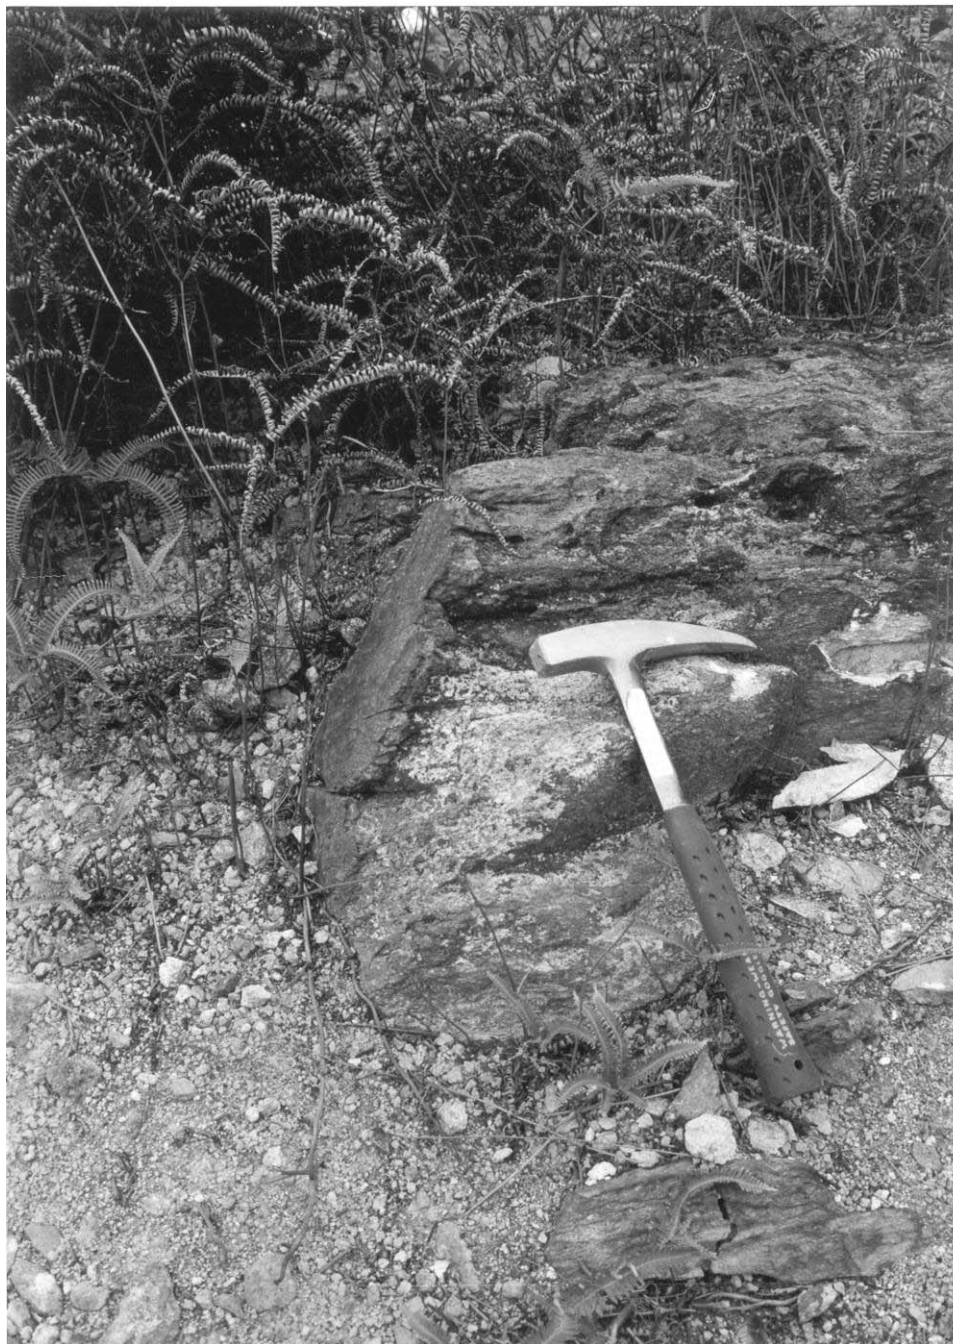
Plate 20 – View of Iron Stained Outer Layer Exposed along MDT Outcrops
(Photographs taken on 14 April 1999)

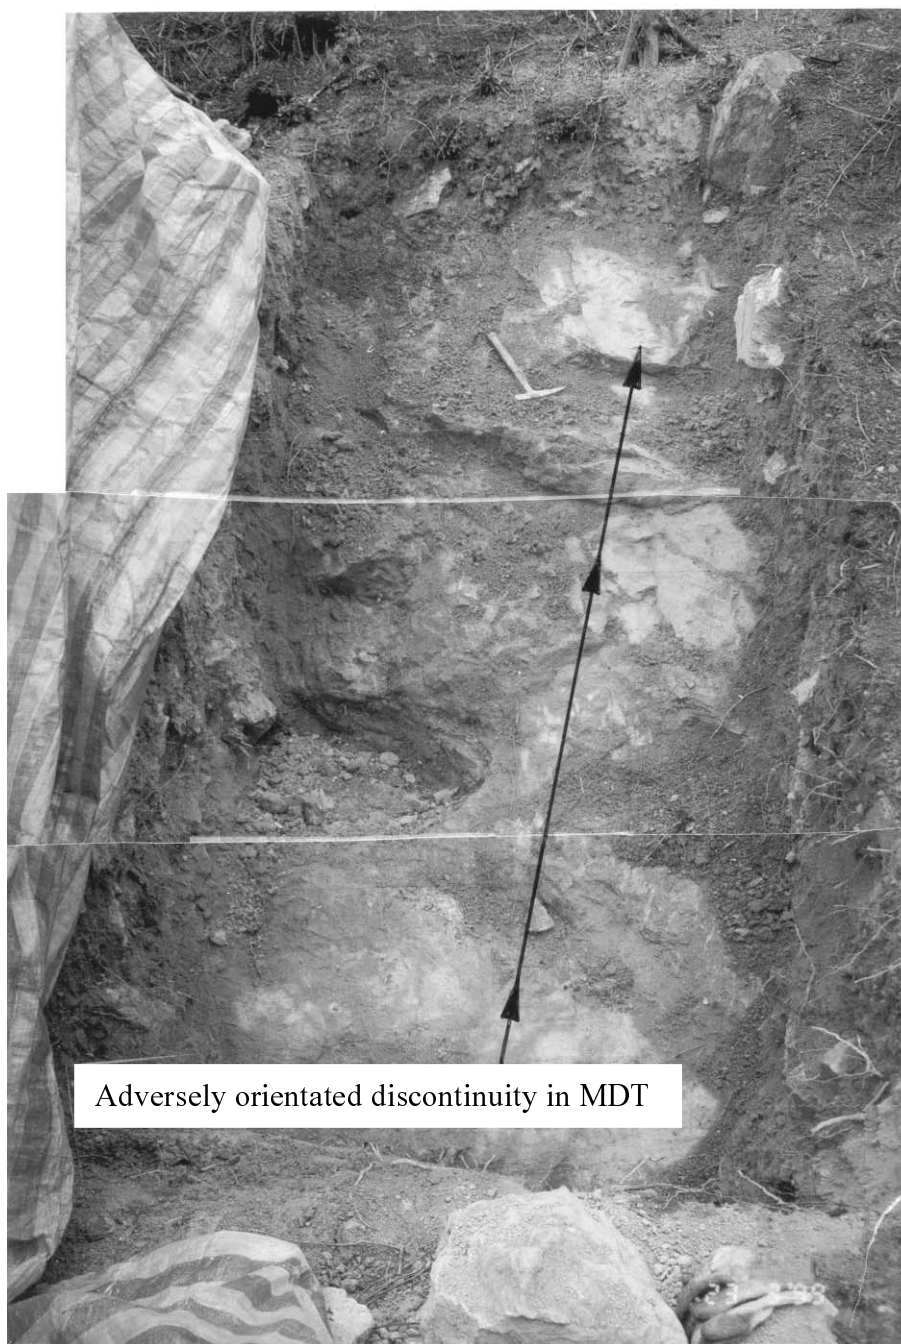
Plate 22 – General View of Trial Trench TT5
(Photographs taken on 23 March 1999)

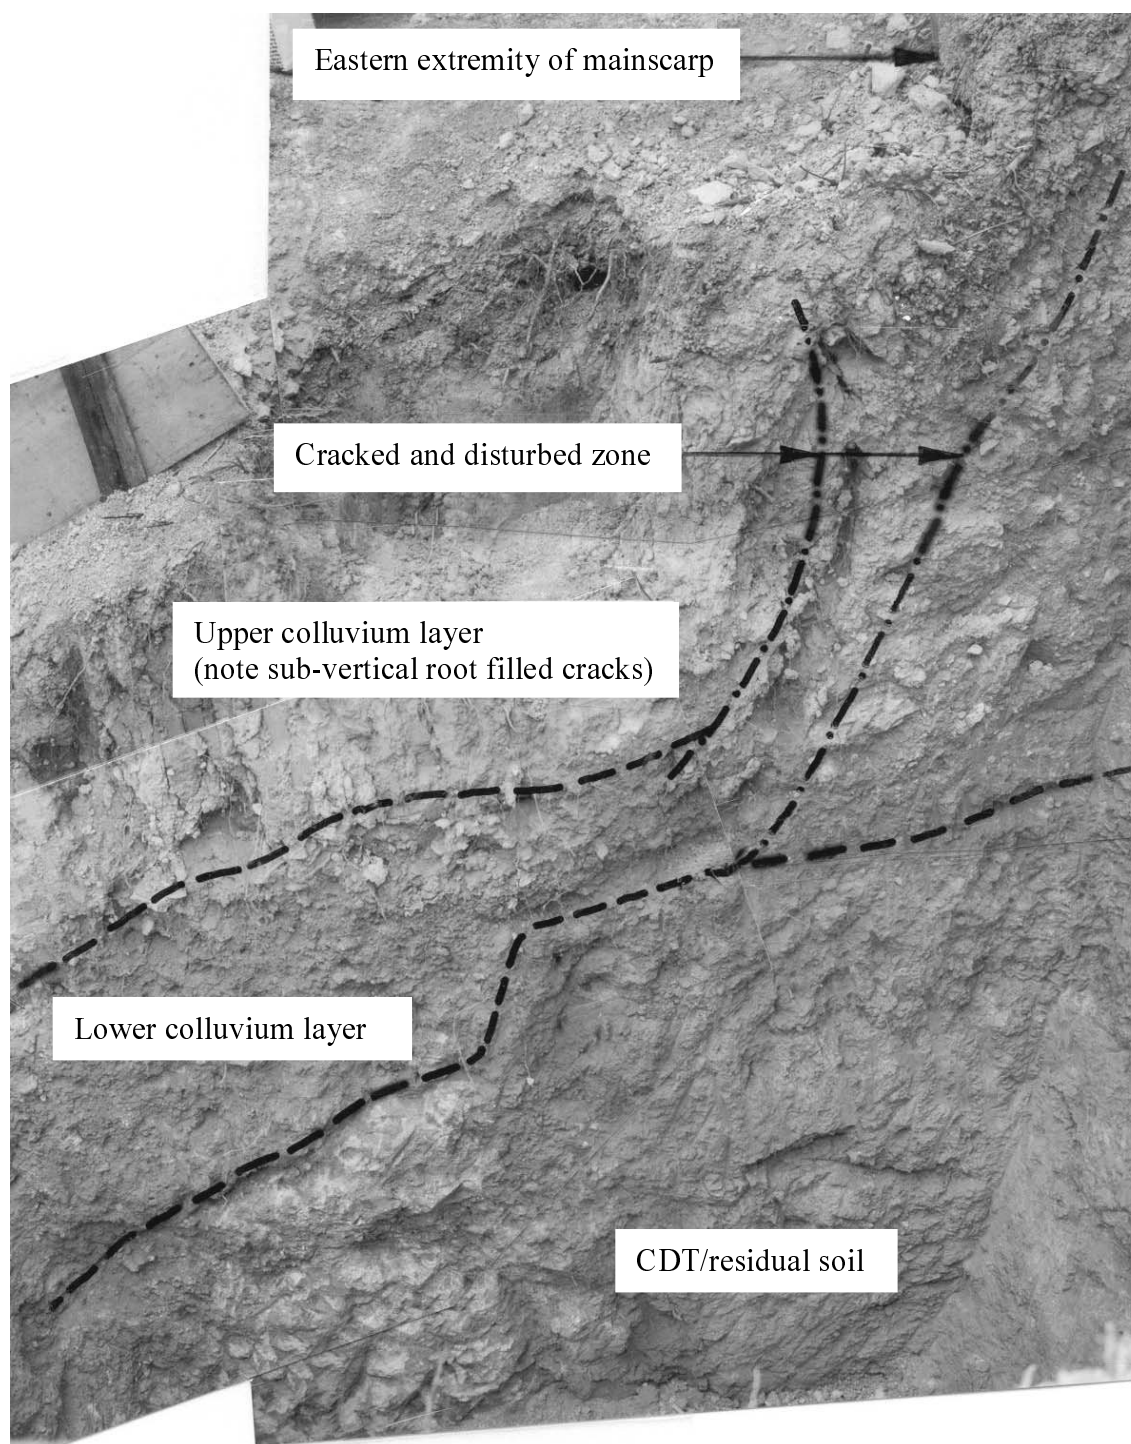
Plate 23 – View of Face D, Trial Trench TT2
(Photographs taken on 23 March 1999)

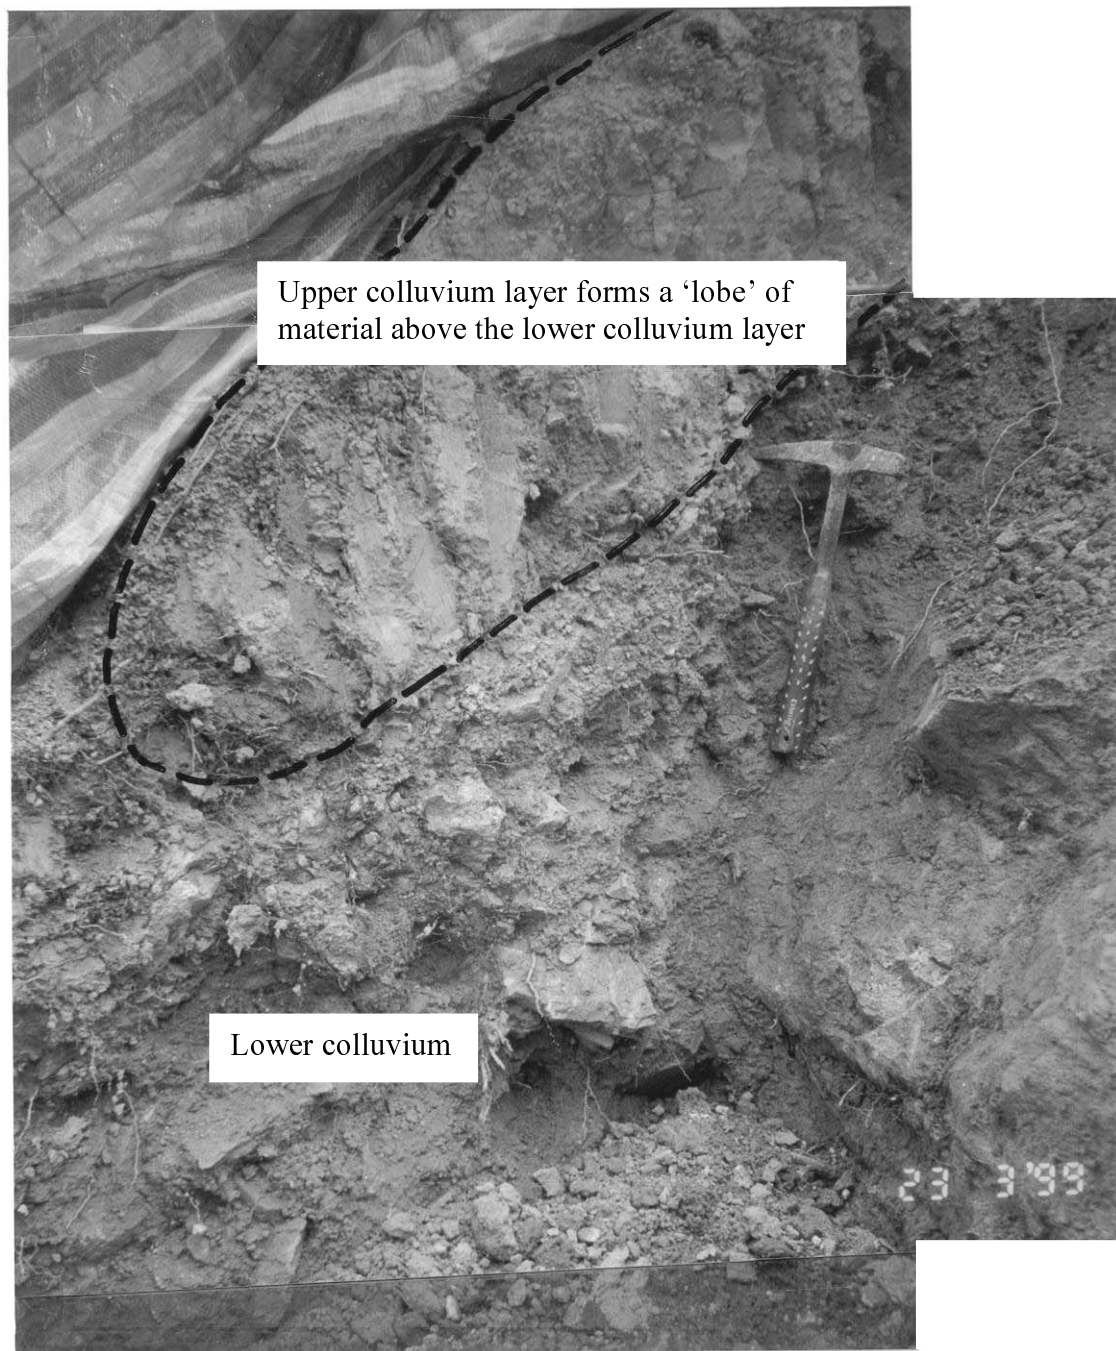
The nature of the upper and lower colluvium suggests that they could be of different origin. The upper colluvium, which occurs in places as localised lobes, appears to be landslide debris probably derived from discrete failures in the past. On the other hand, the lower colluvium is not as loose as that of the upper colluvium and locally it incorporates disturbed CDT. The insitu density of the lower colluvium is higher than that of the upper colluvium and is close to that of the tuff. It is postulated that the lower colluvium could represent a zone of intermittent movement within the upper part of the CDT due to progressive development and deterioration of the near-surface instability into the underlying material without global detachment of material (see Figure 15). This intermittent ground movement, which was probably comparatively limited given the relatively small relief of the hillside, probably occurred over a fairly long timescale. Superimposed on this ongoing

Plate 24 – View of Face D of Trial Trench TT5 Showing Upper Layer of Colluvium Forming a “Lobe” of Material above the Lower Colluvium Layer (Photographs taken on 23 March 1999)

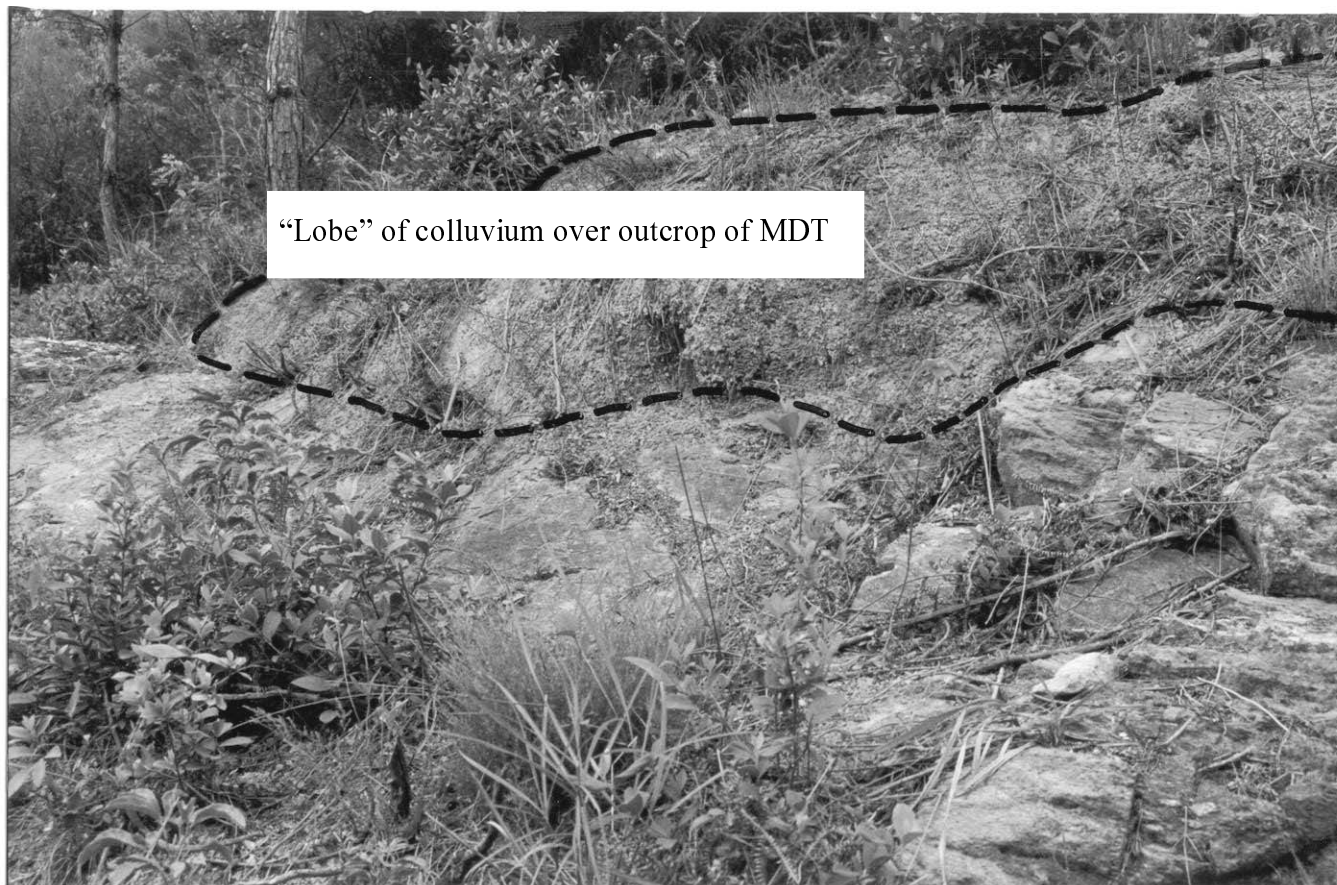
Plate 25 – View of MDT Outcrop. Note “Lobe” of Colluvium Overlying this Surface
(Photograph taken on 14 April 1999)

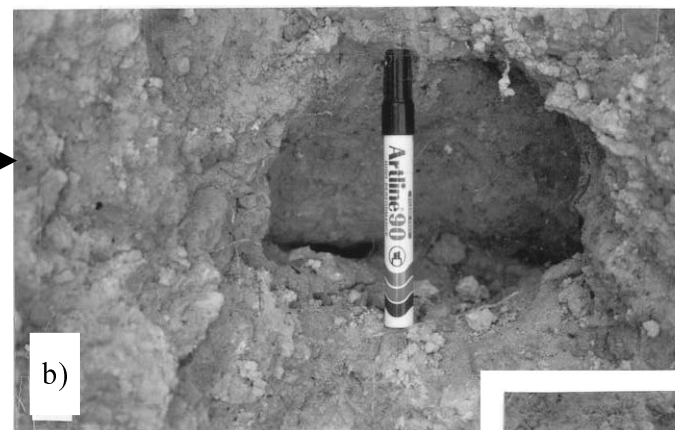
and erosion pipes observed on site may locally exacerbate the process. The significant drop in pore suction following rainfall as measured by the tensiometers demonstrates the susceptibility of the colluvium to rapid infiltration.

Plate 29 – Views of Voids/Soil Pipes Exposed in Trial Trench TT4
(Photographs taken on 4 March 1999)
