**SECTION 2 :  
DETAILED STUDY OF THE  
LANDSLIDE BEHIND  
7C BOWEN ROAD  
ON 11 JUNE 1998**

**Fugro Scott Wilson Joint Venture**

**This report was originally produced in November 1999  
as GEO Landslide Study Report No. LSR 19/99**

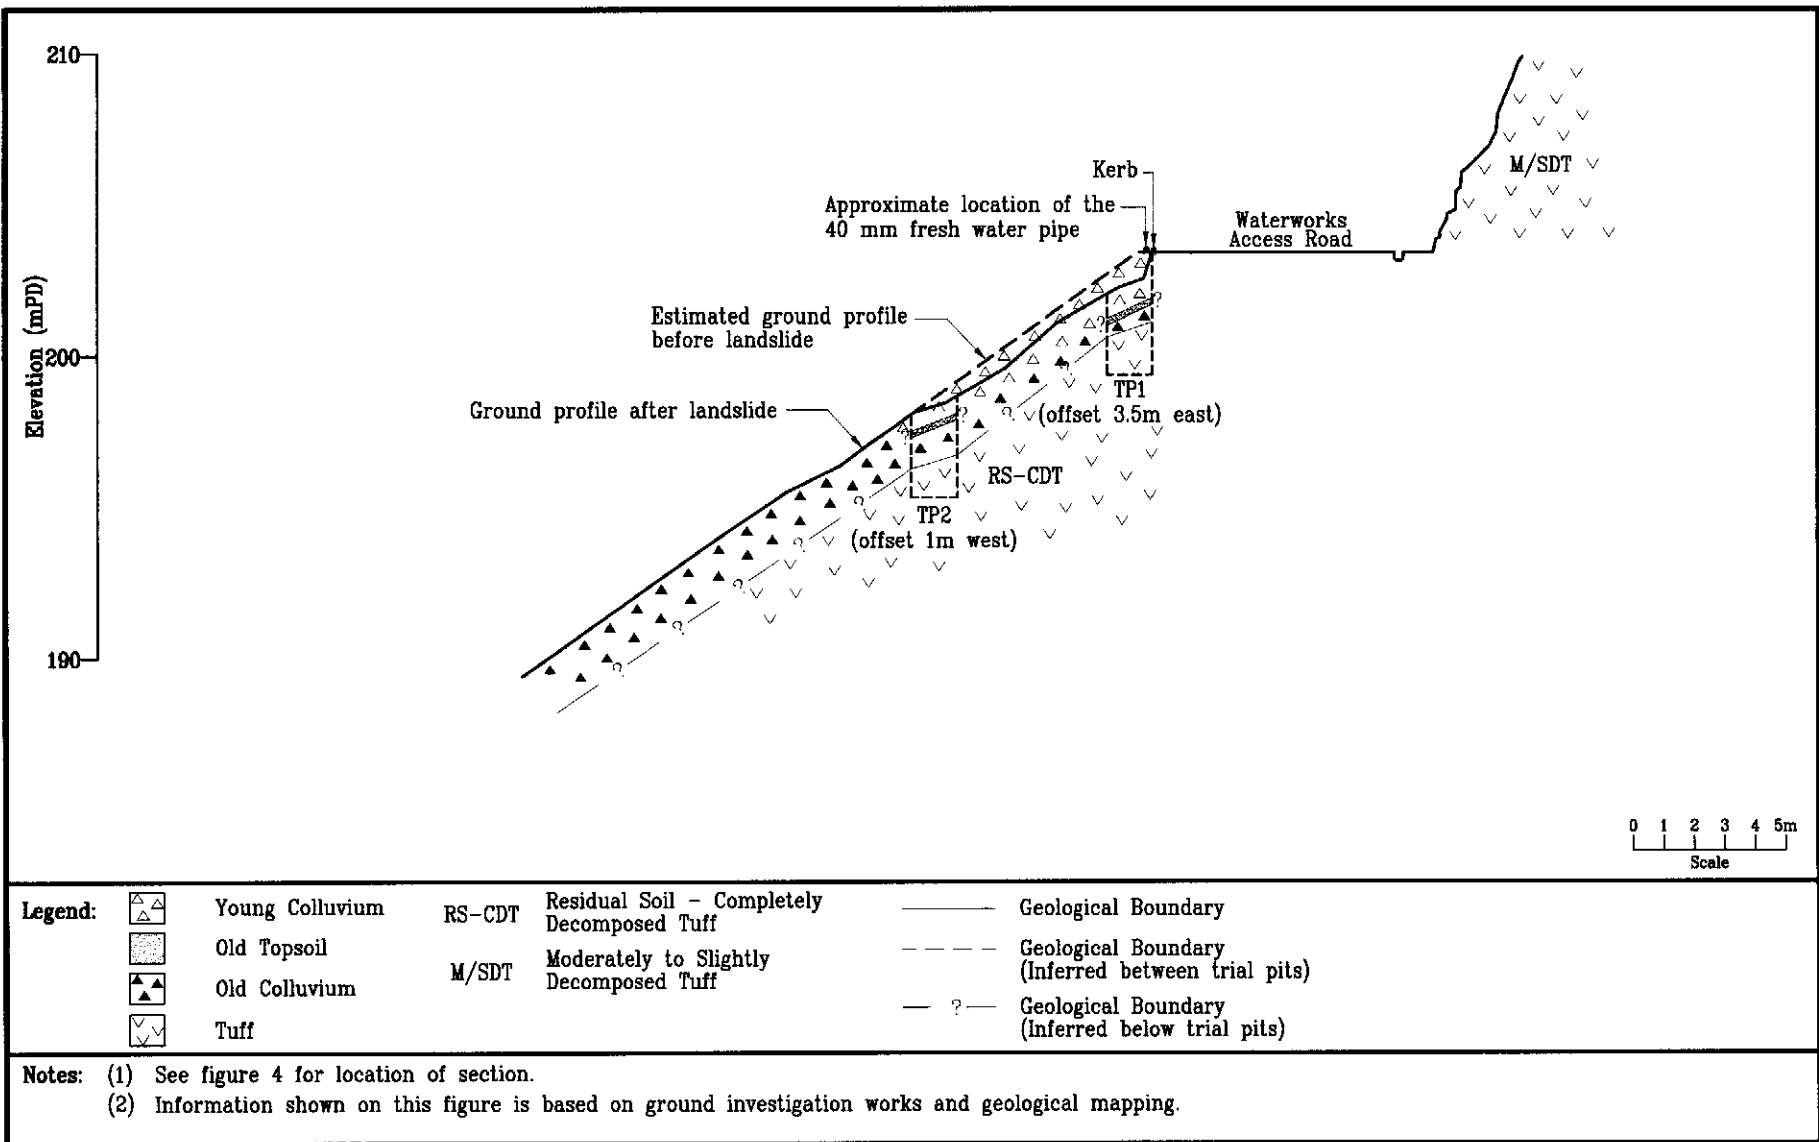
Figure 7 - Geological Section A - A

Based on the results of geological mapping and ground investigation works, an inferred geological profile of the landslide site is presented in Figure 7. The geological mapping and ground investigation results indicate that the landslide occurred mainly in the young colluvium.

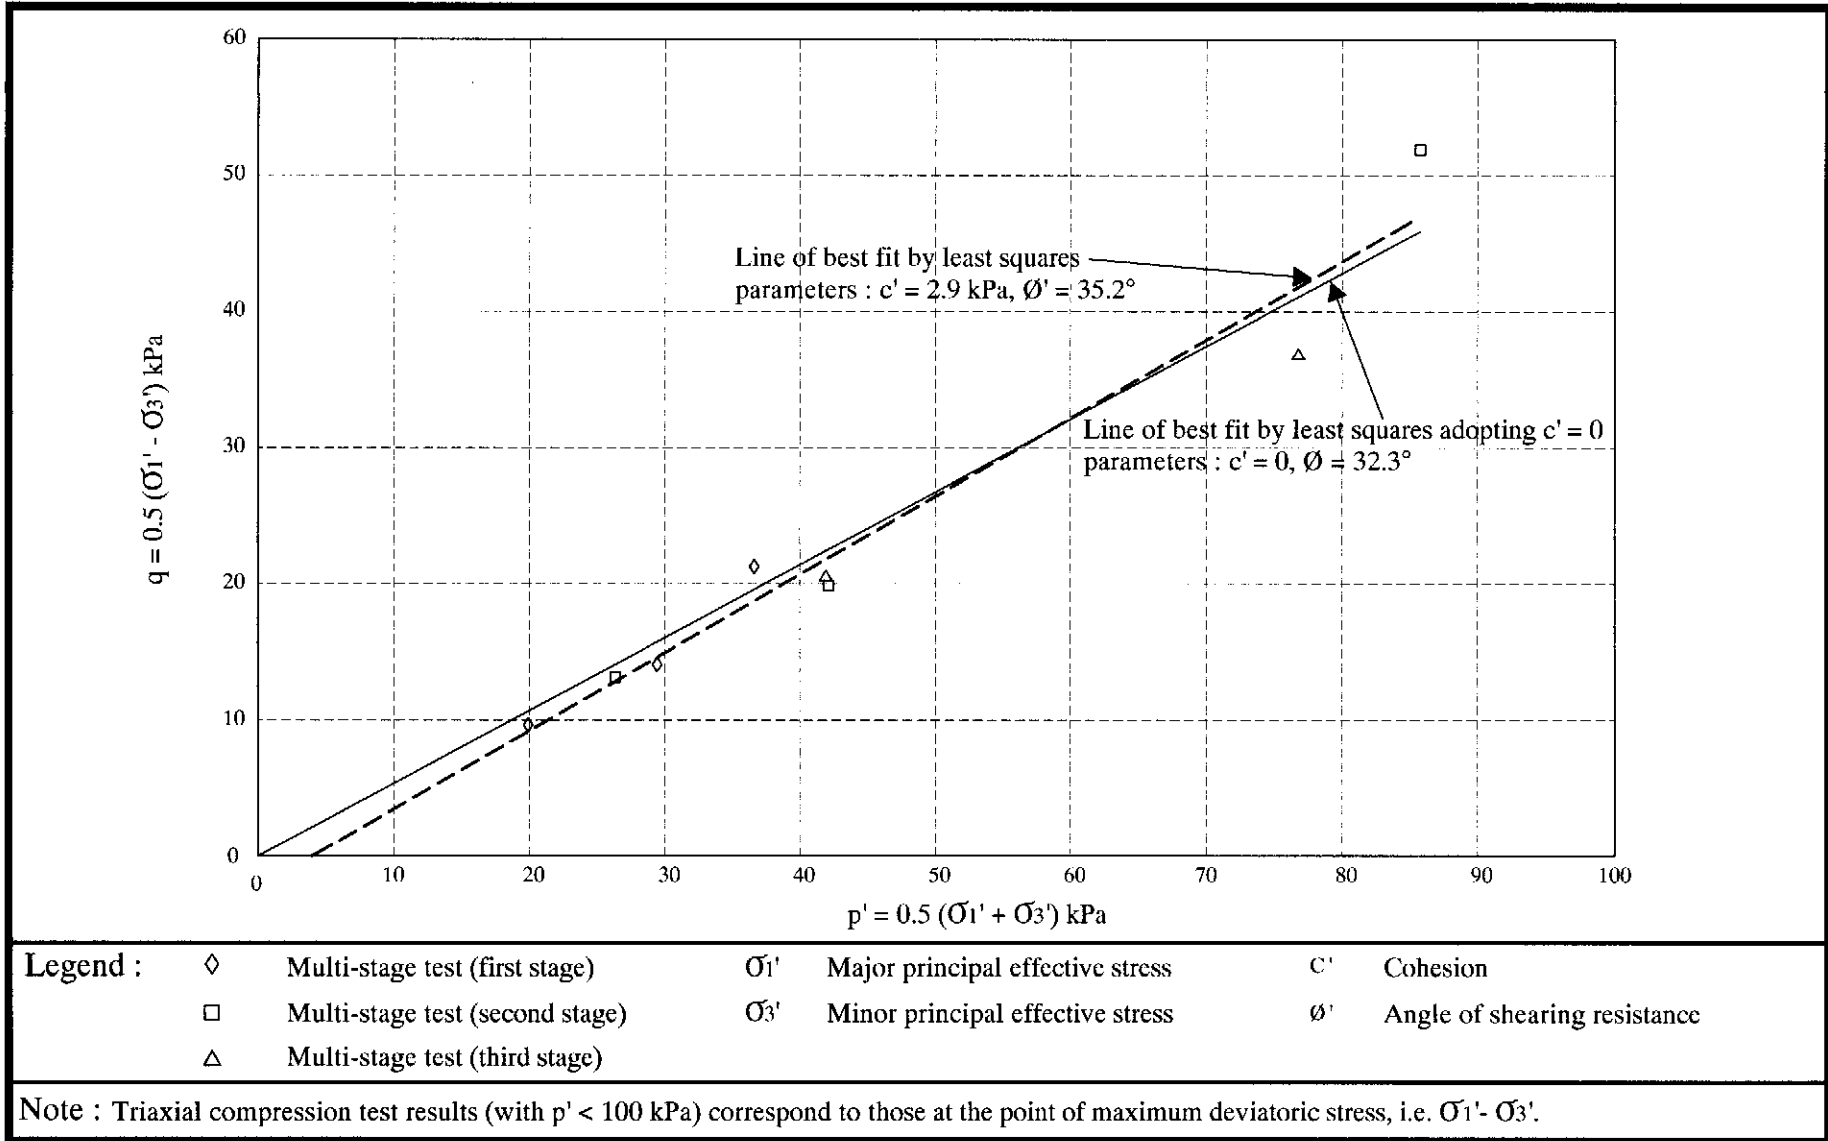
Figure 9 - Triaxial Compression Test Results for Young Colluvium

The shear strength properties of the matrix material of the young colluvium and old colluvium were assessed by triaxial compression tests on eight U100 samples. Results of the triaxial compression tests are summarized in Table 2 and presented in the form of  $p'$ - $q$  plots in Figures 9 and 10. The shear strength of the tested soils are found to be typical for similar materials in Hong Kong. The presence of coarse fractions such as boulder-sized material will, however, increase the mass shear strength.

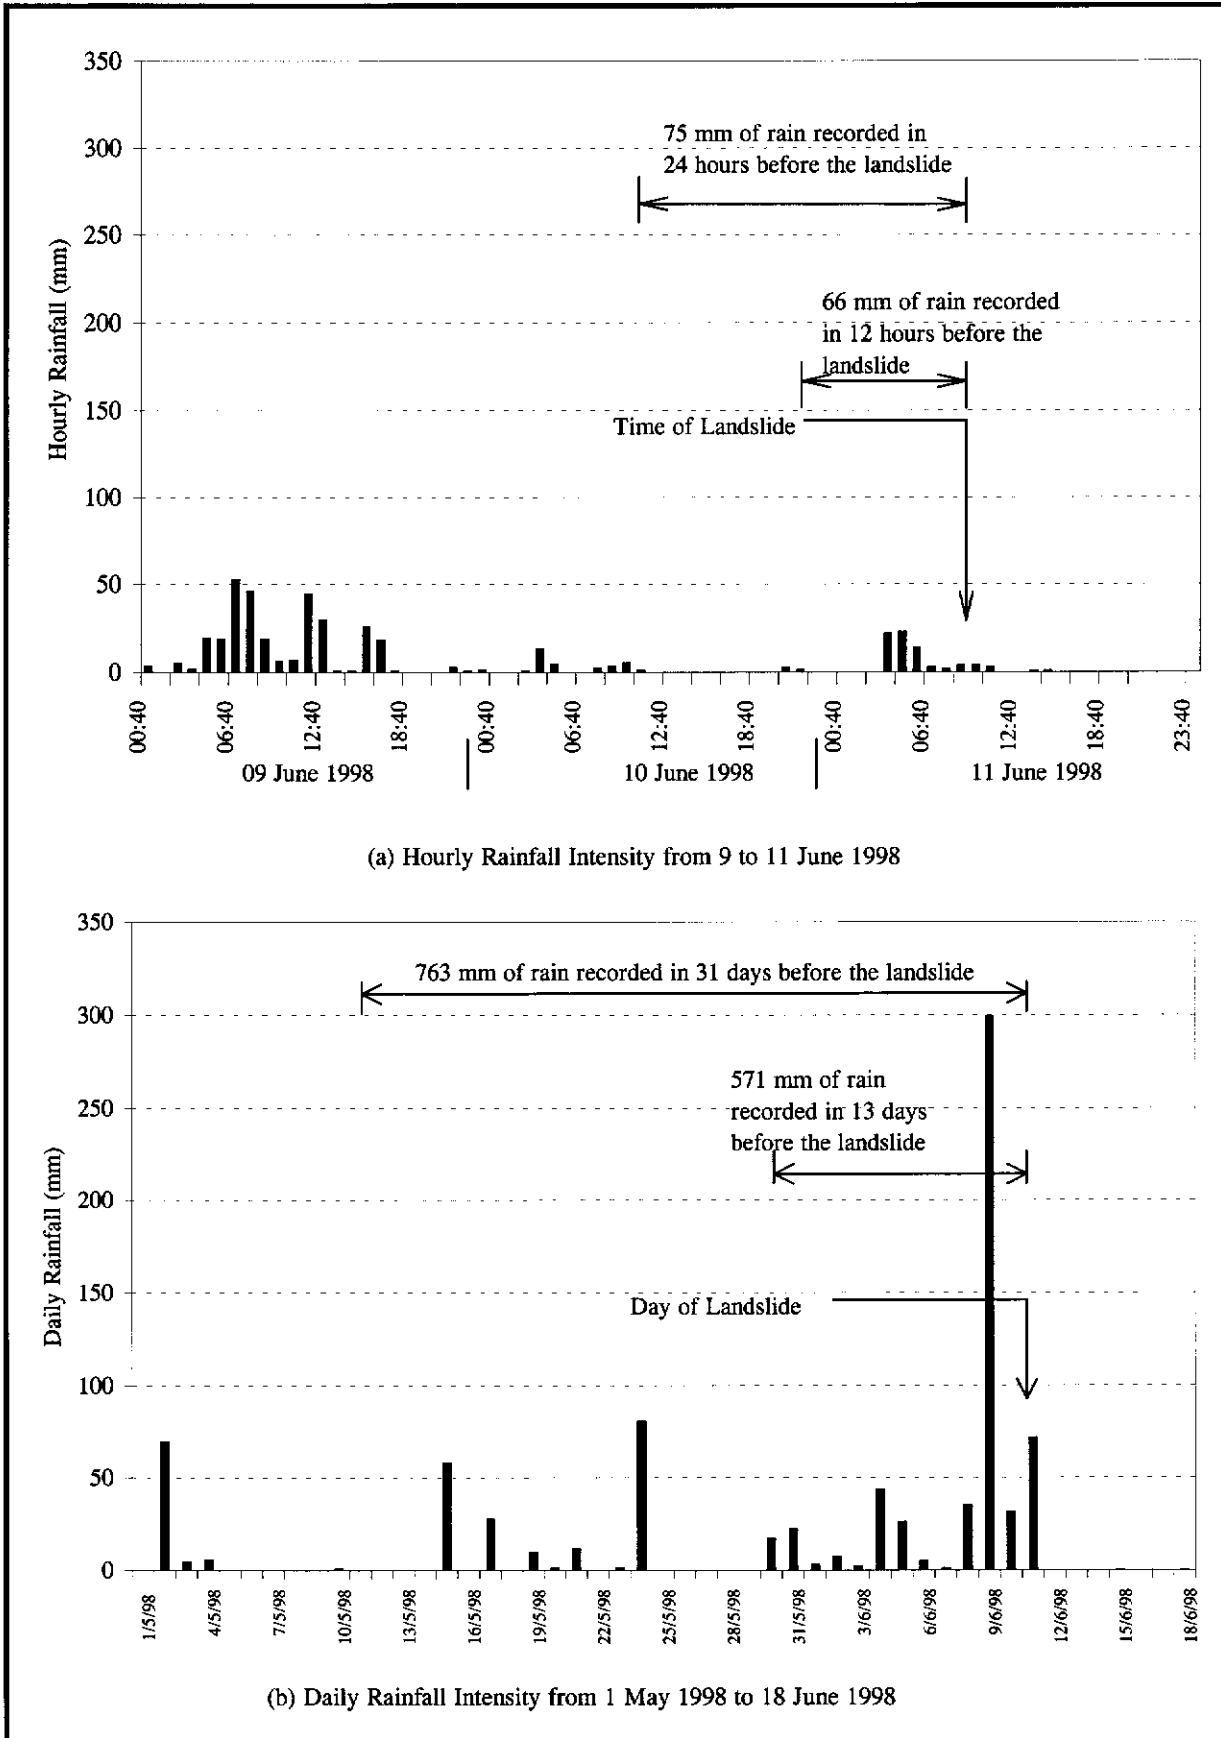
Figure 11 - Rainfall Records of GEO Raingauge No. H17

The nearest GEO automatic raingauge (No. H17) is located at 25 Borrett Road, about 230 m to the southeast of the landslide area (Figure 1). According to the records from this raingauge, a total of 756 mm rainfall was recorded in the 31-day period before the landslide. The hourly and daily rainfall recorded by the raingauge before the landslide are shown on Figures 11a and 11b respectively. It can be seen from Figure 11 that rain was quite heavy in the early morning of the day of the landslide, especially between 3:45 a.m. and 6:45 a.m.

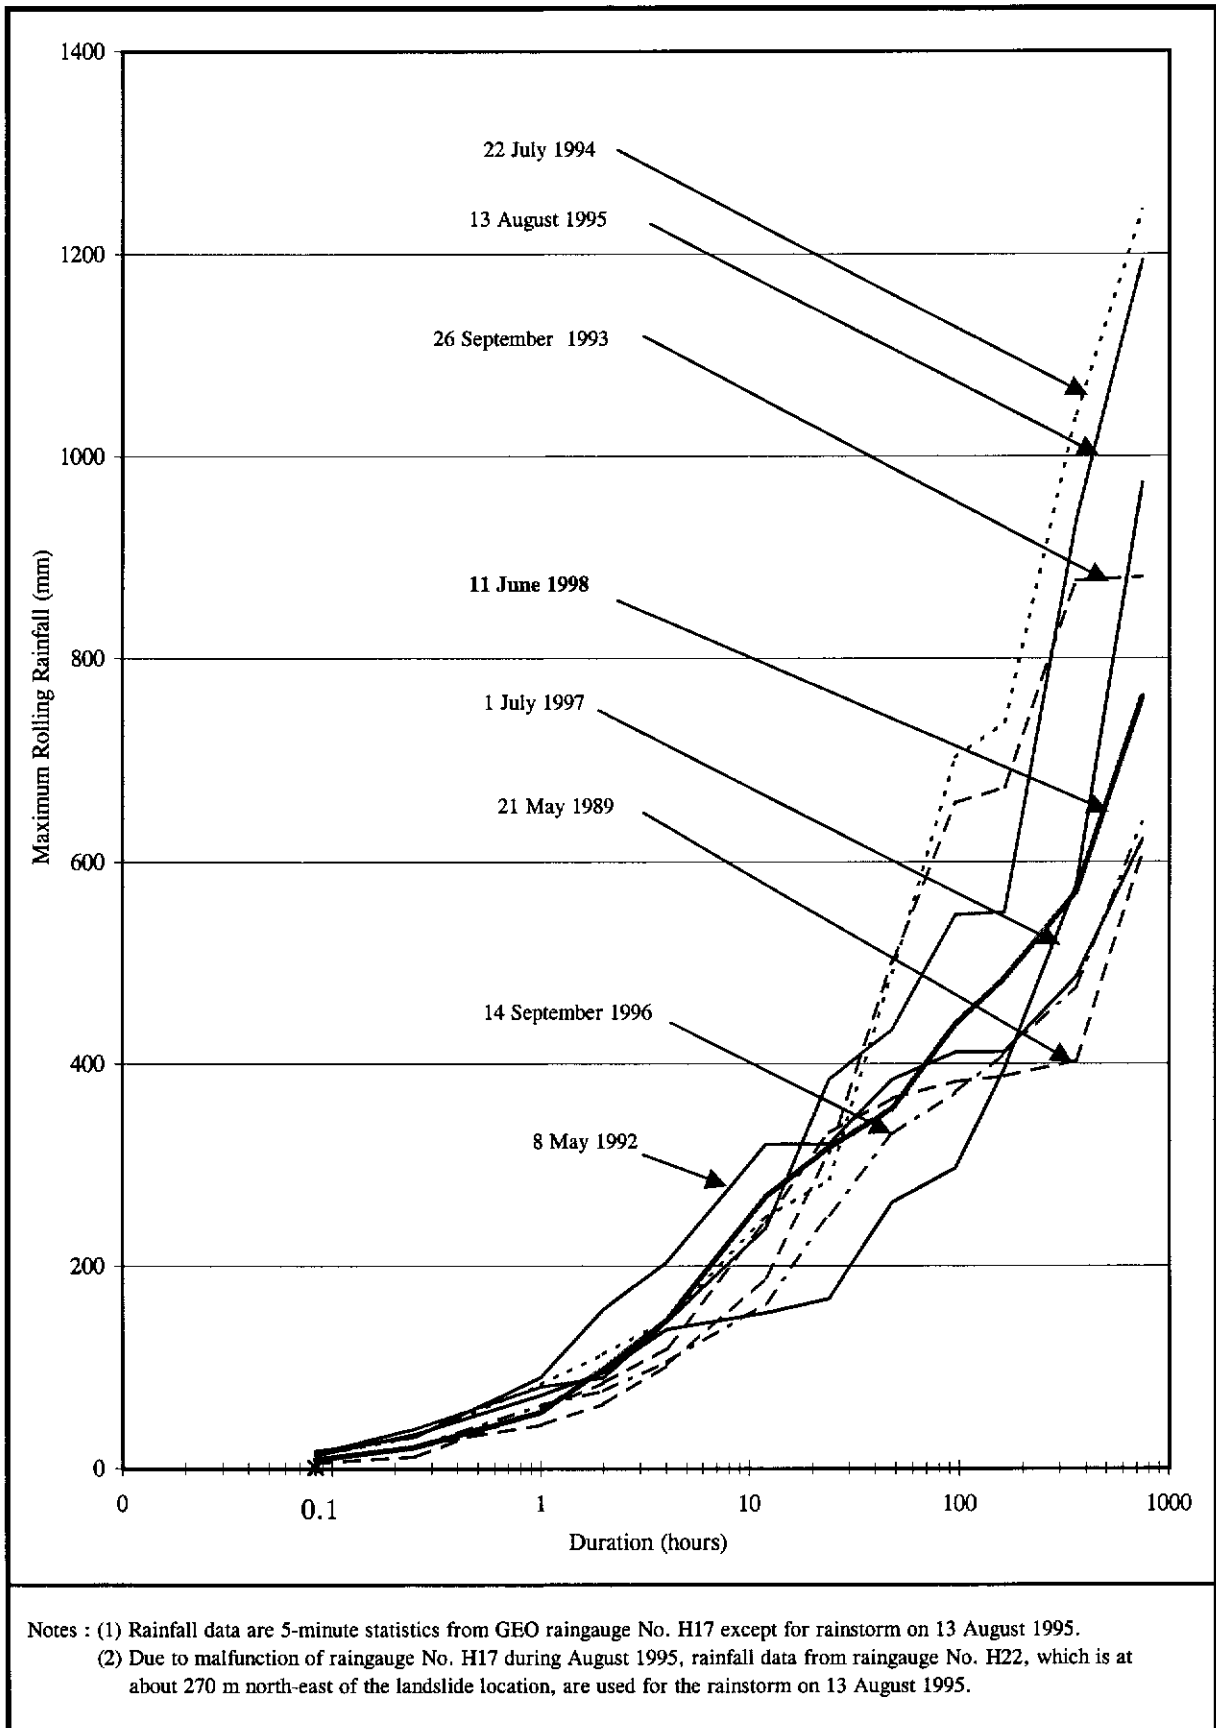
Figure 12 - Maximum Rolling Rainfalls at Raingauge No. H17 for Major Rainstorms

Figure 12 presents a comparison of the pattern of the rainfall prior to the 11 June 1998 landslide with those of previous major rainstorms recorded at GEO raingauge No. H17 since its installation in 1978. It can be seen that the rainfall prior to the landslide was less severe than that experienced before by the raingauge.

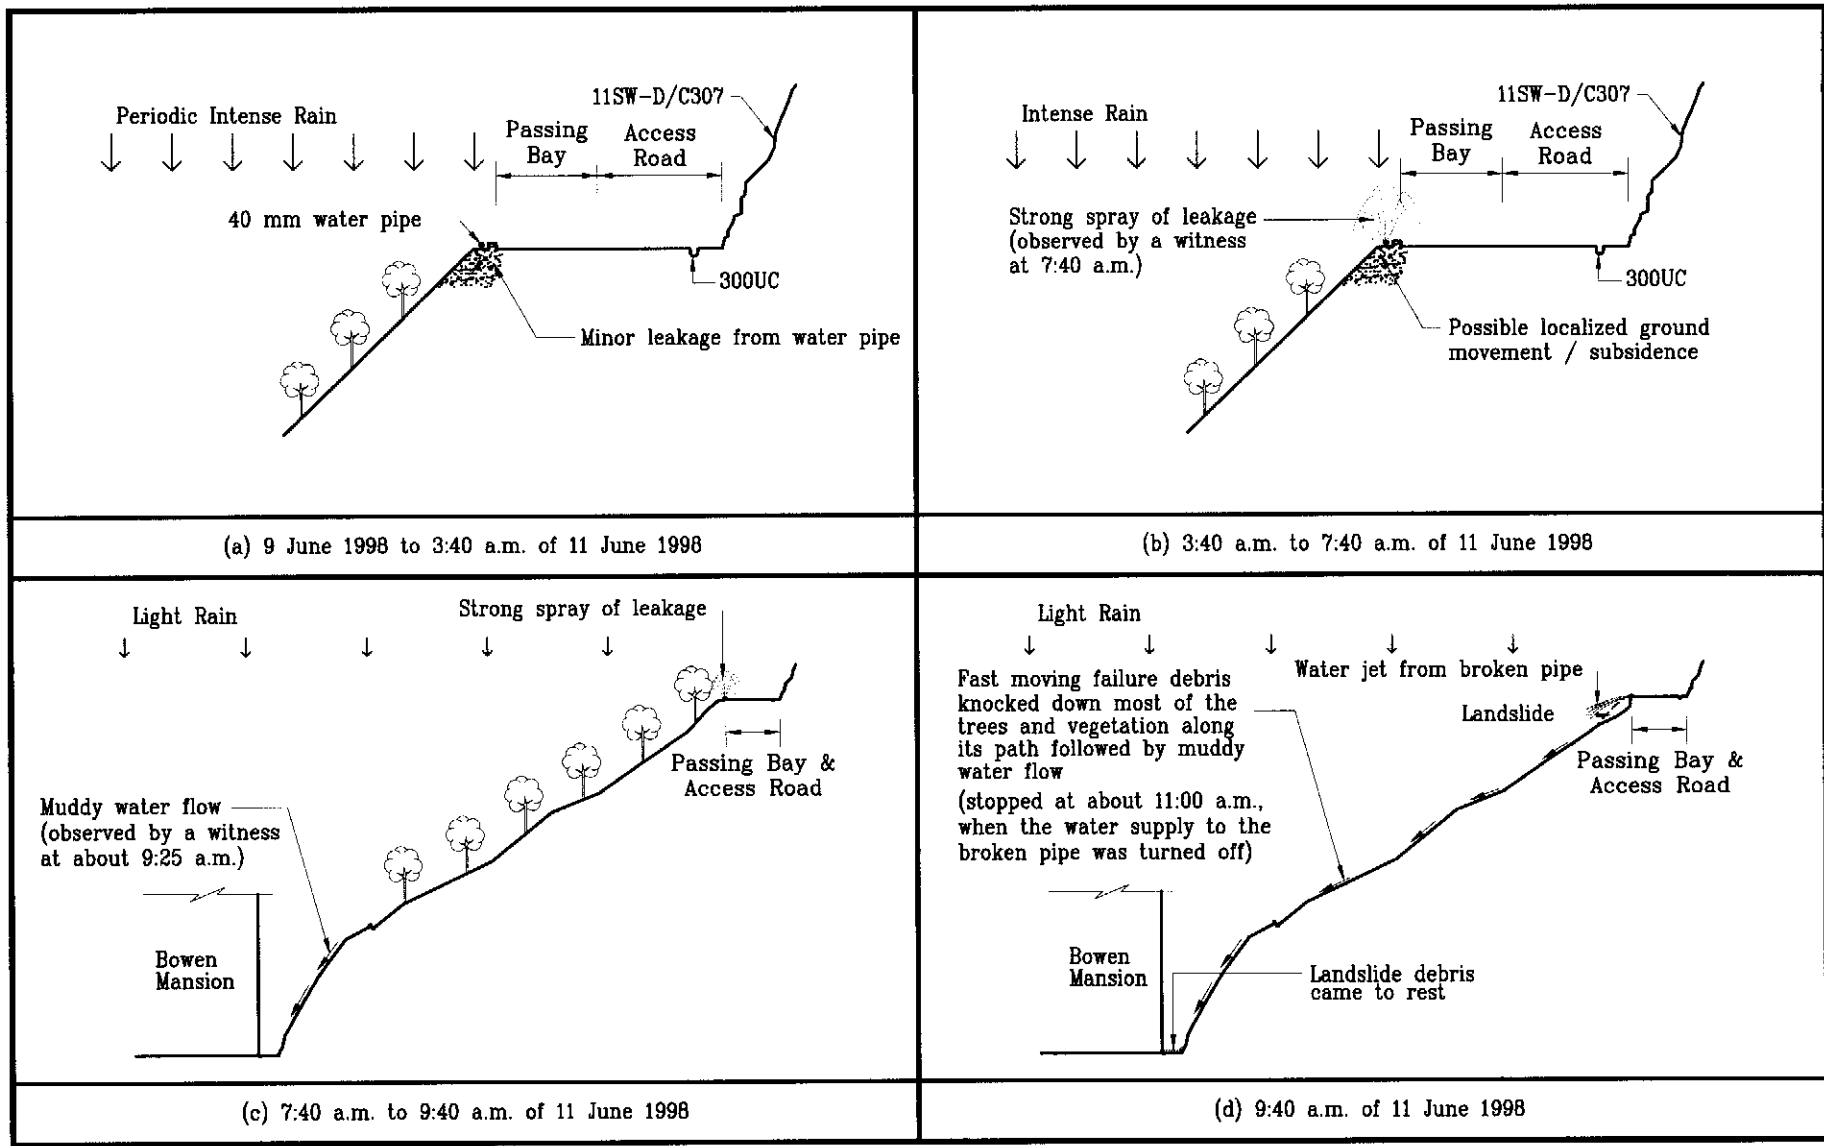
Figure 14 - Probable Sequence of Events

A summary of observations by witnesses and events preceding the landslide is given in Appendix B. The probable sequence of the landslide event has been re-constructed and is illustrated in Figure 14.
