**INVESTIGATION OF SOME
SELECTED LANDSLIDES
IN 1998
(VOLUME 6)**

GEO REPORT No. 113

**GEOTECHNICAL ENGINEERING OFFICE
CIVIL ENGINEERING DEPARTMENT
THE GOVERNMENT OF THE HONG KONG
SPECIAL ADMINISTRATIVE REGION**

**SECTION 1 :
DETAILED STUDY OF
THE LANDSLIDE AT
TATE'S RIDGE,
FEI NGO SHAN ROAD
ON 9 JUNE 1998**

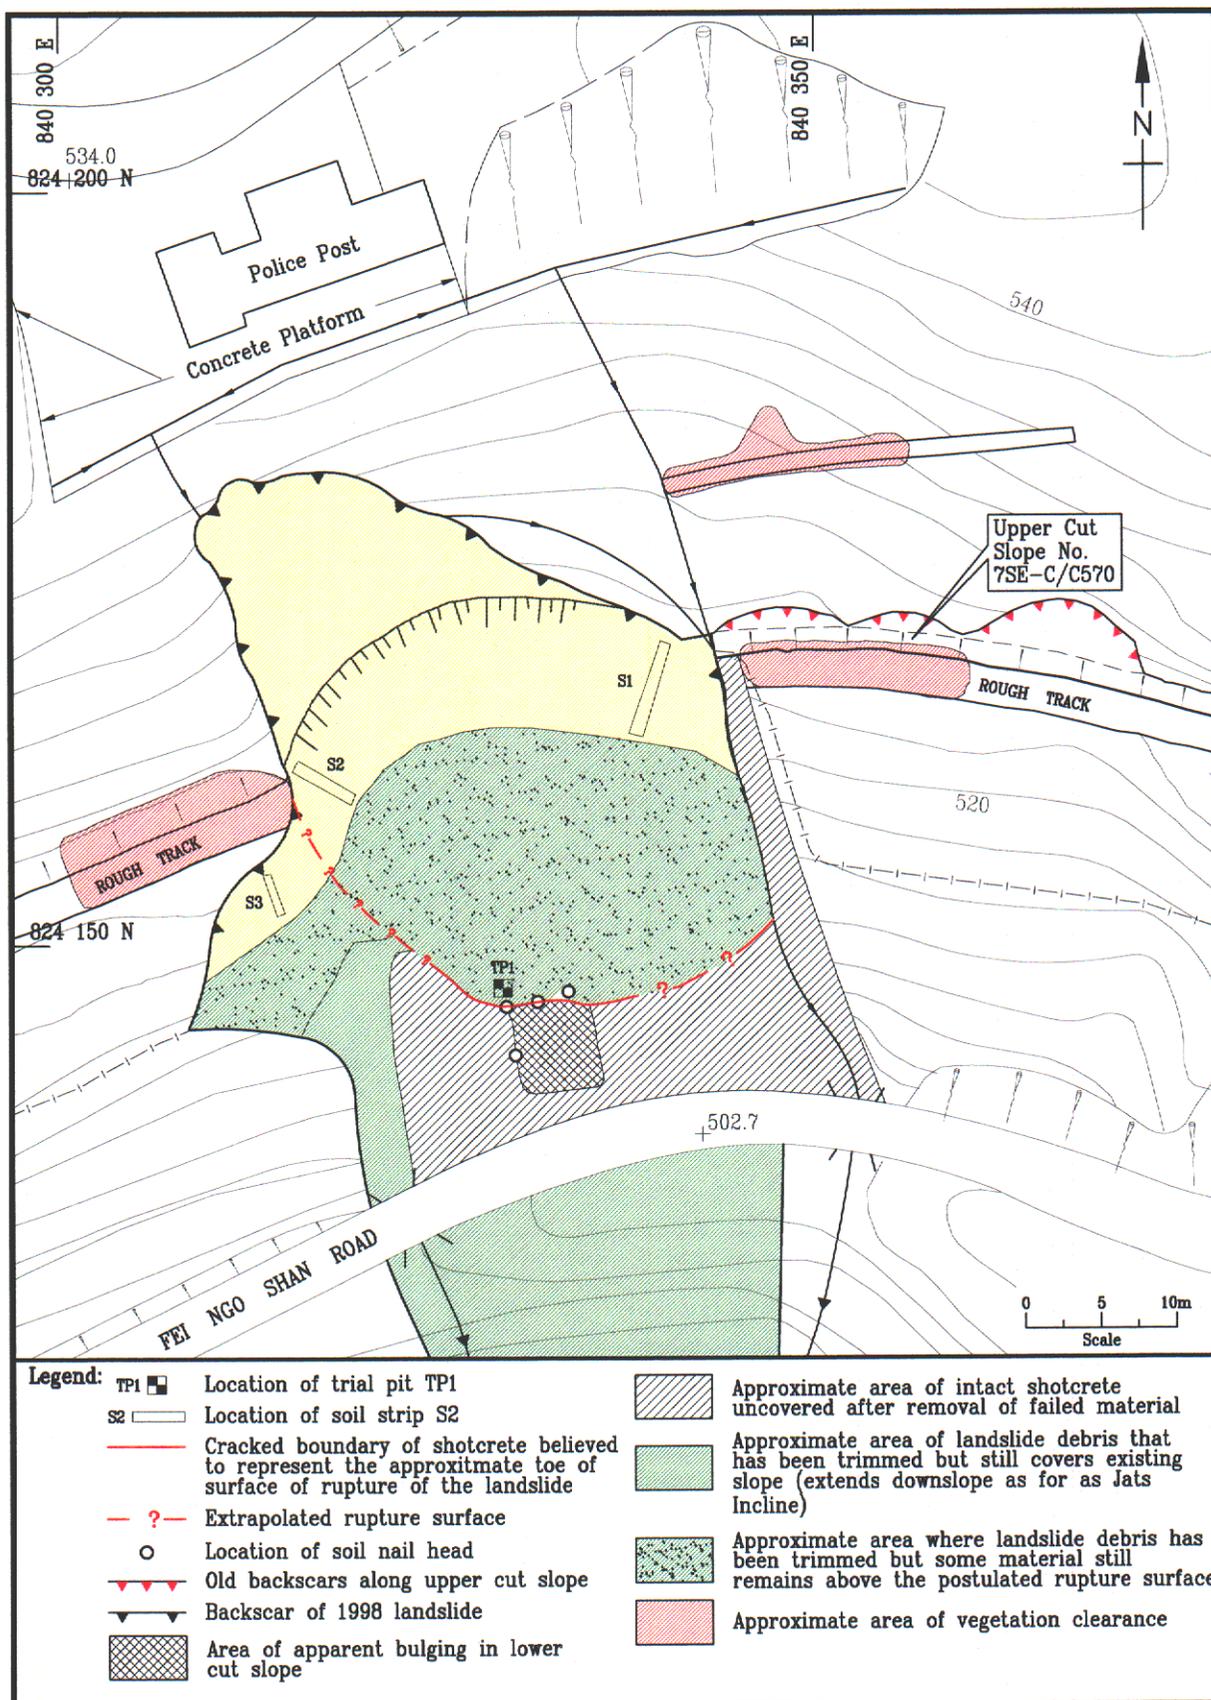
Figure 7 - Layout of Investigation Works and Details of the Site Following Clearance Works

Localised vegetation clearance works were also undertaken along the track on both sides of the landslide, and further up slope in the vicinity of the drainage ditch (Figure 7). The purpose of these was to investigate the presence of tension cracks, but on completion of the clearance works no evidence was revealed to indicate additional signs of instability linked to the current failure.

The installation of soil nails within the bottom 10 m of the lower cut slope suppressed further movement along the pre-existing deep-seated slip plane and effectively forced the unstable mass upslope to fail along a slip plane that daylighted above the soil nailed zone. This shallower failure involved ground that had cracked and opened up as a result of movement associated with the deeper-seated instability. This would have promoted rapid water ingress with the development of cleft water pressure and localised groundwater pressure during heavy rainfall. The failure mechanism may therefore be different to that of the deeper-seated instability. The margin of safety against the failure mode in 1998 was reduced by the removal of toe support from the lower cut slope (Figure 7) due to trimming works undertaken following the 1993 and 1997 instabilities.

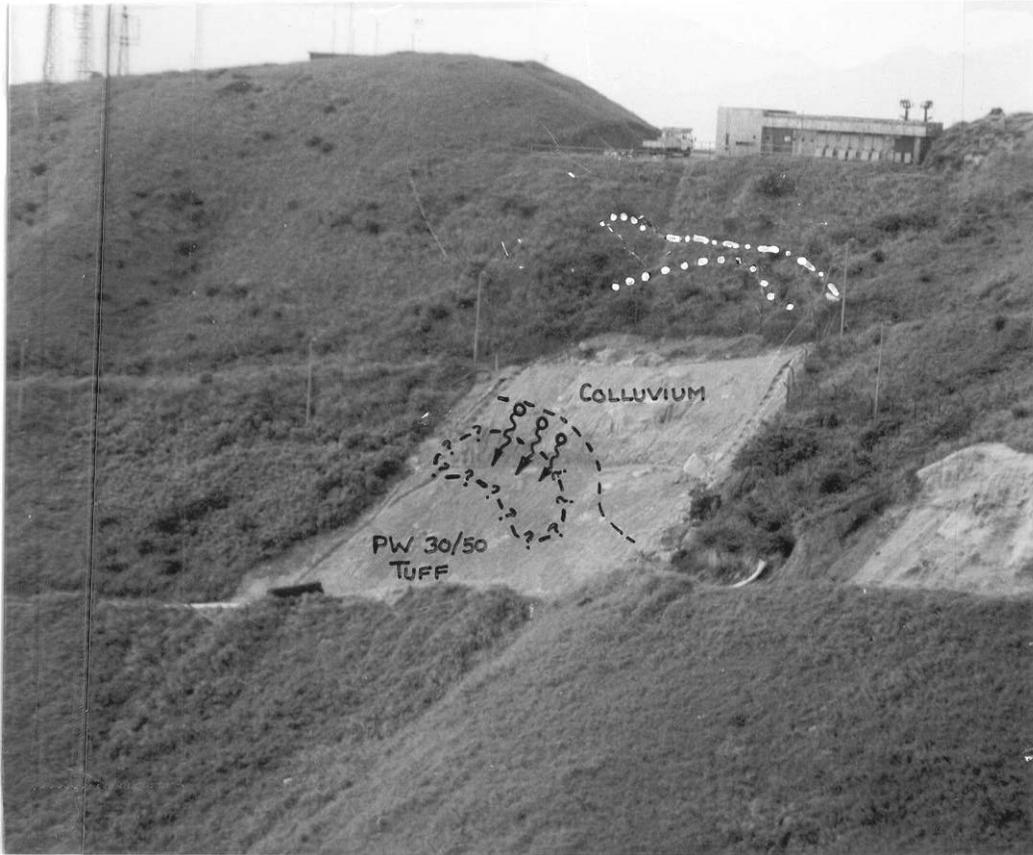
It is possible that the band of finer-grained material cutting across the lower cut slope may have had a local influence on the direction of groundwater flow at the interface with the tuff due to the permeability contrast between the two. Photographs show seepage issuing from the mid to upper-portion of the lower cut slope, suggesting the possible presence of high localised groundwater pressure (Plate 7). This is corroborated by observations made on site by the Planning Division of GEO following the failure in 1997 (Plate 8), as discussed in Section 2.3.3.

Plate 8 – View of Site Showing Observations Made by the Planning Division of GEO after Instability in 1997
 (Photographs taken on 24 September 1997)

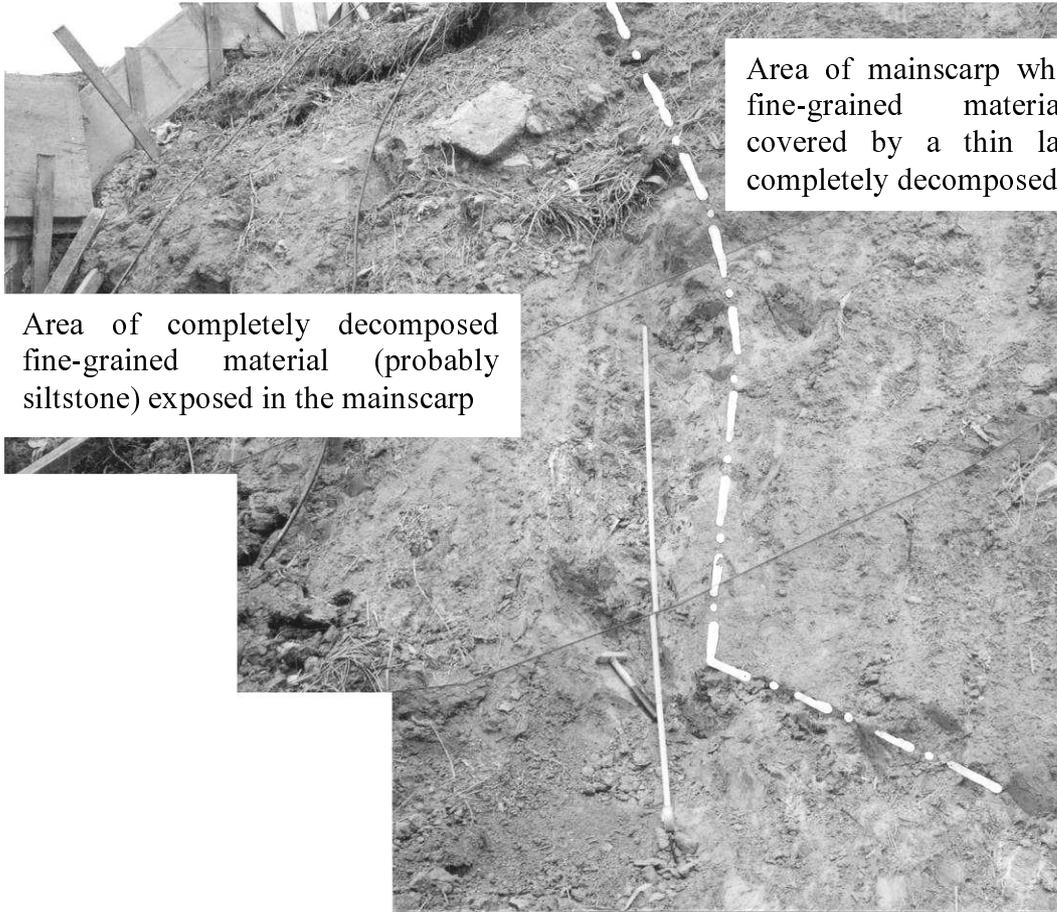
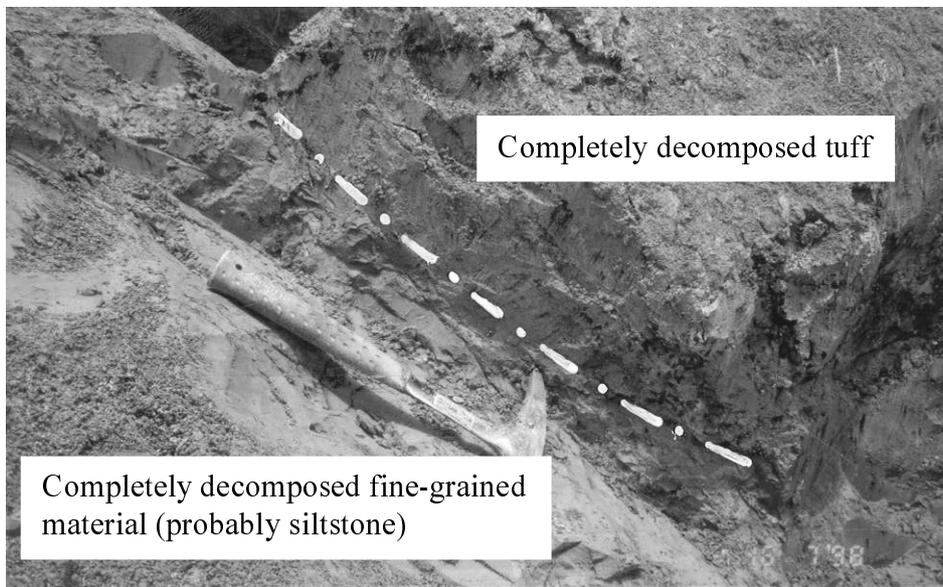
Plate 11 – View of Fine-grained Material (Probably Siltstone) Exposed along the Western Side of the Landslide (Photographs taken on 16 July 1998)

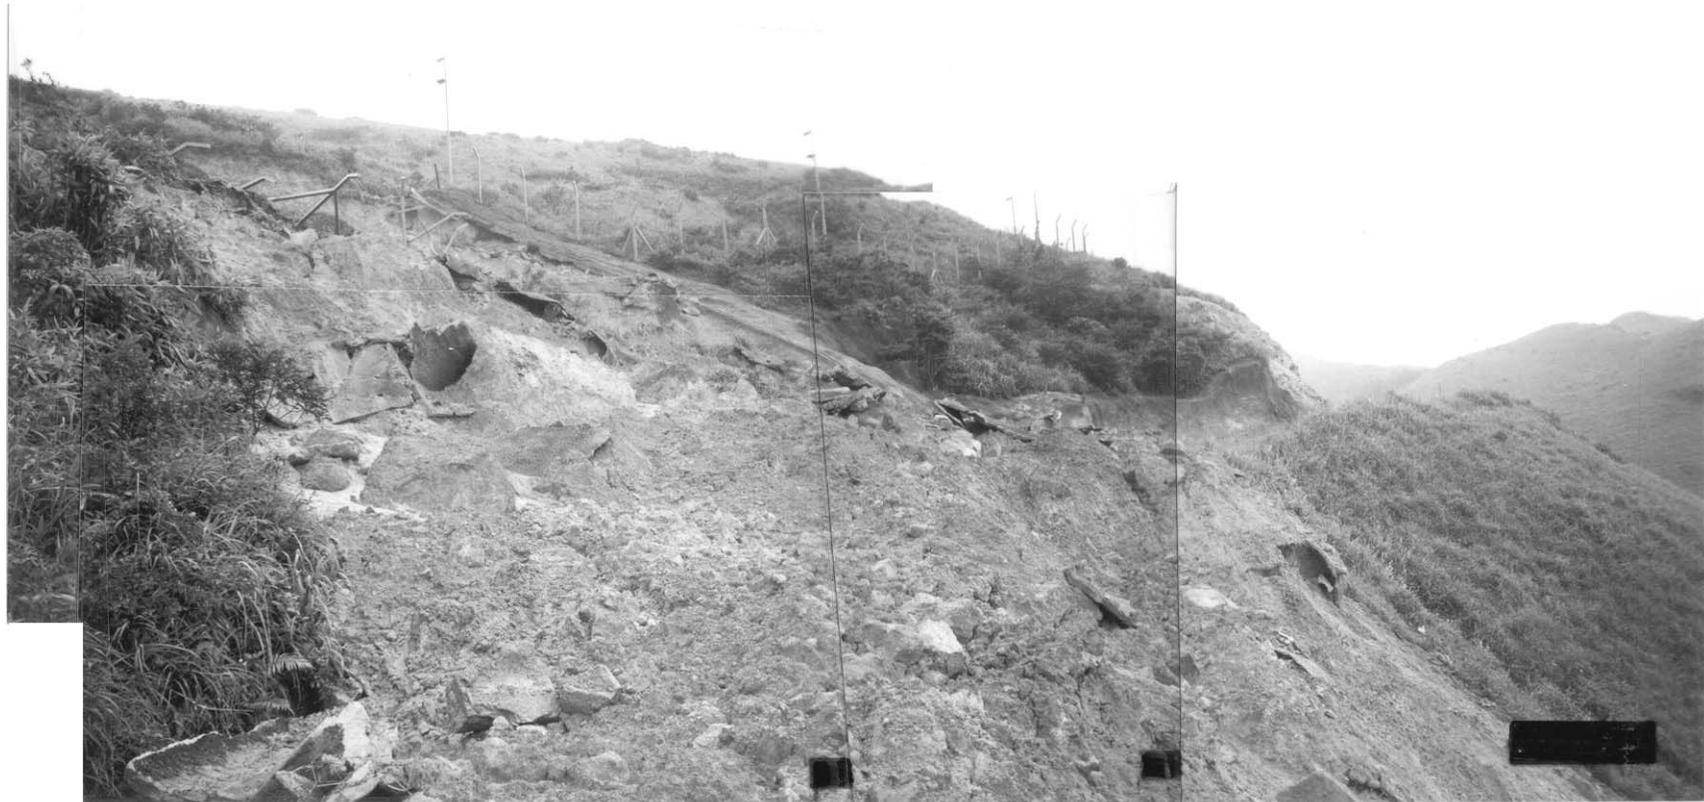
Plate 13 – View of Landslide Debris above Fei Ngo Shan Road Following 9 June 1998 Landslide
(Photographs taken on 10 June 1998)

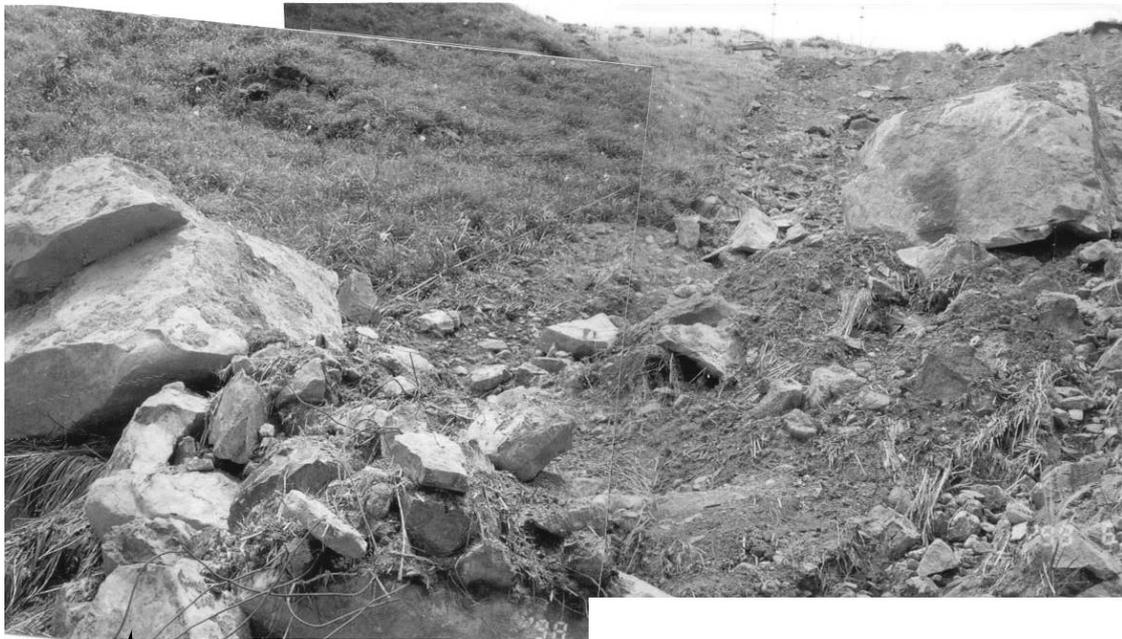
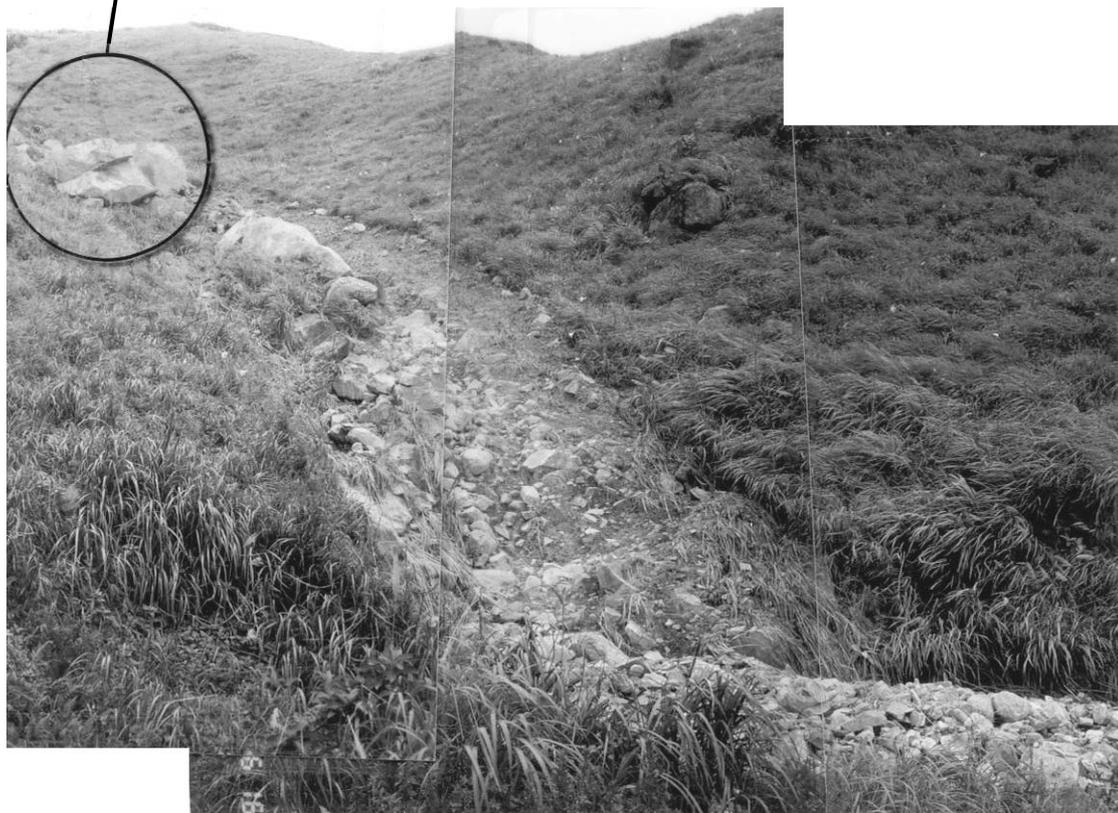
Plate 14 – View of Bouldery Material in the Lower Debris Trail Following
9 June 1998 Landslide
(Photographs taken on 10 June 1998)

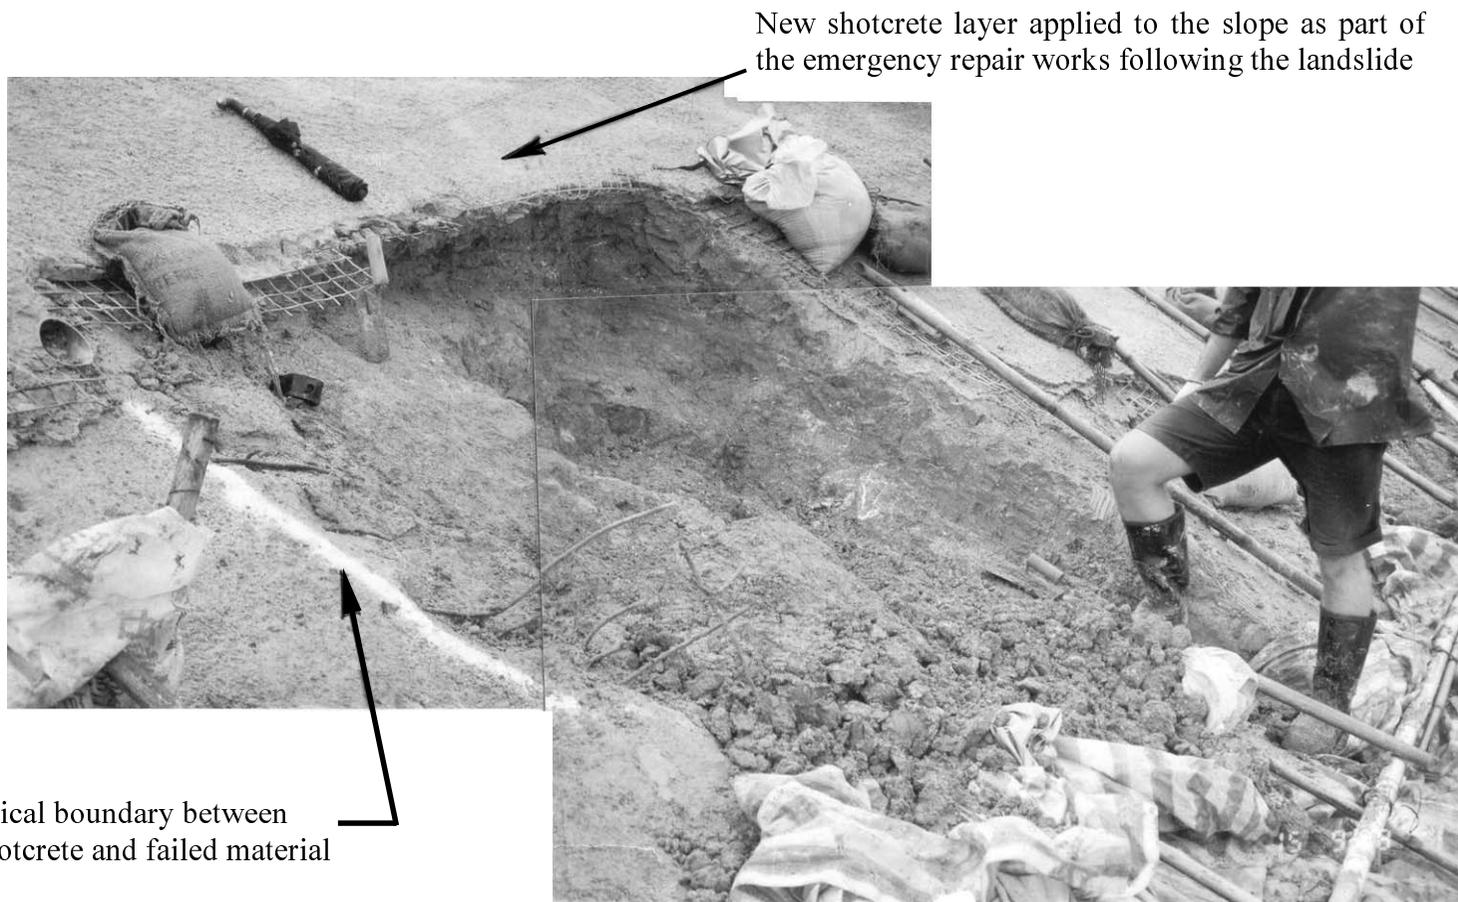
Plate 16 – General View of Trial Pit (TP1) in the Lower Cut Slope
(Photographs taken on 9 September 1998)

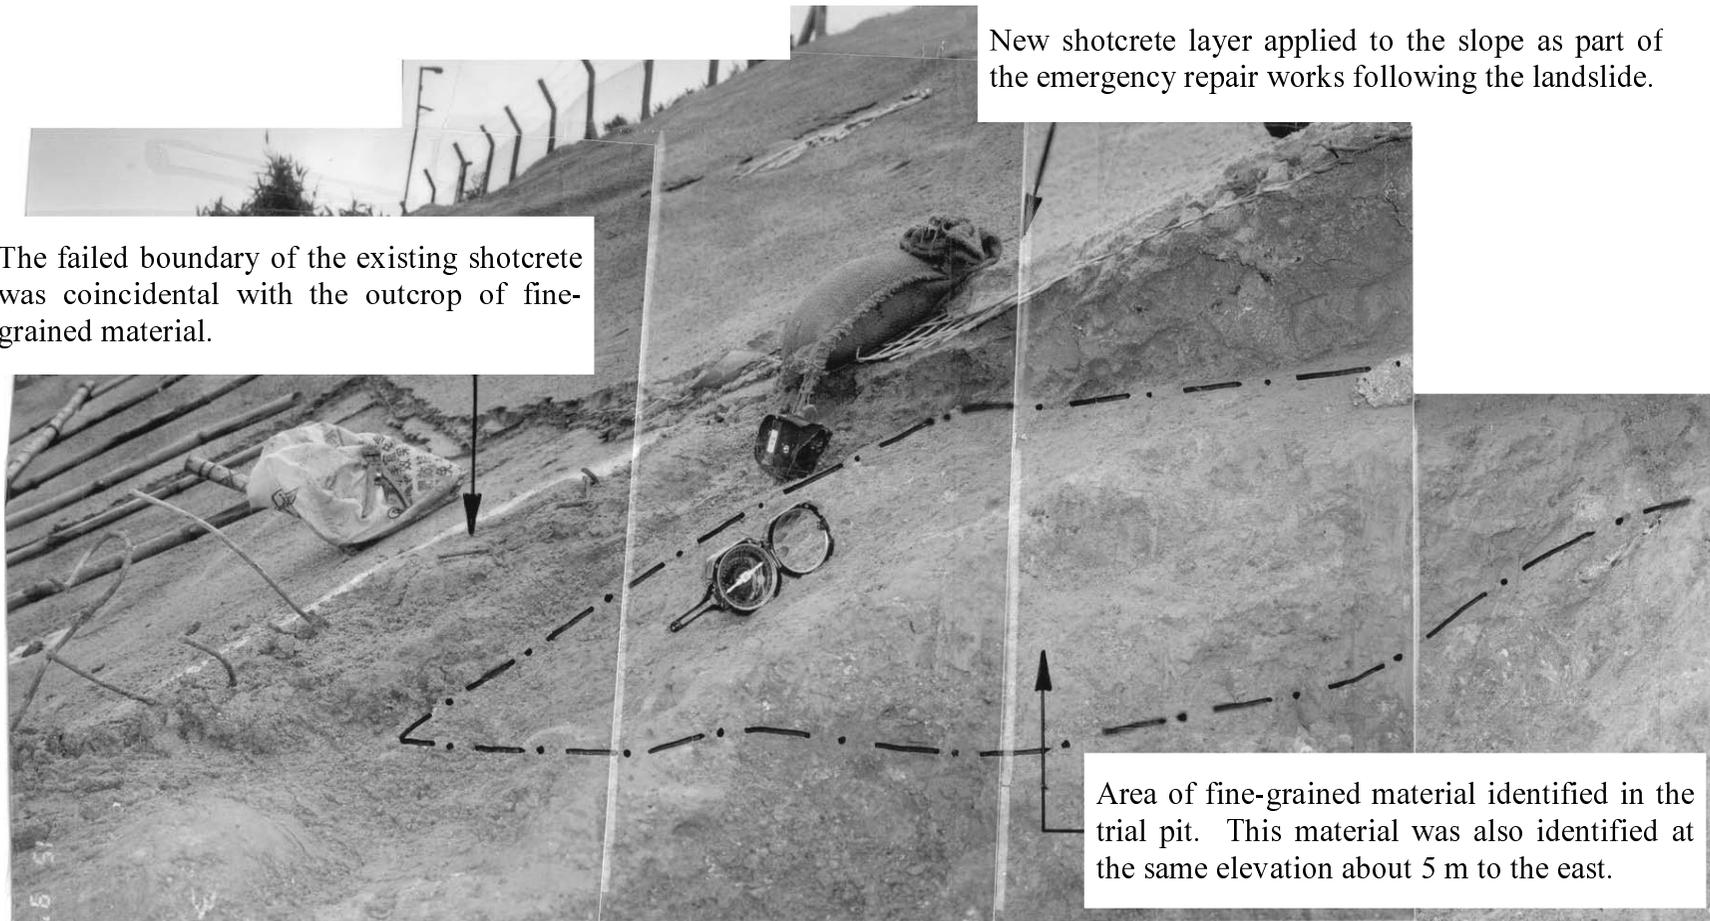
In the westerly face of the trial pit the seam of remoulded material daylighted from the slope above the siltstone (Plate 18). This position of the daylighting seam was coincidental with the sub-vertical sheared shotcrete boundary discussed in Section 3.2. In the easterly face of the trial pit the structure within the CDT that was present in the upslope face was not as distinct. This made it difficult to identify the exact alignment and inclination of the remoulded seam, but it is estimated that it dips out of the slope at an angle of about 25° in a southerly direction. Despite the uncertainty regarding the exact alignment of the remoulded seam, it is clear that in the lower easterly face of the trial pit the seam daylighted above the nail heads exposed following clearance of the landslide debris (Section 3.2). This, together with the sub-horizontal sheared shotcrete boundary identified just below the nail heads, provides a strong indication that this is the area where the toe of the rupture surface daylighted from the slope.

Plate 18 – View of Lens of Fine-grained Material (Probably Siltstone) Exposed in the Trial Pit (TP1)
 (Photographs taken on 9 September 1998)
