INVESTIGATION OF SOME SELECTED LANDSLIDES IN 1998 (VOLUME 7)

GEO REPORT No. 114

Fugro Scott Wilson Joint Venture

**GEOTECHNICAL ENGINEERING OFFICE
CIVIL ENGINEERING DEPARTMENT
THE GOVERNMENT OF THE HONG KONG
SPECIAL ADMINISTRATIVE REGION**

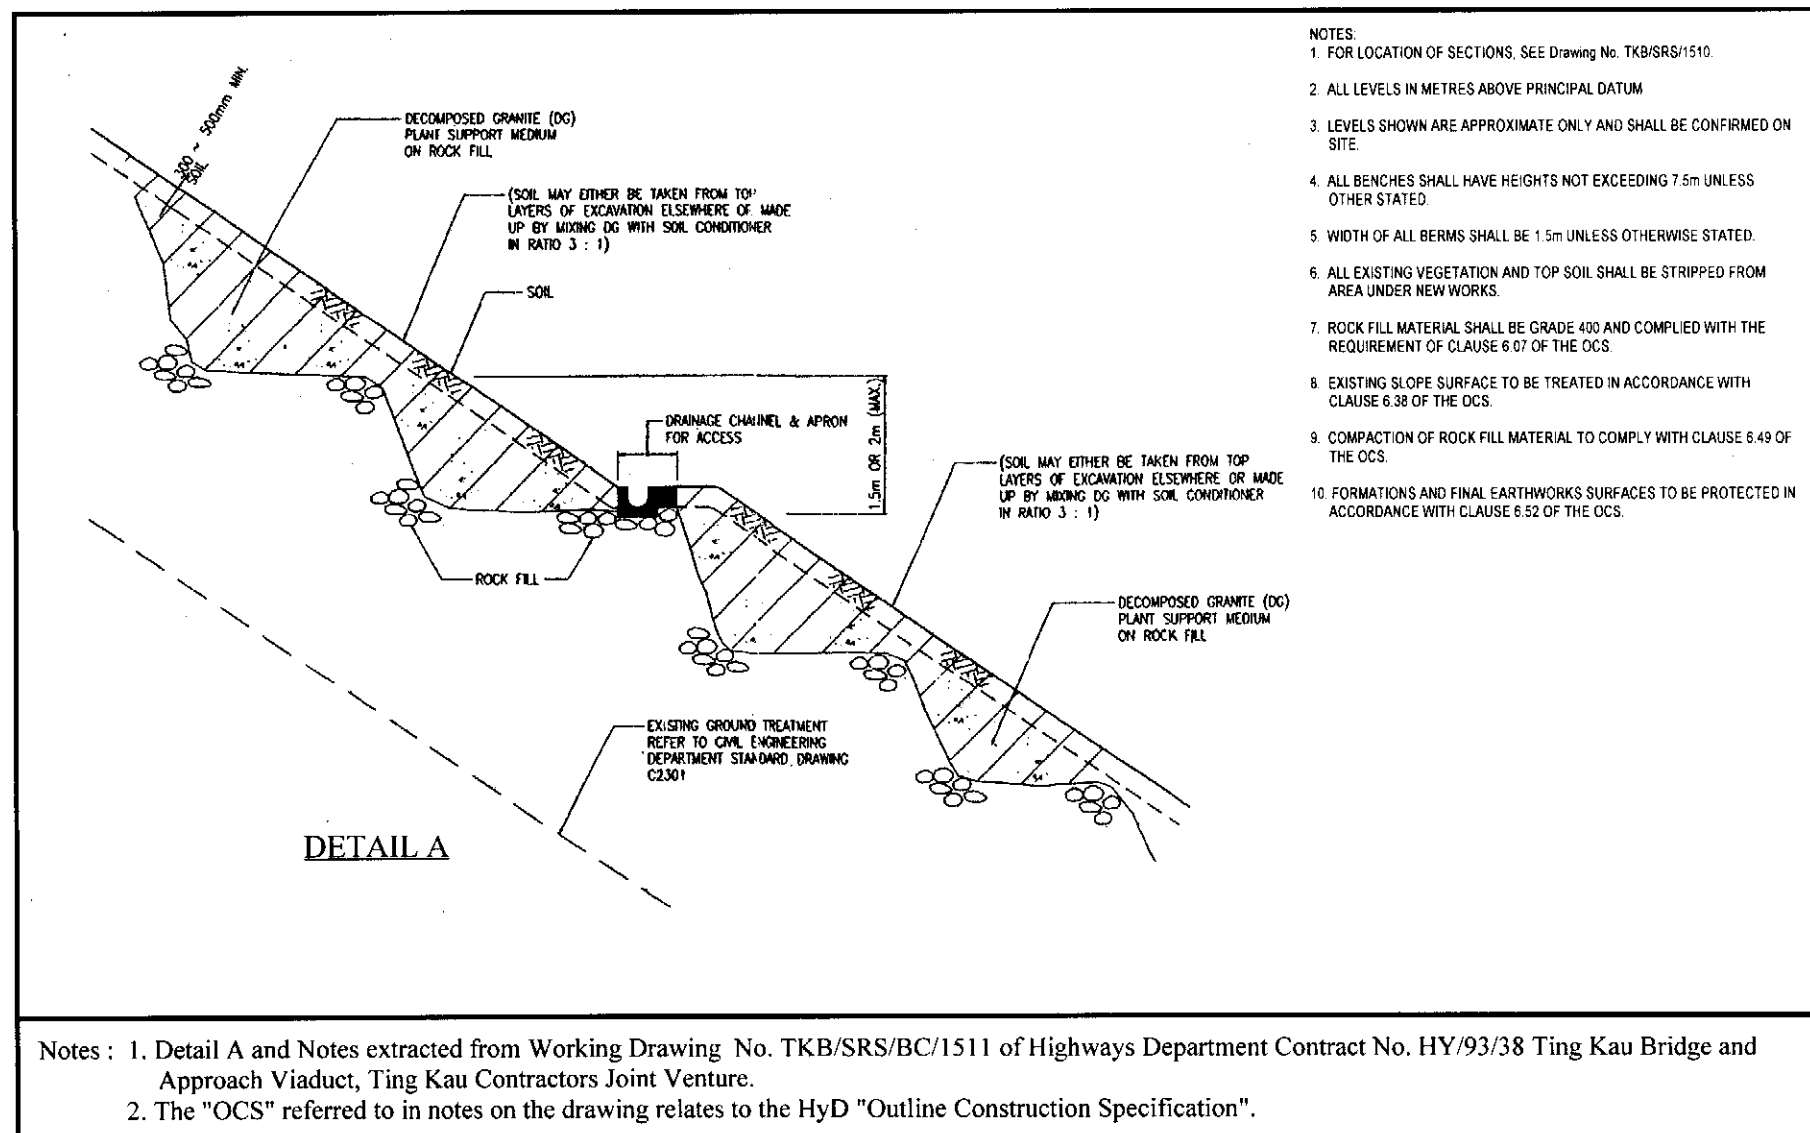
Figure 9 - Typical Detail – Ramp G Slope Construction

With regard to the shallow failures at the slope face, ESA (1998b) note that the drawing (Figure 9) does not specify any benching of the DG fill prior to placement of the

Direct surface infiltration is considered to be the most likely source of water affecting the two vegetated slopes. In addition, the areas opened up for tree planting could have allowed concentrated water ingress into the slope. The detailing of the slope involving termination of the berm aprons before the crest of the batter below (i.e. a horizontal uncovered surface in the landscaping fill) also promoted infiltration (Figure 9 and Plate 58).

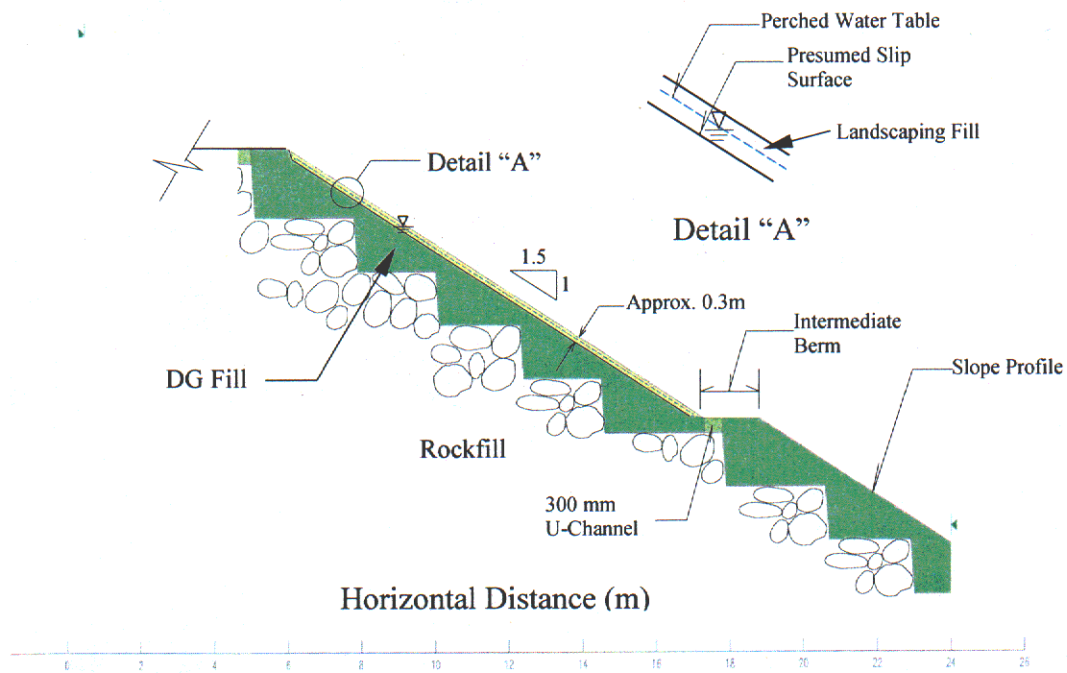
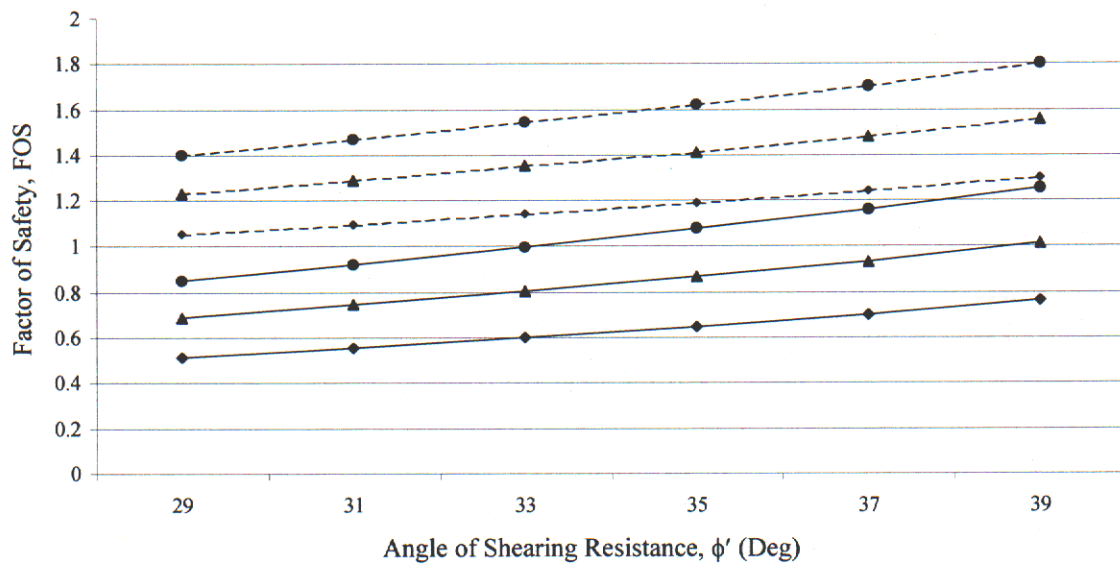
Figure 23 – Theoretical Stability Analysis (Sheet 1 of 3)

For the first failure mode, groundwater was modelled as a phreatic surface parallel to the slope face and above the interface between the DG fill and landscaping fill. The results of the analyses are presented in Figure 23. Shear strength parameters included in the analyses are considered to represent a reasonable range of expected values for the nature of fill materials involved, given the method of placement and the likely variable compaction of the fill material. The analyses suggest that a transient elevated water table in the range of about 100 mm to 200 mm above the DG fill is required to initiate failure.

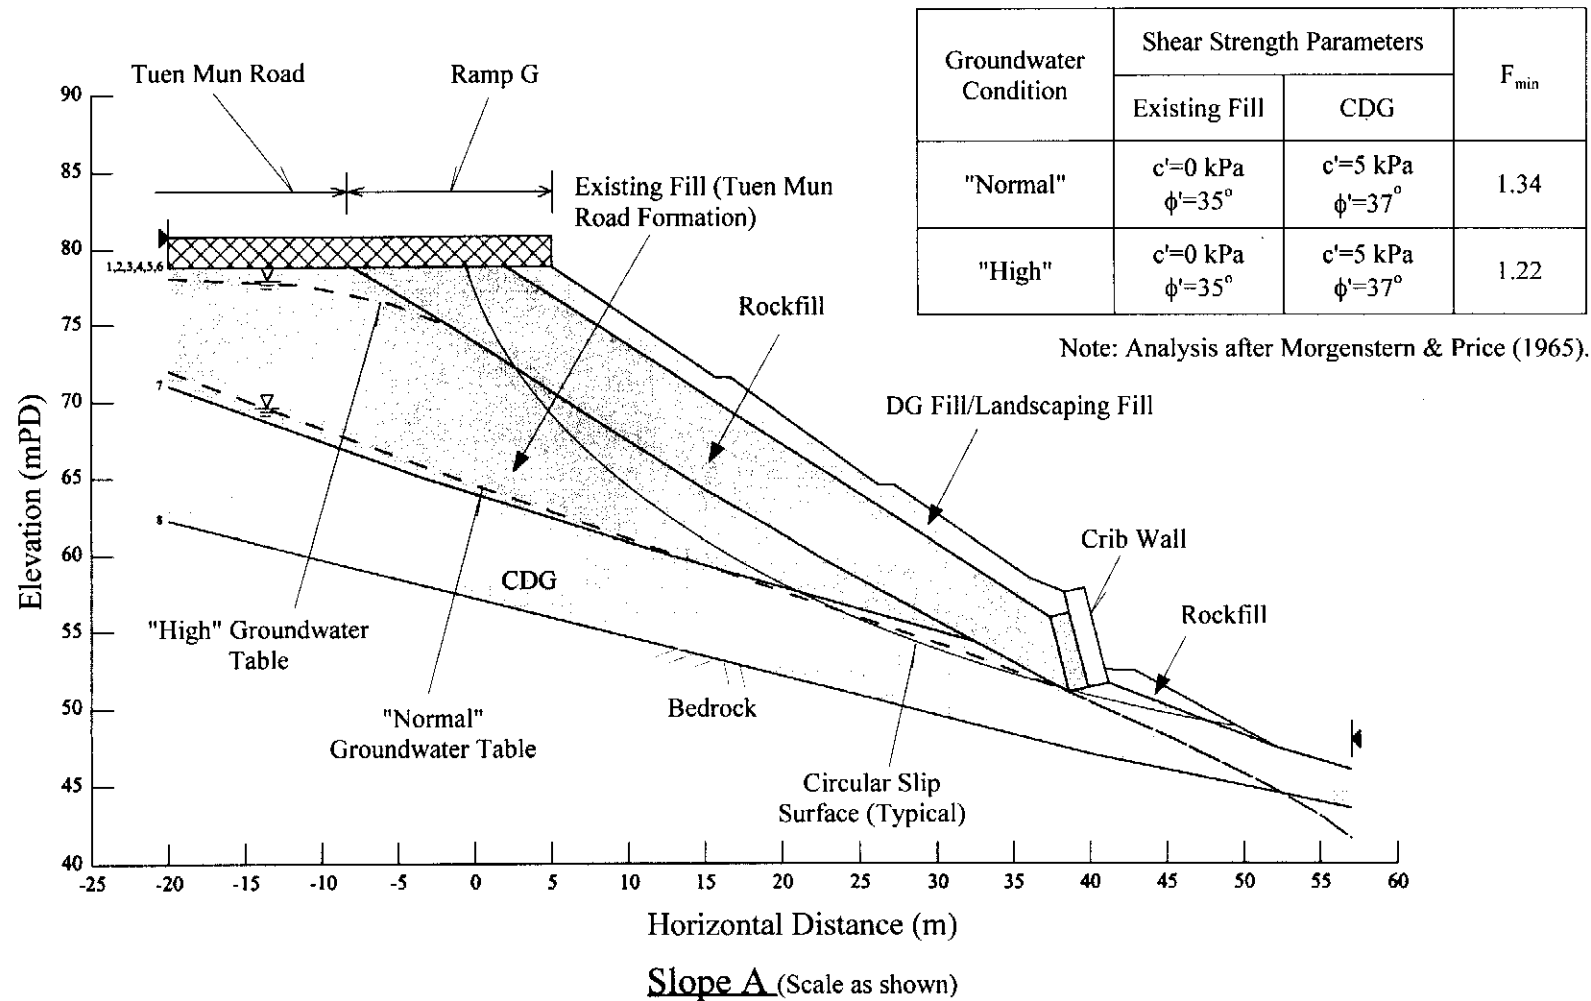
Figure 24 – Theoretical Stability Analysis (Sheet 2 of 3)

Two sections have been analysed for the deeper-seated failure mode, one relating to each of the fill slopes, and are presented on Figures 24 and 25 respectively.

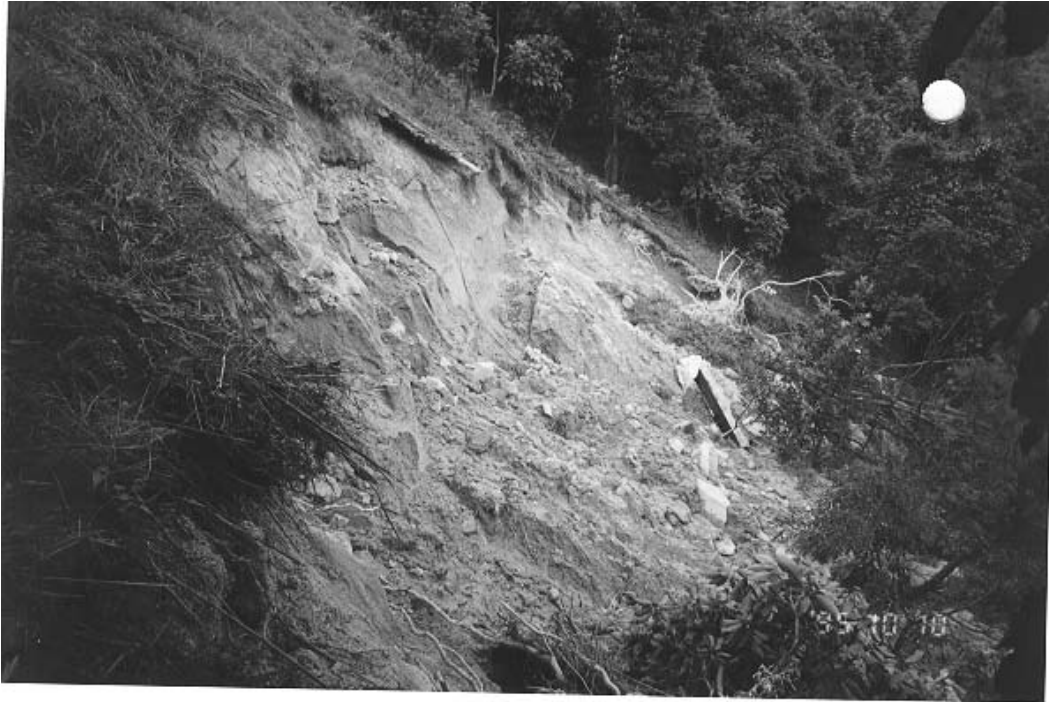
Plate 2 – View North-East Across Landslide Scar in Slope No. 6SE-C/FR13.
(Photograph Taken on 10 October 1995)

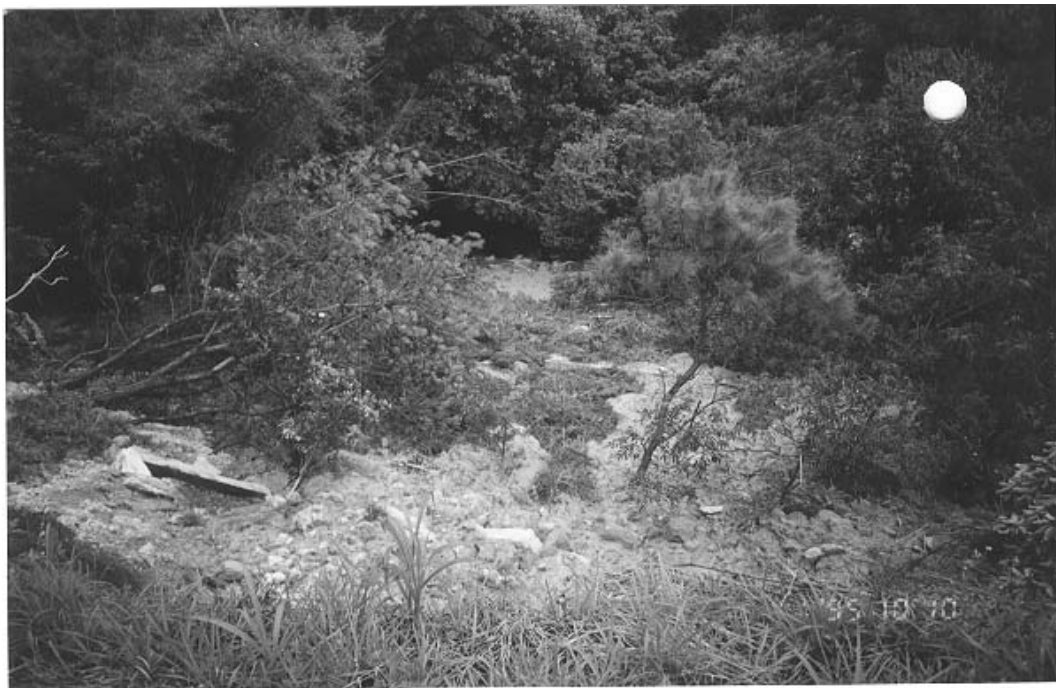
Plate 3 – View South-East Over Landslide Scar Indicating Debris Runout.
Concrete Structure Visible in Debris on Left. Reservoir Filled With
Debris Visible in Centre Background. (Photograph Taken on
10 October 1995)

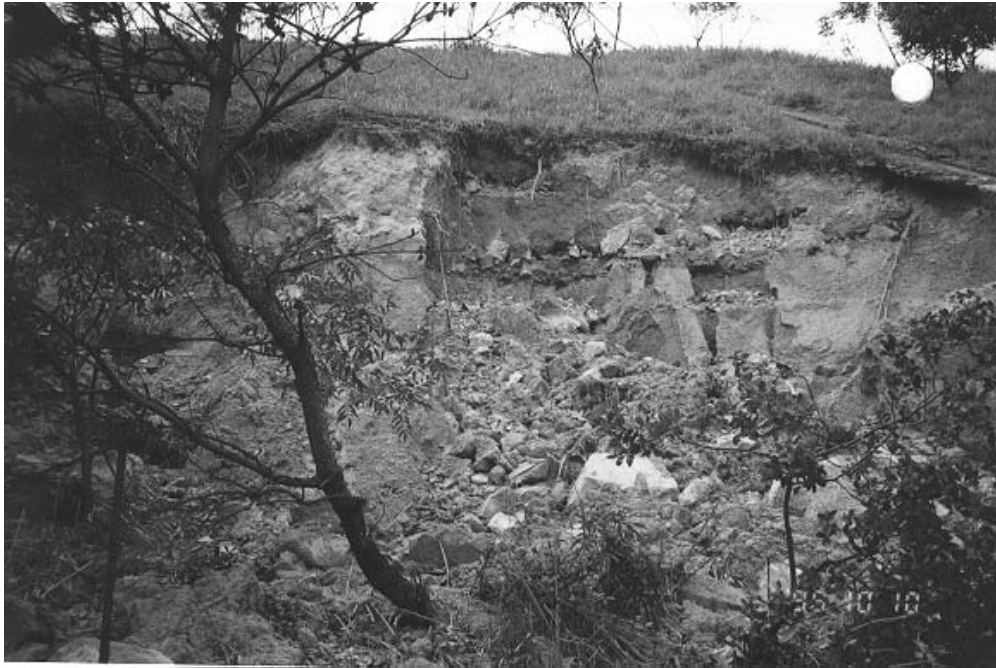
Plate 4 – View North-West Across Landslide Scar Towards Main Scarp.
Horizontal Layering Visible in Exposed Fill.
(Photograph Taken on 10 October 1995)

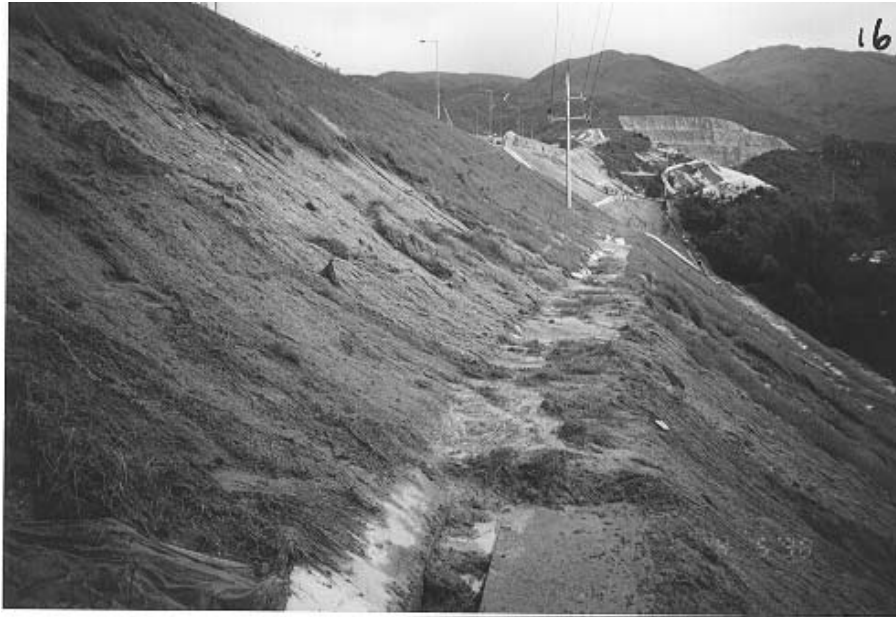
Plate 8 – Event No. 1: 4 May 1998. View North-East Along 60 mPD Berm from South End of Slope B Indicating Scar on Batter Above and Runout of Debris on Batter Below. (Photograph Taken on 4 May 1998)

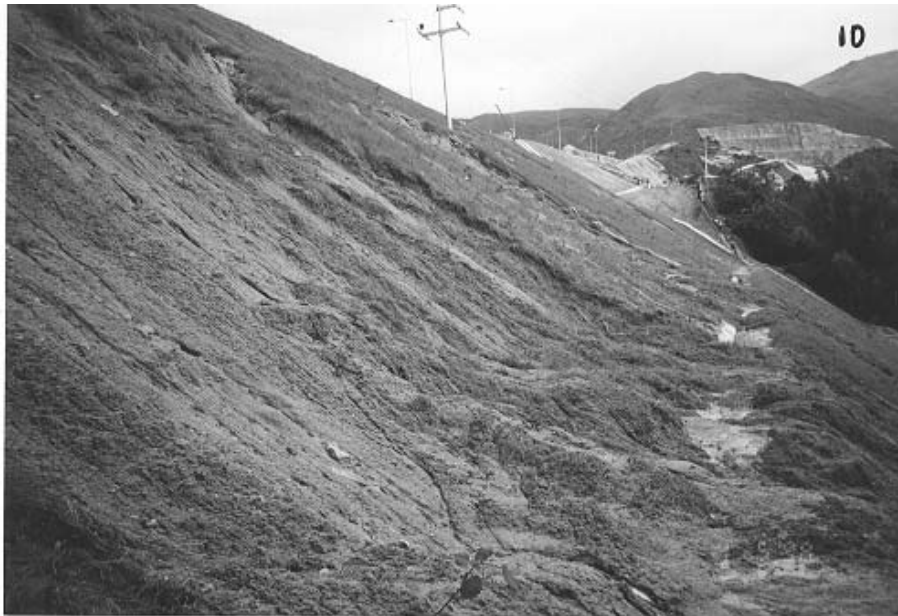
Plate 9 – Event No. 1: 4 May 1998. View North-East Along 52.5 mPD Berm from South End of Slope B Indicating Scars on Batter Above and Debris Deposition on Berm and Batter Below. (Photograph Taken on 4 May 1998)

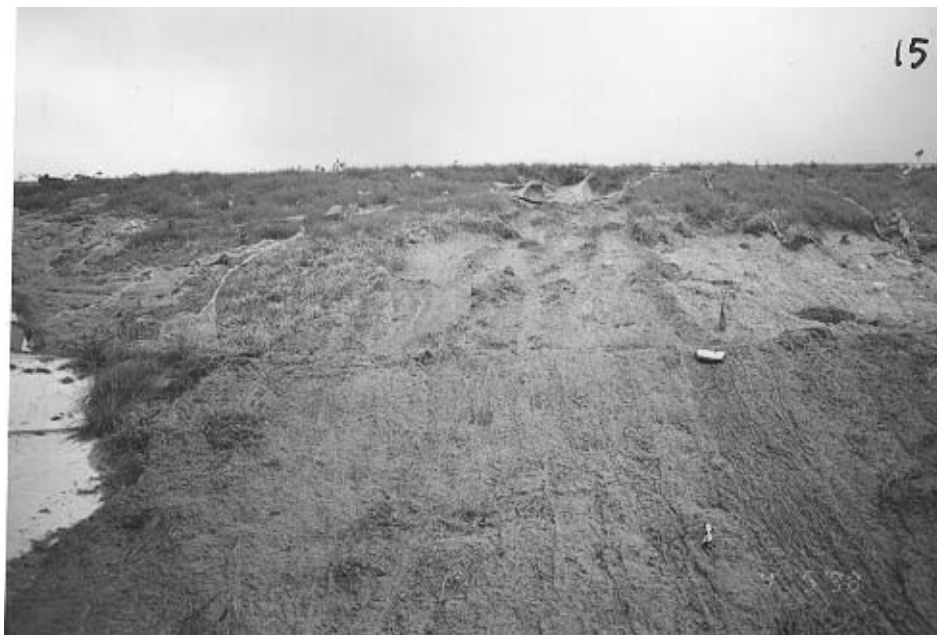
Plate 10 – Event No. 1: 4 May 1998. View North-West Towards Crest of Slope from 52.5 mPD Berm at South End of Slope B. White Tile to Right of Centre is at Edge of 60 mPD Berm. Note Landslide Scar in Batter Above 60 mPD and Debris Runout Over Batter Below (Hydroseed Intact). Note Also Slumping of Face of Batter to Left of Scar. (Photograph Taken on 4 May 1998).

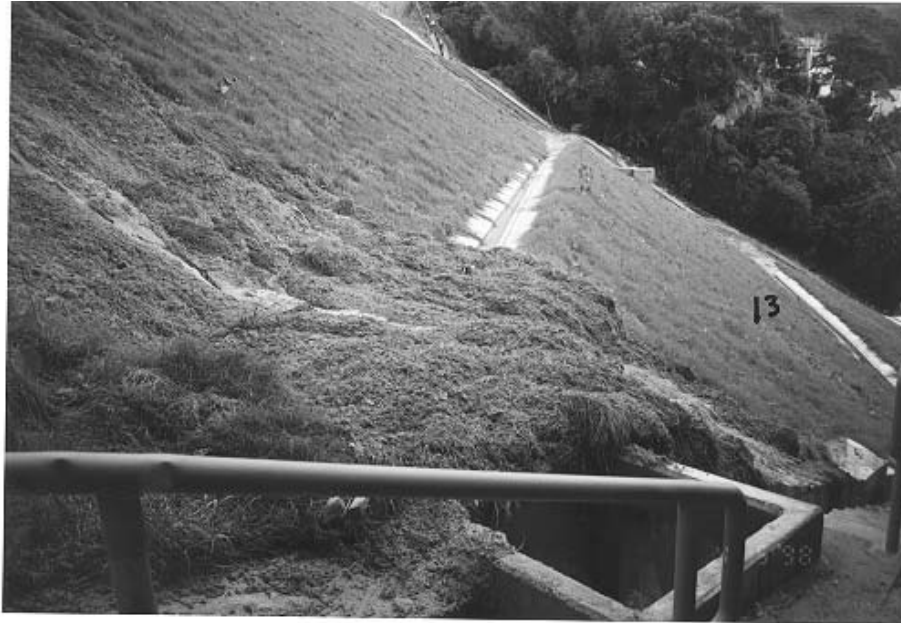
Plate 12 – Event No. 1: 4 May 1998. View North-East Along 45 mPD Berm from South End of Slope B. Accumulated Debris on Berm in Foreground. Note Also Debris on Same Berm in Distance Beyond Manhole on Slope Face, and Debris Deposition on 37.5 mPD Berm Below on Right of Frame. (Photograph Taken on 4 May 1998)

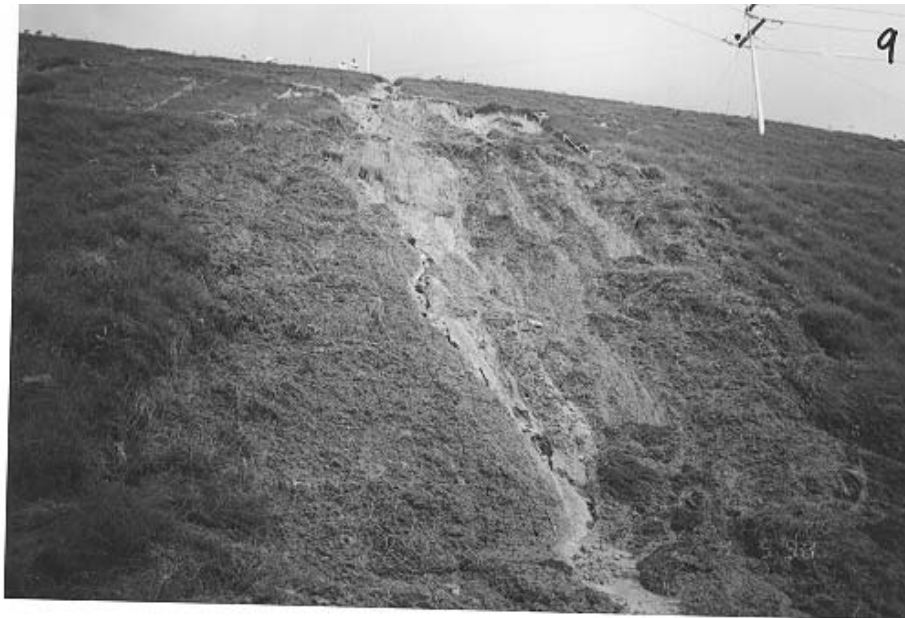
Plate 13 – Event No. 1: 4 May 1998. View North-West Towards Crest of Slope B from 45 mPD Berm up Succession of Landslide Scars Below Road Drainage Outlet Above 67.5 mPD Berm at CH 1000 Note Washout of Scars and Accumulation of Debris on Batter Above 45 mPD Berm in Foreground. (Photograph Taken on 4 May 1998)

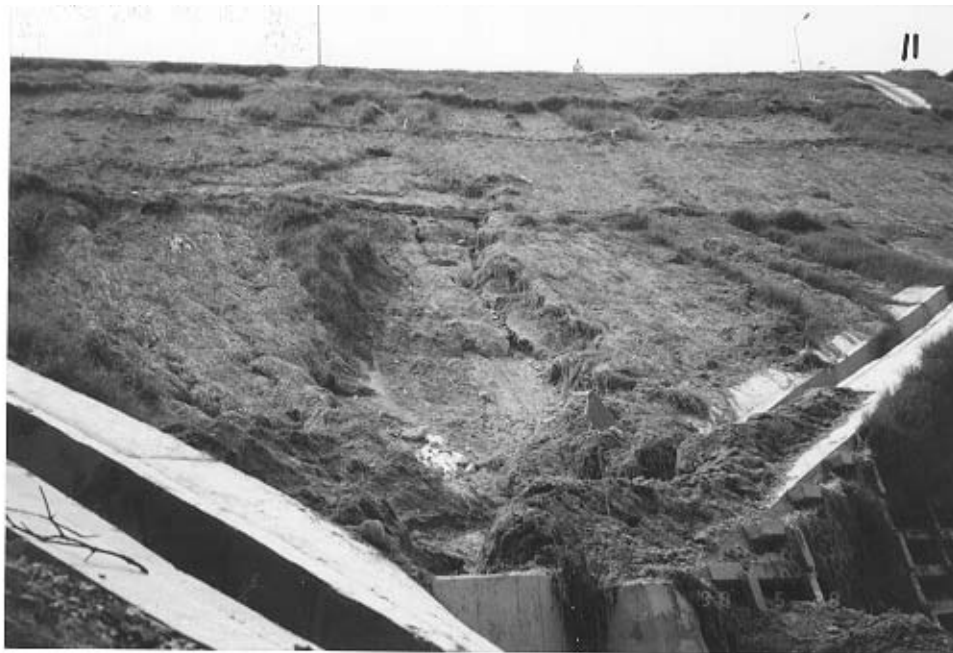
Plate 21 – Event No. 2: 24 May 1998. View North-West Towards Crest of Slope A Indicating Scars and Debris Runout on Slope Face. Note Layering Parallel to Slope Face in Scar on Lower Batter and Secondary Washout of Scar. Note Also Main Scarp in Debris on Batter Above in Right of Frame. (Photograph Taken on 28 May 1998)

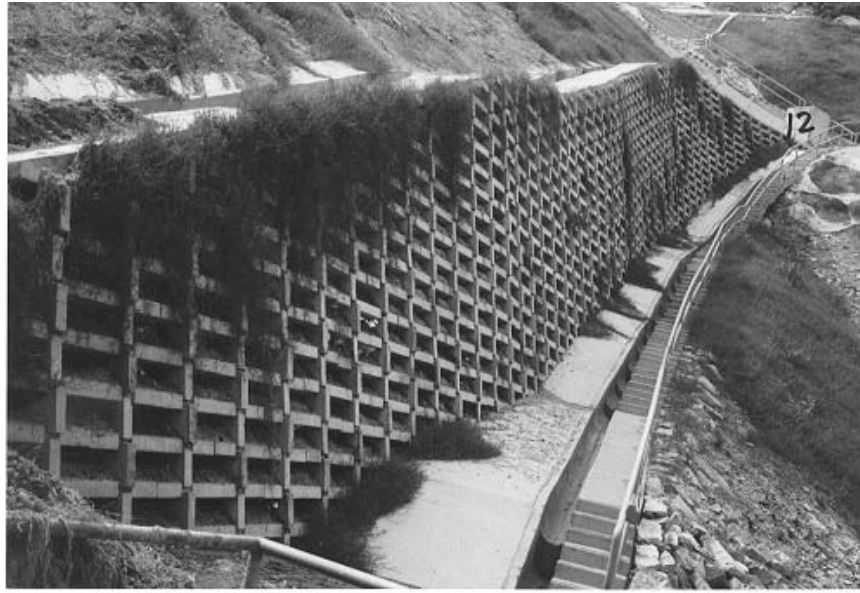
Plate 22 – Event No. 2: 24 May 1998. View North Along Crib Wall at Toe of Slope A. Note Lack of Debris Over-spill at Toe of Wall and Loss of Fine Material (Topsoil) From Wall Infill. (Photograph Taken on 28 May 1998)

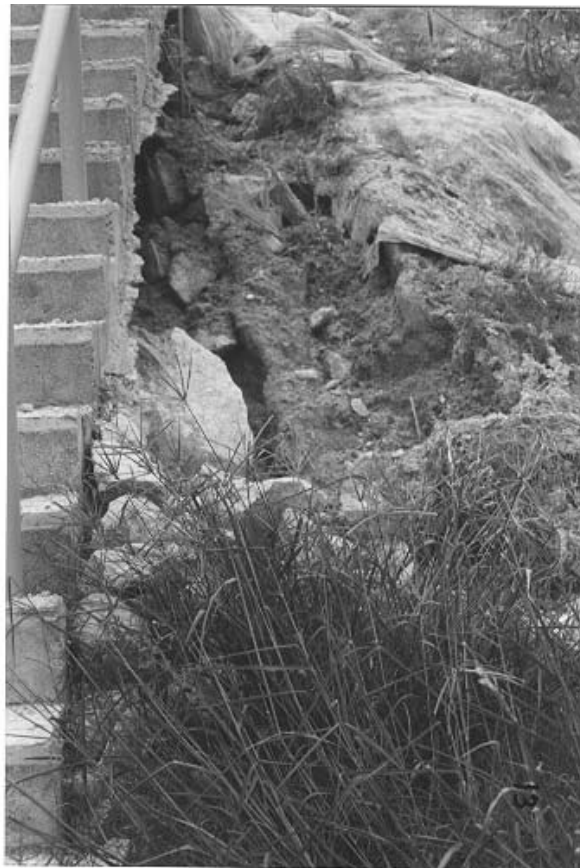
Plate 23 – Event No. 2: 24 May 1998. Close-up of Access stairway Below Crib Wall Indicating Washout of Fill Material and Undermining of Stairs. (Photograph Taken on 28 May 1998)

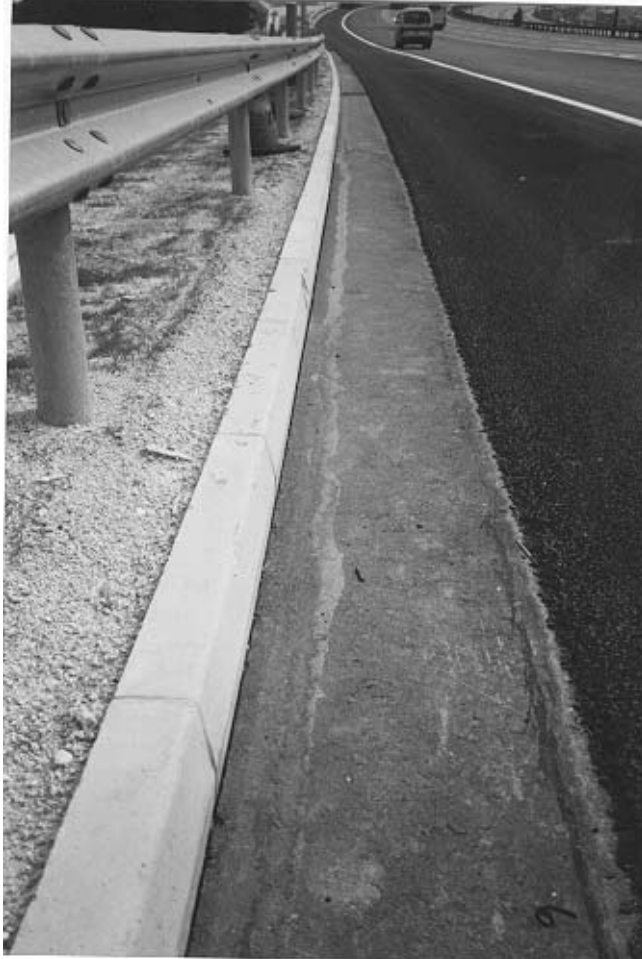
Plate 24 – Event No. 2: 24 May 1998. View South-West Along Crest of Slope B
Indicating Separation Between Asphalt pavement and Kerb Beam.
(Photograph Taken on 28 May 1998)

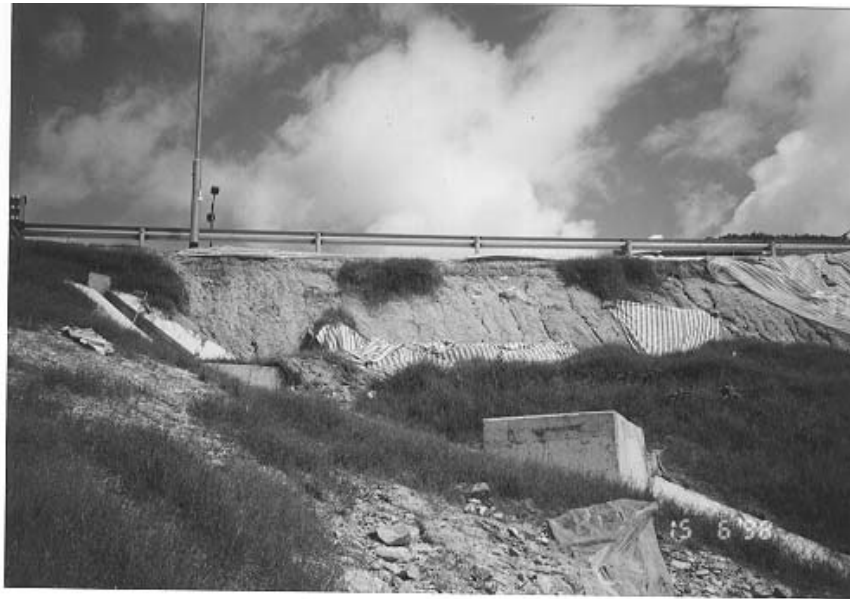
Plate 30 – Event No. 3: 9 June 1998. View North-West Towards Top Batter of Slope A at South End of Slope. Scar Precedes Event No. 3. (Photograph Taken on 15 June 1998)

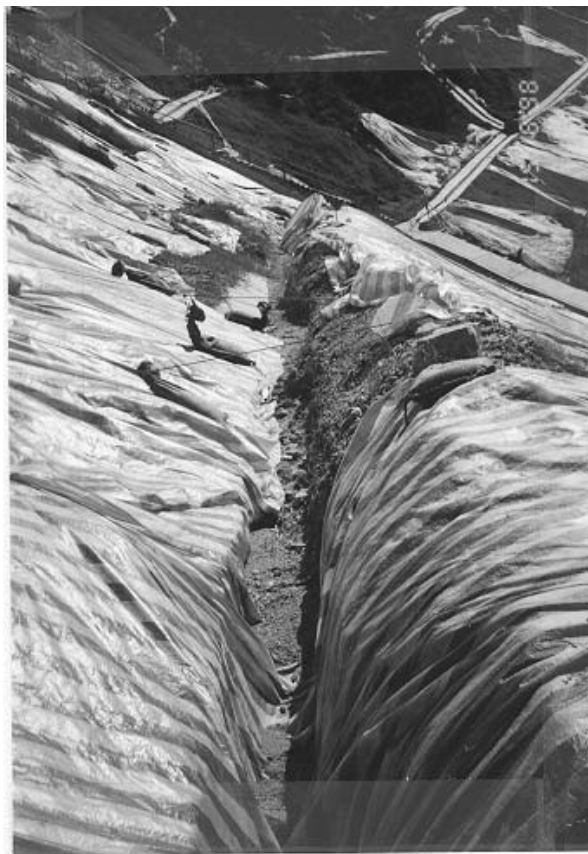
Plate 31 – Event No. 3: 9 June 1998. View North-East Along 64.5 mPD Berm on Slope A Indicating Debris Previously Stockpiled on Berms Washed into Surface Drainage. (Photograph Taken on 15 June 1998)

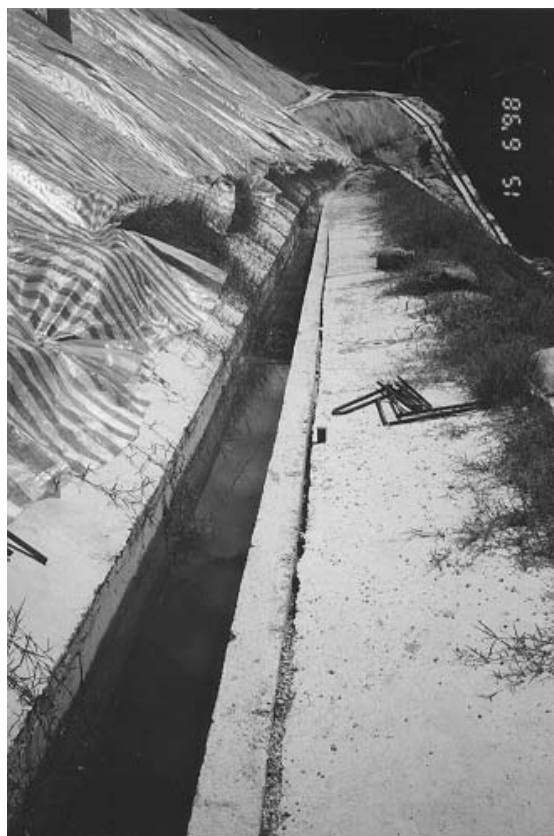
Plate 35 – Event No. 3: 9 June 1998. View North-East Along 60 mPD Berm on Slope B Indicating Separation of Berm Apron Slab from Berm U-Channel. Also Note Standing Water in U-Channel. (Photograph Taken on 15 June 1998)

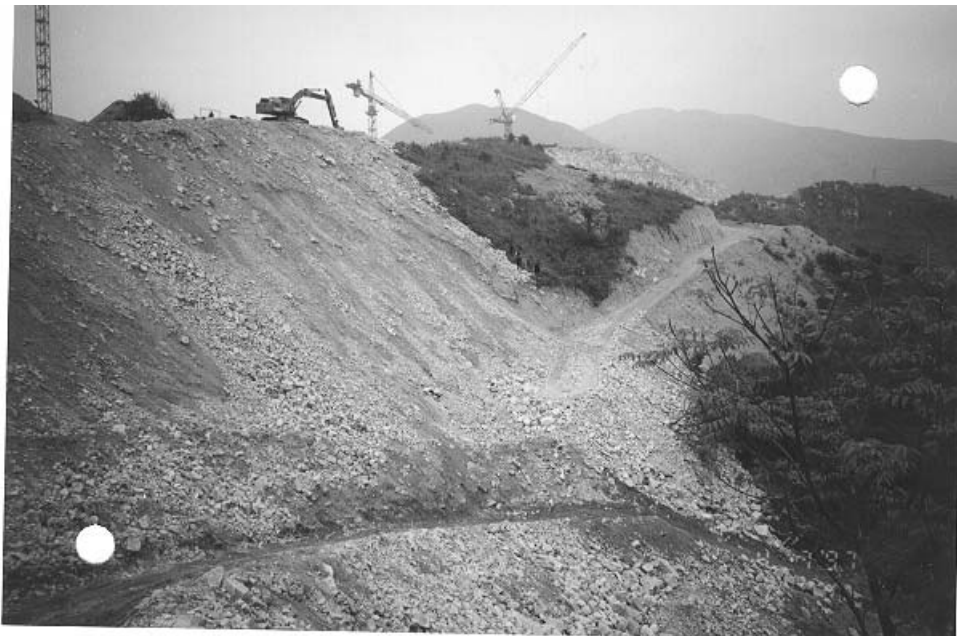
Plate 41 – View North-East Across Upper Portion of Slope No. 6SE-C/FR13 Indicating Haul Road in Natural Slope to North-East and Rock Fill Material (This Rock Fill Apparently Did Not Meet Specification Due to High Fines Content). (Photograph Taken on 7 April 1997)

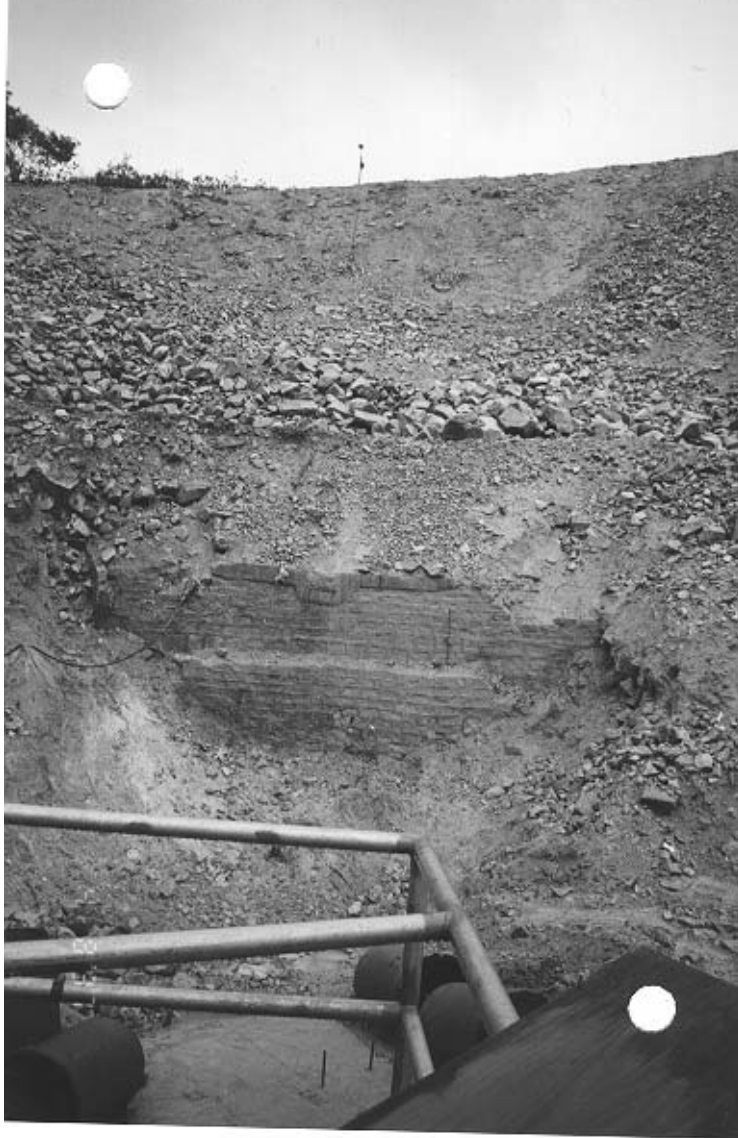
Plate 42 – View North-West from Toe of Slope No. 6SE-C/FR13. Wall of Existing Reservoir Exposed Beneath Loose-Placed Rockfill Material. Crib Wall Footing Visible in Foreground. (Photograph Taken on 8 April 1997)

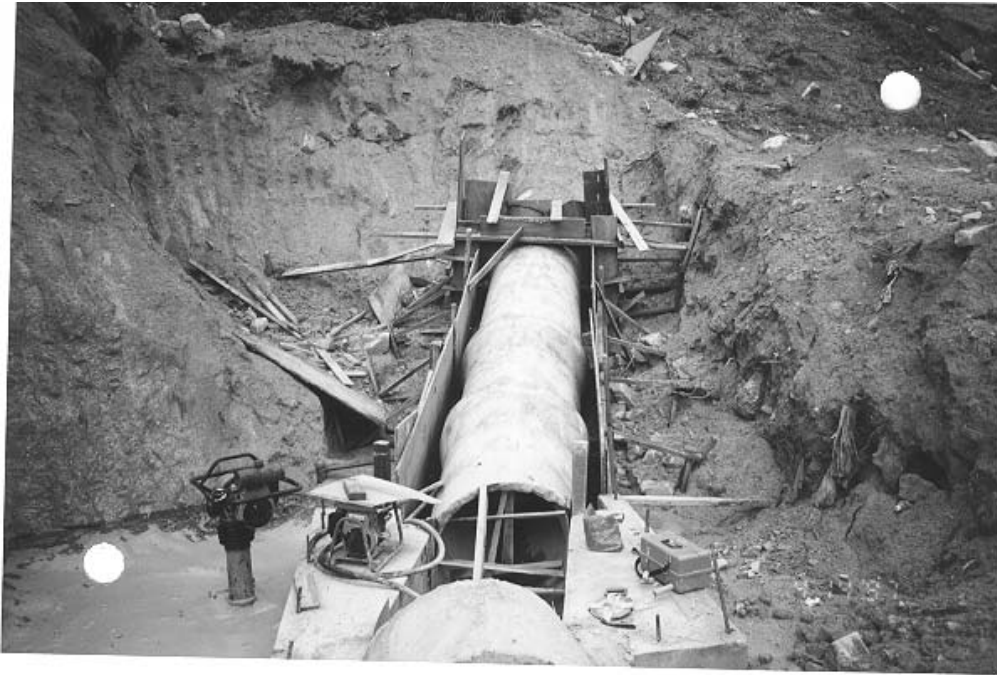
Plate 43 – View North-West from Toe of Slope No. 6SE-C/F14 Indicating New Drainage Works as Extension of Existing Culvert P043 to the Toe of Slope B. (Photograph Taken on 14 April 1998)

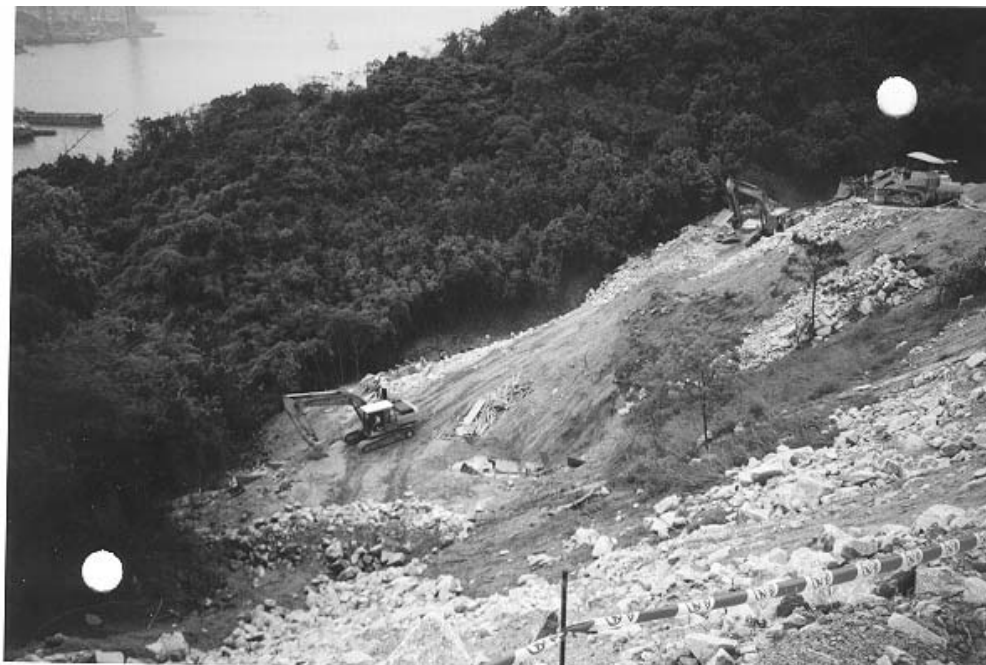
Plate 44 – View South-West Across Slope No. 6SE-C/F14 and the Natural Spur Separating This Slope From Slope No. 6SE-C/F15. Extension of Existing Culvert P043 Visible at Toe of Slope. (Photograph Taken on 14 April 1997)

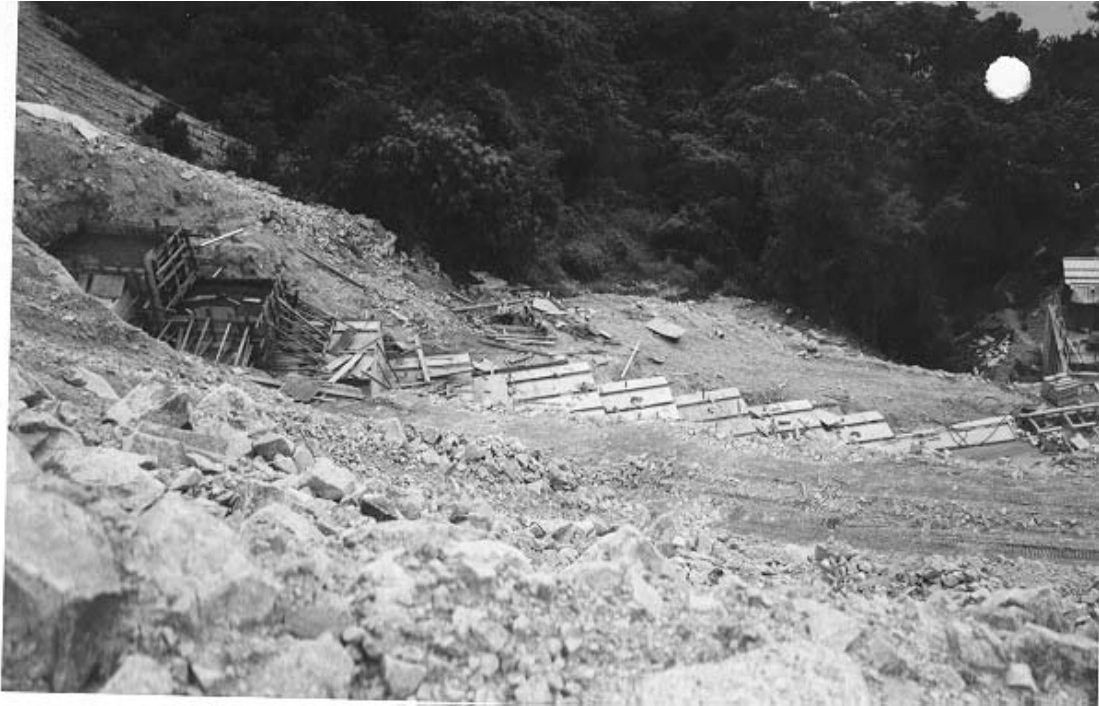
Plate 45 indicates the progress of the crib wall footing construction by mid-September 1997, and Plate 46 provides a general view across the Ramp G works from late October 1997, with bulk filling works for Slope B and haul road construction visible on the left of the frame.

Plate 45 – View East Across Crib Wall Footing at Toe of Slope A. (Photograph Taken on 16 September 1997)

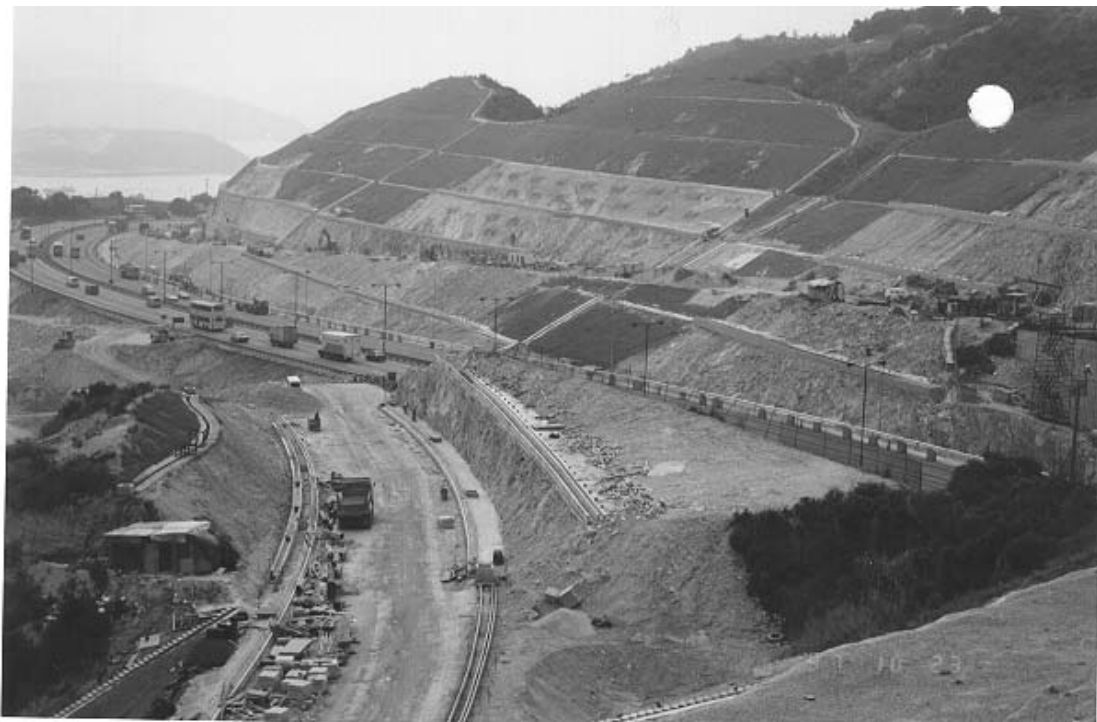
Plate 46 – View South-West Along Ramp G. Slope B Bulk Filling Operations in Progress on Left of Frame. (Photograph Taken on 23 October 1997)

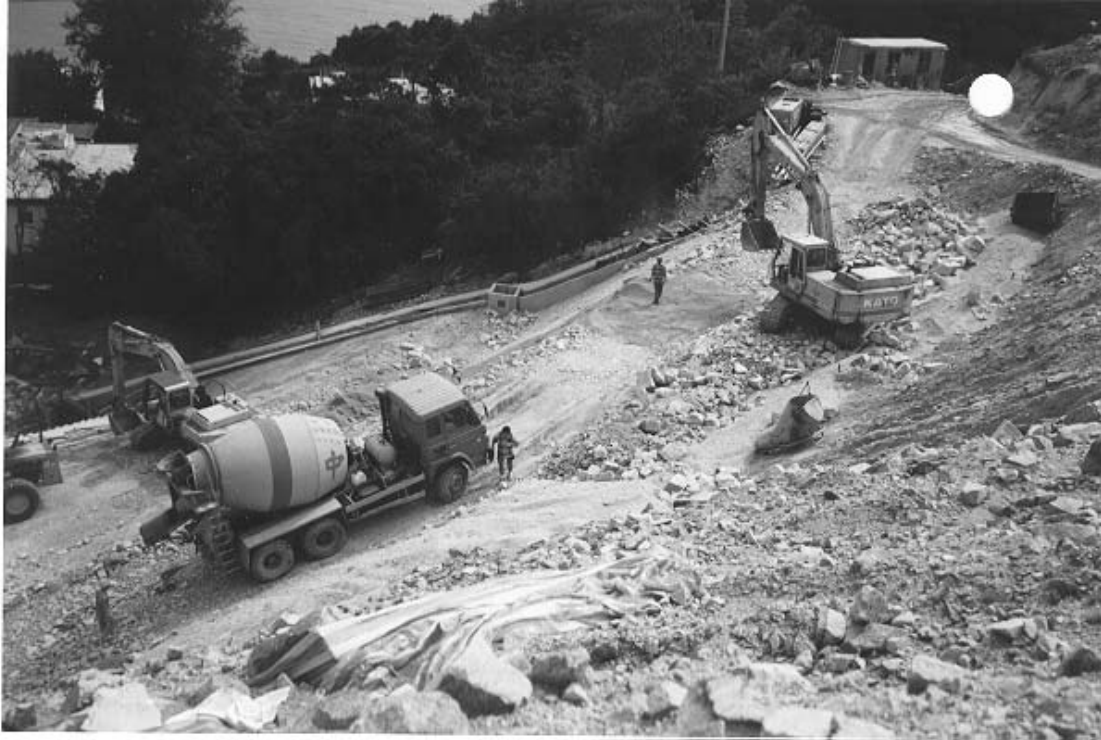
Plate 47 – View South-East Across Slope A Filling Operations. Note Excavator Profiling DG Fill Layer on Left of Frame (Planar Face Formed). Note Also Upstand on Stepped Channel Below Catchpit Indicating Final 300 mm to 500 mm of Landscaping Fill Yet to be Placed. (Photograph Taken 24 October 1997)

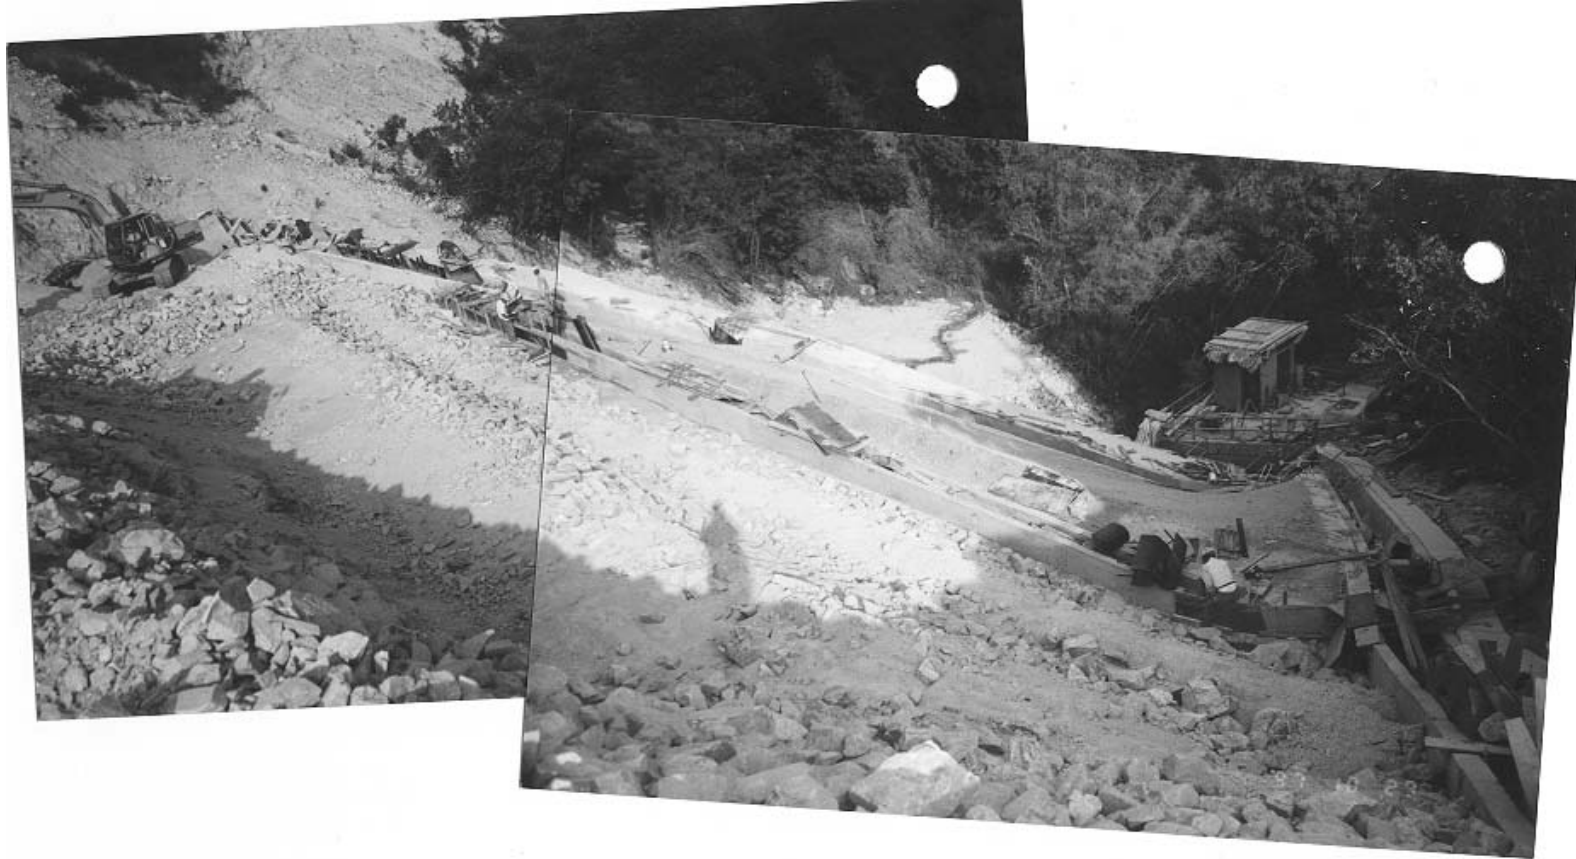
Plate 48, taken five days after Plate 47, shows the landscaping fill placed over the DG fill on the lowest batter of Slope A, and surface drainage formed on the 64.5 mPD berm above. A significant quantity of fine material is visible in the rock fill.

Plate 48 – View East Towards Toe of Slope A from Berm Elevation at 64.5 mPD. Note Rock Fill in Foreground, Channel for 58 mPD Berm Formed and Landscaping Fill Over DG Fill on Lower Batter. (Photograph Taken on 29 October 1997)

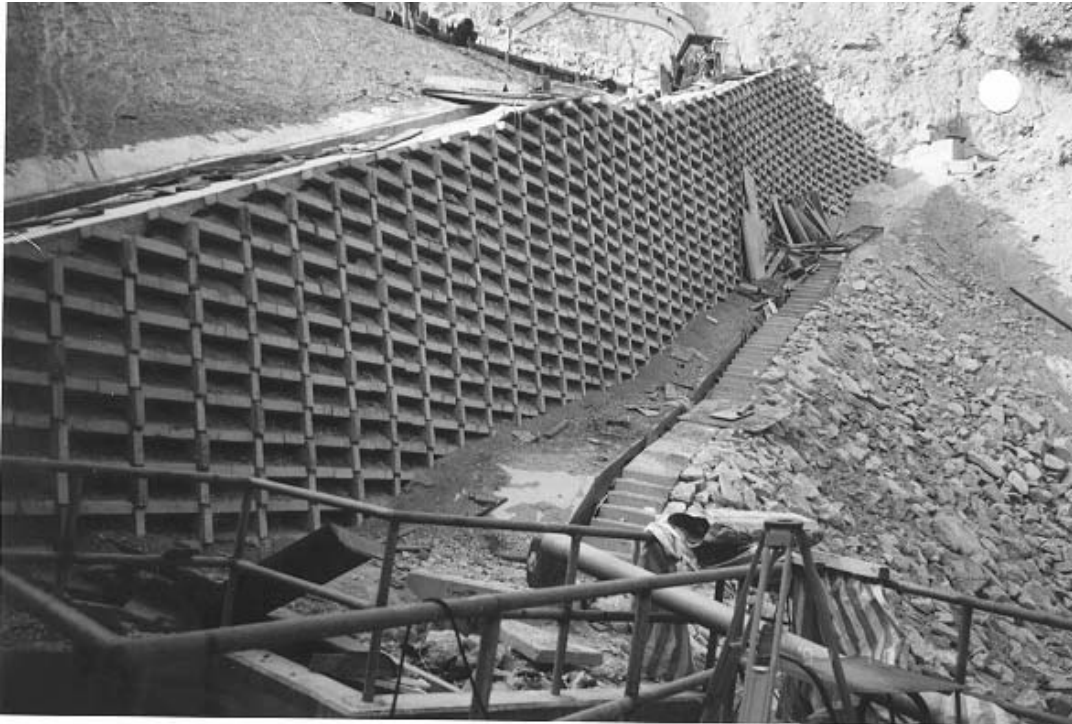
Plate 49 – View North Along Completed Crib Wall From New Reservoir Structure
Note Rock Fill Placed Below Crib Wall. (Photograph Taken on
29 October 1997)
