INVESTIGATION OF SOME SELECTED LANDSLIDES IN 1998 (VOLUME 7)

GEO REPORT No. 114

Fugro Scott Wilson Joint Venture

**GEOTECHNICAL ENGINEERING OFFICE
CIVIL ENGINEERING DEPARTMENT
THE GOVERNMENT OF THE HONG KONG
SPECIAL ADMINISTRATIVE REGION**

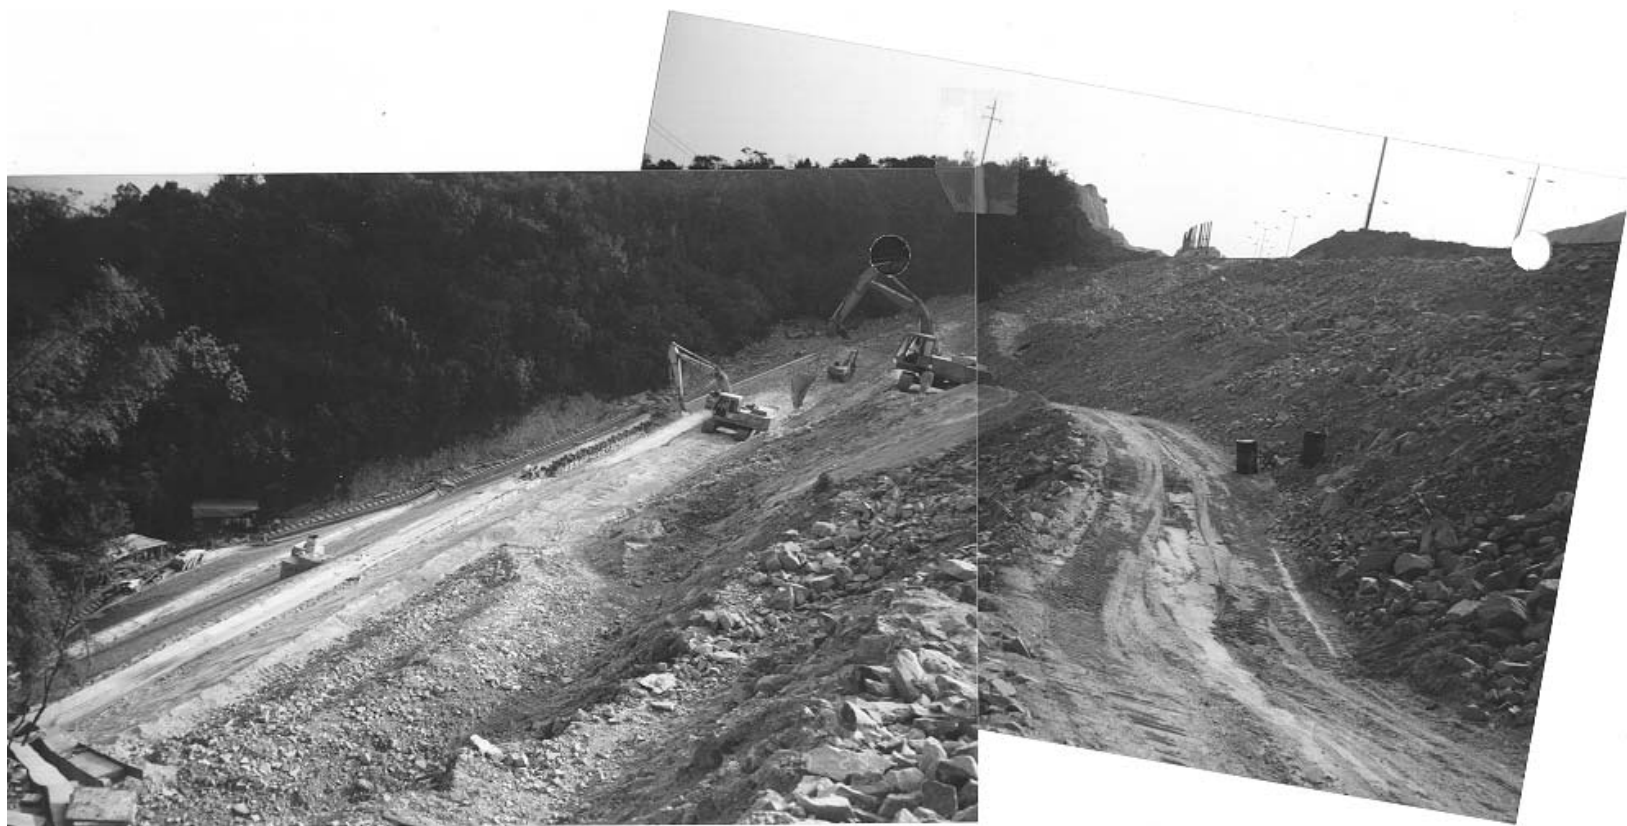
- (a) the height between benches in the rock fill prior to placement of DG fill appears to be often far in excess of the 2 m maximum indicated on the working drawings (Plates 50, 52 and 53 and Figure 9),

- (b) very little overfilling of DG fill appears to have been applied in practice (Plates 50 and 56),
- (c) the sloping face of the DG fill was formed to a planar profile (i.e. no benching) prior to placement of the landscaping fill (Plates 51 to 56),

Plate 50 – View South Across Slope B Construction. Note Placement and Compaction of DG Fill Over Rock Fill in Centre of Frame on Batter Between 52.5 mPD and 45 mPD Berms (Small Roller Visible Behind Lower of two Large Excavators). Note Also Drainage Works in Progress Below Filling Operations, Upstand Remaining on Channel Structure on Left of Frame to Receive Landscaping Fill Layer and Planar Face on DG Fill. (Photograph Taken on 29 October 1997)

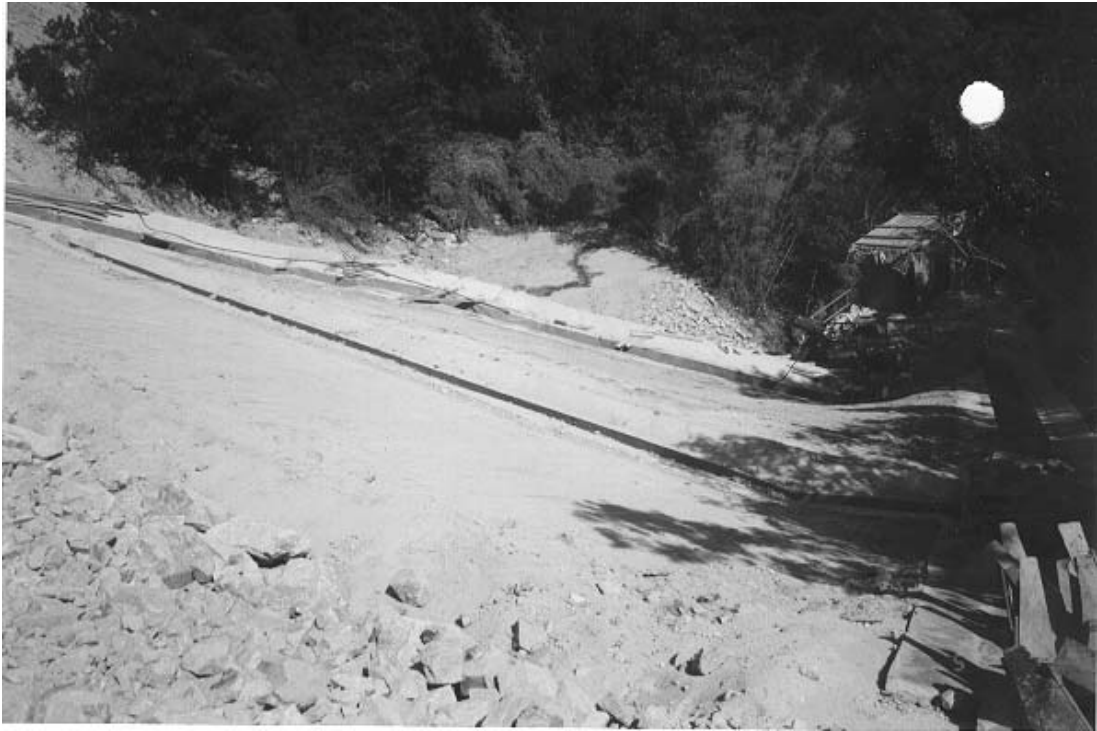
Plate 51 – View East Towards Toe of Slope A Indicating Placement of DG Fill Over Rock Fill Between 64.5 mPD and 58 mPD. Note Planar Face on DG Fill and Upstand at Toe of Batter. (Photograph Taken on 5 November 1997)

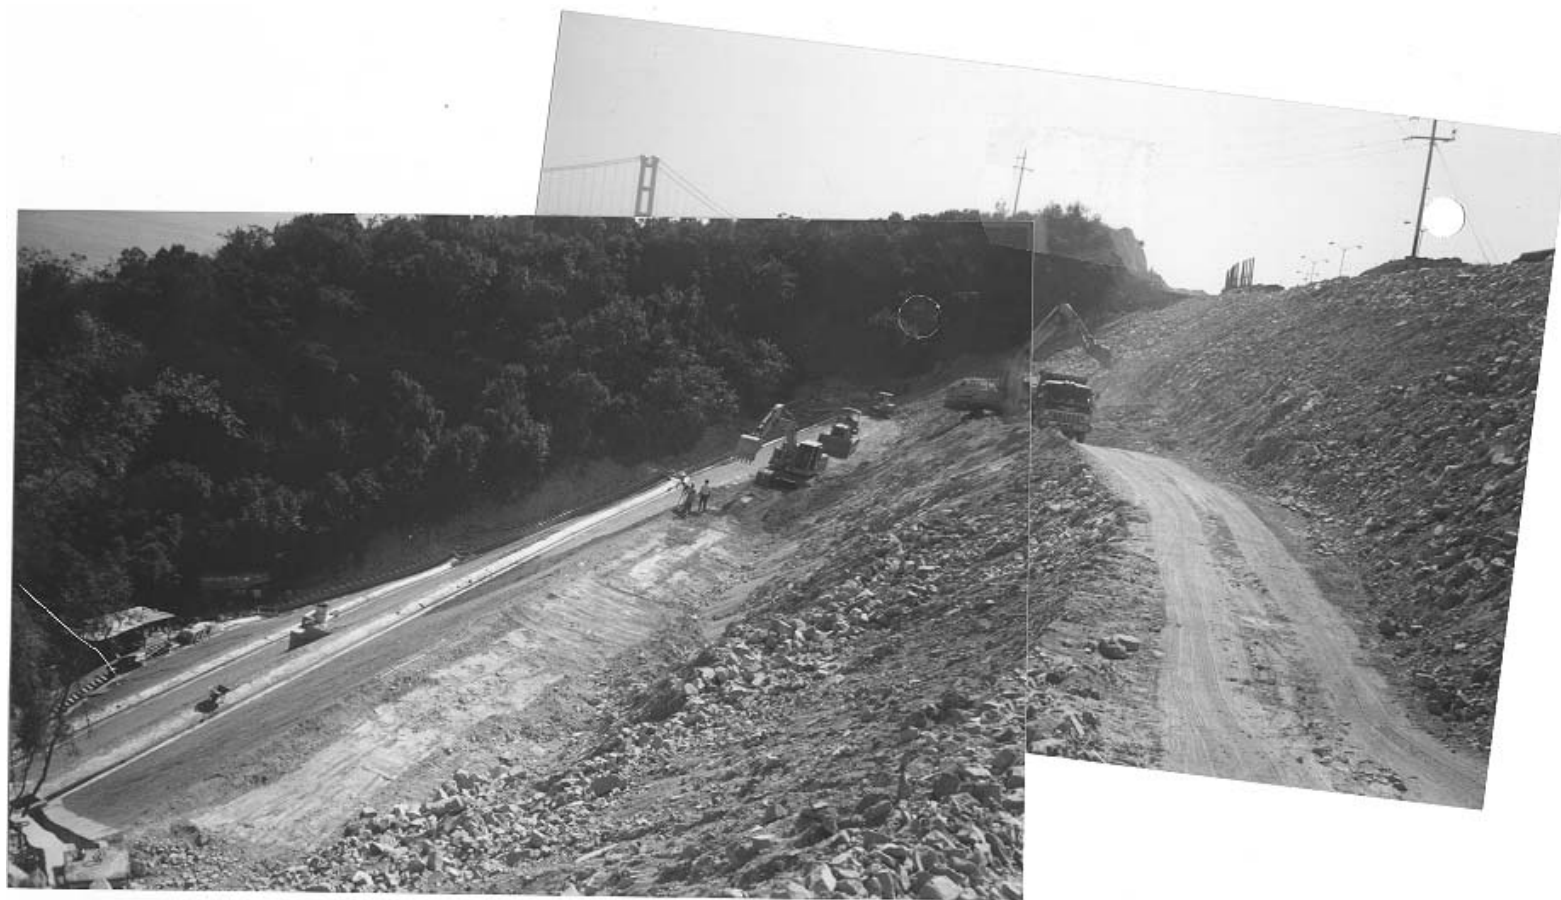
- (e) placement of the landscaping fill appears to have been by tipping from the berm above (Plates 52 and 54), and
- (f) the apron slab formed adjacent to the surface drainage channels on berms did not extend to the edge of the berm (Plates 57 and 58), resulting in an exposed horizontal soil surface between the edge of the apron slab and the crest of the batter below as per the construction drawings (Section 5.3.1).

- (a) Record photographs (Plates 52 to 56) generally show compaction of the rockfill within the 2 m to 3 m zone at the sloping face of the layer (plant access track width) and an irregular surface of stockpiled material behind. It is unclear whether the rockfill behind the outer zone received proper compaction.

- (c) The landscaping fill was essentially a 'conditioned' DG fill material based on the construction method statement and post-failure site observations. This fill was placed by tipping material down the planar slope face and apparently compacted by tamping with the use of an excavator bucket (Plates 52 and 54). The potential exists for layering parallel to the slope face, variation in the compaction state and the likelihood of the lowest degree of compaction near the planar interface between the DG fill and landscaping fill.

Plate 52 – View South Across Slope B indicating Placement of Landscaping Fill Over DG Layer Between 52.5 mPD and 45 mPD. Note Finished Slope Face Now Flush With Drainage Channel Above 45 mPD Berm. (Photograph Taken on 5 November 1997)

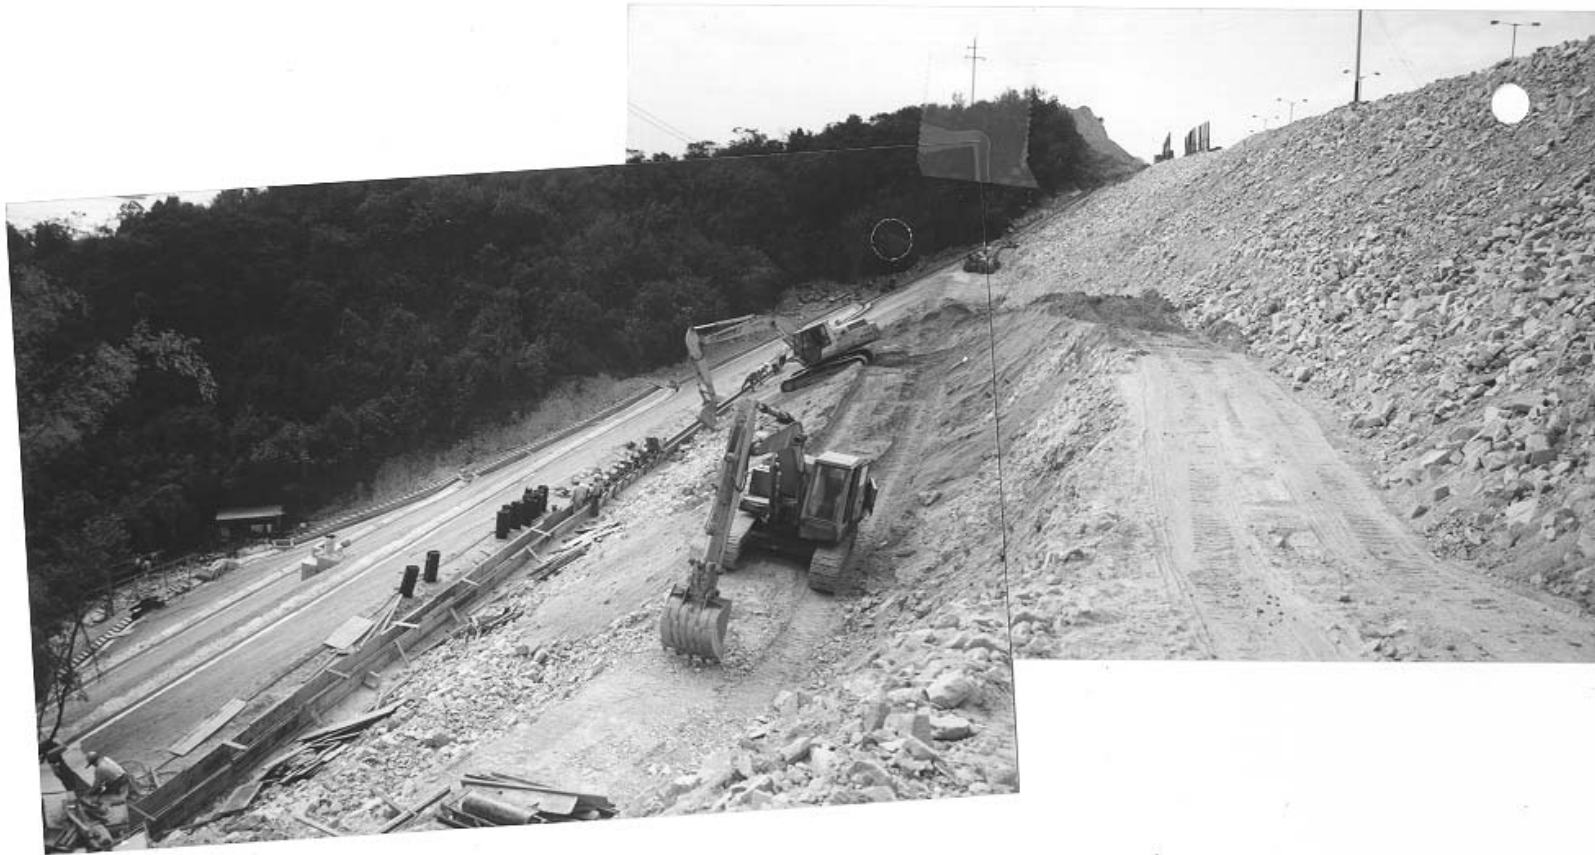
- (d) the DG fill layer was of the order of 200 mm to 300 mm thick in places (Plate 53) and compaction plant was applied to the sloping face in these instances, rather than on a horizontal plane,

Plate 53 – View South Across Slope B Indicating Placement of DG Fill Over Rock Fill on Batter Between 60 mPD and 52.5 mPD. Note Shallow Depth of DG Fill, Apparently Minimal Benching in Rock Fill and Compaction of Fill by Vibrating Plate Compactor on Slope Face (Beneath Arm of Far Excavator) to Produce Planar Face. (Photograph Taken on 12 November 1997)

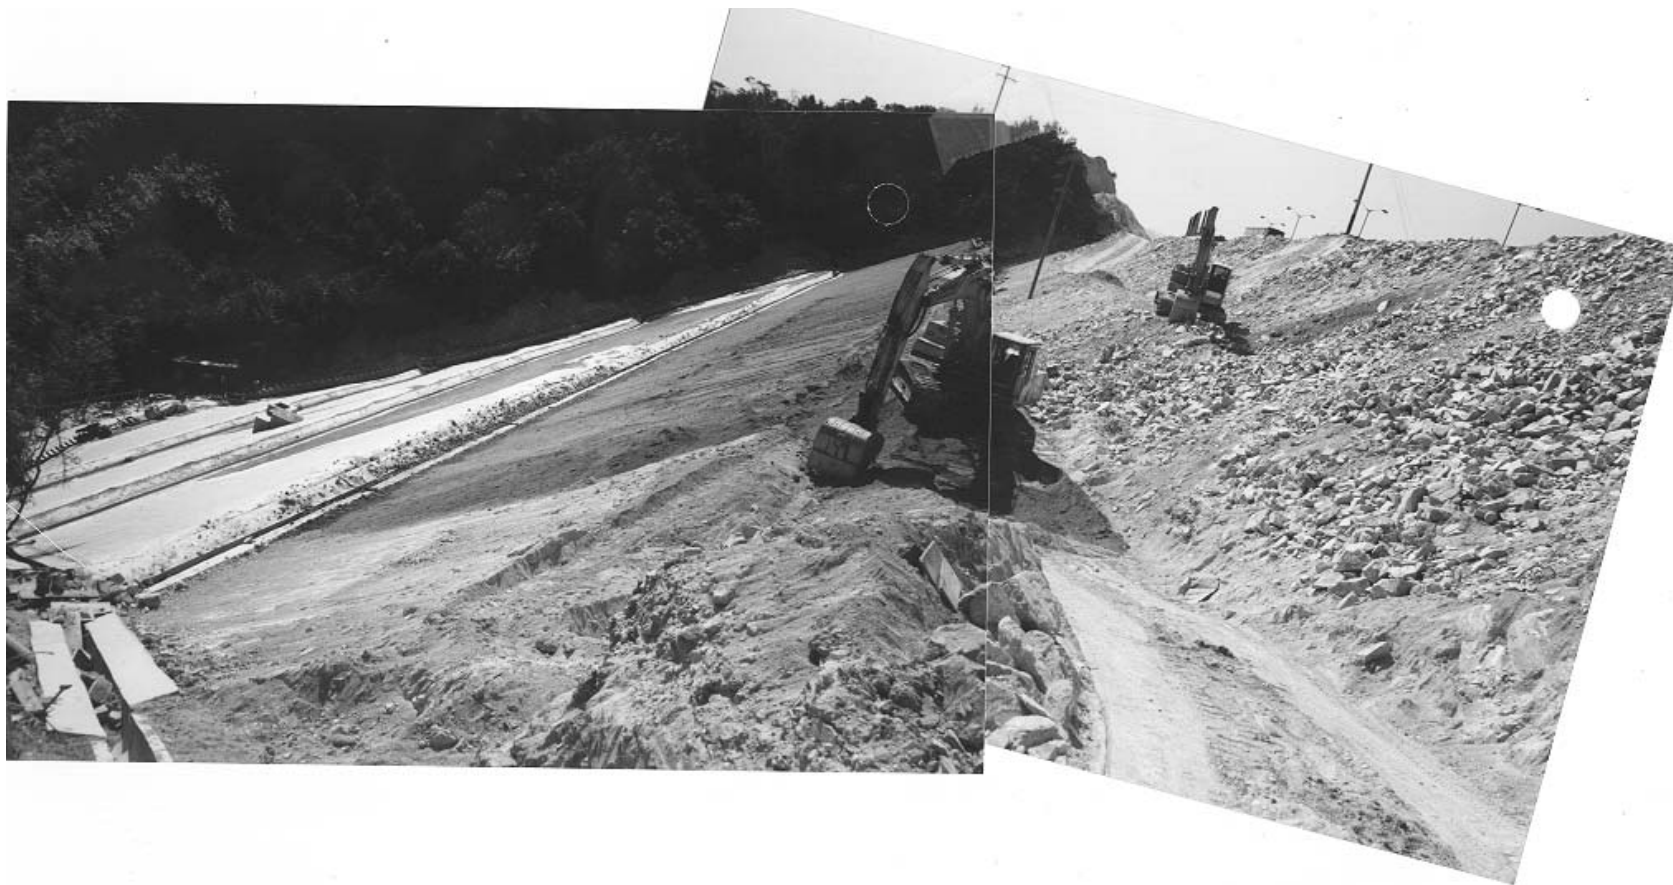
Plate 54 – View South Across Slope B Indicating Placement of Landscaping Fill Over DG Fill Between 60 mPD and 52.5 mPD. Note ‘Loose-Tipping’ Approach and Impressions on Upper Half of Slope Face Suggesting Tamping by The Backhole Bucket. (Photograph Taken on 9 November 1997)

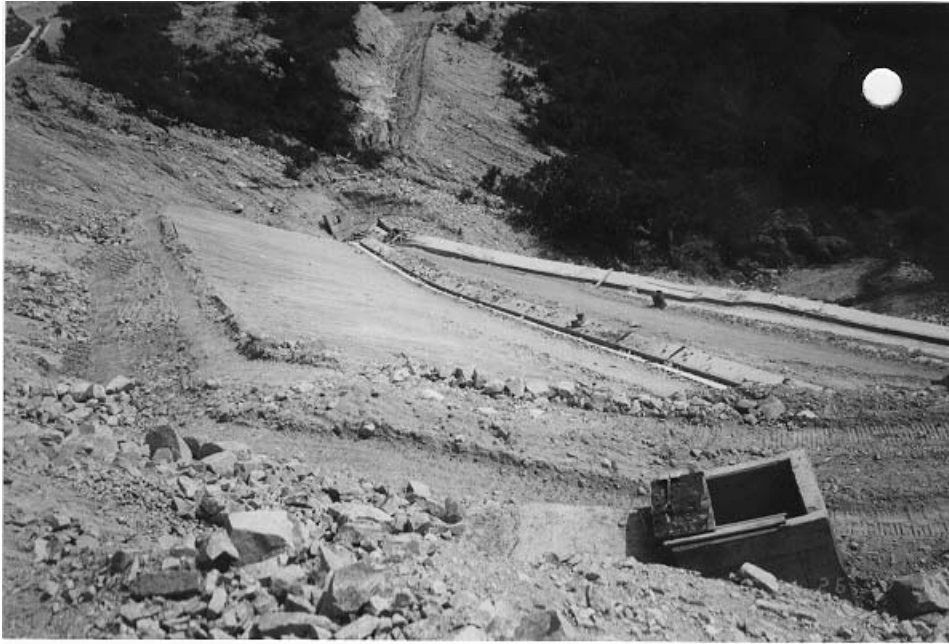
Plate 55 – View North-East Across Slope A From 64.50 mPD Berm Indicating Placement of DG Fill Over Rock Fill on Batter Between 64.50 mPD and 58 mPD, and Landscaping Fill on Batter Between 58 mPD and Crest of Crib Wall. (Photograph taken on 26 November 1997)

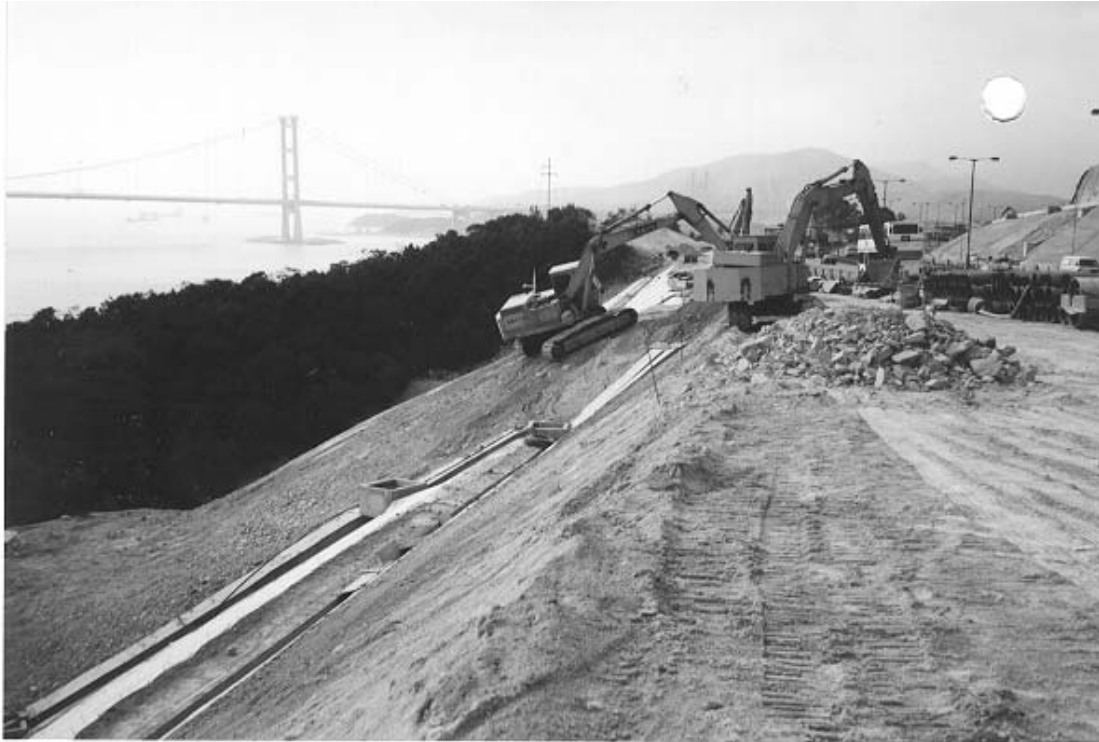
Plate 57 – View South-East Along Crest of Slope A. Landscaping Fill Placed on Upper Batter. Note Also that Berm Apron Slab (67.5 mPD) Does Not Extend to Edge of Berm. Landscaping Fill From Batter Below Trimmed Flush with Berm, Leaving Exposed Horizontal Surface. (Photograph Taken on 31 December 1997)

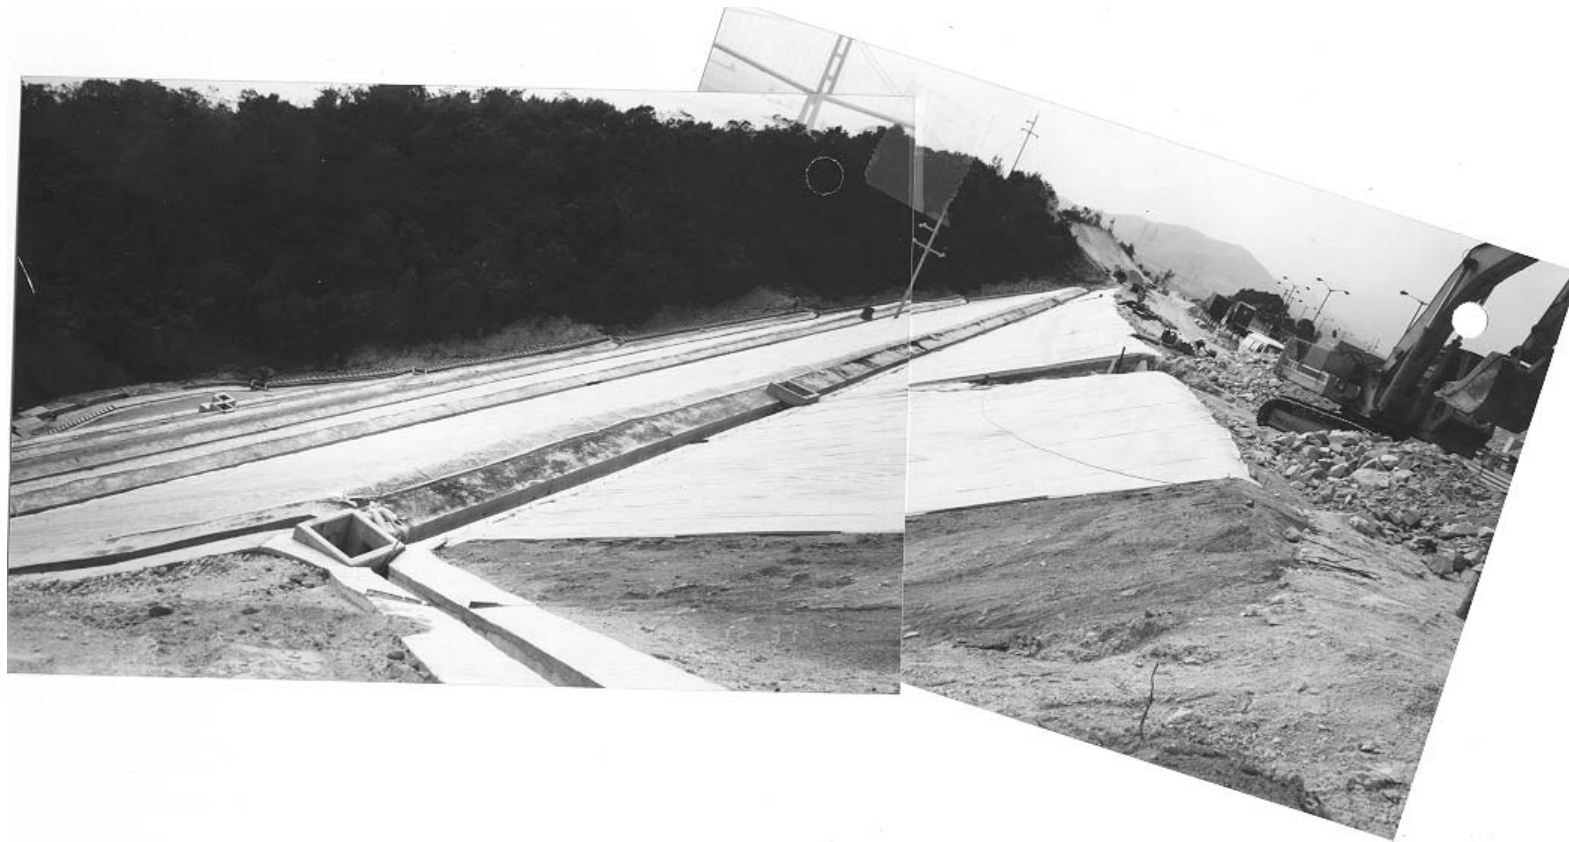
Direct surface infiltration is considered to be the most likely source of water affecting the two vegetated slopes. In addition, the areas opened up for tree planting could have allowed concentrated water ingress into the slope. The detailing of the slope involving termination of the berm aprons before the crest of the batter below (i.e. a horizontal uncovered surface in the landscaping fill) also promoted infiltration (Figure 9 and Plate 58).

Plate 58 – View South Across Slope B Indicating Essentially Completed Slope Works. Drainage Works in Progress on Upper Batter. Similar Comment Regarding Exposed Horizontal Face of Landscaping Fill at Berm Level as for Plate 57. (Photograph Taken on 31 December 1997)

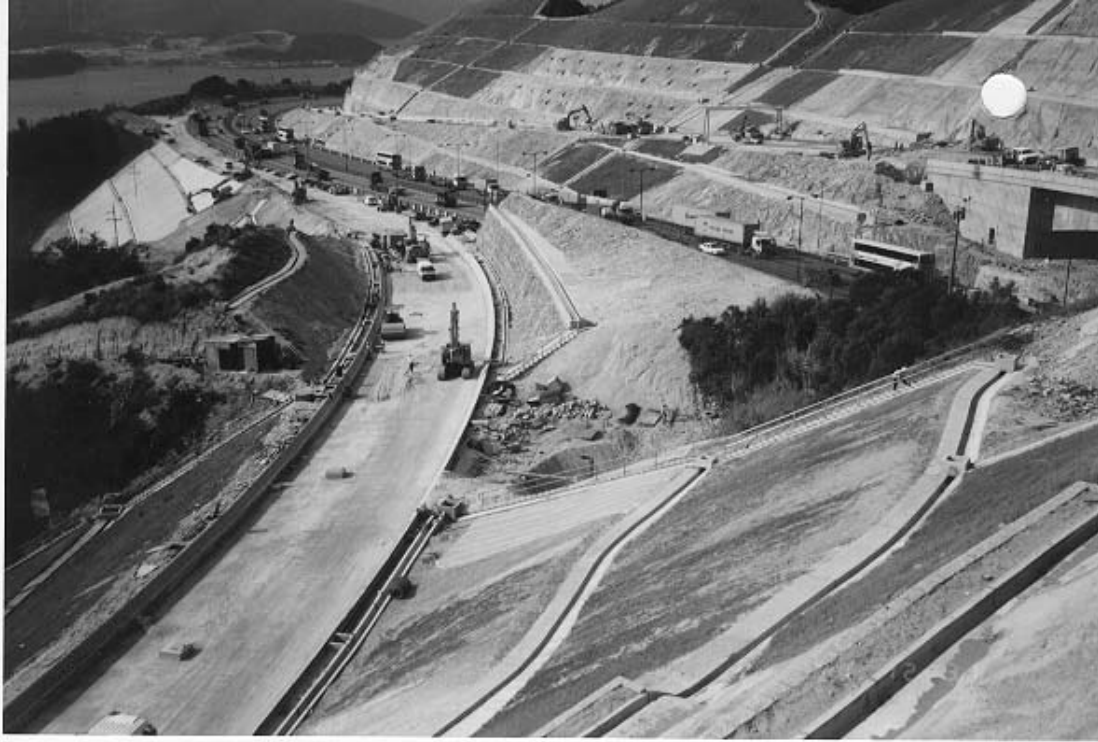
Plate 59 provides a general view along Ramp G, indicating construction progress to the end of 1997. Slope B appears to be essentially complete whereas Slope A is nearing completion and the natural spur line in between is being profiled.

Plate 59 – General View South-West Along Ramp G Indicating State of Construction and Near Completion of Ramp G Fill Slopes. (Photograph Taken on 31 December 1997)
