# **INVESTIGATION OF SOME SELECTED LANDSLIDES IN 1999 (VOLUME 1)**

**GEO REPORT No. 120**

**Fugro Maunsell Scott Wilson Joint Venture**

**GEOTECHNICAL ENGINEERING OFFICE  
CIVIL ENGINEERING DEPARTMENT  
THE GOVERNMENT OF THE HONG KONG  
SPECIAL ADMINISTRATIVE REGION**

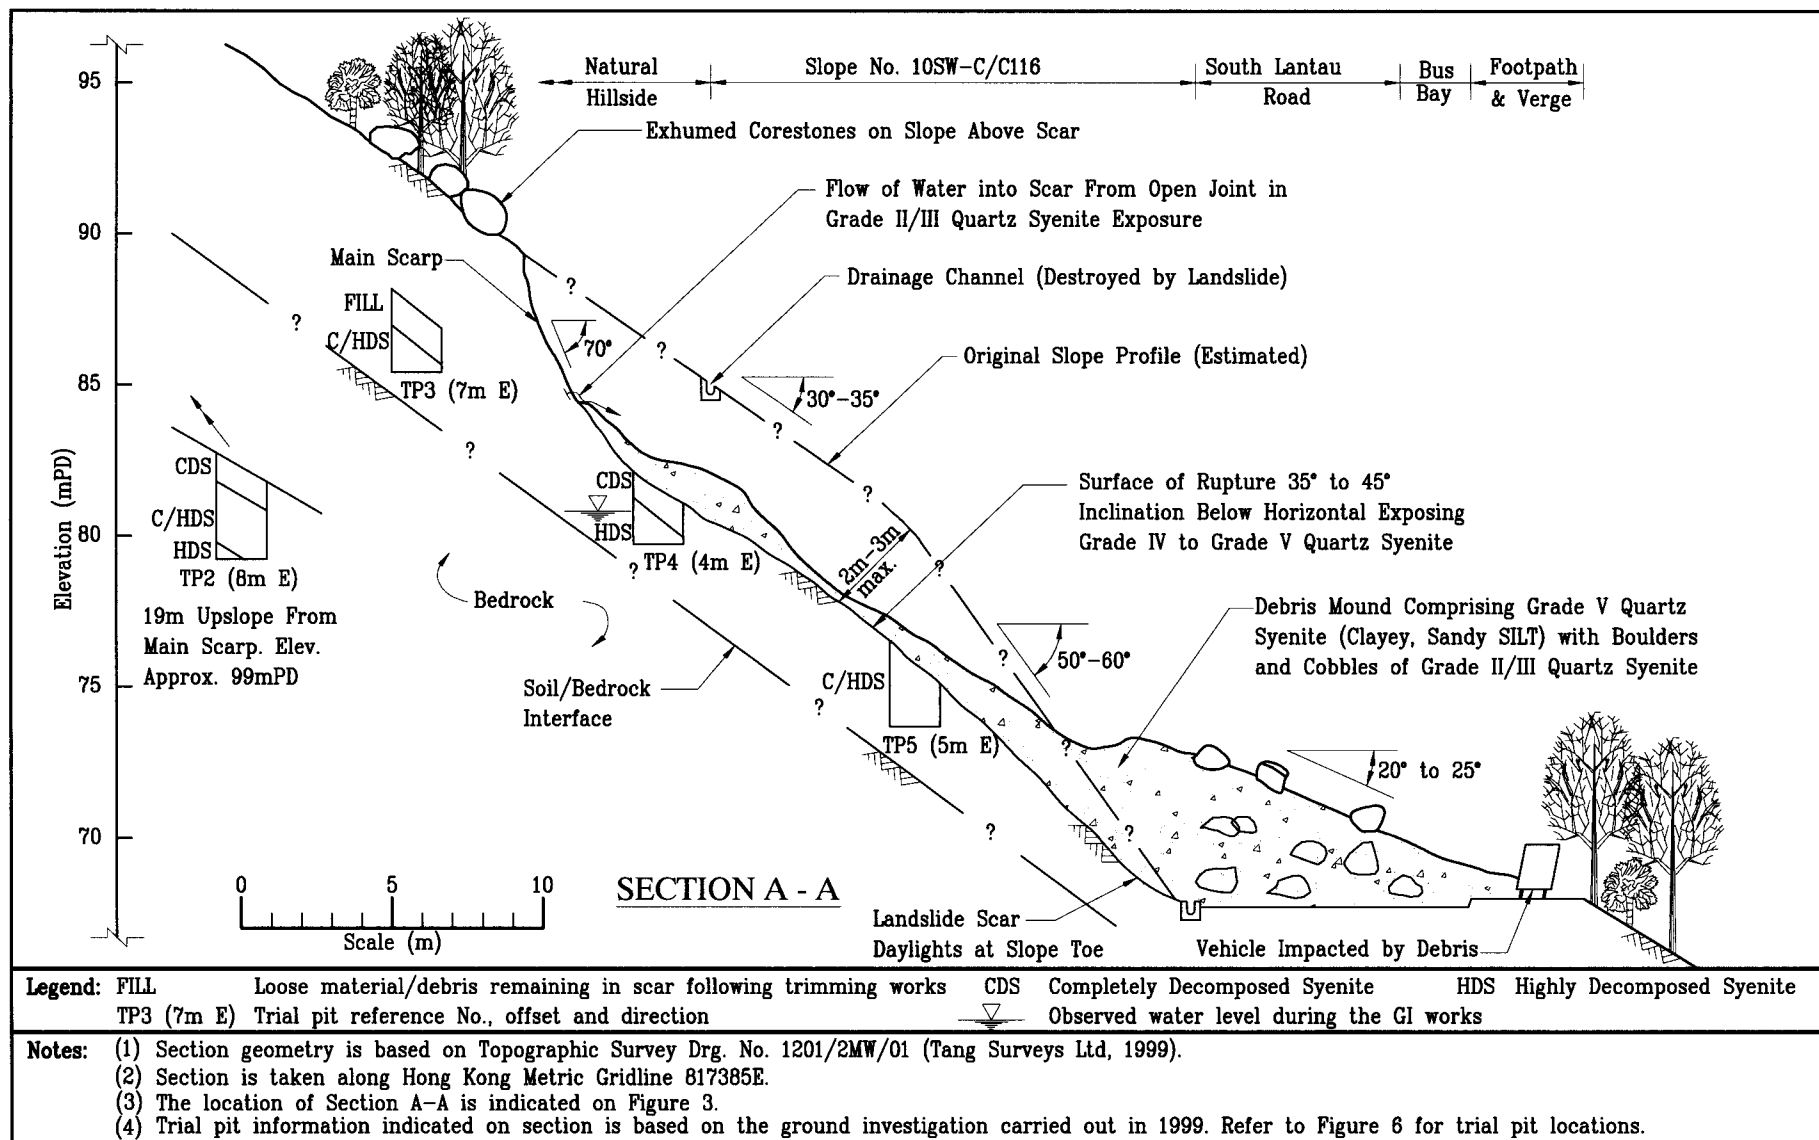
Figure 4 - Section A - A through the Landslide

The cross-section through the landslide included in the stability analyses was based on Section A-A presented in Figure 4. The pre-failure slope profile was based on topographic survey plans, photographic records and engineering judgement. The geometry of the surface of rupture and ground profile is based on site measurements by FMSW, post-failure topographic survey and ground investigation. The idealised section used in the analyses is presented in Figure 13.

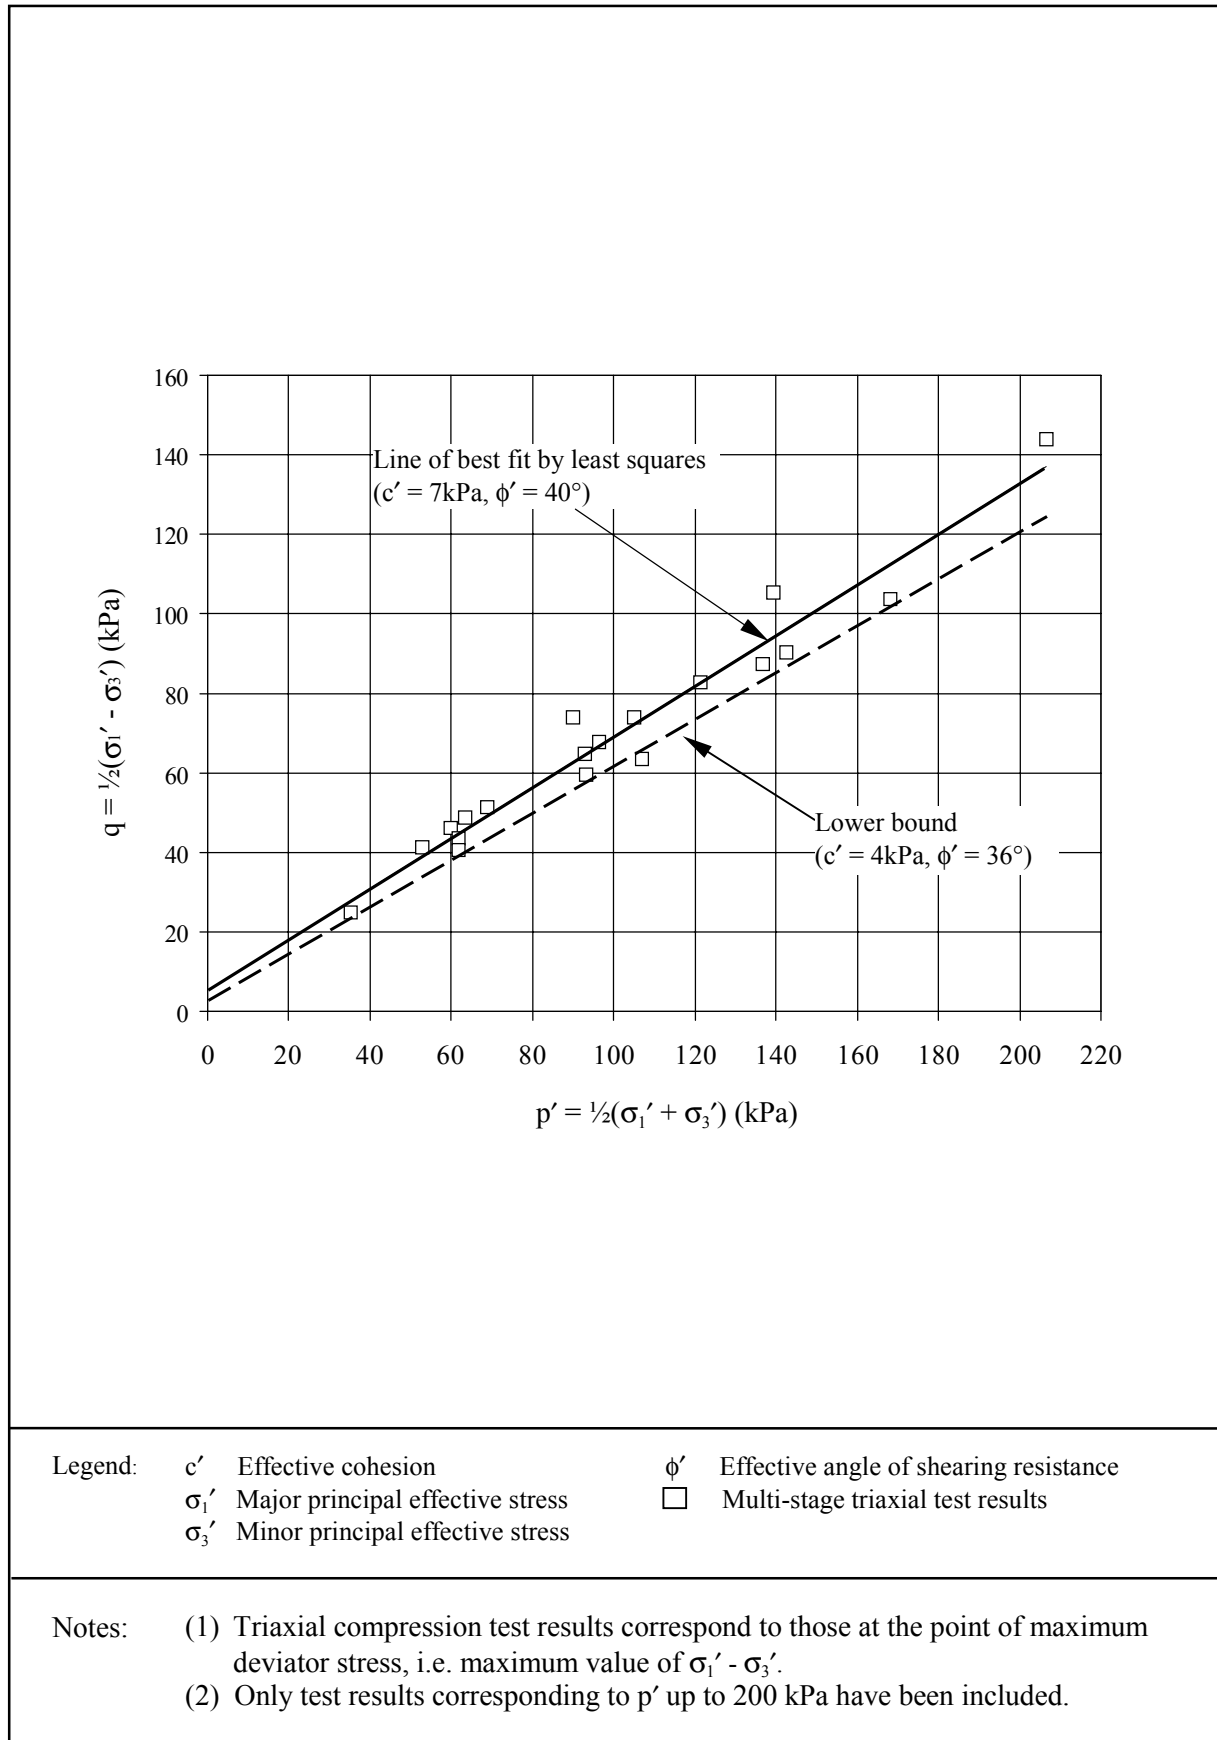
Figure 8 – Results of Triaxial Compression Testing

The results of triaxial testing on samples of Grades IV and V quartz syenite (Table 2 and Figure 8) indicate 'best-fit' shear strength parameters of  $c' = 7$  kPa and  $\phi' = 40^{\circ}$ ,

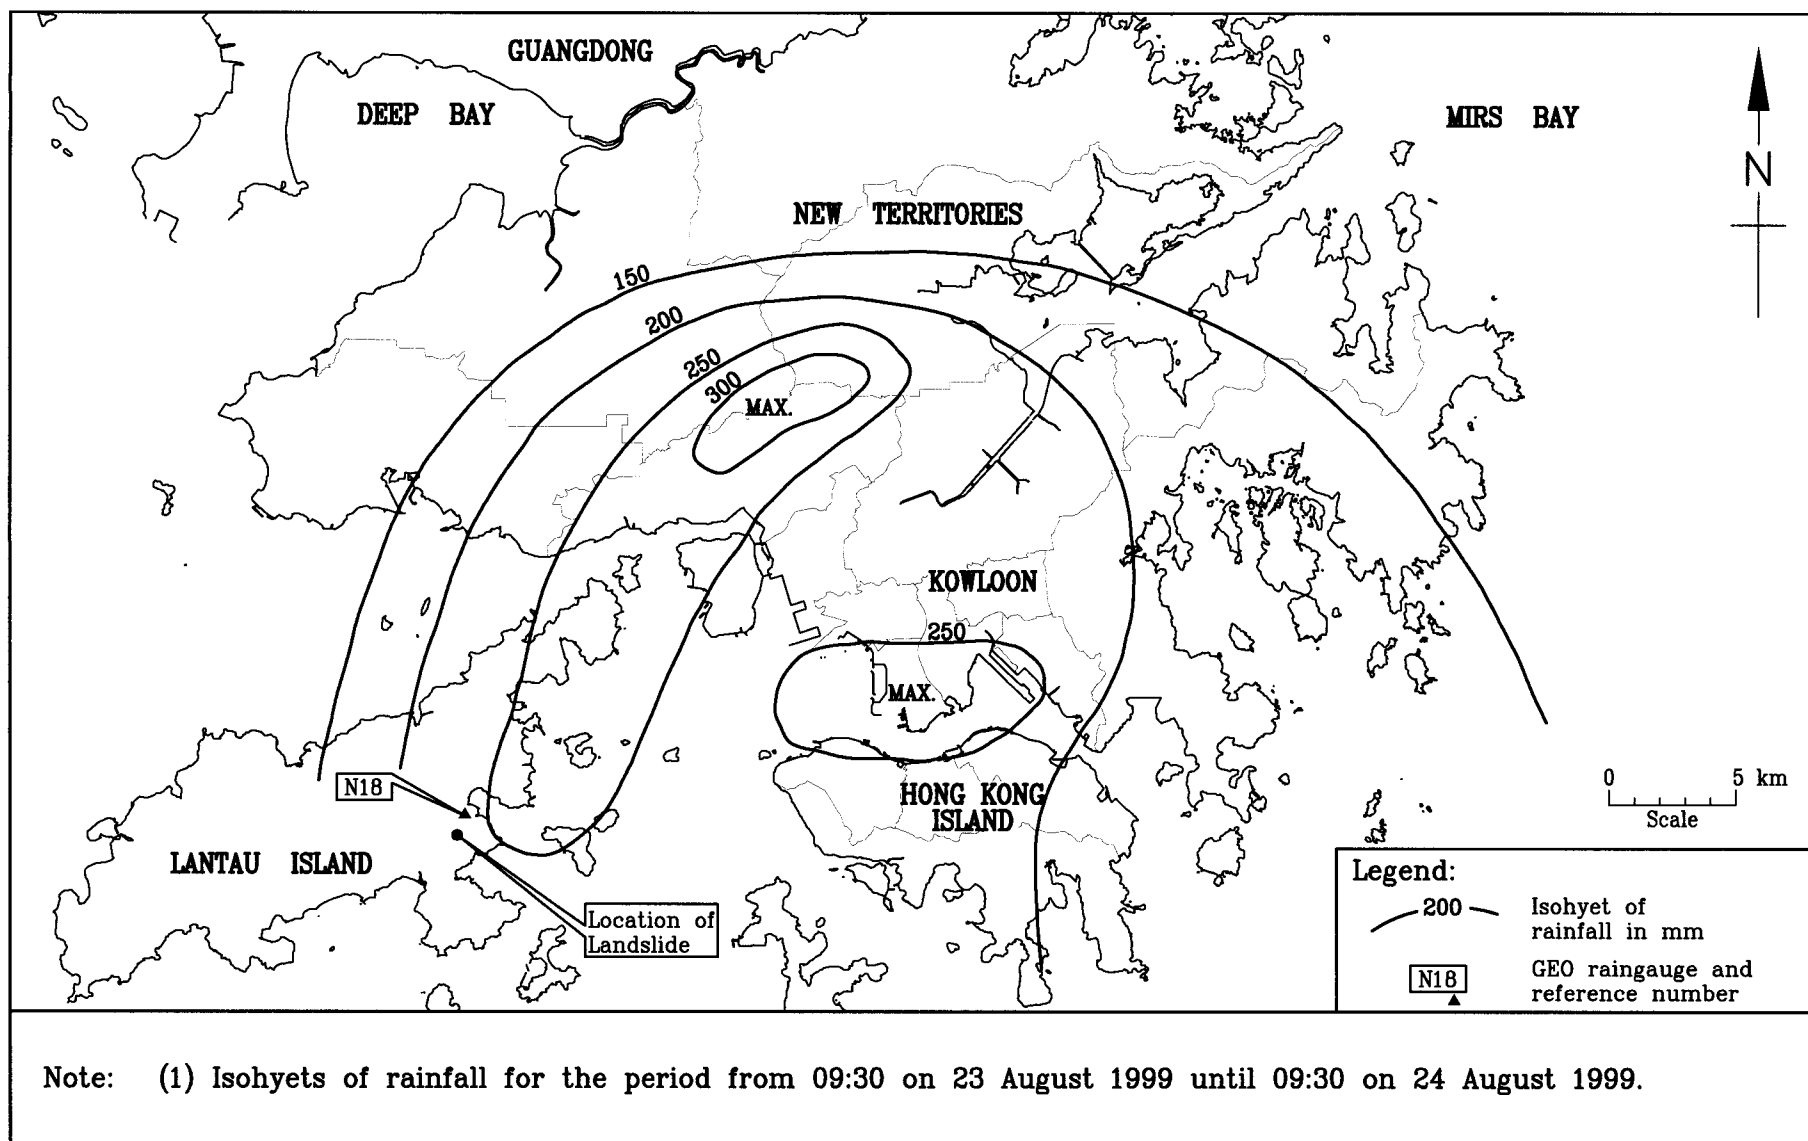
Figure 11 - Rainfall Distribution for the 24-Hour Period Preceding the Landslide of 24 August 1999

Isohyets of rainfall for the 24-hour period preceding the landslide are given in Figure 11.

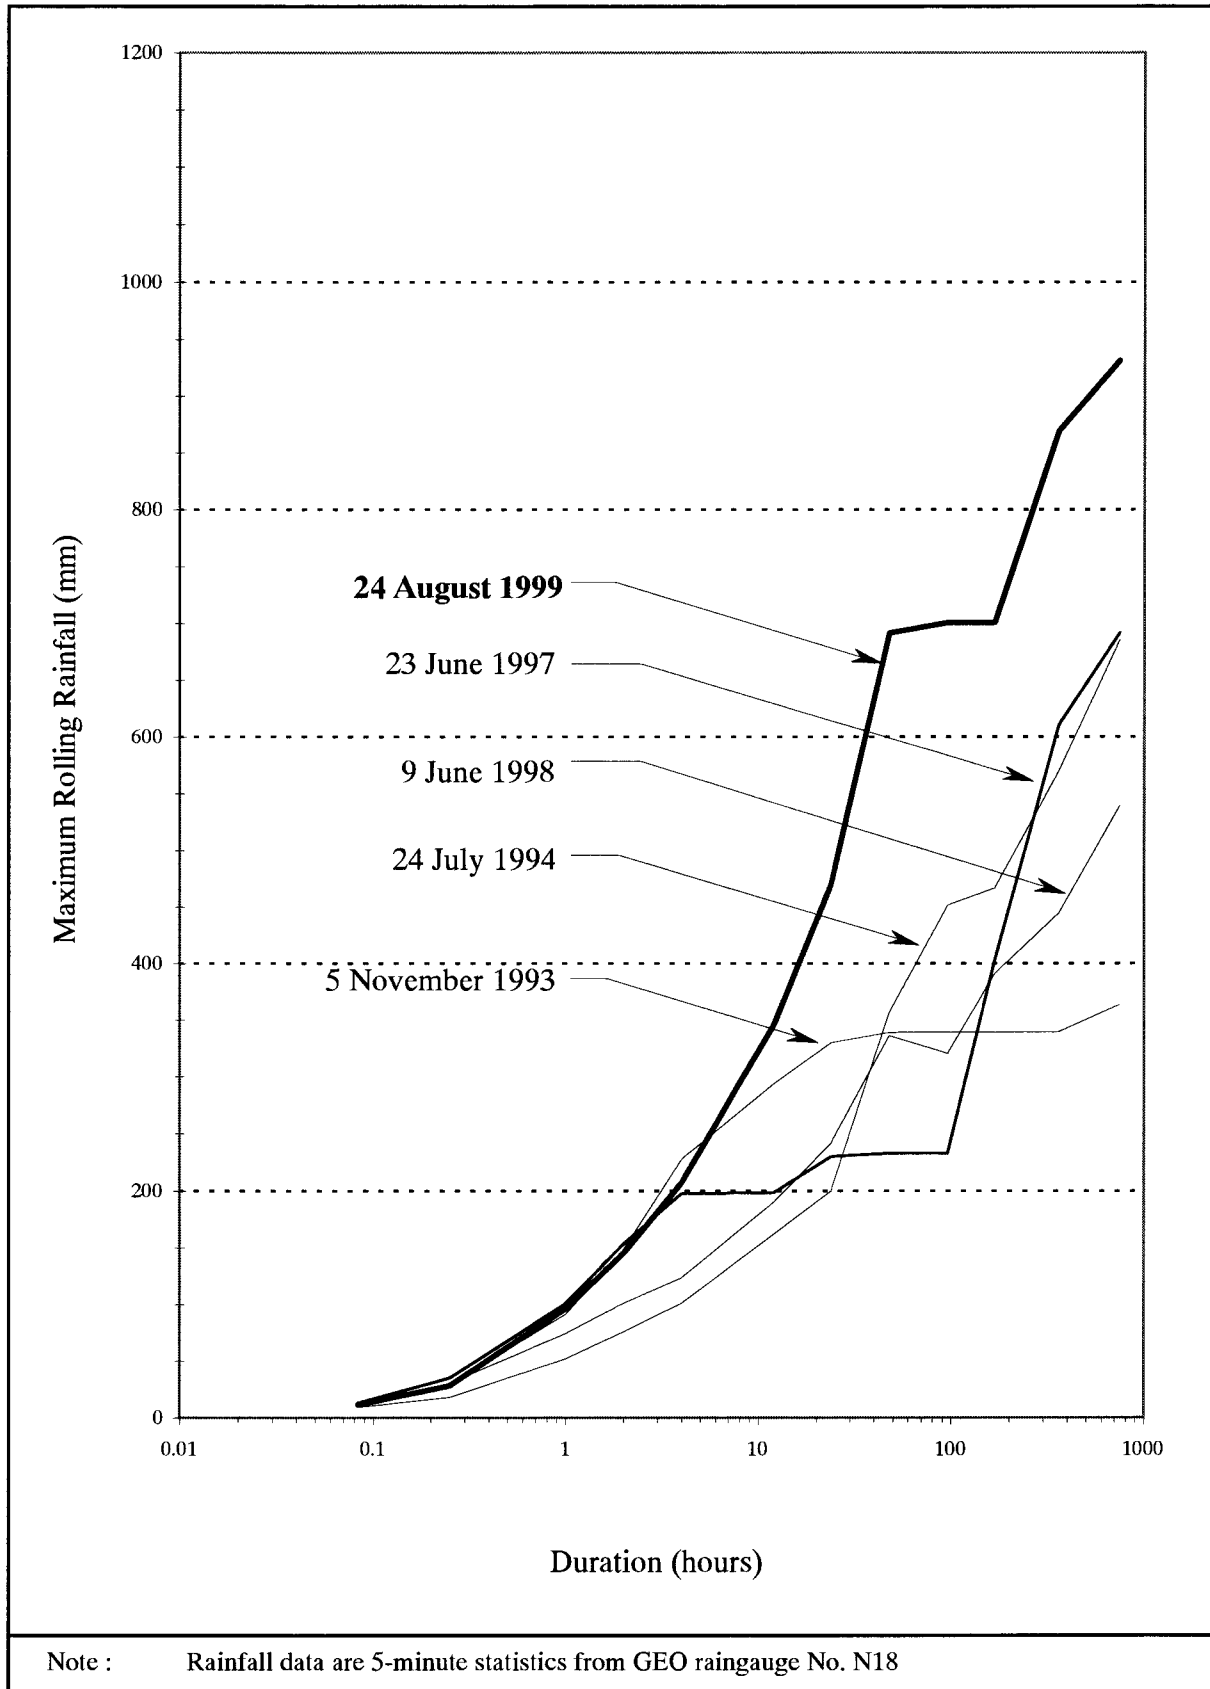
Figure 12 - Maximum Rolling Rainfall Preceding the Landslide of 24 August 1999 and Selected Previous Major Rainstorms Recorded at GEO Raingauge No. N18

Table 5 presents the estimated return periods for the maximum rolling rainfall for various durations based on historical rainfall data at the Hong Kong Observatory (Lam & Leung, 1994). The 48-hour maximum rolling rainfall (692 mm) was the most severe, with a return period of about 150 years. A comparison of the severity of the August 1999 rainstorm and other historical major rainstorms is presented in Figure 12. This shows that the August 1999 rainstorm was the most severe for durations greater than 4 hours, since installation of the raingauge in the early 1990's.

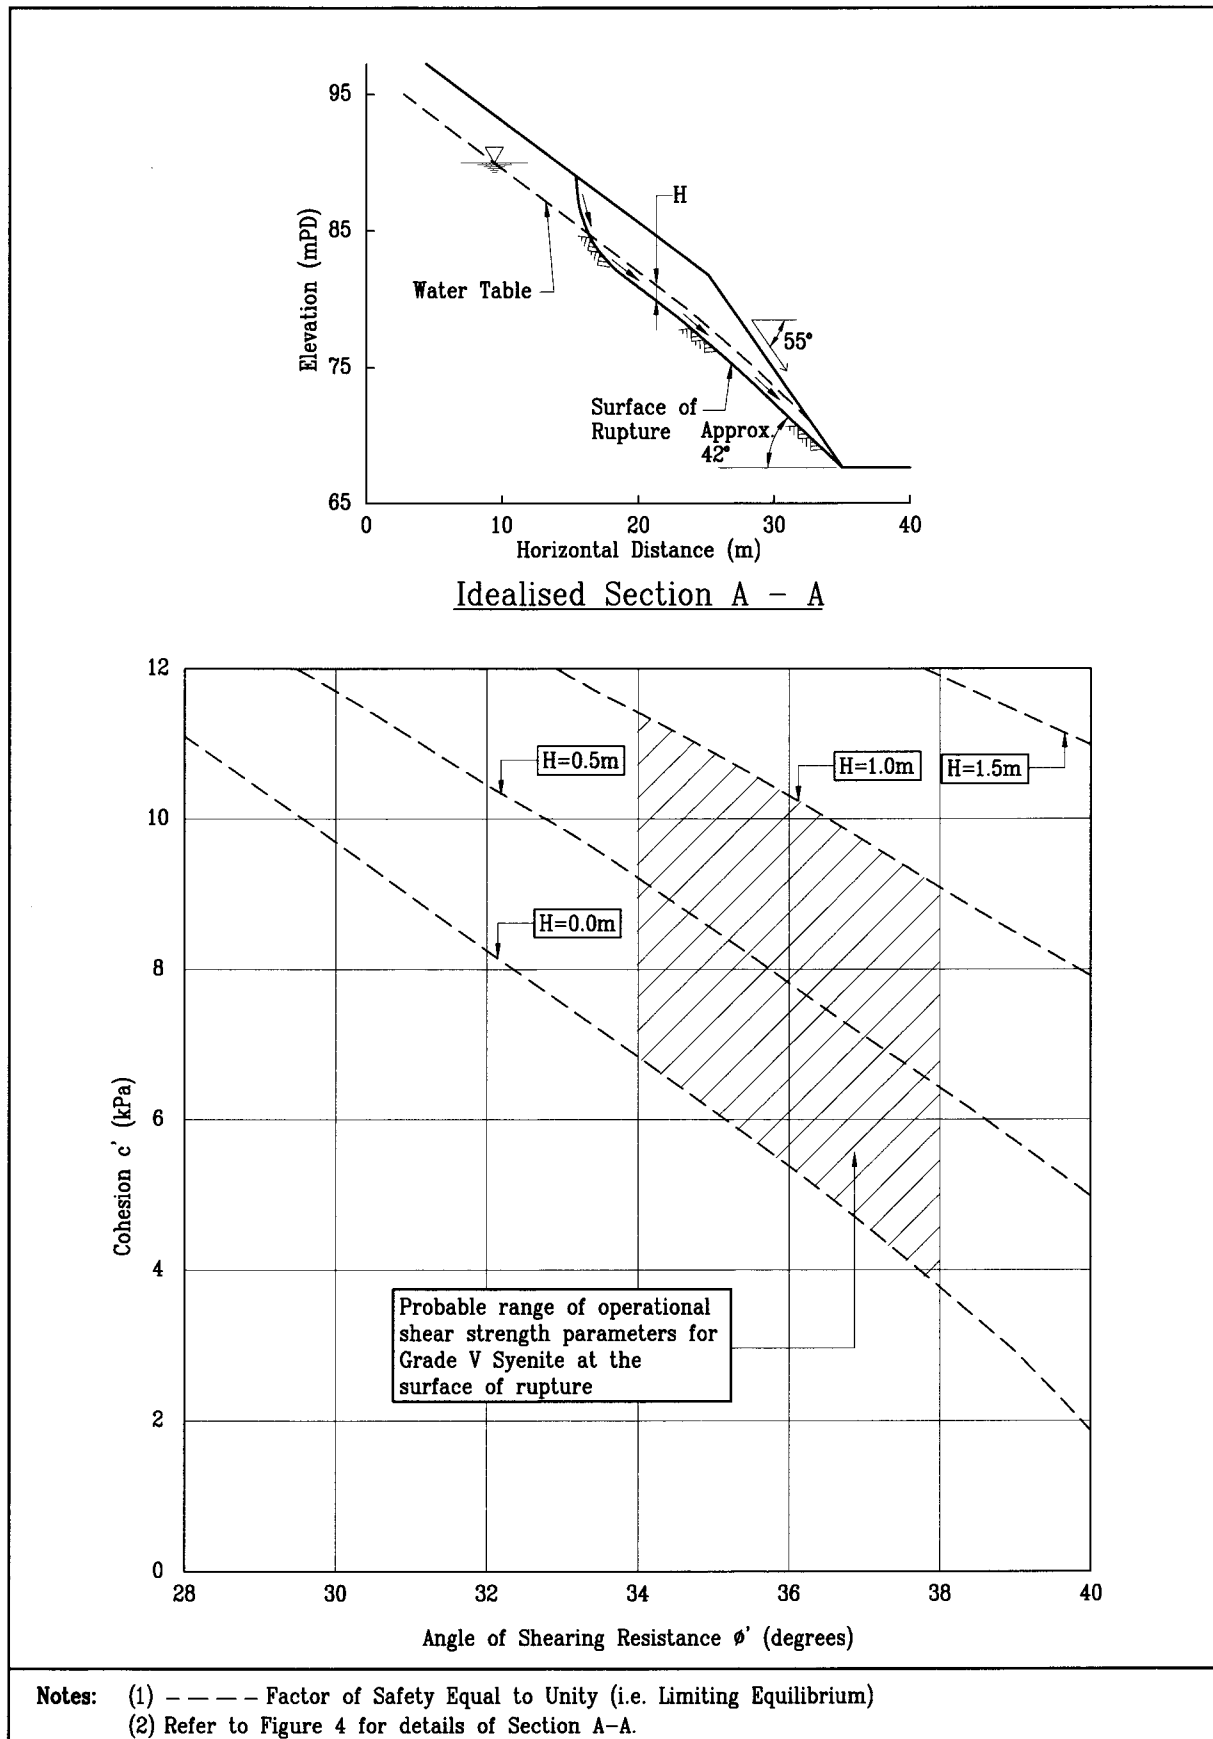
Figure 13 - Summary of Sensitivity Analyses

The results of the analyses are presented in Figure 13. These indicate that the development of an elevated groundwater pressure of about 0.5 m above the surface of rupture would be required to initiate failure in the slope.

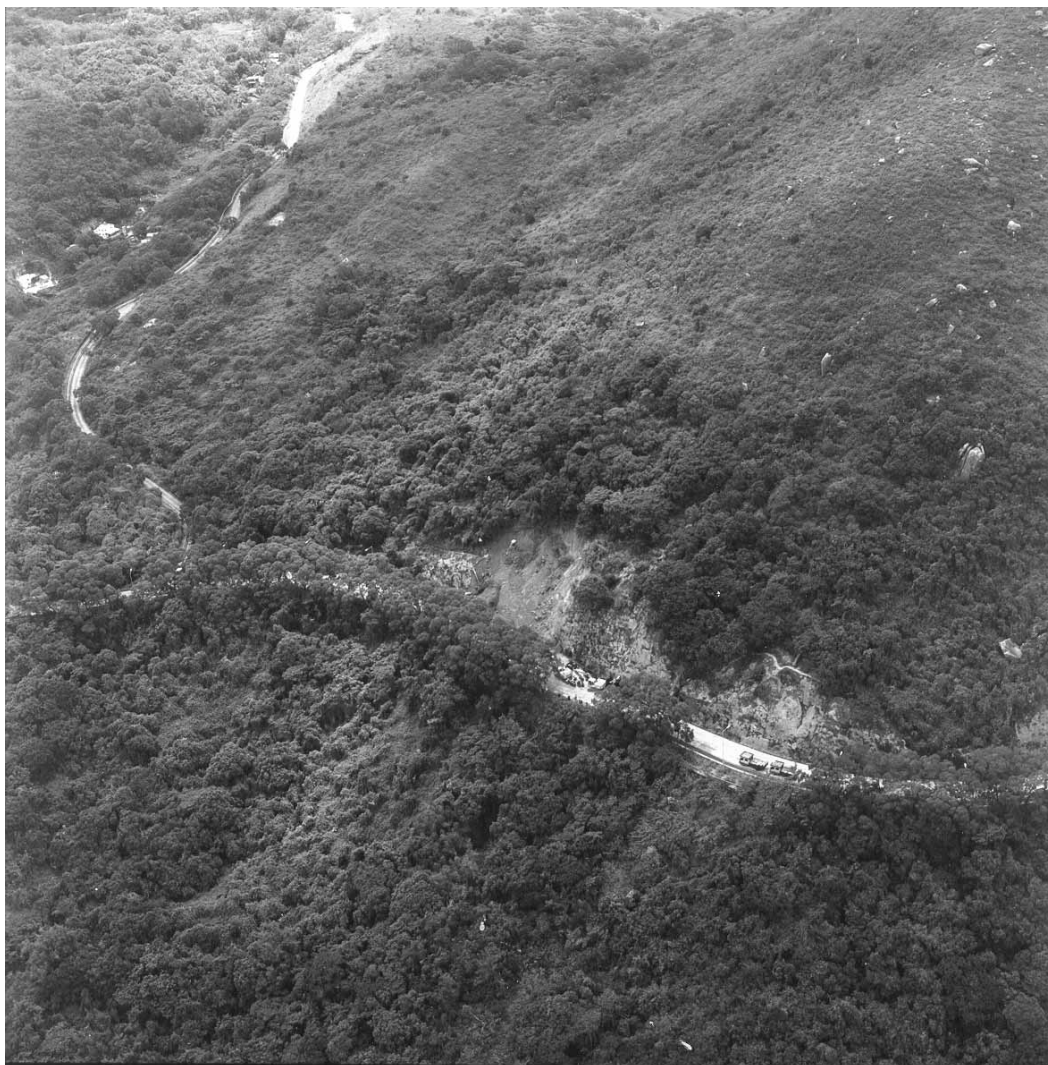
Plate 2 - Oblique View of the Landslide Site and Natural Hillside above.  
Note Change in Vegetation Approximately 30 m above Scar and  
Many Exposed Boulders (Photograph Taken on 25 August 1999)
