**SECTION 2:  
DETAILED STUDY OF THE  
23 AUGUST 1999  
LANDSLIDE AT ROUTE TWISK  
OPPOSITE THE LOOKOUT  
POINT NEAR SHEK KONG**

**Fugro Maunsell Scott Wilson Joint Venture**

**This report was originally produced in August 2000  
as GEO Landslide Study Report No. LSR 5/2000**

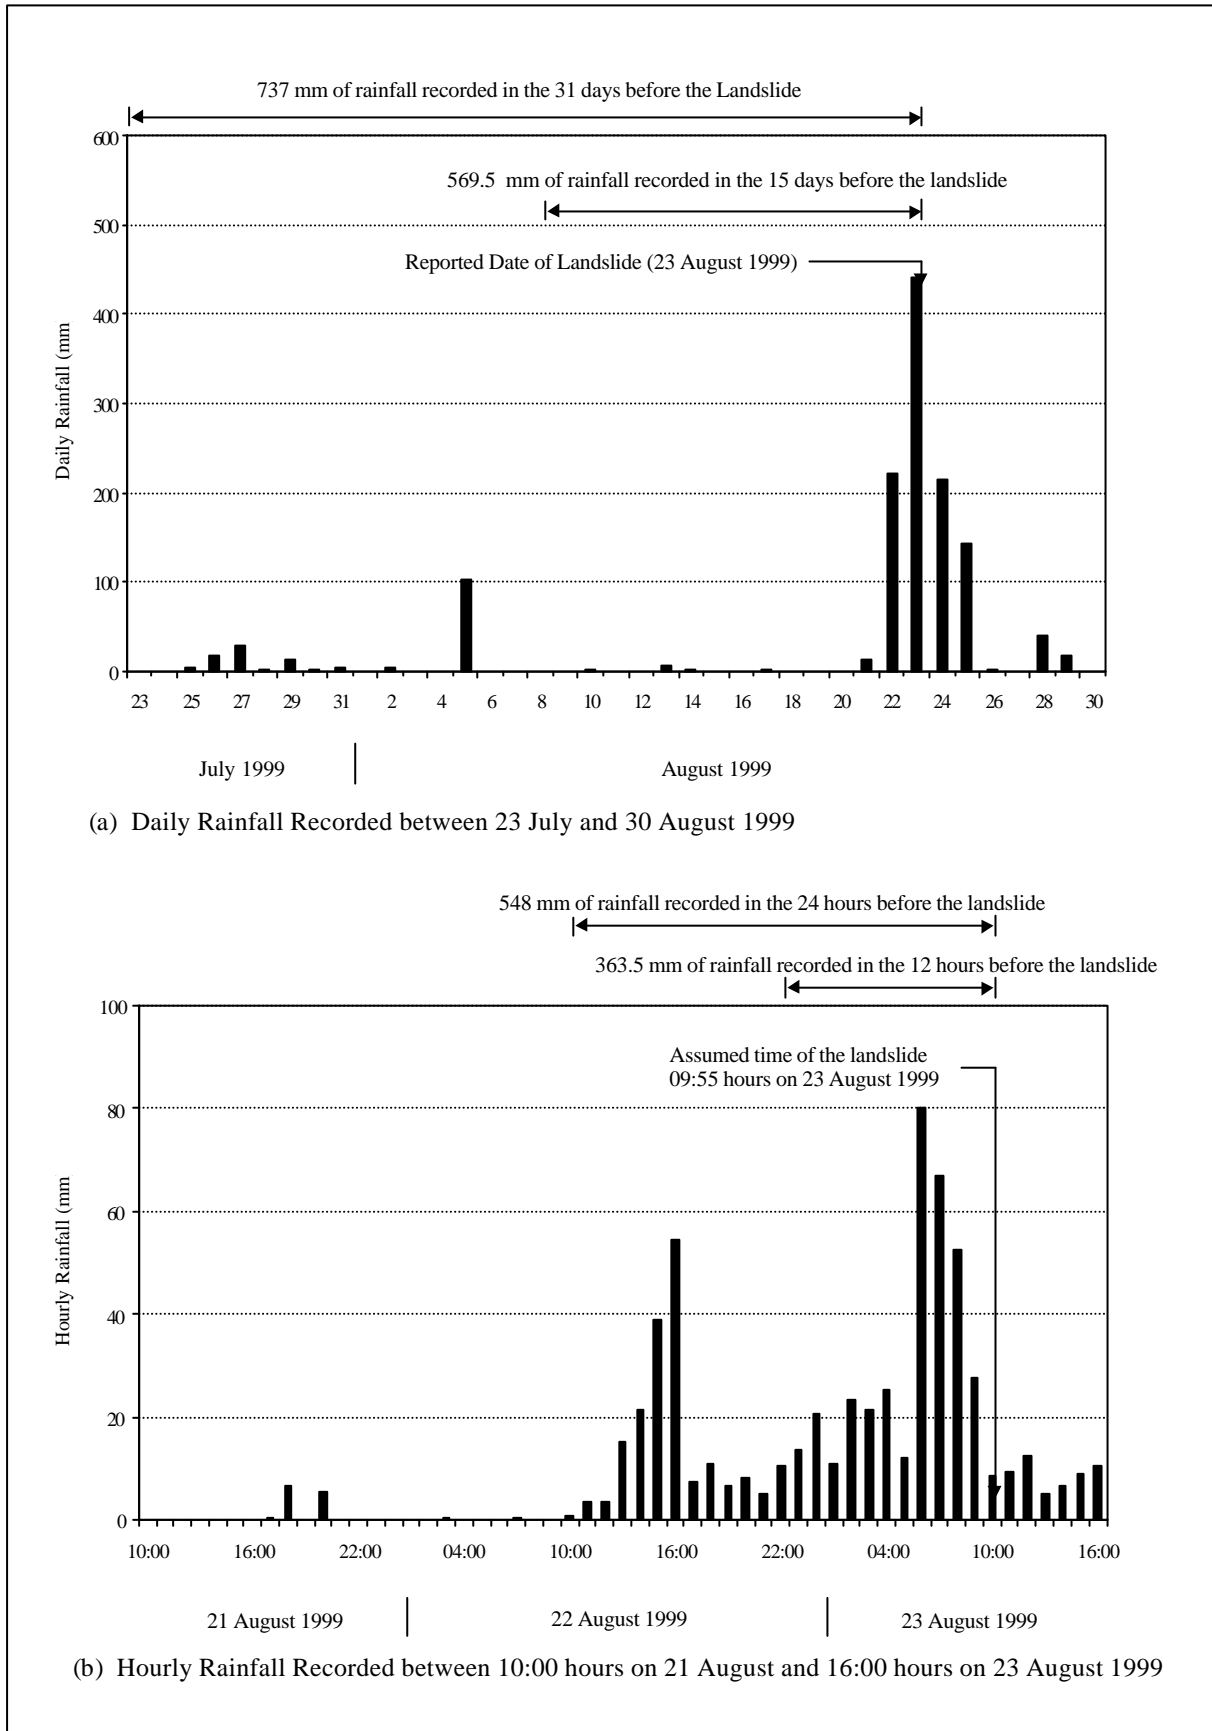
Figure 8 - Rainfall Recorded at GEO Raingauge No. N14

The daily rainfall recorded by this raingauge over the month preceding, and seven days following, the incident is presented in Figure 8. The rainstorm was concentrated on 23 August 1999. The hourly data for the period from 9:55 a.m. on 21 August 1999 until 3:55 p.m. on 23 August 1999 is also shown on Figure 8. Peaks in rainfall intensity between 2:00 p.m. and 4:00 p.m. on 22 August 1999, and between 5:00 a.m. and 8:00 a.m. on 23 August 1999, were generally in the range of 50 mm/hr to 80 mm/hr.

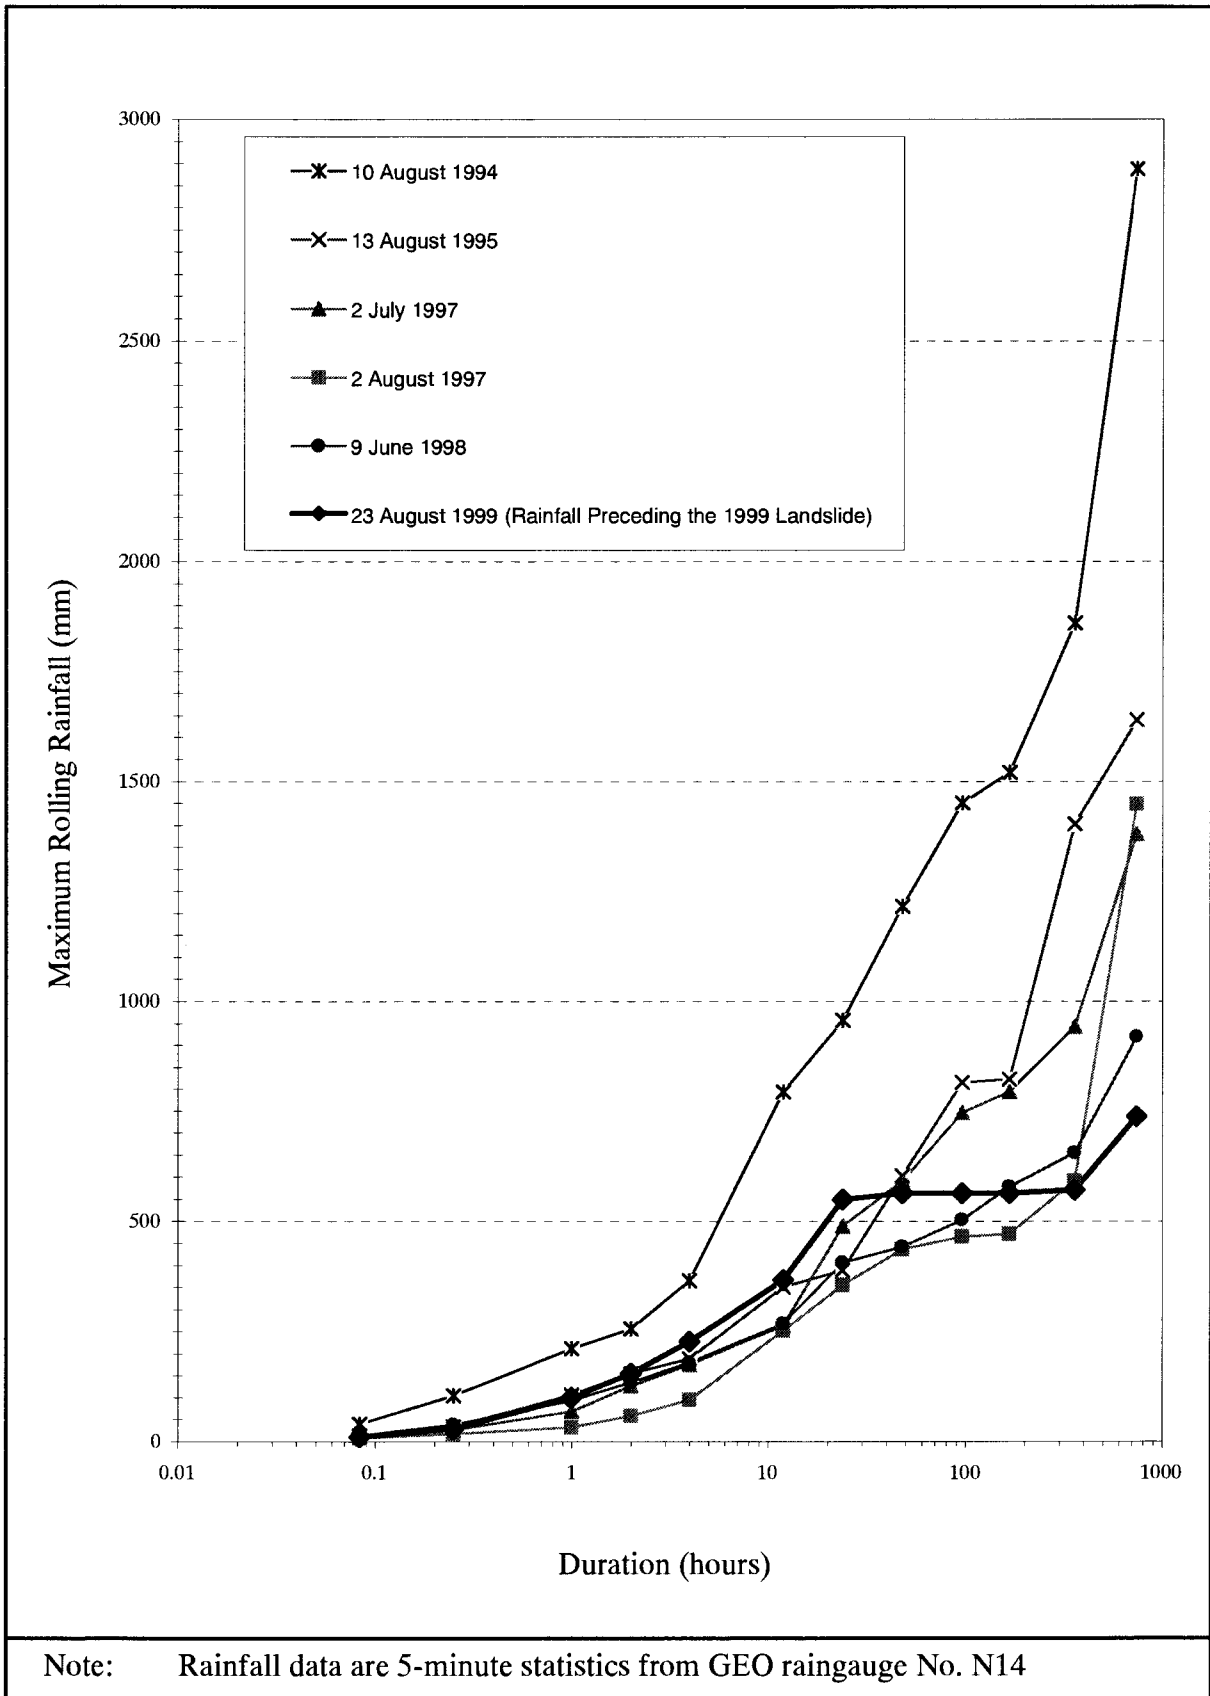
Figure 9 - Maximum Rolling Rainfalls Preceding the Landslide on 23 August 1999 and Selected Previous Major Rainstorms

A comparison between the patterns of past major rainstorms recorded at raingauge No. N14 between 1994 and 1999, is given in Figure 9. The rolling rainfall indicates that the

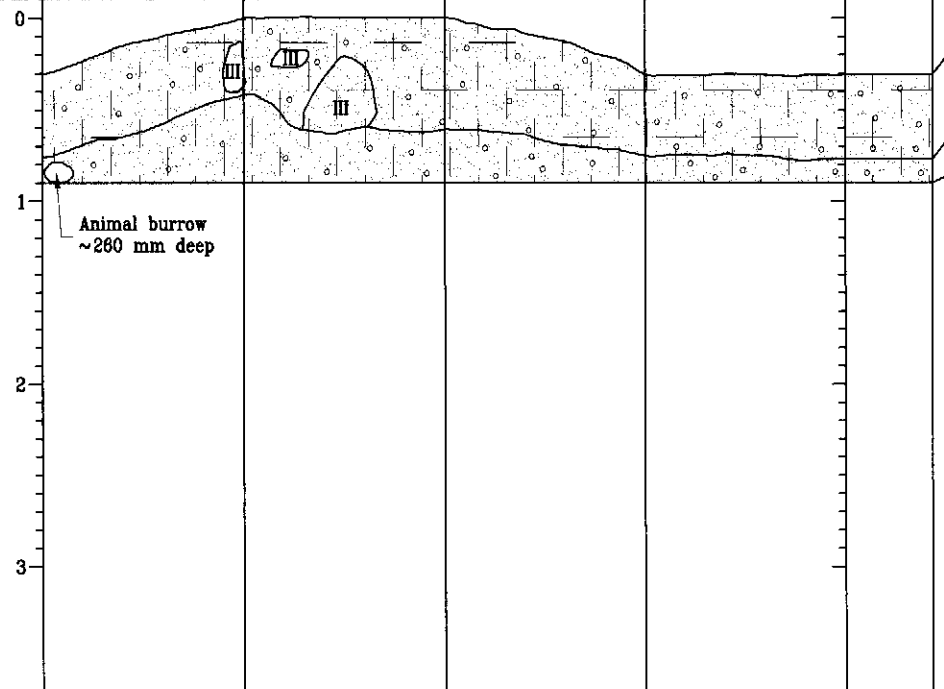
Loose, greyish brown, sandy clayey SILT, with some angular, fine to coarse gravel and cobbles of MDT (FILL/REWORKED residual soil and CDT)

Loose, yellowish brown to reddish brown, sandy SILT with some sub-angular, medium to coarse gravel (Extremely weak completely decomposed coarse ash TUFF)
