**INVESTIGATION OF SOME
SELECTED LANDSLIDES
IN 1999
(VOLUME 2)**

GEO REPORT No. 121

**GEOTECHNICAL ENGINEERING OFFICE
CIVIL ENGINEERING DEPARTMENT
THE GOVERNMENT OF THE HONG KONG
SPECIAL ADMINISTRATIVE REGION**

**SECTION 1:
DETAILED STUDY OF THE
LANDSLIDE ABOVE
KAP LUNG, SHEK KONG,
DURING THE SEVERE
RAINSTORMS BETWEEN
22 AND 24 AUGUST 1999**

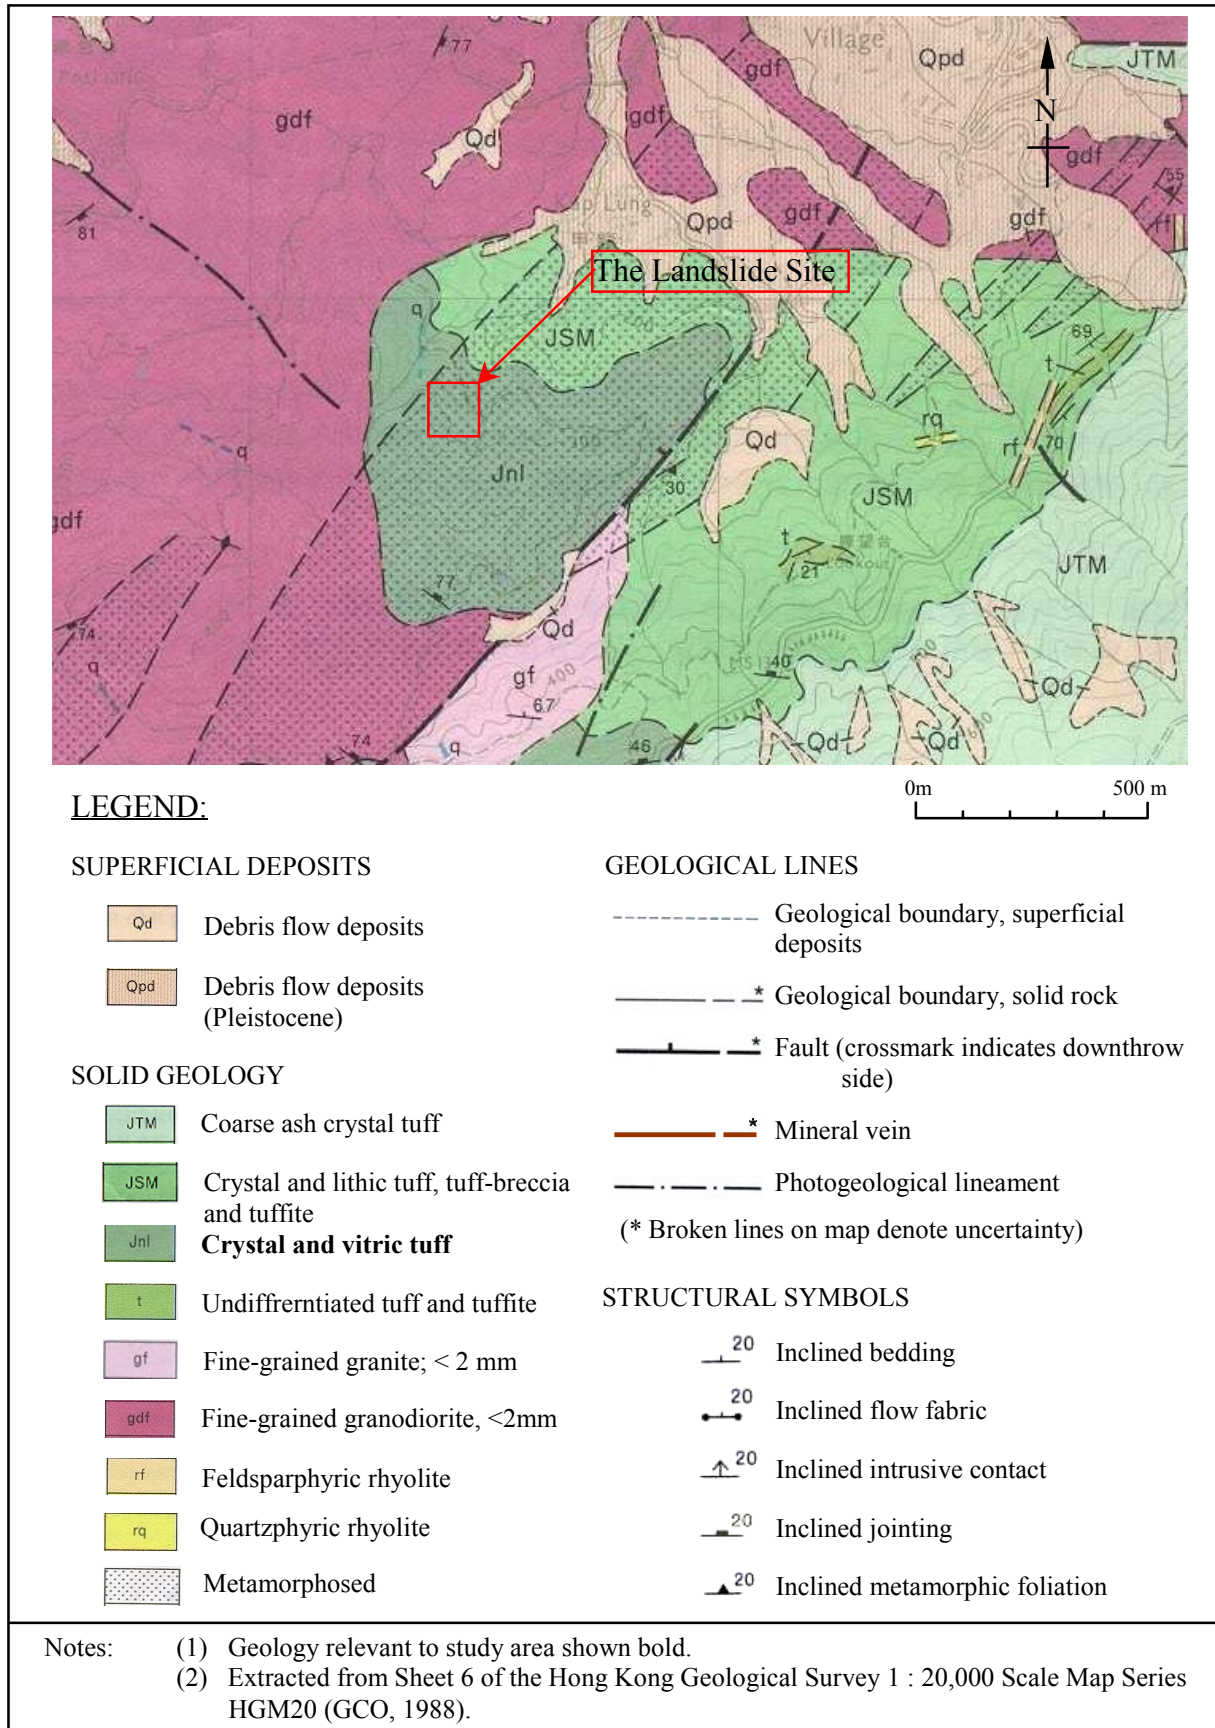
Figure 6 – Regional Geological Map

According to Sheet 6 of the Hong Kong Geological Survey 1:20,000 Map Series (GCO, 1988), the geology at the landslide site comprises crystalline and vitric tuff (Shing Mun Formation of the Upper Jurassic Repulse Bay Group). An extract from the geological map is shown in Figure 6. No major faults are shown as crossing the landslide site.

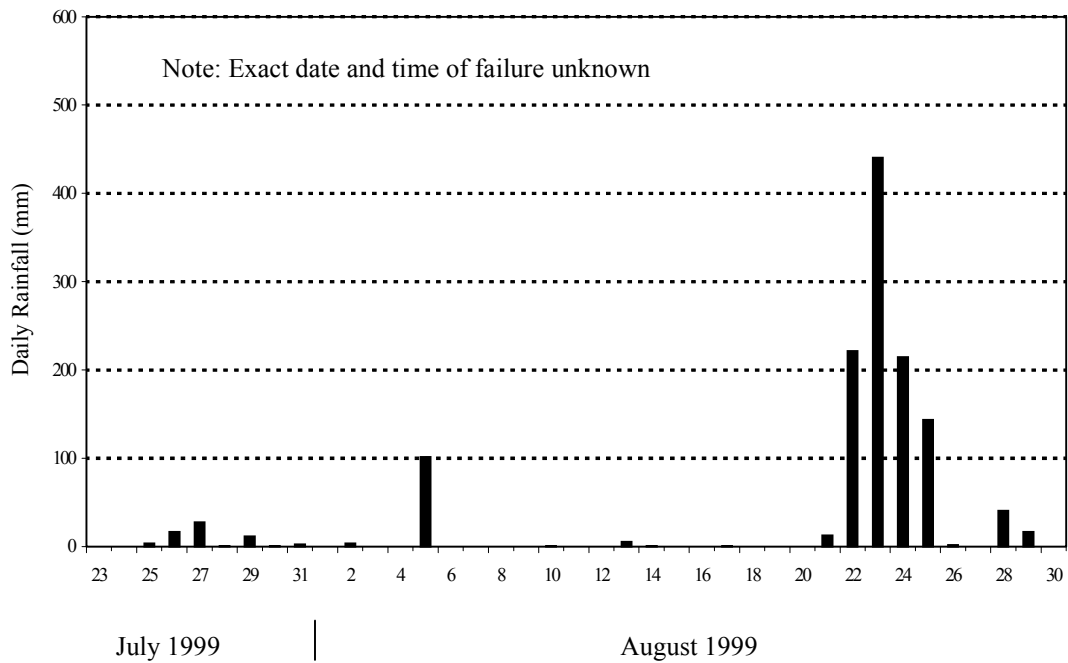
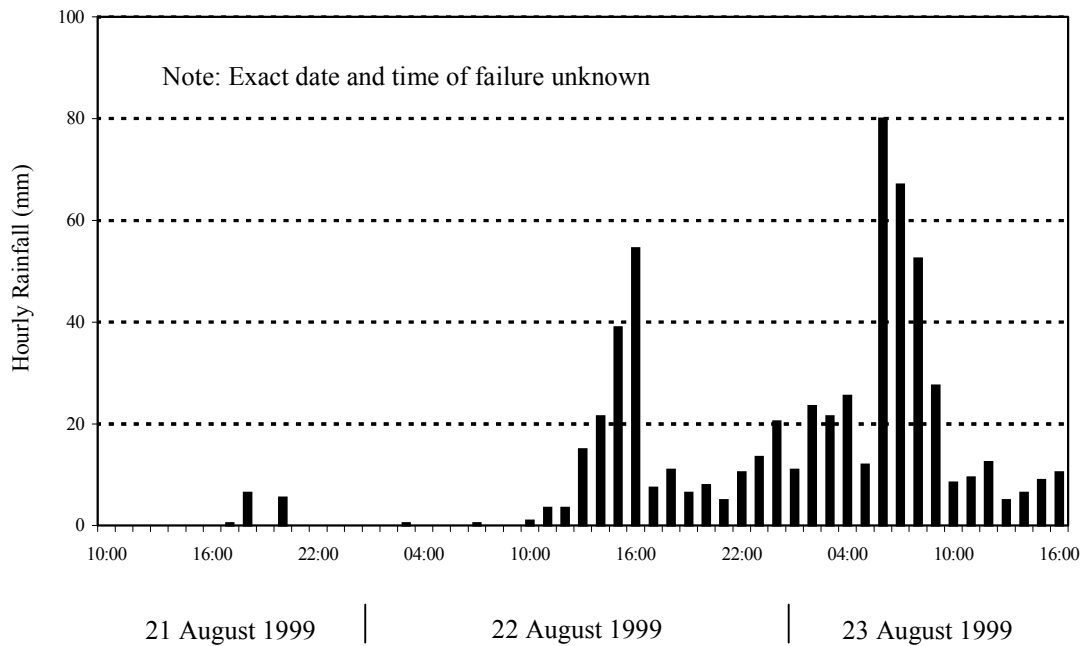
Figure 7 - Rainfall Recorded at GEO Raingauge No. N14

The daily rainfall recorded by the raingauge for the end of July 1999 and the month of August 1999 is presented in Figure 7. The daily rainfall records show that the storm was concentrated around 23 August 1999. The corresponding hourly rainfall for the period from 10:00 a.m. on 21 August 1999 to 4:00 p.m. on 23 August 1999 is also shown in Figure 7. Peaks in rainfall were recorded between 5:00 a.m. and 8:00 a.m. on 23 August 1999 in the range of about 50 mm/hr to 80 mm/hr. The peak rainfall intensity corresponds to a return period of about 85 years based on rainfall analysis. However, as noted above, the timing of the failure is uncertain and it is possible the failure occurred at an earlier stage of the rainstorm, which would have a smaller return period.

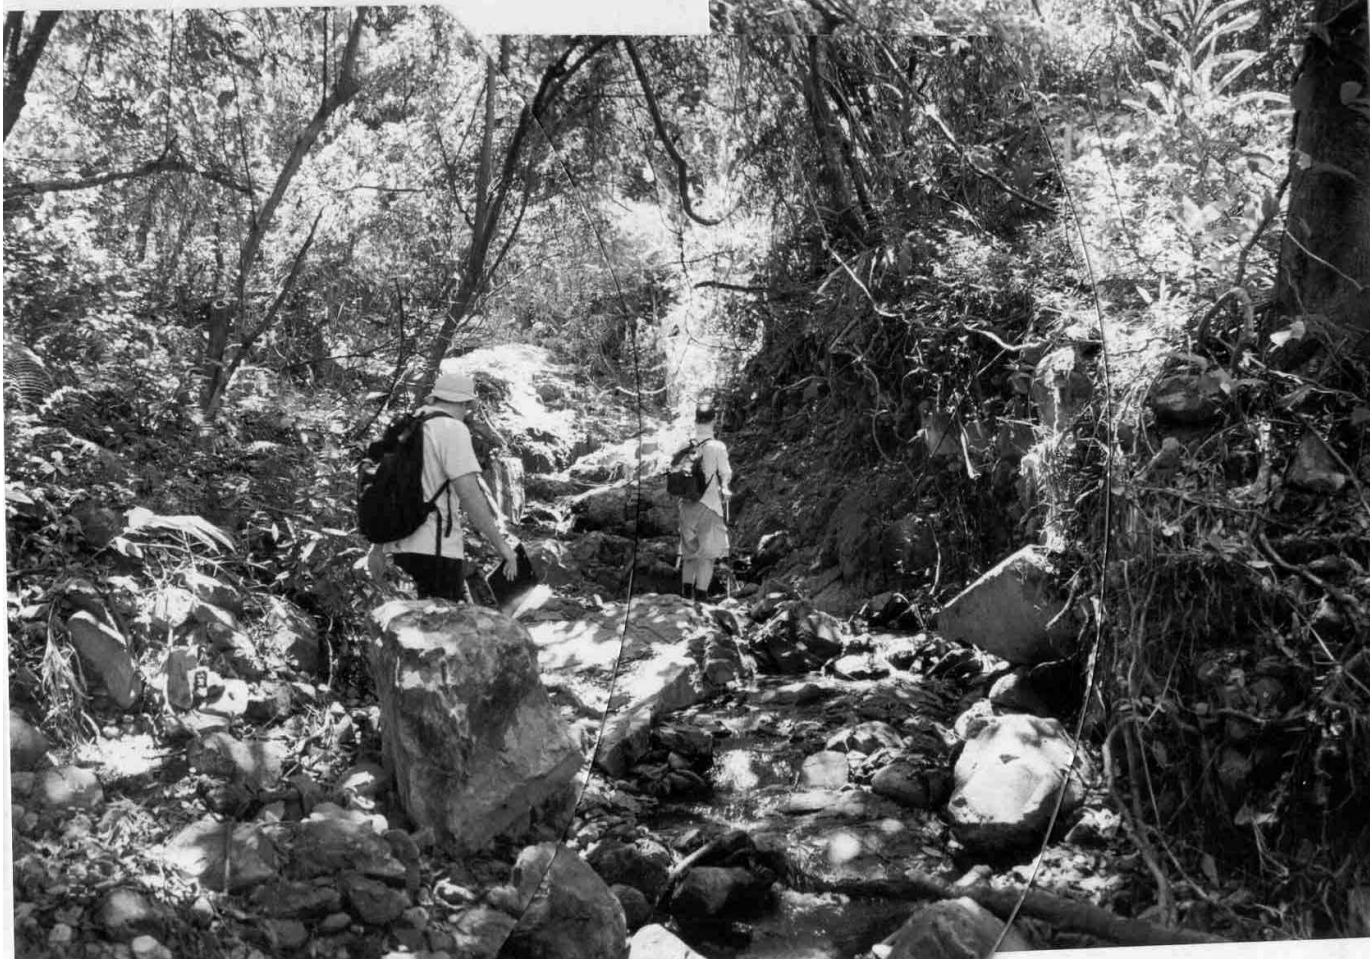
Plate A7 – View Looking Upslope Showing the Typical Profile of the Upper Section of the Drainage Line
