**SECTION 2:
DETAILED STUDY OF THE
LANDSLIDES BELOW
VTC POKFULAM SKILLS
CENTRE, POKFULAM ROAD
ON 23 AUGUST 1999**

**This report was originally produced in October 2000
as GEO Landslide Study Report No. LSR 7/2000**

This report presents the findings of a detailed study of two landslides (GEO Incident No. HK 99/8/11) which occurred on 23 August 1999 in the hillside below the Vocational Training Council (VTC) Pokfulam Skills Centre on Pokfulam Road. Debris from the landslides, estimated at 100 m³ and 200 m³ respectively, was channelised in an ephemeral drainage line and reached Victoria Road, approximately 200 m west of the VTC facility on plan. No casualties were reported as a result of the incident.

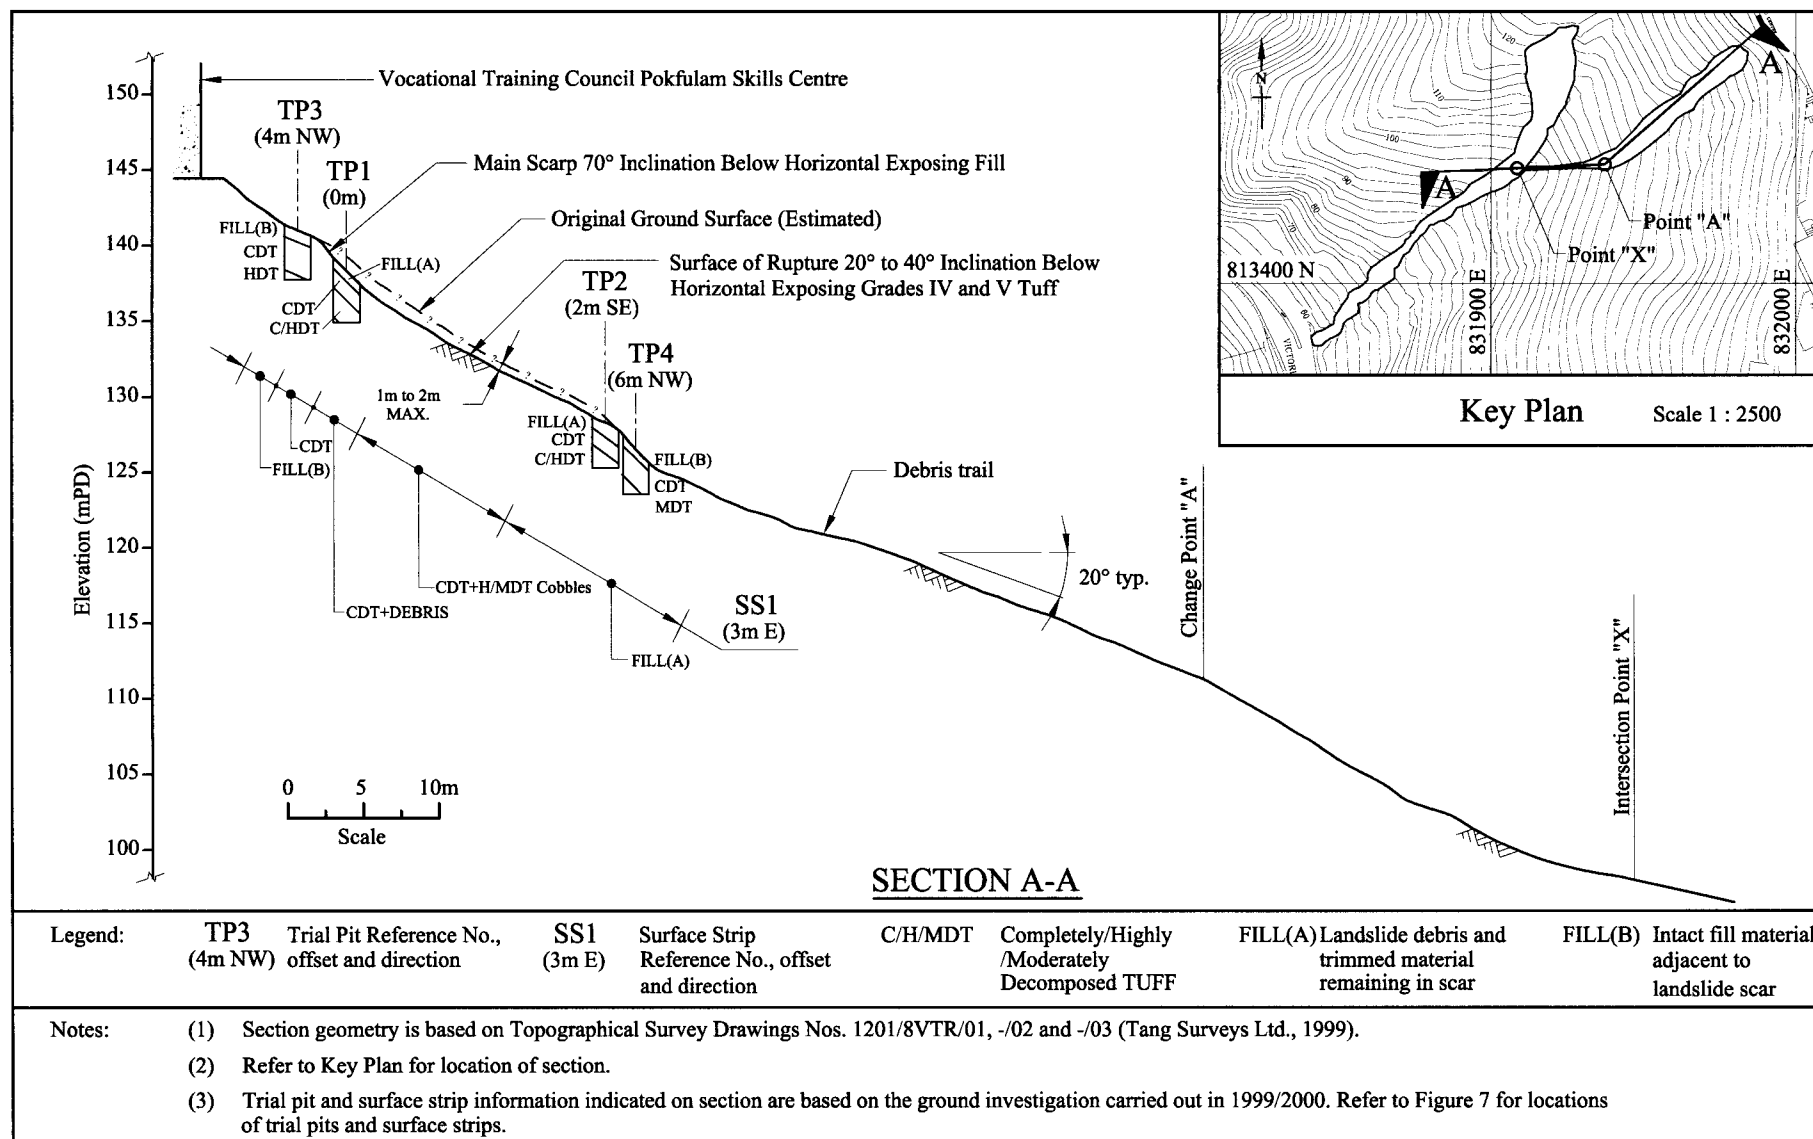
Figure 4 - Section A-A through Landslide A

The results of the analyses are presented in Figures 11 and 12 respectively. The results for Section A-A presented on Figure 11 indicate that elevated groundwater pressures of between 0.25 m to 0.5 m above the surface of rupture (fill/natural ground interface) would be required to initiate failure when effective cohesion corresponds to 1 kPa to 2 kPa. The fill was probably in a loose to medium dense state based on the interpretation of the available test results and site observations. This suggests that cohesion would be low.

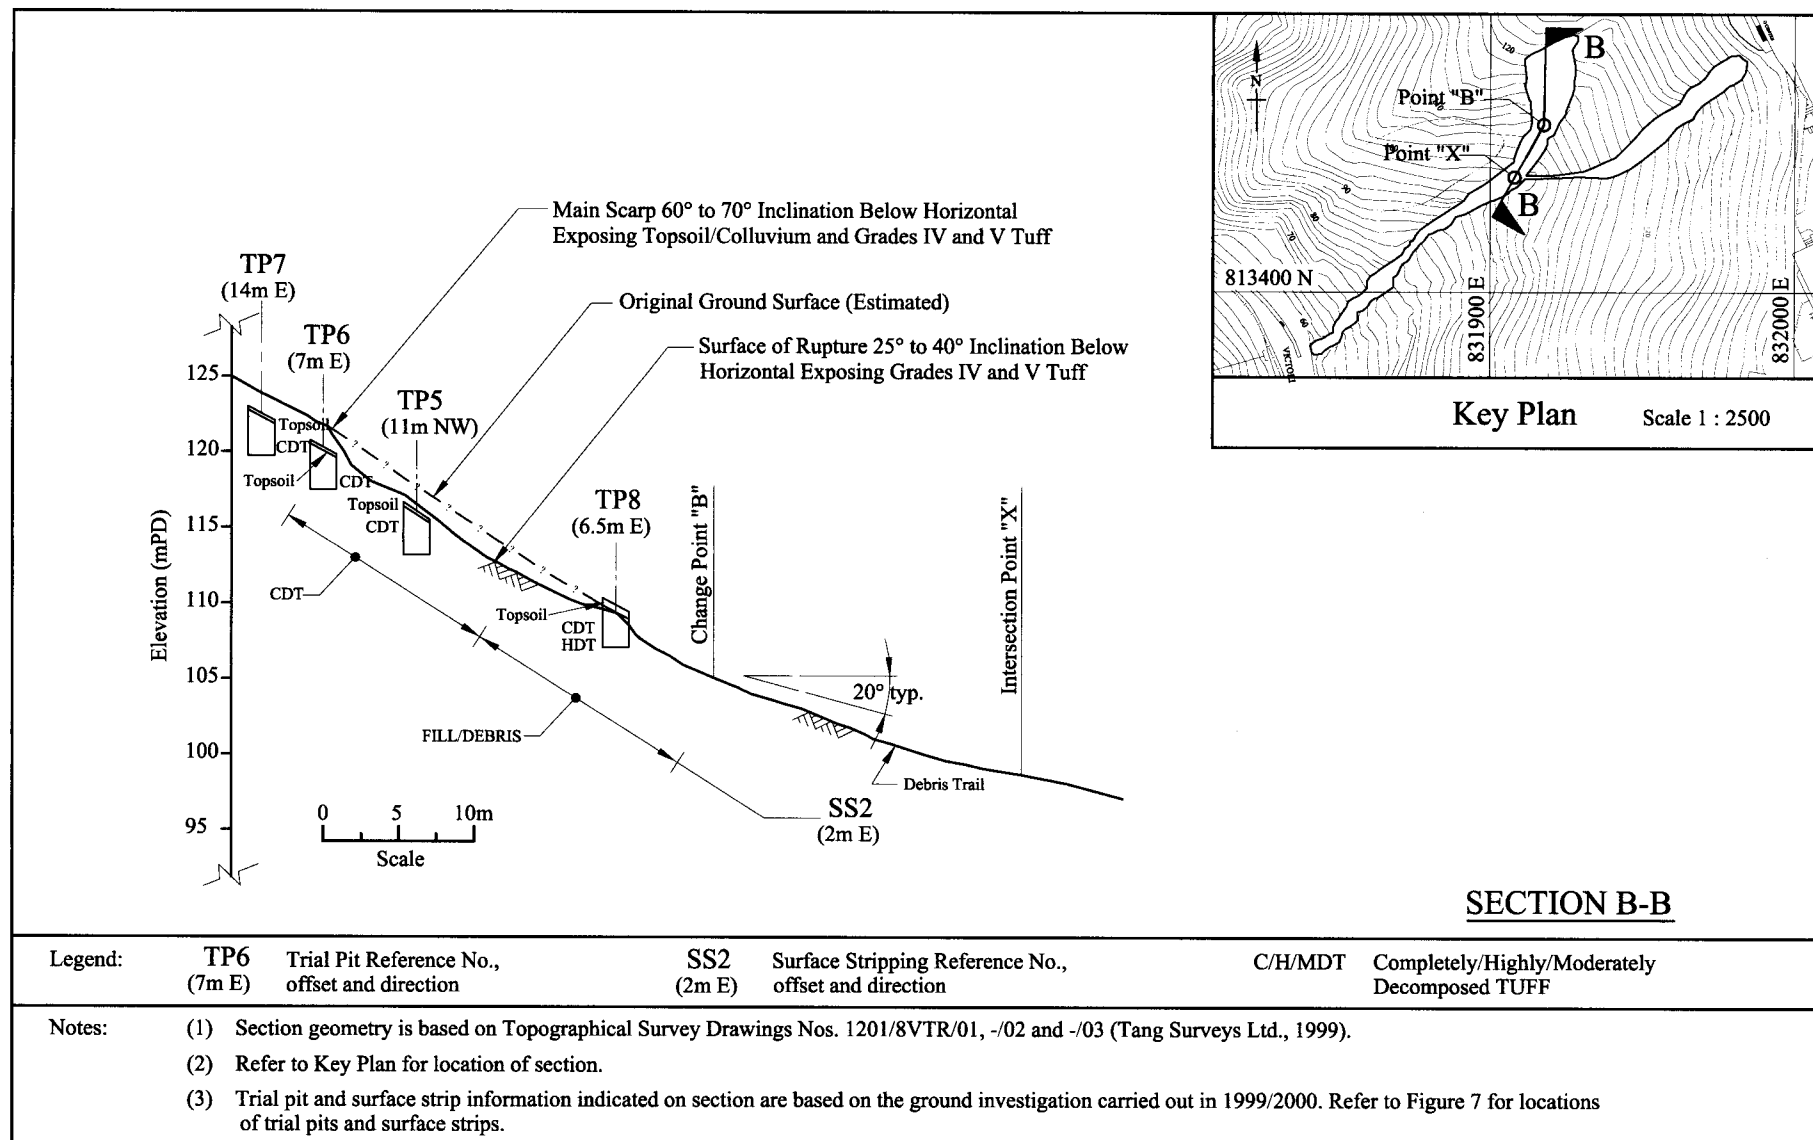
Figure 5 - Section B-B through Landslide B

The results for Section B-B, presented in Figure 12, are similar to those obtained for Section A-A, indicating that the development of elevated groundwater pressures of between 0.25 m and 0.5 m above the surface of rupture would be required to initiate failure in the hillside when the effective cohesion at the surface of rupture is 1 kPa to 2 kPa.

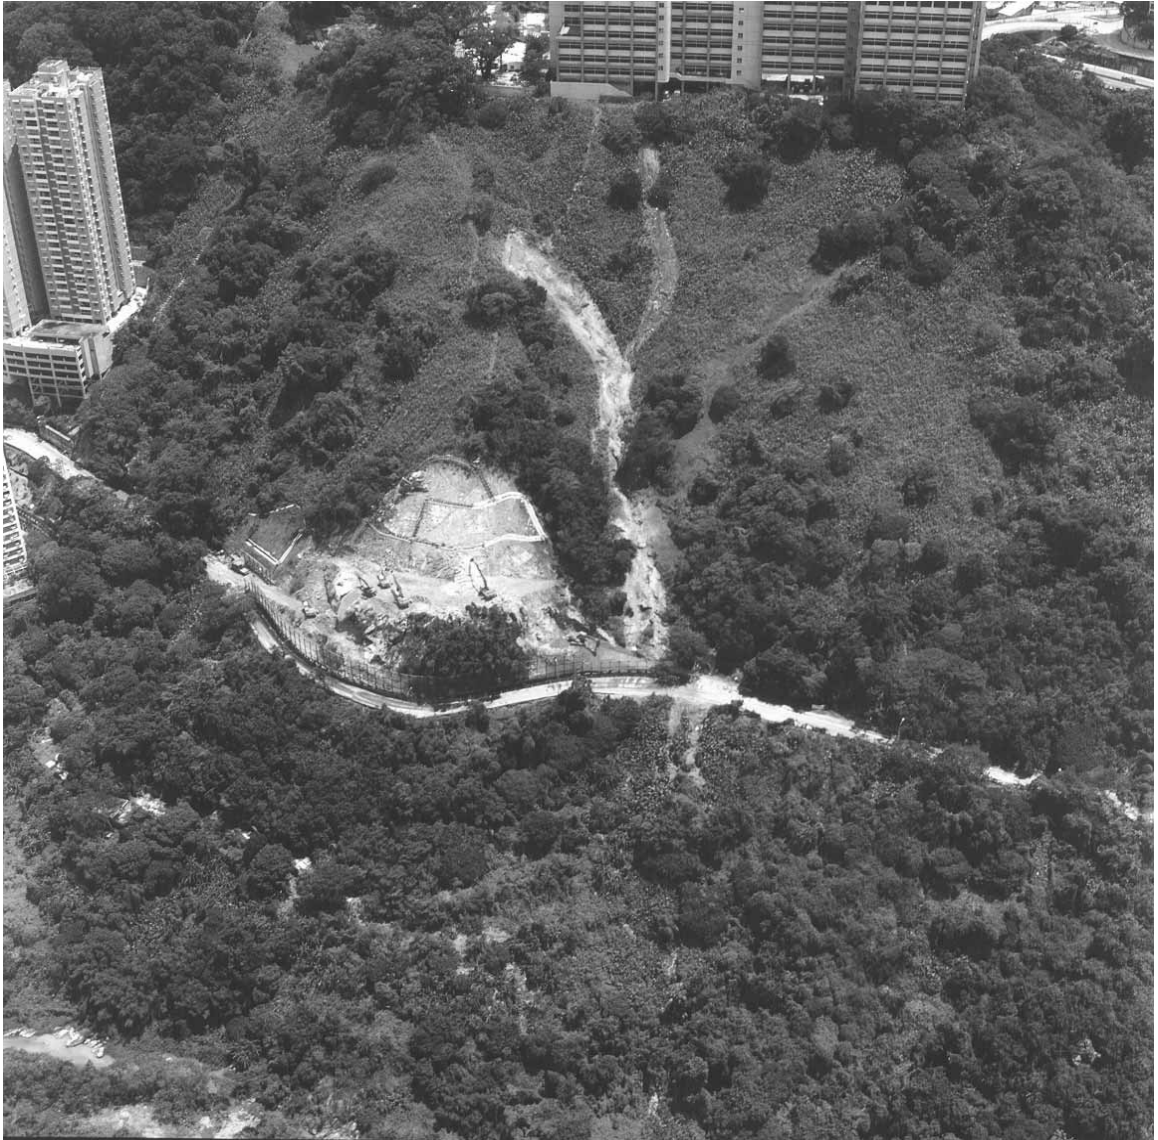
Plate 1 – Oblique View of the Landslide Site Indicating Convergent Debris Trails and Subsequent Runout to Victoria Road. VTC Pokfulam Skills Centre Visible in Upper Portion of Frame. Upper Baguio Villas (Block 26) and Lower Baguio Villas (Block 44) Separated by Victoria Road Visible on Left of Frame. Slope Works in Progress above Victoria Road Associated with Victoria Road Improvement Stage 2 Phase II Project (Photograph Taken on 2 September 1999)

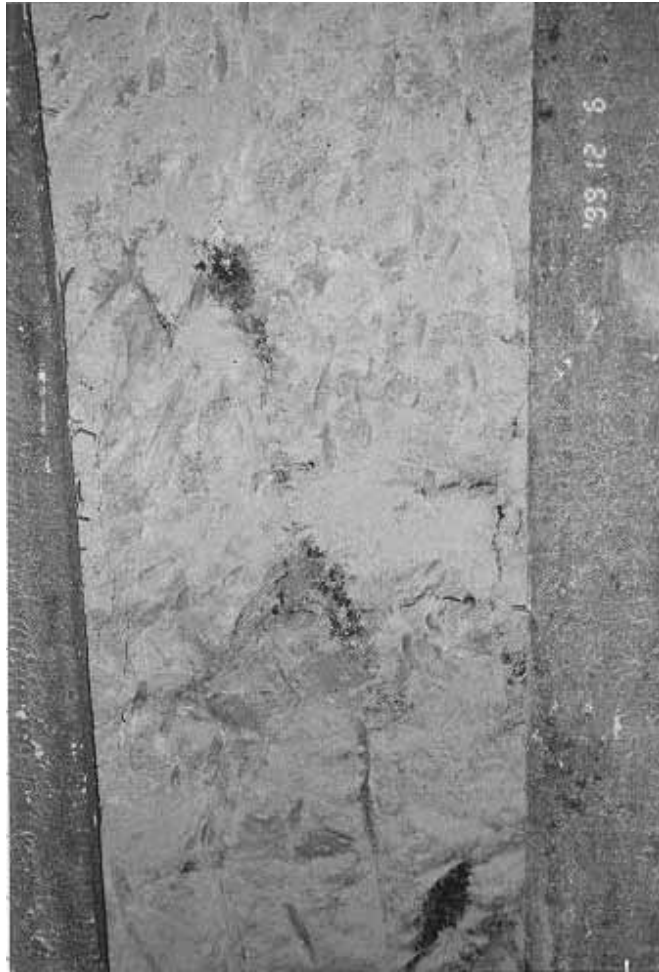
Plate 18 – Trial Pit TP1: General View Showing Insitu Weathering Profile of Fine Ash Vitric Tuff (Photograph Taken on 6 December 1999)

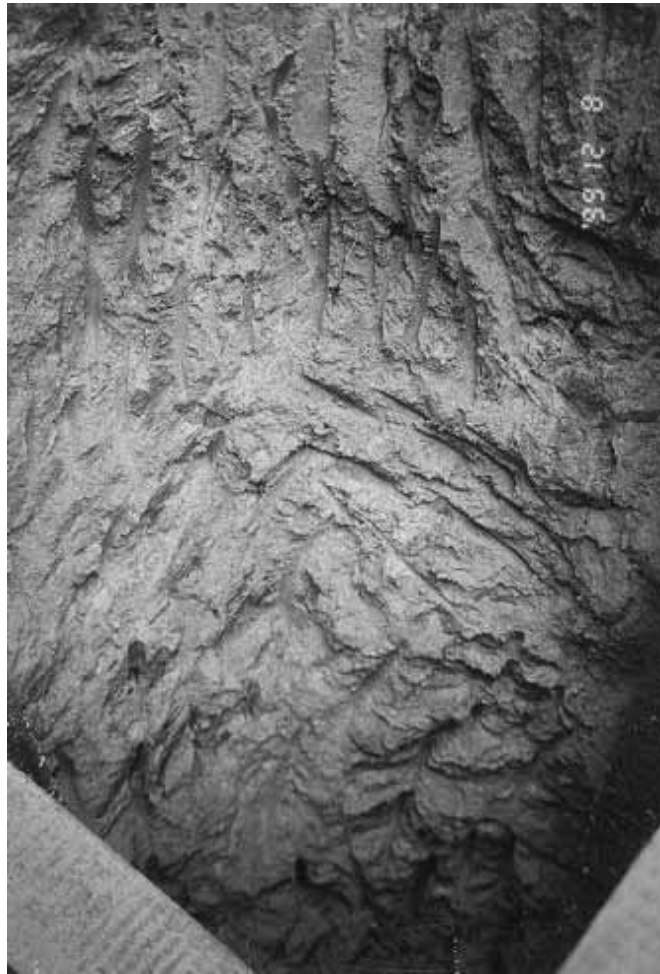
Plate 19 – Trial Pit TP2: General View Showing Insitu Weathering Profile of Fine Ash Vitric Tuff (Photograph Taken on 8 December 1999)

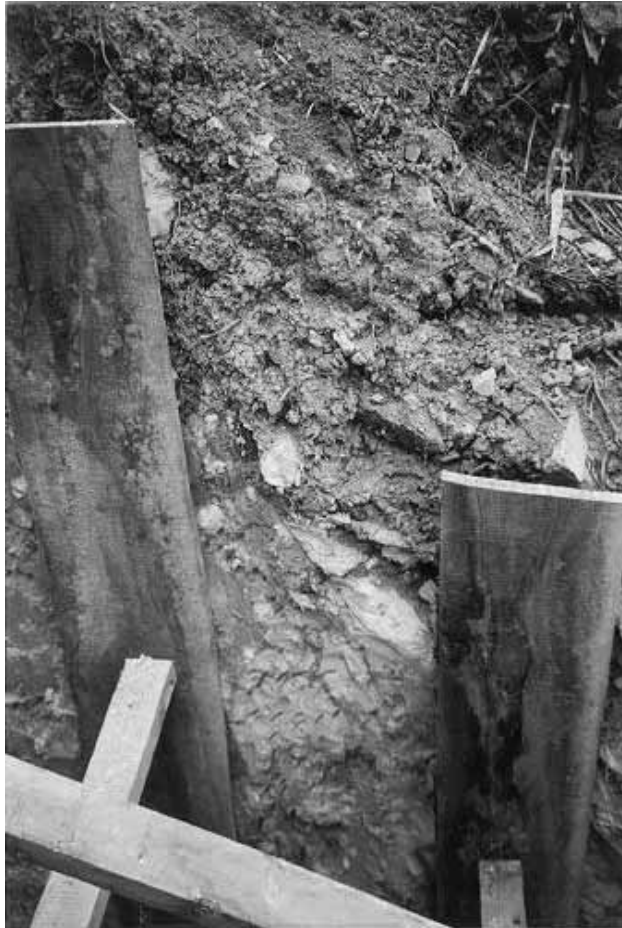
Plate 20 – Trial Pit TP3: South-East Face of Pit Exposing Fill Overlying Insitu Profile (Photograph Taken on 7 December 1999)

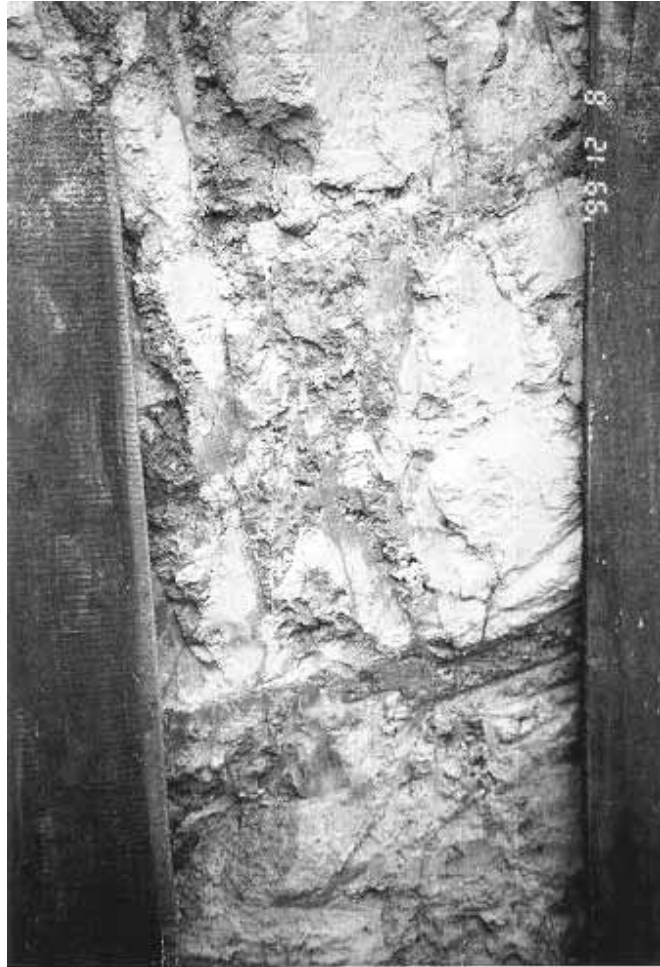
Plate 21 – Trial Pit TP2: General View Indicating Open, Blocky Structure of Grade IV Tuff (Photograph Taken on 8 December 1999)

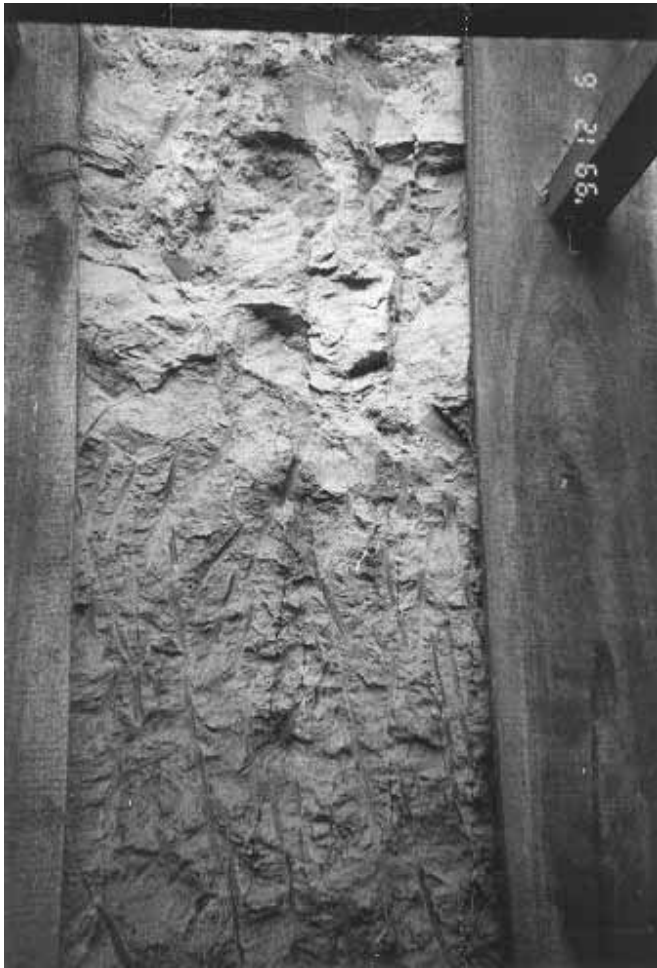
Plate 22 – Trial Pit TP1: General View Showing Relic Joints in Grade IV Tuff Infilled with Grade V Material (Photograph Taken on 6 December 1999)

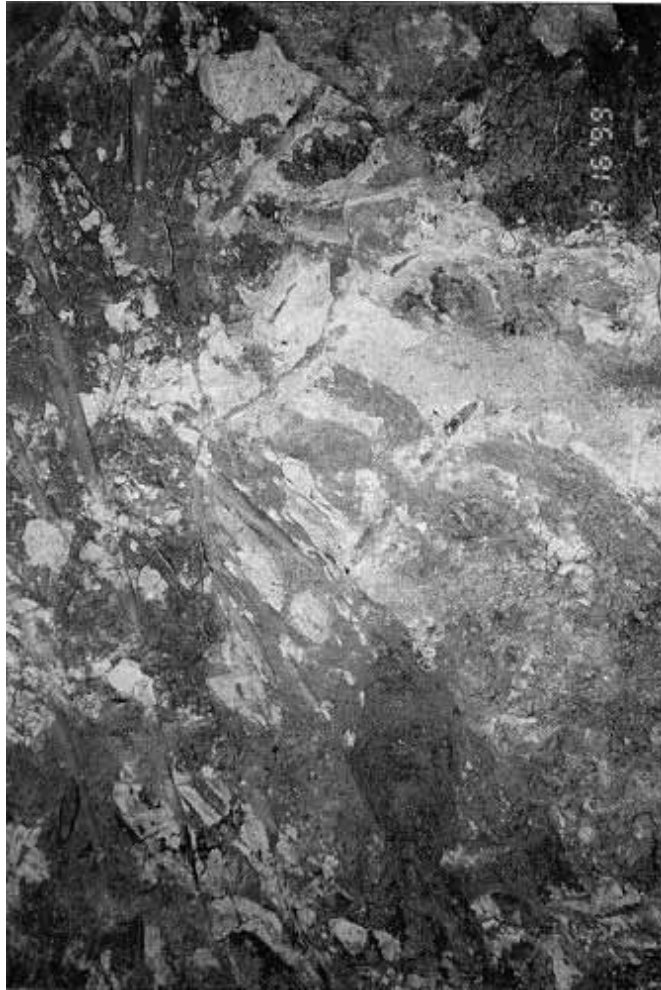
Plate 27 – Trial Pit TP5: Exposure of Grade III/IV Tuff in Western Face of Pit.
(Photograph Taken on 16 December 1999)
