**INVESTIGATION OF SOME
SELECTED LANDSLIDES
IN 1999
(VOLUME 3)**

GEO REPORT No. 122

Fugro Maunsell Scott Wilson Joint Venture

**SECTION 1:
DETAILED STUDY OF THE
24 AUGUST 1999 LANDSLIDE
AT TSING YI ROAD
TSING YI ISLAND**

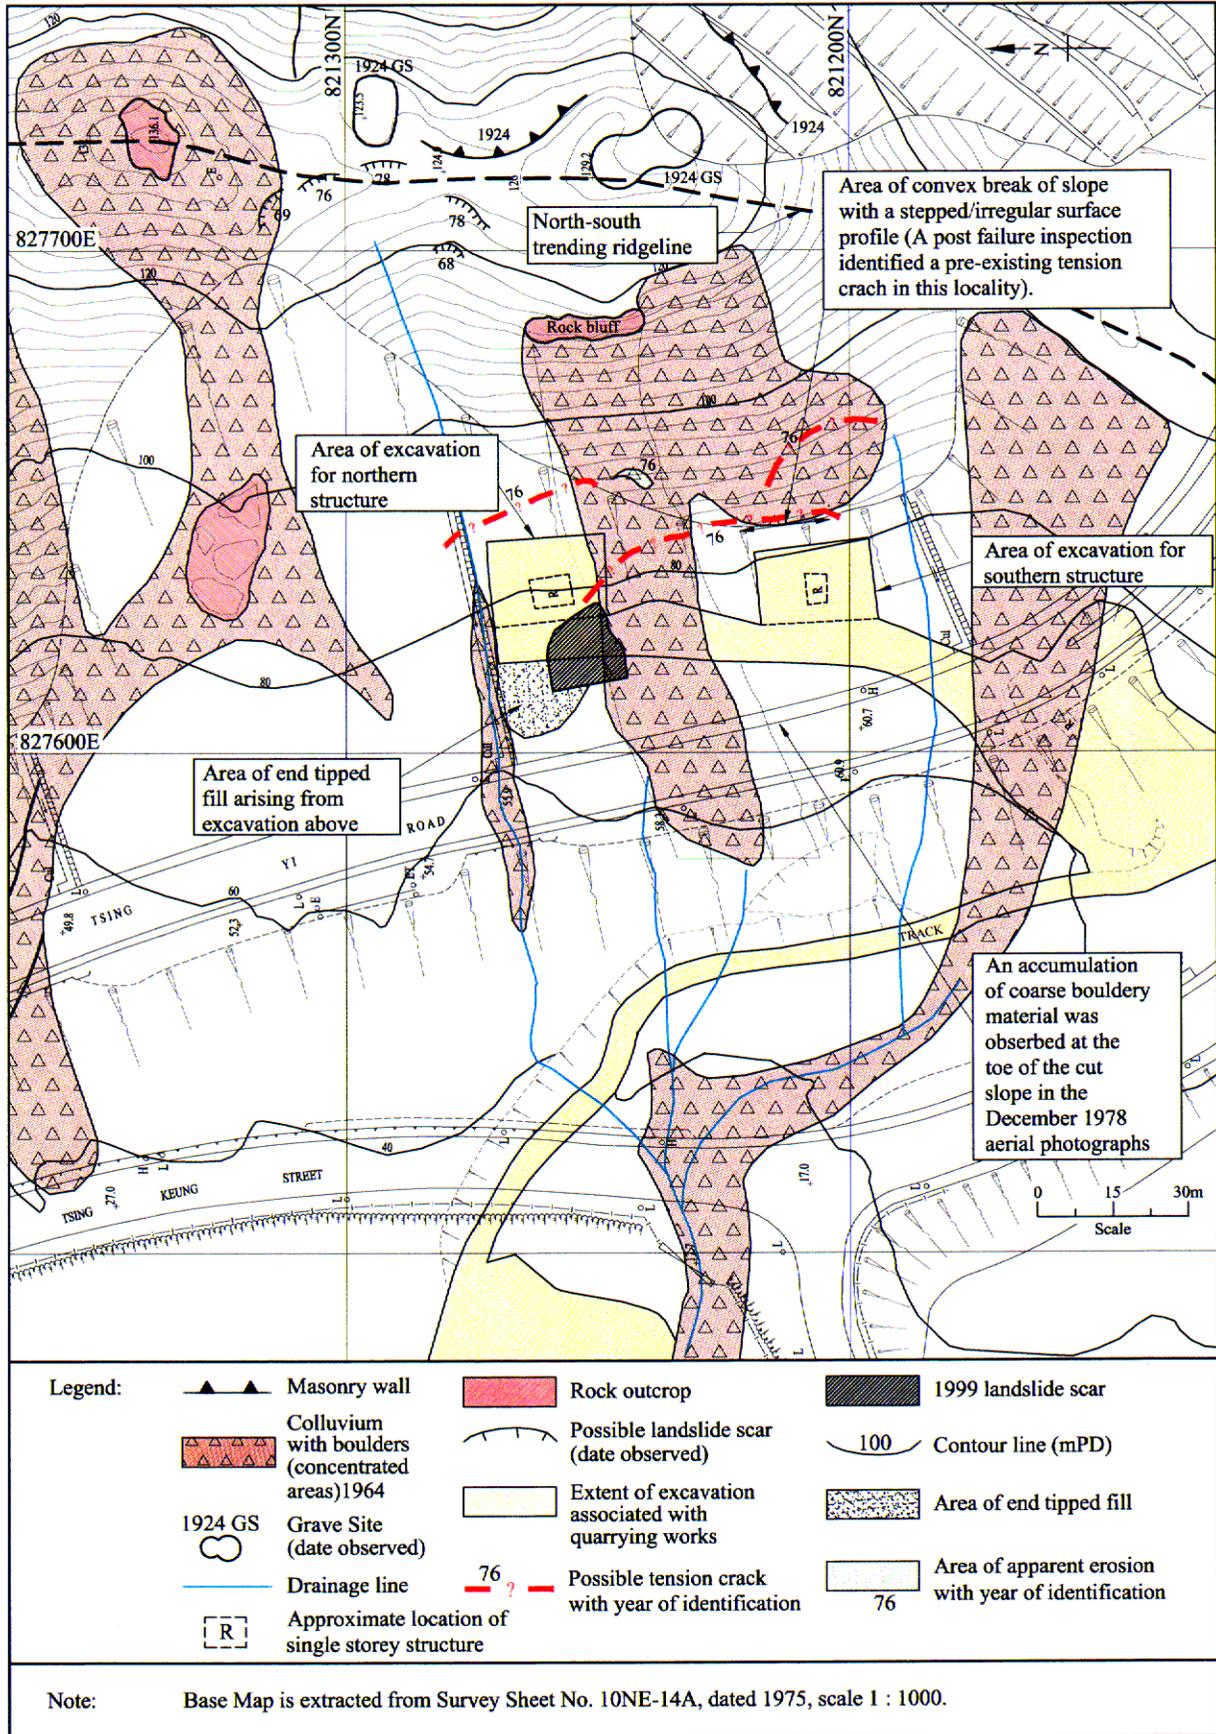
Figure 5 - Features Observed from API (Sheet 1 of 2)

Although horizontal drains have been installed along the slope toe and surface drainage has been constructed at regular intervals across the failed slope, little attention appears to have been given to the control of subsurface water flows in the area where the slope cuts across the ephemeral drainage line. This may have been significant with regard to the 1999 landslide and also the 1982 landslide in slope No. 10NE-B/C262 to the north, which are separated by the ephemeral drainage line (Figure 5).

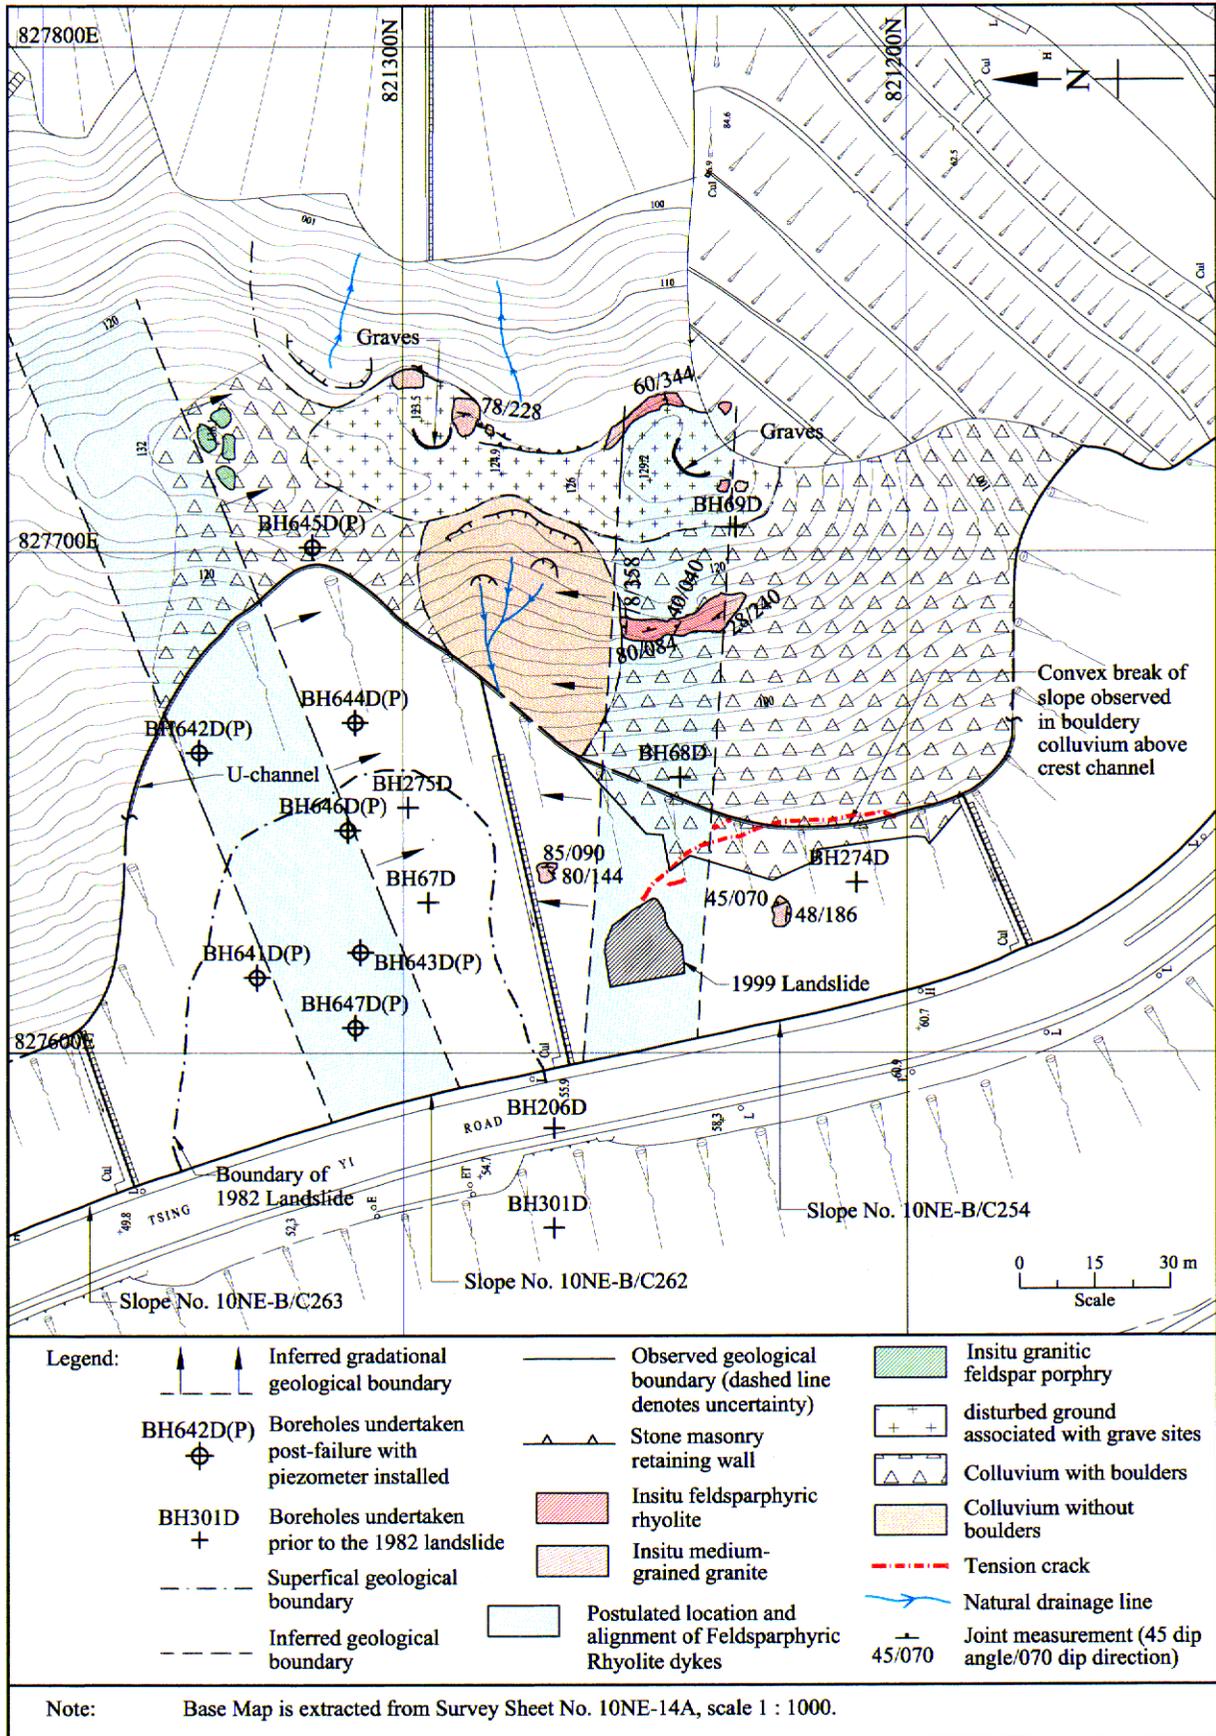
Figure 7 - Geology of the Landslide Site Based on Field Mapping

Along the ridgeline to the east of the 1999 landslide, a shallow depression forming an ephemeral drainage line lies between two prominent hilltop features (Figure 7). The ground below the hilltop is characterised by bouldery colluvium and outcrops of feldsparphyric rhyolite. These correspond to areas where rockhead is at or close to the ground surface. Between the hilltop features is a lower lying saddle, which is characterised as an area with a deeper weathering profile that is overlain by colluvium with less boulders.

Above and to the east of the 1999 landslide, a prominent outcrop of slightly decomposed feldsparphyric rhyolite, approximately 7 m in width, has been mapped. Further outcrops were identified along the ridgeline further uphill indicating that the dyke trends east-west through the area of the 1999 landslide within slope 10NE-B/C254 (Figure 6). The southern contact of the dyke with the granite was abrupt (Plate 21). The northern contact was less distinct with what is considered to be a gradational transition between the outcropping rhyolite and decomposed granite forming the lower lying saddle. The superficial deposits exposed within the area of the saddle comprised residual soil overlain further downhill by colluvium with few boulders. Possible shallow relic landslide scars were visible in the upper portion of the saddle.

Based on visual inspection, toppling is kinematically feasible within the prominent outcrop of slightly decomposed feldsparphyric rhyolite forming the rocky bluff above the 1999 landslide. The basal plane is formed by a joint set dipping at an angle of 28° in a west south westerly direction (240°) with a number of different joint sets intersecting the basal plane to form block edges. Details of joint measurements recorded on site are presented in Figure 7. This may explain the deposits of bouldery colluvium identified below the prominent outcrop.

No significant signs of distress were observed across the hillside above the cut slopes, apart from some small shallow failure scars in the vicinity of the saddle, which may be related to disturbed ground associated with the graves in this area (Figure 7).

The geological setting of the landslide site comprises granite intruded by east-west trending feldsparphyric rhyolite dykes that lie approximately perpendicular to the alignment of Tsing Yi Road, i.e. parallel with the line of the cut slopes (Figure 7). Two dykes have been identified in the vicinity of the landslide site, one of which is considered to pass beneath the location of the 1999 landslide. The dykes form areas of higher ground, with rockhead at or close to the ground surface above an elevation of between 115 mPD and 120 mPD. The area of lower lying terrain between the two dykes forms an ephemeral drainage line, along which possibly exists a locally deeper weathering profile within the granitic materials. The road has been cut through this drainage line and the landslide occurred about 15 m to the south of it.

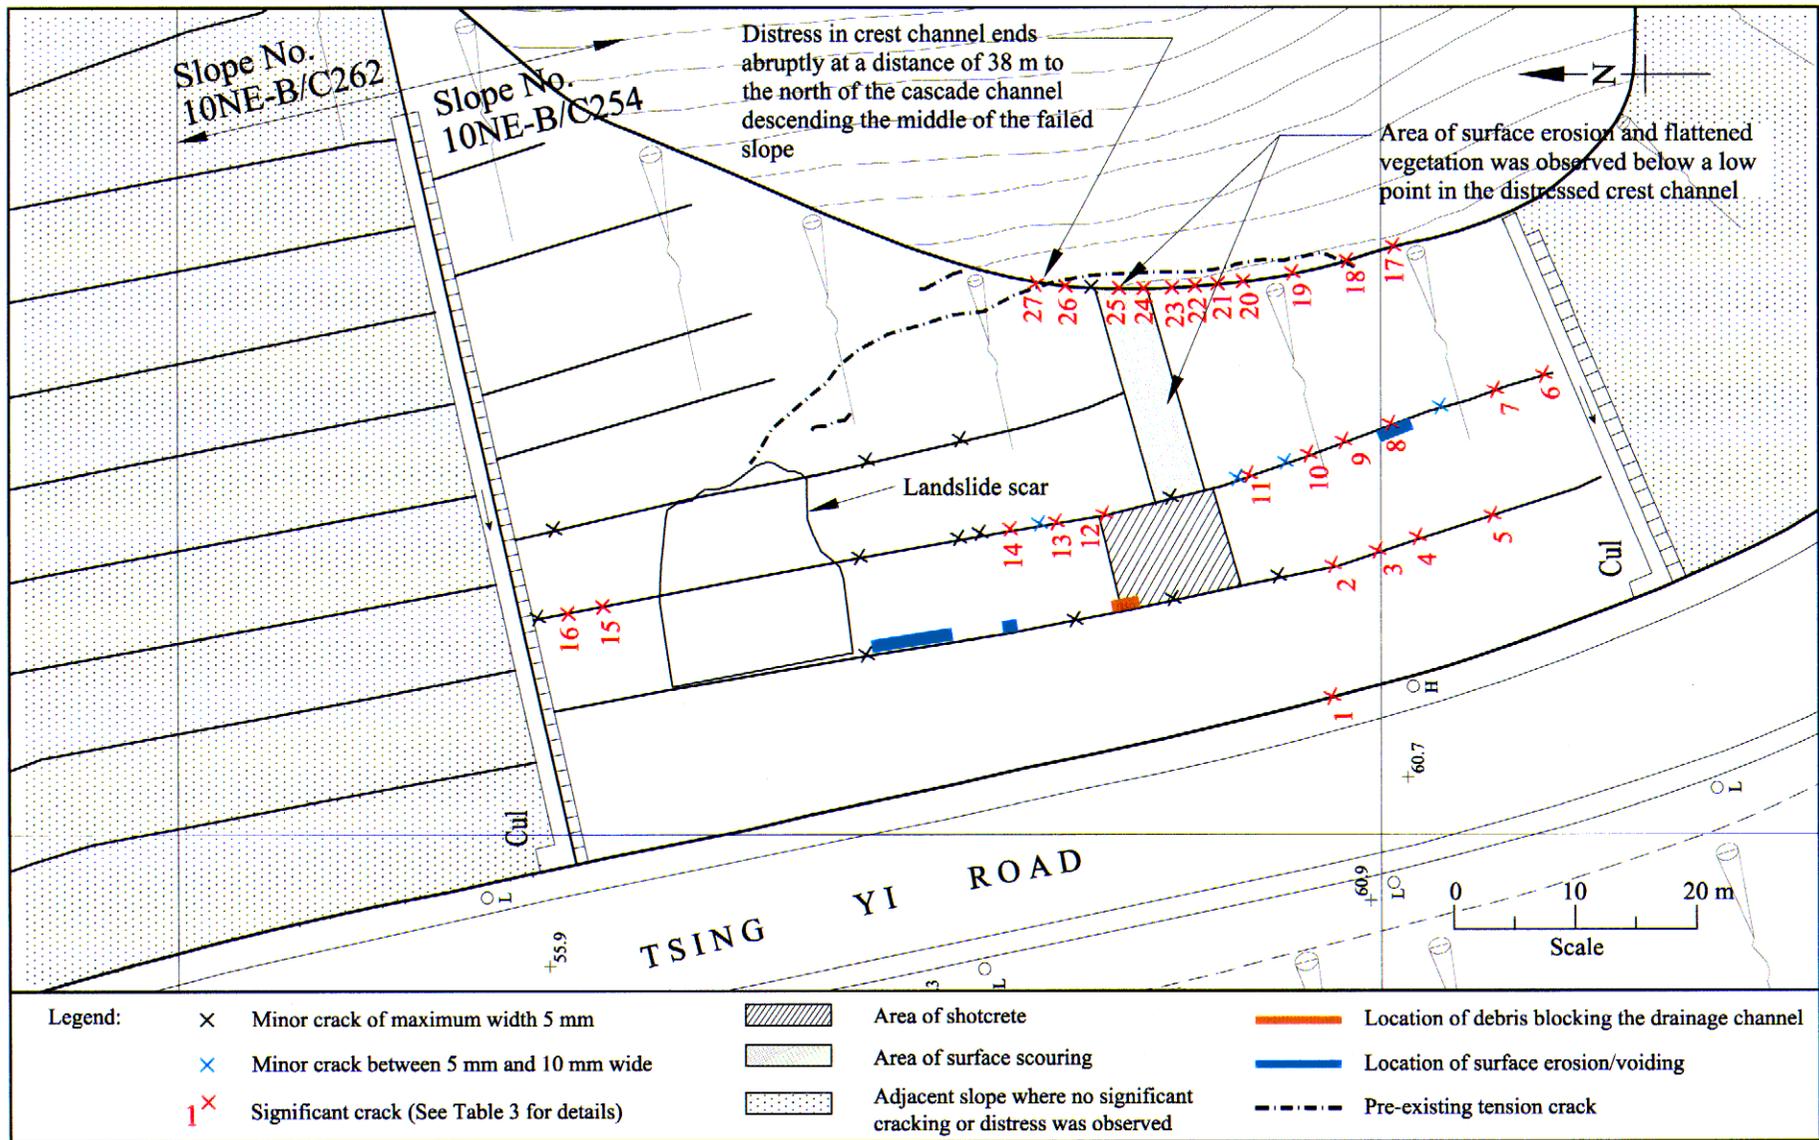
Figure 11 - Plan Showing Slope Distress Observed Following the 1999 Landslide

13	20 mm sep.	27	Location of old shotcrete repair to severed crest channel and renewed movement
14	50 mm sep. vertical disp. with 50 mm outward movement

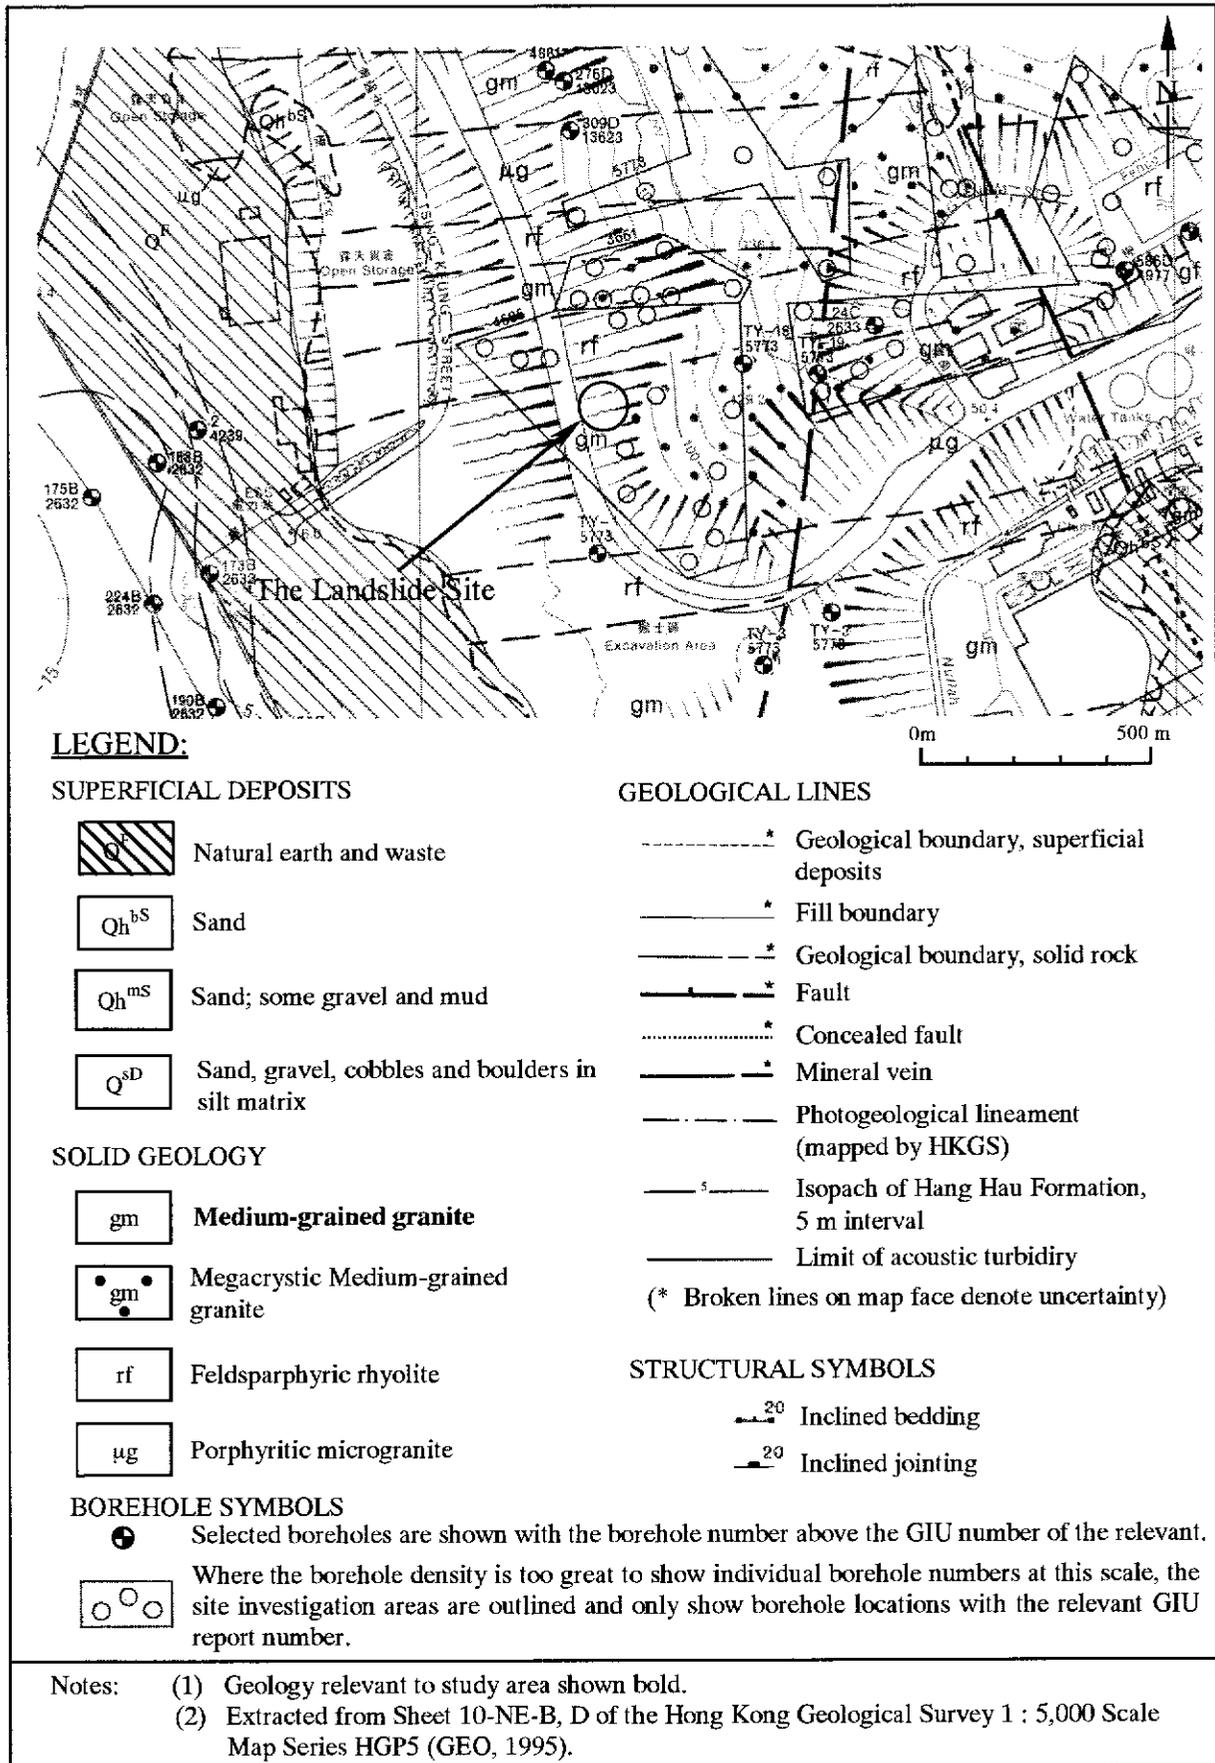
Figure 12 – Solid and Superficial Geology of the Site

south-southeast trend are indicated to the east of the landslide site on the geological plan (Figure 12).

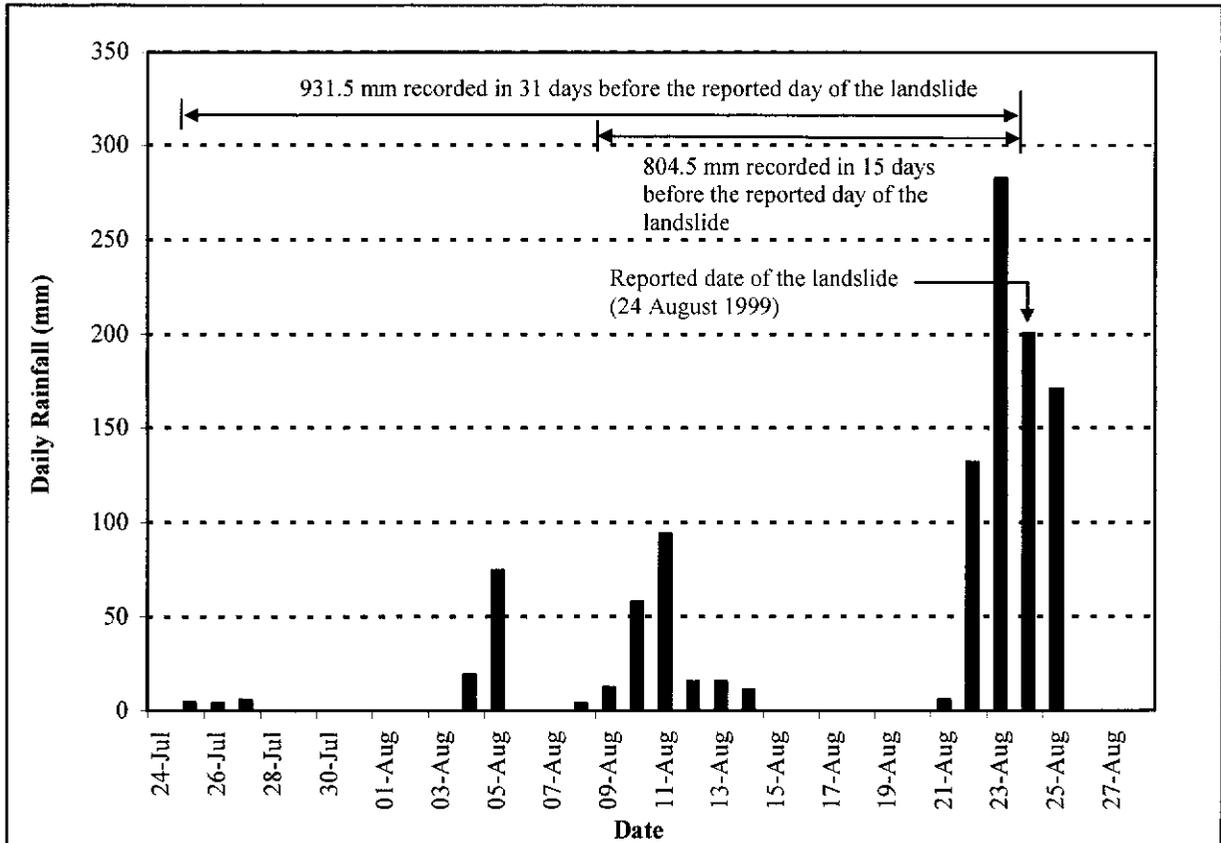
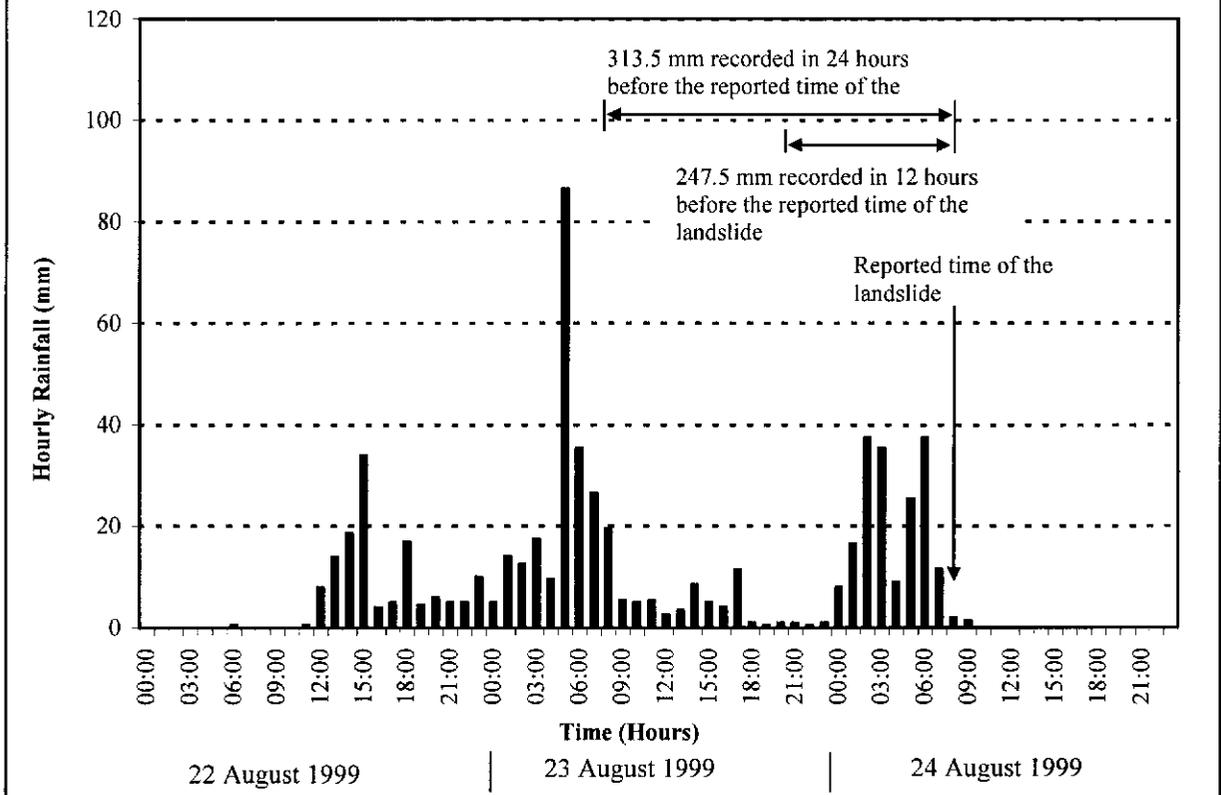
Figure 13 – Daily and Hourly Rainfall Recorded at GEO Raingauge No. N11

The daily rainfalls recorded by the raingauge in July and August 1999, together with the hourly rainfalls from the 22 to 24 August 1999, are shown in Figure 13. The storm was concentrated around the day of 23 August 1999, with a peak rainfall of 86 mm/hour between 5:00 a.m. and 6:00 a.m. The storm intensified again in the morning of 24 August 1999, with a peak rainfall of about 40 mm/hour between 2:00 a.m. and 7:00 a.m.

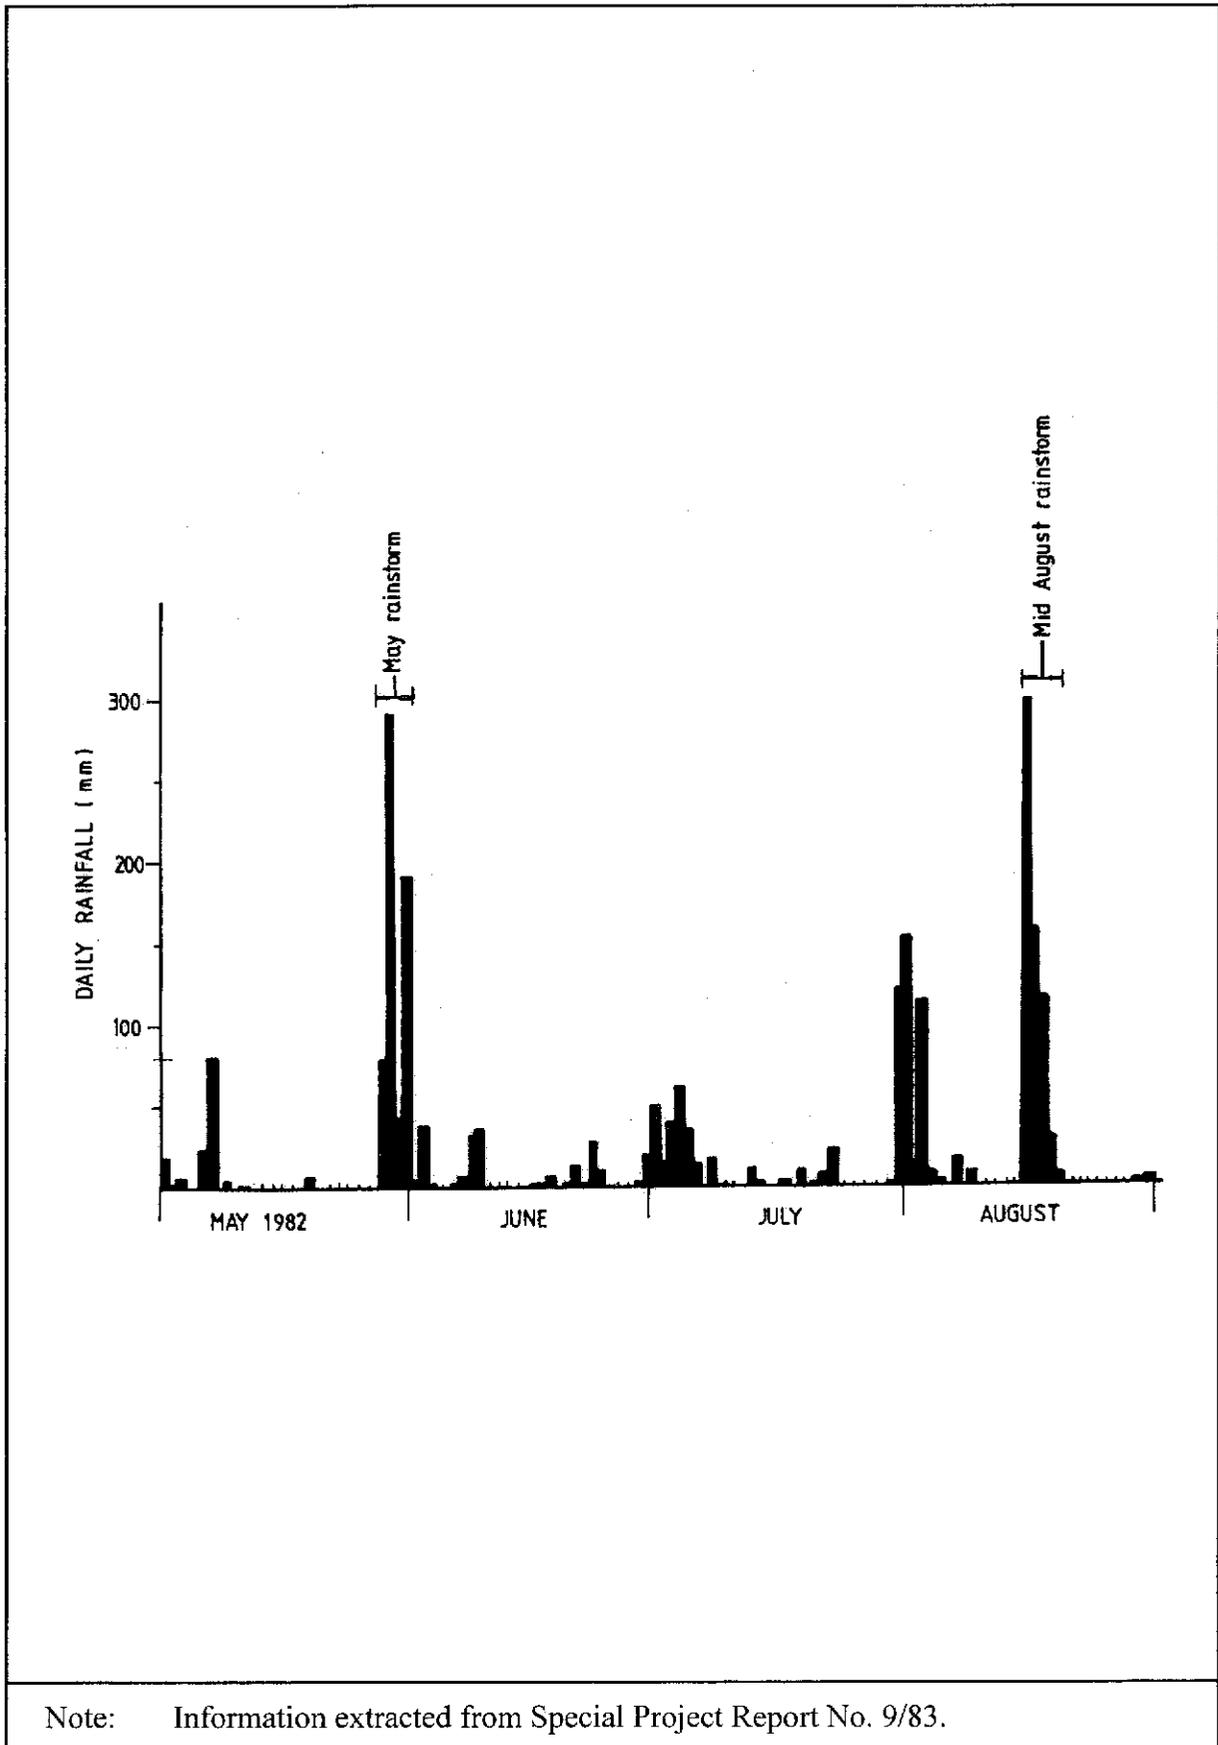
Figure 14 -- Daily Rainfall Recorded at RO Raingauge No. 105 for the May 1982 Rainstorm

Daily rainfalls for the May 1982 rainstorm recorded at the Hong Kong Observatory's raingauge No. 105, located at the western end of Tsing Yi Bridge, approximately 3 km from the landslide, were analysed as part of Special Project Report No. 9/83 (Hencher, 1983). No hourly breakdown of rainfall was provided, but a peak daily rainfall intensity of 290 mm was recorded on the 29 May 1982 (Figure 14). This is very similar to that recorded during for the rainstorm prior to the 1999 landslide, with a peak daily rainfall of about 285 mm on 23 August 1999.

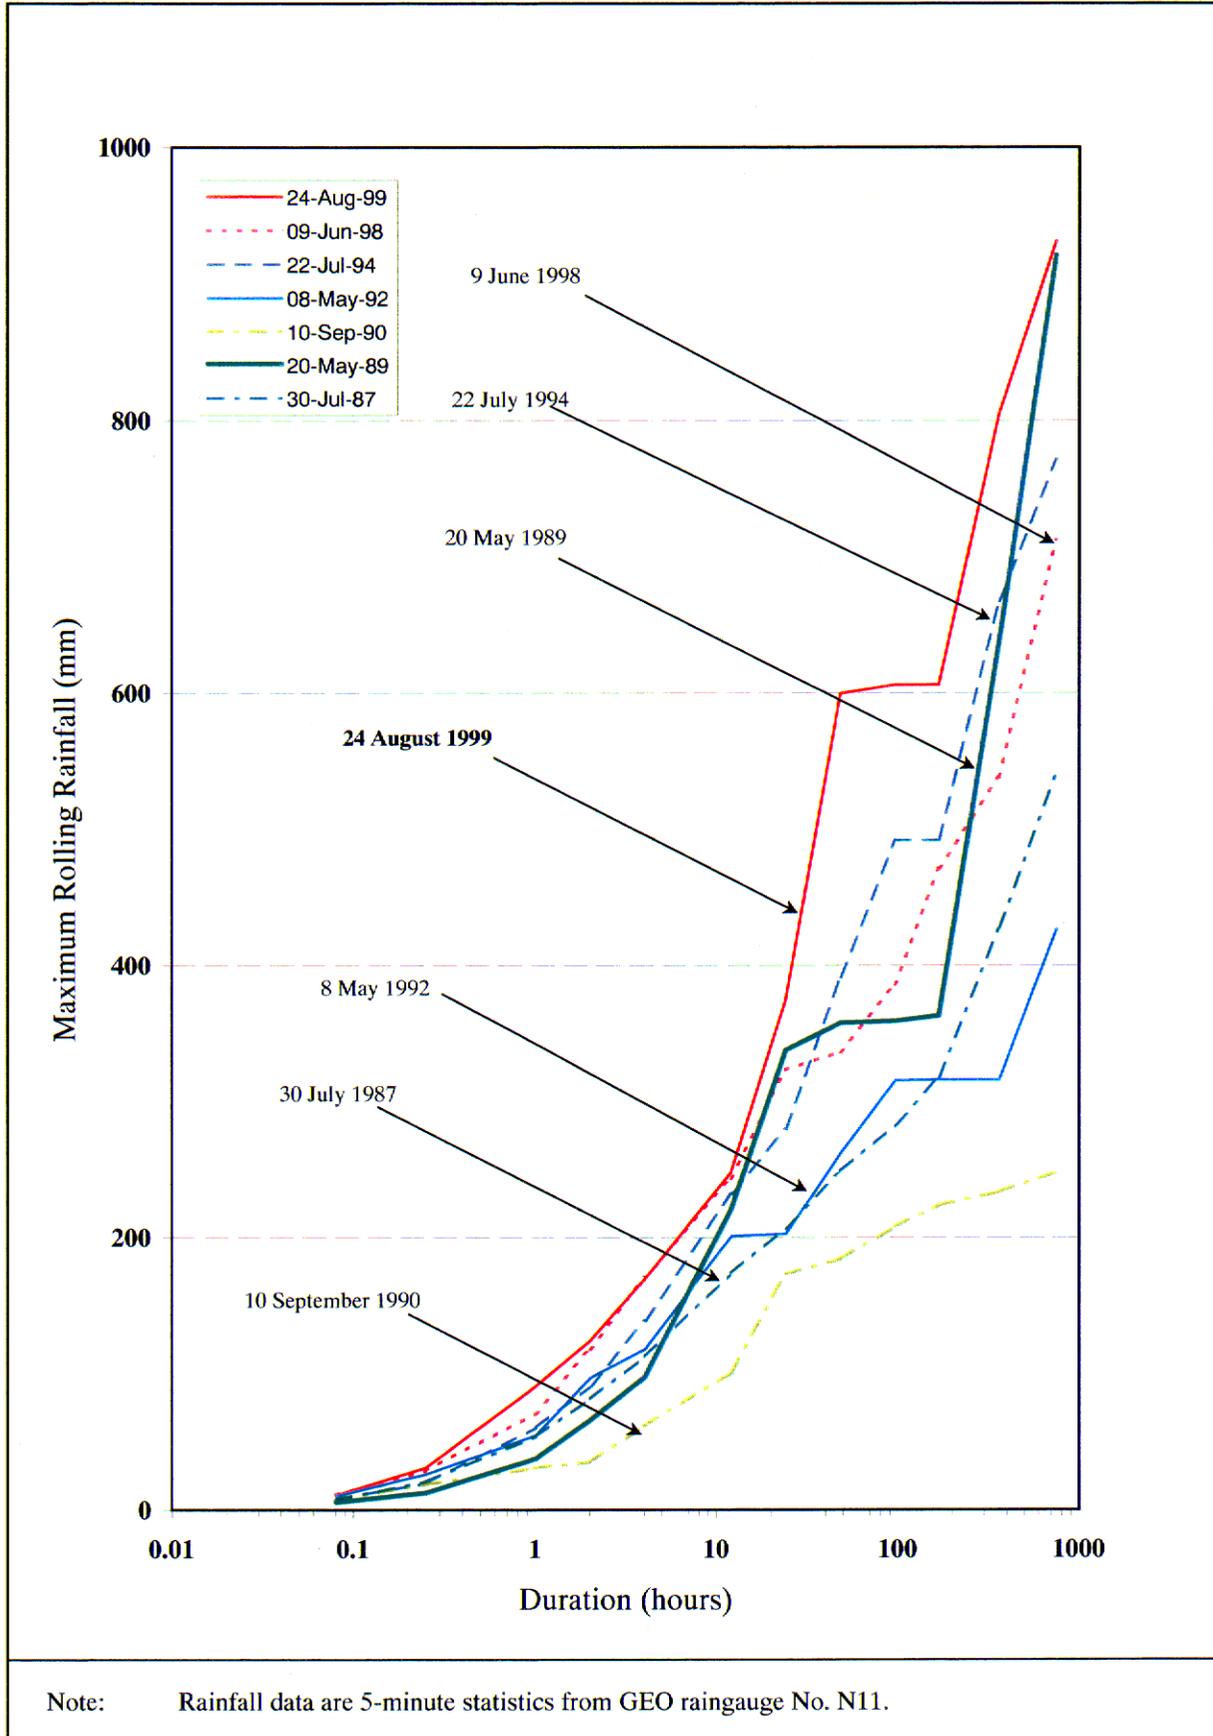
Figure 15 - Maximum Rolling Rainfall at GEO Raingauge No. N11 for Major Rainstorms

A comparison of the patterns of previous heavy storms affecting the landslide site is shown in Figure 15. It is evident from the rolling rainfall profile that the 22 to 24 August 1999 rainstorm was the most severe event experienced by the site since the raingauge came into operation in August 1984. A comparison of the rolling rainfall profile arising from the 22 to 24 August 1999 rainstorm with that prior to the 1982 landslide in slope No. 10NE-B/C262 was not possible as the monitoring records were not directly comparable.

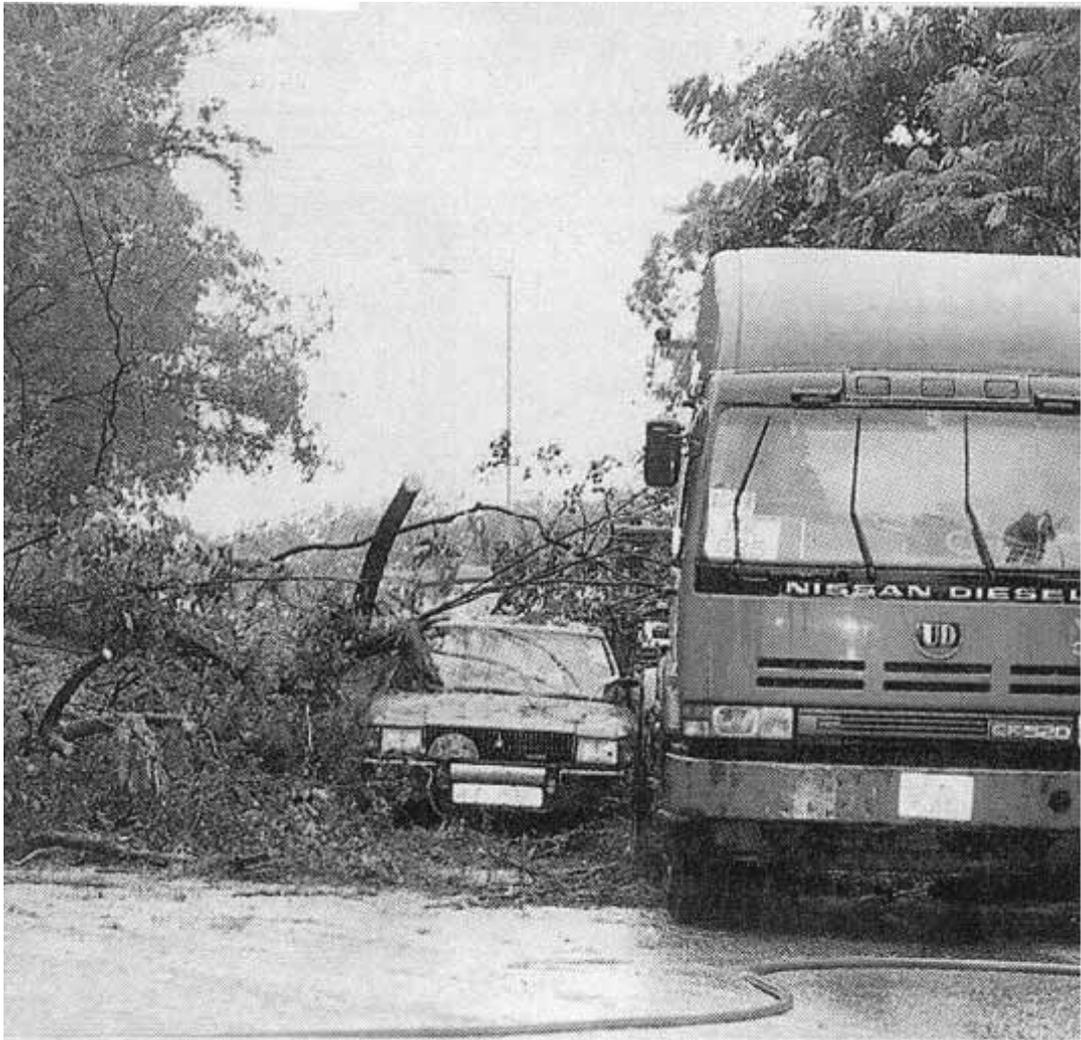
Plate 2 – View of the Taxi and Lorry Trapped in the Landslide Debris at the Toe of the Slope (Photograph Taken on 24 August 1999)

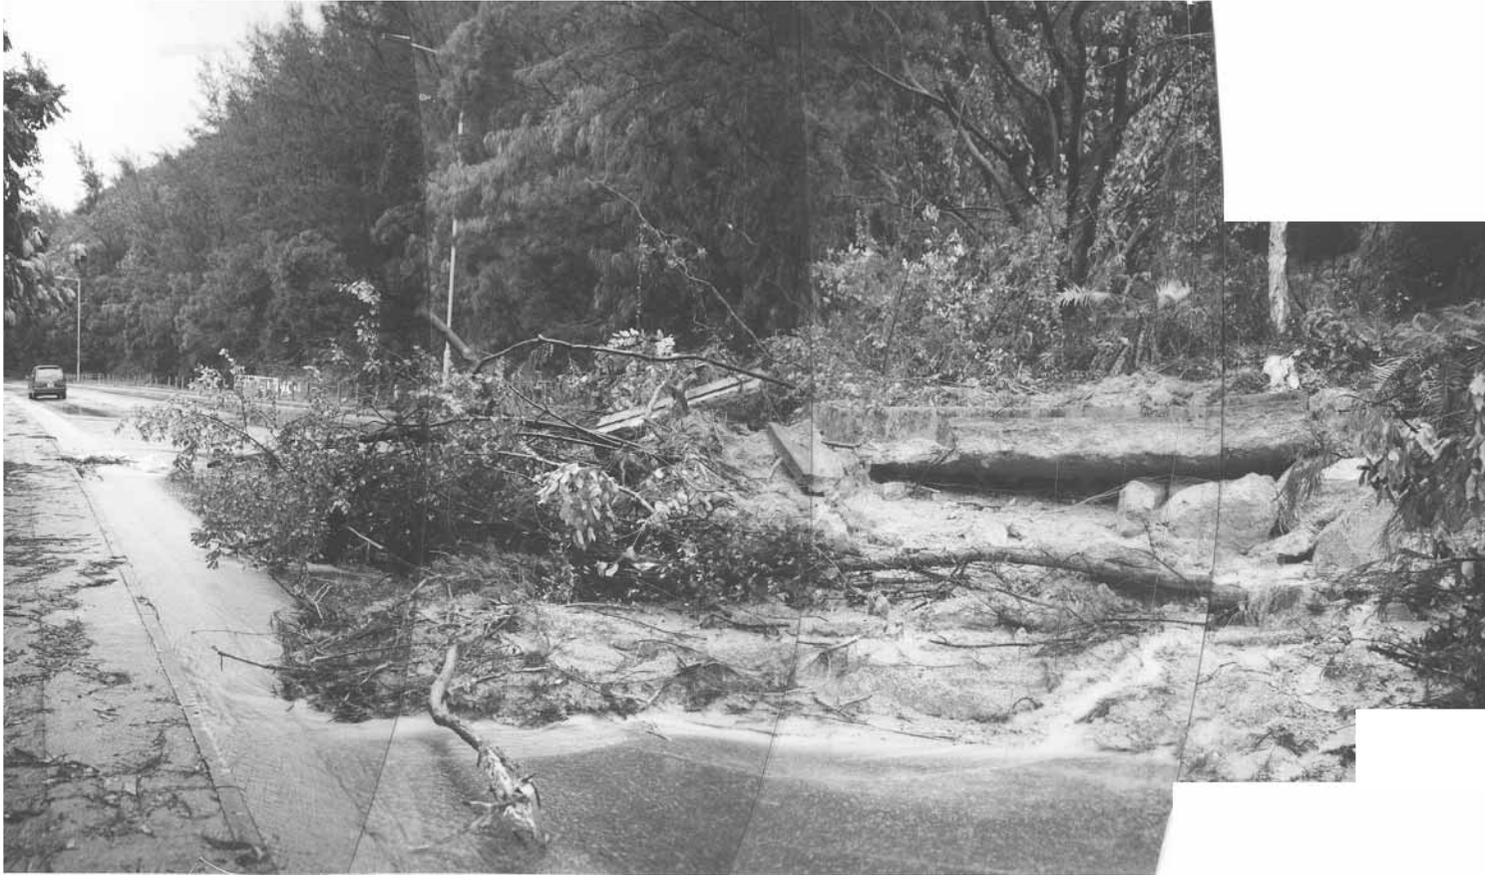
Plate 4 – View of Landslide Debris Covering Tsing Yi Road at the Toe of the Slope
(Photographs Taken on 25 August 1999)

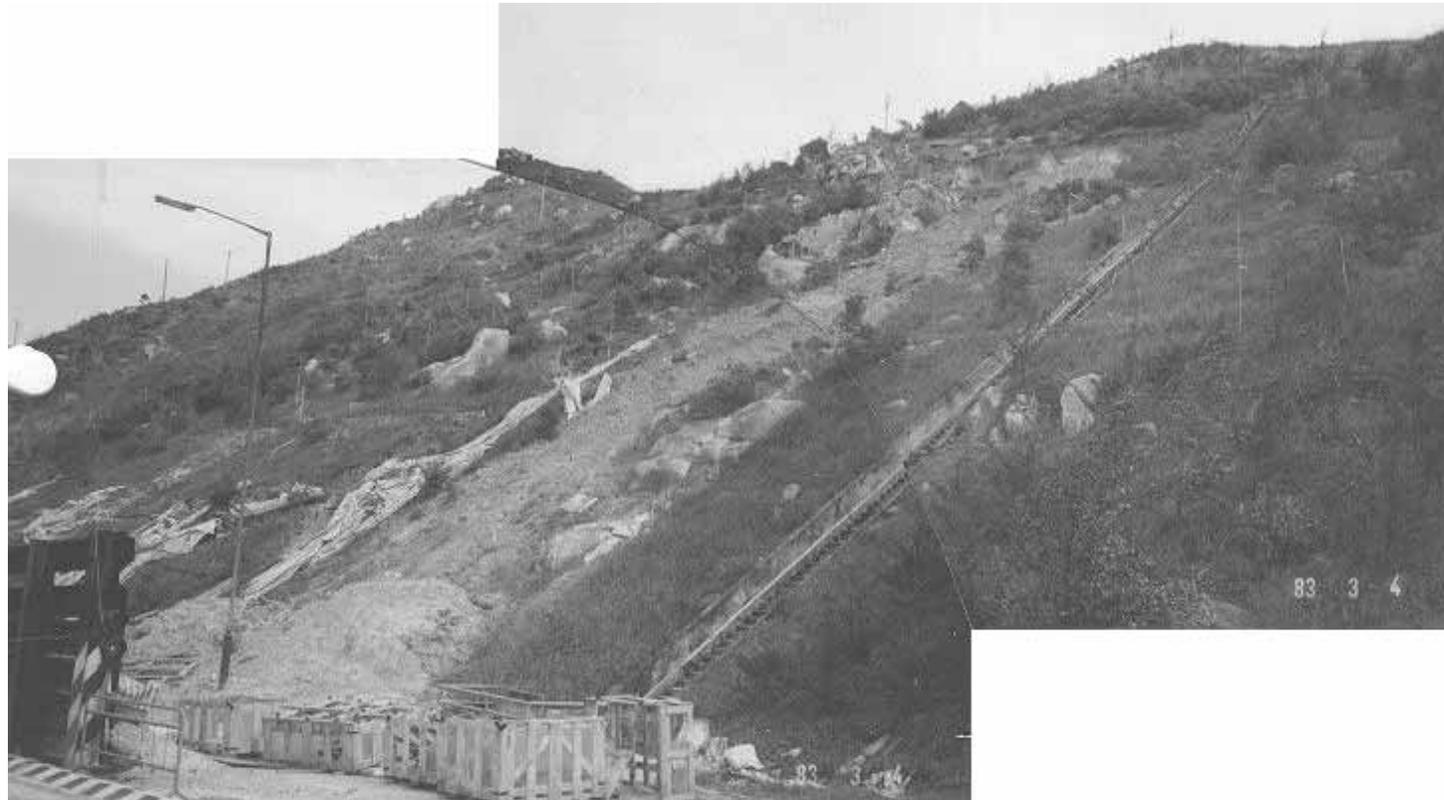
Plate 6 – View of 1982 Landslide Located in Slope No. 10NE-B/C262
(Photographs Taken on 4 March 1983)

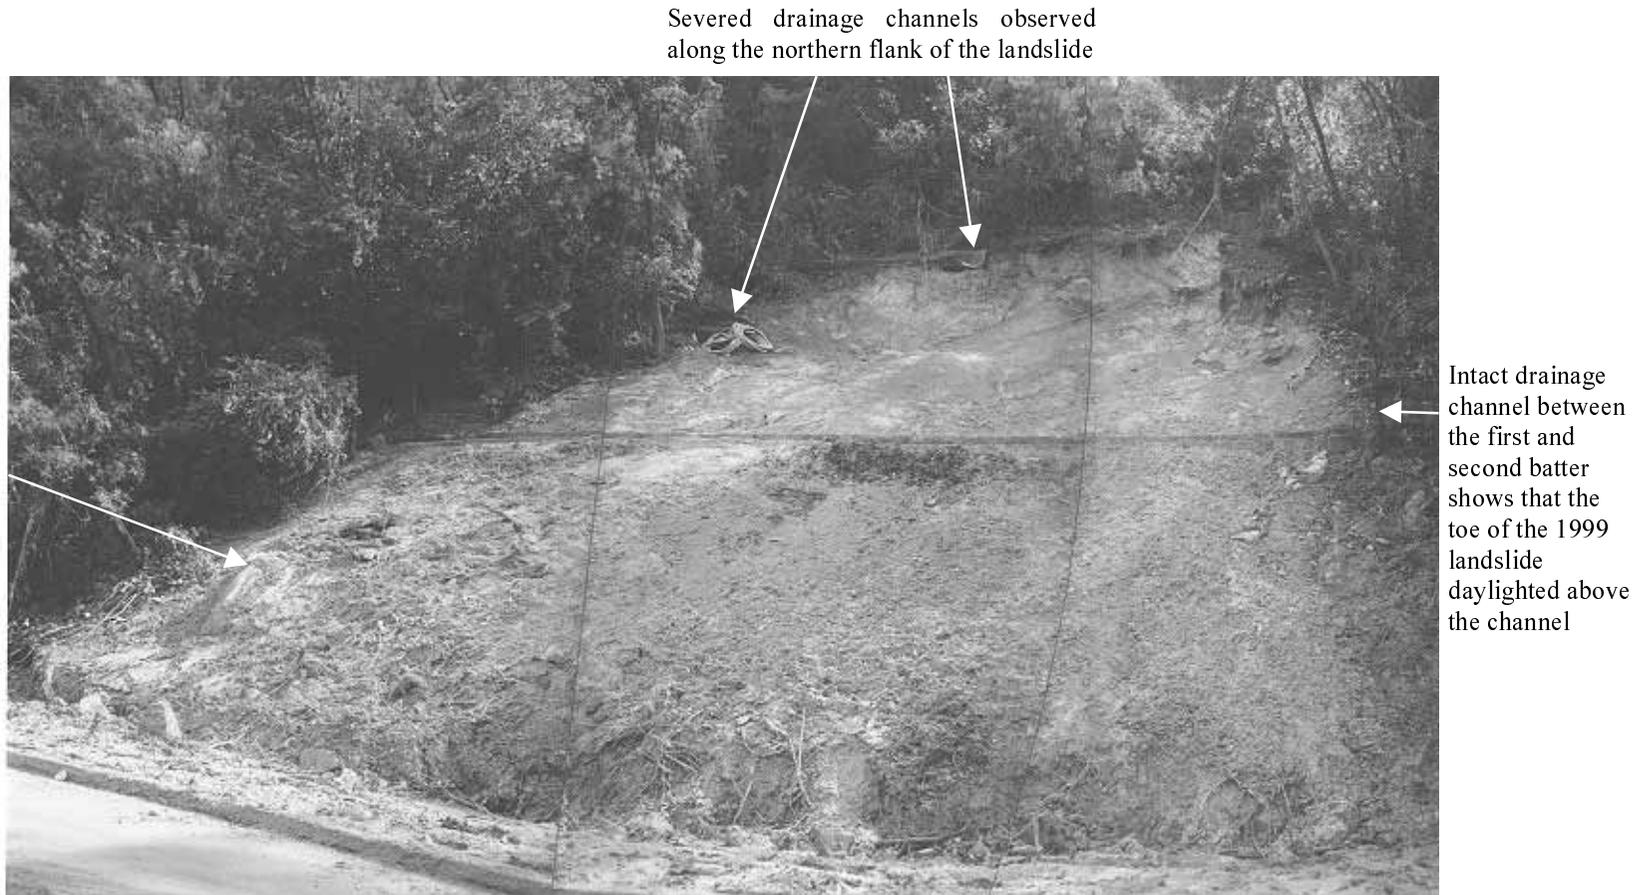
Plate 9 – General View of the Landslide Scar Following Removal of Failed Material
(Photographs Taken on 27 August 1999)

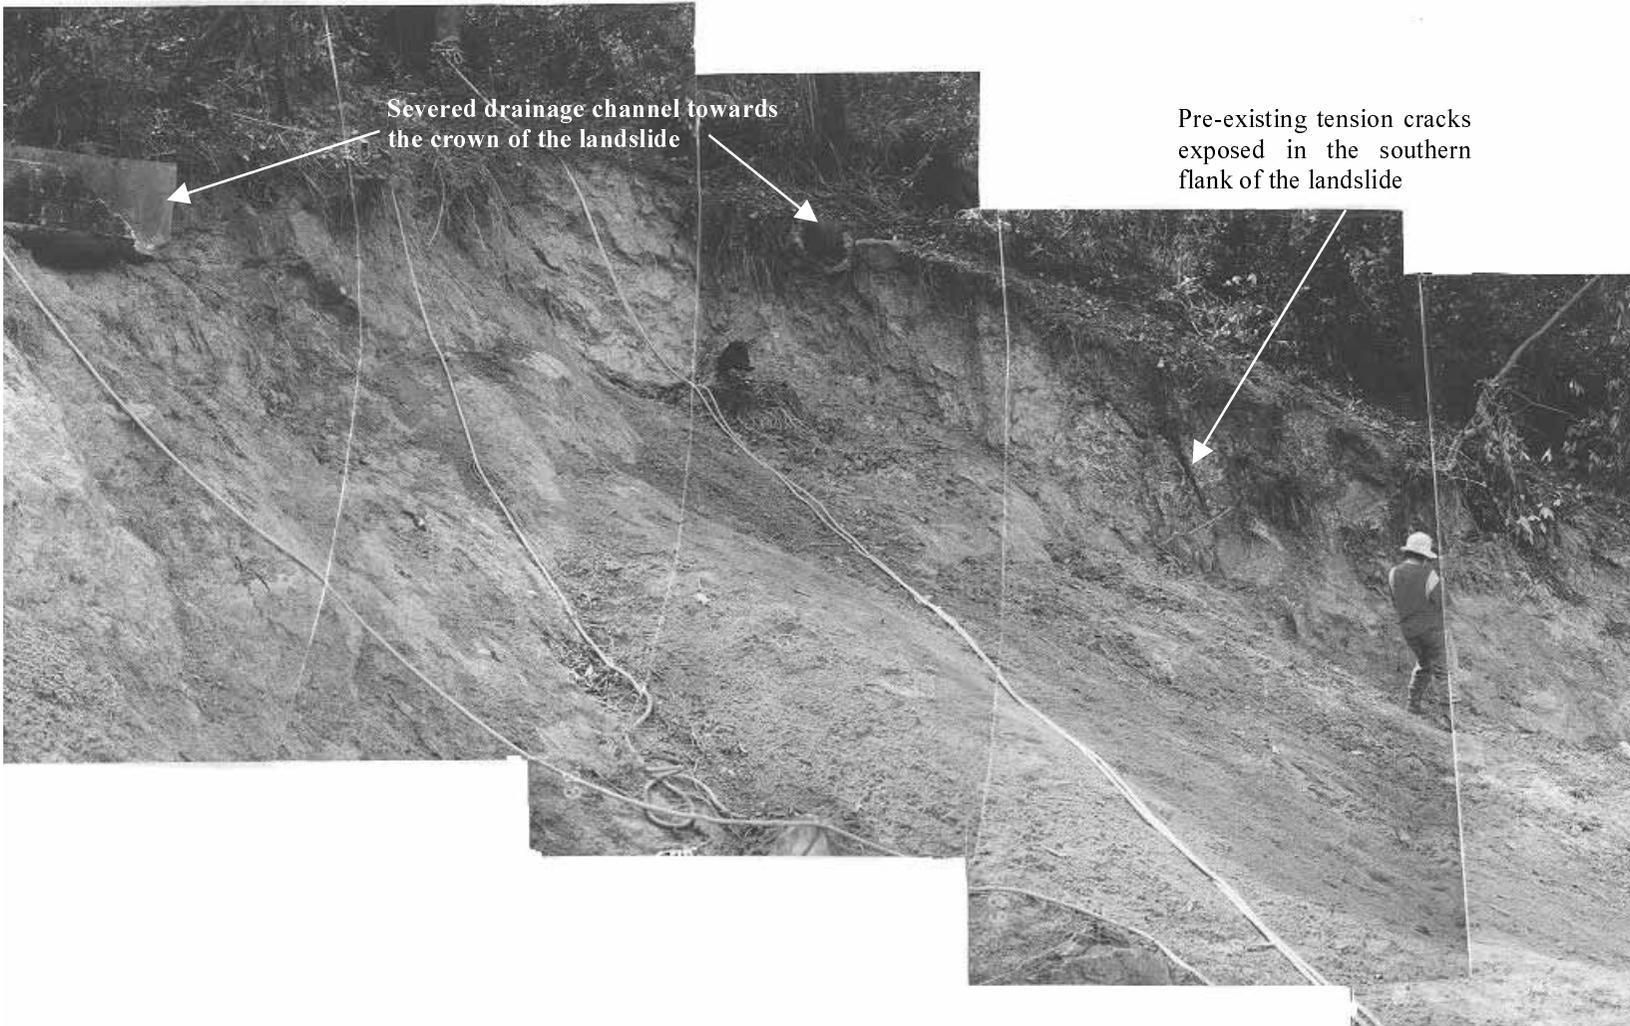
Plate 11 – View of the Southern Portion of the Main Scarp
(Photographs Taken on 27 August 1999)
