**INVESTIGATION OF SOME
SELECTED LANDSLIDES
IN 1999
(VOLUME 3)**

GEO REPORT No. 122

Fugro Maunsell Scott Wilson Joint Venture

**SECTION 1:
DETAILED STUDY OF THE
24 AUGUST 1999 LANDSLIDE
AT TSING YI ROAD
TSING YI ISLAND**

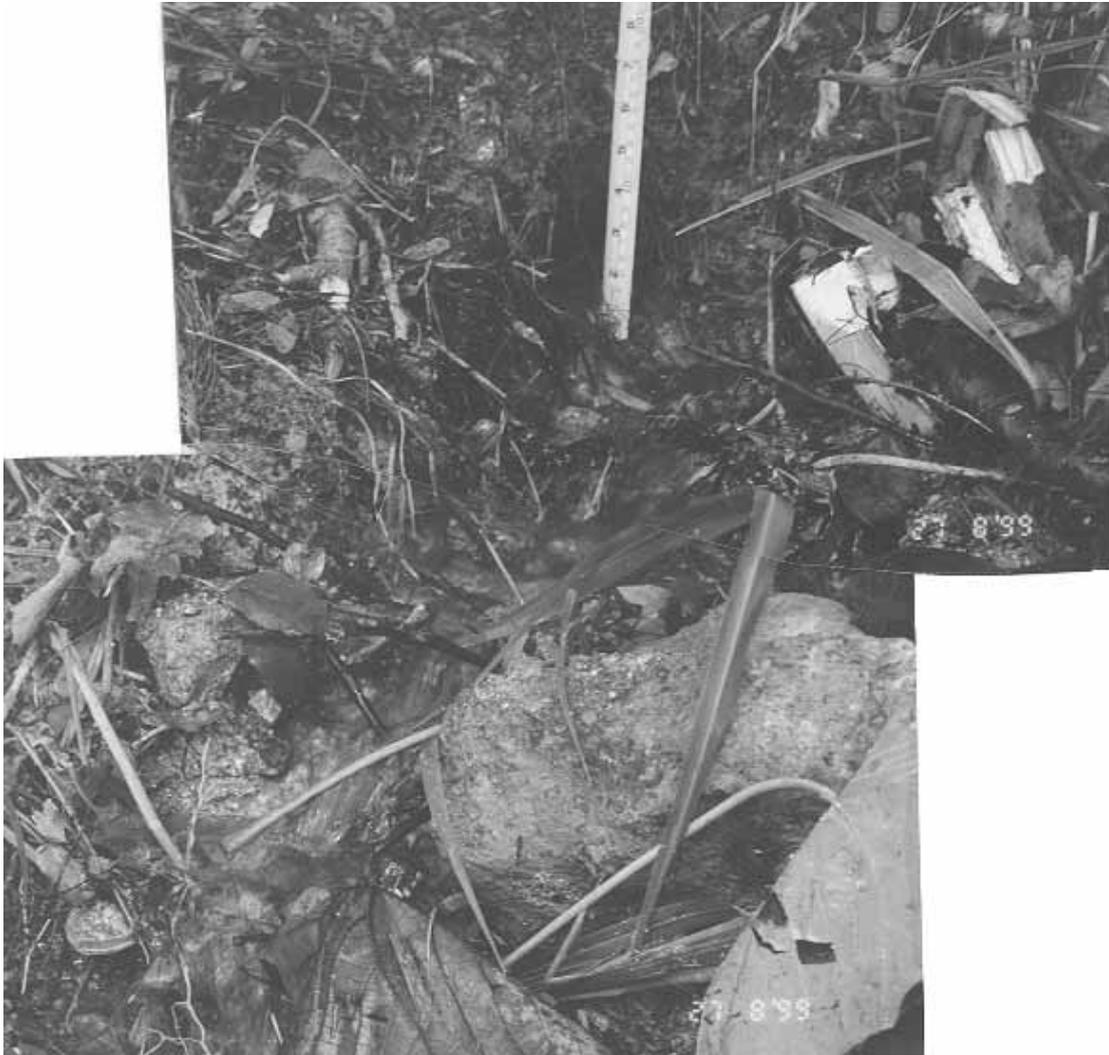
Plate 13 – View of Groundwater Flows from a Possible Soil Pipe at the Base of the Failed Slope (Photographs Taken on 27 August 1999)

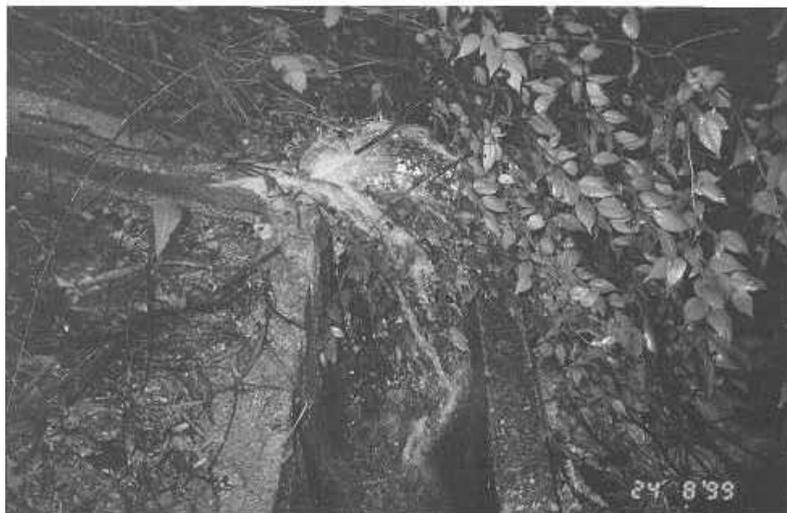
Plate 14 – View of Strong Groundwater Flows from the Horizontal Drain to the South of the 1999 Landslide (Photographs Taken on 25 August 1999)

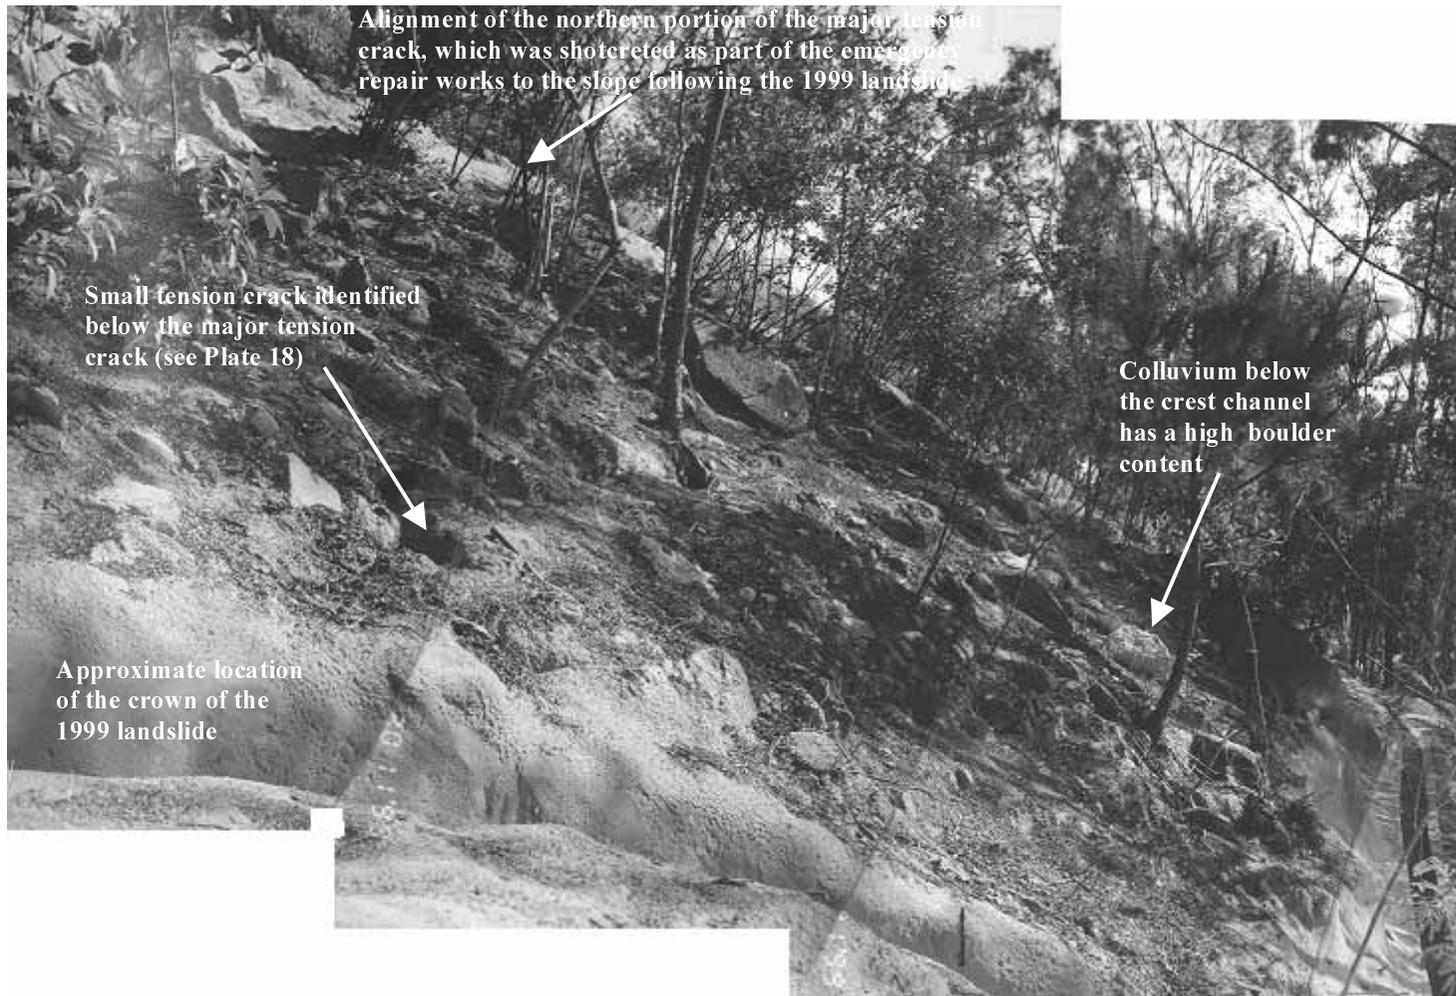
Plate 20 - General View of Slope Above and to the Southeast of the 1999 Landslide Showing Bouldery Nature of Colluvium (Photographs Taken on 30 November 1999)

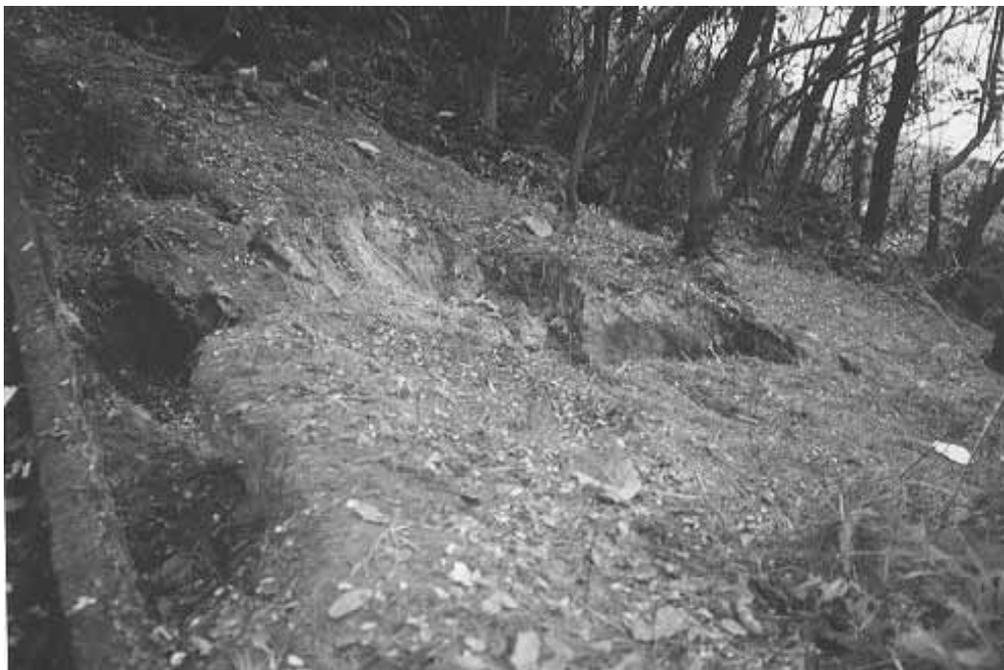
Plate A2 – Side View (Looking South) of Erosion Scar in First Batter at the Northern End of Slope No. 10NE-B/C254 (Area 1)

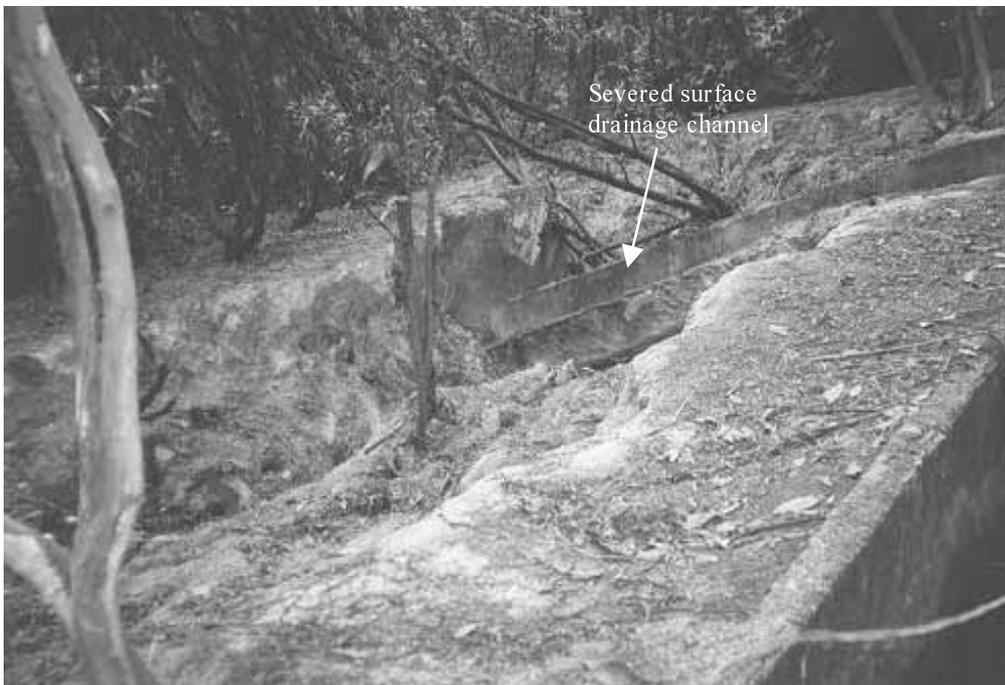
Plate A7 – Side View (Looking Northwards) of the Scar in the Fourth and Fifth Batter at the Southern End of Slope No. 10NE-B/C262 (Area 2)

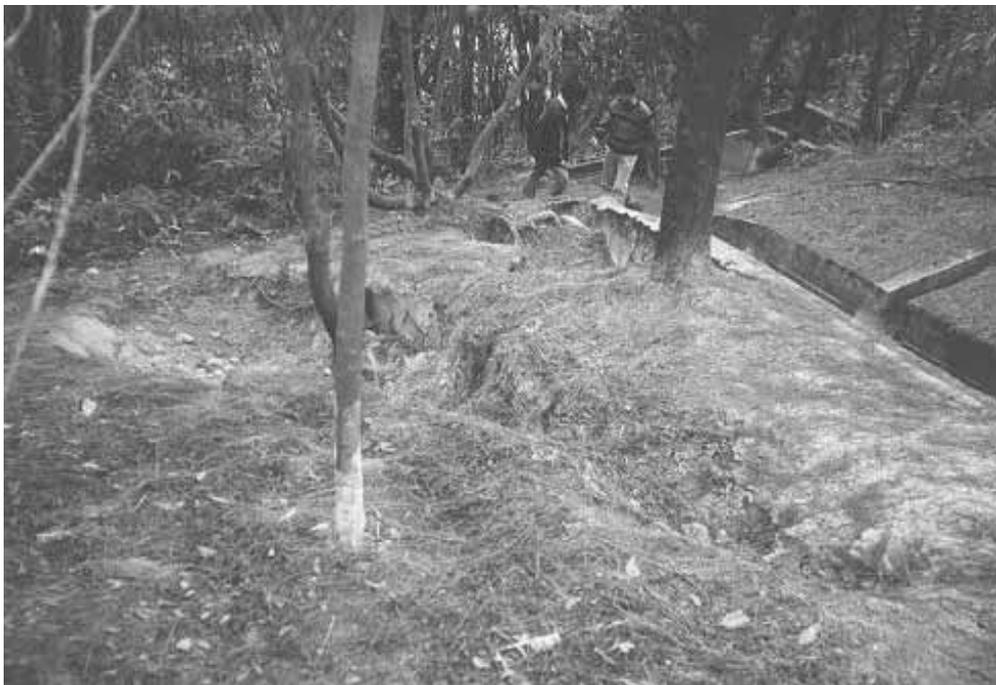
Plate A9 – View Looking Downslope of the Erosion below the Crest Channel at the Northern End of Slope No. 10NE-B/C262 (Area 3)

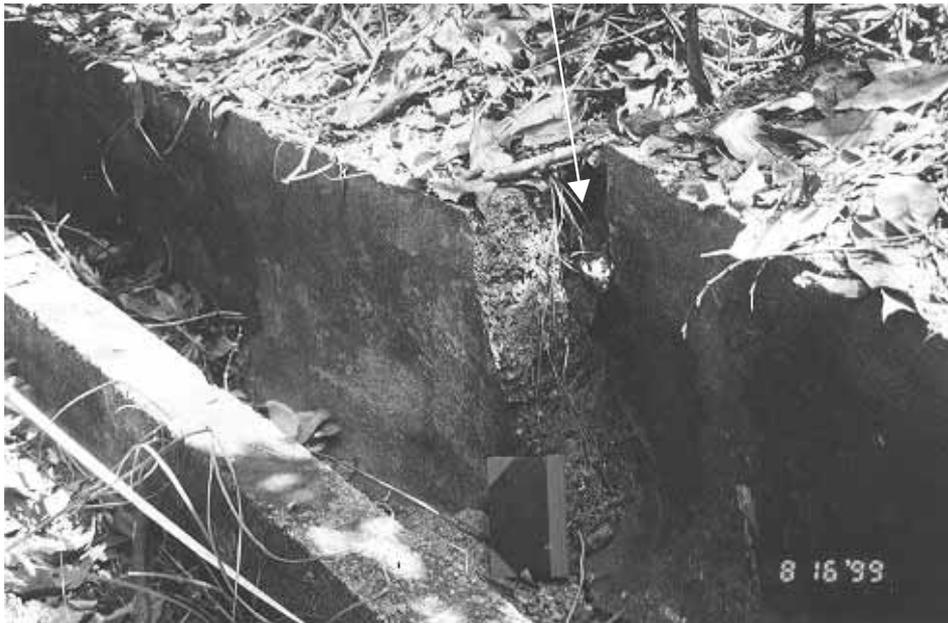
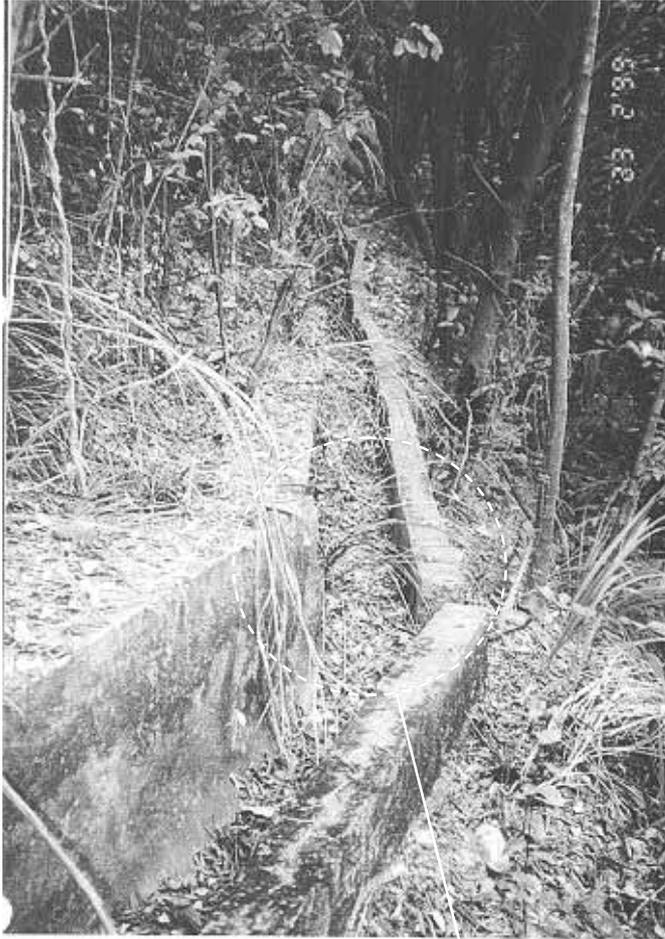
Plate B3 - View of Major Dislocation in the Channel above the Second Batter at the Northern End of Slope No. 10NE-B/C254 (Area 1)
