**SECTION 2:
DETAILED STUDY OF THE
24 AUGUST 1999 LANDSLIDE
AT SLOPES NOS. 9SW-D/C114
AND 9SW-D/C115
AT SHAM WAT ROAD
LANTAU ISLAND**

Fugro Maunsell Scott Wilson Joint Venture

**This report was originally produced in January 2001
as GEO Landslide Study Report No. LSR 1/2001**

This report presents the findings of a detailed study of the landslide (GEO Incident No. MW1999/8/107) that occurred on 24 August 1999 at slopes Nos. 9SW-D/C114 and 9SW-D/C115 located above Sham Wat Road, Lantau Island. The landslide blocked the single lane road that serves as the sole road access to Sham Wat Wan village. There were no casualties or damage to property as a result of the landslide.

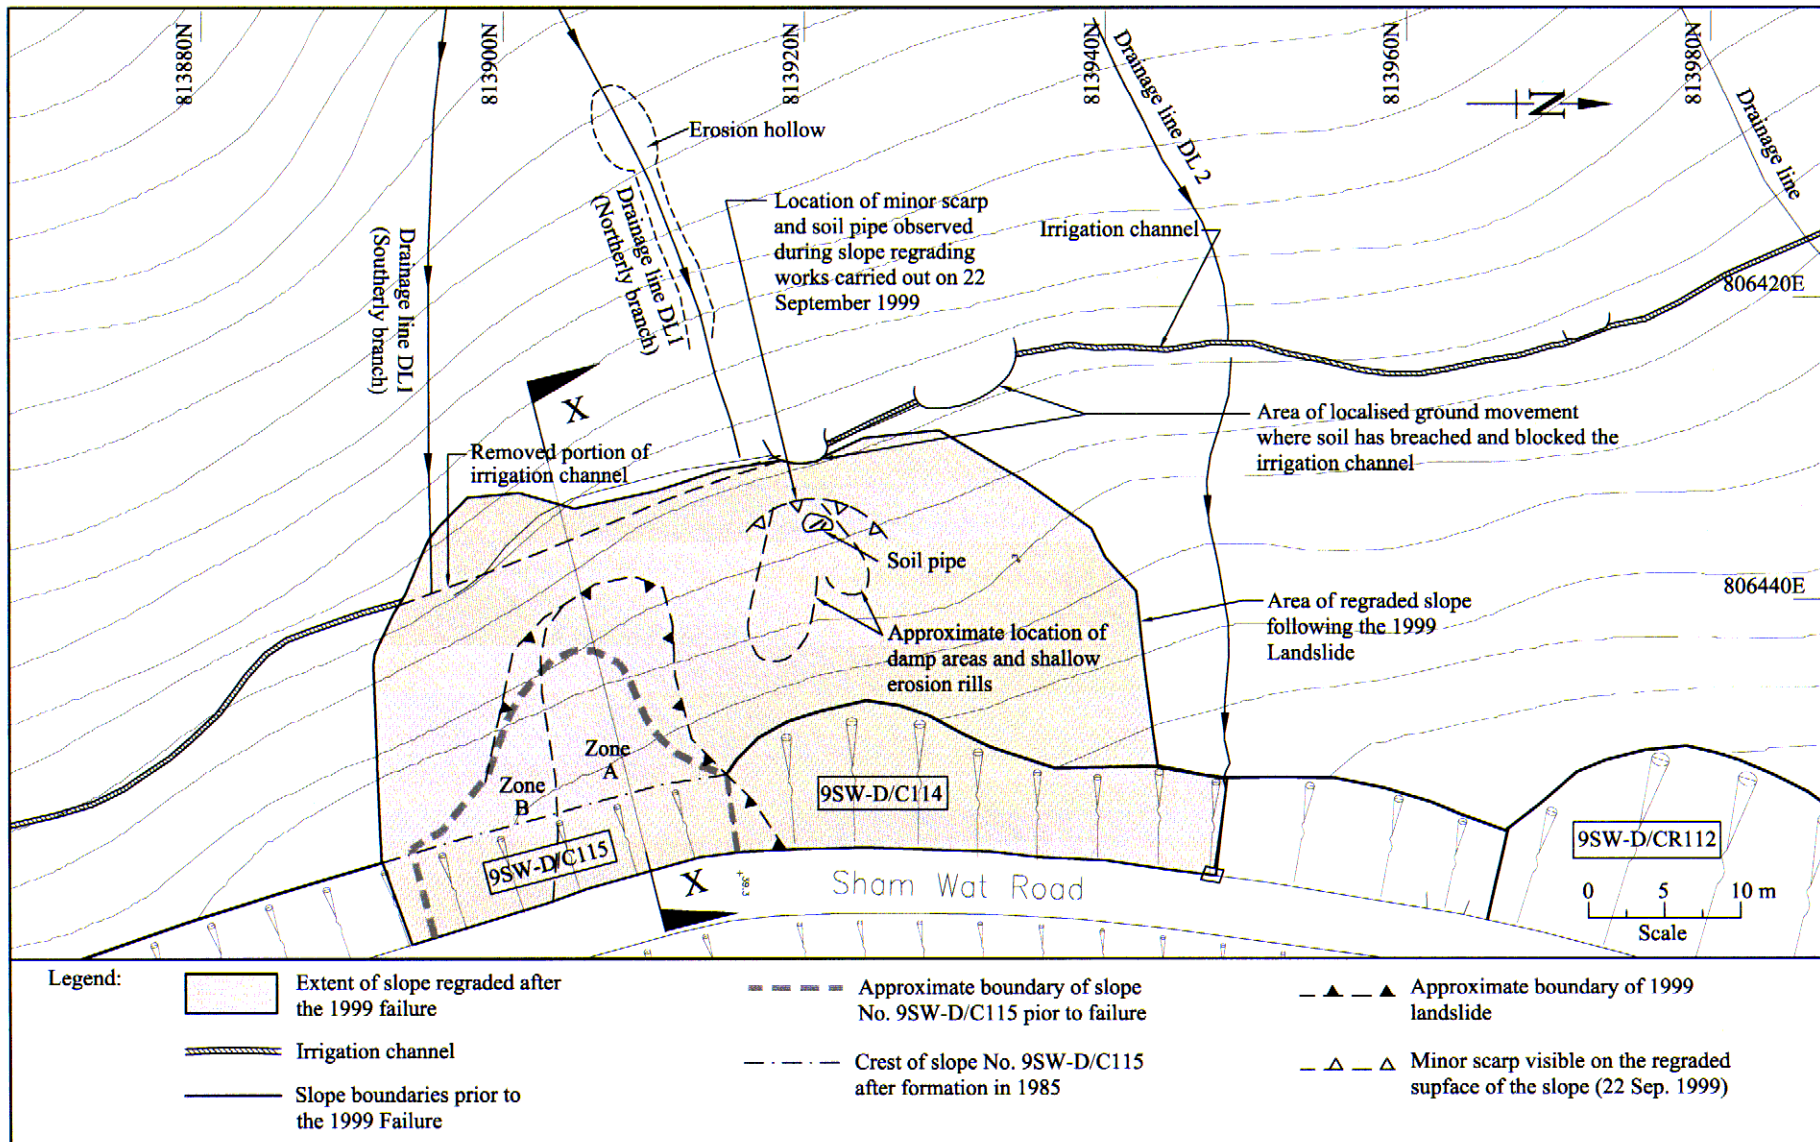
Figure 2 - Plan of the Landslide Site

The failed area was about 30 m wide and could be divided into two distinct portions (Figure 2). The northern portion (Zone A) comprised an area of disturbed ground about 20 m wide by 18 m long with a maximum depth of about 1 m. Debris along the southern flank of

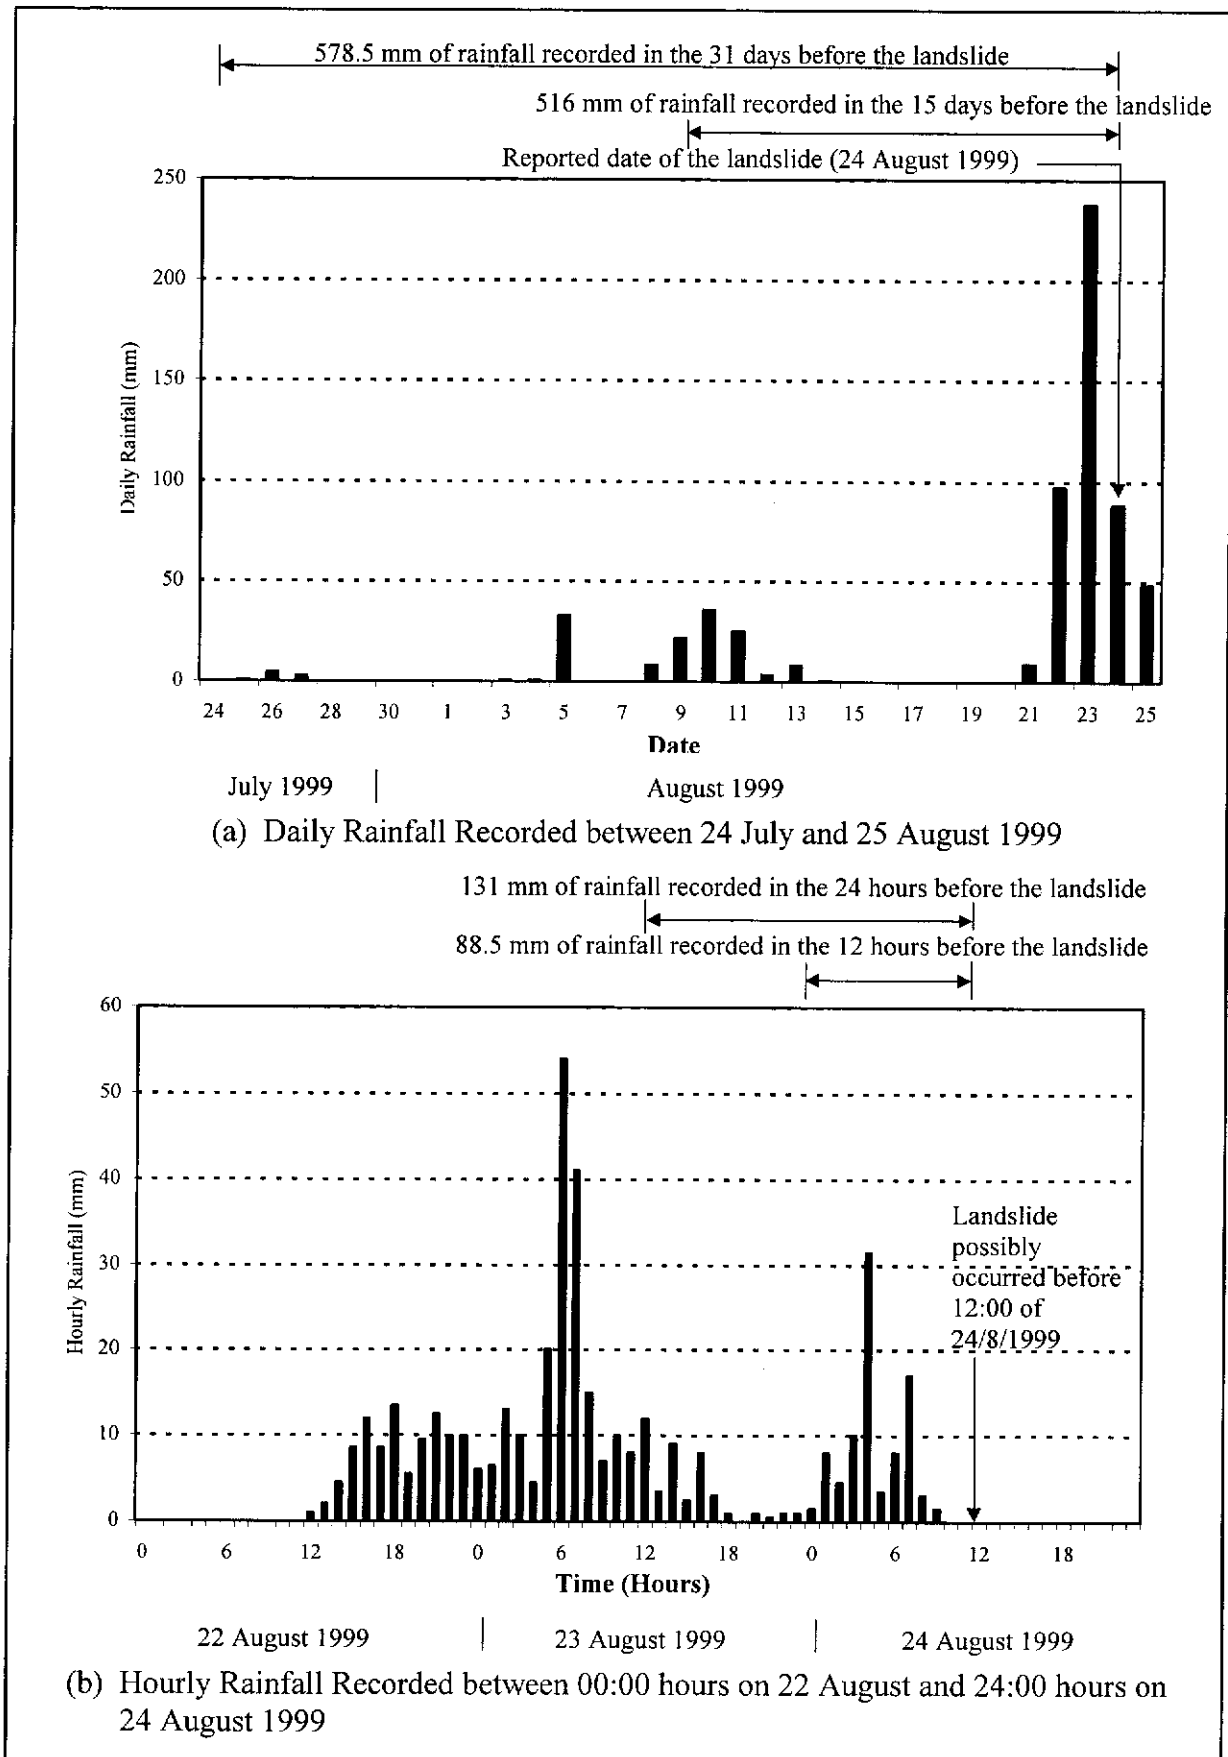
Figure 9 – Rainfall Recorded at GEO Raingauge No. N17

For the purpose of the rainfall analysis, the landslide was assumed to have occurred at 12:00 p.m. on 24 August 1999. The daily rainfall recorded by the raingauge for the period from 24 July to 25 August 1999, together with the hourly rainfall from 22 to 24 August 1999, are shown in Figure 9. It can be seen that on the day of the landslide, about 90 mm of rainfall was recorded prior to the landslide event and that nearly 250 mm rainfall was recorded in the

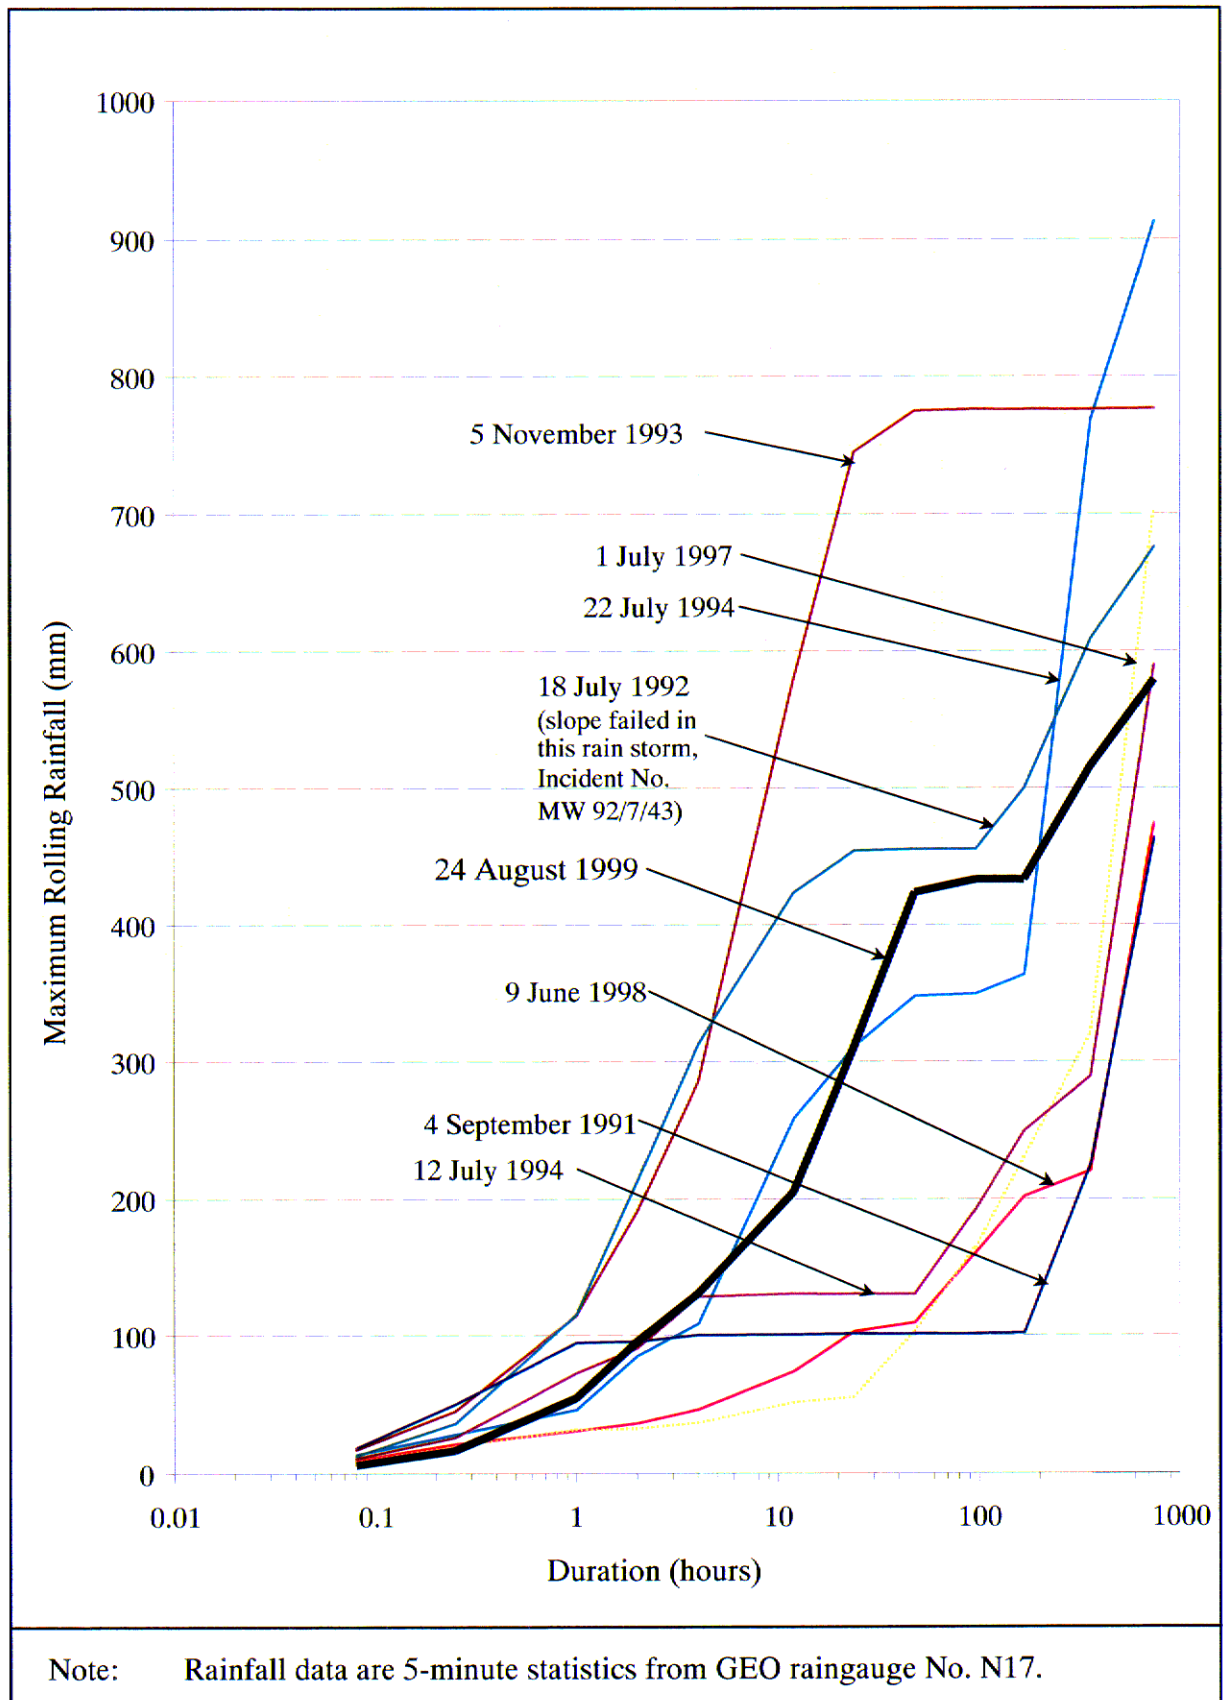
Figure 10 – Maximum Rolling Rainfall at GEO Raingauge No. N17 for Selected Major Rainstorms between 1991 and 1999

A comparison of the patterns of previous severe rainstorms recorded by raingauge No. N17 is shown in Figure 10. It is evident that the rolling rainfall for the 22 to 24 August 1999 rainstorm was not the most severe event experienced by the site, with a particularly severe storm experienced on 5 November 1993.
