INVESTIGATION OF SOME SELECTED LANDSLIDES IN 1999 (VOLUME 4)

GEO REPORT No. 123

Fugro Maunsell Scott Wilson Joint Venture

**SECTION 1:
DETAILED STUDY OF THE
LANDSLIDE BELOW THE
BENJAMIN FRANKLIN CENTRE
CHINESE UNIVERSITY OF
HONG KONG
ON 7 JUNE 1999**

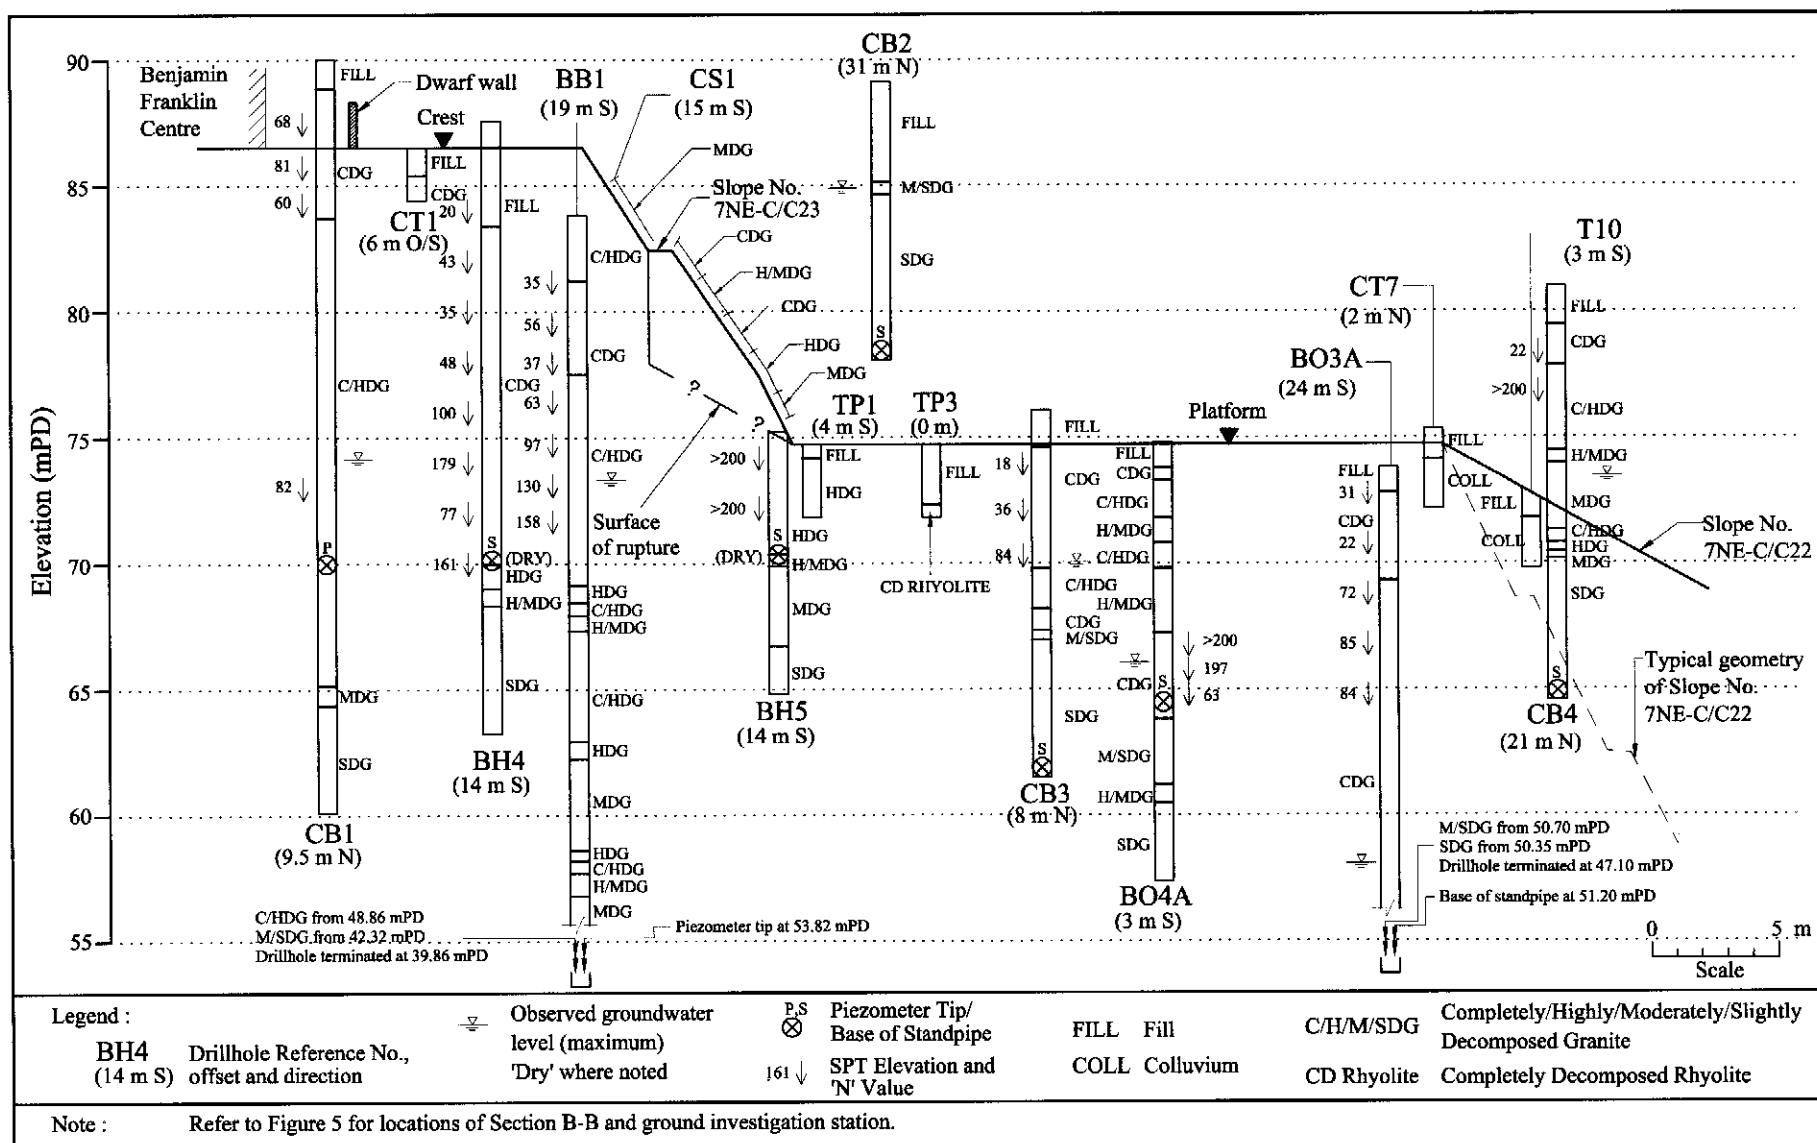
Figure 7 - Section B - B through the Site

Available groundwater monitoring data for the site is limited. Piezometer and standpipe installations and groundwater levels, where recorded, are presented on Figure 7. Installations typically extend to at least 71 mPD, i.e. approximately 3 m to 4 m below the slope toe (75.5 mPD).

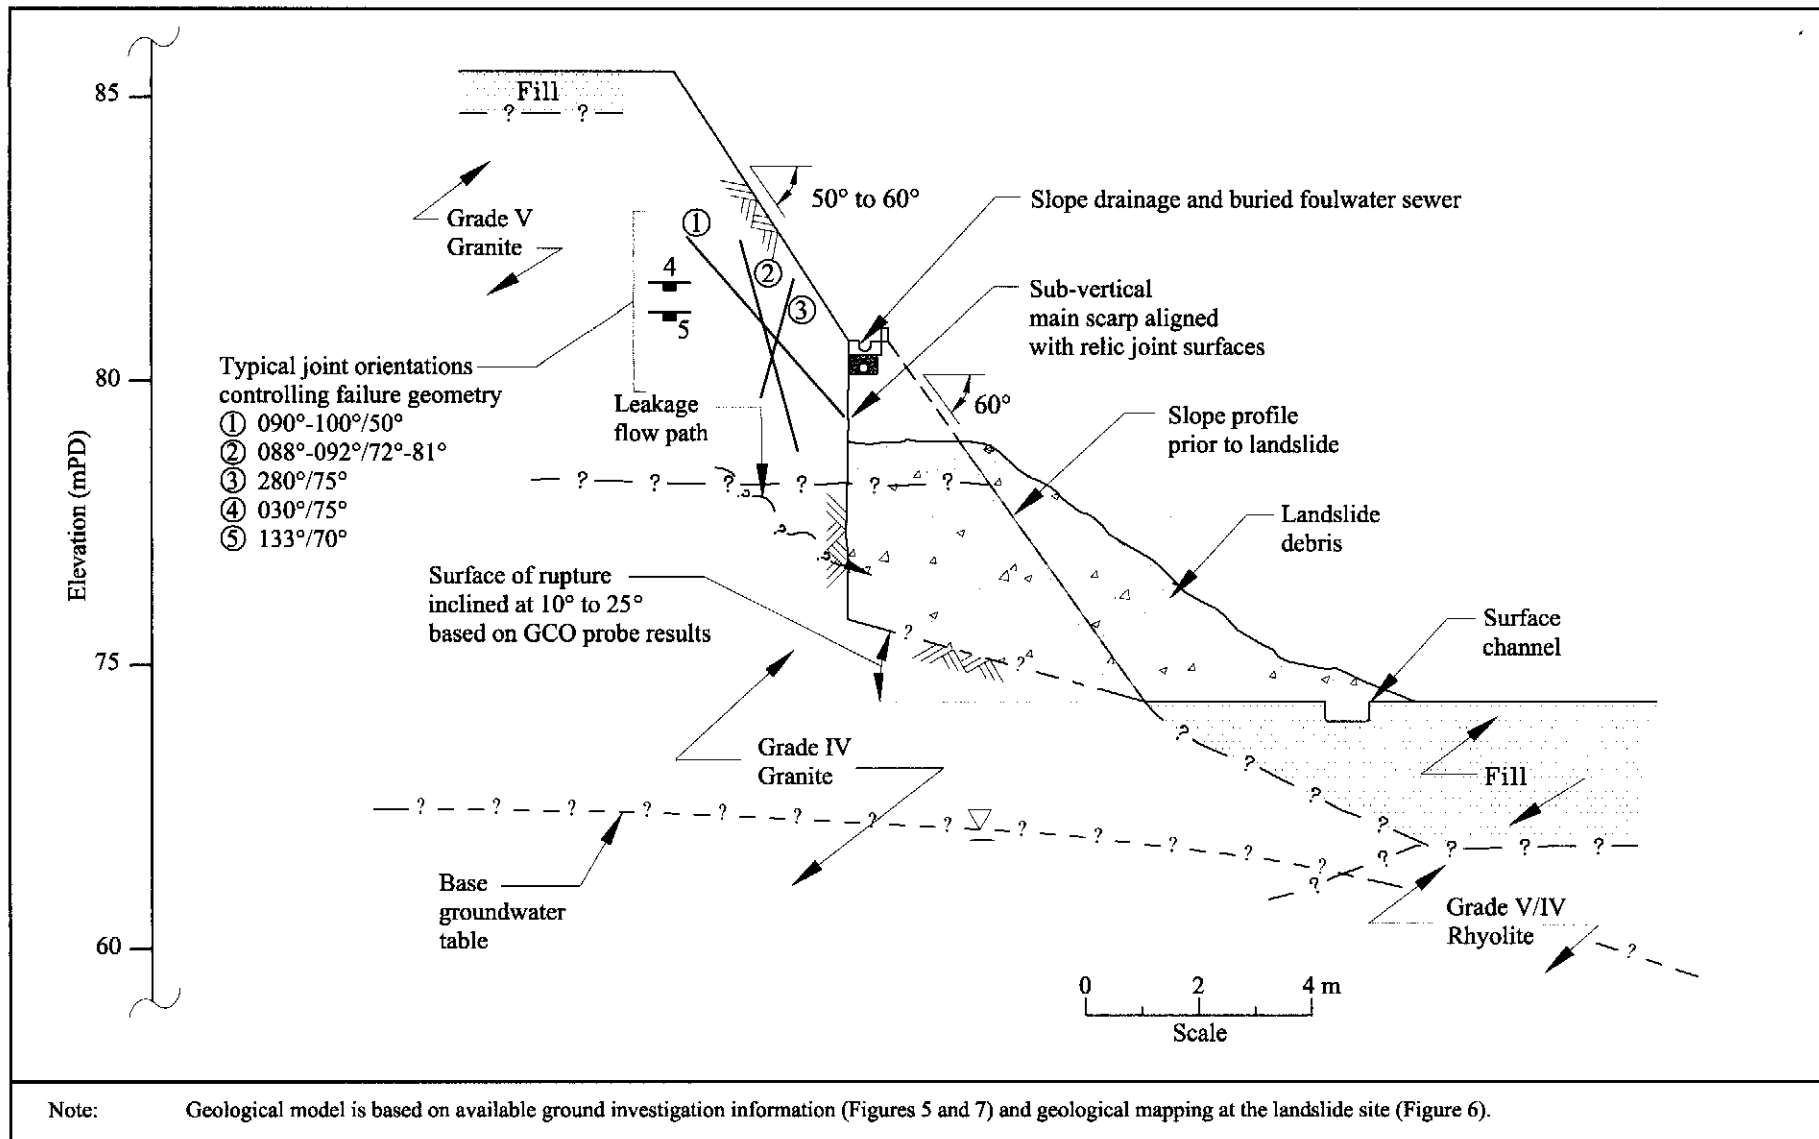
Figure 8 - Geological Model

A geological model of the landslide site, constructed from the available ground investigation information, is presented in Figure 8.

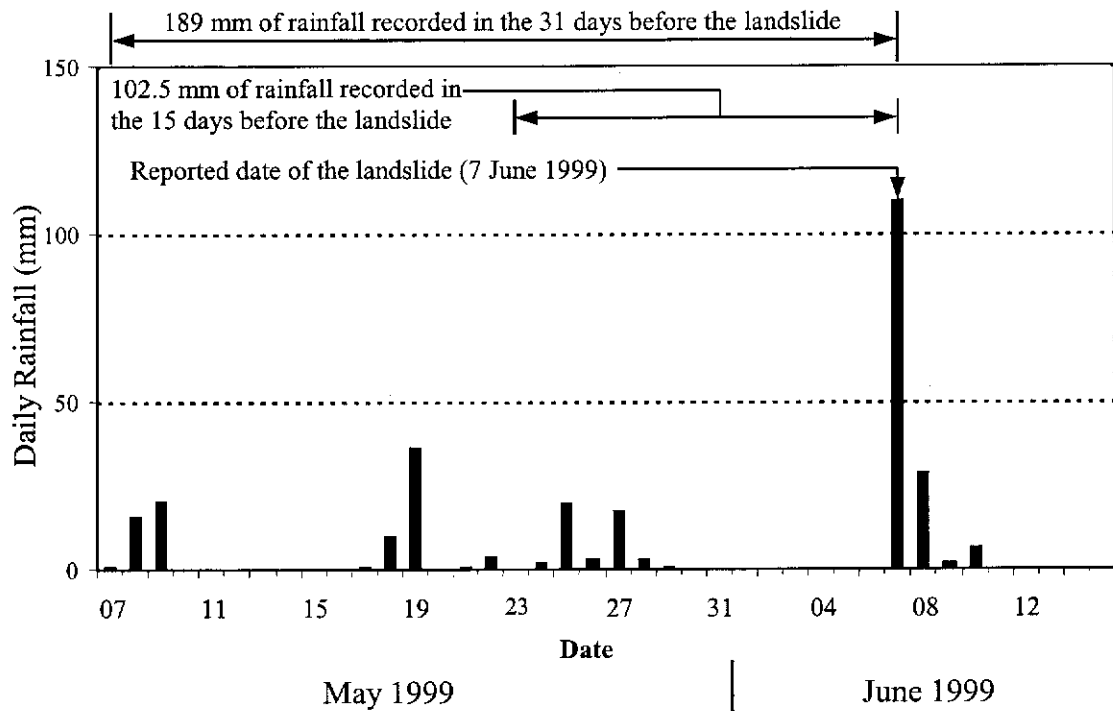
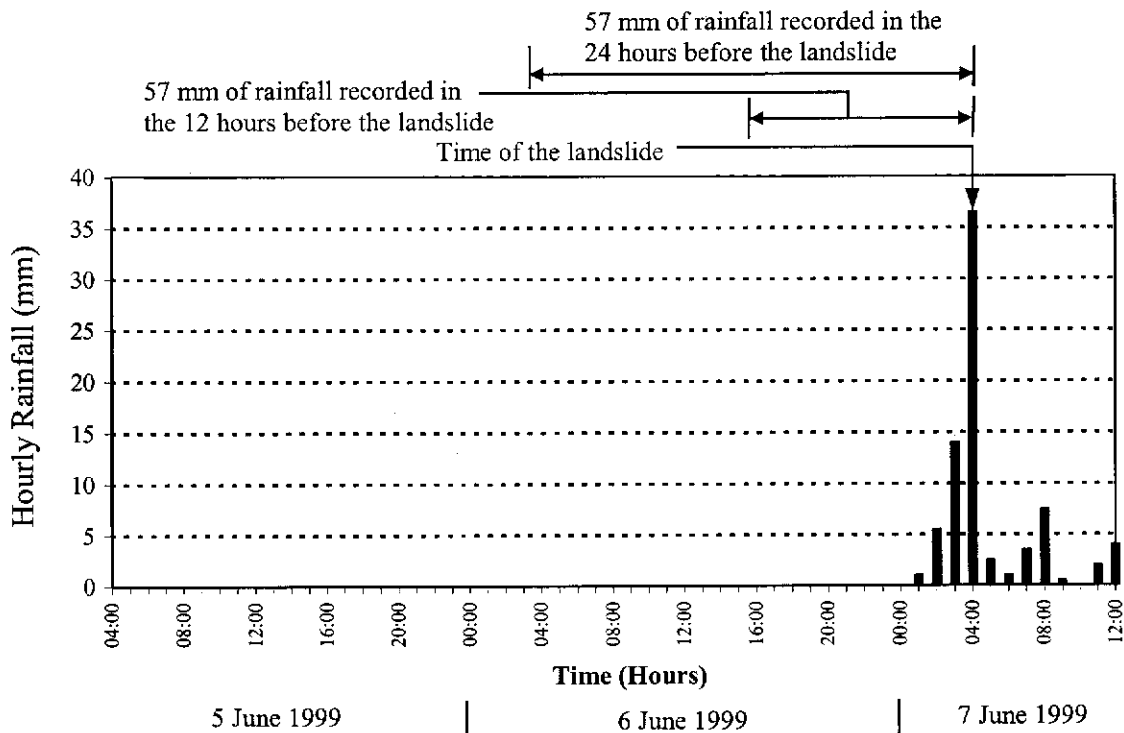
Figure 9 - Rainfall Recorded at GEO Raingauge No. N09

Daily rainfall for one month preceding and seven days following the reporting of the landslide, together with hourly rainfall for 48 hours before and 8 hours following the time of reporting, are given in Figure 9.

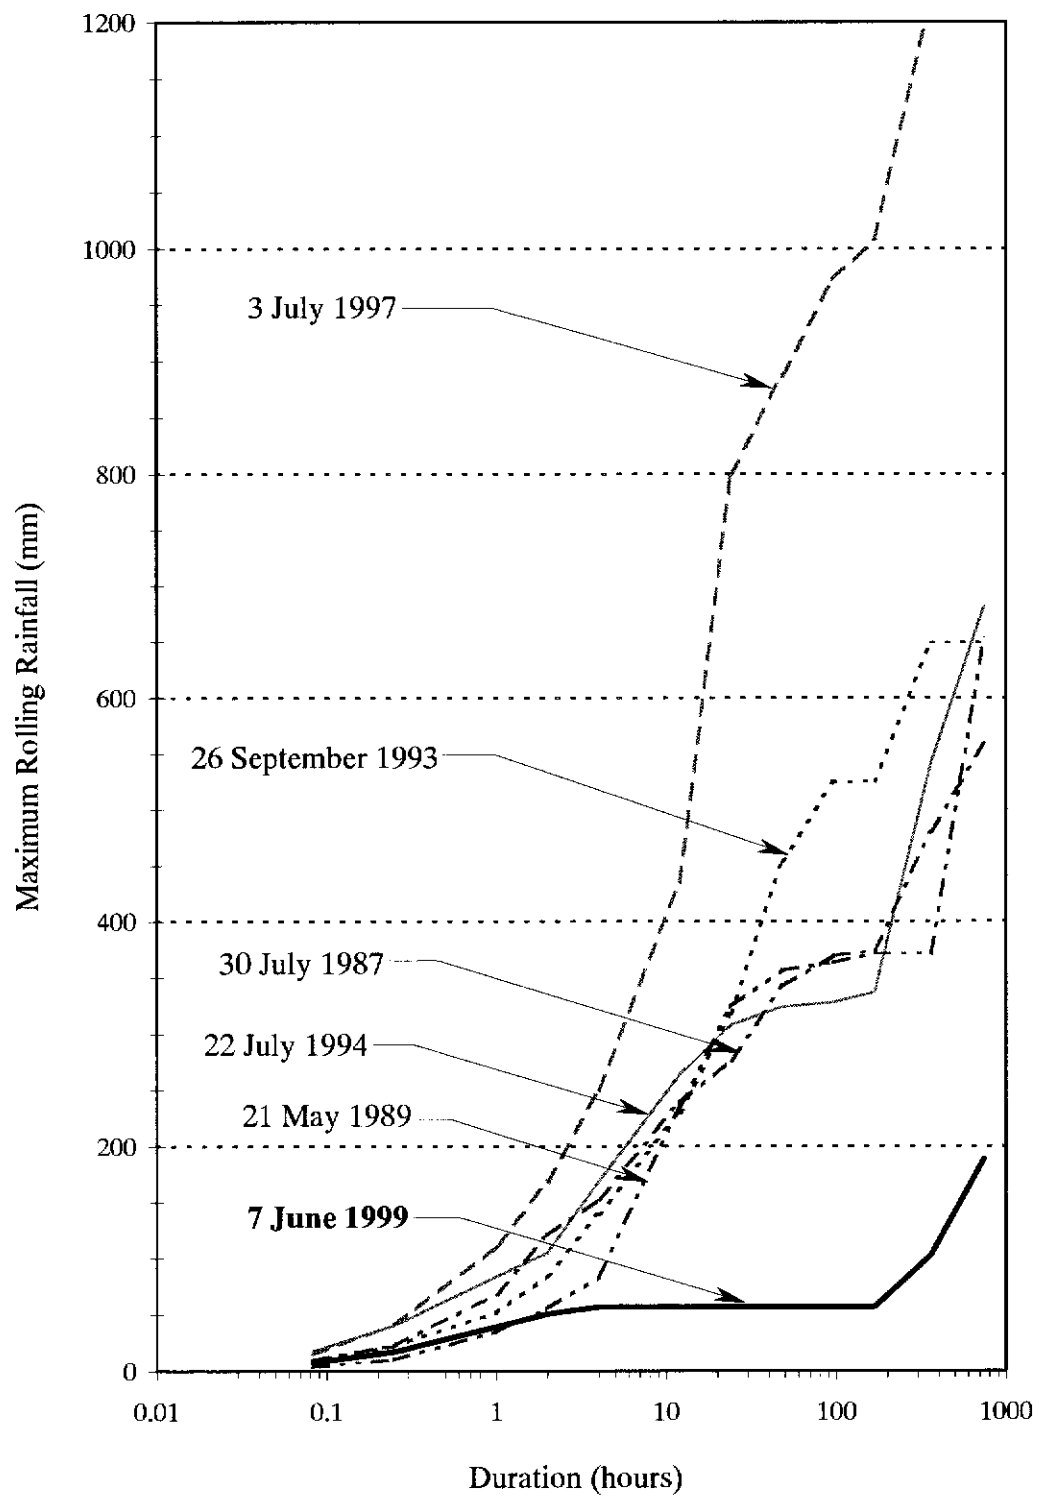
Figure 10 - Maximum Rolling Rainfall Preceding the Landslide of 7 June 1999 and Selected Major Rainstorms Recorded at GEO Raingauge No. N09

Table 3 presents the estimated return period for the maximum rolling rainfall for various durations based on historical rainfall data at the Hong Kong Observatory (Lam & Leung, 1994). A return period of less than two years is indicated for duration ranging from 5 minutes to 31 days. A comparison of the severity of the June 1999 rainstorm and past major rainstorms is presented in Figure 10. This shows that a number of substantially more severe rainstorms have been previously experienced at the site.

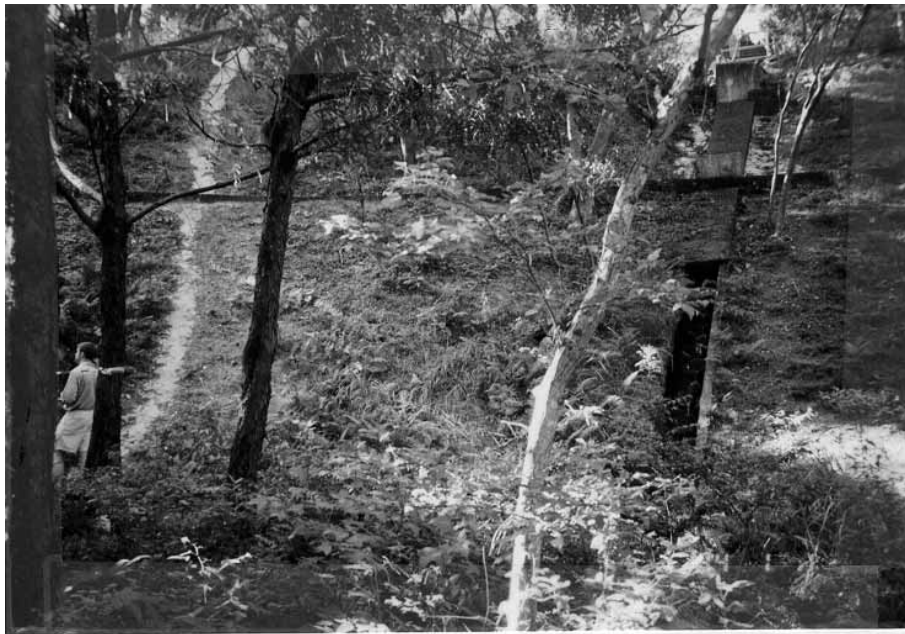
Plate 3 – View North across Eastern Portion of Slope Indicating Flatter Geometry (30°), Vegetation Cover and Surface Drainage (Photograph Taken on 10 June 1999)

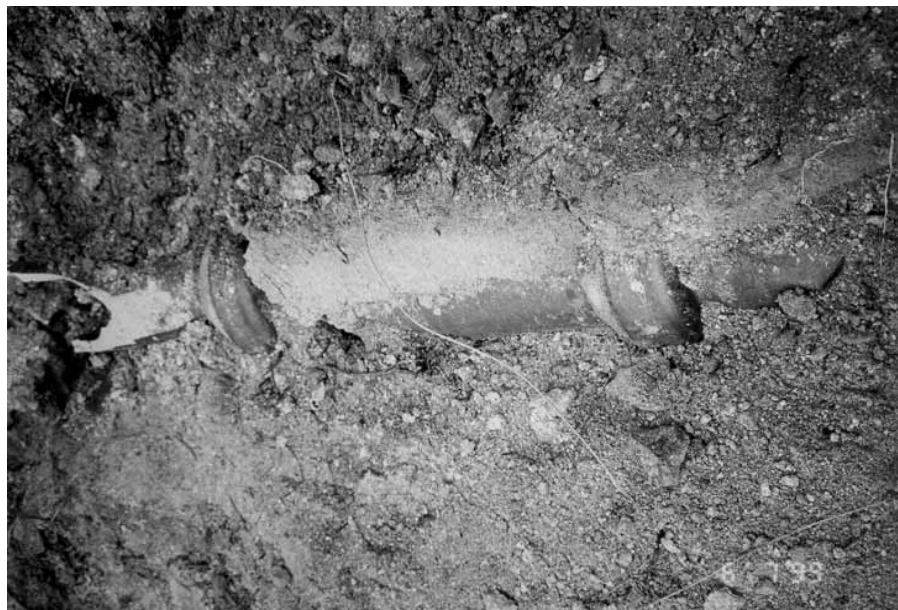
Plate 10 – Intact Length of Foulwater Sewer in Landslide Debris (Photograph Taken on 6 July 1999)

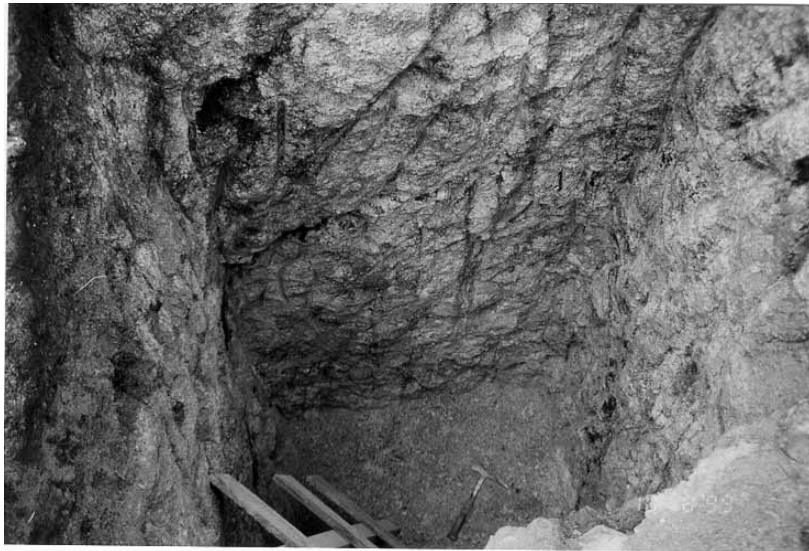
Jointing exposed in trial pits was often infilled with manganese oxide up to 2 mm in thickness and a number of quartz veins were observed, also with manganese oxide present (Plates 20, 21 & 23). Kaolin was also present as joint infill material, although not to the same extent as observed in the landslide scar. Joint infill surfaces were often slickensided and a further indication of past movement encountered in trial pit TP2 where about 200 mm of vertical displacement was indicated across a sub-horizontal quartz vein (Plate 23).

Plate 20 – Trial Pit TP1: Grade IV/V Weathering Profile Exposed in Pit. Note Staining on Relic Joints and Dark Brown/Black Manganese Oxide Deposits (Photograph Taken on 8 October 1999)

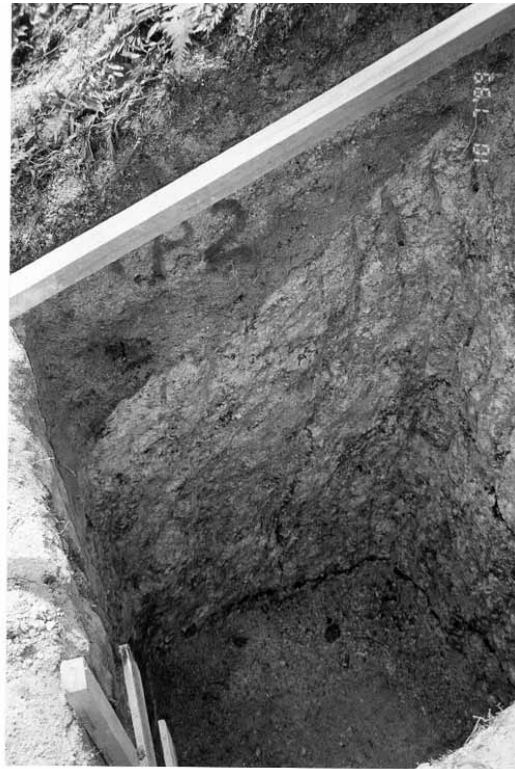
Plate 21 – Trial Pit TP2: Western Face of Pit Exposing Fill Overlying Insitu Ground Profile (Photograph Taken on 7 October 1999)

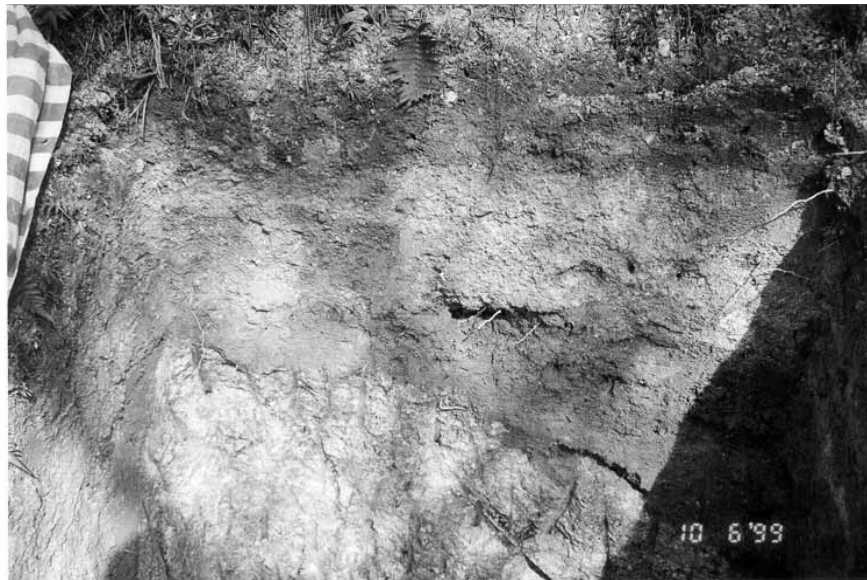
Plate 22 – Trial Pit TP2: Northern Face of Pit Exposing Fill Overlying Insitu Ground Profile. Note Interface Sloping to East. (Photograph Taken on 6 October 1999)

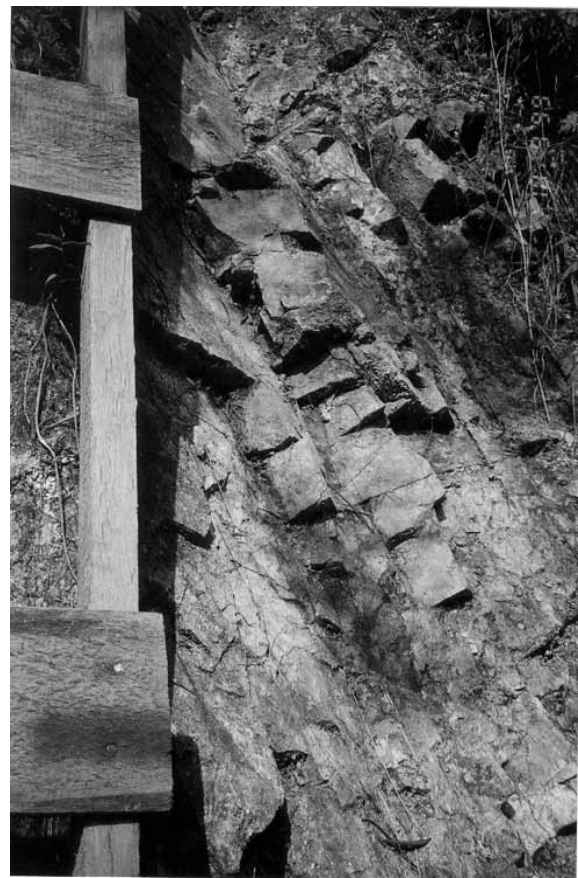
polishing and slickensiding of exposed joint surfaces, with slickensides typically plunging parallel to the joint dip direction. Jointing of similar orientations to those observed in the scar was also exposed in the surface strip to the south (Plate 26), as well as a joint set dipping into the slope ($270^{\circ}/35^{\circ}$).

Plate 26 – Strip SS1: Joint Surfaces Exposed in Grade III Outcrop (Photograph Taken on 9 October 1999)
