**SECTION 2:
DETAILED STUDY OF THE
LANDSLIDE ON SLOPE
No. 11NW-A/FR84
BELOW CASTLE PEAK ROAD
NEAR KAU WAH KENG
VILLAGE**

**This report was originally produced in October 2001
as GEO Landslide Study Report No. LSR 10/2001**

This report presents the findings of a detailed study of the landslide (GEO Incident No. MW 2000/01/07) on slope No. 11NW-A/FR84 above Kau Wah Keng Village, below Castle Peak Road, Kwai Chung, which was reported on 14 January 2000. Debris from the failure was transported along the natural stream course leading to the Kau Wah Keng Village. There were no casualties as a result of the slope failure.

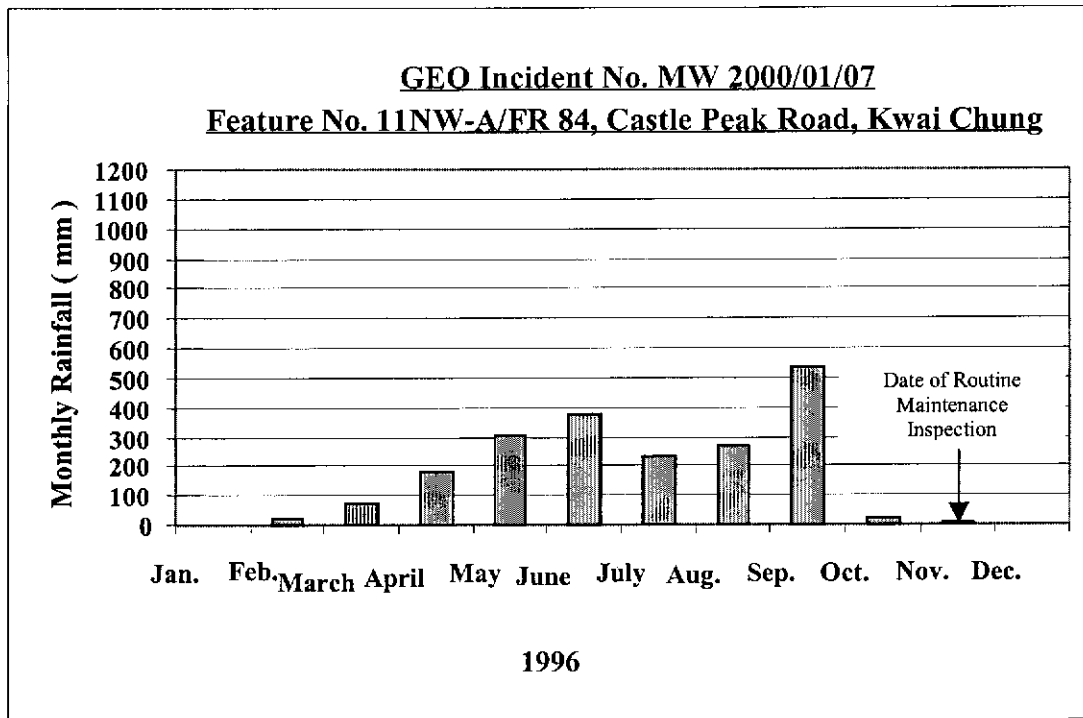
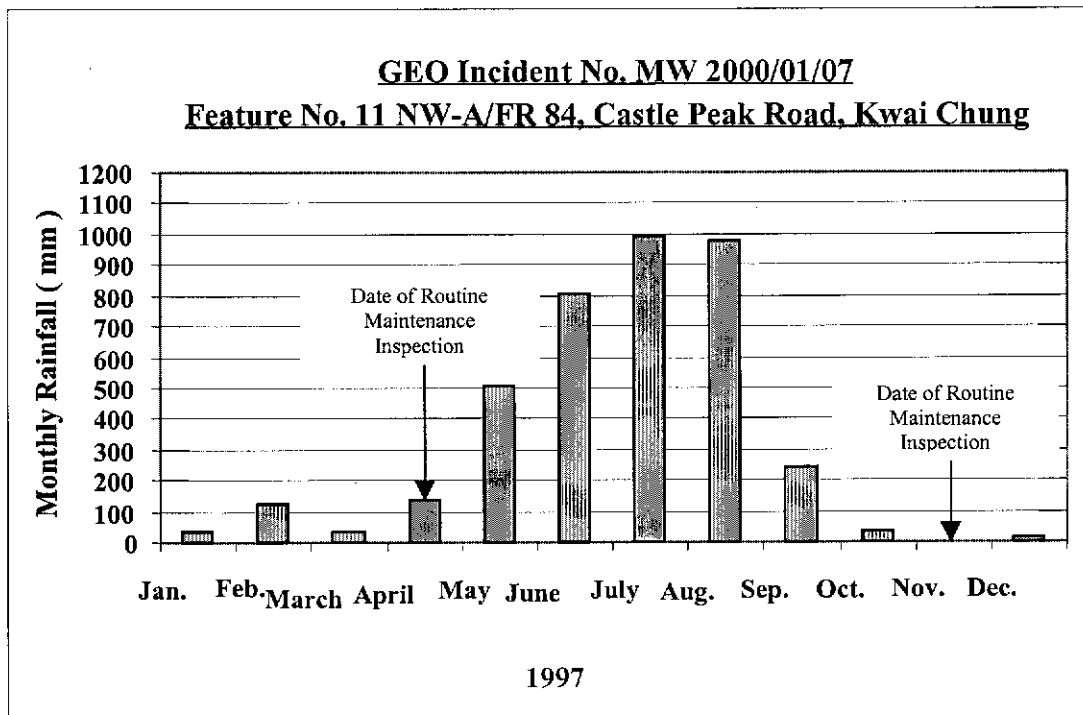
Figure 11 – Rainfall Records at Raingauge N04 for 1996 and 1997

It can be seen from Figure 11 that at the time of RMI in 1996, there had been little rainfall in the area for more than a month before the inspection. Accordingly, the significant discharge from the overflow pipe observed in the upper batter of the slope and wet slope surface in the lower batter were unlikely to have been the result of surface infiltration from rainfall. Also, based on previous groundwater monitoring data this is unlikely to have been due to a rise in the main groundwater table. This suggests that the probable source of water observed in the 1996 RMI was leakage from the watermain.

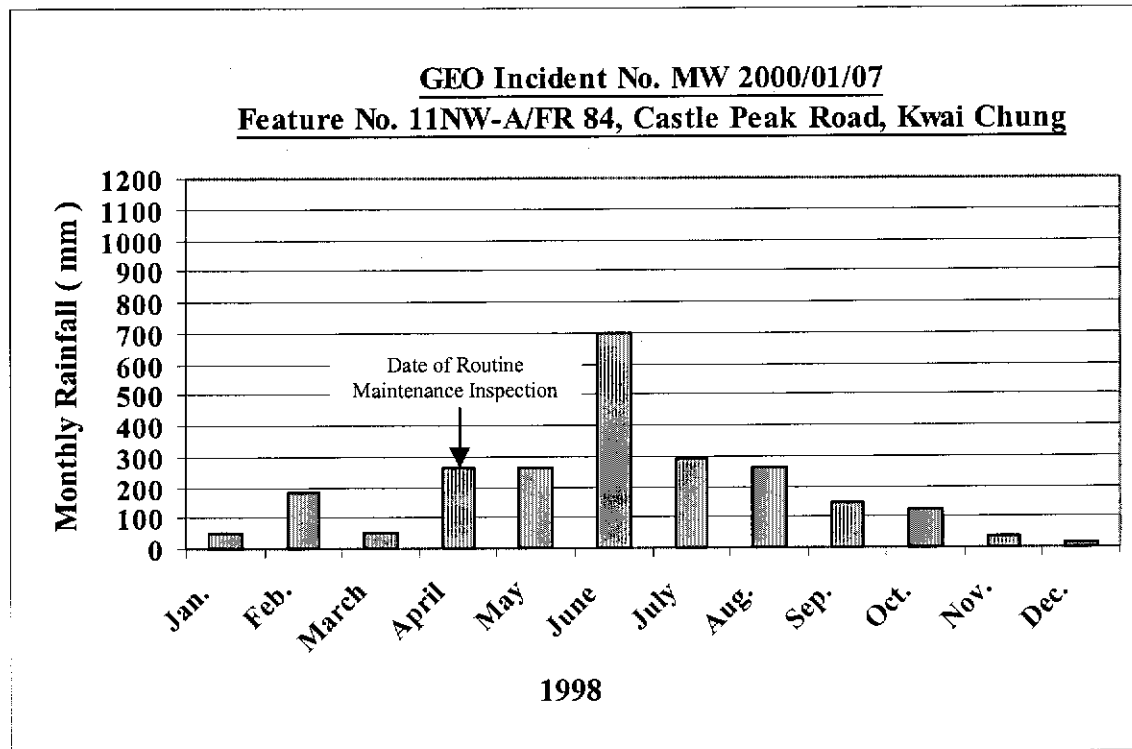
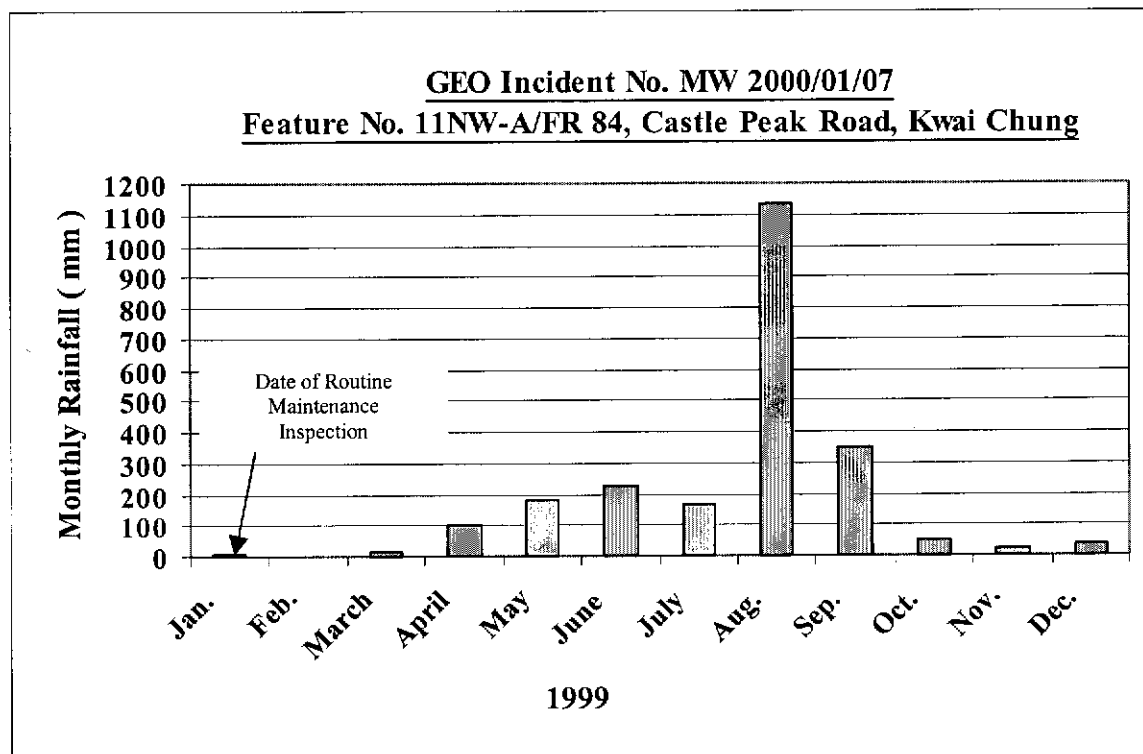
Figure 12 – Rainfall Records at Raingauge N04 for 1998 and 1999

The monthly rainfall plots for the remaining years (Figures 11 and 12), show heavy rainfall between the months of June and August ranging from a minimum of 700 mm in June 1998 to a maximum of about 1150 mm in August 1999.

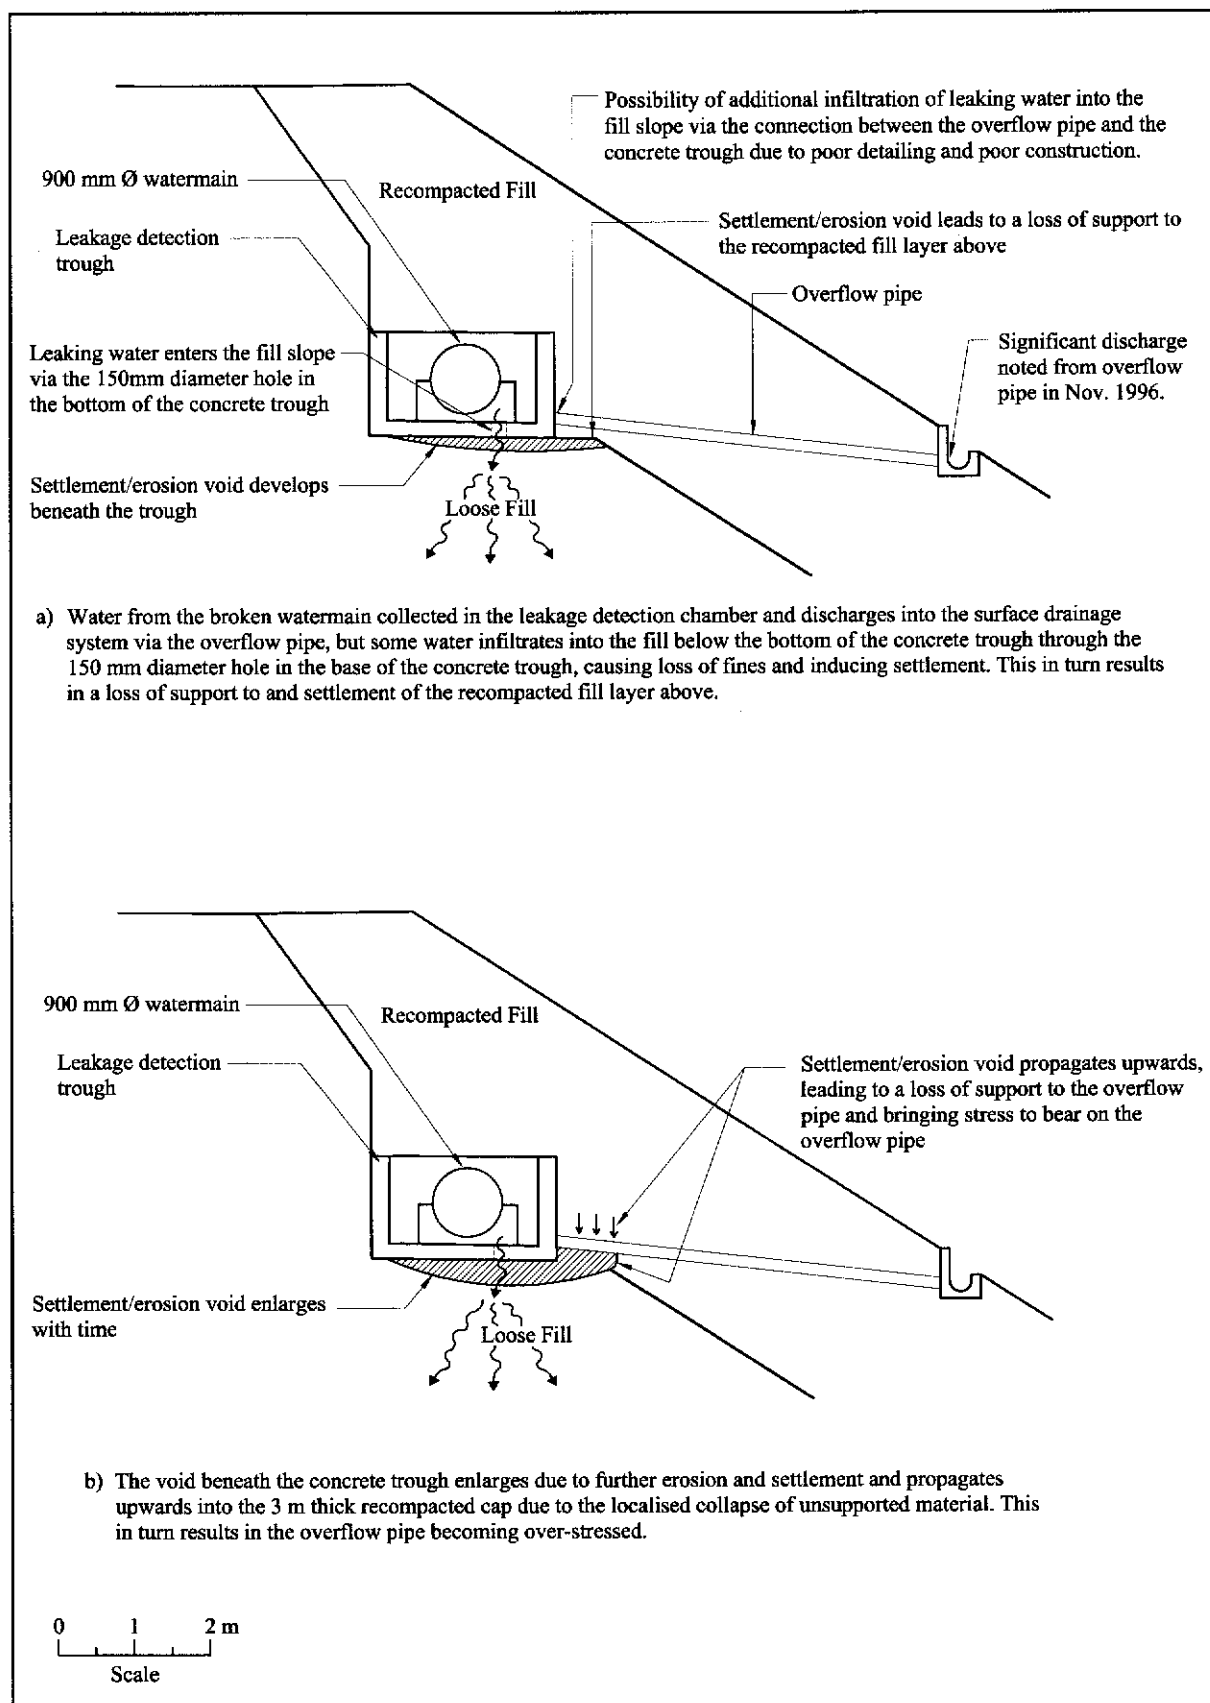
Figure 13 - Schematic Diagrams Showing Possible Sequence of Events Leading to Slope Failure (Sheet 1 of 3)

considered that over time the constant flow of water from the leaking main led to a degree of settlement below the trough (Figure 13 (a)).

The settlement-induced void in the loose fill layer would have led to a loss of support to the overlying material, causing the void to propagate upwards into the 3 m thick recompacted fill layer through the localised collapse of unsupported material. The lack of support to the recompacted fill layer would eventually bring to bear increased stresses onto the overflow pipe connecting to the leakage detection trough as the internal void enlarged (Figure 13 (b)). The additional stresses would cause the pipe joints and connections to open and allow more water to leak into the body of the fill slope, thereby speeding up the settlement and erosion processes (Figure 13 (c)).

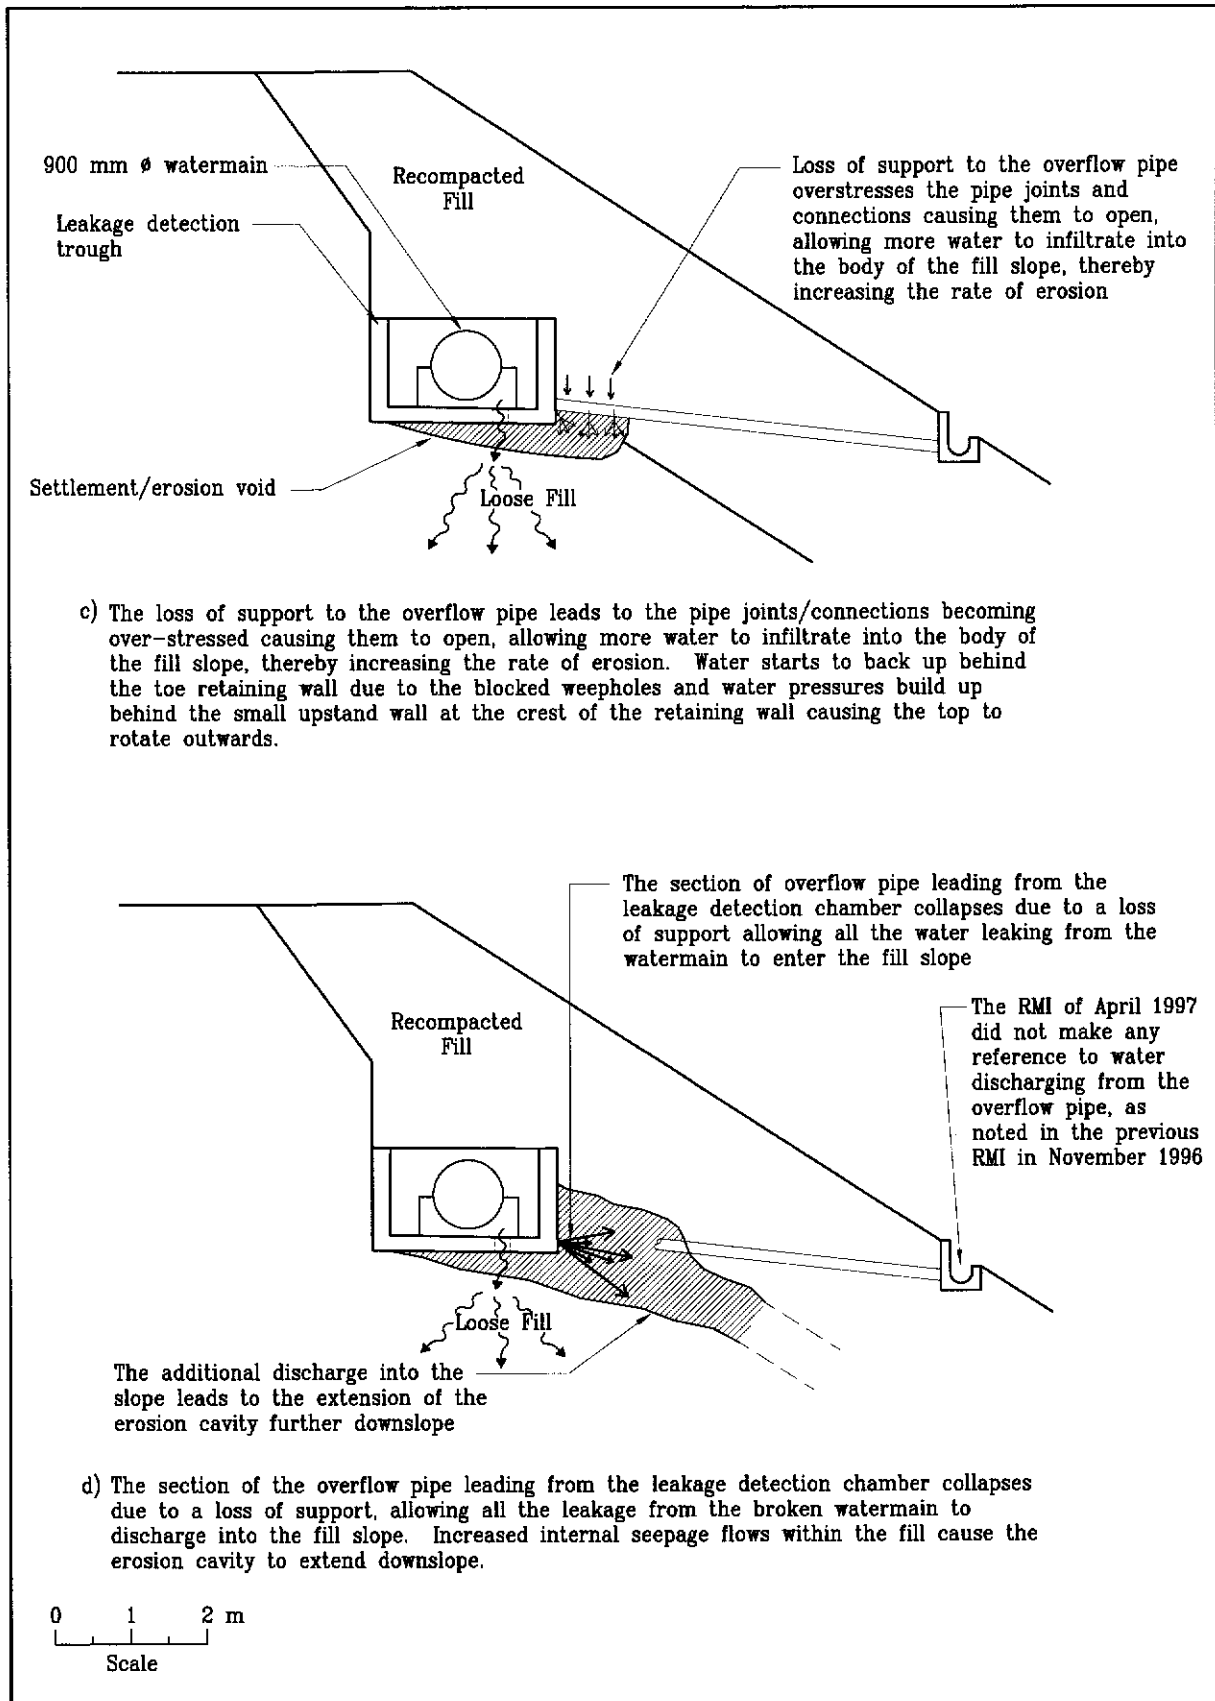
Figure 13 - Schematic Diagrams Showing Possible Sequence of Events Leading to Slope Failure (Sheet 2 of 3)

Based on post-failure observations by FMSW of poor workmanship during construction to the connection between the overflow pipe and the leakage detection trough, it is unlikely that the connection between the two was watertight (Section 3.2), thereby providing another outlet for leaking water to infiltrate into the fill slope. Furthermore, the poor detailing of the connection between the overflow pipe and the leakage detection trough (Section 2.6) may have led to a concentration of stresses at this 'weak' connection and caused the eventual detachment of the overflow pipe from the leakage detection trough (Figure 13 (d)). Based on the RMI undertaken by HyD, it is considered probable that this occurred sometime between November 1996 and April 1997, because the significant water flow noted in the November 1996 inspection was not referred to in the April 1997 inspection report. However, the WSD have doubts as to the validity of this postulation because this would mean that the watermain had been leaking for a prolonged period of time. This postulation apparently contradicts WSD's observations made of the pipe crack following the 2000 incident and information from the leakage detection test carried out by WSD's consultant on the watermain on 25 March 1999 (Section 7).

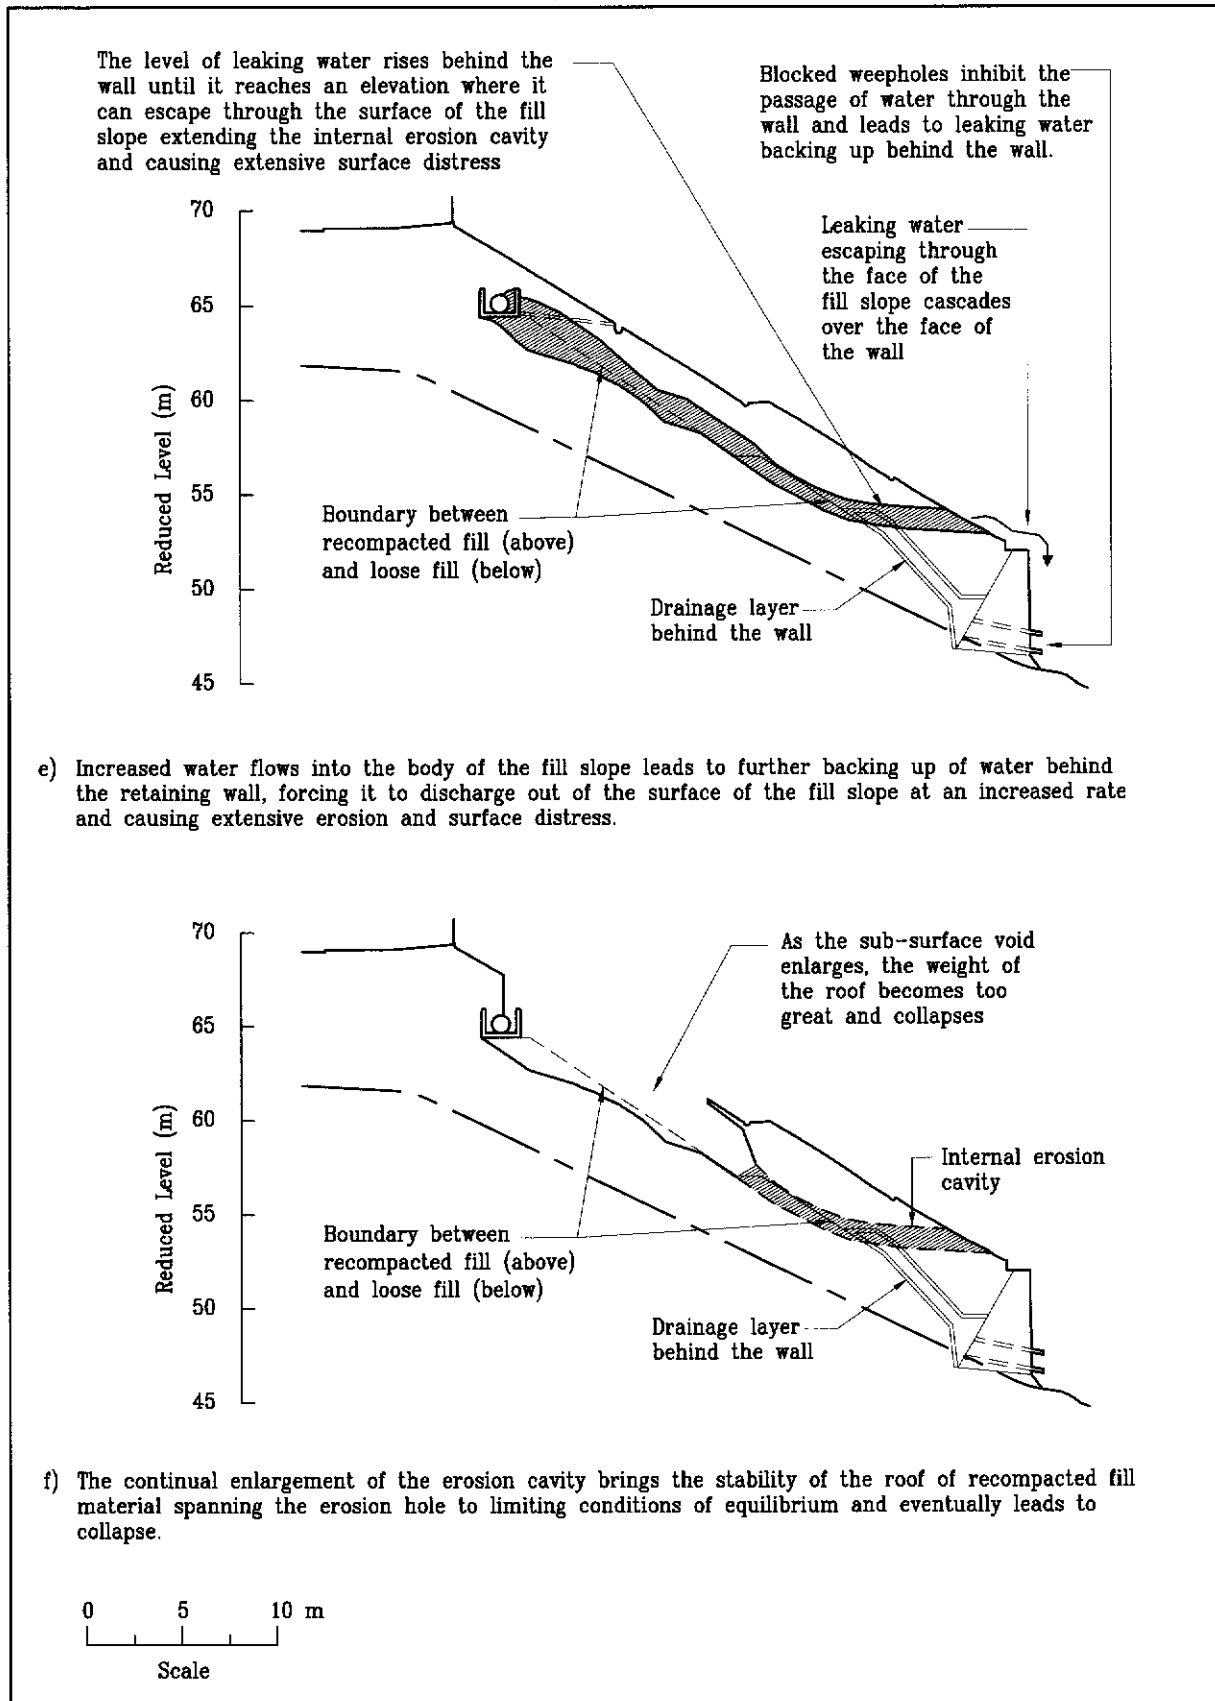
Figure 13 - Schematic Diagrams Showing Possible Sequence of Events Leading to Slope Failure (Sheet 3 of 3)

Following the collapse of the overflow pipe, all water leaking from the main would have entered the body of the fill slope. A photograph taken on 15 January 2000 by the WSD, following the identification of the failed slope, shows water cascading out of the hole in the concrete trough where the overflow pipe used to connect (Plate 6). This constant, preferential sub-surface flow probably resulted in an increased rate of internal erosion and the development of erosion cavities and further surface distress at the toe of the fill slope (Figure 13 (e)).

conditions of equilibrium and eventually collapsed (Figure 13 (f)). The exact date at which the underground cavity collapsed is unknown, but from desk study records and API, it occurred sometime between July 1999 and December 1999. Therefore, internal erosion of the slope may have been ongoing for over two years.
