# **REVIEW OF 1999 LANDSLIDES**

**GEO REPORT No. 127**

**K.K.S. Ho, H.W. Chan & T.M. Lam**

This report presents the findings of a detailed review of landslides that occurred in 1999. It serves to review the performance of Government's slope safety system and identify improvement to current slope engineering practice in Hong Kong.

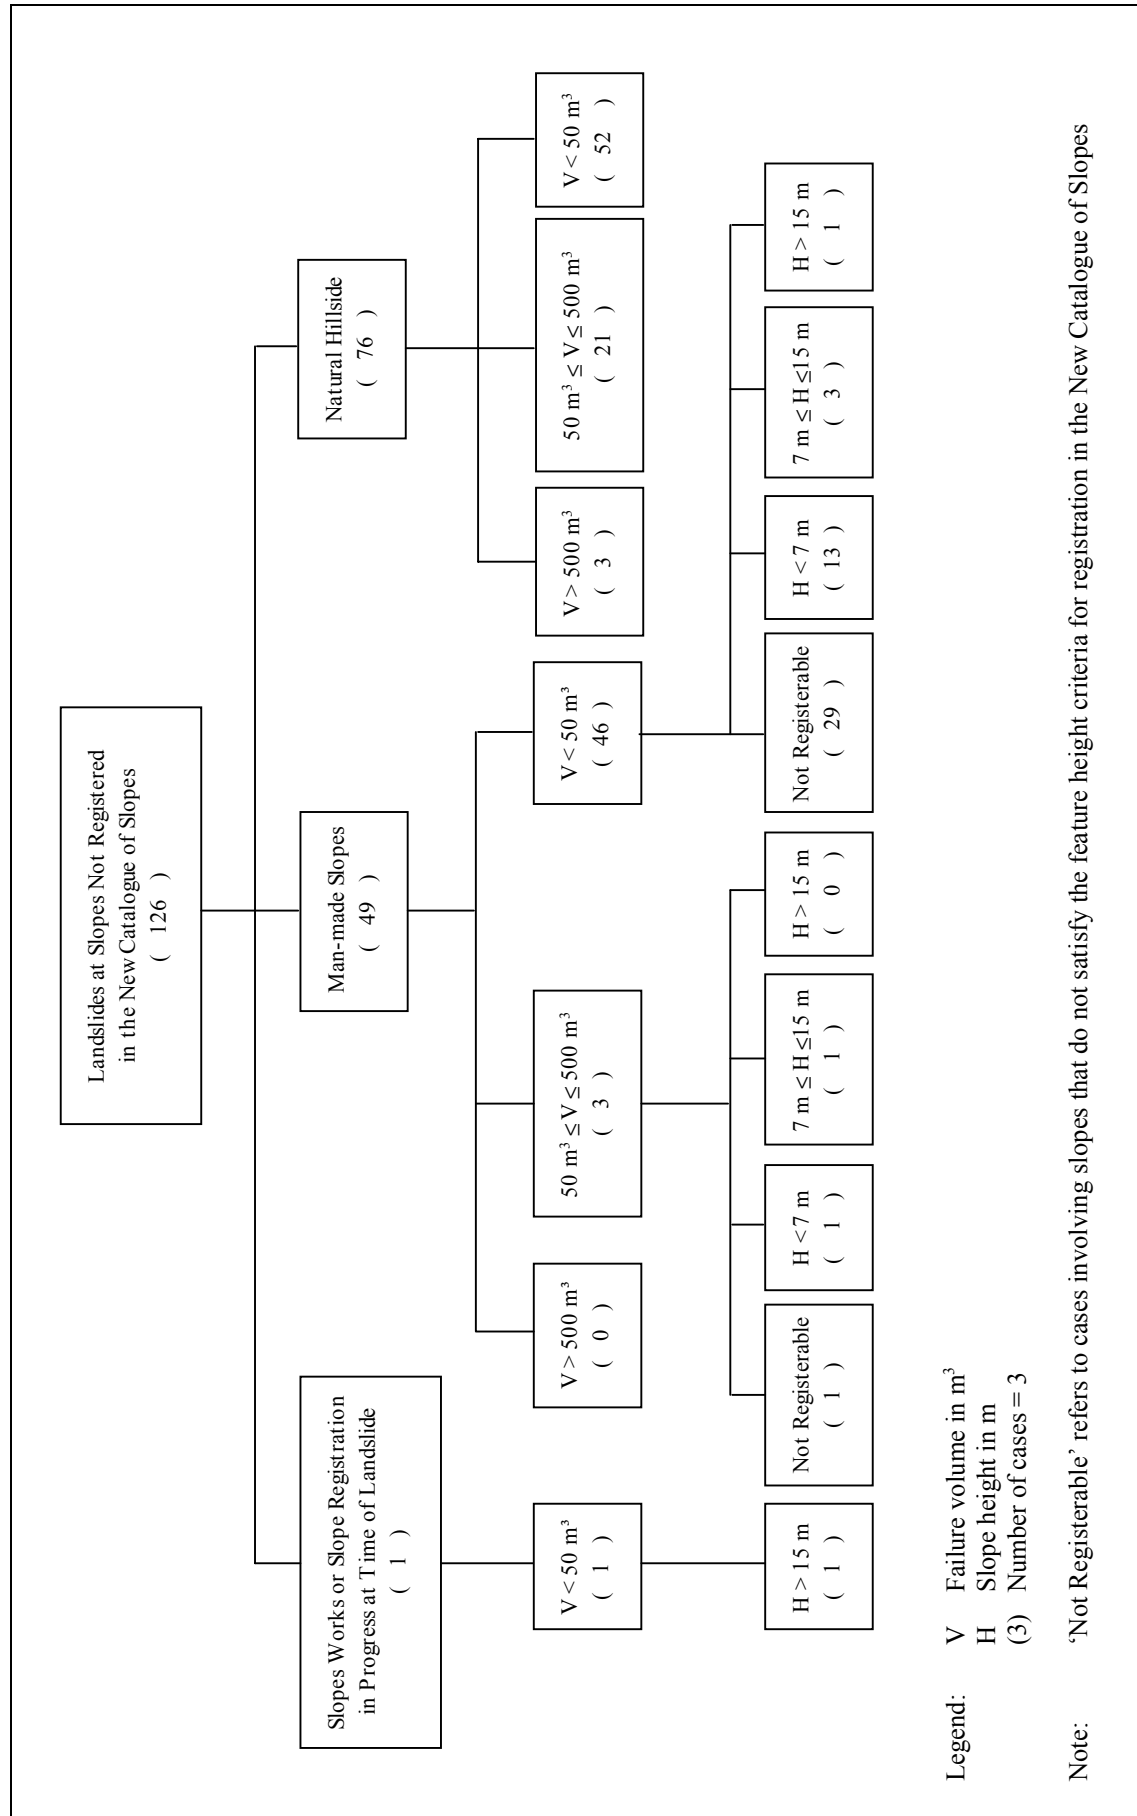
Figure 1 - Breakdown of Landslides at Unregistered Slopes in 1999

one incident that involved an active construction site) of the landslide incidents occurred on unregistered slope features at the time of their failure. A breakdown of these incidents is given in Figure 1.

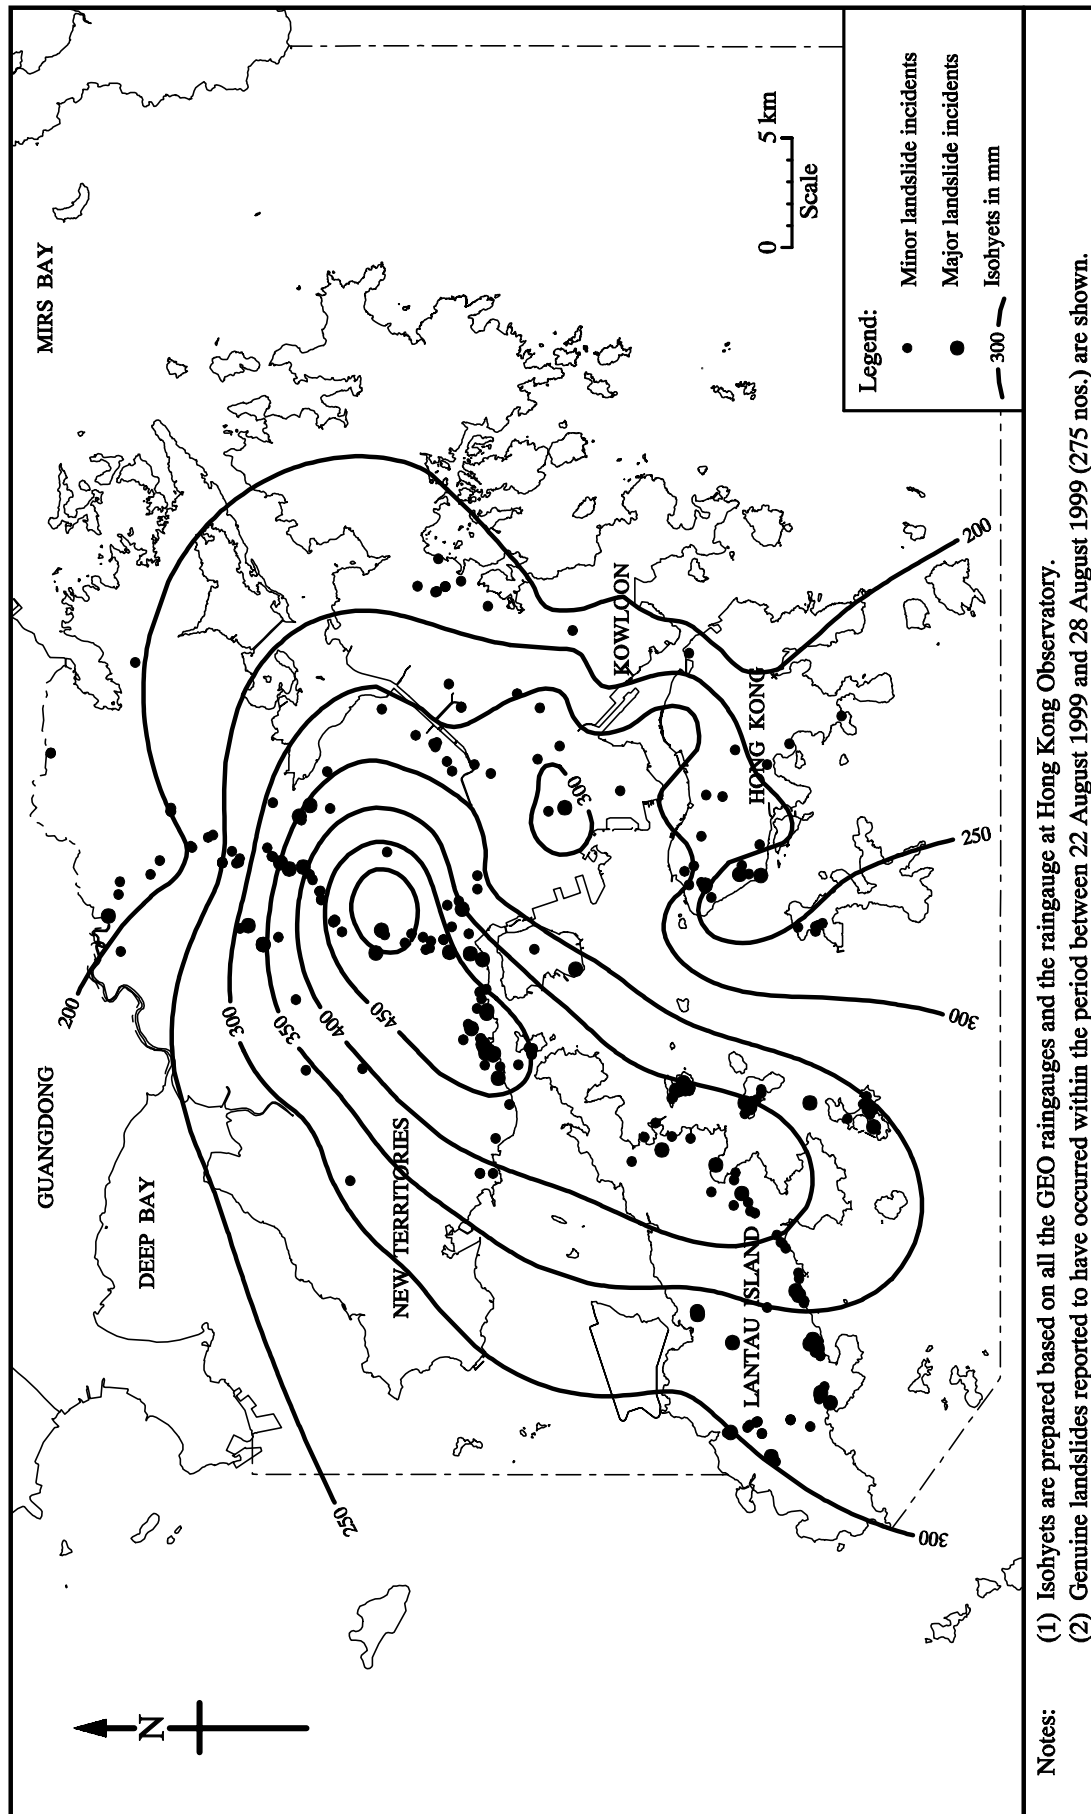
Figure A3 - Maximum Rolling 24-hour Rainfall Distribution for the Period between 00:00 22 August 1999 and 23:55 26 August 1999 and Locations of Landslides

There were 20 significant rainstorms (defined as those in which the rolling 24-hour rainfall exceeded 50 mm anywhere in Hong Kong) during 1999. Of these, two caused the Landslip Warning to be issued. Table A1 provides details of these events. Figures A3 and A4 show isohyets of the maximum rolling 24-hour rainfall during these two storms, with the locations of associated landslides.
